1981

**Study of Blue Route Bridge
Defects and Structural Response**

**AN ASSESSMENT OF THE BLUE ROUTE
BRIDGE ELECTROSLAG WELDMENTS**

**December 1981
Report No. 457-1 (81)**

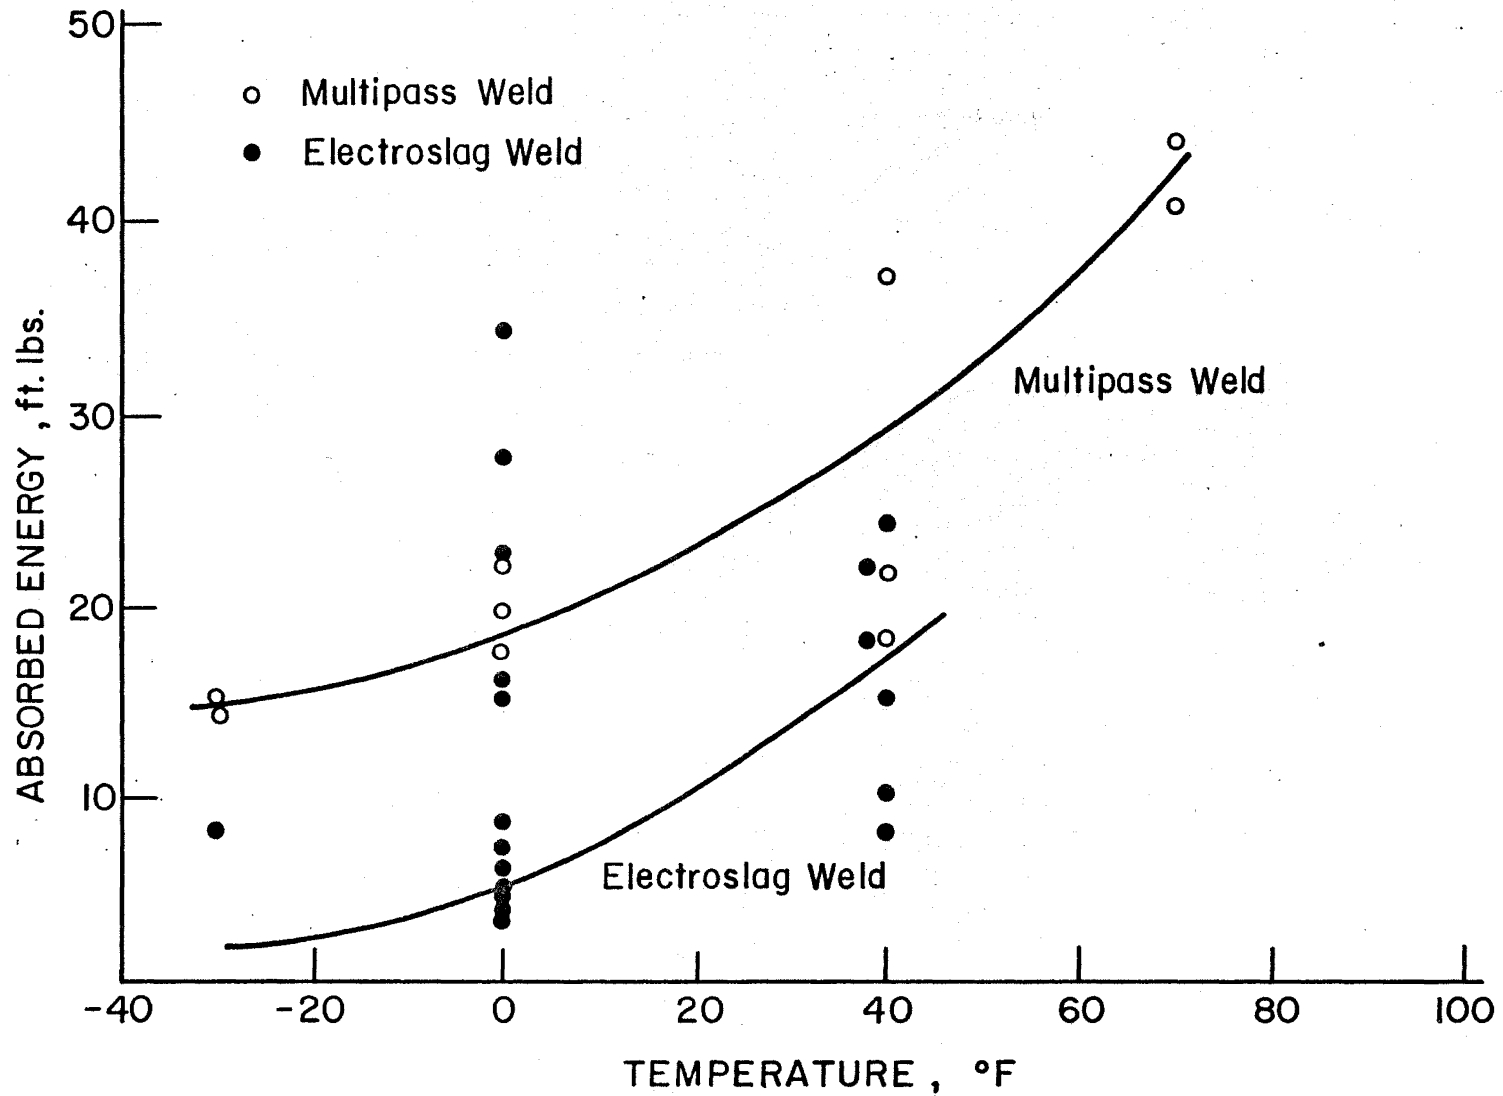
Fig. 26 CVN Absorbed Energy vs. Temperature

The Charpy V-notch specimens were all notched at the centerline of the welds. The results of these additional tests are summarized in Table 6. All of the Charpy V-notch tests summarized in Tables 5 and 6 are plotted in Fig. 26. It is readily apparent that the electroslag weldments had much lower levels of absorbed energy than the the multiple pass submerged arc weld. The electroslag welds exhibited more scatter in the test data.

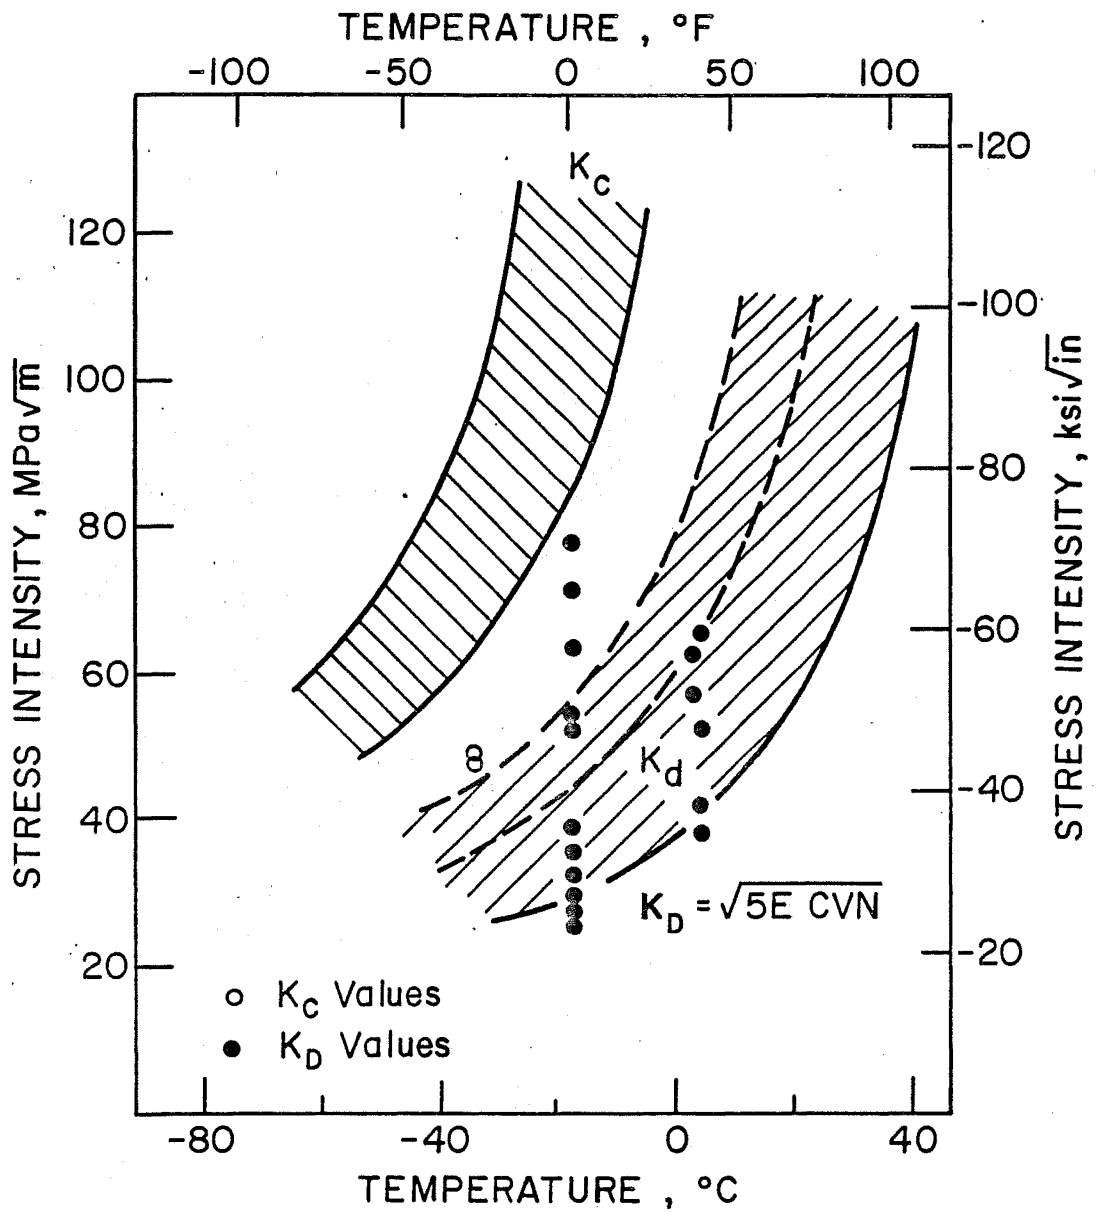
Fig. 27 Comparison of Fracture Toughness Estimates from Charpy V-Notch Data with Available K Data from Electroslag Welds

The results of this transformation are plotted in Fig. 27 for the electroslag welds. The test points are compared with the range of fracture toughness reported in Refs. 4 and 5 for dynamic and static loading.

The results of the tests on Cores G5K and G6D indicate low fracture toughness at 0°F. Only two CVN tests were conducted on Core G1E at 0°F, with one high and one low value of absorbed energy being obtained. All tests on Core G6A were performed at 40°F. The electroslag weldments showed lower absorbed energy values than the submerged arc weldment as is evident in Fig. 26. The wide scatter in the data can be attributed to the variation in grain size and grain orientation with respect to the notch.

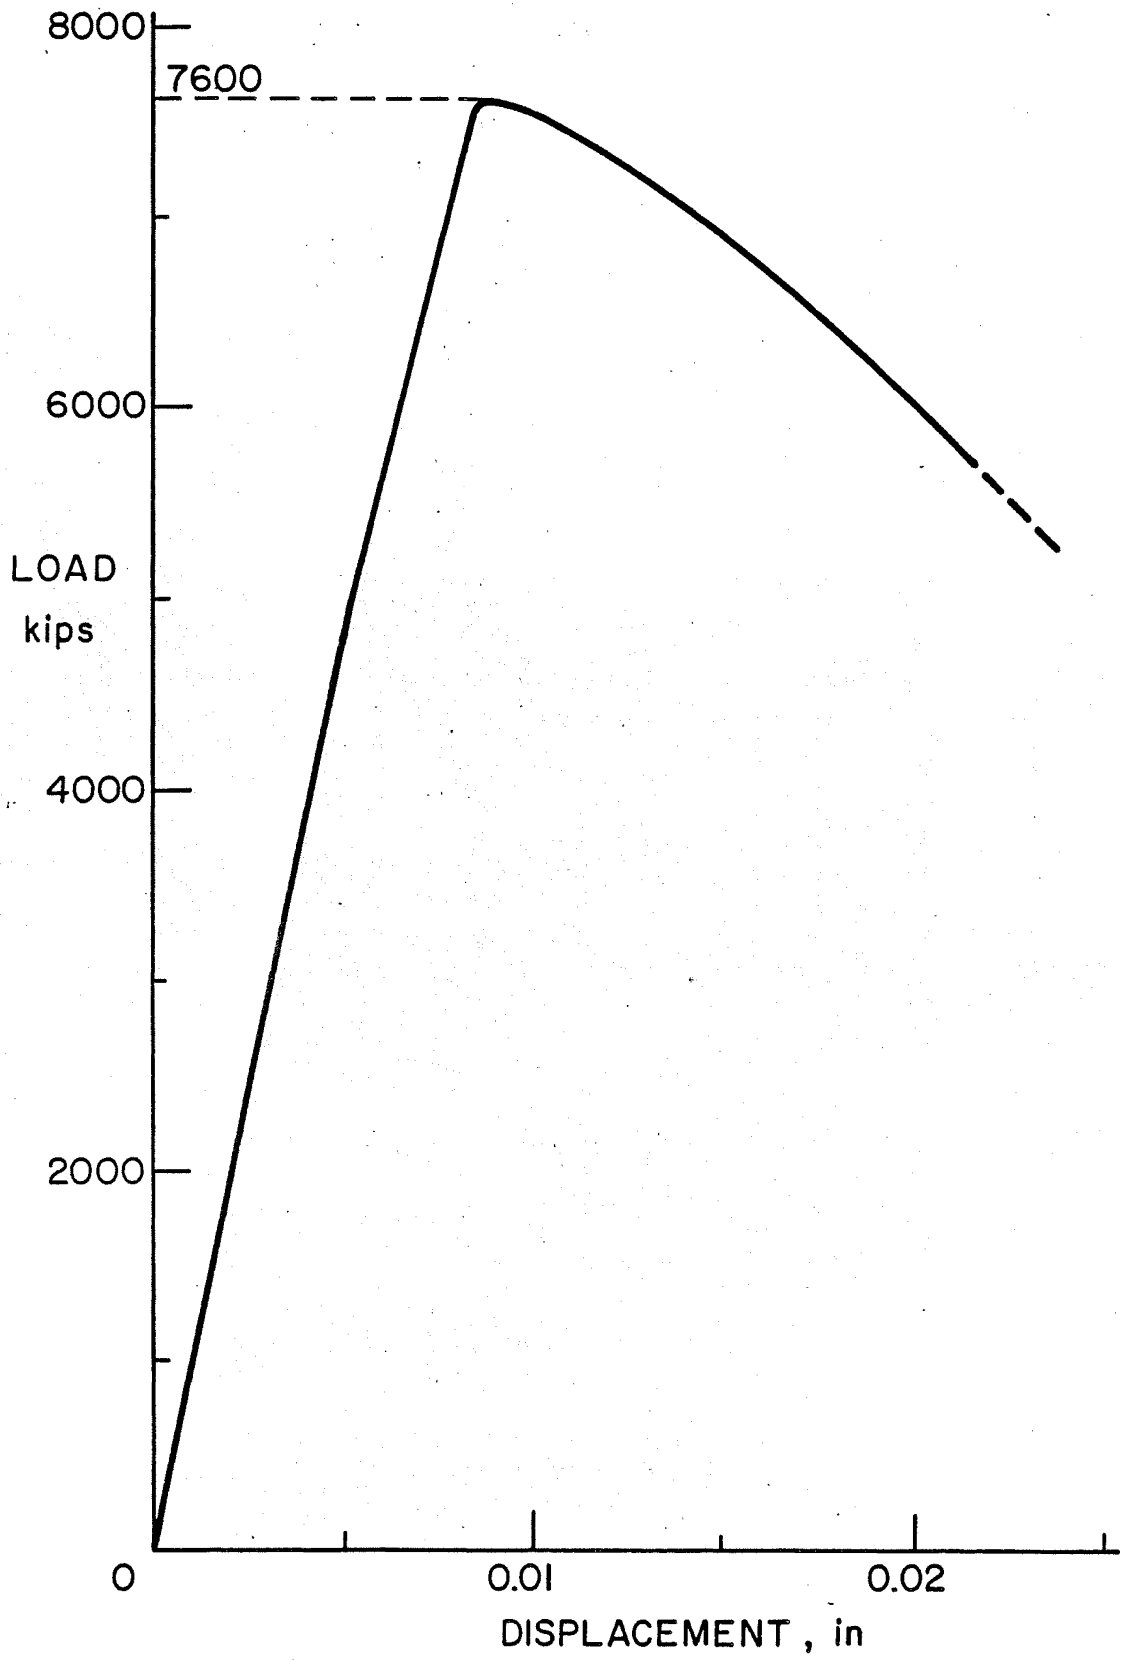
Fig. 28 Load-Deflection Curve for Compact Tension Specimen G6A

Two 1 in. thick compact tension tests were carried out on specimens fabricated from electroslog weld Cores G1E and G6A. Both tests were carried out at -30° F at a 1 sec. loading rate. Figure 28 shows the load-deflection curve for the specimen from core G6A. The K_{Ic} values obtained for 1 second loading rate were low, with values of 44.3 and 44 ksi $\sqrt{\text{in.}}$ for Cores G1E and G6A, respectively. These results are shown in Fig. 27 as the open dots. It can be seen that the 1 sec. loading rate level of fracture resistance is about equal to the upper bound dynamic fracture toughness at -30° F.

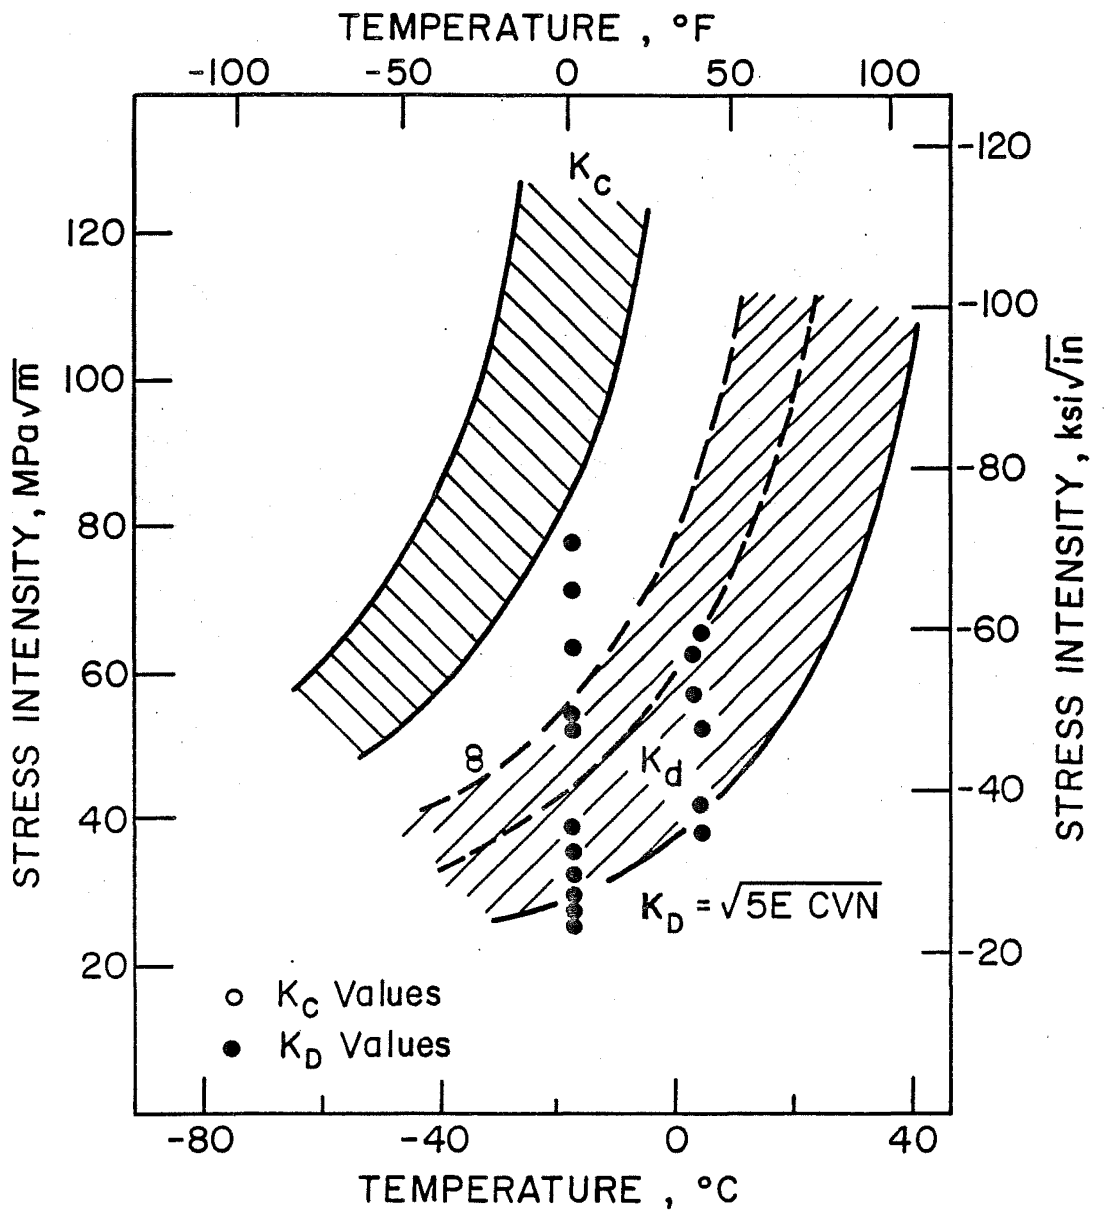
Fig. 29 Comparison of Fracture Toughness Estimates from Charpy V-Notch Data on Submerged Arc Weld G7A with Electroslag Weld Data

The Charpy V-notch data from submerged arc weld Core G7A are plotted in Fig. 29. It is apparent that the dynamic fracture toughness is near the upper bound of the electroslog weld scatter band.

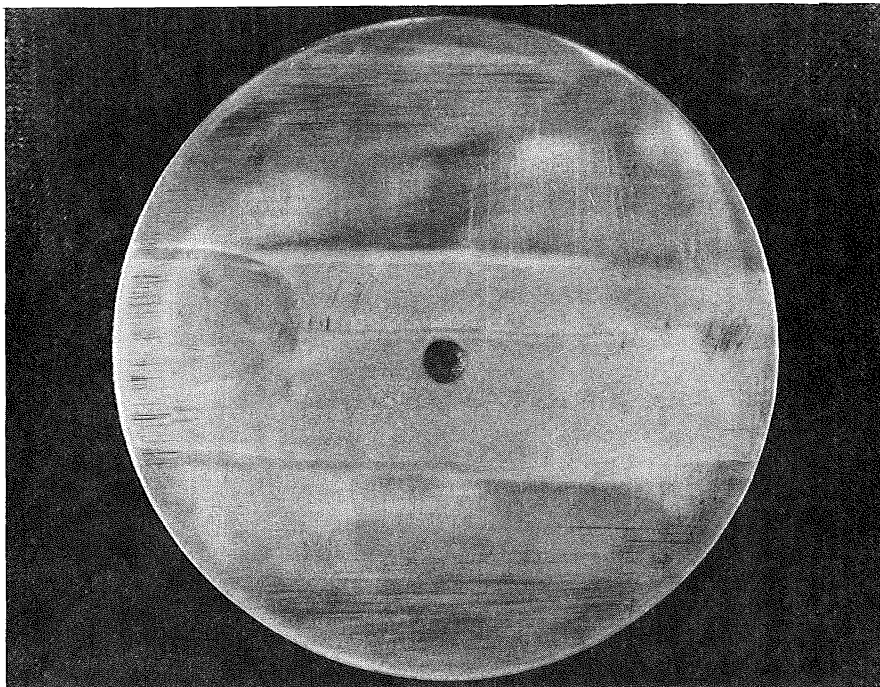
Fig. 31 Polished and Etched Surface of Core G7A

Cores G1E, G6A and G7A were also polished and etched to reveal the welds. The electroslag weldment from G1E (see Fig. 23) had substantial repair welds along the fusion lines as can be seen in Fig. 30. Figure 31 shows the multipass submerged arc weldment G7A with a repair weld near one end. Figure 32 shows the electroslag weldment from G6A. No defects were detected on the surfaces of any of these weldments.

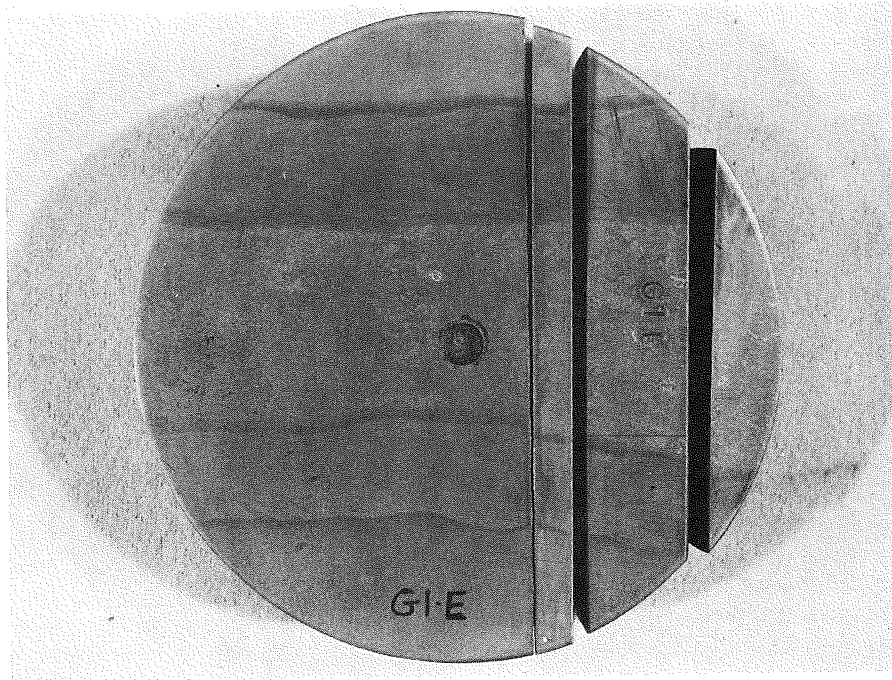
Fig. 33 Core G1E Cut into Segments for Destructive Examination

Table 7 provides a summary of the nondestructive test results reported at the location of each core. The weldment defects indicated by the ultrasonic and radiographic tests were used to develop destructive cutting schemes. These are shown in Figs. 33 to 35. Each of the slice segments was polished and etched in order to examine and identify the type and location of any defect.
