Strength of rectangular composite box girders: testing of large size composite box girders

**TESTING OF LARGE SIZE
COMPOSITE BOX GIRDERS**

Report No. 380.11

1. Report No. FHWA/PA 82-012 ⁰¹⁰	2. Government Accession No.	3. Recipient's Catalog No.	
4. Title and Subtitle Testing of Large Size Composite Box Girders		5. Report Date April 30, 1982

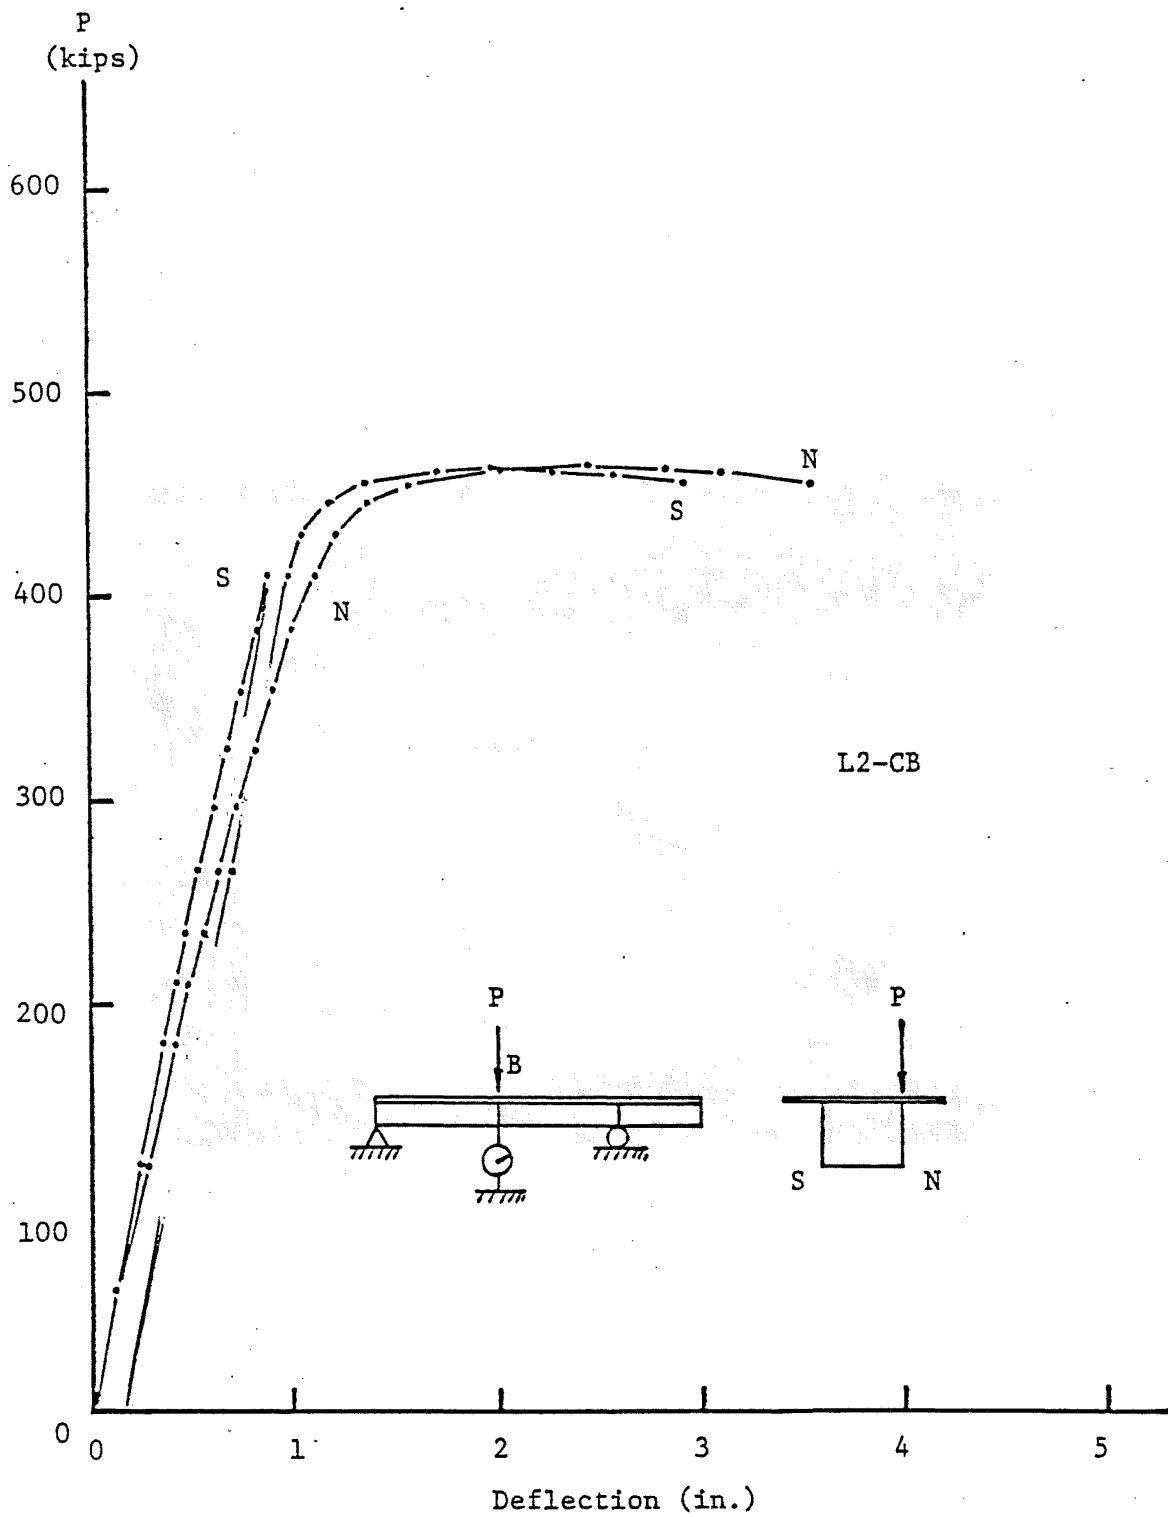
Fig. 4.7 Load-Deflection Curves, Composite Box Girder Test L2-CB

The load deflection curve of L2-CB in Fig. 4.7 also has the general characteristics of a steel-concrete composite beam, as described earlier.

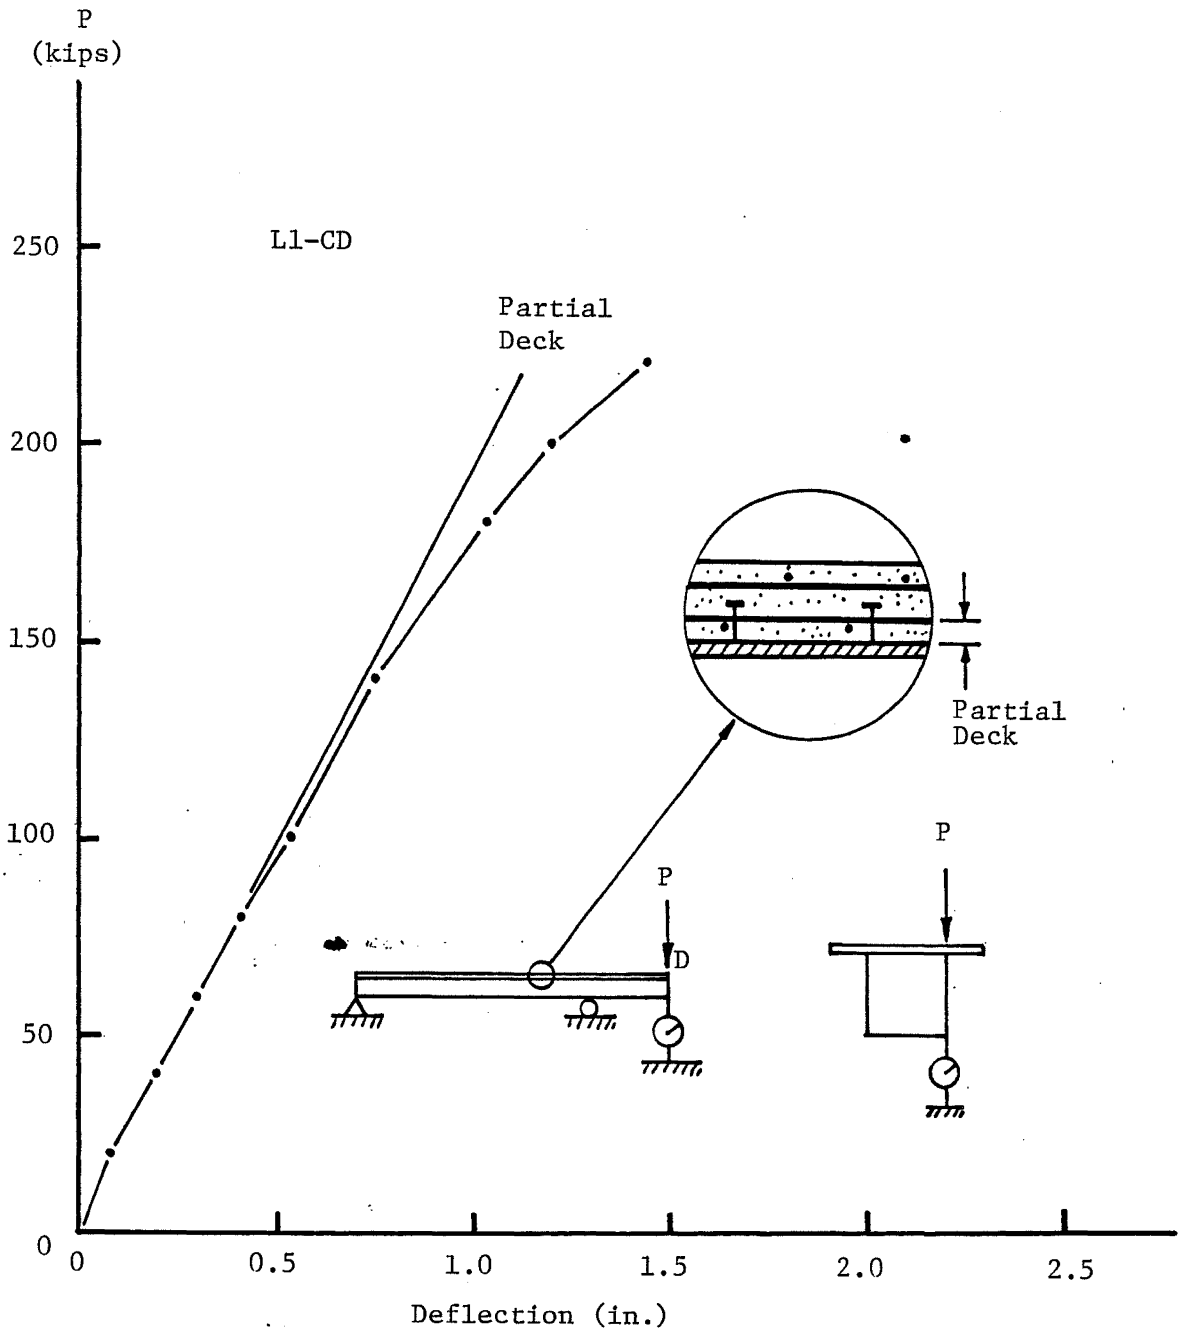
Fig. 5.11 Partial Deck Thickness for Negative Bending Moment

No attempt was made to examine the concrete crack depth. For practical purpose, an effective deck thickness was considered for analysis. It was found from this and other tests^(1.8) that a partial deck thickness equal to the distance between the bottom of the deck and the center of the bottom layer longitudinal reinforcing steel bars, could provide satisfactory comparison of stresses and deflections in the linear elastic stage of composite box girder behavior. An example of comparison is given as Fig. 5.11, in which the box girder deflection of Test L1-CD is fairly well estimated by the partial deck thickness assumption.

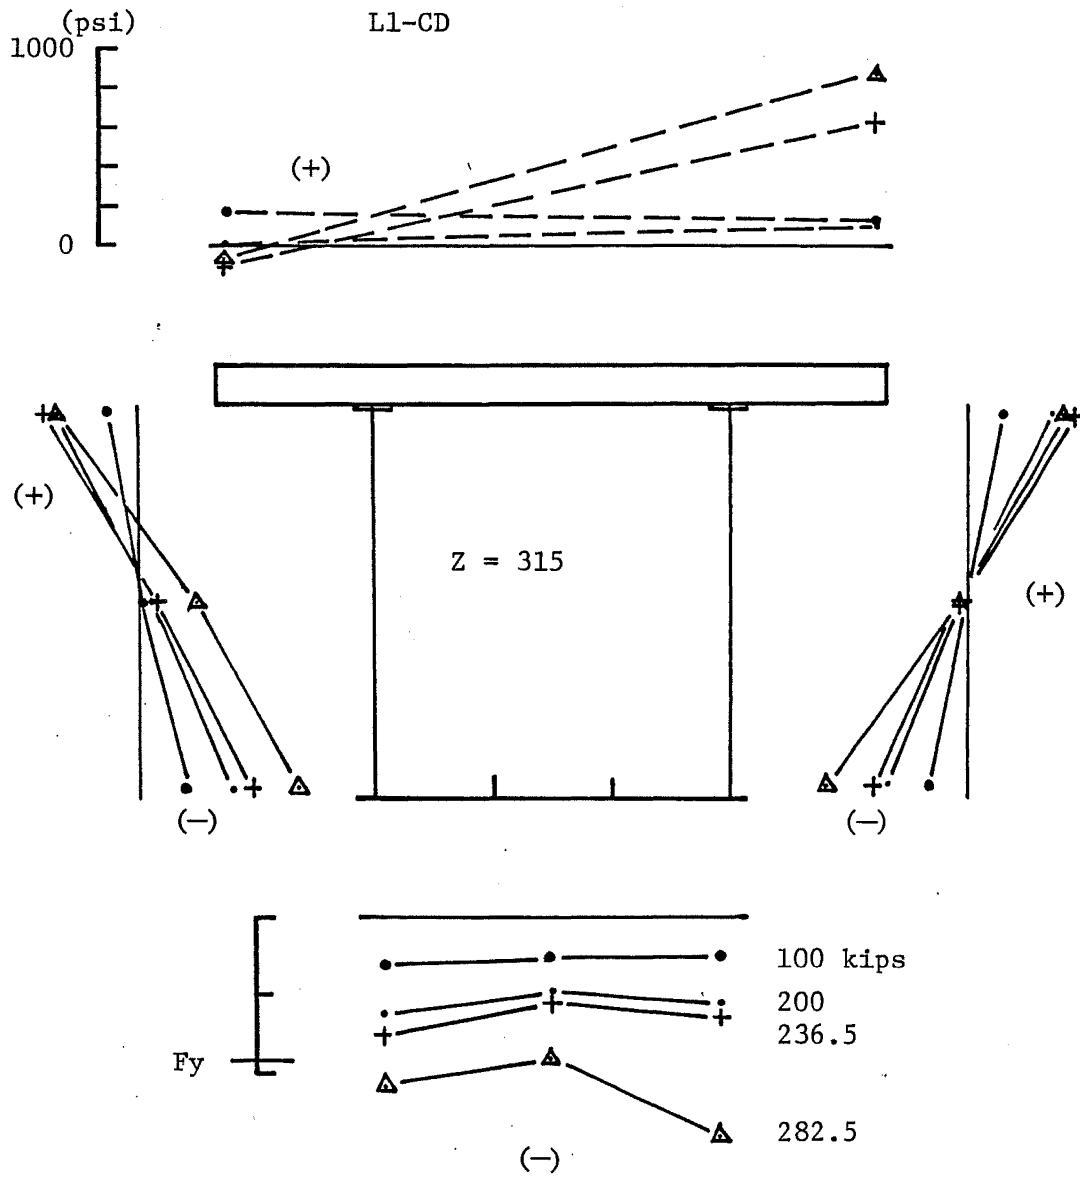
Fig. 5.13 Stress Distribution in Cross-section, $Z = 315$ in.,
L1-CD

Strain distribution in cross-sections of composite box girders also can only be used to record changes which had taken place, not to predict failure of the steel compression flange. The distribution of longitudinal strains in two cross-sections are shown in Figs. 5.13 and 5.14. Cross-section $Z = 315$ in. in Fig. 5.13 is at the center of panel 11 (see Fig. 5.1). At lower loads, such as 100 kips here, the distribution of mean strain in the steel plates were linear. At 200 kips, the slight deviation from linear distribution was an indication of deflection of the flange and the web plates. The condition of the web plate strains is typical of plate girders.^(4.3) At 236.5 kips, when testing was temporarily suspended the strain distribution did not differ much from that for lower loads. Only at the maximum load of the box girder, at 282.5 kips, did the pattern of strain distribution change to a large degree.

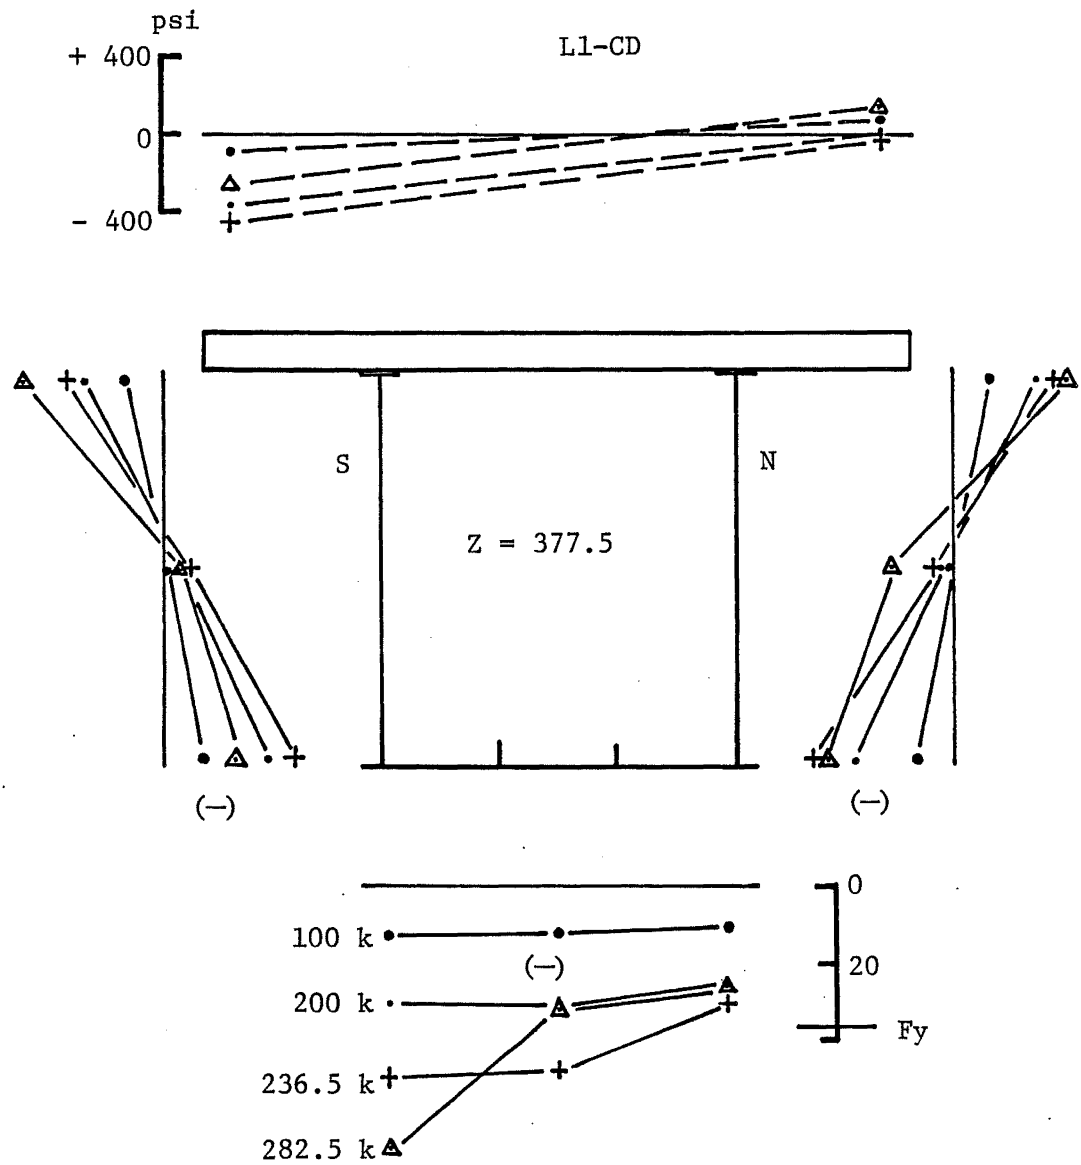
Fig. 5.14 Stress Distribution in Cross-section, $Z = 377.5$ in.,
L1-CD

The same general condition of strain distribution occurred at cross-section $Z = 377.5$, shown in Fig. 5.14. The cross-section was in the overhanging span, about one and a half feet from the support. At the maximum load of 282.5 kips, although failure happened at the other side of the support, the north web of this panel was well into tension field action. (See the diagonal yield band in the panel next to the bearing stiffeners of Fig. 5.9.) The change of strain distribution pattern testifies to this development of tension field. The recorded strains on the inside and outside surface of the north

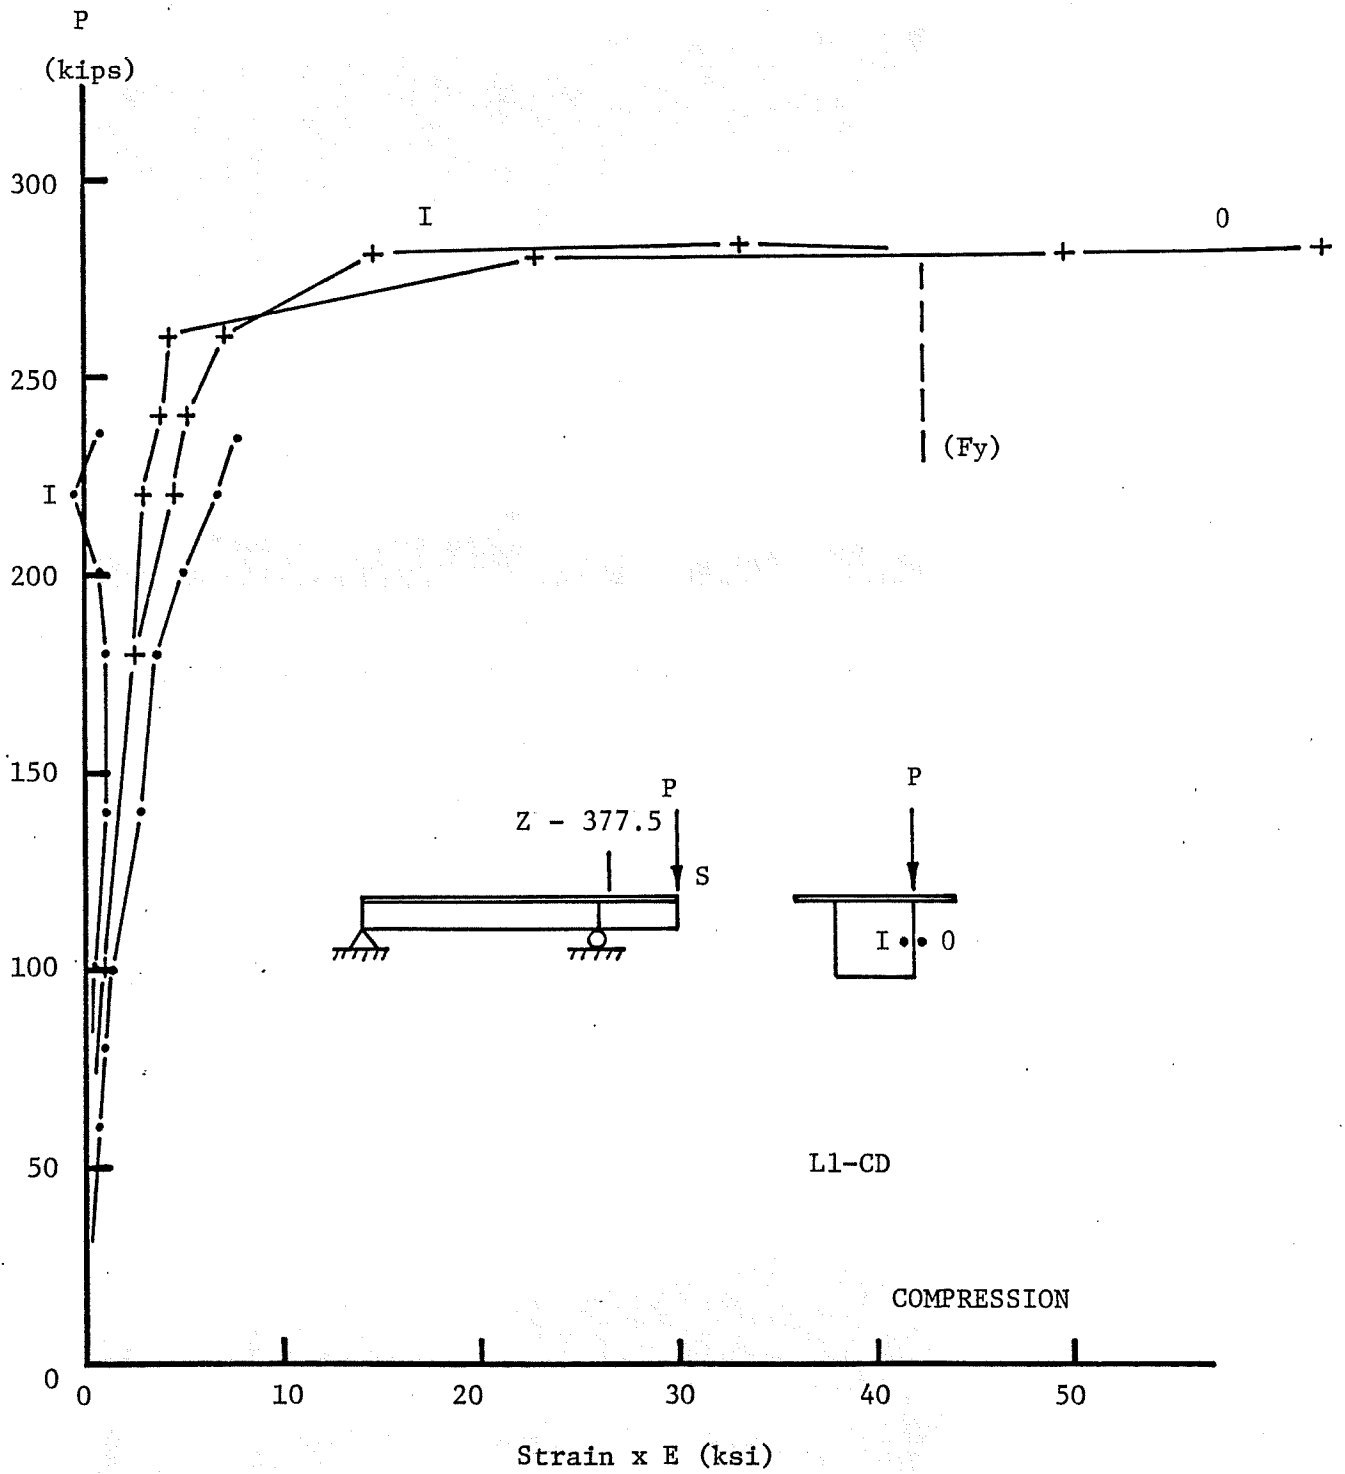
Fig. 5.15 Normal Strains on Surface of North Web, $Z = 377.5$ in., L1-CD

web, shown in Fig. 5.15, reveal more on the behavior of the web at this location.

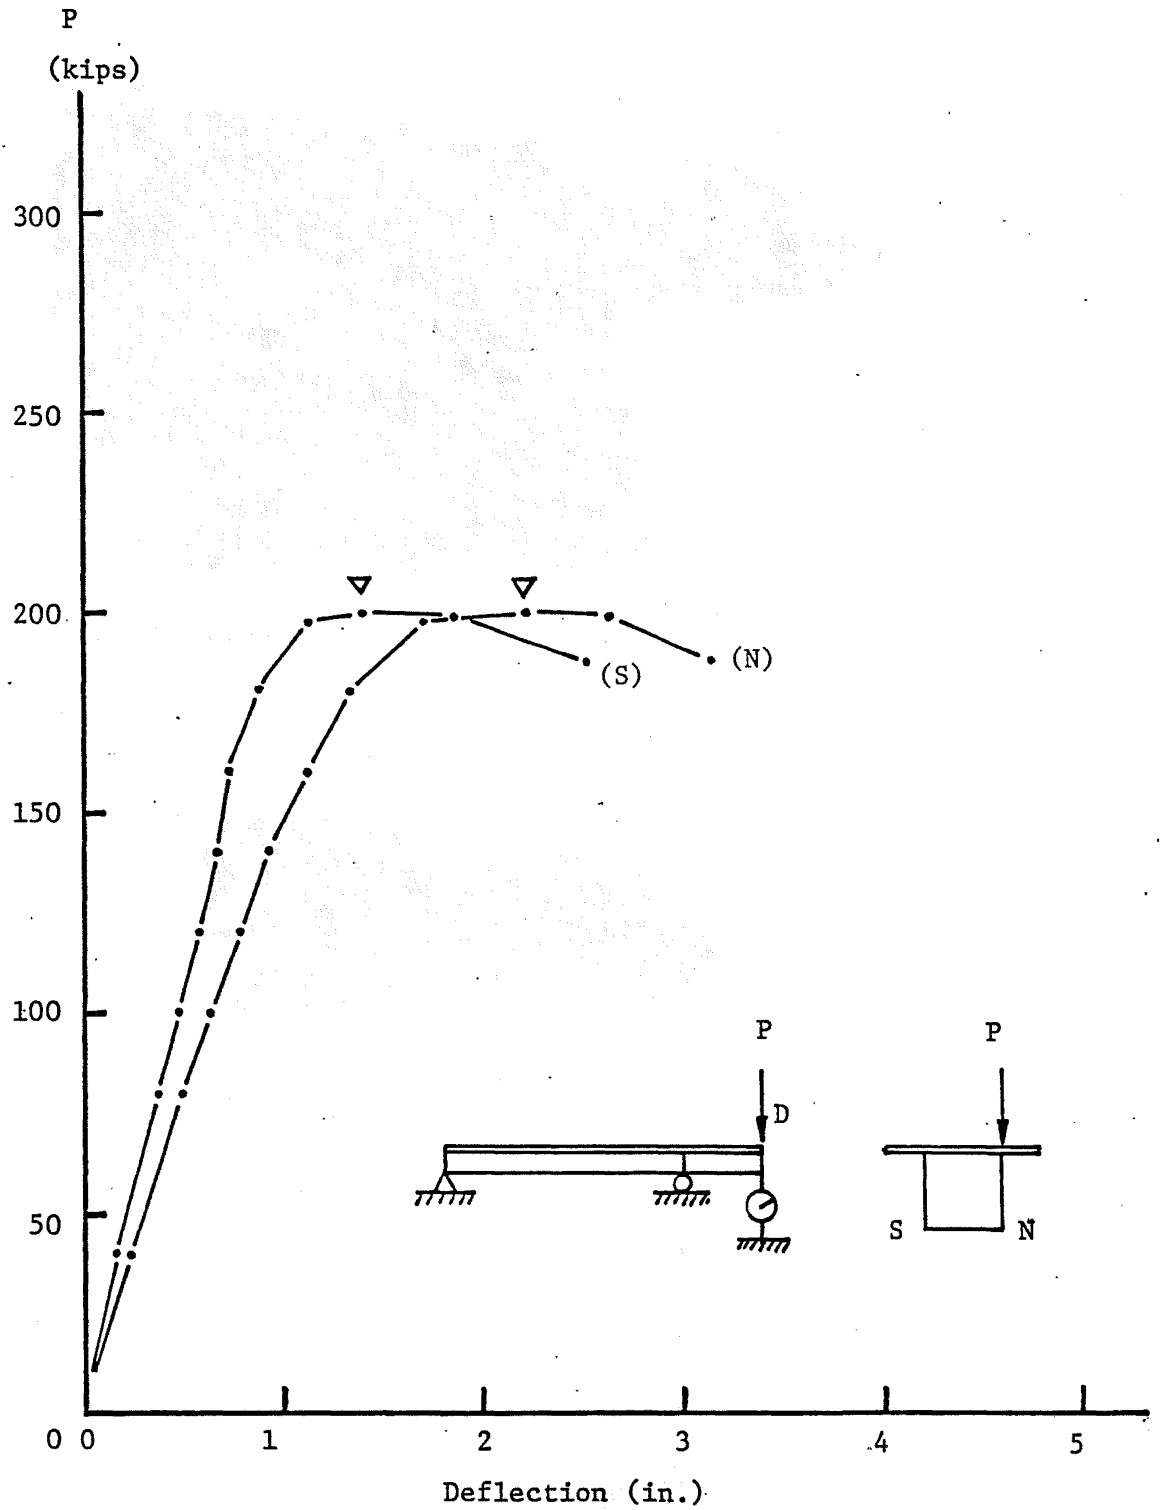
Fig. 5.20 Load-Deflection Diagram, -Test L2-CD

overhanging portion of the composite box girder was subjected to additional deflections (50%) beyond those at the maximum load. The load versus end deflection diagrams for Test L2-CD are plotted in Fig. 5.20. These type of load deflection diagrams are typical of welded plate girders with slender webs and normal size compression flanges. (4.3)

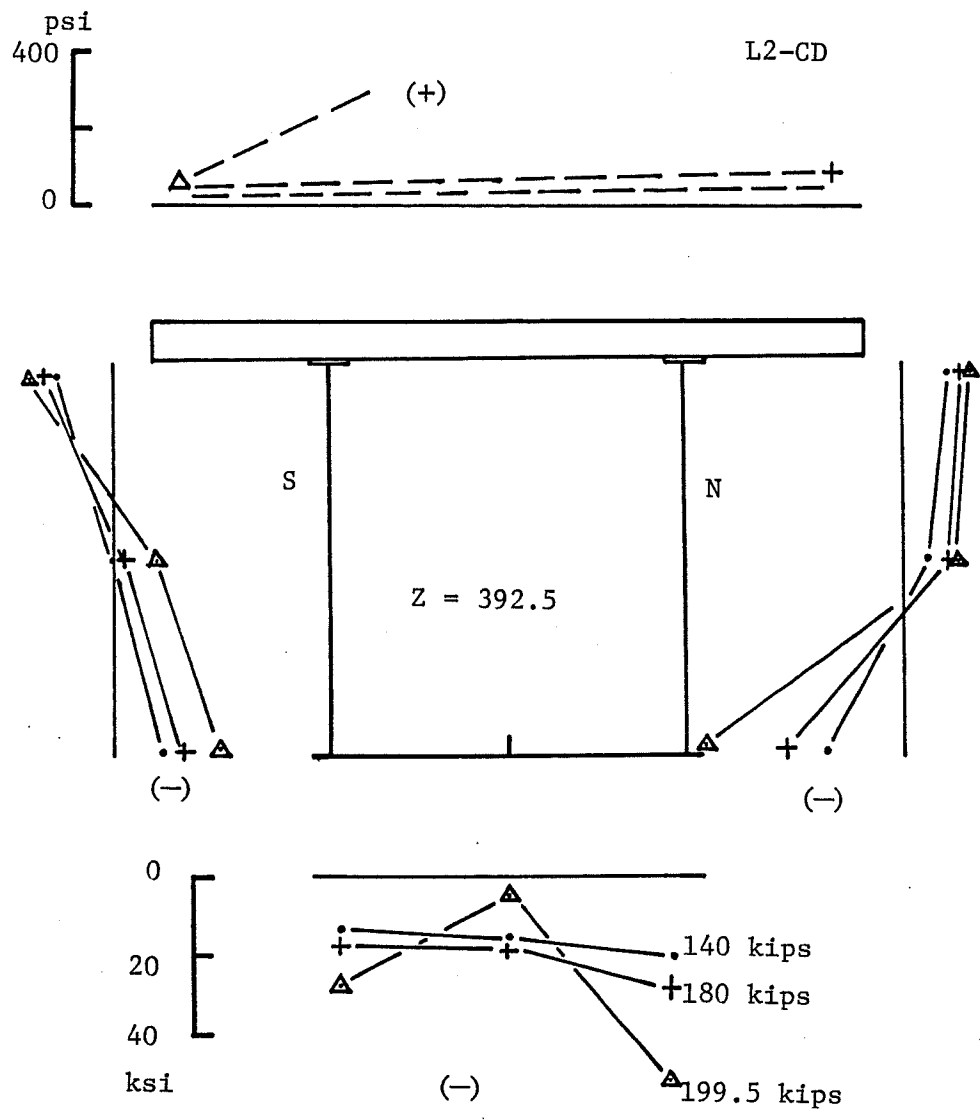
Fig. 5.25 Stress Distribution in Cross-section, $Z = 392.5$ in.,
L2-CD

of the north web and the bottom flange. The distribution of longitudinal direction stresses at cross-section at midpanel ($Z = 392.5$) is plotted in Fig. 5.25. The relatively low stresses at mid-depth of the north web and the corresponding nonlinear distribution of stresses in the web are indications of web buckling. For the bottom flange, although there was a longitudinal stiffener, buckling occurred and the compressive stress was reduced at the mid-width with corresponding increase of stresses at the flange-to-web junctions. By examining the stress distributions at lower loads, it can be seen that the bottom flange was capable of resisting compression at 180 kips and the north web had already buckled at 100 kips.

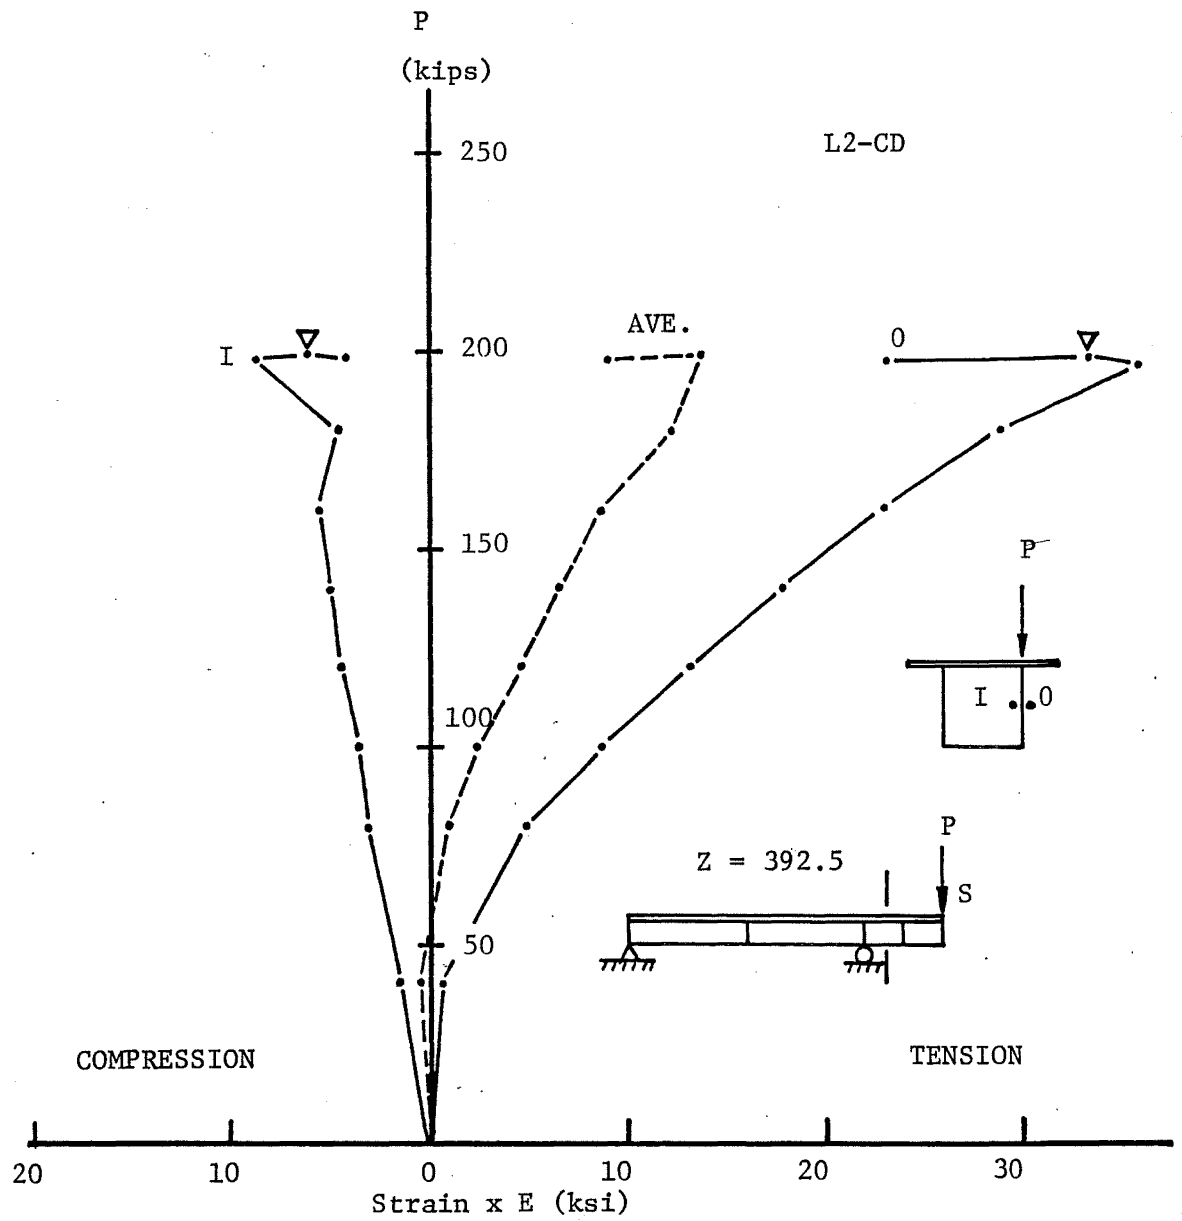
Fig. 5.26 Normal Strain on Surface of North Web, $Z = 392.5$ in.,
L2-CD

The development of strains in the longitudinal direction at the center of the failed north web panel, is depicted by Fig. 5.26. The outside surface was bending concavely thus had increasingly higher compression; the inside face convexly, tension. This condition and web deflection, or buckling, continued until just before the maximum load, when the compression flange also buckled. The average of these two stress diagrams is also plotted in Fig. 5.26. It has the same general trend as that for the outside surface.

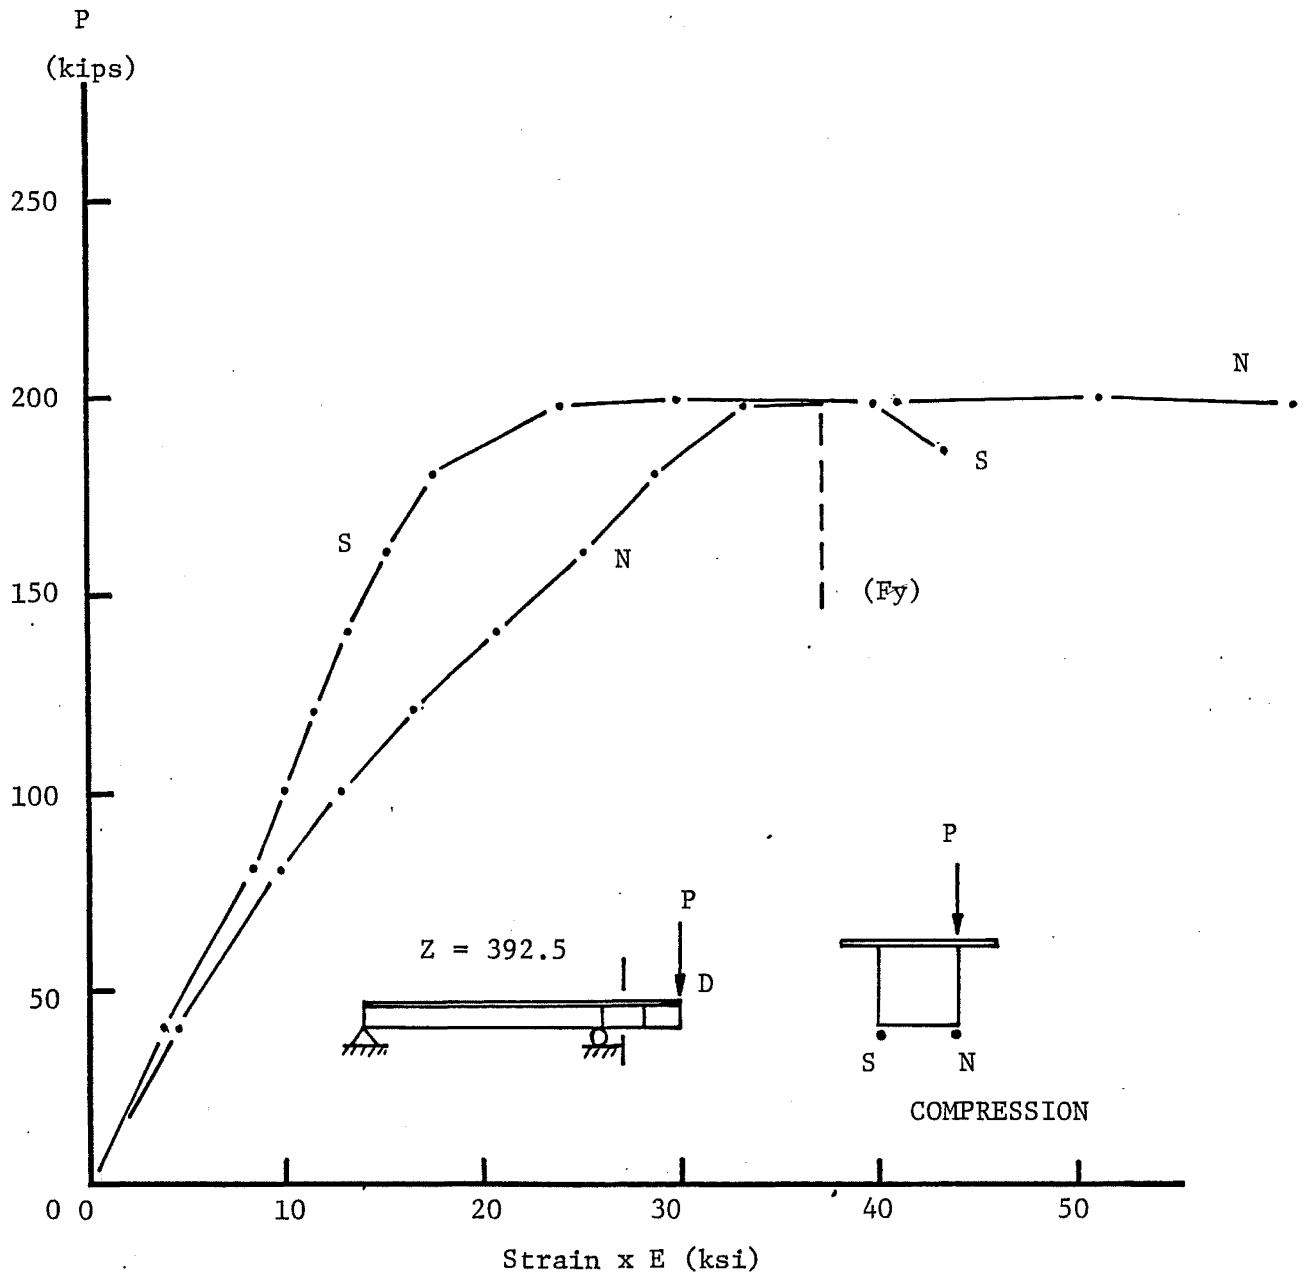
Fig. 5.27 Strains in Bottom Flange, $Z = 392.5$ in., L2-CD

The average longitudinal stresses in the bottom flange at the web junctions of the cross-section, $Z = 392.5$, are given in Fig. 5.27 as load-strain diagrams. The corresponding strains near the edge of the concrete deck are plotted in Fig. 5.28. The steel flange yielded toward the end of testing. The through-the-thickness stresses in the concrete deck was always low, except at the north side over the support.
