Fatigue tests of welded plate girders in shear, November 1965

Progress Report on the Fatigue Strength
of Welded Plate Girders

FATIGUE TESTS OF WELDED PLATE GIRDERS IN SHEAR

Lehigh University
Department of Civil Engineering
Fritz Engineering Laboratory Report 303.6
November, 1964

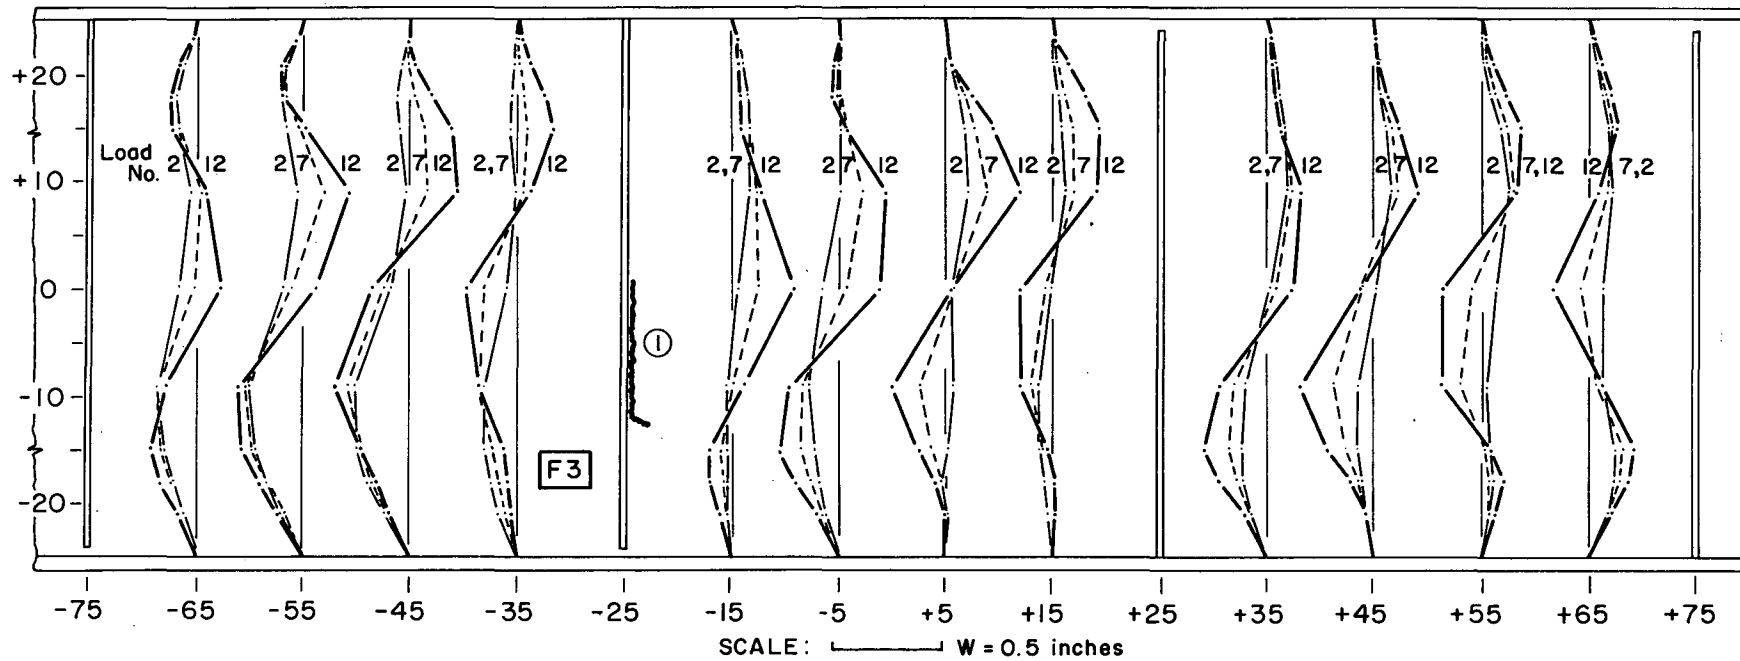
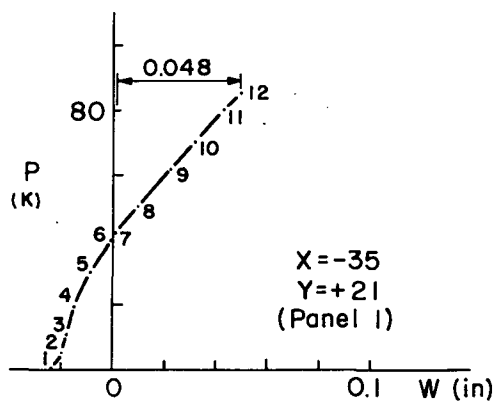
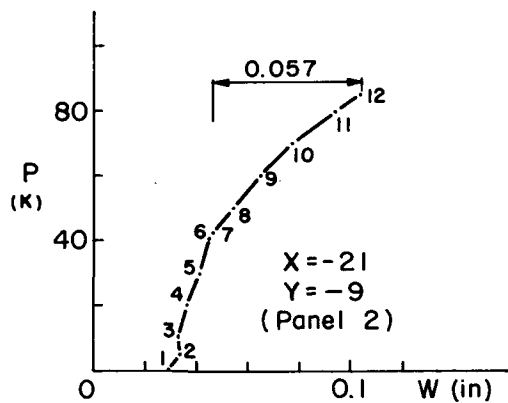
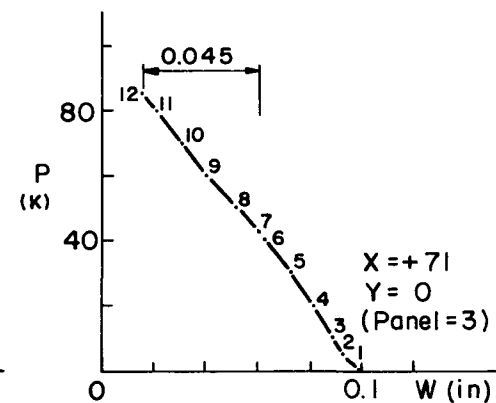
Fig. 11 Lateral Web Deflections, Girder F3

Deflected cross-sectional shapes such as those shown in Fig. 11, 12, and 13 depict the relative positions of cross sections at different load magnitudes. For an overview of the deflected shape of a panel, web deflection contours are presented next.

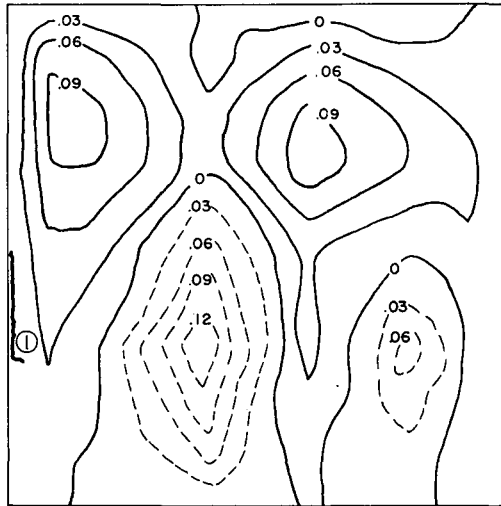
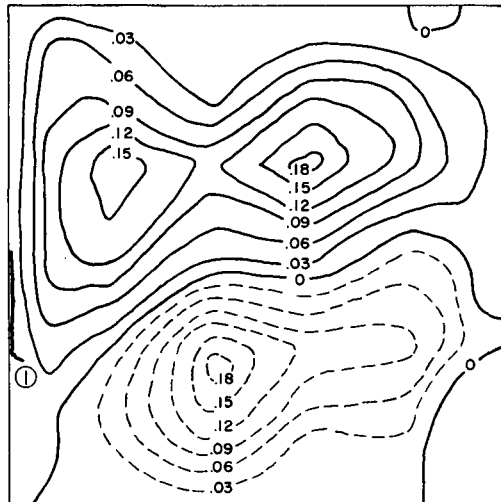
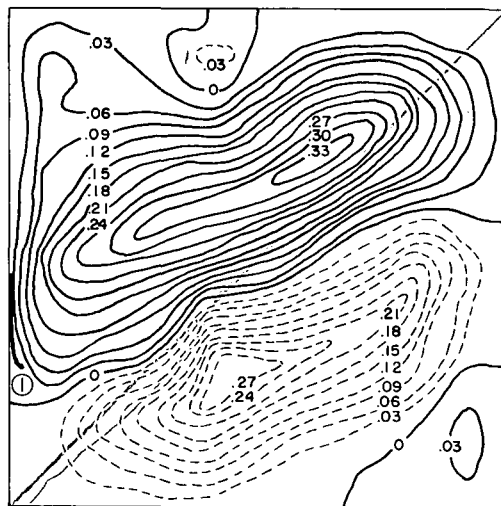
Fig. 14 Web Deflection Contours, Girder F3

The contours of lateral web deflections of girder F3 are shown in Fig. 14 for panel 2 at three different loads: 5, 42.5, and 85 kips. A

As in all human experience, an effect has been observed - the cracks. This inevitably leads to the search for the cause. Some consistent parameter should eventually be uncovered which relates crack occurrence with the number of load applications. At first, the applied load range may appear to be some measure of the number of cycles until cracks initiate. But a comparison between girders F2 and F3, both loaded within a range of $0.35 P_u$ to $0.71 P_u$, shows that cracks appeared as early as 800,000 cycles in F3 but no sooner than 2,000,000 cycles in F2. In the same light, girders F4 and F5 were both loaded from approximately $0.05 P_u$ to $0.65 P_u$. Once again, the first crack of F4 appeared at about 430,000 cycles while F5 never incurred a crack in over 3,000,000 cycles. Thus, there is little consistency in a given load range. A second parameter to be reviewed is the lateral web deflections, both initial and final. A direct comparison from panel to panel is possible because all corresponding bounding elements of the panels were nominally the same. From an examination of the web deflection contours, Figs. 14, 15, and 16, it appears that all maximum initial deflections were of the

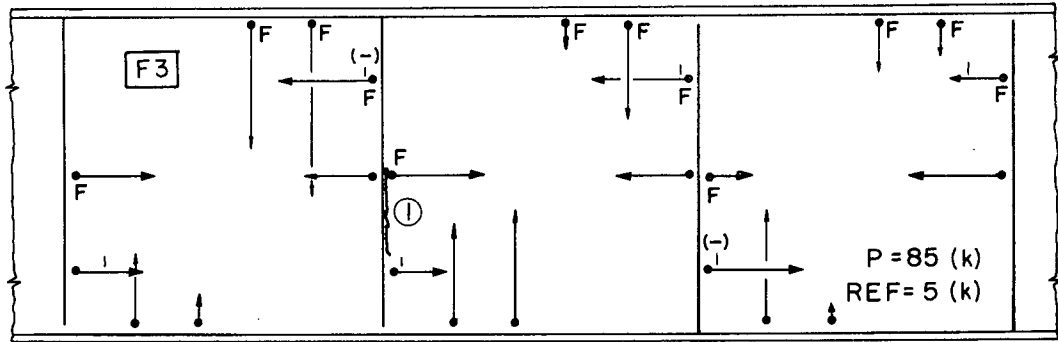
a. Surface Stress

In the upper portion of the figure, Fig. 17(a), the maximum tensile surface stresses are plotted. These stresses were found on the far side of the web at certain gage points, where an "F" is placed nearby, or otherwise they were on the near side of the girder. Small vertical index marks near the gage points at $Y = \pm 15$ indicate the magnitudes of the predicted longitudinal stresses—the primary bending stresses by beam theory. Thus, in the third panel at $X = 25\frac{5}{8}$, $Y = -15$, a surface stress of about 15 ksi is on the near side whereas its corresponding theoretical stress is about 2 ksi in compression. Further discussion of these and other stresses is presented in Section 5.2.

The surface stresses perpendicular to the boundaries shed very little light as to a consistent relationship between crack occurrence and number of load applications. Consider Fig. 17a, girder F3. In the upper right corner of panel 1, a tensile surface stress of about 26 ksi existed at $P = 85$ kips, with about 9 ksi at $P = 42.5$ kips, giving a stress range of about 17 ksi. This was considerably higher than the stresses in the center panel near the first crack where values of 14.5 and 3.5 ksi were obtained at the maximum and minimum loads with an accompanying range of 11 ksi. As a further example, in Fig. 20a, the maximum stress in the center panel was 31 ksi at the load range of 36^k to 110^k , while the minimum stress was about 5 ksi. This produced no cracks at that location during the application of over one million cycles of load. Thus, comparisons based on the surface stresses appear to be less than fruitful.

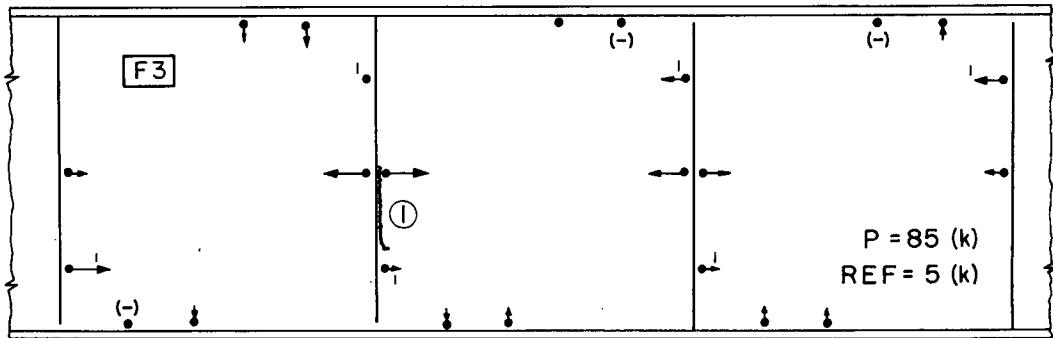
b. Membrane Stress

The central plot of Fig. 17 shows the web membrane stresses at their respective locations. Stresses less than 1 ksi are indicated by a small solid dot and negative signs adjacent to them indicate compressive stresses. It may be observed that these membrane stresses at the girder's neutral axis are as high as 7 ksi and are of the same order of magnitude on both sides of the transverse stiffeners.

it is convenient to separate the surface stresses into their membrane components and their secondary bending components. In Fig. 17b, the membrane stresses along the neutral axis on either side of the center panel's intermediate stiffeners are essentially the same. These are 6.7 versus 6.7 ksi and 5.5 versus 4.3 ksi on either ^{side} ~~wide~~ of the stiffeners at $X = -25$ and $X = +25$, respectively. Membrane stresses along the neutral axis of +0.8 versus +1.0 ksi were also recorded for girder F4 on either side of the stiffener at $X = -25$ as is shown in Fig. 18b. These observations give some indication that the membrane stresses are essentially constant over a distance of a few inches and, thus, the membrane stresses at the gages represent the membrane stresses at the toe of the weld. With the secondary bending stresses, the opposite is true. This is because the curvature of the web at the flanges and stiffeners has little affect on the membrane stresses, whereas its affect is pronounced on the secondary web bending stresses. Further explanation is given below.

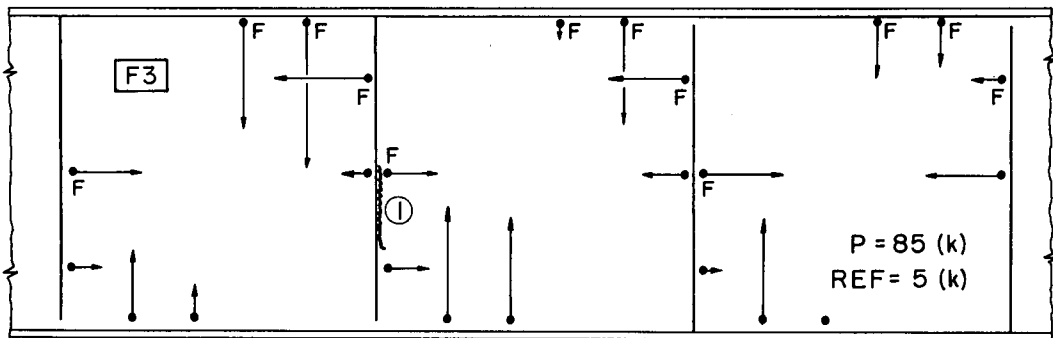
c. Secondary Bending Stress

Finally, in the lower part of Fig. 17, the tensile secondary bending stresses are shown. No indices of theoretical stresses are indicated, since the web is assumed planar in the beam theory. The letter "F" again indicates those stress vectors on the far side of the web. Except in a few cases, these secondary bending stresses are much larger

to approximate the deflected shape of the cantilever, the secondary bending stresses are obtained and are plotted in the lower portion of Fig. 28. The bending stress at the toe of the weld is 36.1 ksi and a stress of 10.7 ksi exists at the center of the gages. From Fig. 17c, it is seen that a value of 8.0 ksi was calculated from this gage point using the measured surface stresses. Even though 36.1 ksi might be somewhat higher than the actual value of the stress at the toe of the weld, this calculation demonstrates that measured web bending stresses are much lower than those at the toe of the weld. In the case treated above the weld stress was about four times the bending stress measured at the gage.

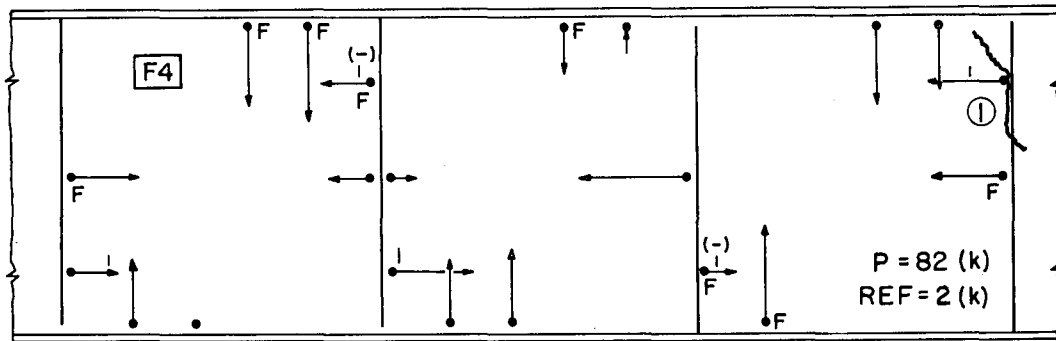
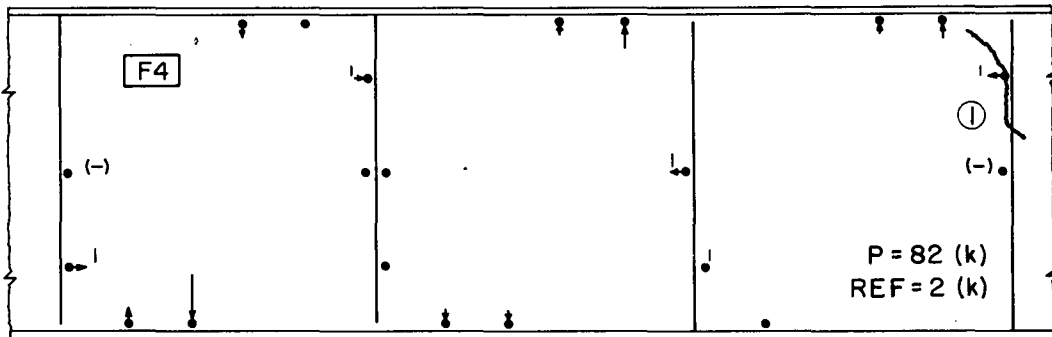
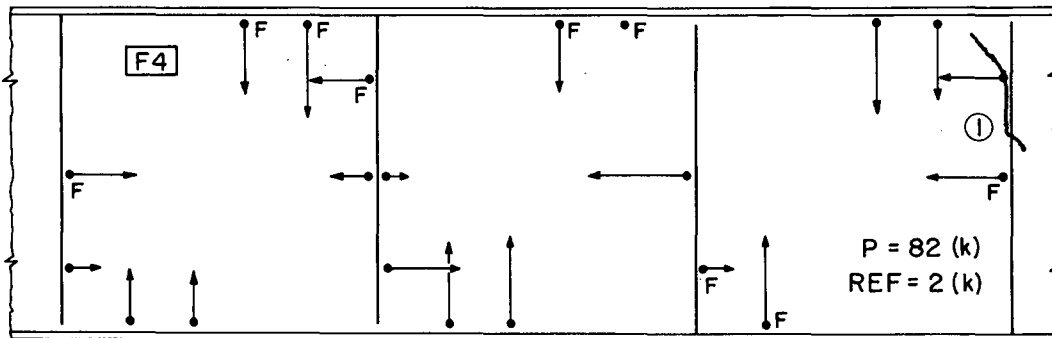
Fig. 18 Web Stresses Normal to Boundary, Girder F4

Presented in Fig. 18 are the web stresses of girder F4 arranged as in the previous figure. The stresses are shown for the maximum load of 82 kips, using as reference for computation the strains obtained at 2 kips. Again, all gages were $1\frac{1}{2}$ inches from the bounding elements. From the membrane stresses in the center of the figure, it is seen that the maximum tensile value is about 7 ksi and that the stresses on both sides of the stiffener at $X = -25$, $Y = 0$ are tensile and are less than 1 ksi. In Fig. 19, the web stresses of girder F5 are shown for the maximum load of 72 kips with its reference of 4 kips. All stresses were obtained by strain rosettes which were located $\frac{3}{4}$ inches from the web boundary elements. Membrane stresses were less than 3 ksi throughout and the maximum secondary bending stress was about 16 ksi near the top flange. Finally, in Fig. 20 are given the web stresses of girder F5 under its latter maximum load of 110 kips. It is interesting to note that the membrane stresses were no larger than 5 ksi, even at the maximum load of 110 kips which was the computed static strength of the girder.

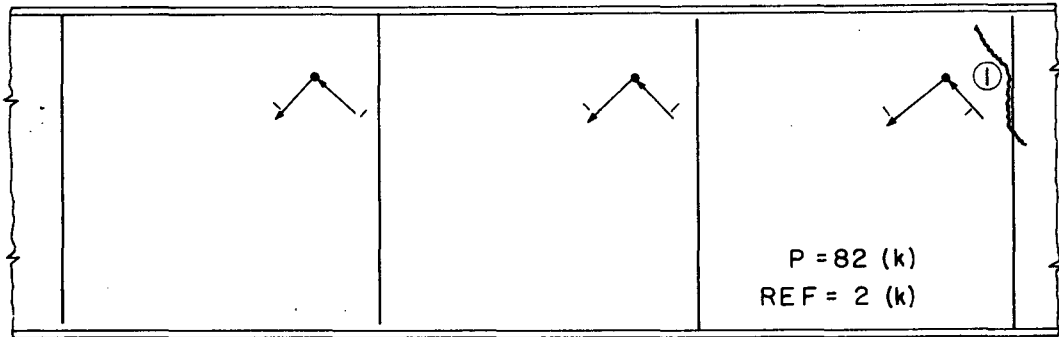
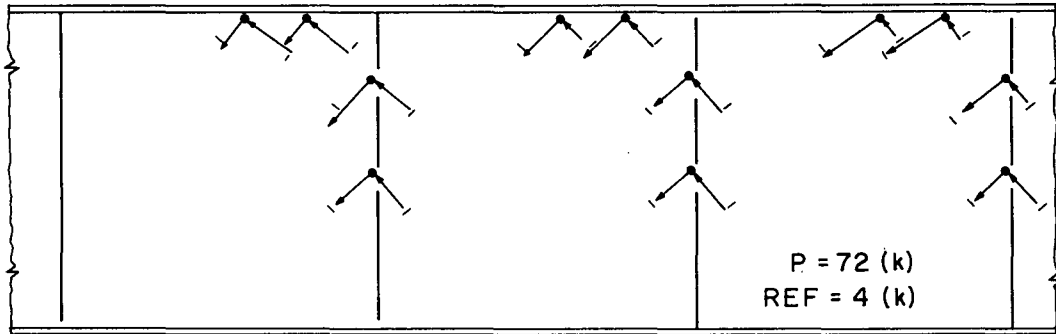
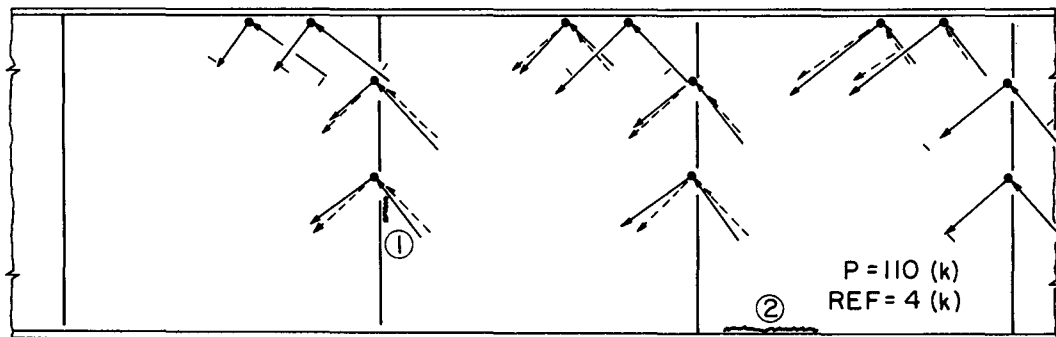
Corresponding to the surface stresses discussed in Fig. 22, the computed principal membrane stresses are plotted in Fig. 23. In general, there is a marked resemblance between the test values and those predicted by the beam theory. This is true in both magnitude and direction. For example, in Fig. 23(a), the tensile and compressive magnitudes are 12 ksi and 9 ksi for those computed from test data and are 11 ksi and 7 ksi according to beam theory predictions. Angular differences in Fig. 23(a) and (b) were so small as not to allow their plotting and, thus, index marks are used instead of dashed vectors to indicate stress magnitudes. Even in Fig. 23(c), for which the applied load was at the static ultimate load of the girder, stress directions did not differ by more than ten degrees and magnitudes were quite comparable to those predicted values.

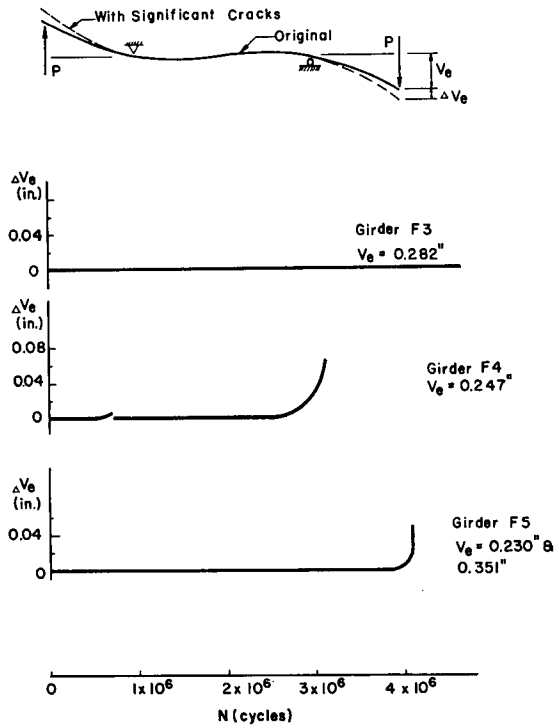
Fig. 26 Girder Stiffness Versus Applied Load Cycles

Changes in the overall girder stiffness are reflected in changes in the girder end deflection. As crack lengths increase to significantly large values, there is an accompanying loss of overall stiffness and the end deflection (V_e) would increase by a certain amount (ΔV_e). This increase is depicted in the uppermost portion of Fig. 26, where the changes in the end deflection (ΔV_e) are plotted against the number of applied load cycles (N). Individual ordinates are shown for each girder while the common abscissa (N) is located at the bottom of the figure. It may be noted that the effect of temperature changes or load fluctuations was the order of 0.002 inches and changes of this order are neglected. Referring to the figure, it is seen that girder F3 had no essential change in its stiffness, even though crack lengths totaled about 21 inches at the completion of the test. Girder F4 had an increase in its end deflection of about 0.006 inches at 700,000 cycles when Crack 1 was 14 inches long. After the first repair of this crack, the end deflection remained constant until 2,600,000 cycles when Cracks 3, 4, and 5 were approximately 18, 10, and 4 inches long, respectively. The final change of deflection was about 0.062 inches or 25% of the girder's maximum elastic end deflection of 0.282 inches when the crack lengths progressed to their final values of 29, 30, and 30 inches. Finally, girder F5 retained the same end deflection during the first 3,000,000

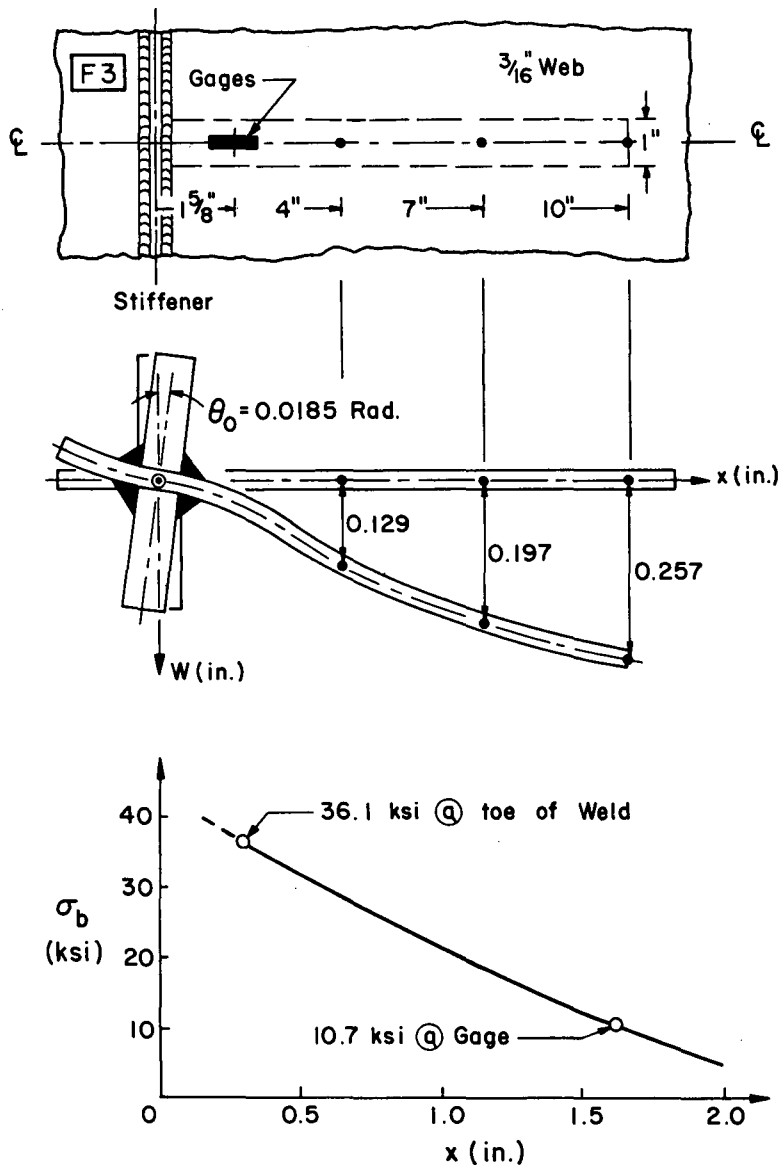
Fig. 28 Secondary Bending Stress Approximation

Let a small cantilever strip, one inch wide and ten inches long, be cut out of the web of girder F3 at $Y = 0$ and $X = -25$ to -15 as shown in the top sketch of Fig. 28. In this sketch the location of a pair of electrical resistance strain gages is indicated, together with the points along the neutral axis of the girder at which lateral web deflection readings were taken. The center sketch shows a plan view of the deflected web at 85 kips in relation to the web at 5 kips which is shown as being straight. For this maximum load of $P = 85$ kips, w equals 0.129, 0.195, and 0.257 inches, respectively at $X = 4, 7,$ and 10 inches. A change in the end slope of the cantilever of about 0.0185
