Low-Cycle Fatigue

CRACKED BEAM TEST

May, 1969

Fritz Engineering Laboratory Report No. 358.4

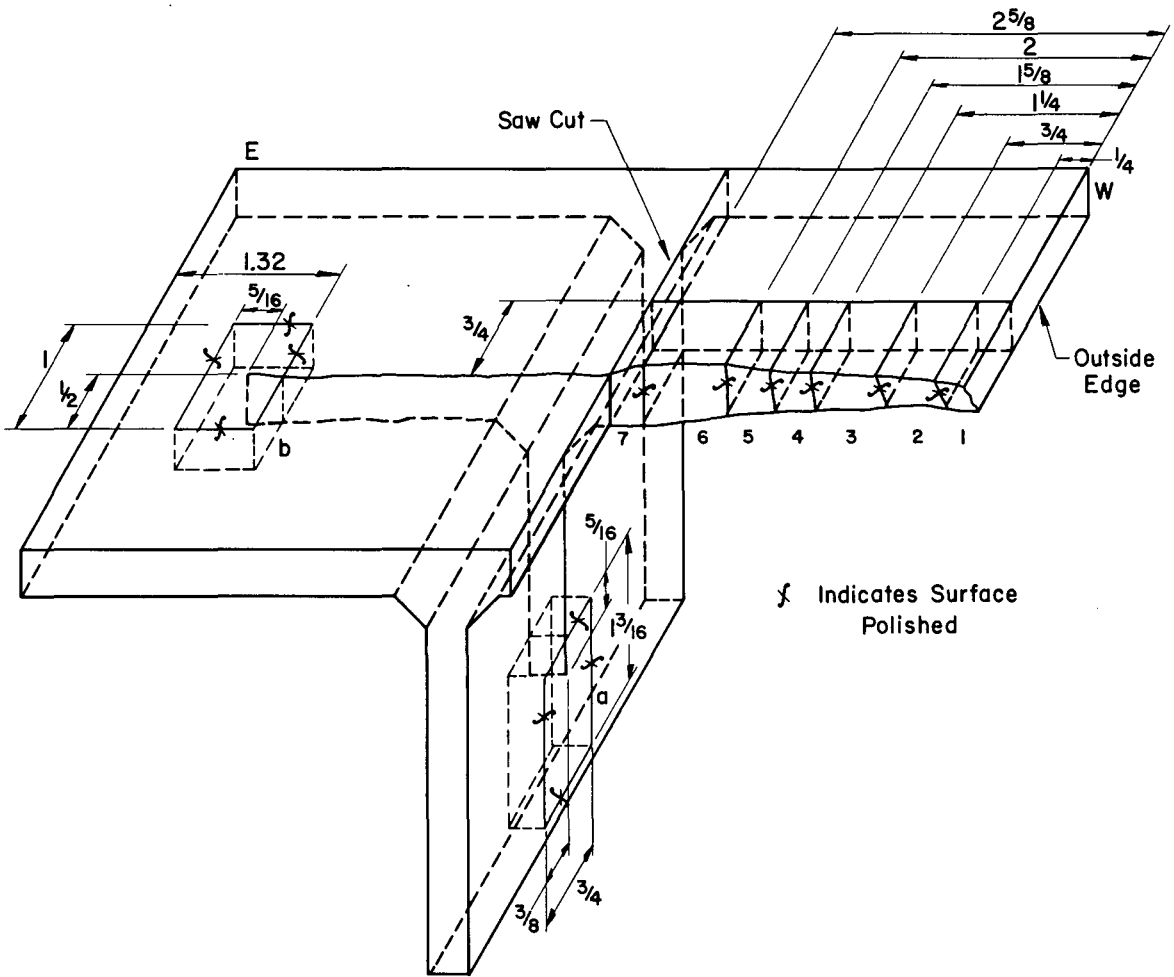
Fig. 4 Sectioning of the Beam for Metallurgical Investigation.

The ends of the flange and web cracks were polished parallel to their planes as shown in Fig. 4. The web crack was approximately 20° to the web surface. The flange crack was approximately 60° to the flange surface. Polished sections (Figs. 13 and 14) reveal that the nature of the cracks are quite different.

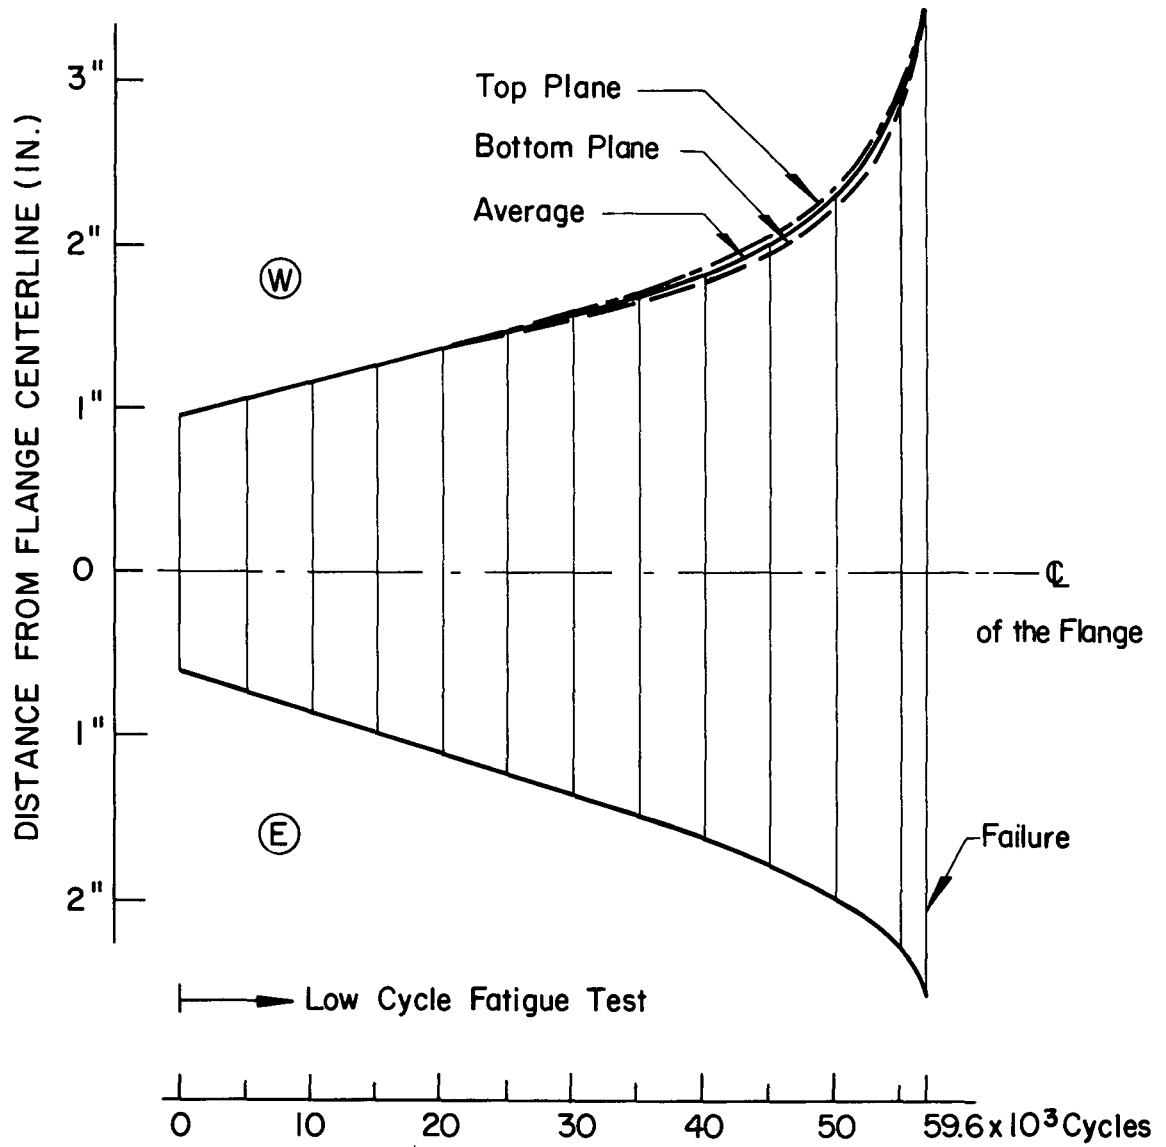
Fig. 6 Crack Length Versus Number of Cycles.

The crack length versus the number of cycles for the low-cycle fatigue test is shown in Fig. 6. The rate of crack propagation $\frac{d(2a)}{dN}$ versus nondimensional ratio $\frac{2a}{w}$ is plotted in Fig. 17, where $2a$ is the total length of the crack, N - number of cycles and w - width of the flange.

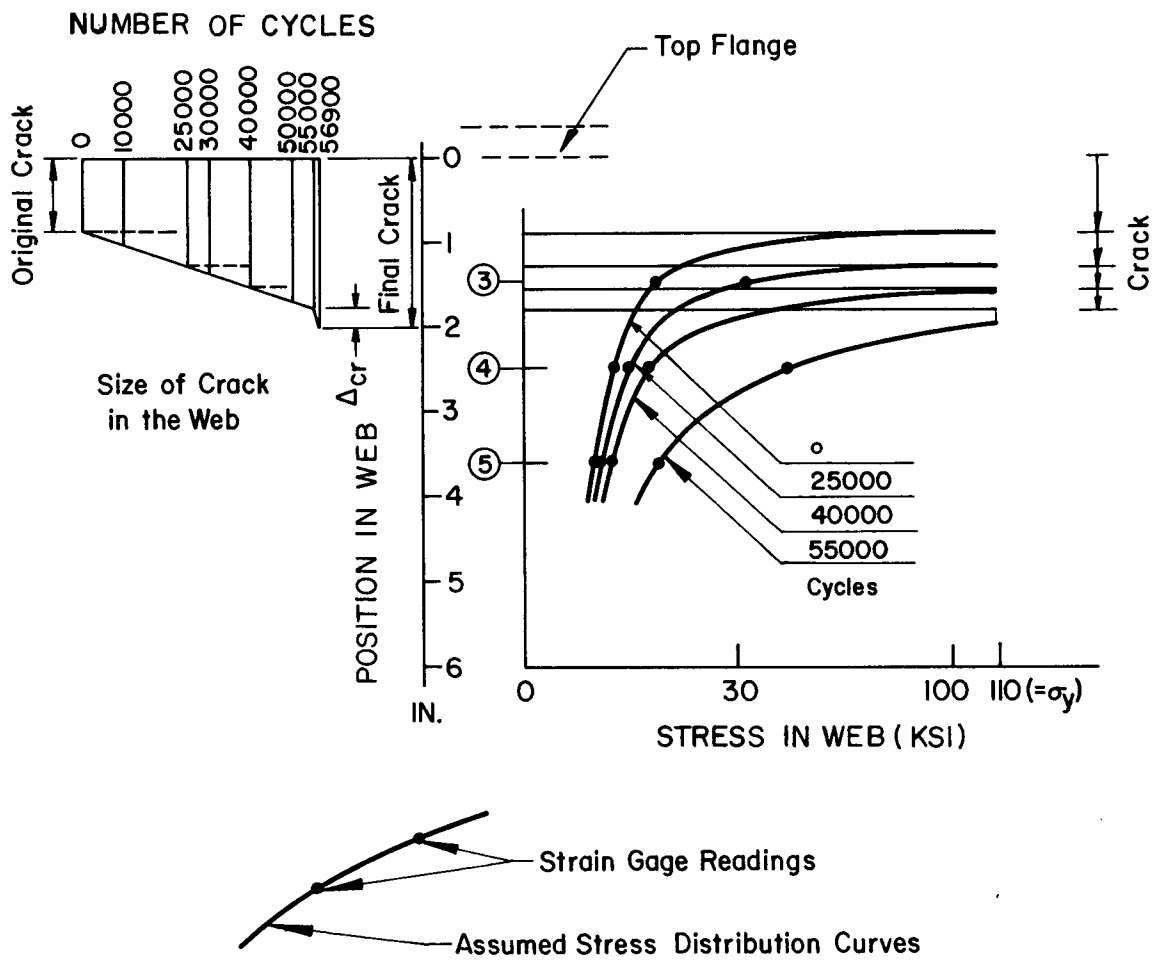
Fig. 10 Crack Propagation and Stress Redistribution in the Web.

The stress distribution in the cracked cross section as obtained from strain gage readings is shown for the web in Fig. 10 and for the flange in Fig. 19.

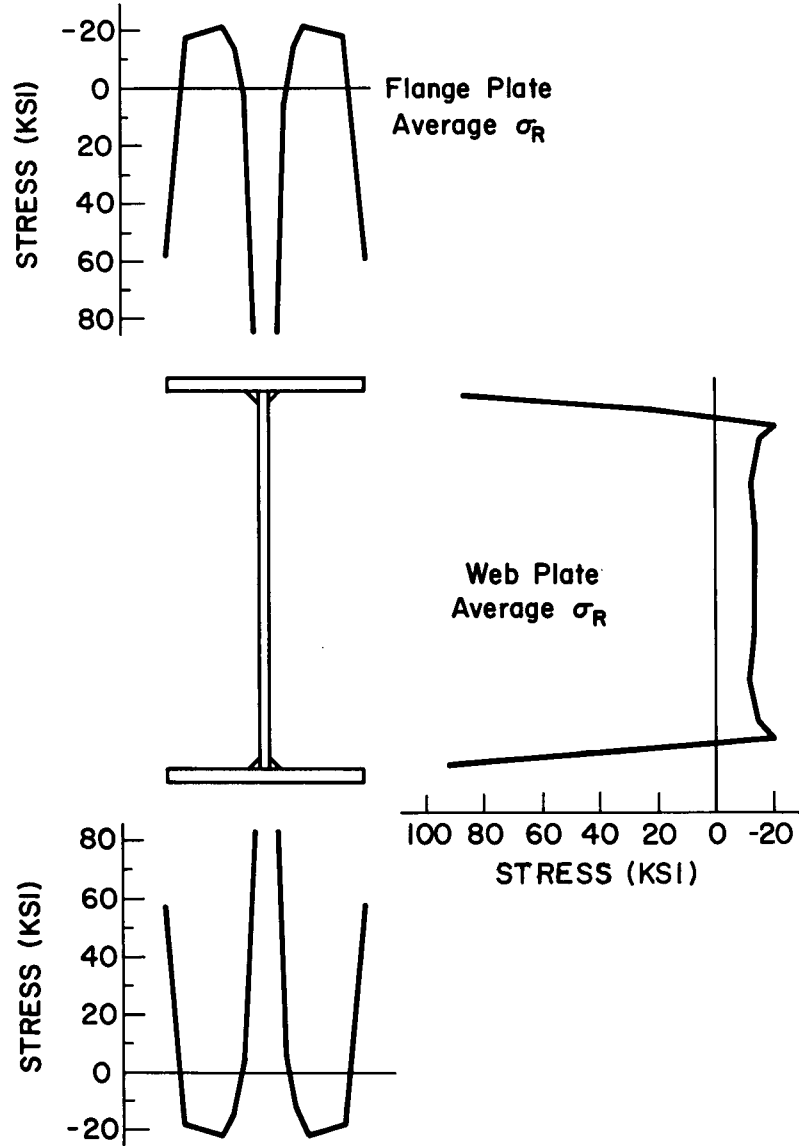
Fig. 16 Residual Stress in PWC152 Beam.

Similar weld shapes were investigated to obtain information about residual stresses in the virgin beam and the stress redistribution after loading.⁽²⁾ The average residual stress pattern for the beam PWC 152 is shown in Fig. 16.

The stress distribution in the flange was first analyzed theoretically using the simplified mathematical model and computer program described in Ref. 4. The residual stress pattern (Fig. 16) was taken into consideration. The stress redistribution was obtained for some crack propagation stages also by the computer program. The stress distribution for $N = 0$ and loading $L_1 = 80$ kips was used as the reference curve and recorded stresses were plotted to get comparison of theoretical and recorded stresses. For strain gage No. 2 the results are coincident, but for strain gage No. 20 the theoretical values are slightly higher than the recorded data. This difference is caused mainly by simplification of the theoretical assumptions (such as simple plate, 3-ended crack neglected, uniaxial stress taken into consideration).

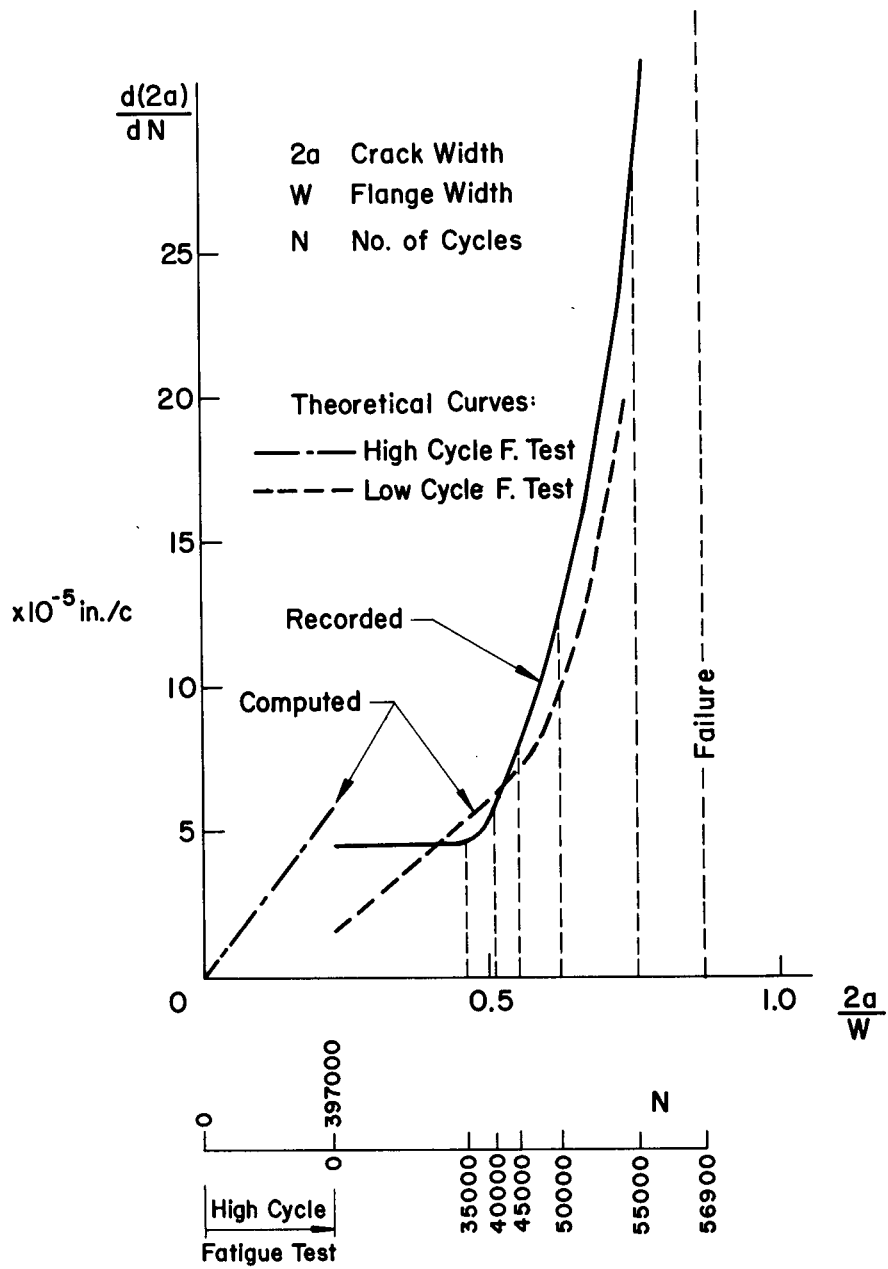
Fig. 17 Crack Propagation Rate Versus Position in the Flange.

In Fig. 17 theoretical values are also shown for both high- and low-cycle fatigue tests of crack propagation rate versus $\left(\frac{2a}{w}\right)$ to allow comparison with the measured values.

The discontinuity of crack propagation rate in high- and low-cycle fatigue test (Fig. 17) is apparently caused mainly by the

decrease in stress range from high-cycle to low-cycle testing and the restraining effect of three-ended crack propagation. The recorded values of the crack propagation rate in the first phase of the low-cycle fatigue test are higher than the theoretical values, and the crack length (Fig. 18) coincides with recorded values only in the last phase of fatigue life. A possible explanation for the recorded behavior of the crack growth curve in the first phase of the low-cycle test may be that the region at the crack tip produced in the high-cycle tests, which has already seen a rather high level of Δk , undergoes fatigue damage. As a result, in the subsequent low-cycle tests, growth rates are higher than theoretically expected. However, this physical region of rapid crack growth is too large to attribute to fatigue damage alone. Therefore it appears that the residual stress pattern and the complex (three-ended) crack shape might also be of importance.

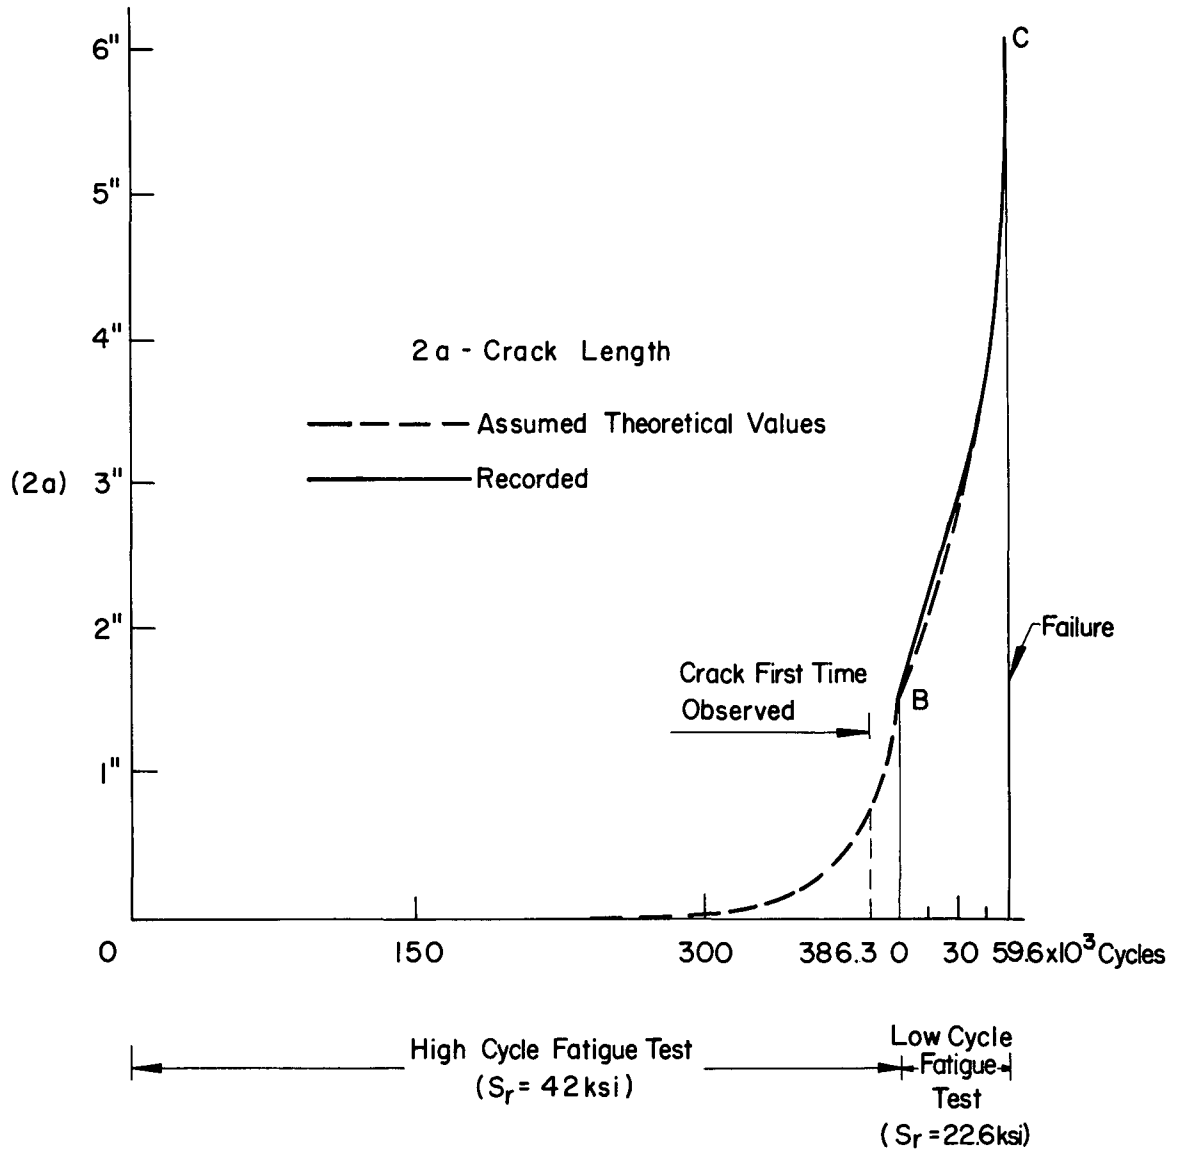
Fig. 18 Crack Length Versus Number of Cycles.

The values of $2a$ for the low-cycle fatigue test were obtained in a similar way. The computed values are plotted in Fig. 18 for comparison with the values recorded in the low-cycle test.
