FAILURE TESTS OF RECTANGULAR MODEL BOX GIRDERS

April 1972

FAILURE TESTS OF RECTANGULAR MODEL BOX GIRDERS^a

By Joseph A. Corrado¹, A.M., ASCE and Ben T. Yen², M. ASCE

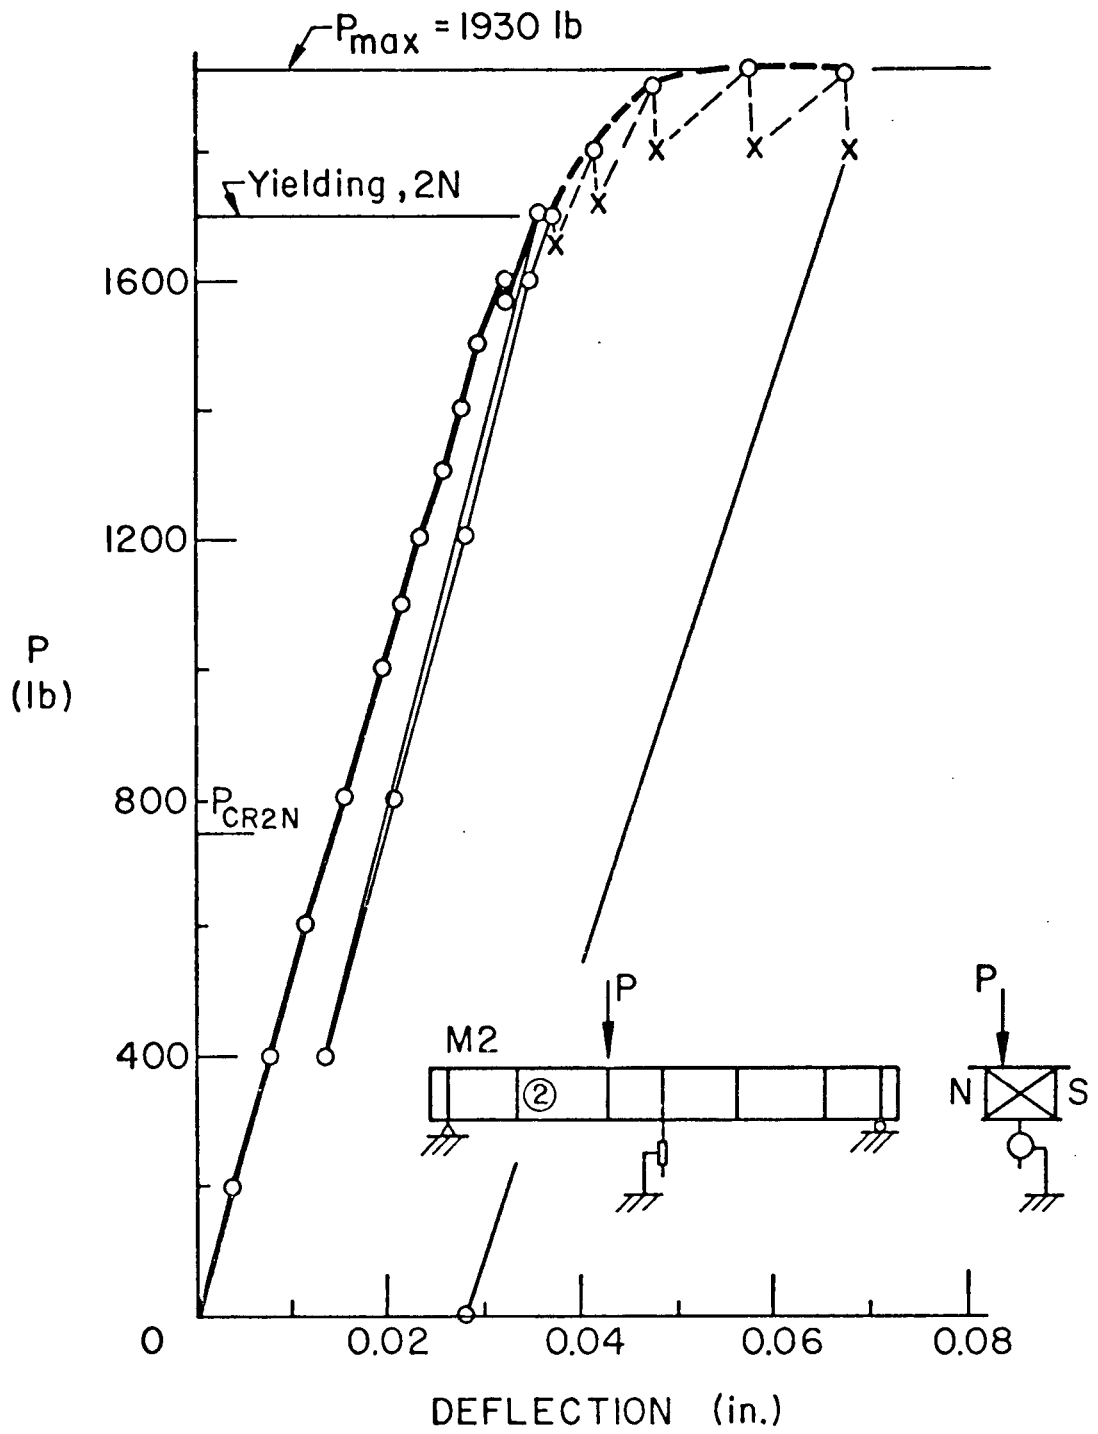
Fig. 13 Midspan Deflection - Specimen M2
(Unsymmetrical Load)

Additional loading eventually caused general yielding along the tension diagonal of web panel 2S (Fig. 12) and an increased rate of deflection (Fig. 13). Prior to the attainment of the maximum load, flange deformations resembling the frame action described in the previous section occurred quite substantially on the north side of panel 2, and to a somewhat lesser degree on the south side of the same panel.

Analogous to the results for symmetrical testing of M2, the data points denoted by circles and x's in the inelastic region of the load-deflection plot of Fig. 13, respectively, represent the upper and lower bounds of the static loads of the unsymmetrical load test of specimen M2.

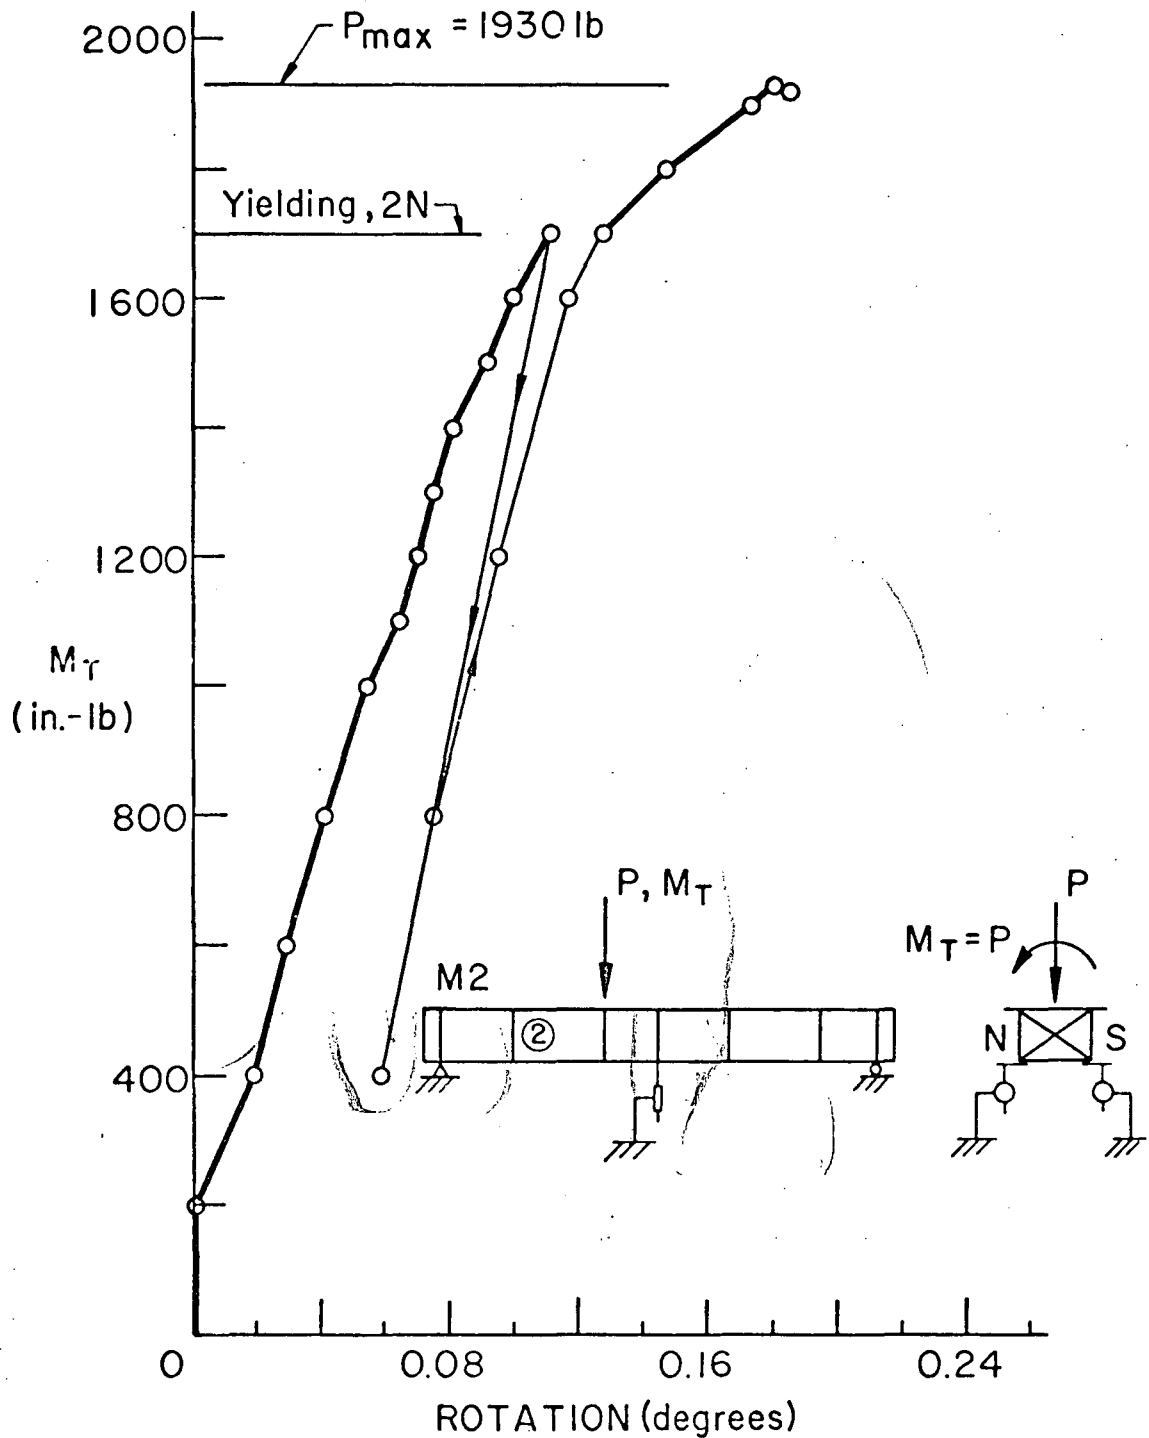
Fig. 14 Midspan Rotation - Specimen M2
(Unsymmetrical Load)

and therefore any additional flexural shear was carried by the web on the south side. Yielding of web panel 2N also affected the torsional stiffness of the member as can be seen in Fig. 14. The segment of the member containing panel 2 (the length to the left of the load point) could no longer support its full share of the twisting moment due to its decreased torsional stiffness. Therefore, a greater portion of the twisting moment had to be carried by the section to the right of the loading point. This redistribution phenomenon caused the shear stresses to change. This is clearly indicated in the shear stress plots for panel 5 in Fig. 15.

It is interesting to note that the load-rotation curve in Fig. 14 has not flattened out upon attainment of the maximum load. This infers that the torsional capacity of the member has not yet been exhausted and additional torsional moment could be supported by the undamaged portion to the right of the loading point.

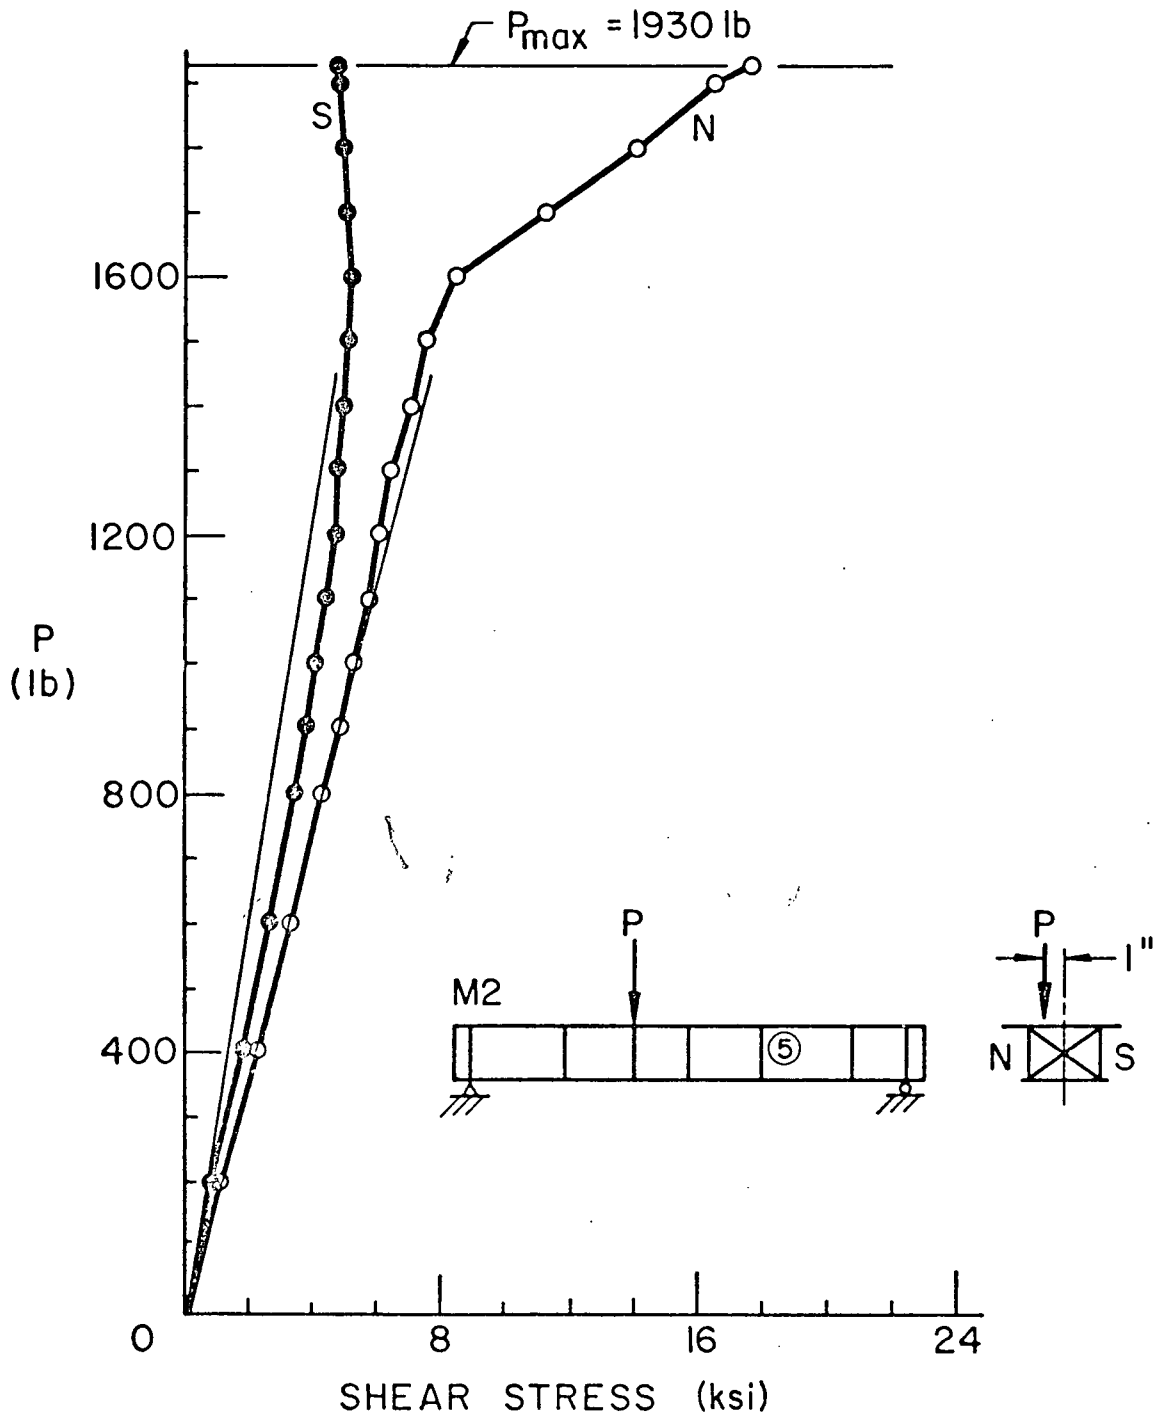
Fig. 15 Shear Stress at Centerline of Panel 5 - Specimen M2 (Unsymmetrical Load)

The change in the load versus shear stress curves of Figs. 12 and 15 can be explained by again simply considering the superposition of the shear flow due to bending and St. Venant torsion. For the given direction of torsion, shear flows add on the north side and subtract on the south side. It is important to note that effects due to warping torsion and distortion of the cross section have been examined. However, because of the rather good correlation between the experimental stresses and those predicted by considering only bending and St. Venant torsion, detailed consideration of warping and distortion is not deemed necessary for evaluation of the behavior of the specimen and the mode of failure ⁽⁷⁾.

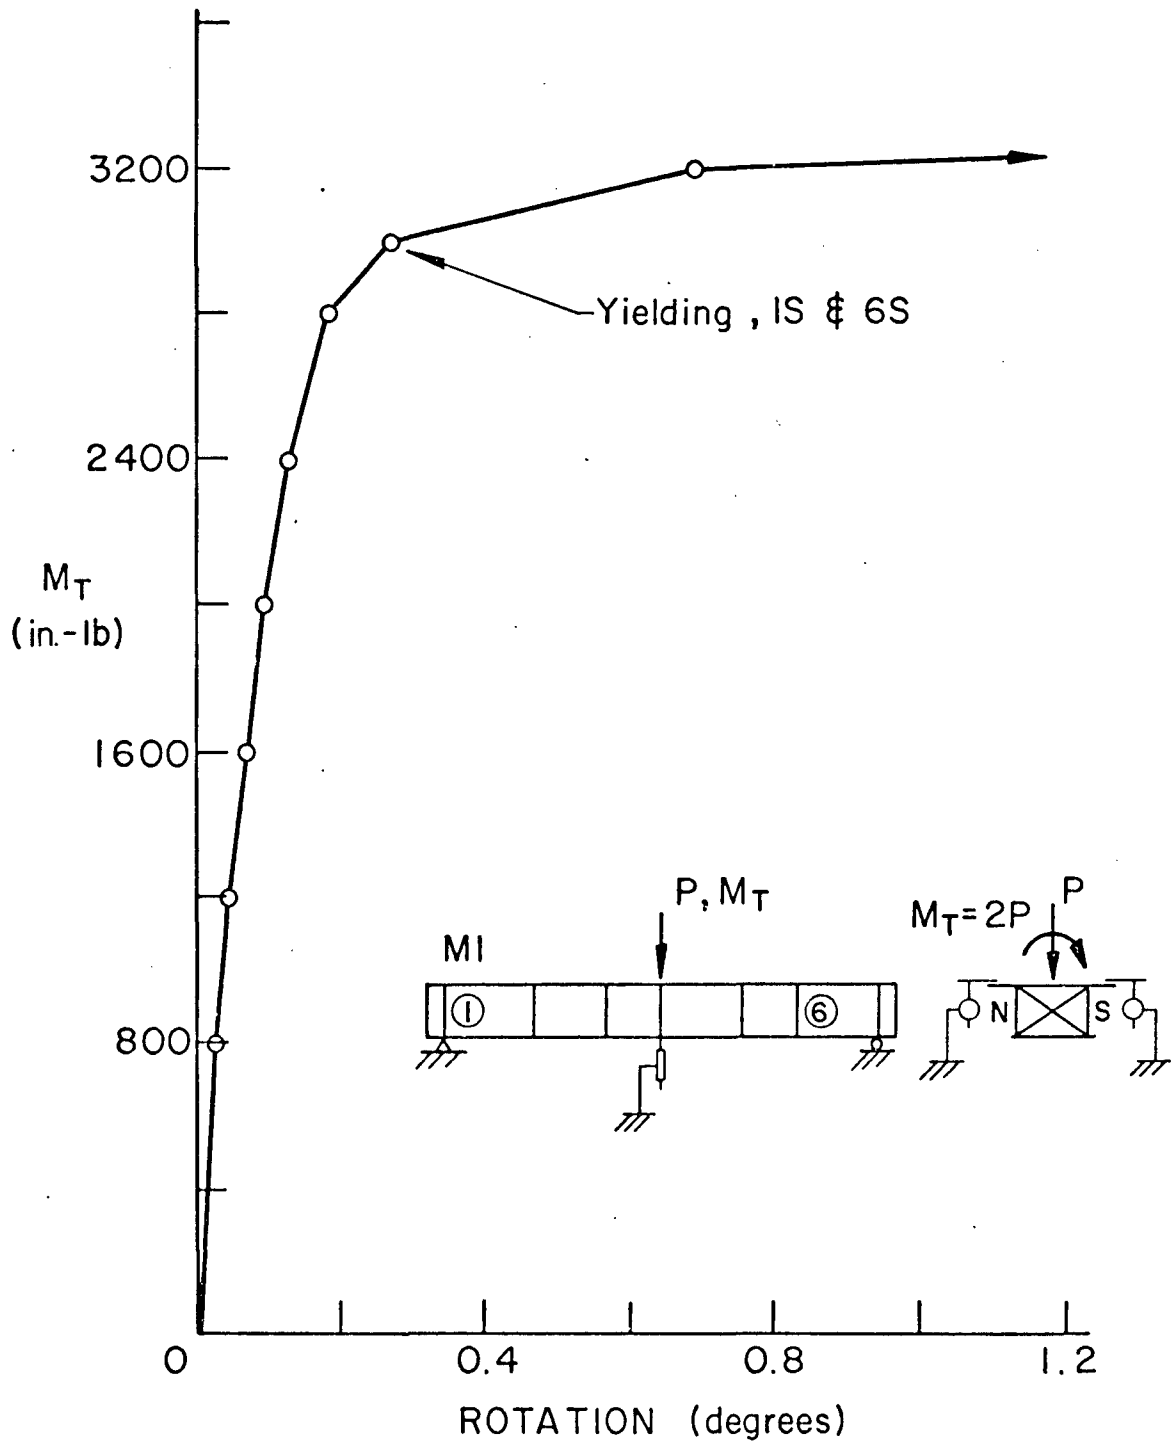
Fig. 17 Midspan Deflection - Specimen M1
(Unsymmetrical Load)

The load-deflection and load-rotation curves of Figs. 17 and 18, respectively indicate that little flexural or torsional stiffness remained once web panels 1S and 6S had yielded. This is also quite different than the behavior of M2 which possessed appreciable torsional and flexural stiffness after web panel 2N had yielded. Of course, the lack of torsional stiffness in M1 could be expected because web panel failures occurred almost simultaneously (1S and 6S) in each shear span. (For M2, web failure occurred in only one of the shear spans.) On the contrary, the absence of significant flexural stiffness was not anticipated and must be
