Analysis of stresses in superstructure of glenfield bridge over back channel, October 1977

Project 77-5: Evaluation of the Fracture of the Glenfield Bridge Girder

ANALYSIS OF STRESSES IN SUPERSTRUCTURE
OF GLENFIELD BRIDGE OVER BACK CHANNEL

Fritz Engineering Laboratory Report No. 425/1/77

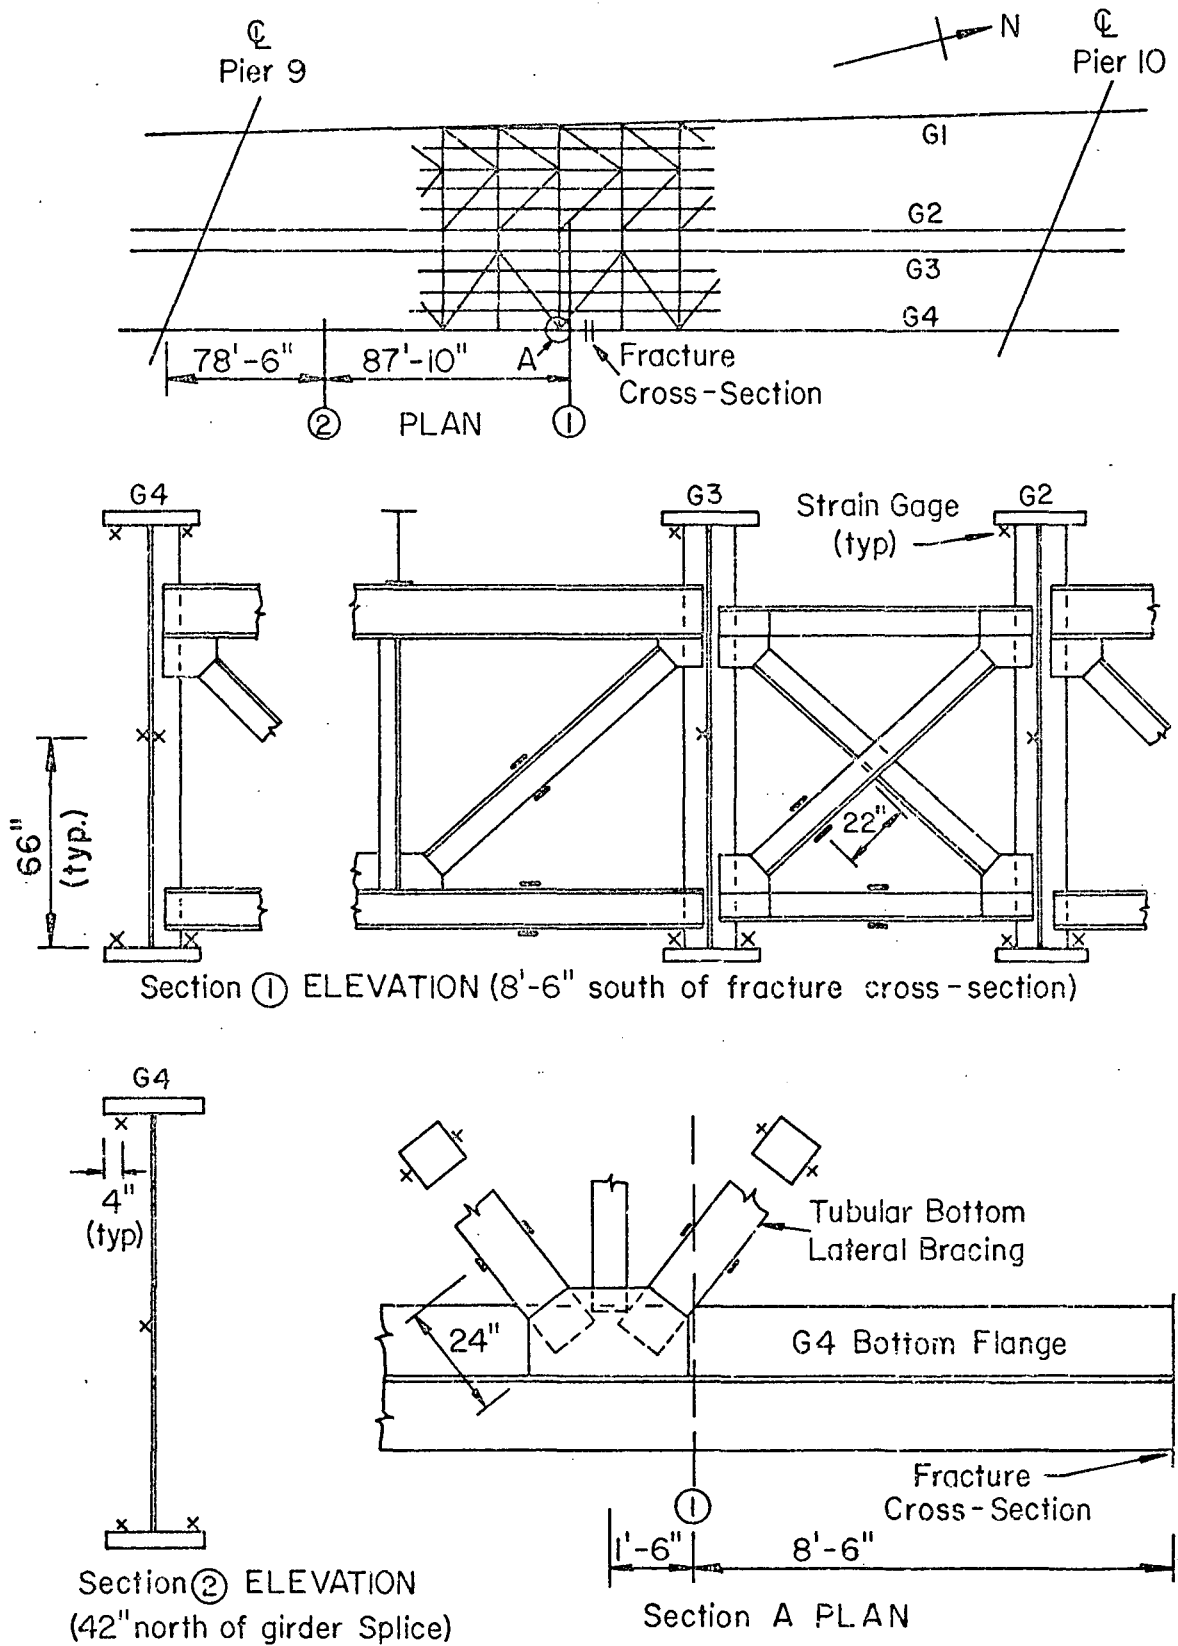
Fig. 3 Instrumentation of Bridge Members

The measured stress distributions in girders G2 and G3 are shown in Fig. 9. Figure 9a shows the stress distributions on section 1 (Fig. 3)

Table 1 shows the measured and computed strains and stresses in selected members of the floor beam truss and bottom lateral bracing system near the fracture cross section. (See Fig. 3 for location of strain gages.)

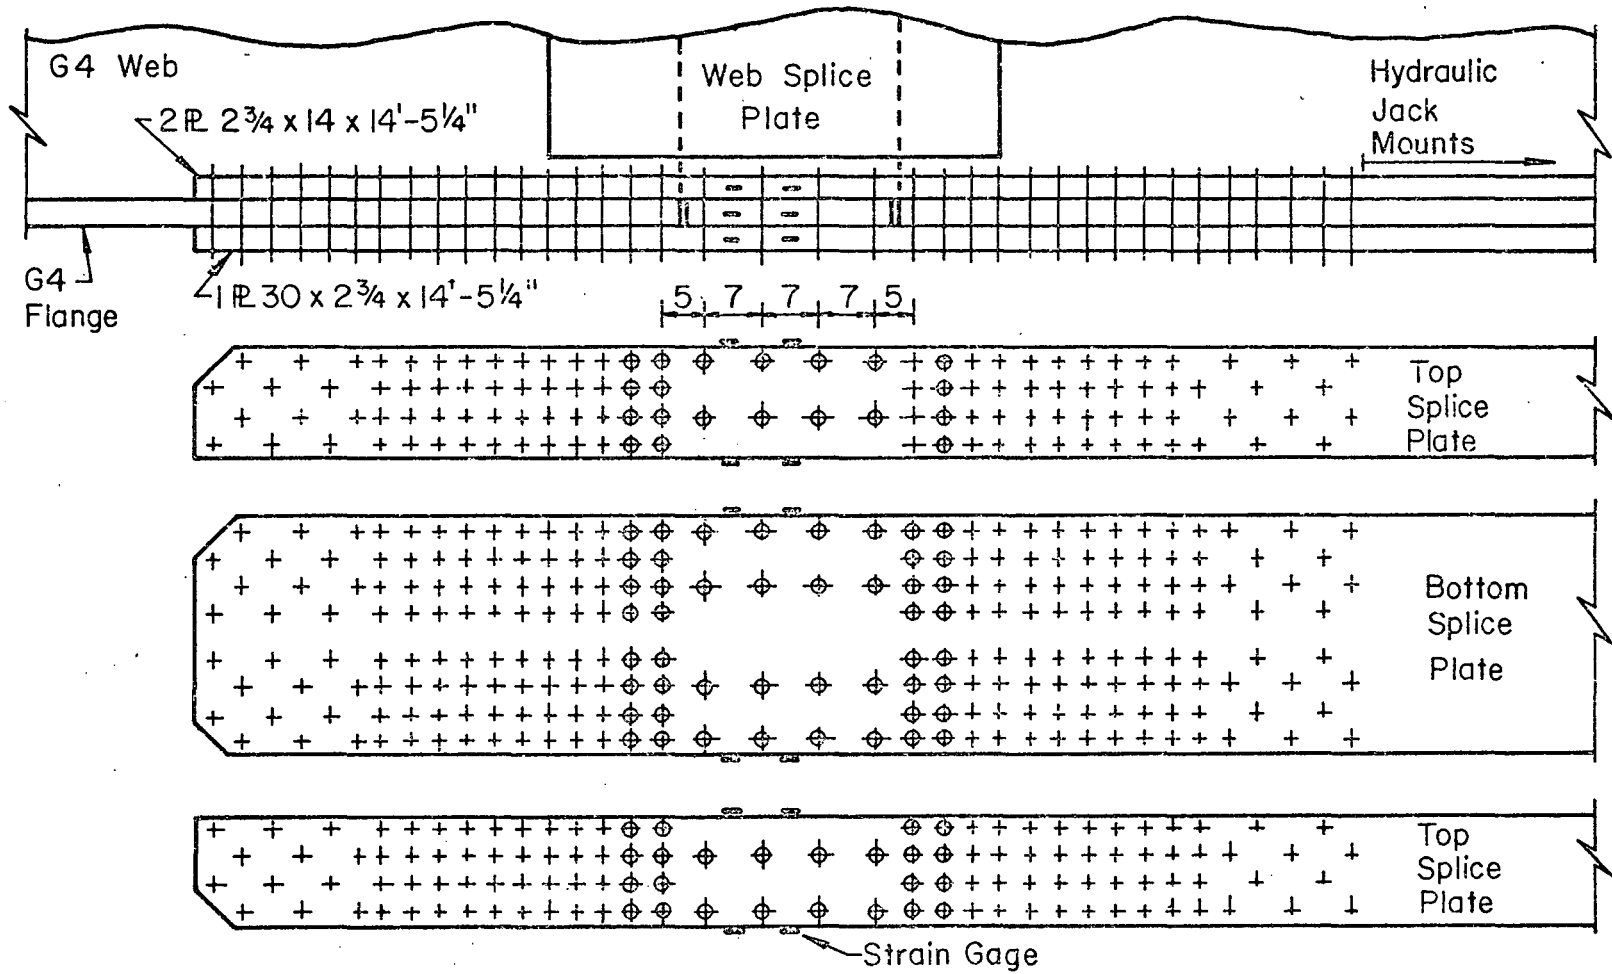
Fig. 4 Instrumentation of Splice Plates

It is evident from an examination of Fig. 7 that the splice plate force, as determined by strain gages (Fig. 4), does not completely agree with the total jack force as determined by calibrated pressure gages. The force in the splice plates is consistently lower whenever the jacks are under pressure and closing the tension flange.

2. The strain gages on the splice plates (Fig. 4) were placed in the field. The splice plates were not calibrated, thus some inaccuracy is possible in the measurement of the splice plate forces. However, errors were minimized by placing four gages on the edges of each splice plate and averaging the readings at each displacement increment.
3. Differential temperature conditions between the concrete slab and the steel superstructure also introduces stresses into the 3-span continuous structure. This is particularly noticeable from the differences between the splice plate force at S10 and S11. As noted this measured increase was observed over a thirteen-hour period (6:30 p.m. to 7:30 a.m.) when the air temperature decreased by 15°F. Measurements during June 1977 further confirmed these observations.

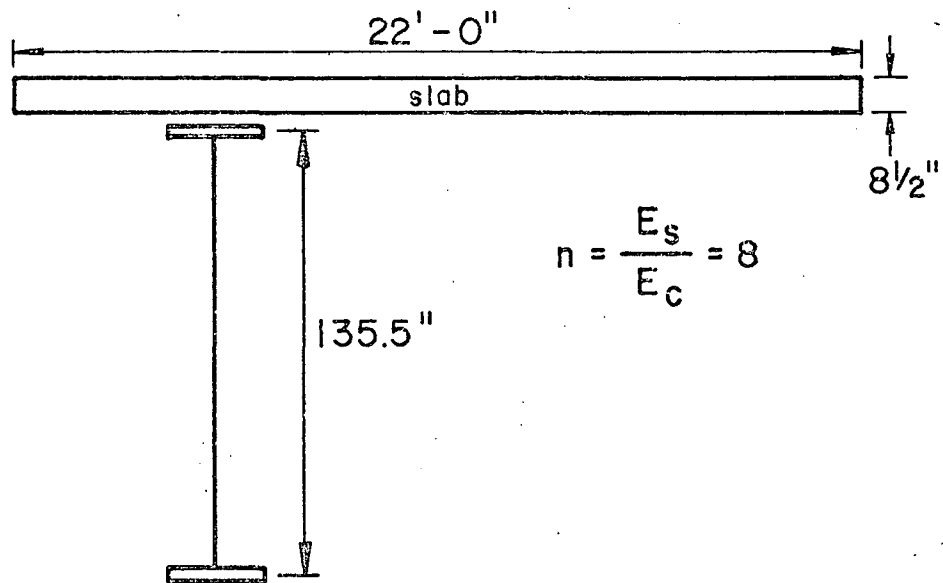
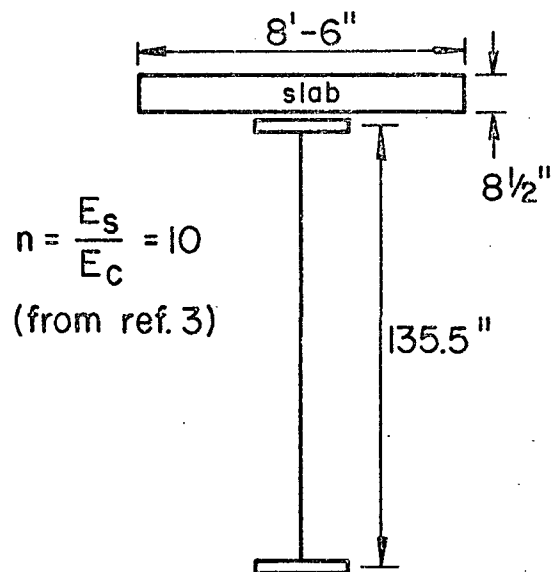
Fig. 11 Composite Girder Cross Section Used
in Finite Element Analysis

Figure 11 shows the two composite cross sections which were used in the FE analysis. The smaller cross section was selected to agree with Ref. 3 which used an 8 ft-6 in. slab together with a modular ratio, n , of 10 in predicting strains at sections 1 and 2 of girder G4 (Fig. 3) under composite action. The 22 ft slab width was selected to represent one-half the concrete roadway between girders G3 and G4 and to include the mass of concrete forming the railing wall shown on the right side of Fig. 5. A modular ratio of 8, corresponding to 4000 psi concrete, was used in transforming the 22 ft wide slab.

Figures 8a and 8b also include predicted stress profiles from Ref. 3 based upon an expected total jacking force of 1950 kips. The values given in Ref. 3 were also modified to show predicted stress profiles at the 1674 kip level. The composite section used in Ref. 3 included a slab width of 8-1/2 ft (Fig. 11).
