Fatigue tests of curved box girder assemblies, April 1980 (DOT-FH-11.8198.4) (80-20)

FATIGUE OF CURVED STEEL BRIDGE ELEMENTS

Fatigue Tests of Curved Box Girders

Interim Report

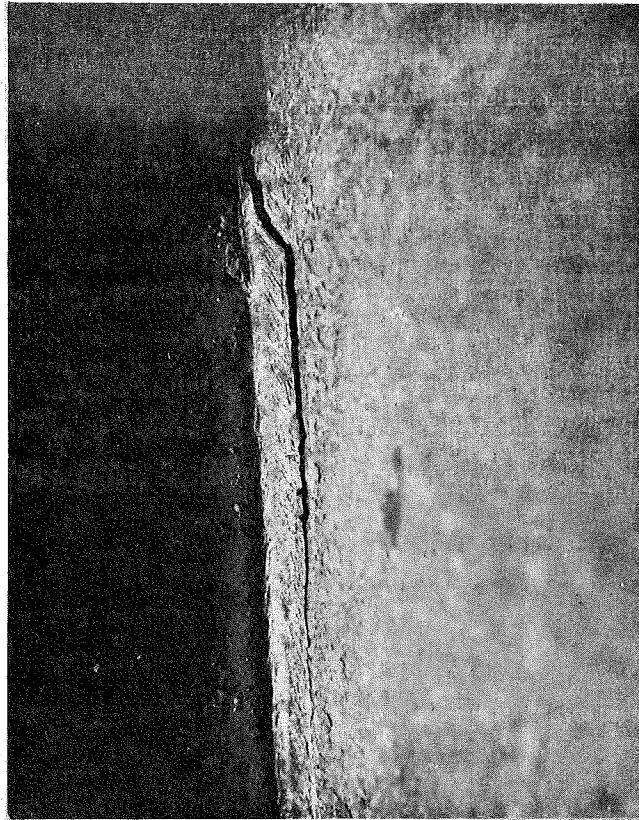
Fig. 63 Girder 3 - Diaphragm Torn
away from Web at Joint 6
as Viewed from the East
after 0.084 Million Cycles

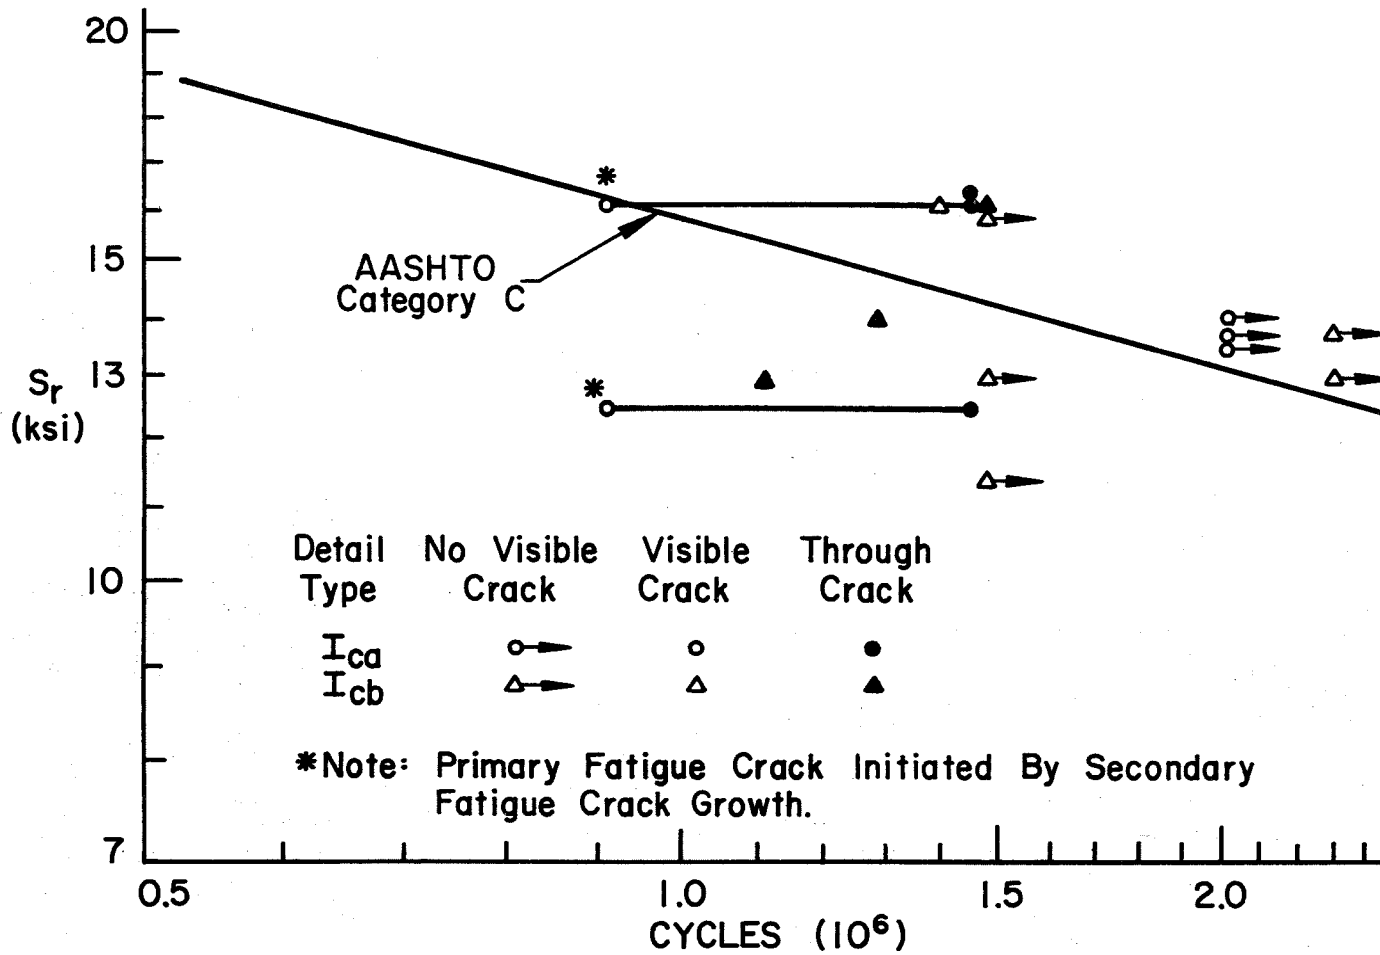
The eight Type I_{cb} details tested were subjected to stress ranges from 13.0 to 16.1 ksi. Four of these details exhibited fatigue strengths which exceed the AASHTO Category C design curve. Two Type I_{cb} details were not subjected to stress ranges high enough to evaluate their adequacy as Category C details. However, no visible cracks developed at these details prior to the end of the test. The two remaining Type I_{cb} details exhibited fatigue strengths that are significantly below the AASHTO Category C design curve.

Close inspection of these details showed that fatigue crack growth stemmed from regions marked by significant undercut at the weld toe. In addition, the detail that developed the through-thickness crack at 1.10 million cycles exhibited an extremely steep flank angle. This same detail forced the suspension of testing of Girder 2 at 1.47 million cycles when

Fig. 68 Fatigue Results - Type I_{ca} and I_{cb} Details

fatigue cracks grew through the bottom flange at a number of points, rendering repair unfeasible. Although the poor fatigue strength of these details might be justified on the basis of abnormally large initial flaw sizes the question of possible size effects arises. With a fillet-welded stiffener traversing the entire width of the bottom flange, it is more likely that such otherwise abnormally large flaw sizes may occur. However, the performance of the majority of the Type I_{cb} details indicates that with careful welding procedures and proper inspection, Type I_{cb} details will achieve fatigue strengths exceeding the AASHTO Category C design curve.

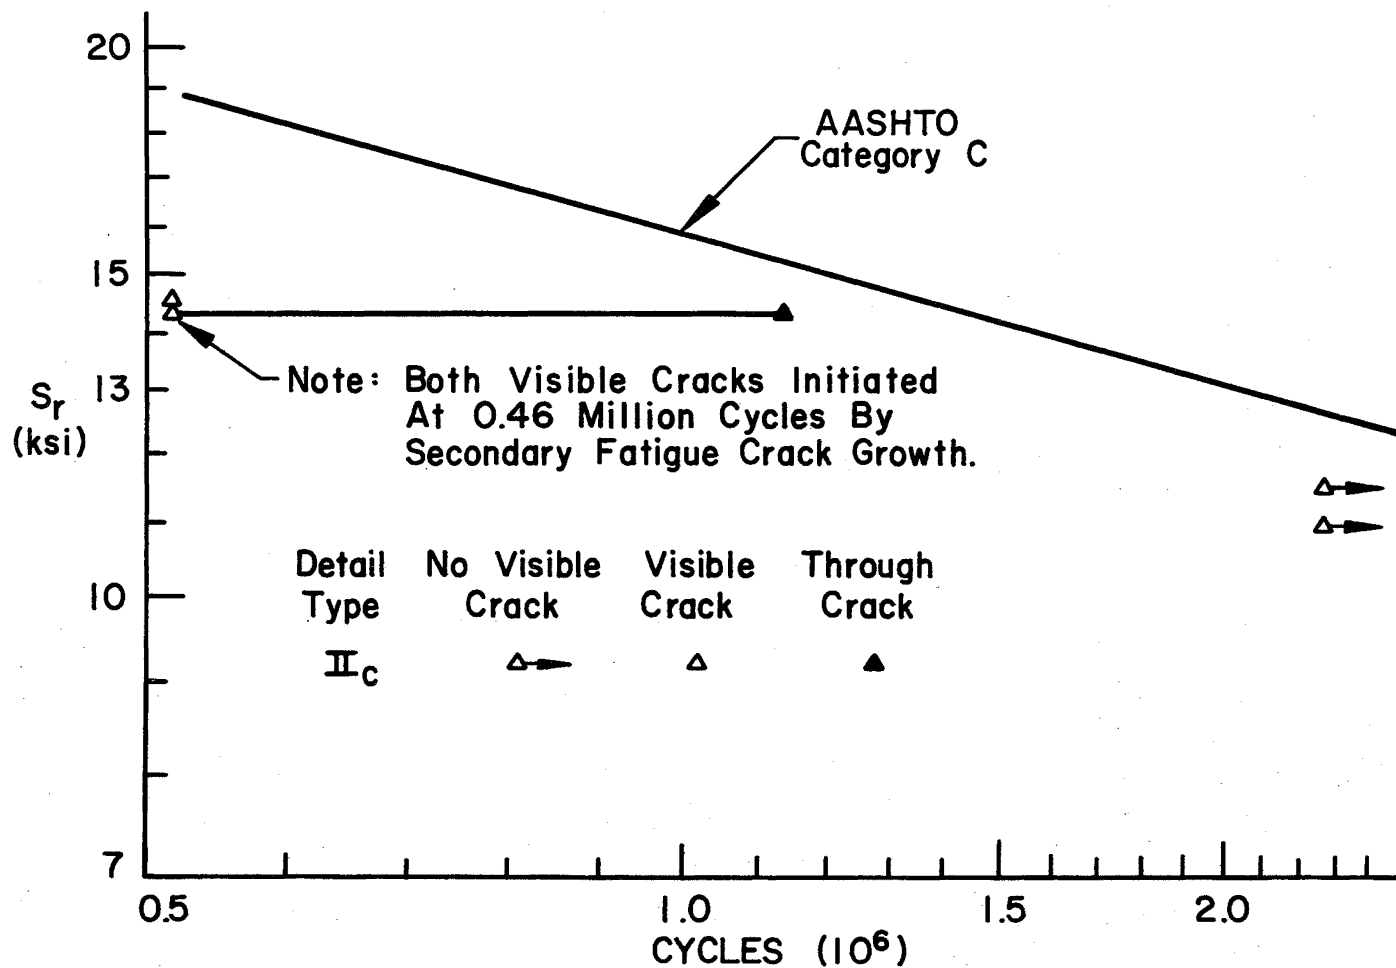
Fig. 69 Fatigue Results - Type II_c Details

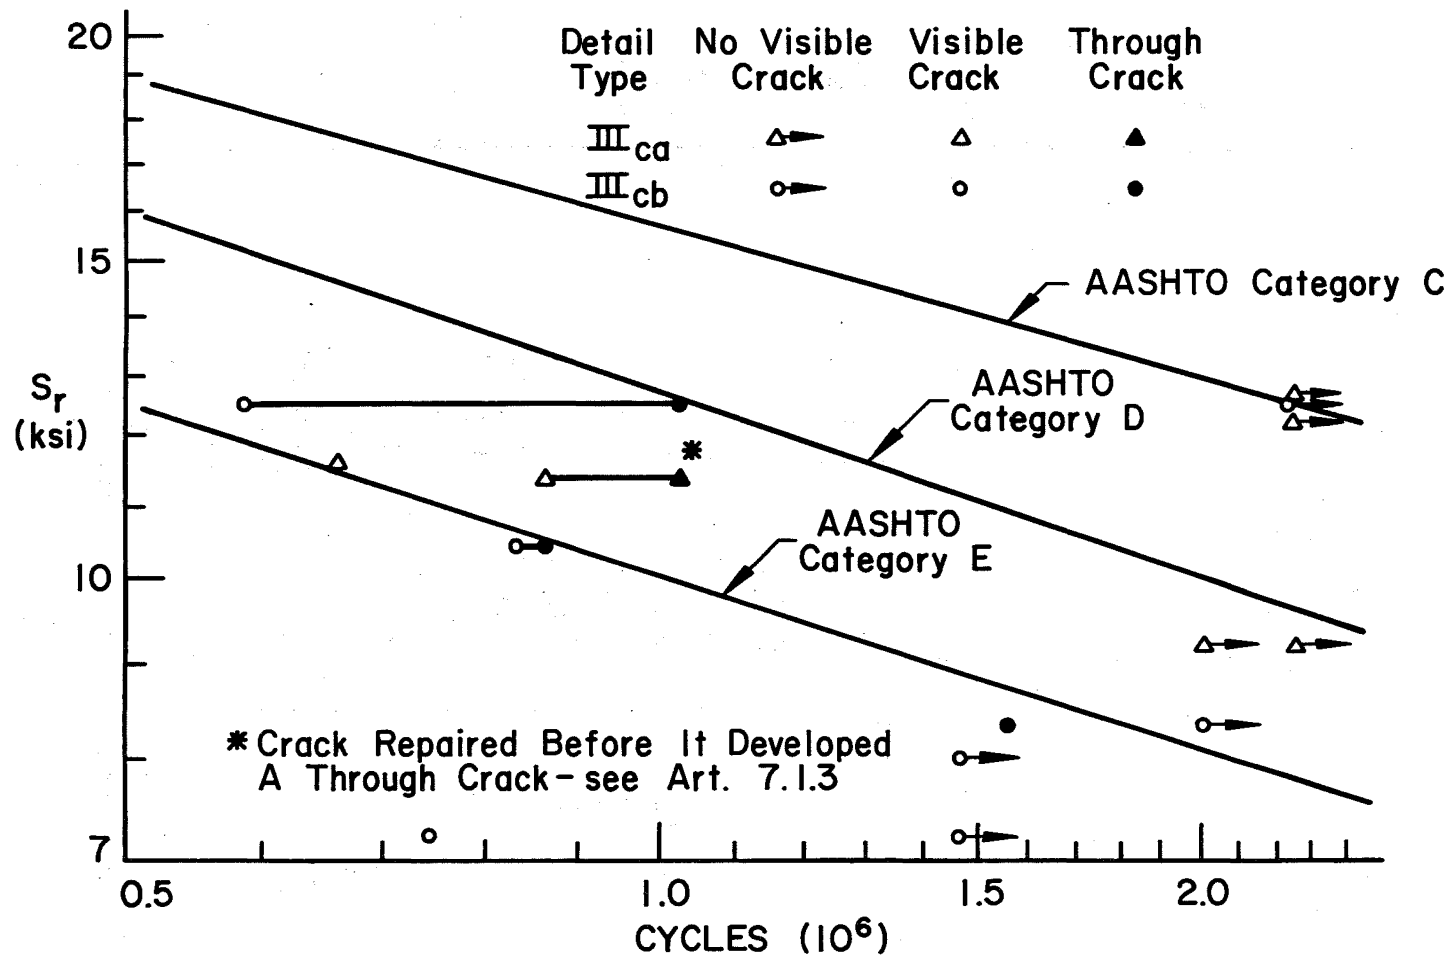
The Type III_{ca} details tested were subject to stress ranges from 9.2 to 12.6 ksi. Of the six Type III_{ca} details tested only two conclusively demonstrated the fatigue strength of an AASHTO Category C detail.

Fig. 70 Fatigue Results - Type III_{ca} and III_{cb} Details

Figure 70 also shows one Type III_{ca} detail as having developed a through-thickness crack at 1.02 million cycles. This detail actually never developed a through-thickness crack. It was repaired at 1.02 million cycles in order to permit continued fatigue testing over a weekend when a repair would have been impossible. The stress ranges at the three remaining Type III_{ca} details were not adequate to permit conclusive determination of their fatigue strengths. Further study of Type III_{ca} details is warranted before it can be considered an AASHTO Category C detail.

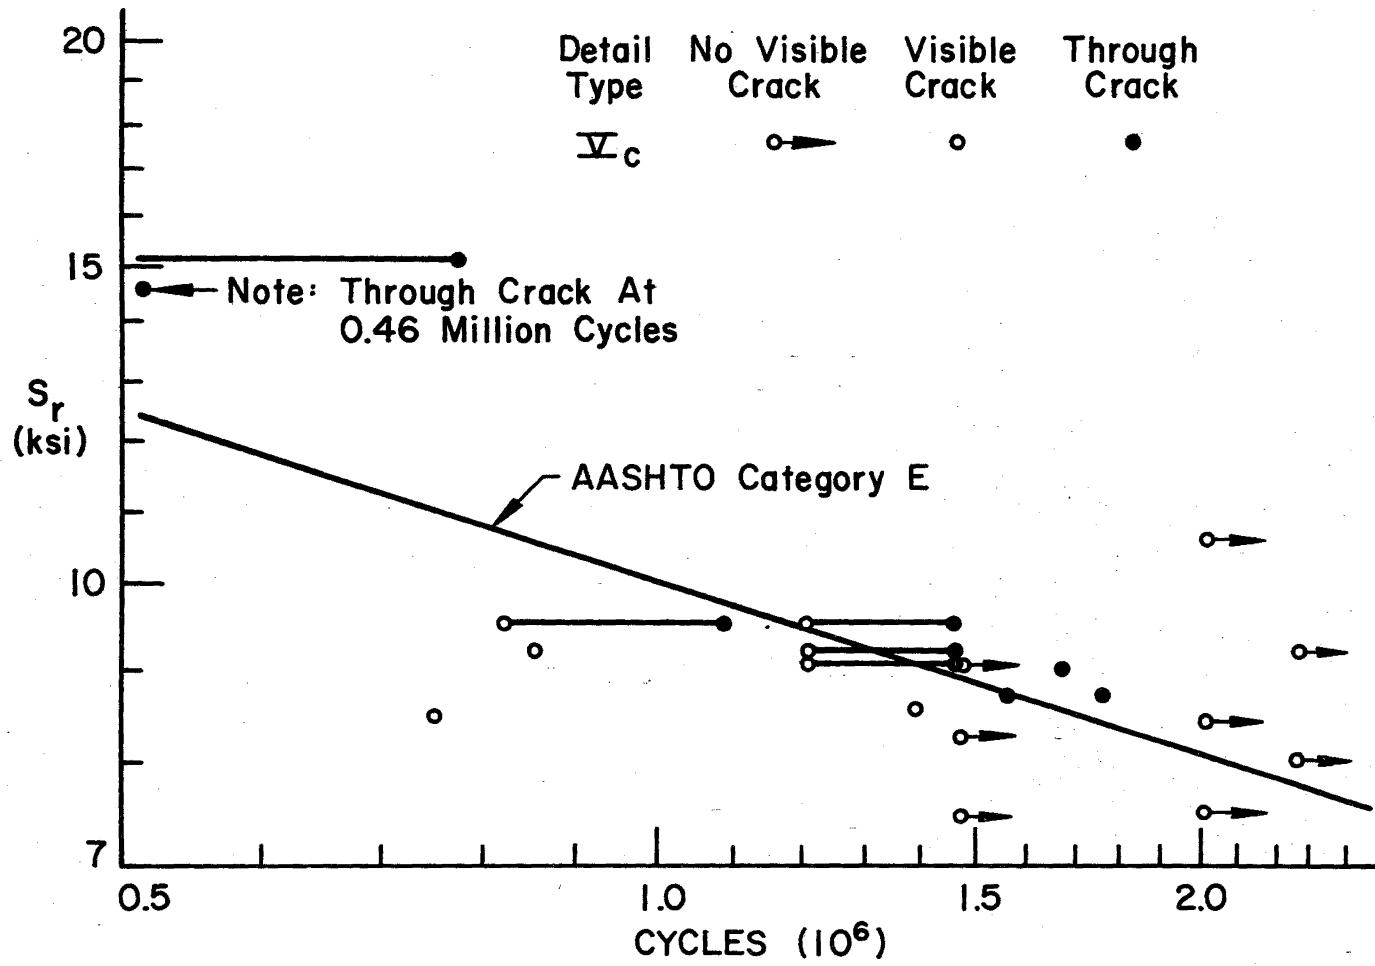
The Type V_c details were subject to nominal stress ranges of 7.4 to 15.1 ksi. Although several Type V_c details did not experience stress ranges high enough to demonstrate their adequacy as Category E details, the fatigue tests constituted a valid test of fourteen Type V_c details. Of these details, only one demonstrated a fatigue strength below the Category E design curve. The premature failure of this detail may be explained in terms of the statistical nature of the detail category design

Fig. 72 Fatigue Results - Type V_c Details

curves. The AASHTO design curve (lower bound) is selected as the 95% confidence of 95% survival.⁽¹⁹⁾ On this basis then, the AASHTO detail Category E adequately describes the fatigue strength of the Type V_c details tested.

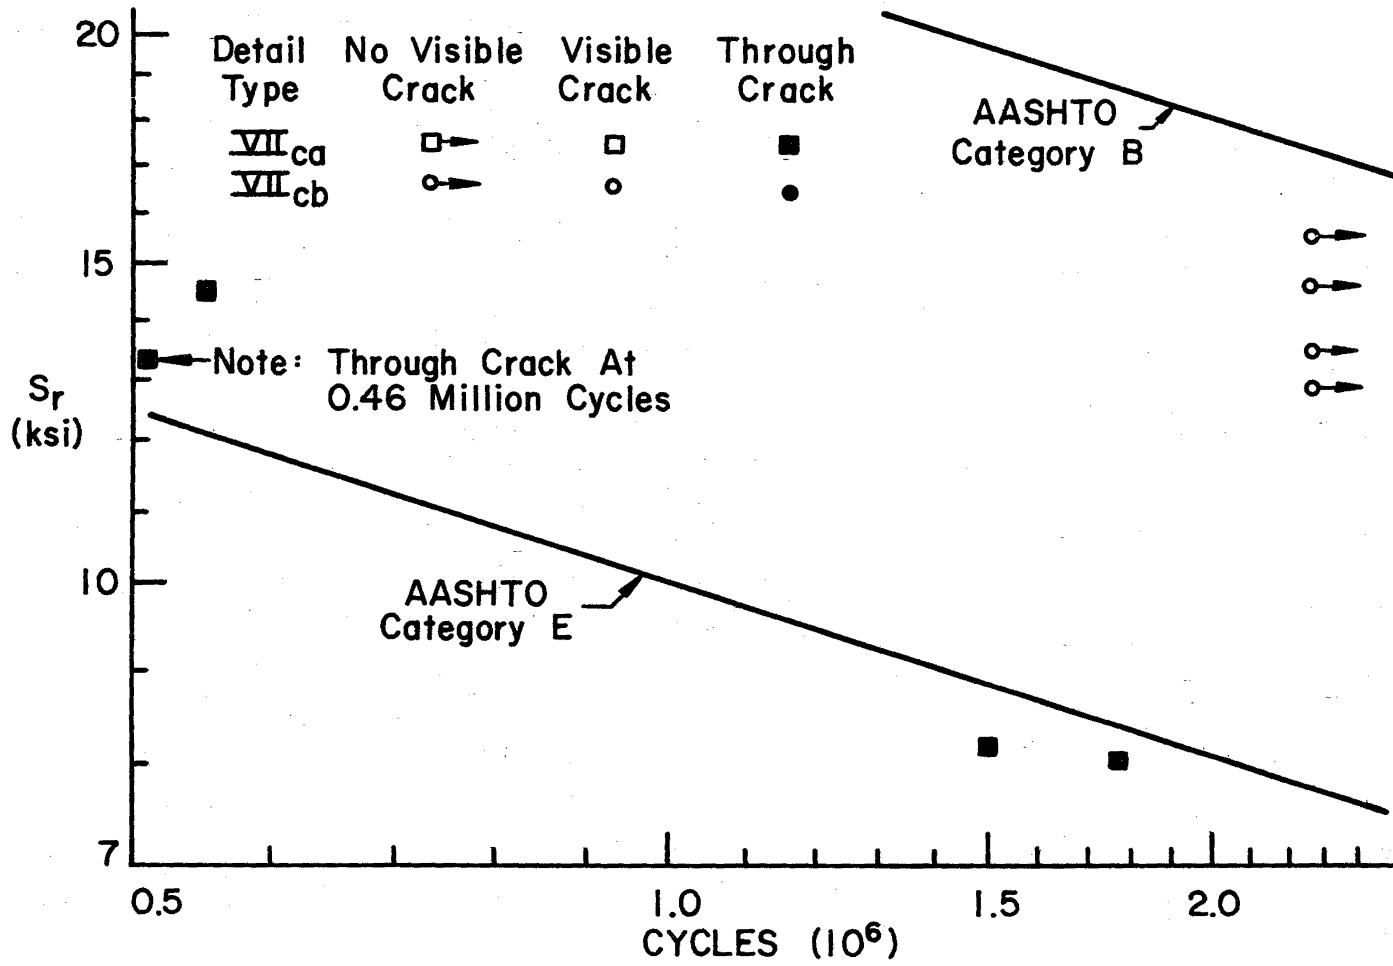
Fig. 74 Fatigue Results - Type VII_{ca} and VII_{cb} Details

All Type VII_{ca} details developed visible cracks prior to 83,400 cycles. These fatigue cracks began at the backup bar discontinuity. After growing through the tack weld across the backup bar discontinuity, the fatigue cracks progressed through the thickness of the flange as shallow surface flaws. Through cracks developed at 0.46 million to 1.76 million cycles due to nominal stress ranges from 14.5 to 8.0 ksi, respectively. As shown in Fig. 74 the observed fatigue strengths of two of the Type VII_{ca} details fall significantly below the AASHTO Category E design curve.

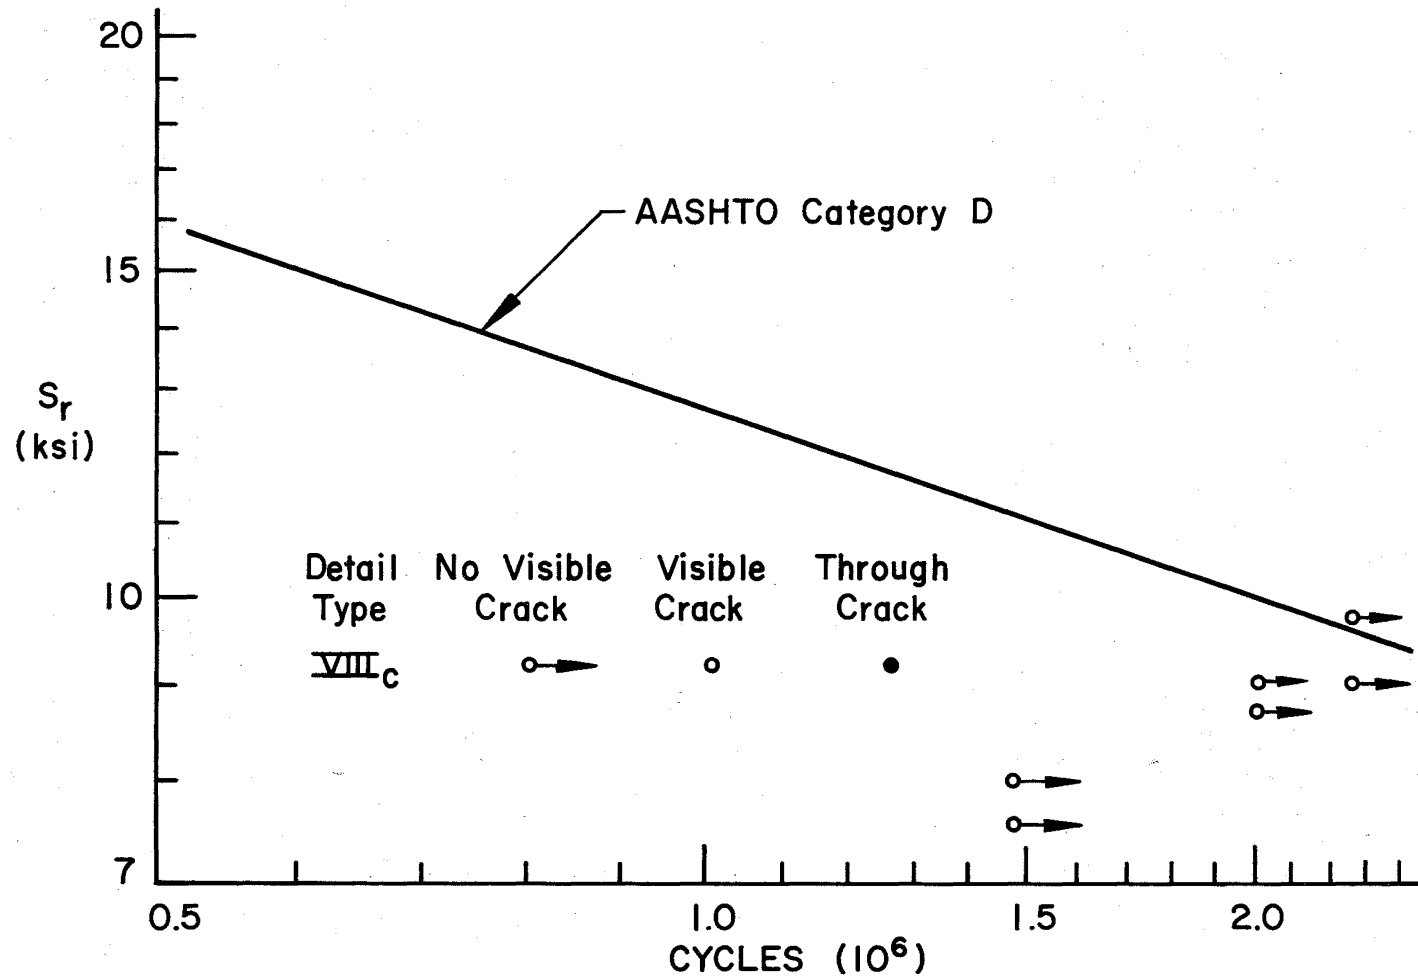
Fig. 75 Fatigue Results - Type VIII_c Details

The fatigue test results for six Type VIII_c details are shown in Fig. 75. The results for three other Type VIII_c details are not shown because the nominal stress ranges fall below 7.0 ksi. None of the Type VIII_c details tested developed visible or through-thickness cracks.

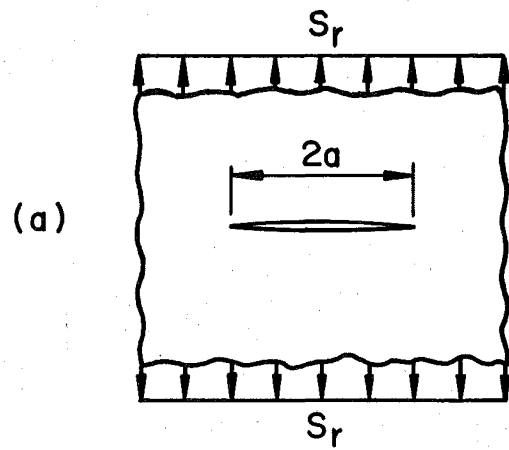
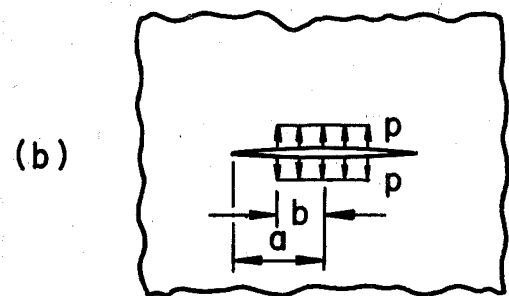
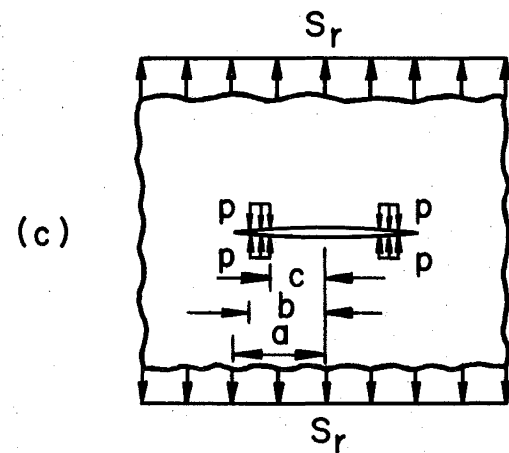
Fig. C1 Crack Tip Stress Solutions

For example, consider a through-thickness crack, 3 inches long ($a = 1.5$ in), in an infinite plate subjected to a stress range of 15 ksi. The corresponding range of the stress intensity is 32.6 ksi/ $\sqrt{\text{in}}$. The suggested repair of this fatigue crack consists of drilling 13/16 inch diameter holes located as shown in Fig. C2 and installing 3/4" diameter A325 high strength bolts. Locating the edge of the holes at the crack tips as shown, ensures that the bolts will be fully effective in reducing ΔK . The bolts are installed by the turn-of-the-nut procedure.

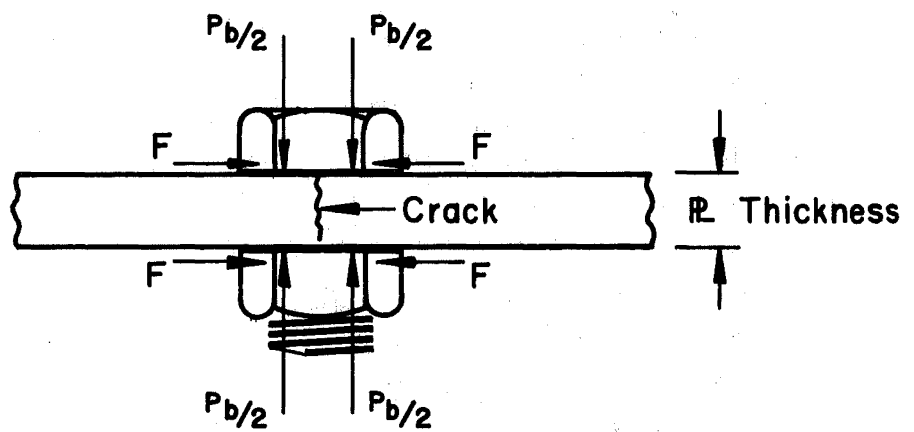
Fig. C3 Normal and Frictional Forces Developed
Beneath the Head and Nut of a Bolt

Friction beneath the head and nut of the high-strength bolts generates the normal and friction forces shown in Fig. C3. These forces

tend to resist the crack opening displacements. For a 3/4" diameter A325 bolt, the crack closing force, P, is equal to 6.63 K/Bolt. Distributing the crack closing force, P, over the width of the bolt head across the flats and the thickness of the plate, t, results in a uniform crack surface traction, p, equal to 14.1 ksi. The solution for the range of the stress intensity shown in Fig. C1(c) then yields a ΔK equal to 8.5 ksi $\sqrt{\text{in}}$. Thus, the repair of the fatigue crack results in a 74% reduction in the range of the stress intensity for the given fatigue crack and stress conditions.
