Characterization of corrosion fatigue damage in the fastener holes of a Boeing 707

**CHARACTERIZATION OF CORROSION FATIGUE DAMAGE IN
THE FASTENER HOLES OF A BOEING 707**

A Thesis
—Presented to the Graduate and Research Committee
of Lehigh University
in Candidacy for the Degree of
Master of Science

Lehigh University
April 2001

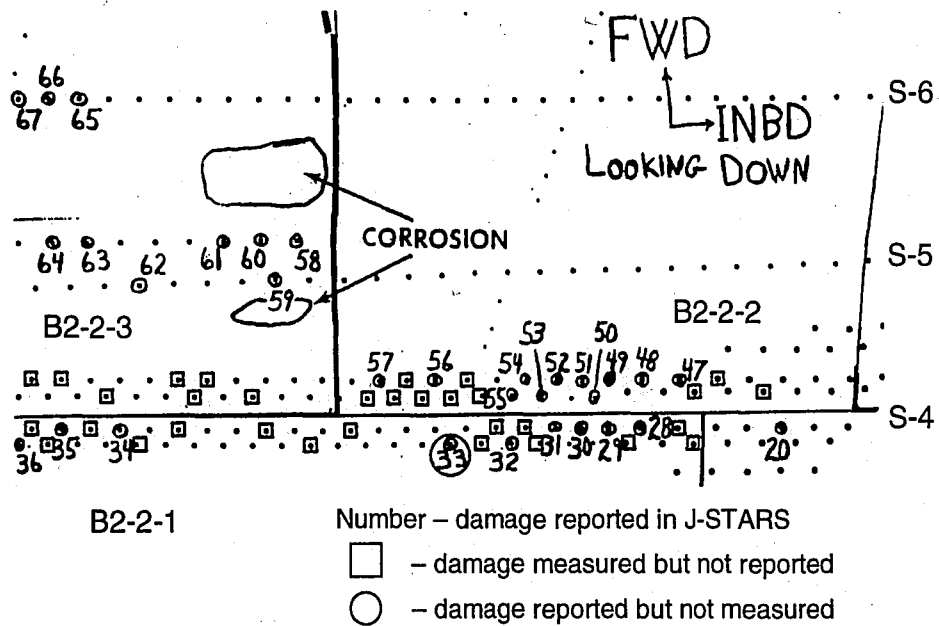
Using the Hi-Scope™ system, 110 holes from panel B2-2 along stiffener 4 (S-4) were observed and the findings were compared to those in the initial J-STARS report. Figure 2.6 shows the panel and stiffener that were inspected. The numbered holes in the figure are those in which damage was observed by the J-STARS analysis. Thirty-two additional holes that are circumscribed with a square were found to have damage by using the Hi-Scope™, and these holes were not included in the J-STARS report. Only hole #33 was reported to have damage, but none was observed [18]. Figure 2.7 is a comparison of the probability of occurrence (PoO) for all MHWC lengths reported in J-STARS compared to those measured at Lehigh University with the Hi-Scope™.

Figure 2.6: A portion of Section 2 along Stiffener 4 from the CZ-184 aircraft for which microscopy and statistical analyses are made [18].

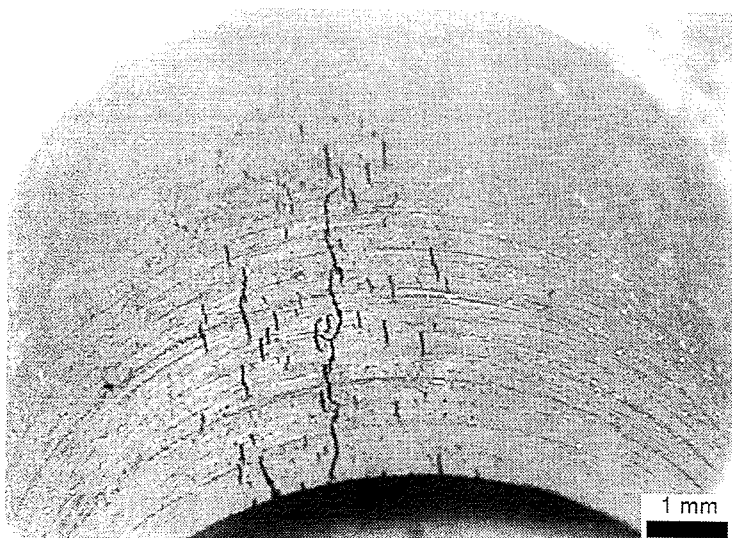
In order to evaluate the extent of damage in fastener holes, several highly damaged holes were examined carefully by optical microscopy. Hole #107 and hole #103 of panel B3-2-2 are shown respectively in Figure 2.11 and Figure 2.12 to highlight the magnitude of MWHCs. The longest crack measured was 4.78 mm in a skin section of thickness 9.65 mm, or about 50% of the thickness. For a bore thickness of 6.22 mm, the crack is approximately 75% of this thickness. Furthermore, it can be seen that the dominant crack resulted from the coalescence, or link-up, of several other cracks [18].

Figure 2.11: Optical micrograph of a highly stressed region of hole #107 in wing panel B3-2-2 of the CZ-184 aircraft showing extensive corrosion fatigue cracking [18].

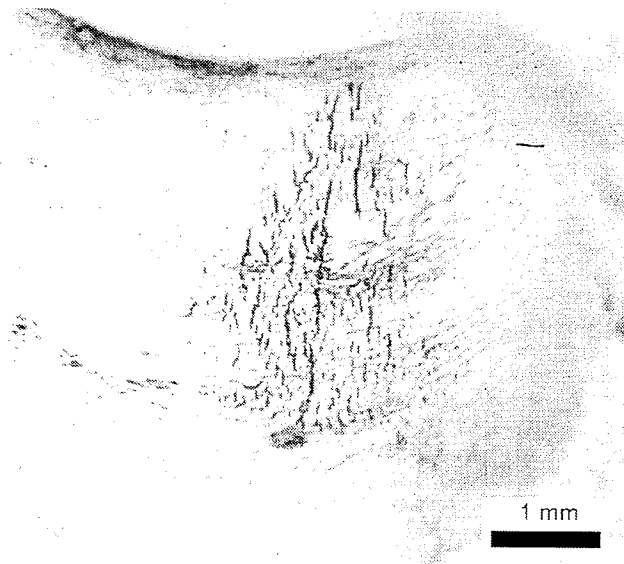
Figure 2.12: Optical micrograph of a highly stressed region of hole #103 in wing panel B3-2-2 of the CZ-184 aircraft showing extensive corrosion fatigue cracking [18].

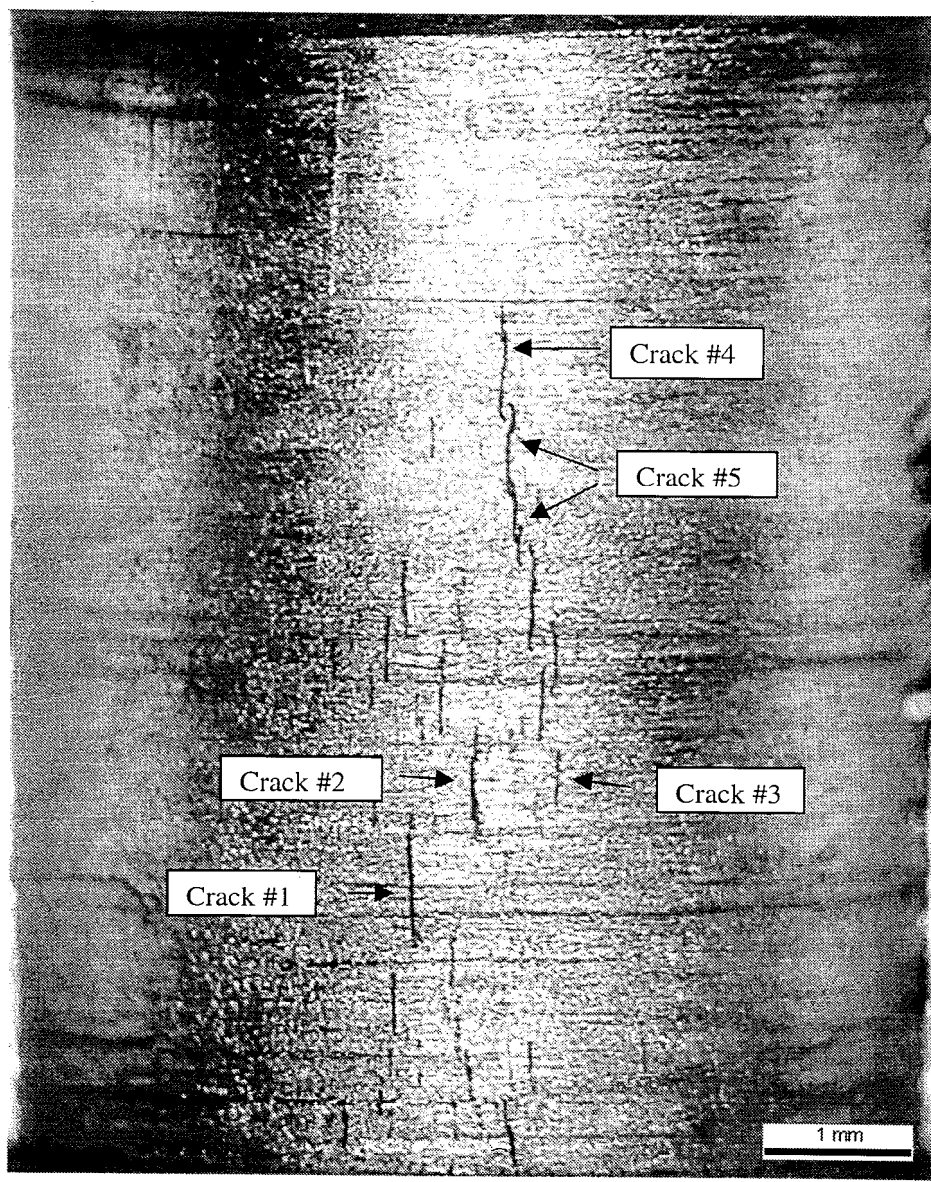
Figure 4.1: 50X Optical micrograph of hole #32 on panel B3-2-6 prior to serial sectioning.

The profile and crack growth trend for Crack #4 in hole #32 on panel B3-2-6 is shown in Figure 4.15. Recall that the profile of this crack contains error because serial sectioning did not begin at a point where the entire shallow damage region was included for analysis. Rather, serial sectioning began at approximately 0.20mm into the shallow damage region, so error bars have been added to the data points. It appears that the shallow damage, which unfortunately was not considered, transitions into more severe damage shortly before linking-up with the main crack. The main crack (solid curve) grew for some time before linking with the shallow damage (dashed curve) to form a dominant crack. If growth continued, eventually the main crack would have engulfed the shallow damage and continued to grow as the dominant crack, which may have later linked-up with Crack #5, as potentially seen in Figure 4.1.

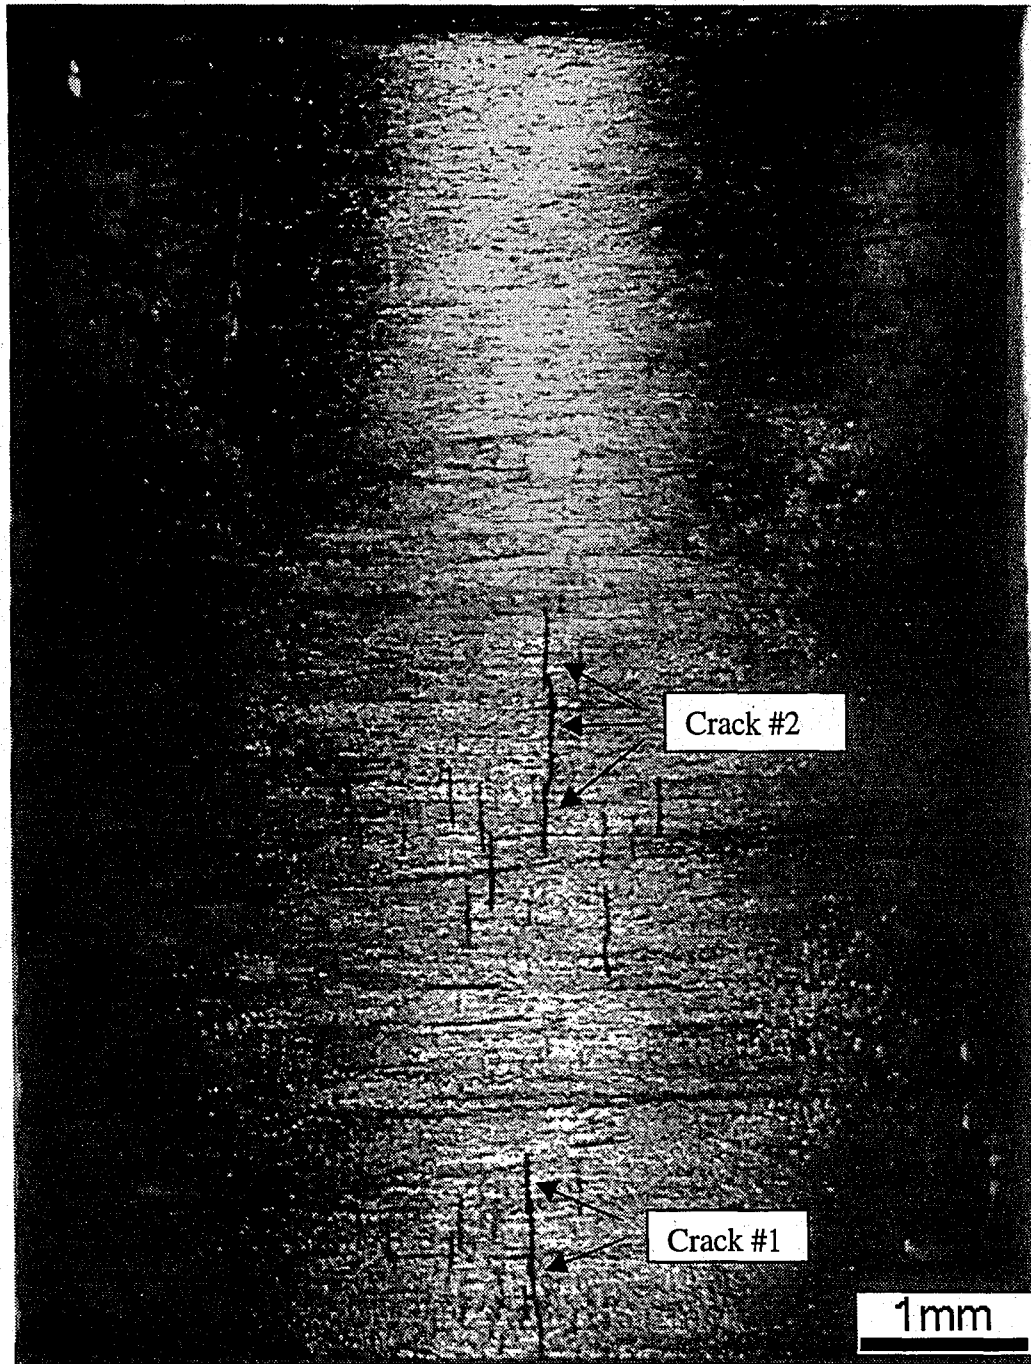
Figure 4.2: 50X Optical micrograph of hole #107 on panel B3-2-2 prior to serial sectioning.

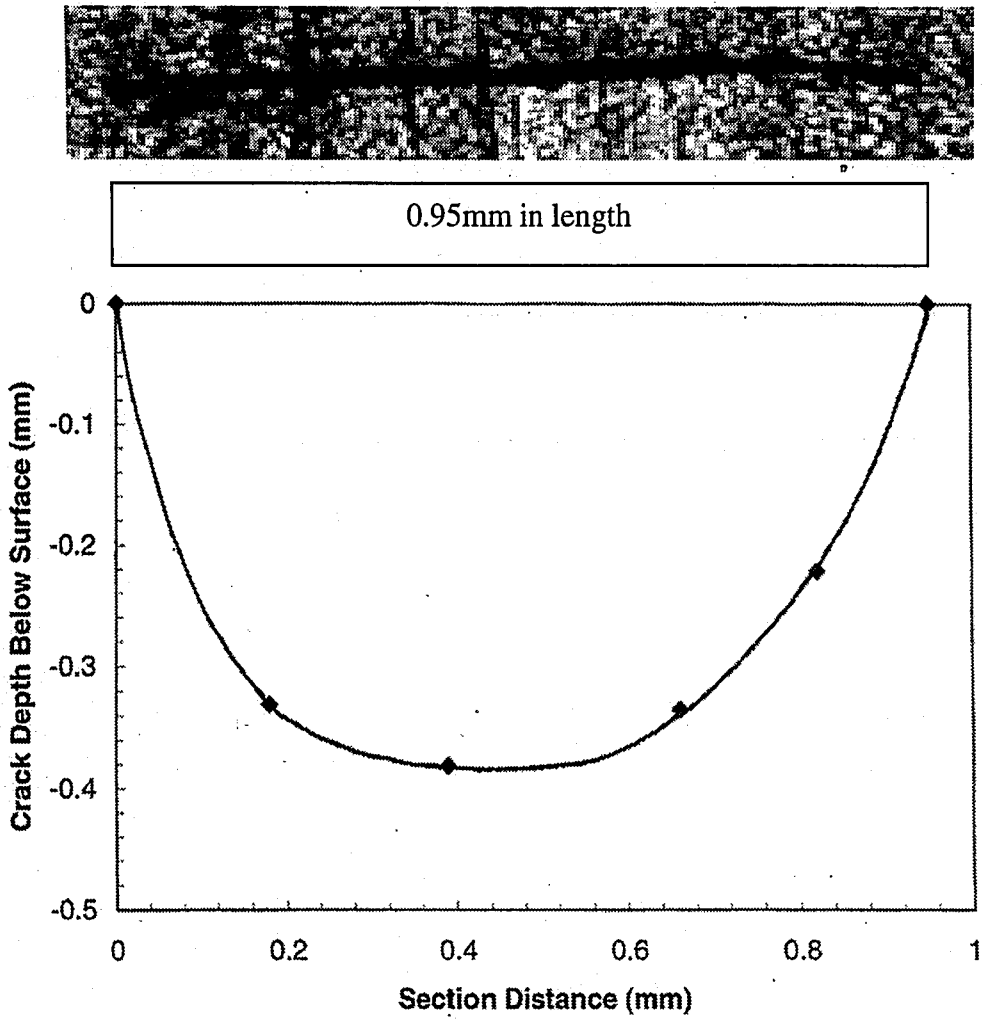
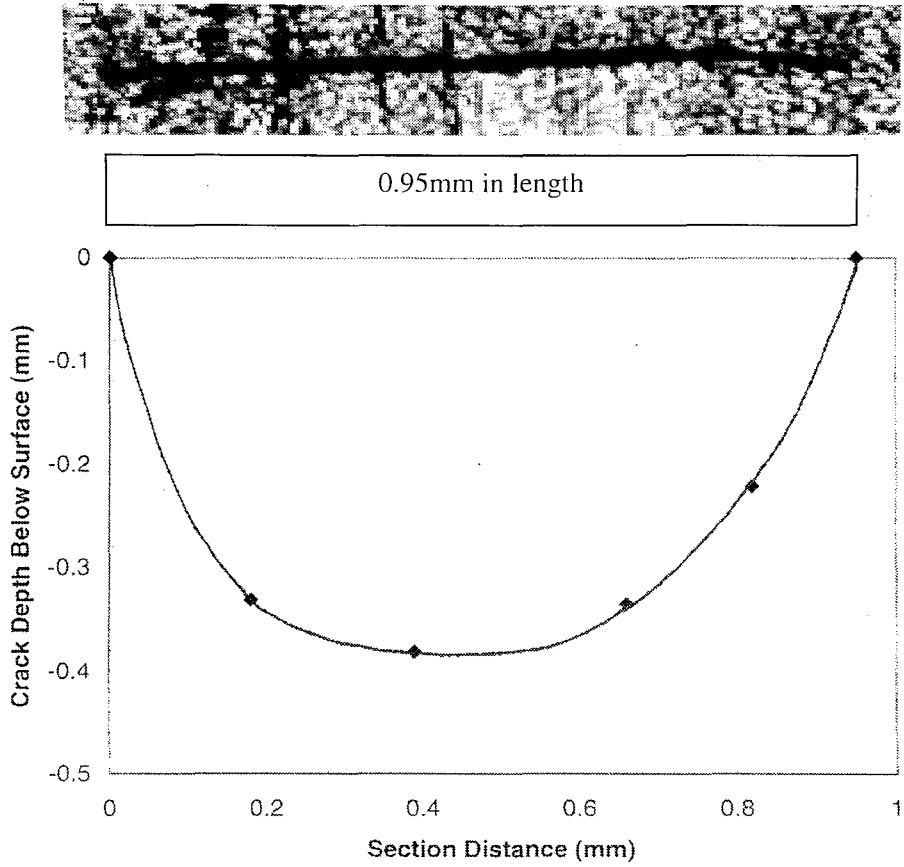
The constructed profiles for Crack #1 and Crack #3 in hole #32 on panel B3-2-6 are shown in Figures 4.11 and 4.12, respectively. These cracks originated from a single nucleation site and propagated as shown in the profile. Both are practically semi-

elliptical in shape, with the deepest section at a depth of about 40% of the crack length. It should be noted that there may be measurement error in the zero reference point for Crack #3. A pit located to the left of the crack may have served as the zero reference point, and this discrepancy is shown by a dashed curve in Figure 4.12. Neither of these cracks has encountered other damage sites, and are thereby isolated cracks that can be modeled as single dominant cracks, as done previously [1]. However, since the cracks are semi-elliptical in shape as opposed to semi-circular as used in the mechanistically based probability model, modifications to the model should be made to incorporate the geometrical variations.

Figure 4.11: Constructed profile showing the growth trend of Crack #1 in hole #32 on panel B3-2-6. Crack #1 is a single, isolated crack.

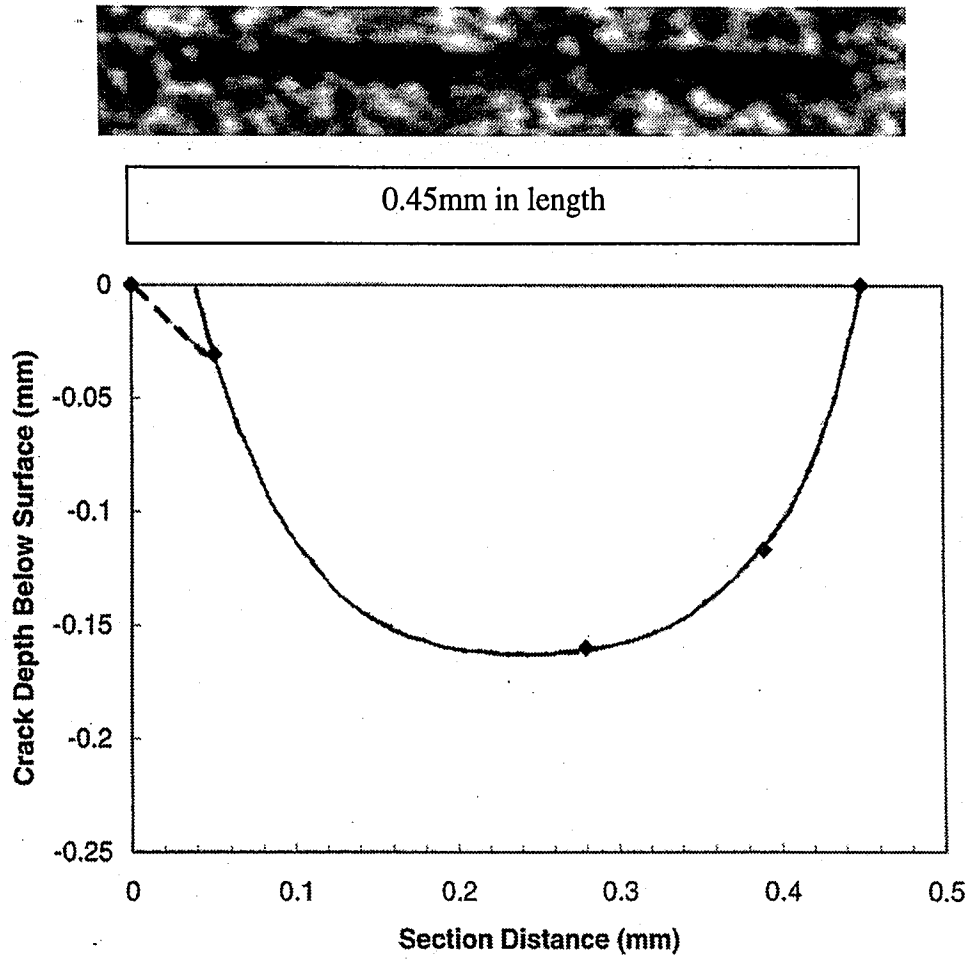
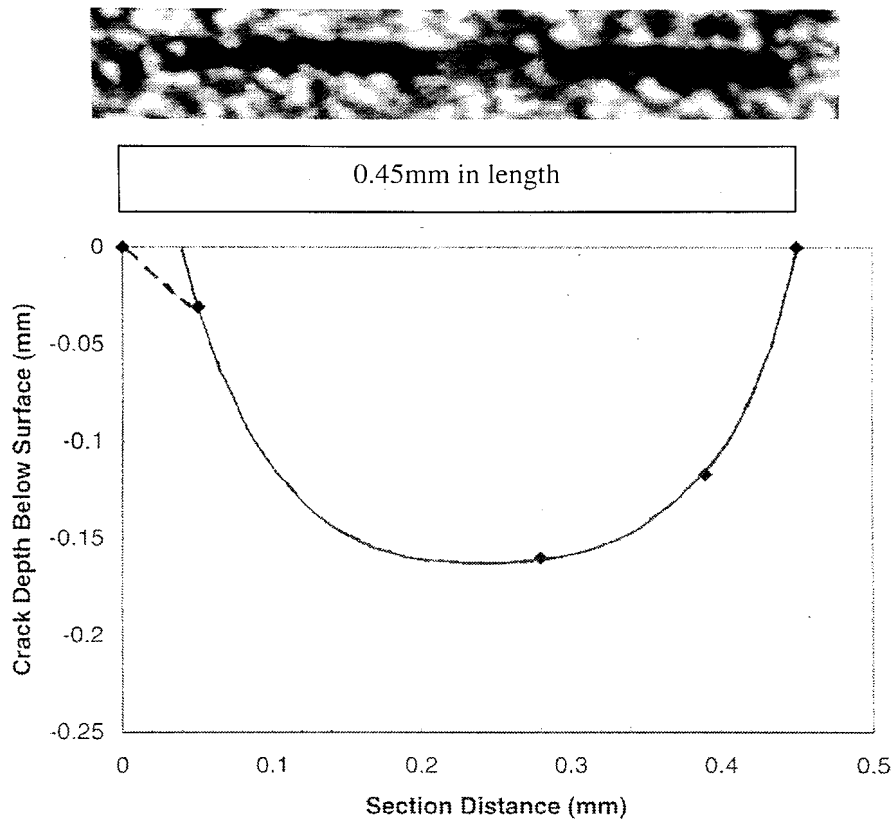
Figure 4.12: Constructed profile showing the growth trend for Crack #3 in hole #32 on panel B3-2-6. Crack #3 is a single, isolated crack.

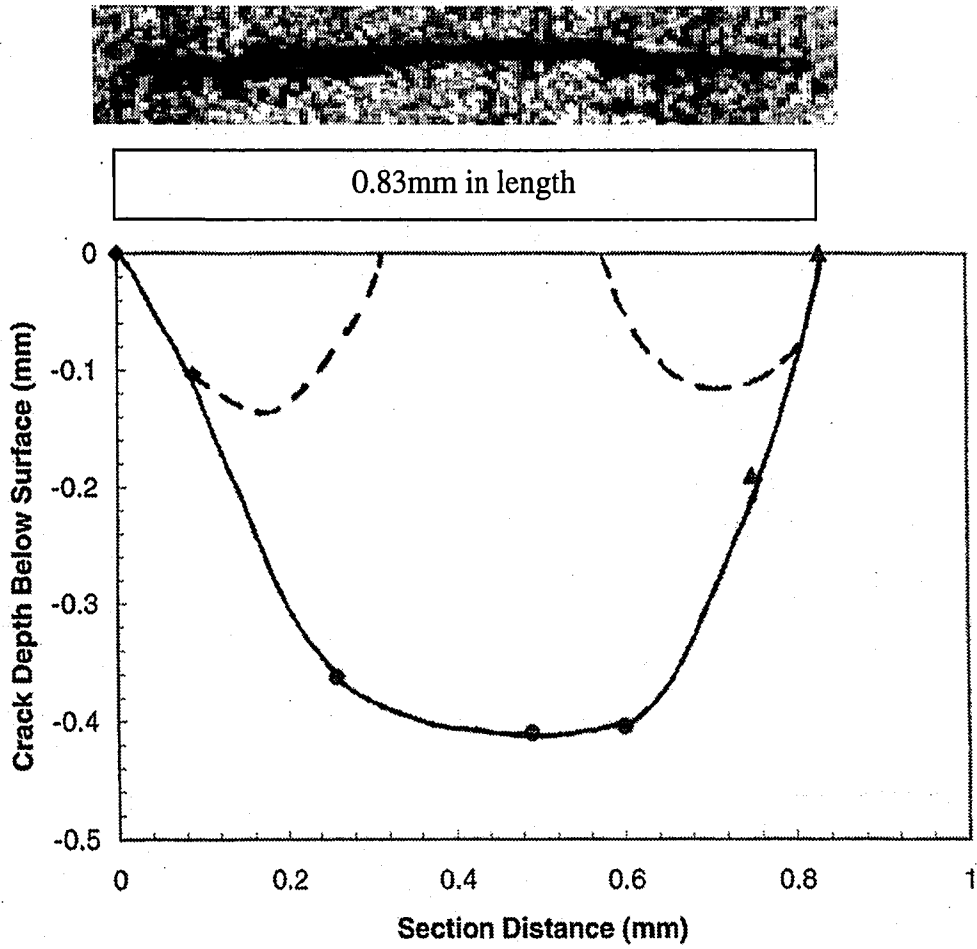
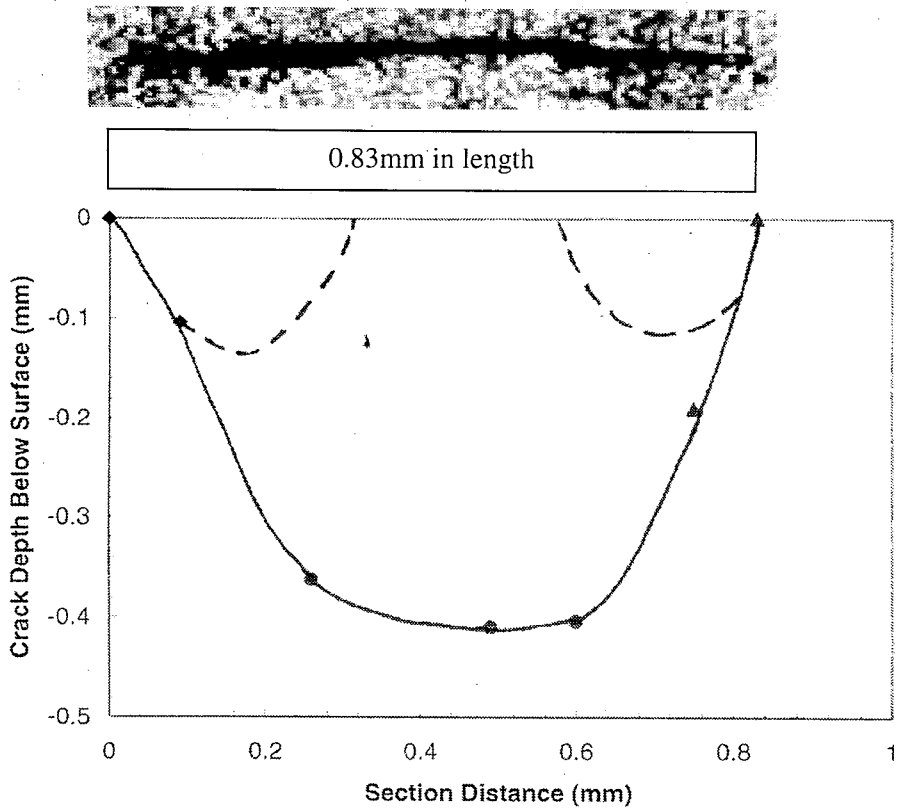
are shown in Figure 4.14. The dominant crack profile is shown as a solid curve, and the dashed curves represent the smaller multiple cracks. It appears that the left and right link-up sites are shallow damage that linked with more severe elongated damage, joined, and propagated as a dominant crack. The longest damage was the earliest to nucleate from a flaw site since the crack is deepest (0.41mm) at a section in this region. The shallow damage sites formed later, grew independently for some time, and later linked-up with the elongated damage to grow as one crack, as shown in Figure 4.14. Possible refinements to the mechanistically based probability model based on this profile may include information on individual crack growth at the multiple sites during the early stages, and the transition to a dominant crack at the later stages.

Figure 4.14: Constructed profile showing the growth trend for Crack #2 in hole #32 on panel B3-2-6. Crack #2 consists of multiple cracks.

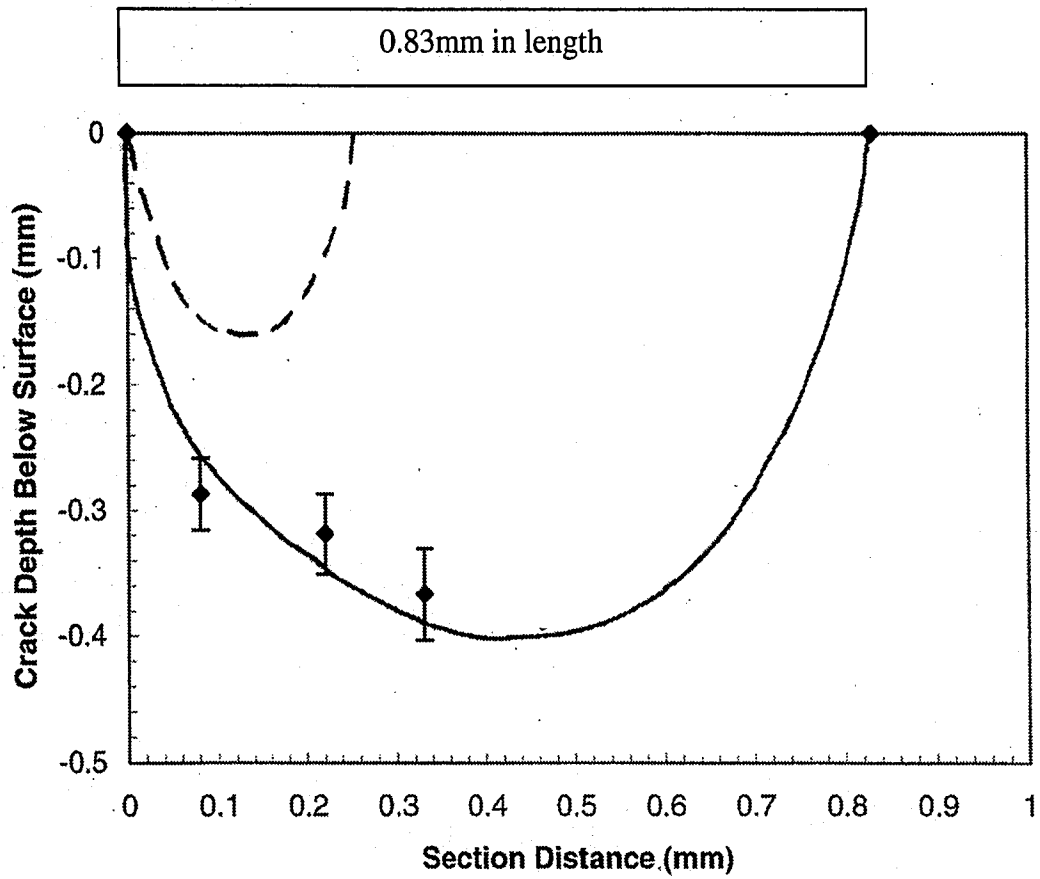
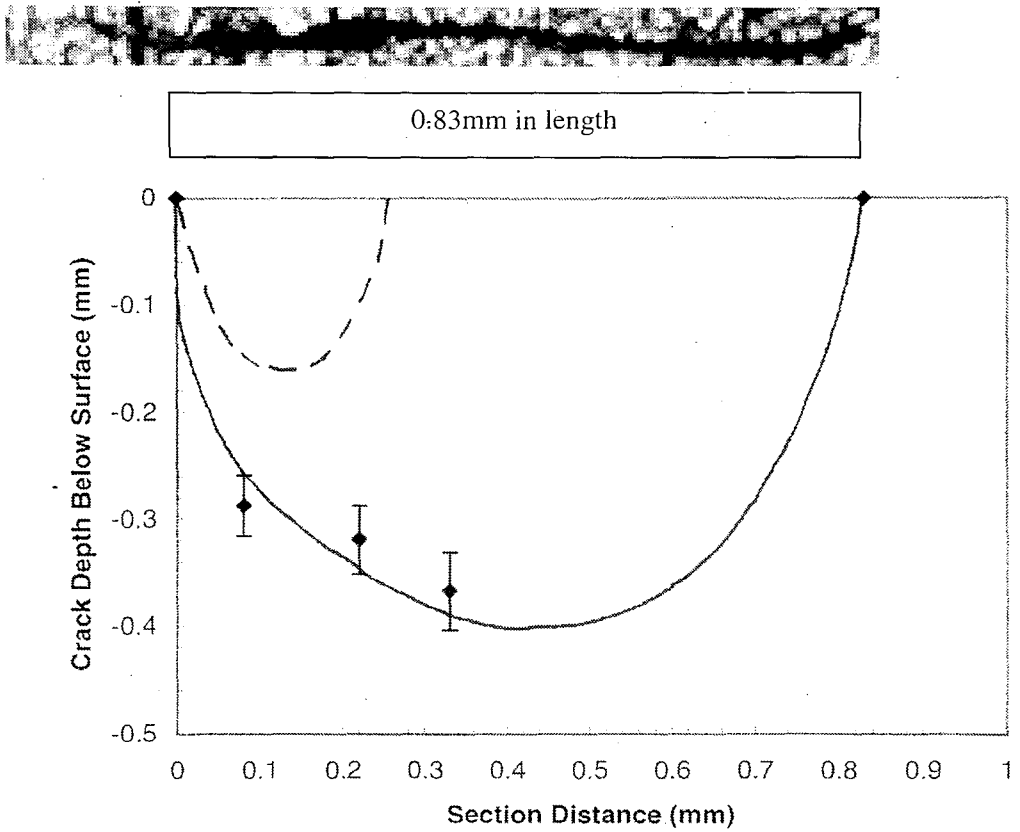
Figure 4.15: Constructed profile showing the growth trend for Crack #4 in hole #32 on panel B3-2-6. Error bars are as a result of measurement error. Crack #4 consists of multiple cracks.

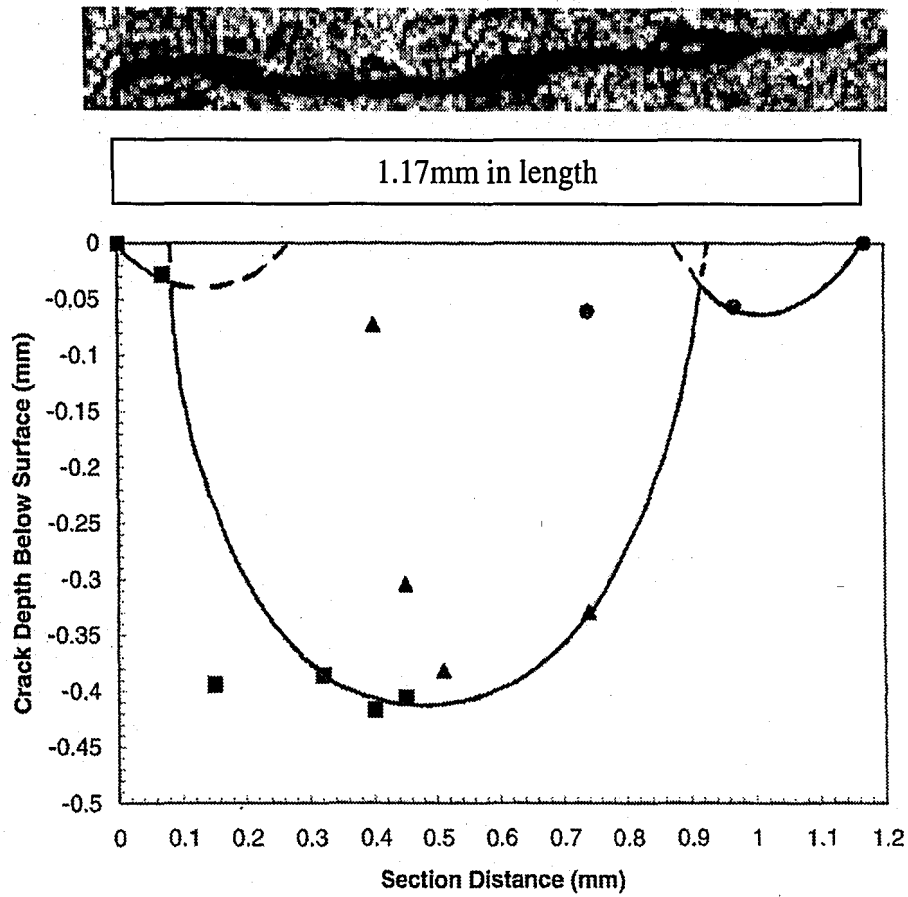
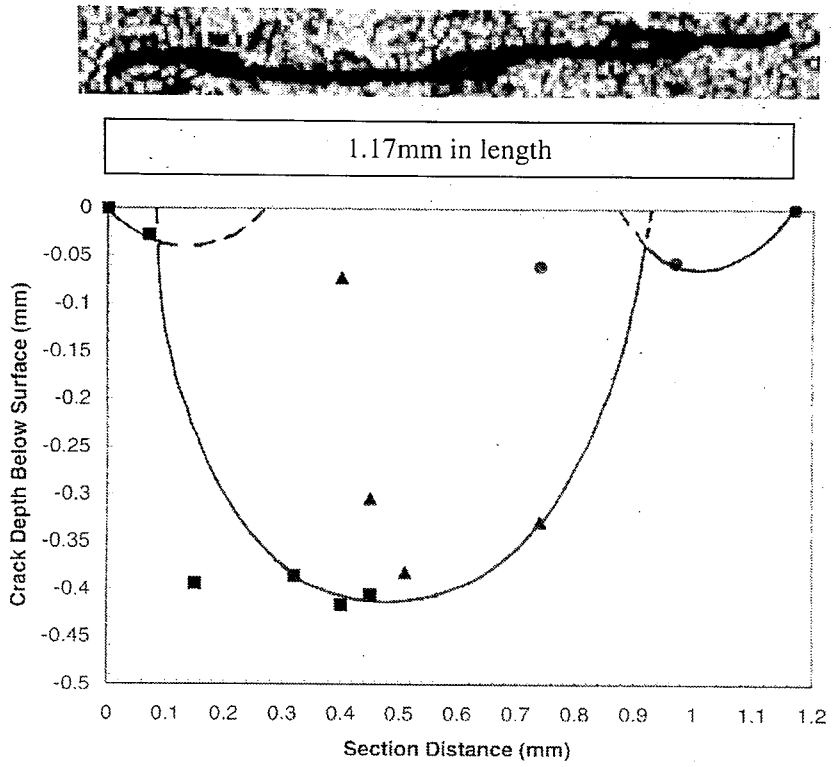
The constructed profile and growth trend for Crack #5 in hole #32 on panel B3-2-6 is seen in Figure 4.16. There are four distinct damage sites that have linked-up to form this crack. The elongated damage in the center nucleated earlier than the damage on the left and right ends of the crack, which is in an earlier stage of growth. Each crack initially grew independently of each other, until the elongated damage linked up and grew as a dominant crack, as denoted by the deep, solid curve. The other damage is more shallow, suggesting that these cracks nucleated later. It can be seen that the shallow damage continues to grow independently of the dominant crack, but would have been overcome by the dominant crack if growth continued. The observations made from this crack further the need for model refinements that include the multiple crack damage processes. In addition, the multiple cracks and link-up cause Crack #5 to have lateral and longitudinal spacing which may influence the crack growth rate, and therefore may be considered as an area of future work that would influence the mechanistically based probability model.

Figure 4.16: Constructed profile showing the growth trend for Crack #5 in hole #32 on panel B3-2-6. Crack #5 consists of multiple cracks.

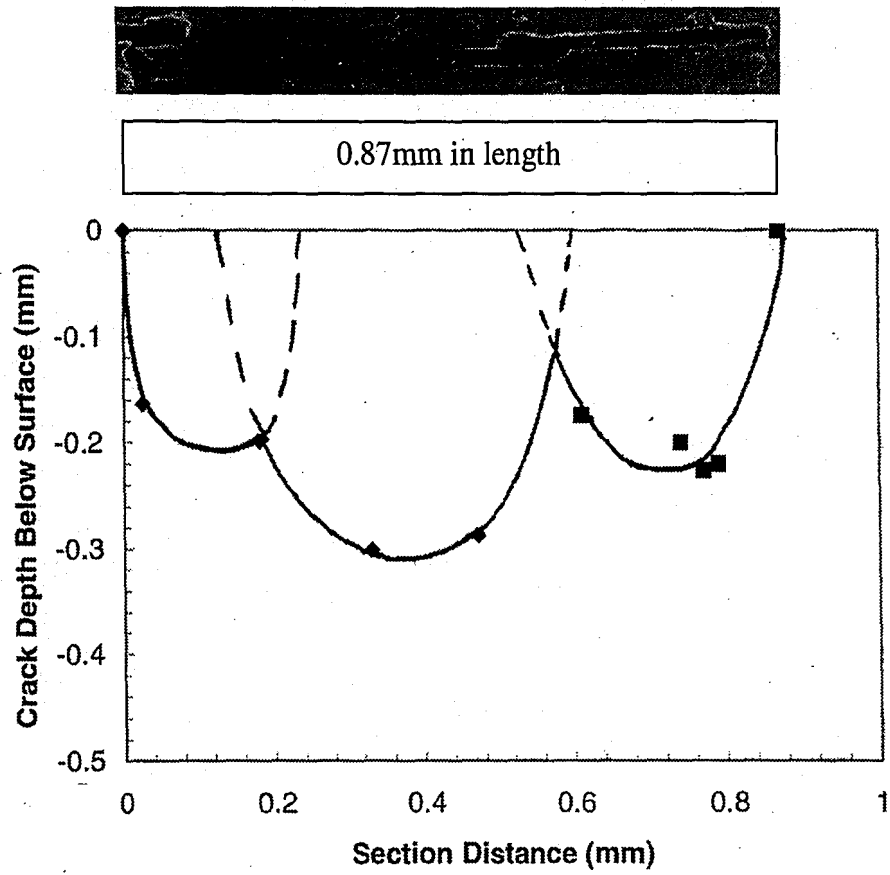
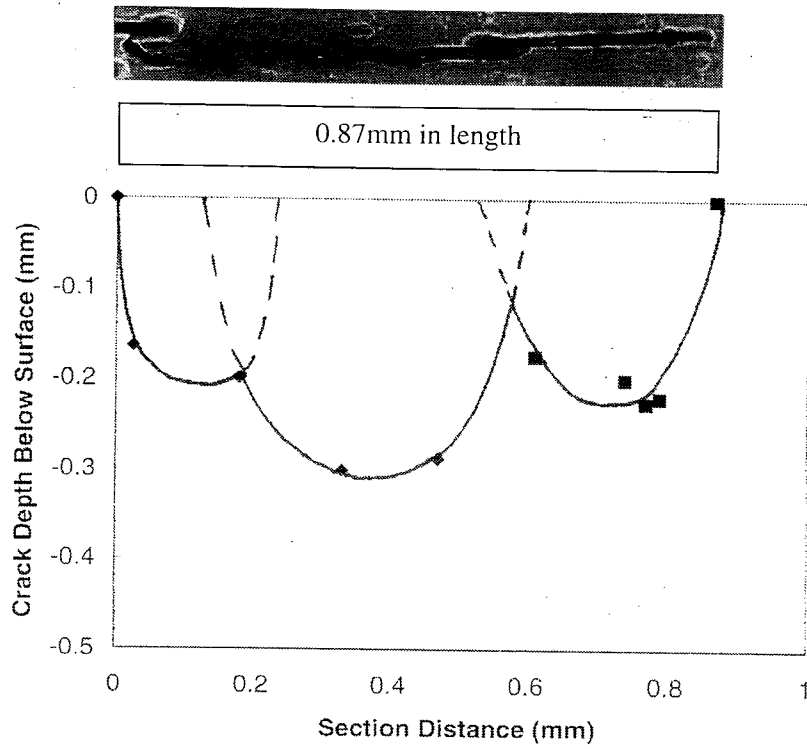
Figure 4.17: Constructed profile showing the growth trend of Crack #1 in hole #107 on panel B3-2-2. Crack #1 consists of multiple cracks.

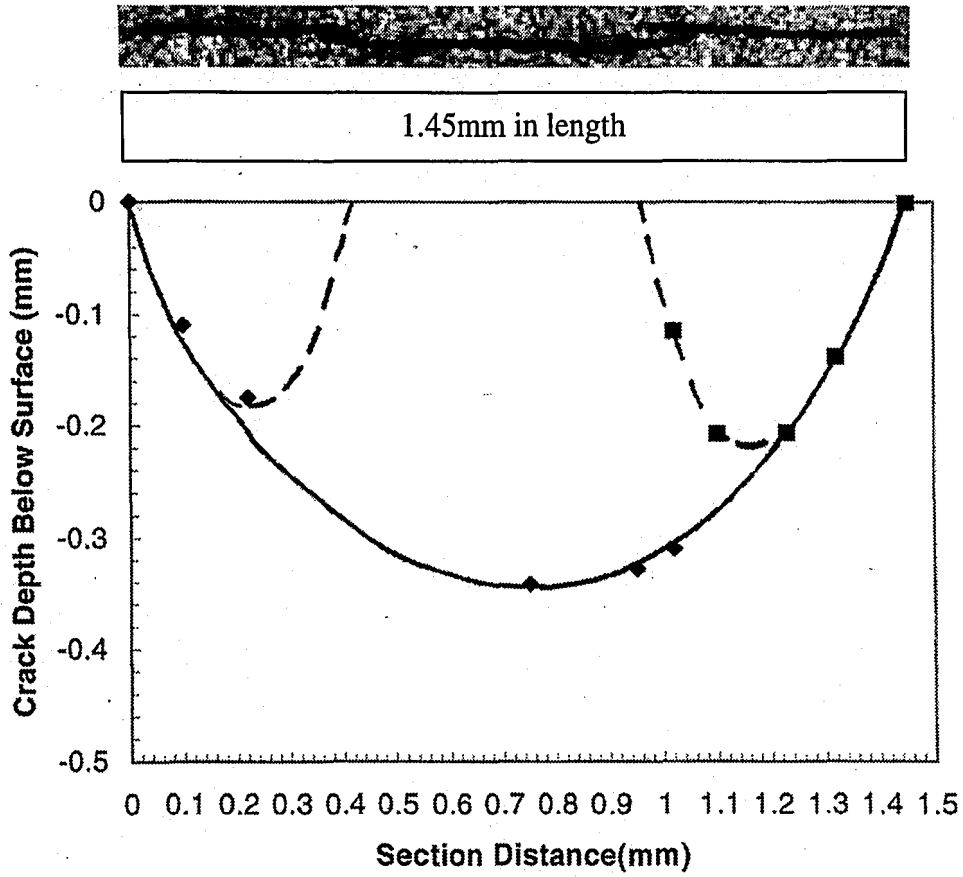
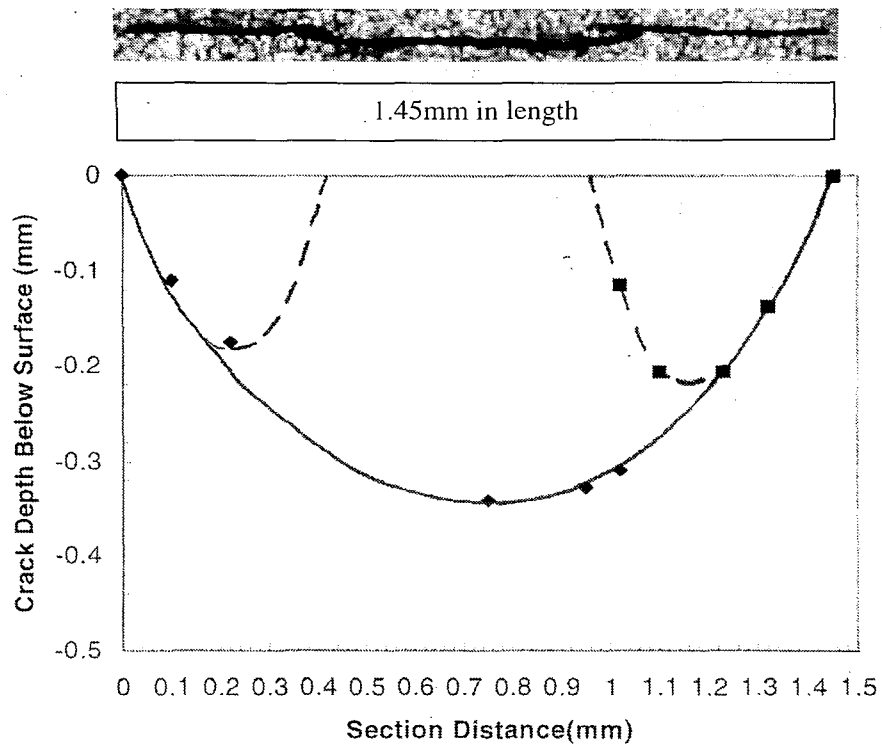
Figure 4.18: Constructed profile showing the growth trend for Crack #2 in hole #107 on panel B3-2-2. Crack #2 consists of multiple cracks.

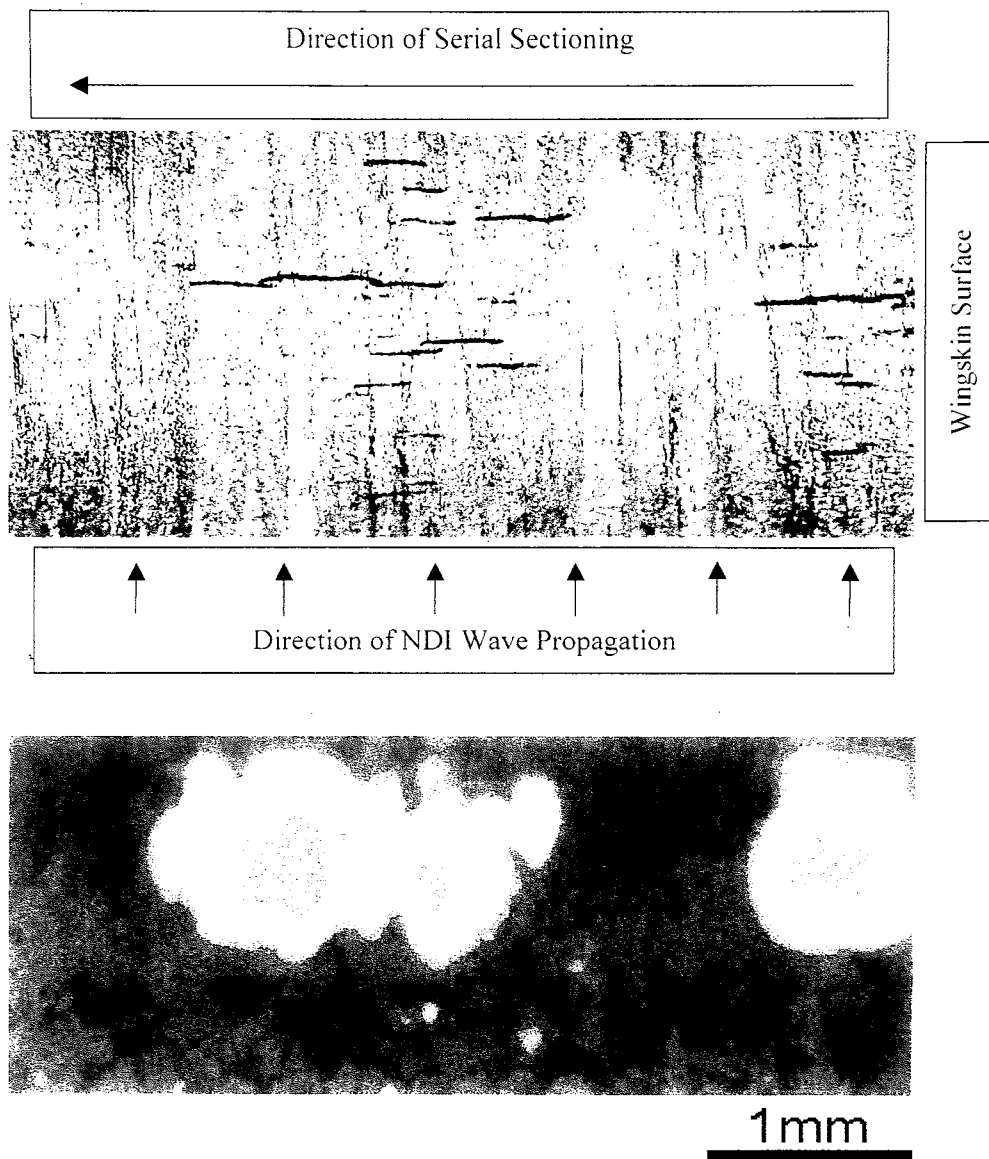
The specimen was placed in a medium of water, and ultrasonic waves traveled thorough the water to the fastener hole in a direction perpendicular to the cracks, as described in Chapter 3.3. If the waves reach a crack, or a discontinuity in the material, the image returned will show the location of the crack and its depth into the material. NDI output is shown for this hole in Figure 4.20. Certainly NDI has acknowledged that damage exists in the fastener holes, but the resolution of this technique is inadequate for determining the character of cracks. The actual shape of the damage cannot be discerned from these figures, although it does show that relatively shallow and deep damage exists in the hole.

Figure 4.20: NDI photo of hole #107 on panel B3-2-2. NDI was performed with assistance from ALCOA.

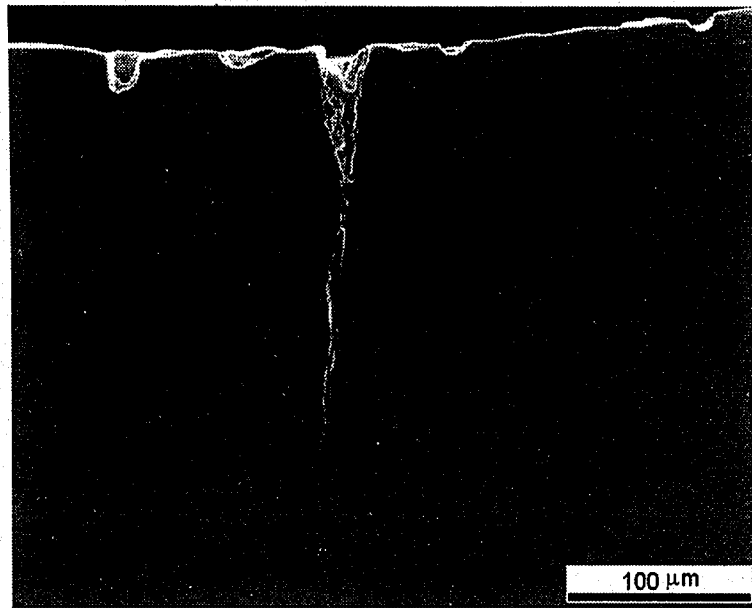
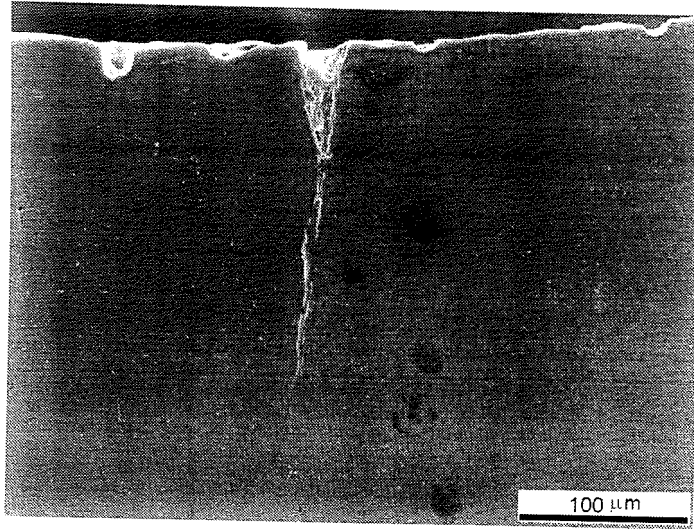
<u>Section Number</u>	<u>Section Distance (mm)</u>	<u>Crack Depth (μm)</u>
1	0.08	287
2	0.22	319
3	0.33	367

Figure B.1: SEM micrographs shown of Crack #4 in hole #32 on panel B3-2-6 for (a) Section 2 at 270X and (b) Section 3 at 170X.

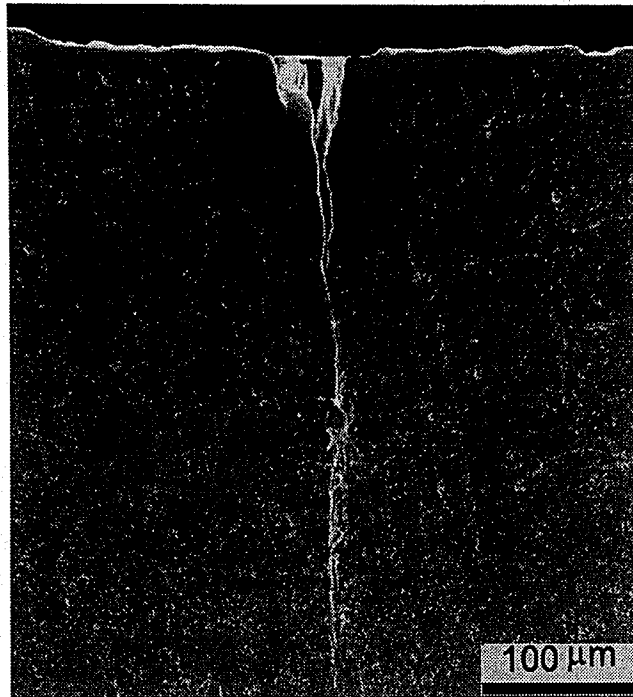
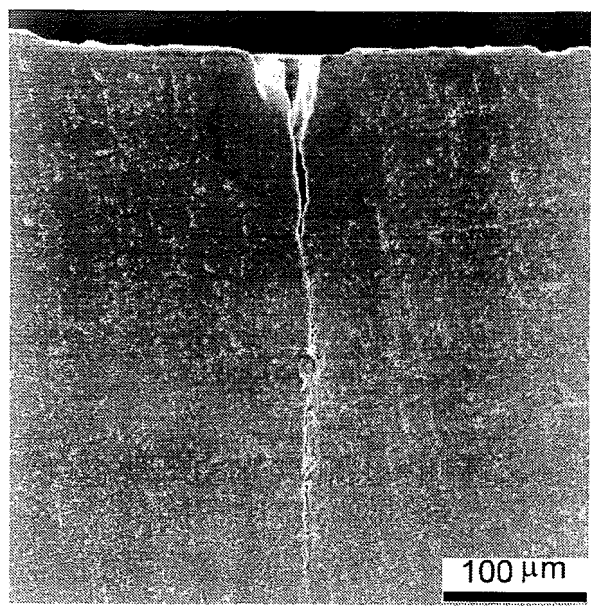
<u>Section Number</u>	<u>Section Distance (mm)</u>	<u>Crack Depth (μm)</u>	
1	0.07	28	
2	0.15	394	
3	0.32	386	
4	0.40	73(L)	417
5	0.45	305(L)	406
6	0.51	382(L)	
7	0.74	61(L-1)	329(L)
8	0.97	57(L-1)

Figure C.1: SEM micrographs for Crack #5 in hole #32 on panel B3-2-6 taken for (a) Section 4 at 160X and (b) Section 5 at 170X.

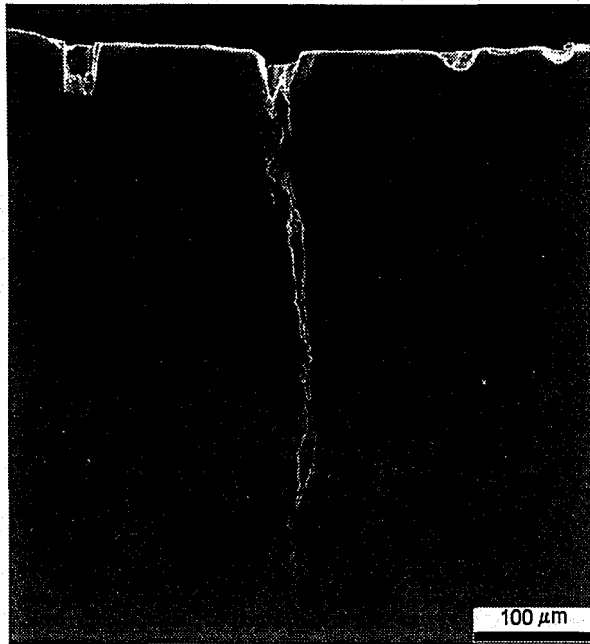
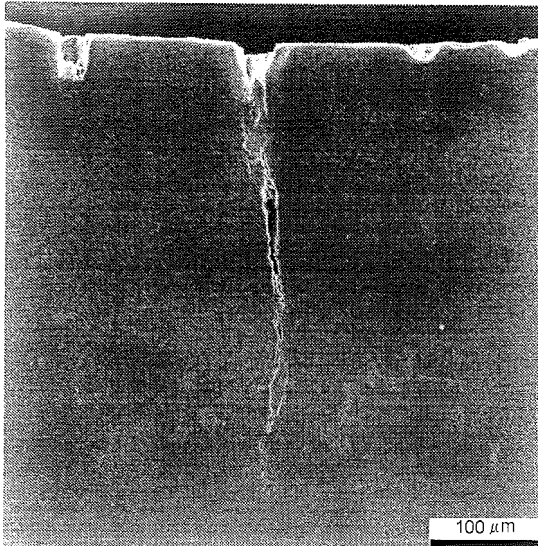
Figure C.1 (cont'd): SEM micrographs for Crack #5 in hole #32 on panel B3-2-6 taken for (c) Section 6 at 180X and (d) Section 7 at 200X.

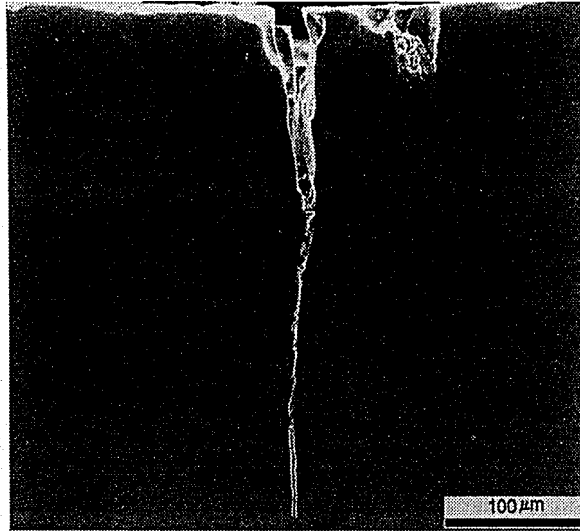
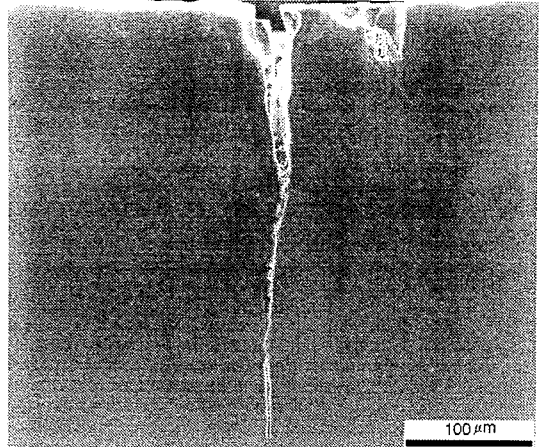
Figure C.1 (cont'd): SEM micrographs for Crack #5 in hole #32 on panel B3-2-6 taken for (e) Section 8 at 200X.
