Characterization of corrosion fatigue damage in the fastener holes of a Boeing 707

**CHARACTERIZATION OF CORROSION FATIGUE DAMAGE IN
THE FASTENER HOLES OF A BOEING 707**

A Thesis
—Presented to the Graduate and Research Committee
of Lehigh University
in Candidacy for the Degree of
Master of Science

Lehigh University
April 2001

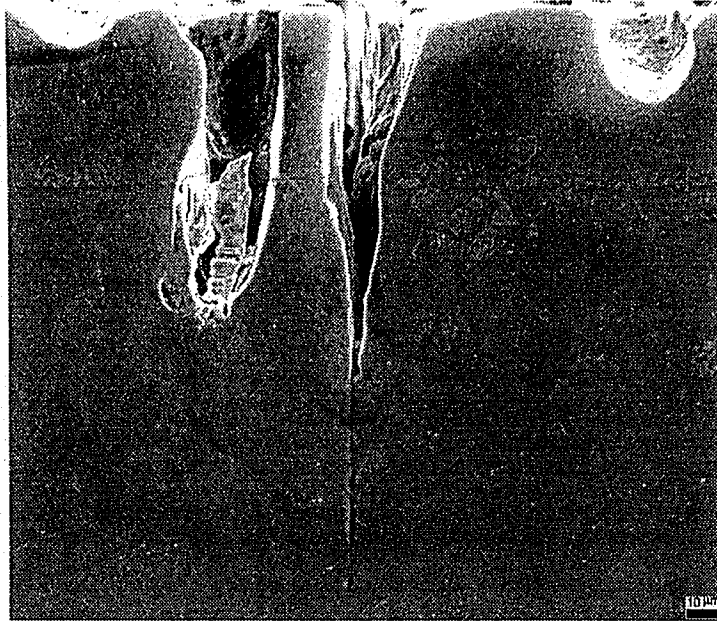
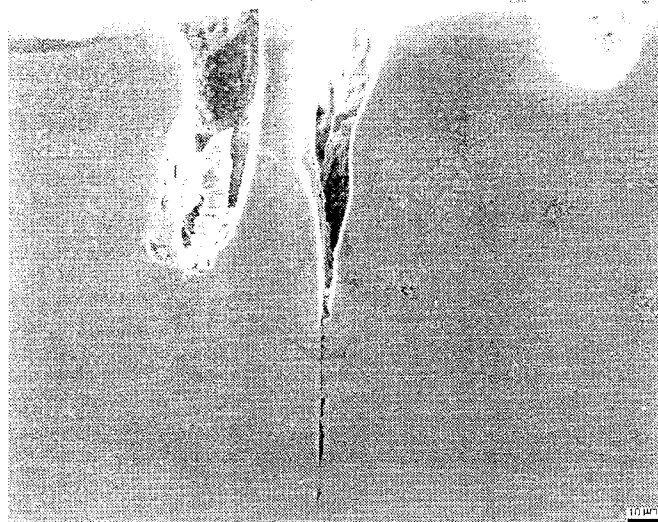
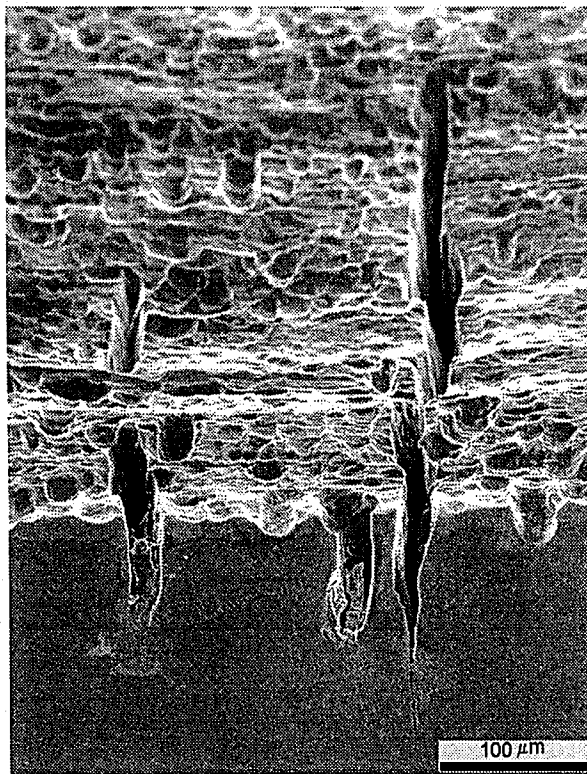
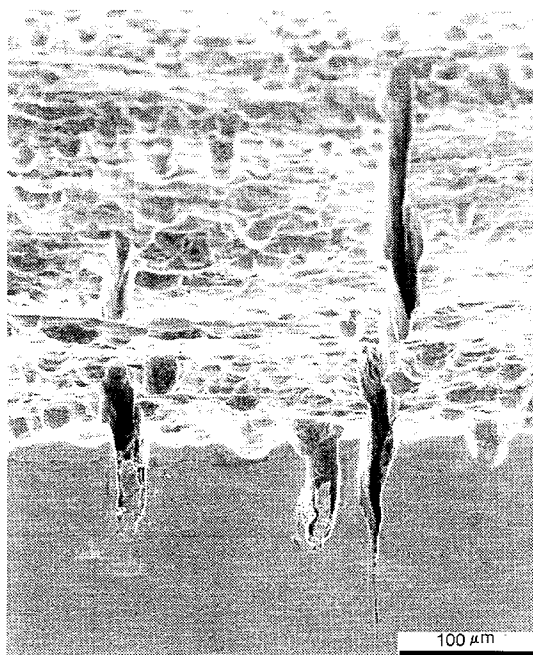
<u>Section Number</u>	<u>Section Distance (mm)</u>	<u>Crack Depth (μm)</u>
1	0.025	164
2	0.18	199
3	0.33	301
4	0.47	287
5	0.61	174(L)
6	0.74	200(L)
7	0.77	226(L)
8	0.79	220(L)

Figure D.1: SEM micrographs for Crack #1 in hole #107 on panel B3-2-2 taken for (a) Section 1 at 450X and (b) 30° tilted micrograph at 200X for Section 1.

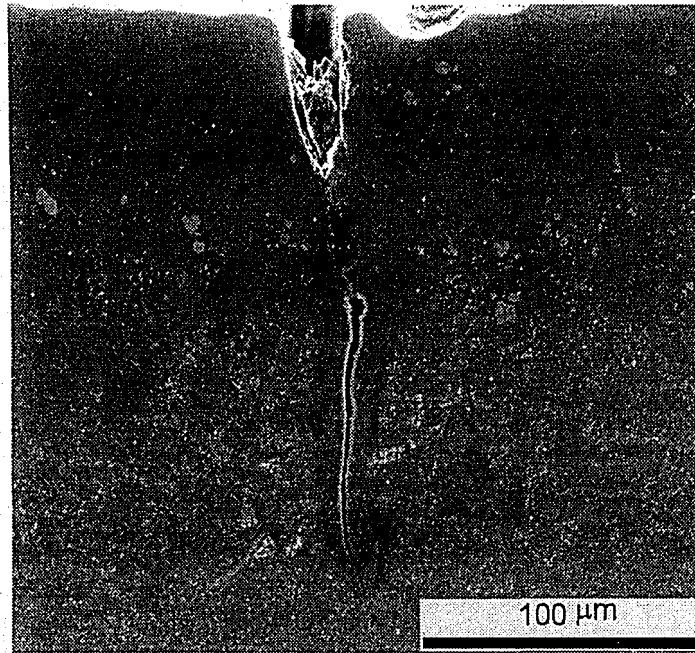
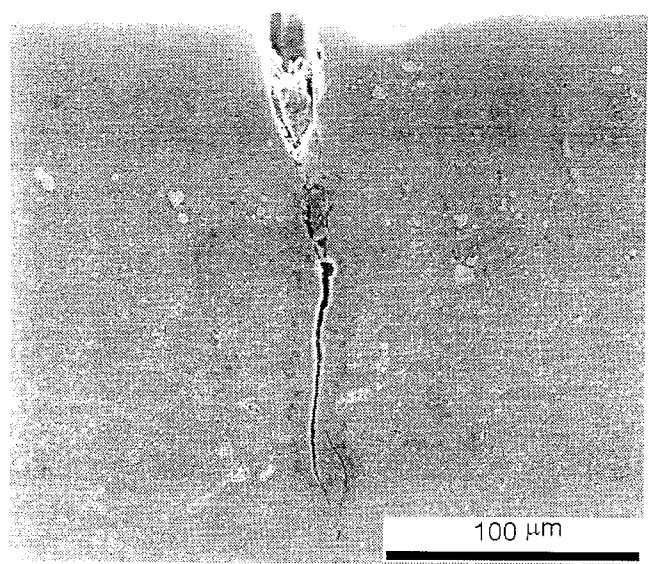
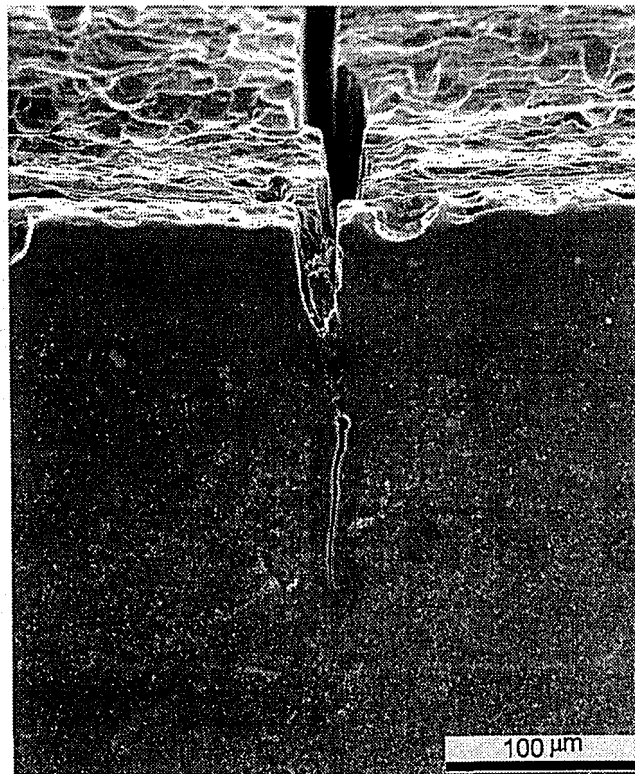
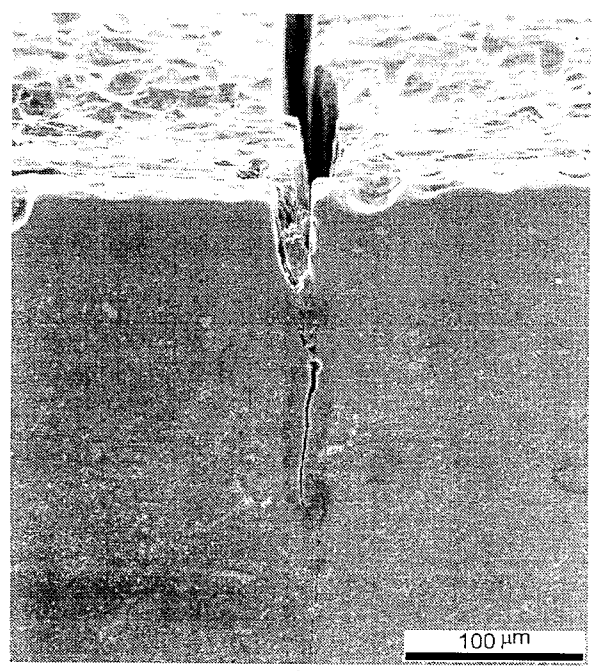
Figure D.2: SEM micrographs for Crack #1 in hole #107 on panel B3-2-2 taken for (a) Section 2 at 200X and (b) 30° tilted micrograph at 250X for Section 2.

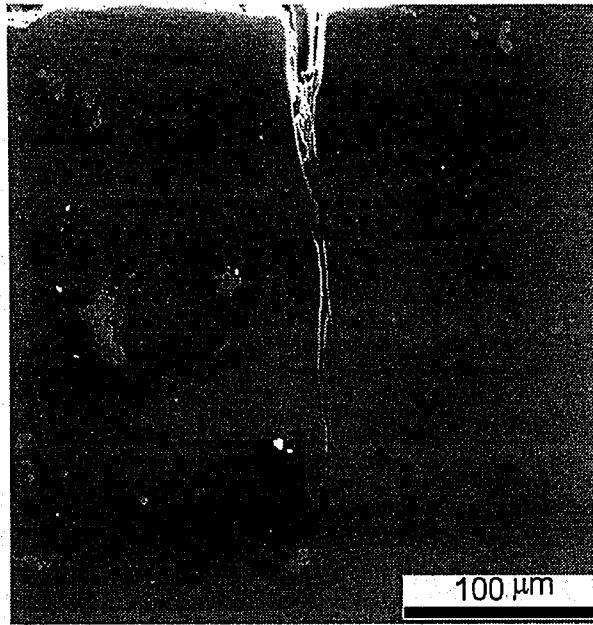
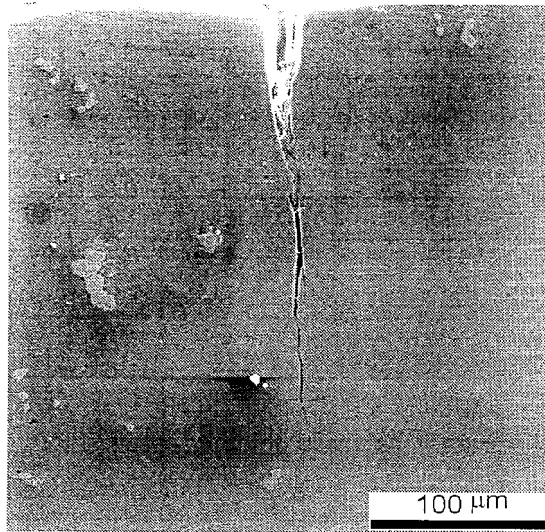
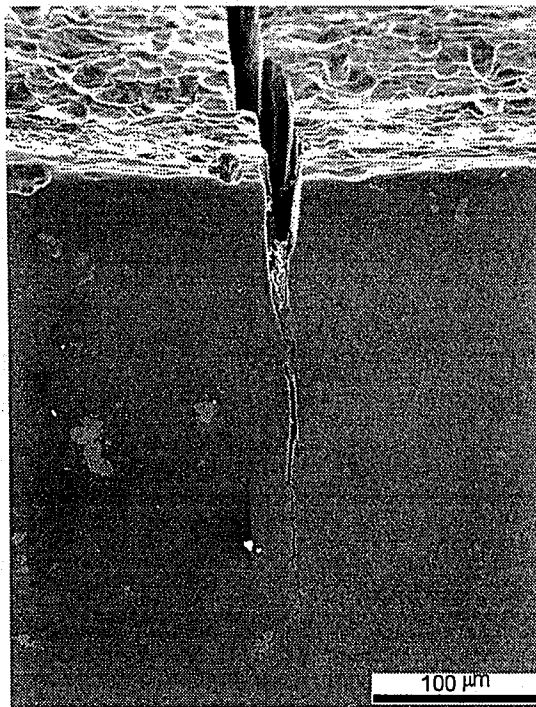
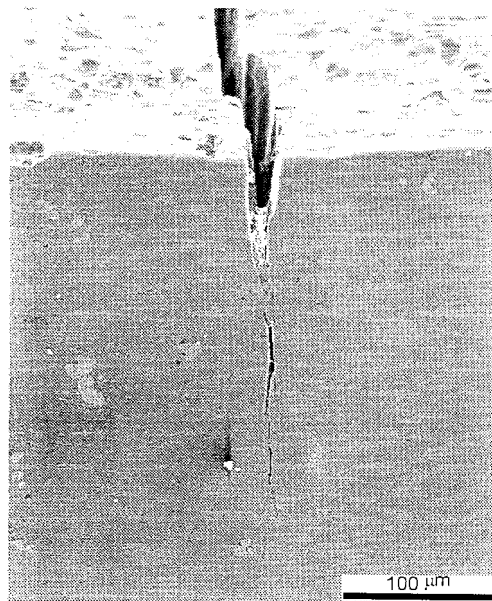
Figure D.3: SEM micrographs for Crack #1 in hole #107 on panel B3-2-2 taken for (a) Section 3 at 200X and (b) 30° tilted micrograph at 250X for Section 3.

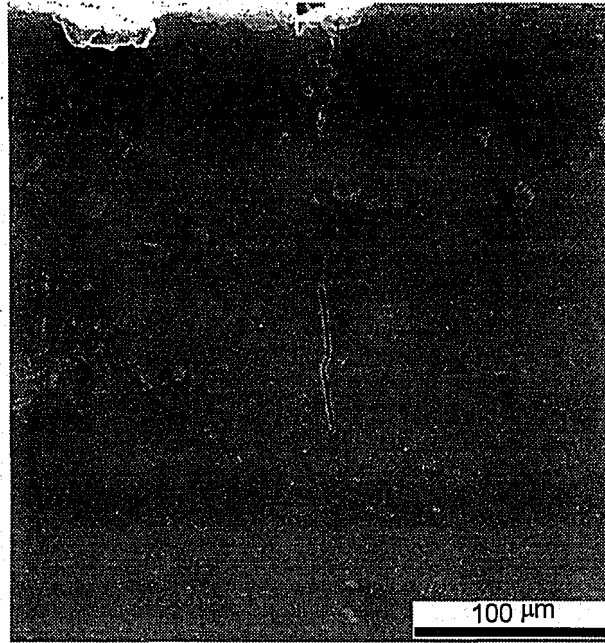
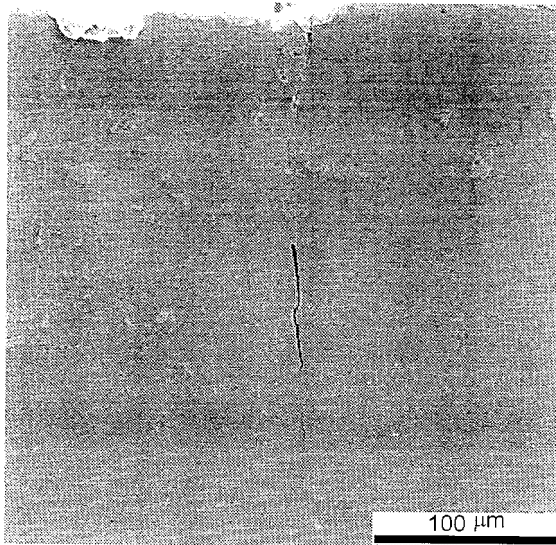
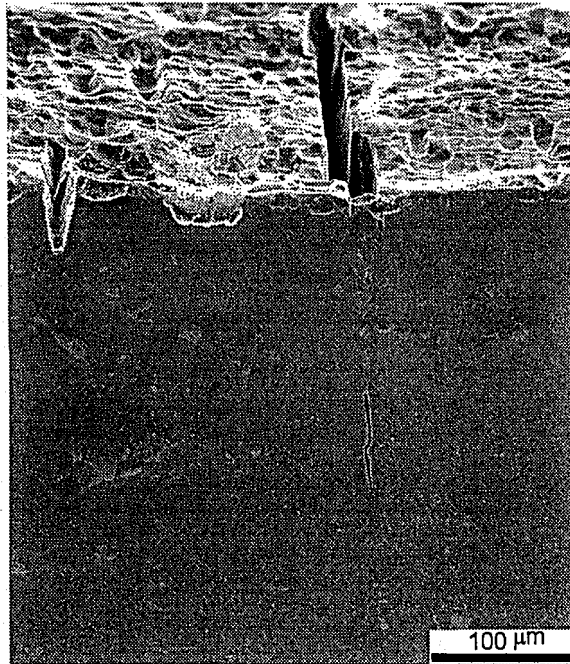
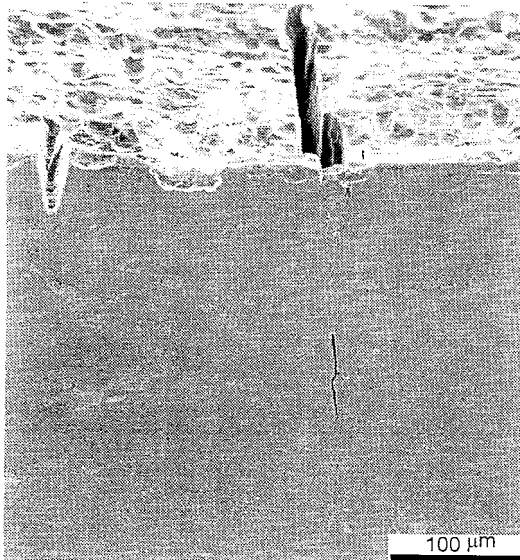
Figure D.4: SEM micrographs for Crack #1 in hole #107 on panel B3-2-2 taken for (a) Section 4 at 250X and (b) 30° tilted micrograph at 200X of Section 4.

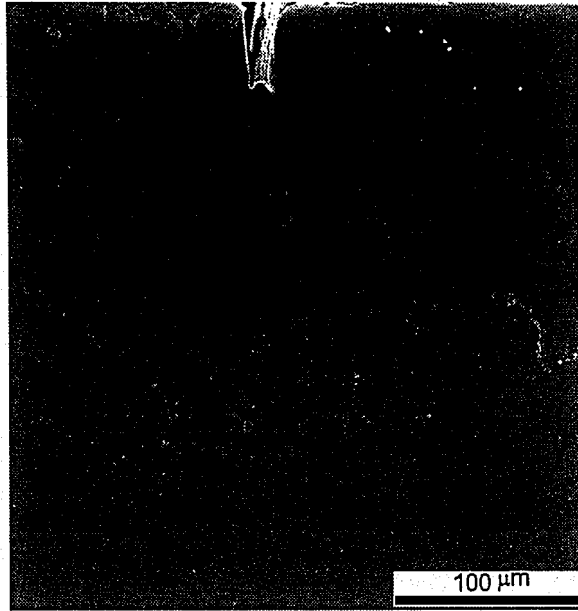
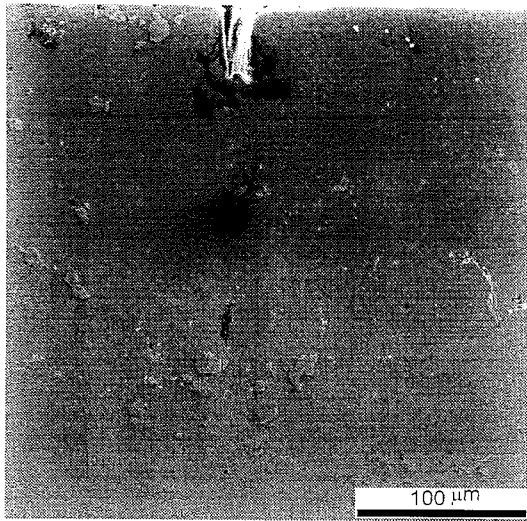
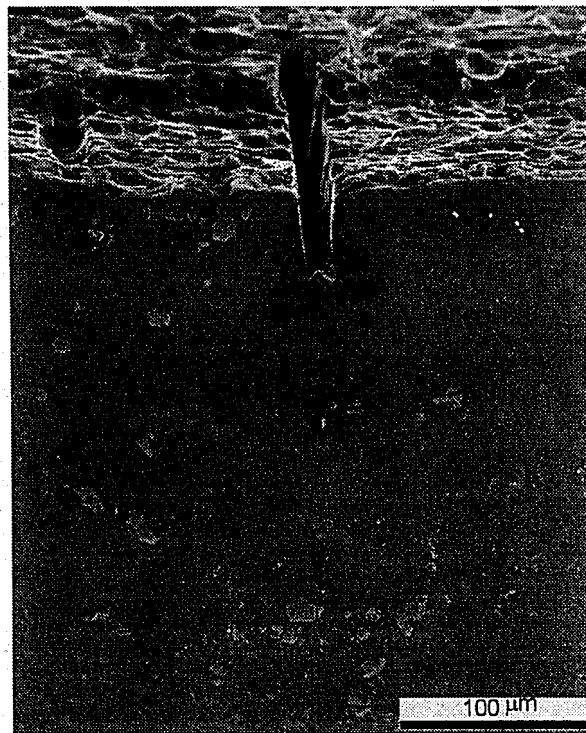
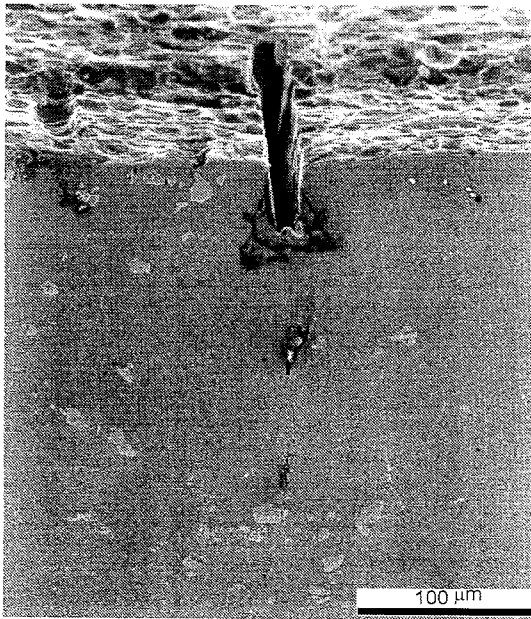
Figure D.5: SEM micrographs for Crack #1 in hole #107 on panel B3-2-2 taken for (a) Section 5 at 250X and (b) 30° tilted micrograph at 270X for Section 5.

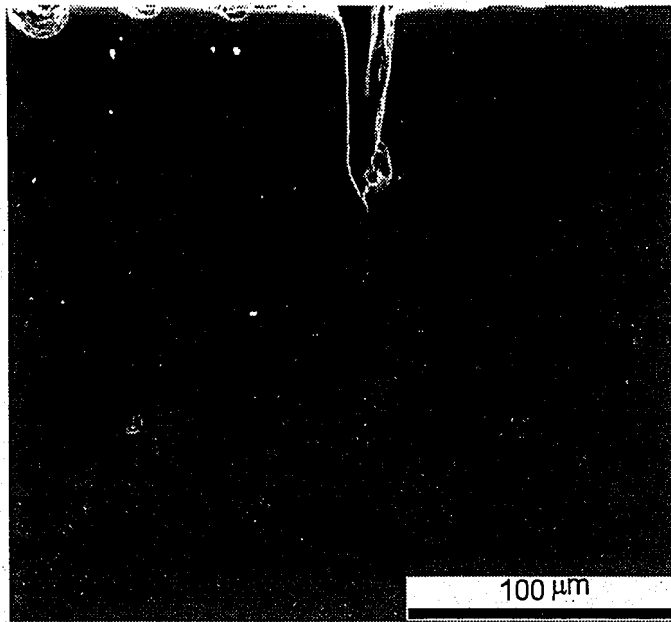
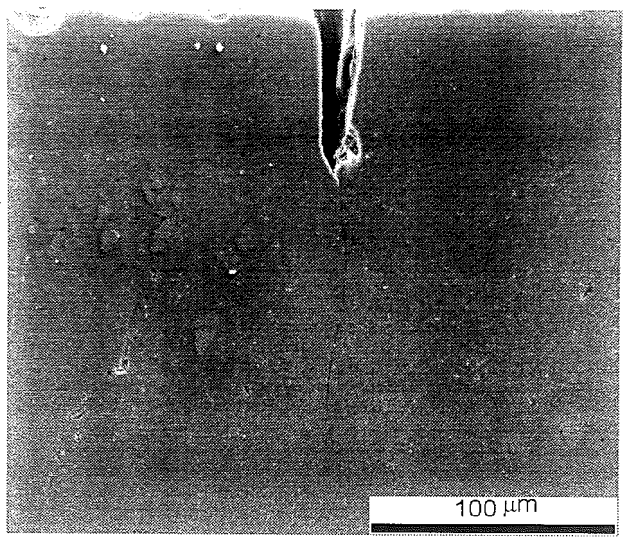
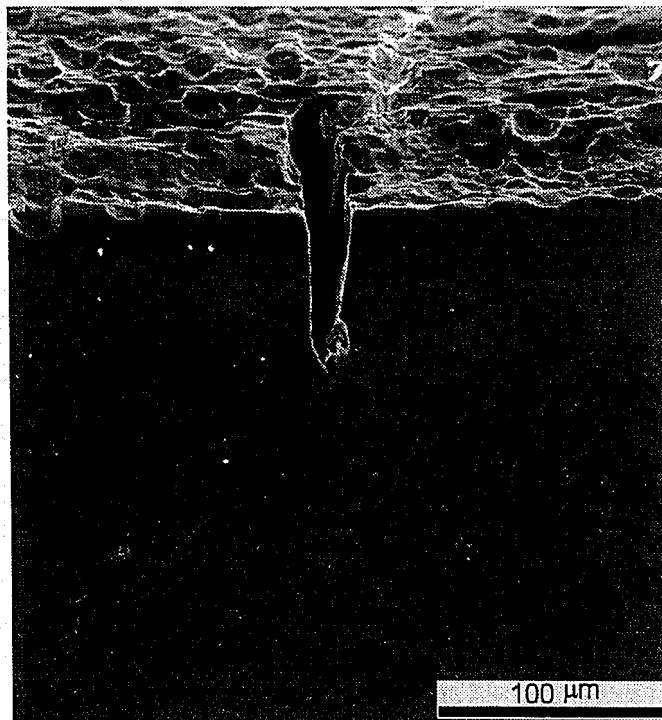
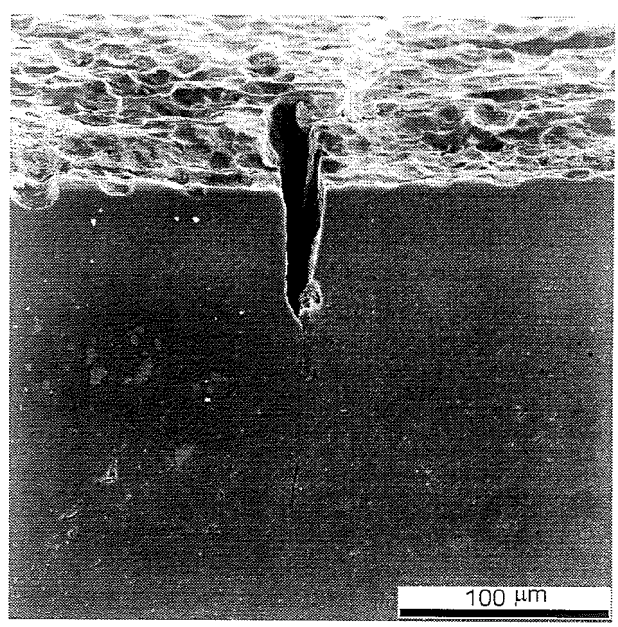
Figure D.6: SEM micrographs for Crack #1 in hole #107 on panel B3-2-2 taken for (a) Section 6 at 300X and (b) 30° tilted micrograph at 270X for Section 6.

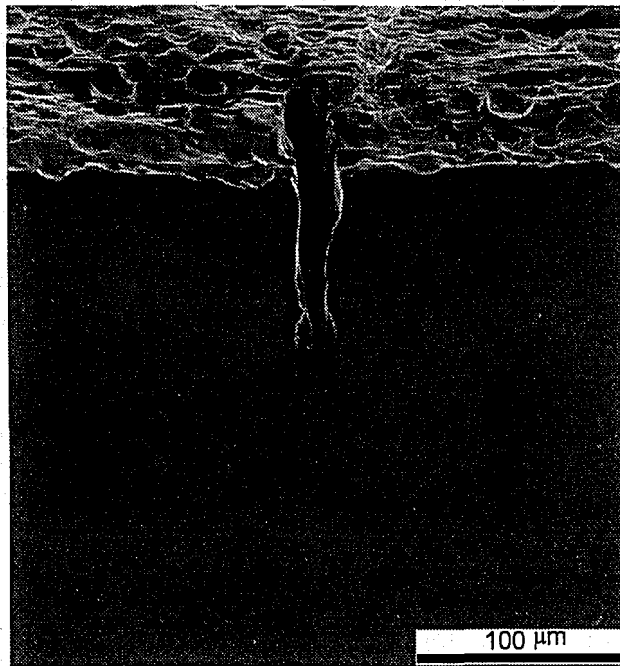
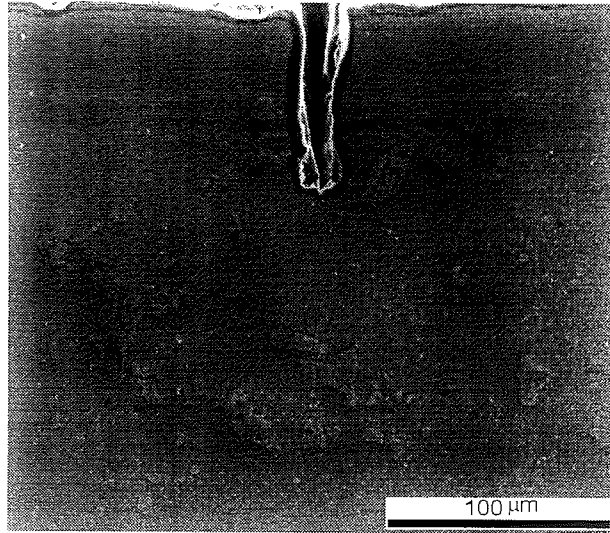
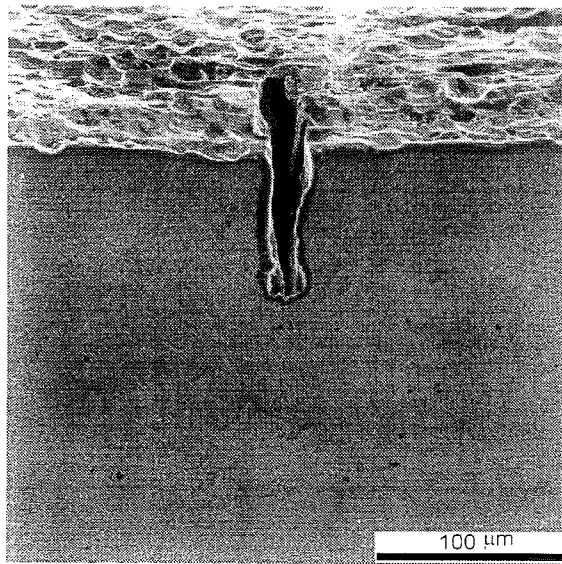
Figure D.7: SEM micrographs for Crack #1 in hole #107 on panel B3-2-2 taken for (a) Section 7 at 300X and (b) 30° tilted micrograph at 270X for Section 7.

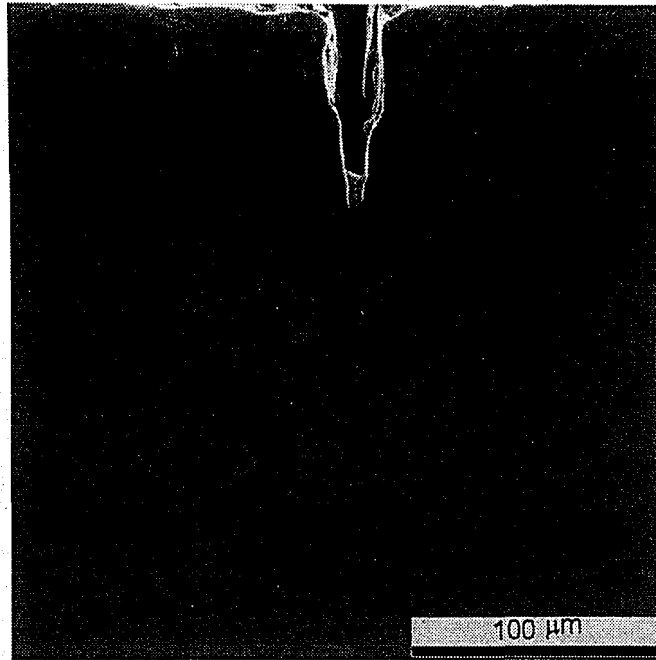
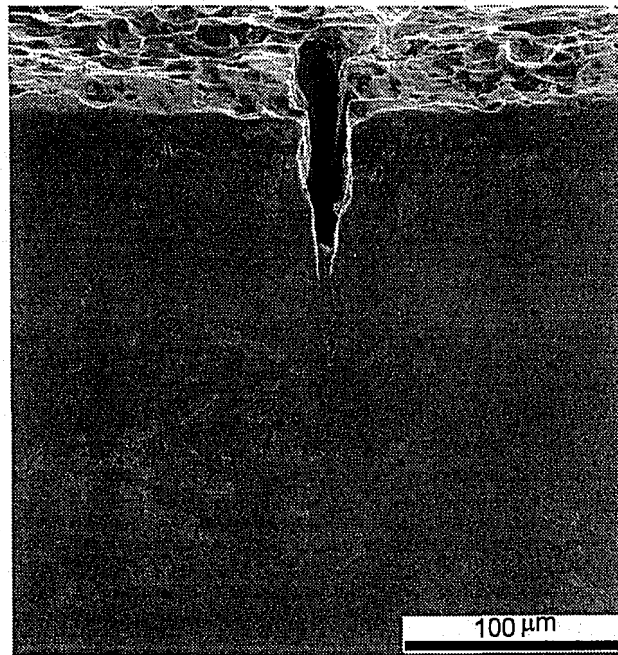
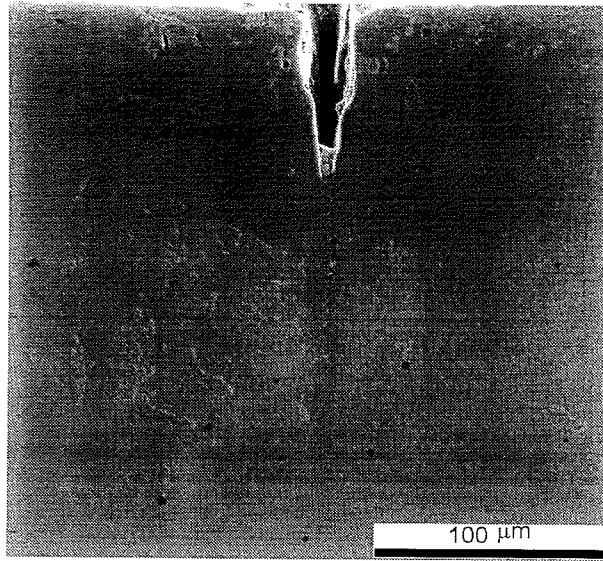
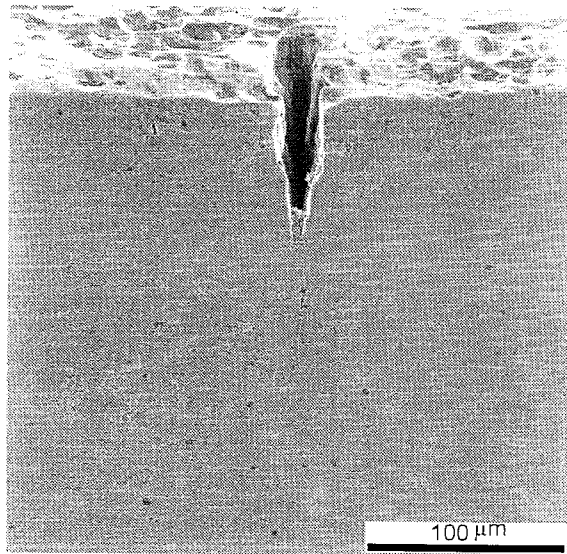
Figure D.8: SEM micrographs for Crack #1 in hole #32 on panel B3-2-2 taken for (a) Section 8 at 300X and (b) 30° tilted micrograph at 270X for Section 8.

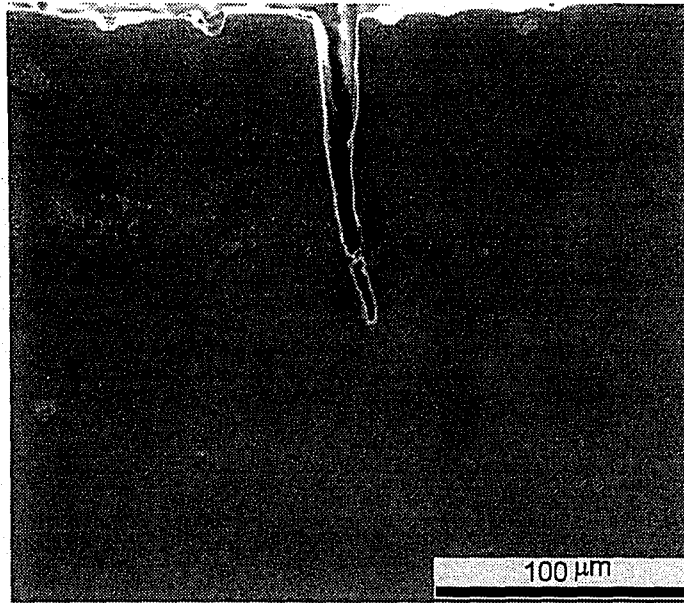
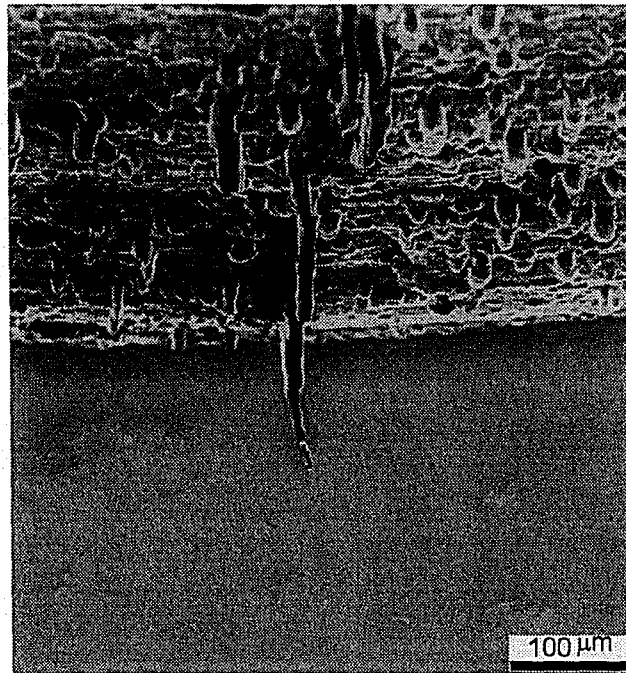
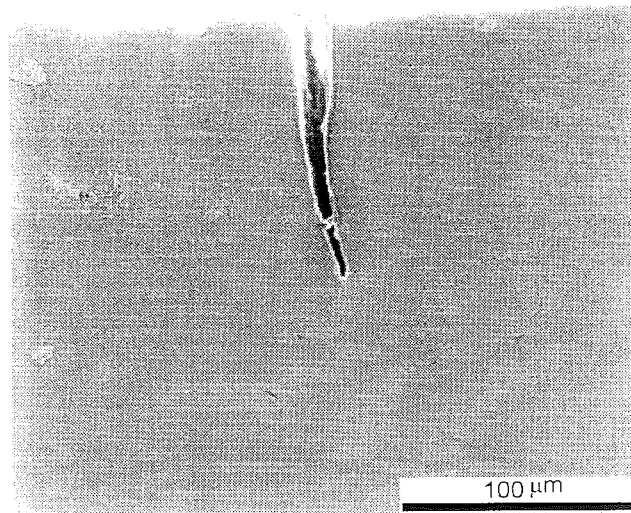
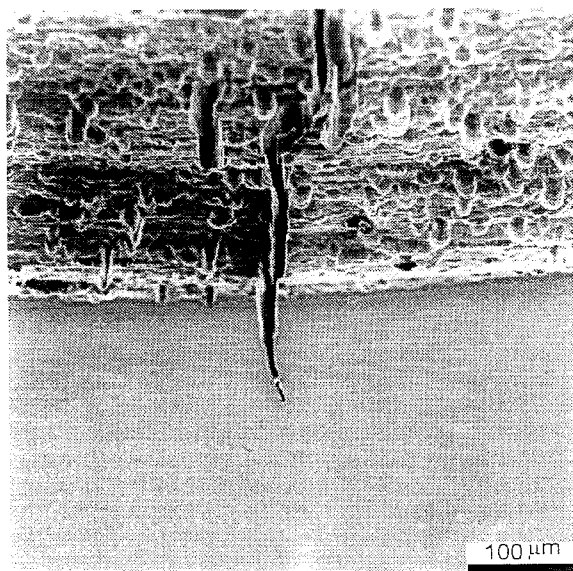
Figure E.1: SEM micrographs of Crack #2 in hole #107 on panel B3-2-2 taken for (a) Section 1 at 300X and (b) 45° tilted micrograph at 150X of Section 1.

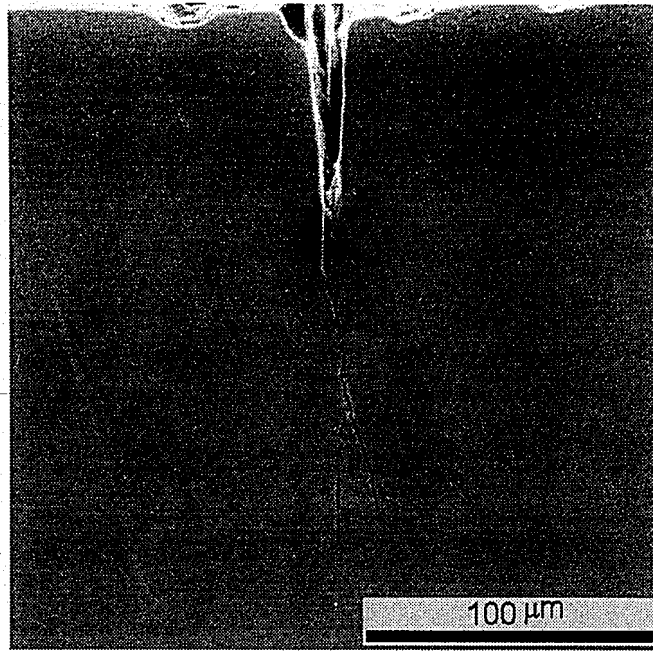
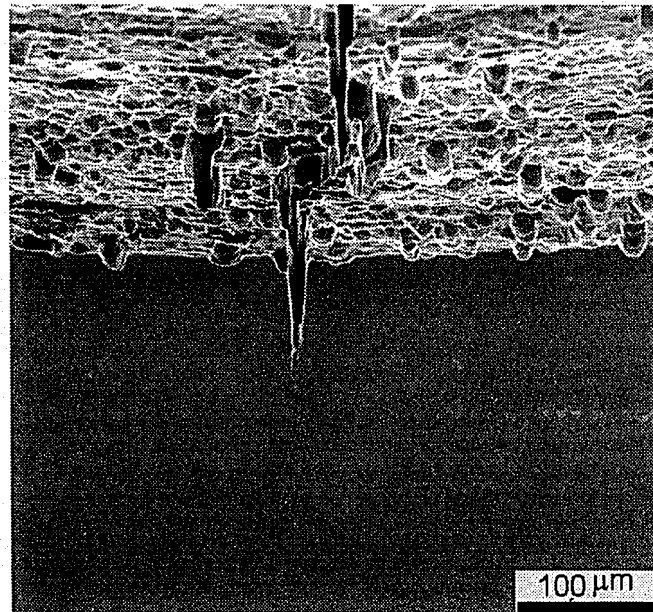
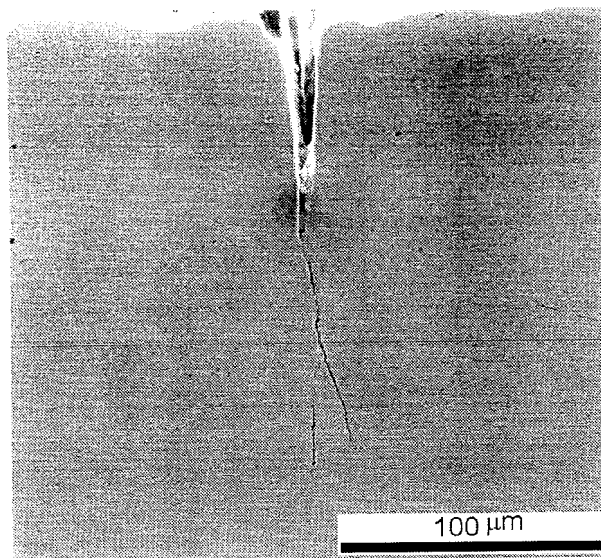
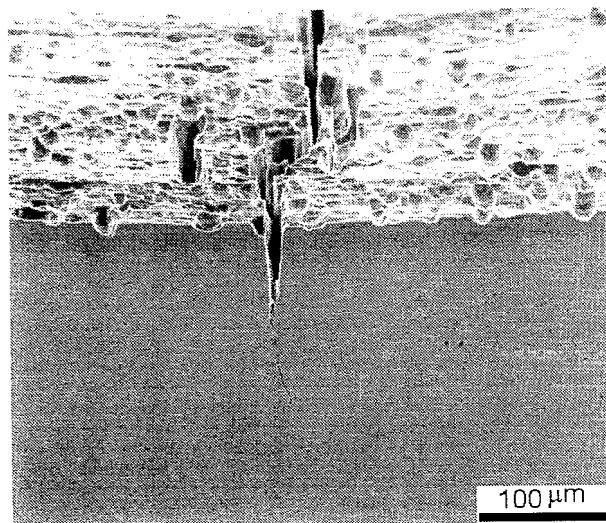
Figure E.2: SEM micrographs of Crack #2 in hole #107 on panel B3-2-2 that show (a) Section 2 with crack branching at 300X and (b) 30° tilted micrograph of Section 2 at 150X.

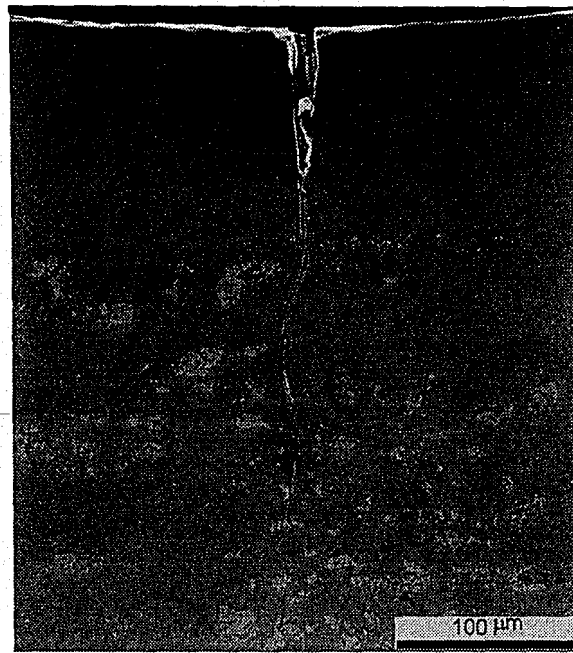
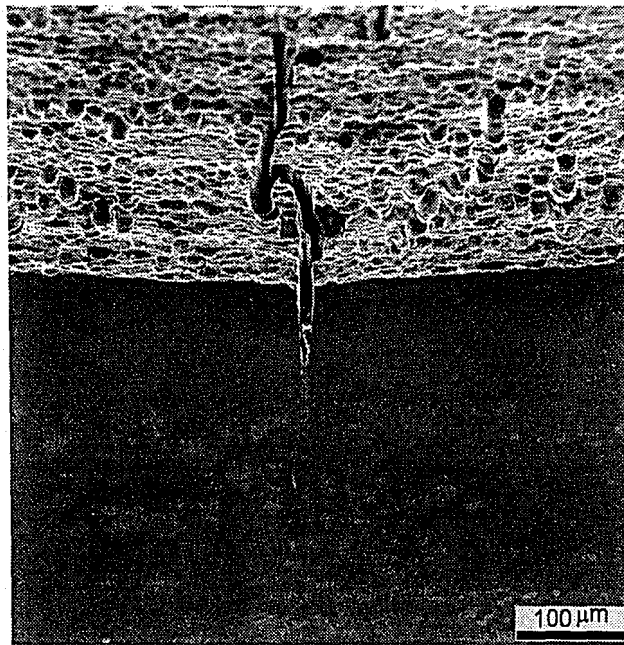
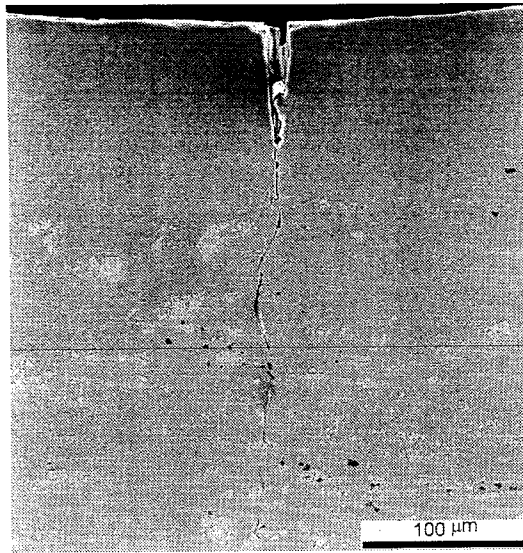
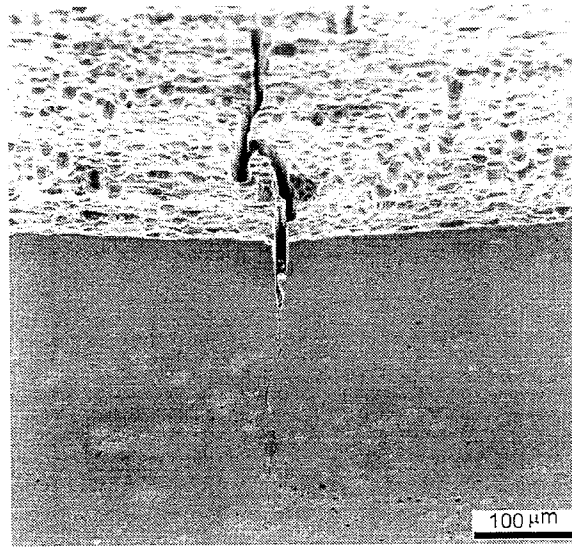
Figure E.3: SEM micrographs of Crack #2 in hole #107 on panel B3-2-2 that show (a) Section 3 at 270X and (b) 30° tilted micrograph at 150X of Section 3.

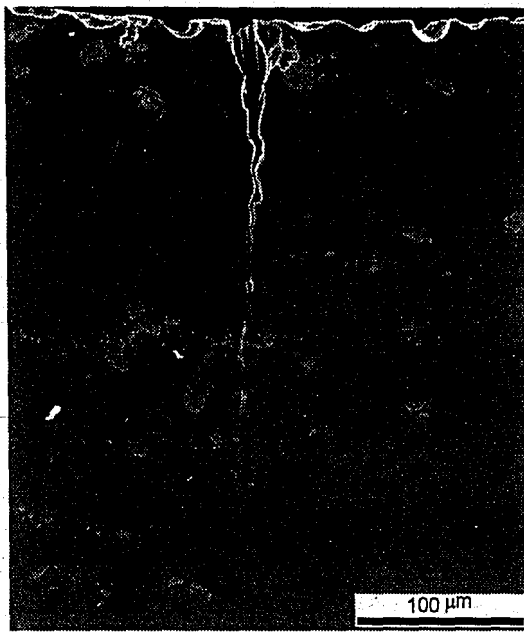
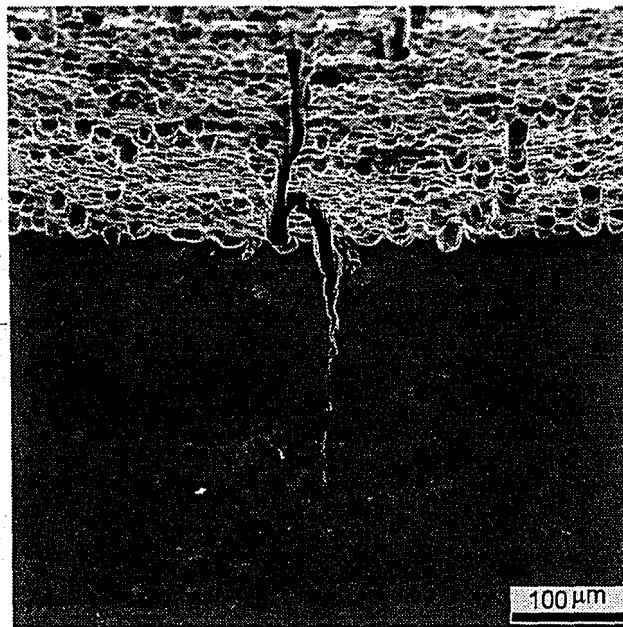
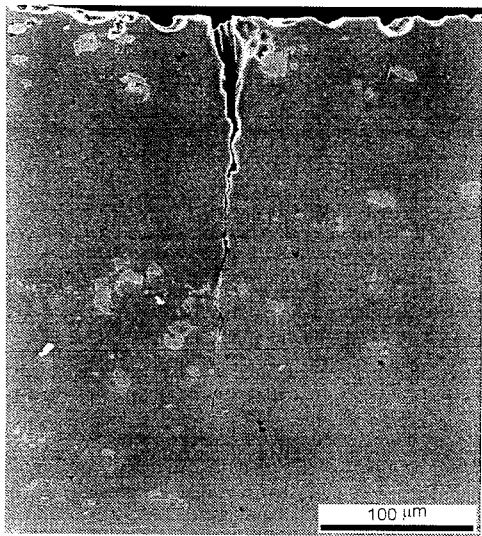
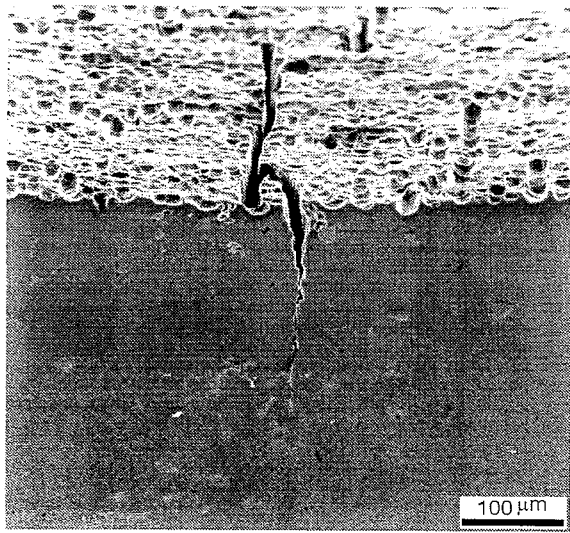
Figure E.4: SEM micrographs of Crack #2 in hole #107 on panel B3-2-2 that show (a) Section 4 at 270X and (b) 30° tilted micrograph at 150X of Section 4.

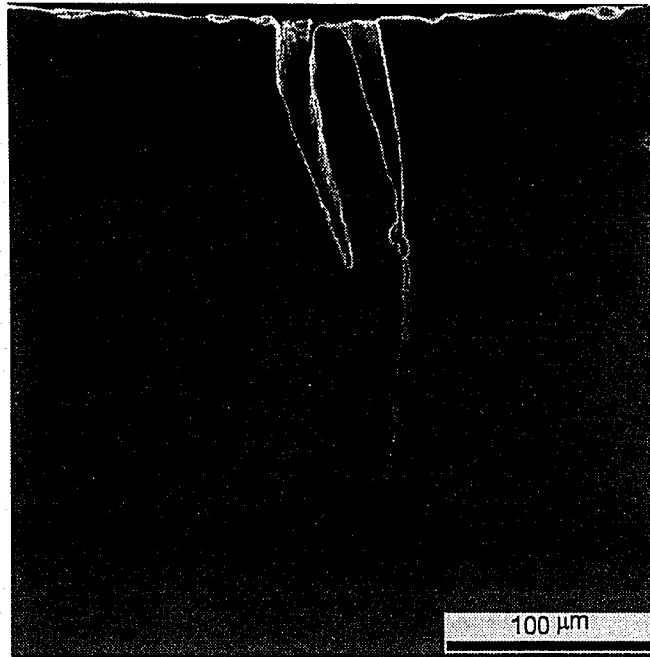
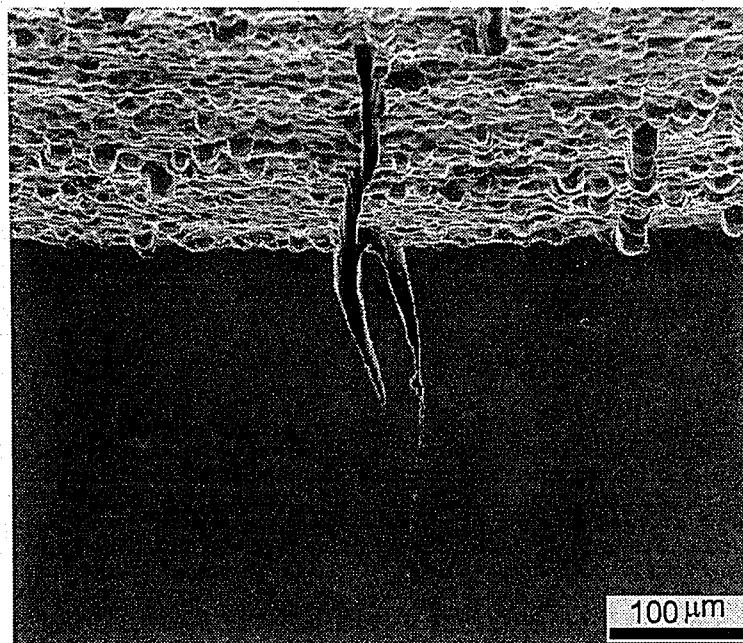
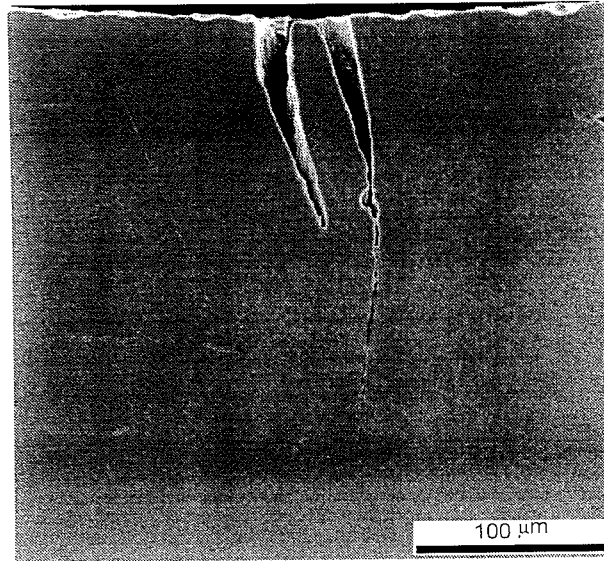
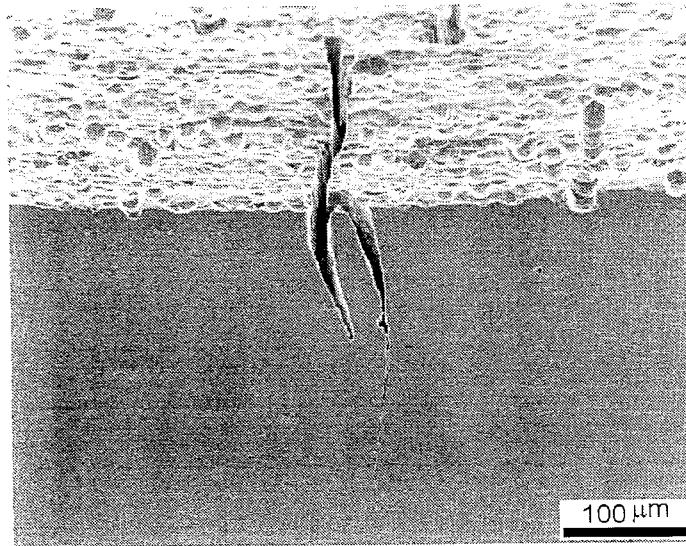
Figure E.5: SEM micrographs of Crack #2 in hole #107 on panel B3-2-2 that show (a) Section 5 and the link-up at 270X and (b) 30° tilted micrograph at 150X of Section 5 and the associated link-up.

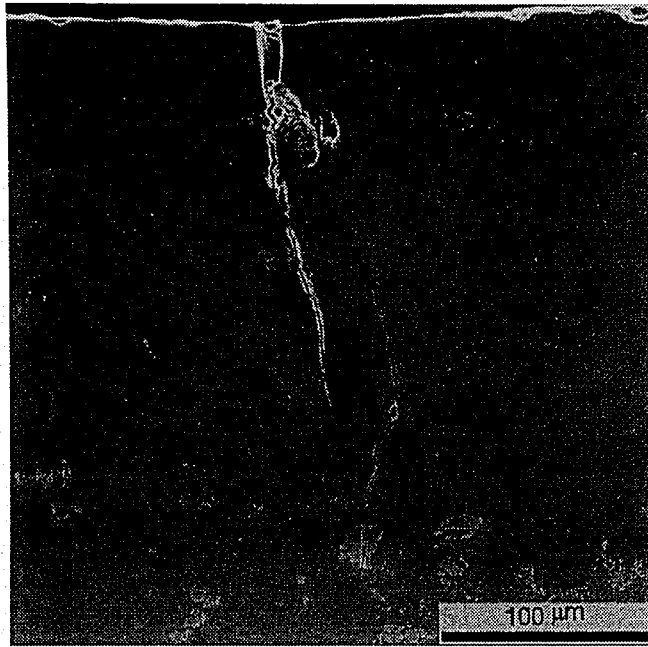
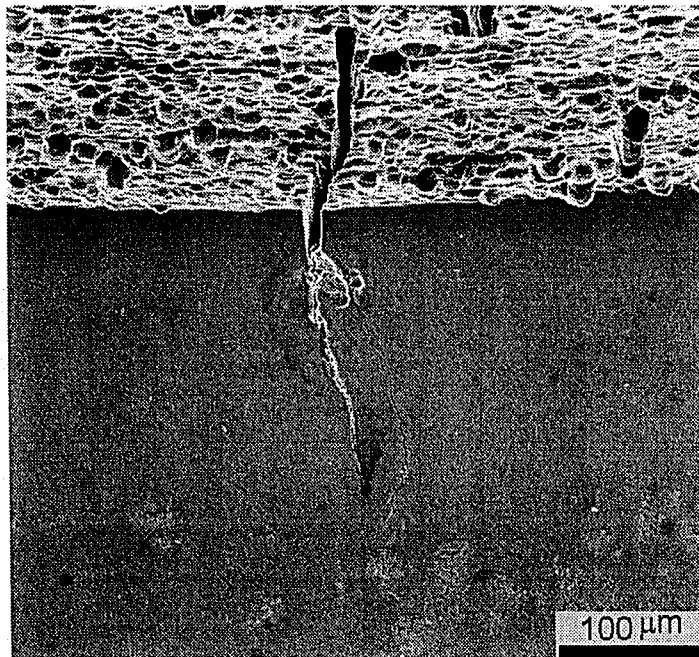
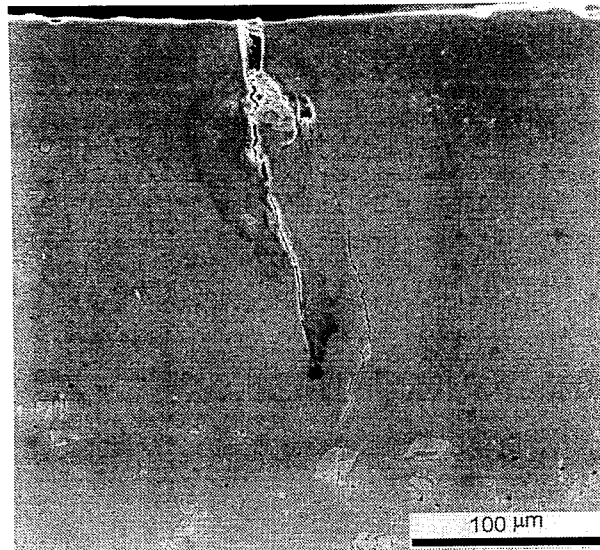
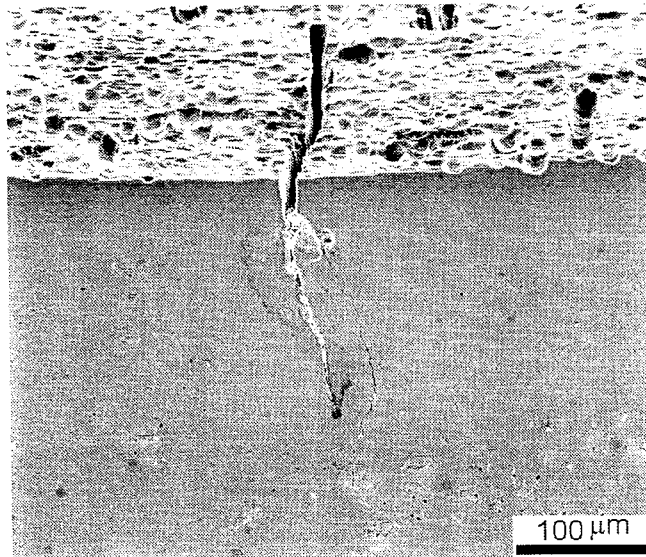
Figure E.6: SEM micrographs of Crack #2 in hole #107 on panel B3-2-2 to show (a) Section 6 at 270X and (b) 30° tilted micrograph at 150X of Section 6.

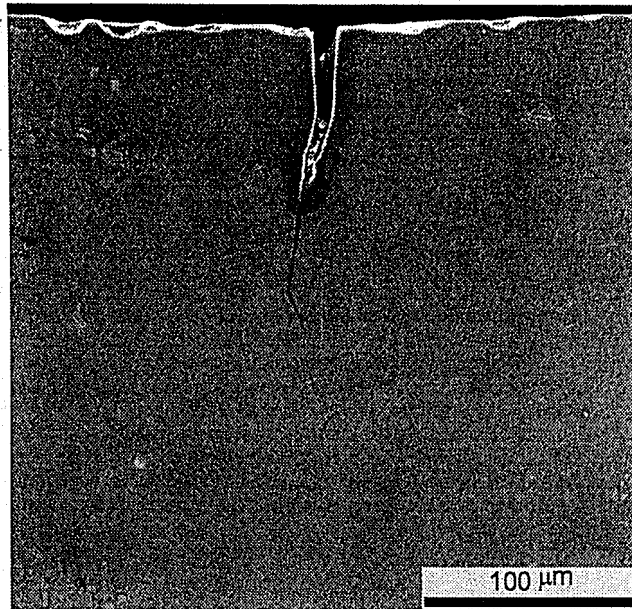
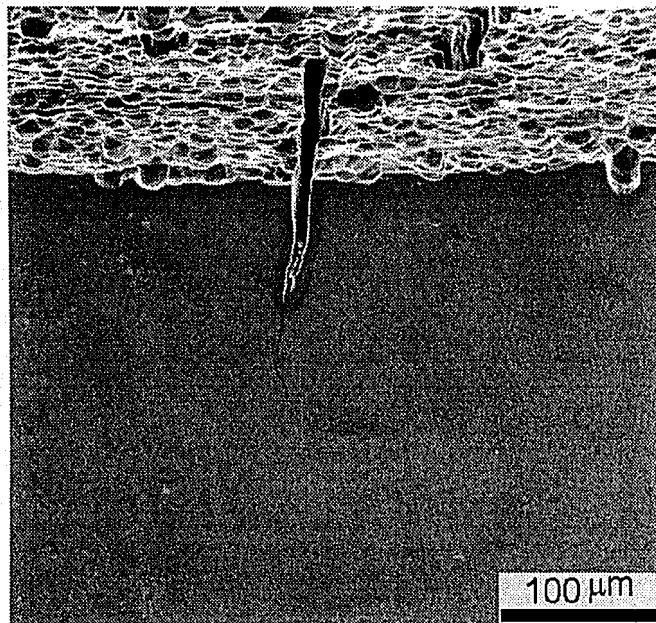
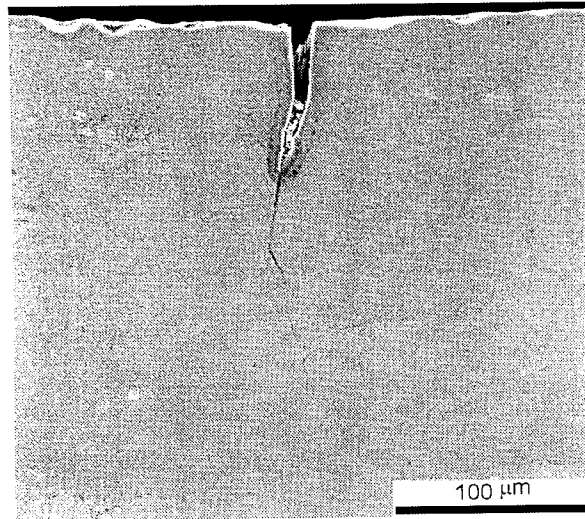
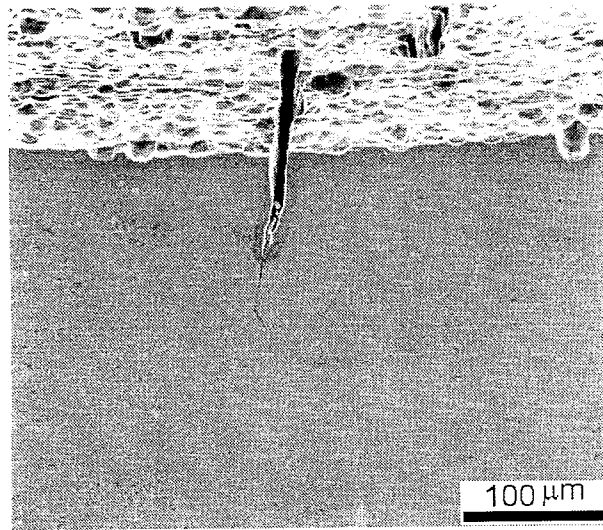
Figure E.7: SEM micrographs of Crack #2 in hole #107 on panel B3-2-2 that show (a) Section 7 at 270X and (b) 30° tilted micrograph at 150X of Section 7.
