Characterization of corrosion fatigue damage in the fastener holes of a Boeing 707

**CHARACTERIZATION OF CORROSION FATIGUE DAMAGE IN
THE FASTENER HOLES OF A BOEING 707**

A Thesis
—Presented to the Graduate and Research Committee
of Lehigh University
in Candidacy for the Degree of
Master of Science

Lehigh University
April 2001

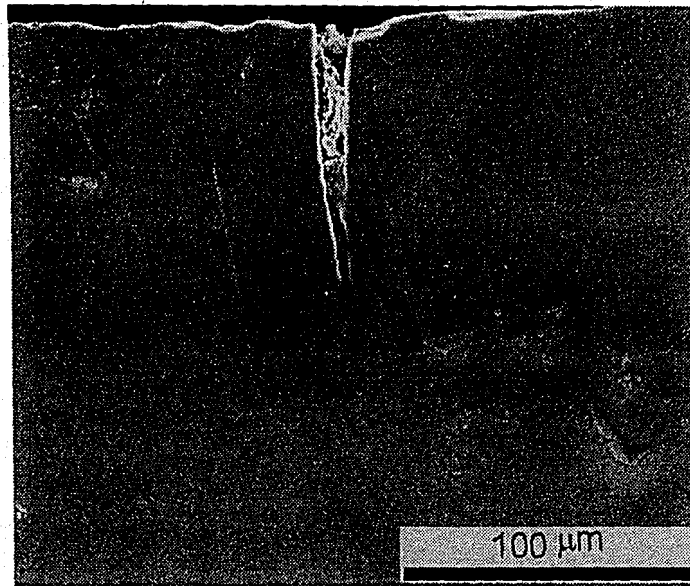
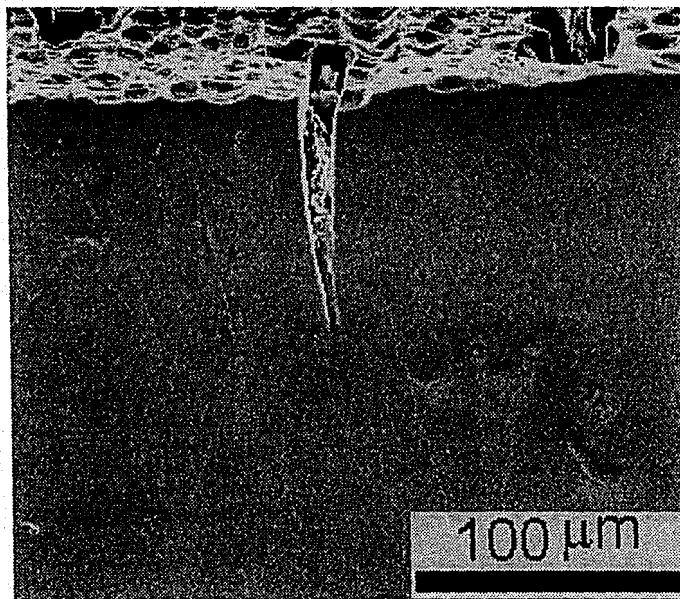
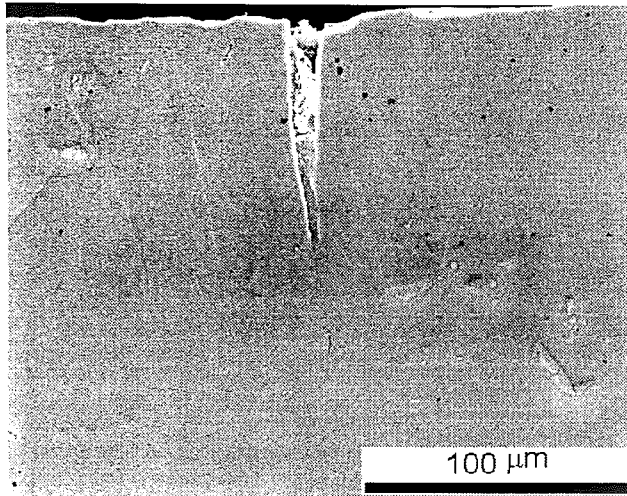
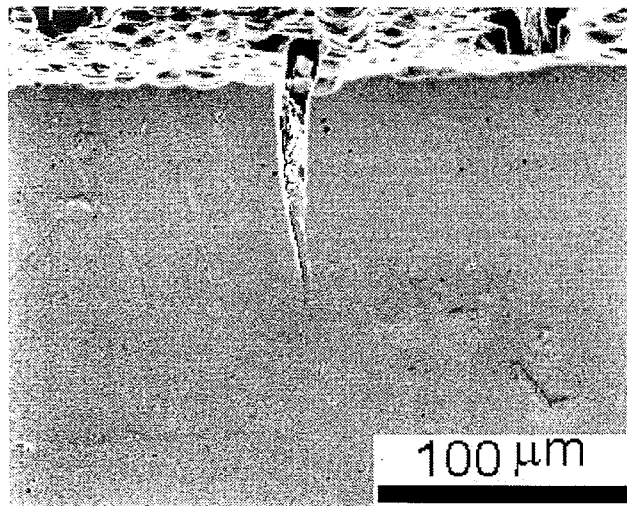
Figure E.8: SEM micrographs of Crack #2 in hole #107 on panel B3-2-2 to show (a) Section 8 at 270X and (b) 30° tilted micrograph of Section 8 at 250X.
