Concrete Deck Cracking Investigation SR309 over Church Road, Montgomery County, PA

Final Report

ATLSS Report No. 09-07

August 2009

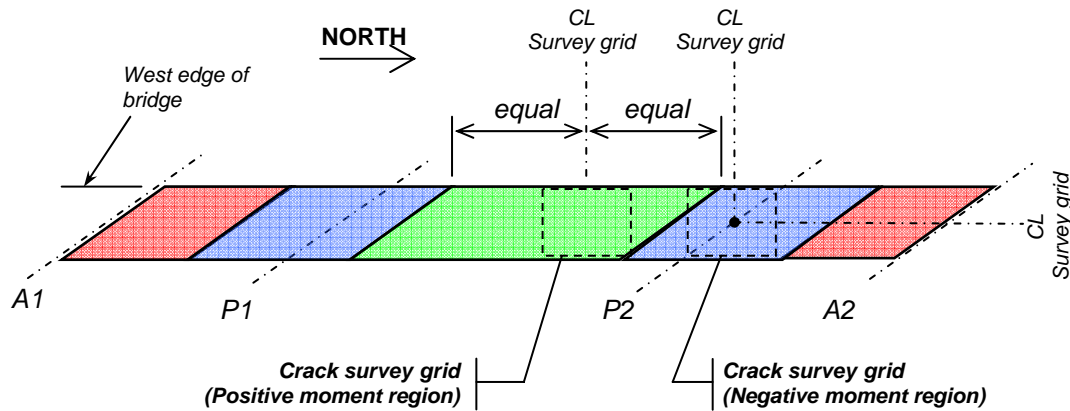
Figure 2.1 – Location plan of the two crack survey grids of the Stage 4 deck

Figure 2.1 is a schematic drawing of the bridge deck (Stage 4 placement). The figure indicates where the positive and negative moment region crack survey grids were placed.

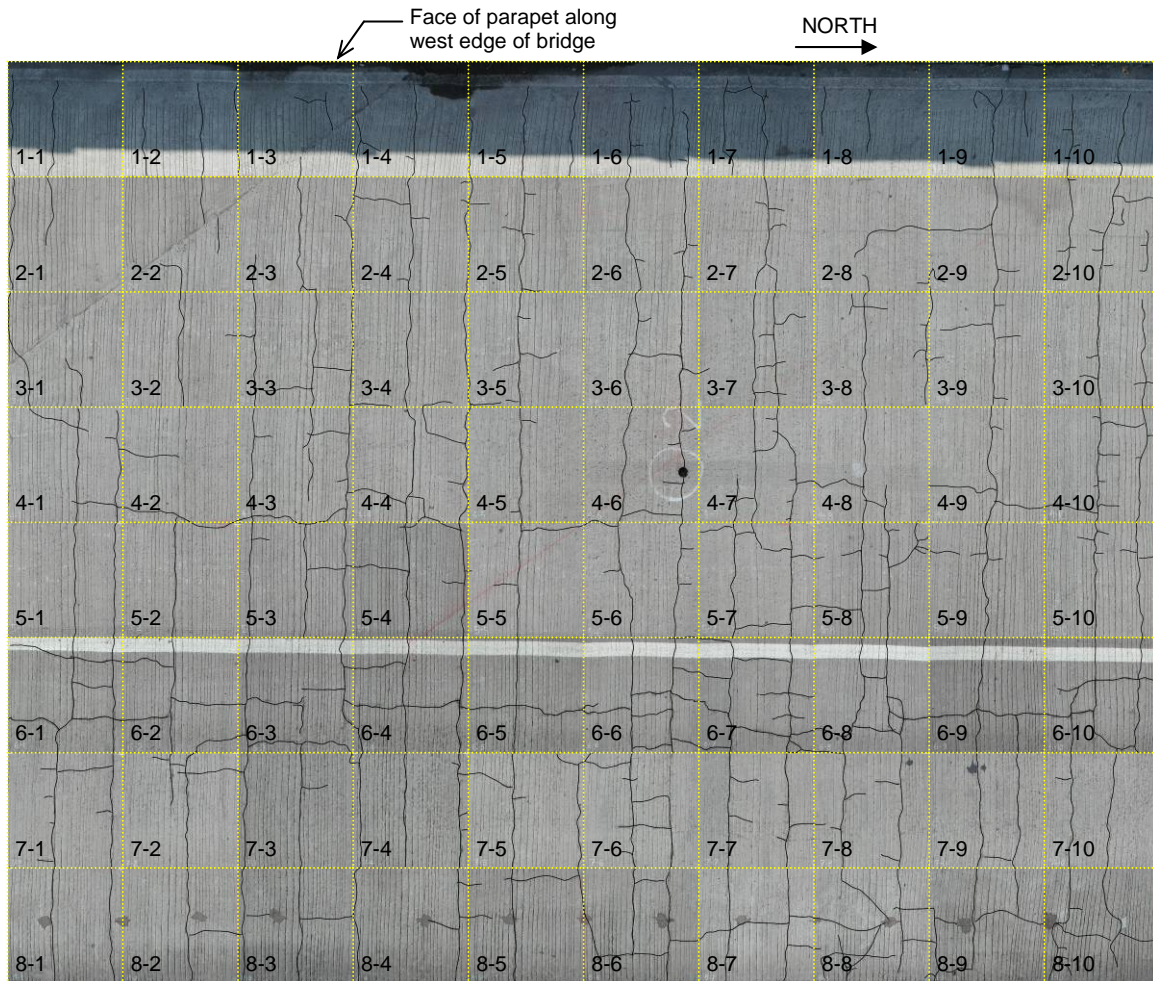
Figure 2.6 – Composite image of cracking in negative moment crack survey grid with grid numbering overlay

Figure 2.5 is the composite image of the negative moment crack survey grid. The crack locations have been highlighted in the composite image for clarity. The transverse locations of Girders G1 through G5 are indicated in the figure. Girders G1 and G2 are the new welded steel plate girders while Girders G3, G4, and G5 are original riveted plate girders. Locations of the diaphragms are also shown in the figure. A number of diaphragms exist and are either perpendicular to the girders or parallel with the pier. The roadway stripe separating the shoulder (upper portion of the image) from the southbound right lane (lower portion of the image) can be seen between Girders G3 and G4.

Figure 2.6 is an image of the negative moment crack survey grid with an overlay showing the grid identification numbers.

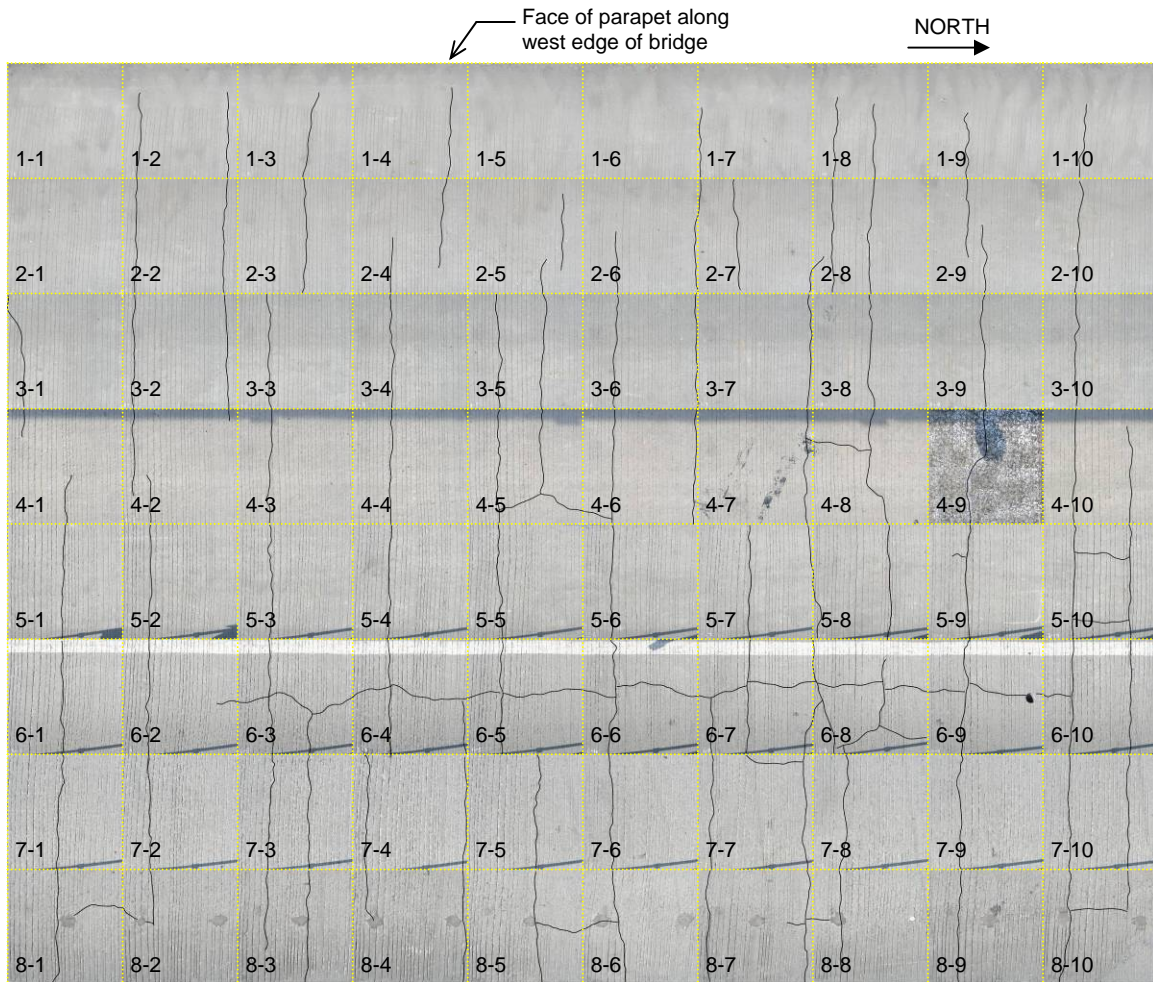
Figure 2.8 – Composite image of cracking in positive moment crack survey grid with grid numbering overlay

Figure 2.7 is the composite image of the positive moment crack survey grid. The crack locations have been highlighted for clarity. Again, the locations of Girders G1 through G5 are indicated in the figure. The roadway stripe separating the shoulder (upper portion of the image) from the southbound right lane (lower portion of the image) can be seen between Girders G3 and G4.

Figure 2.8 is the crack survey grid from the positive moment region with an overlay showing the grid identification numbering.

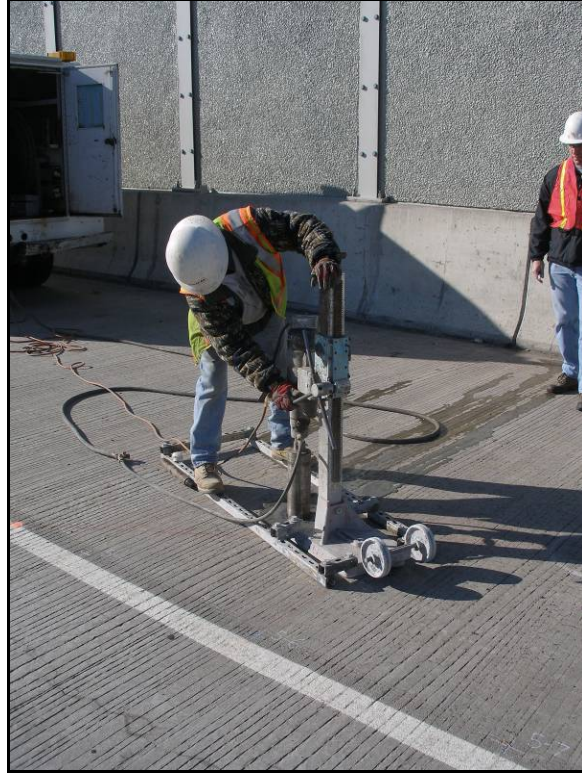
Figure 3.1 – Coring operation during removal of Core #1

Three core samples were removed from the bridge in October 2008 (see Figure 3.1). Complete petrographic examinations of each core were performed by Mr. Bernard Erlin of The Erlin Company. The complete petrography report is presented in Appendix A.

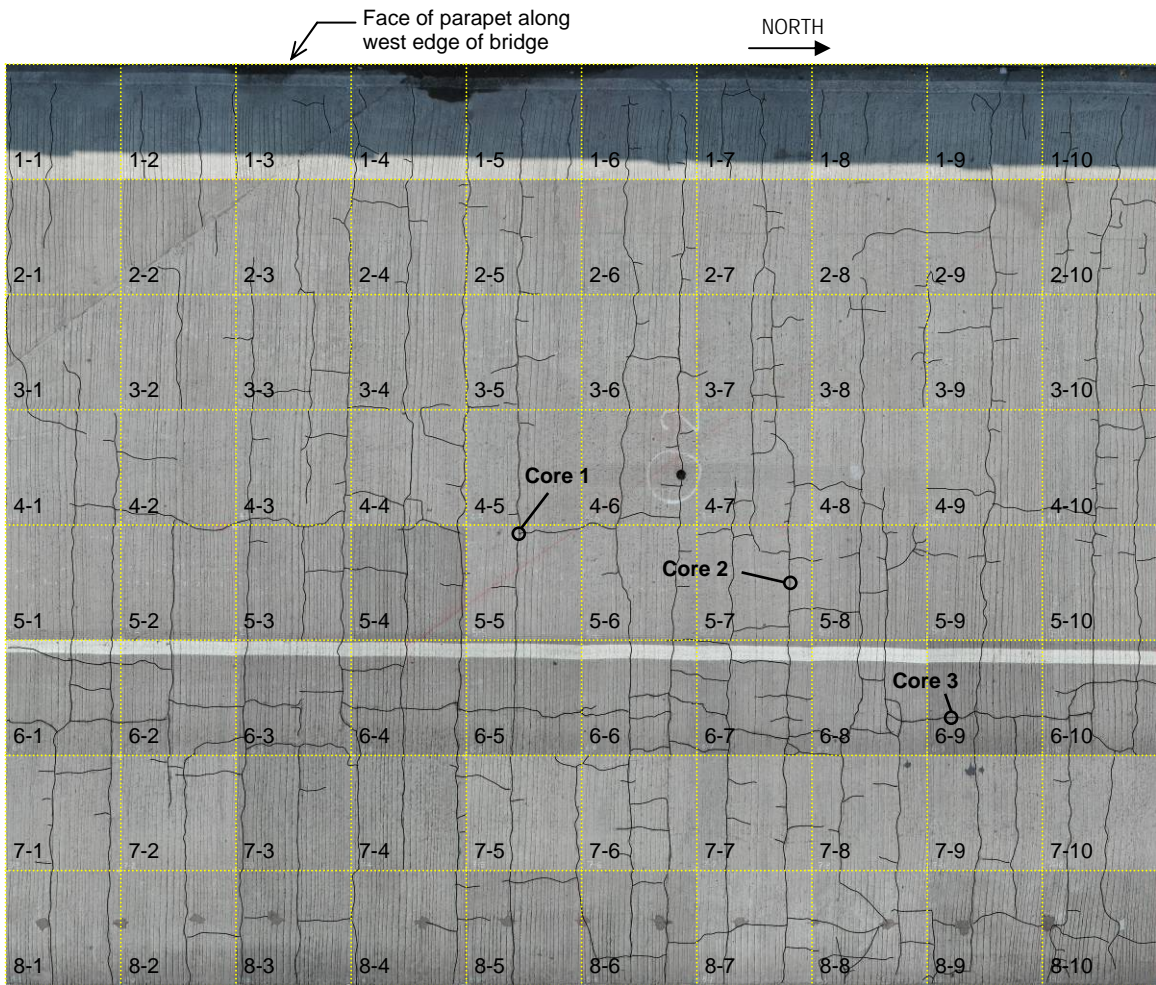
Figure 3.2 – Composite image of cracking in negative moment crack survey grid over Pier 2 in southbound shoulder and right-hand lane with grid numbering overlay

As noted above, three core samples were removed from the deck and identified as Core #1, #2, and #3. Each core was taken through the full depth of the slab. The cores have 3-3/4 inch diameters and respective lengths of 8-3/4, 8-3/8, and 8-1/2 in. Top core ends are tined surfaces with impressions spaced variably but usually 1-3/4 to 2 in. apart; bottom core ends are formed surfaces. All cores were removed from within the negative moment crack survey grid located in Stage 4 slab over Pier 2 (southbound SR309 shoulder and right lane). A layout of the three cores with respect to the crack survey grid is presented in Figure 3.2.

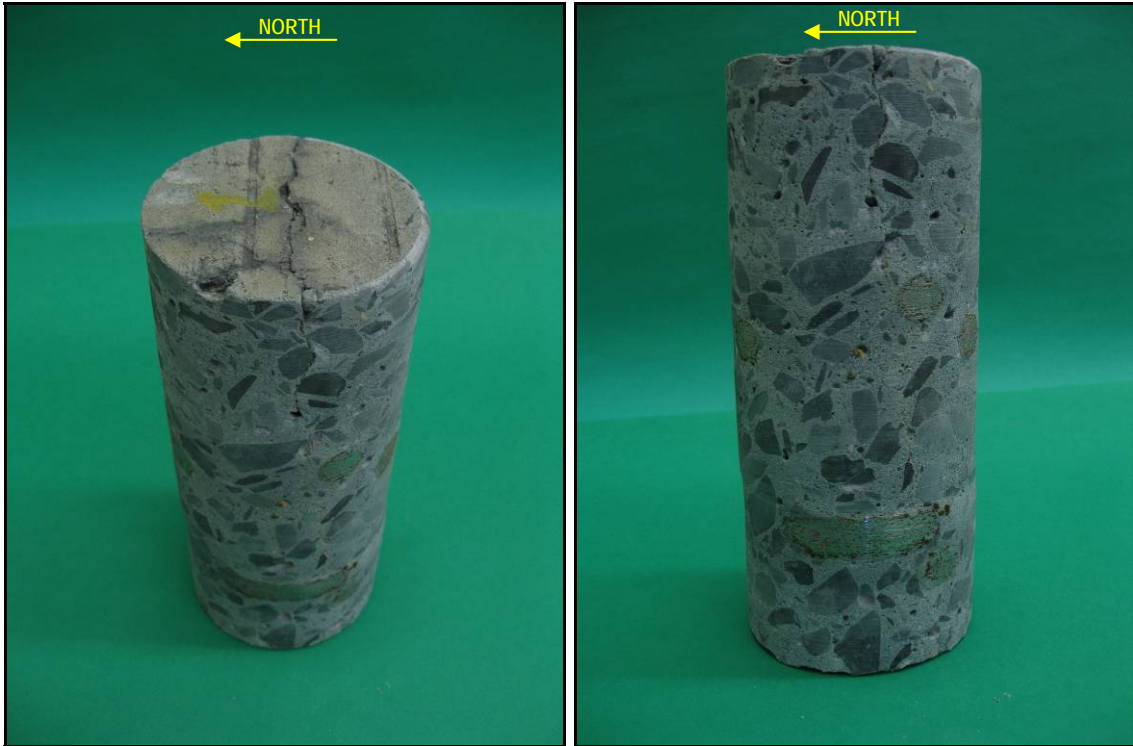
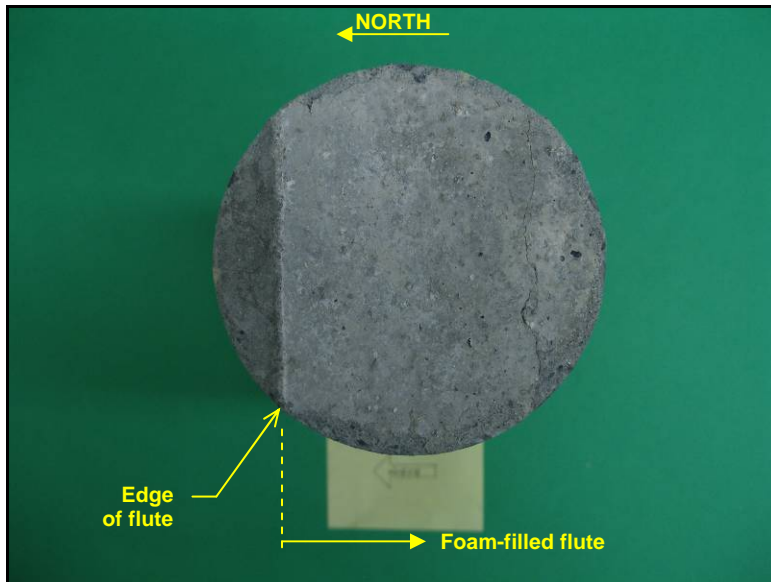
Core #1 was taken at the intersection of a transverse and longitudinal crack, located within Grid 5-5, in the southbound shoulder. A detailed photograph of Grid 5-5 showing the location of Core #1 is presented in Figure 3.3. Finally, three photographs of Core #1 are shown in Figure 3.4.

Sections of green epoxy-coated No. 5 bars are present in the upper and lower part of Cores #1 and #2 and the upper half of Core #3. Associated with bars in Cores #1 and #2 are yellow epoxy-coated tie-wires. Sections of 7/32- and 3/16-inch diameter mesh are present in Core #1.

Figure 3.4 – Photographs of Core #1; (a) overall, (b) from the west side, (c) underside

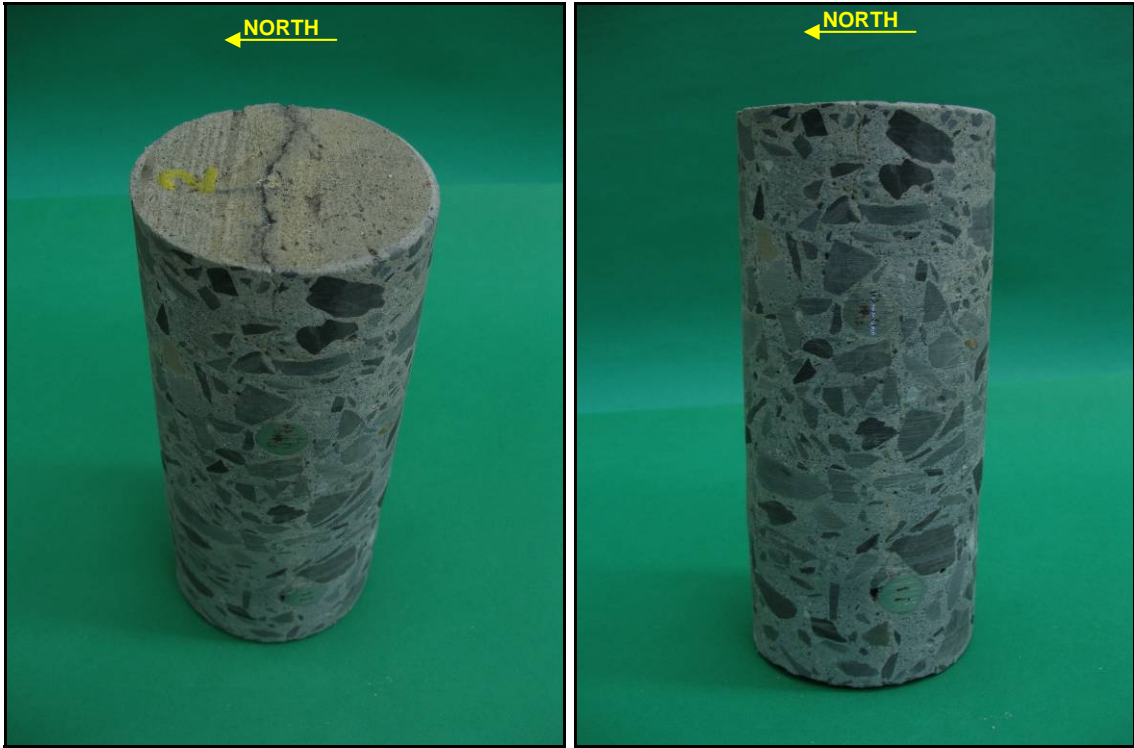
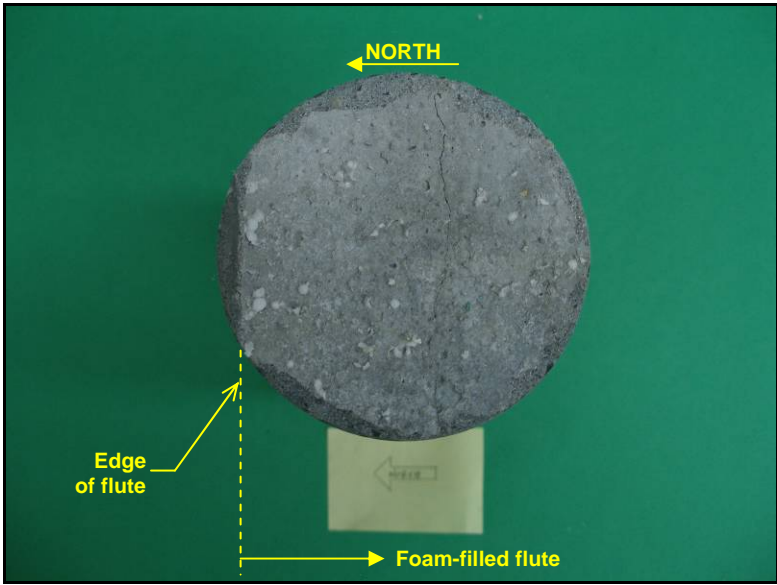
Core #2 was taken through a transverse crack, located within Grid 5-7, in the southbound shoulder. A detailed photograph of Grid 5-7 showing the location of Core #2 is presented in Figure 3.5. Finally, three photographs of Core #2 are shown in Figure 3.6.

Figure 3.6 – Photographs of Core #2; (a) overall, (b) from the west side, (c) underside

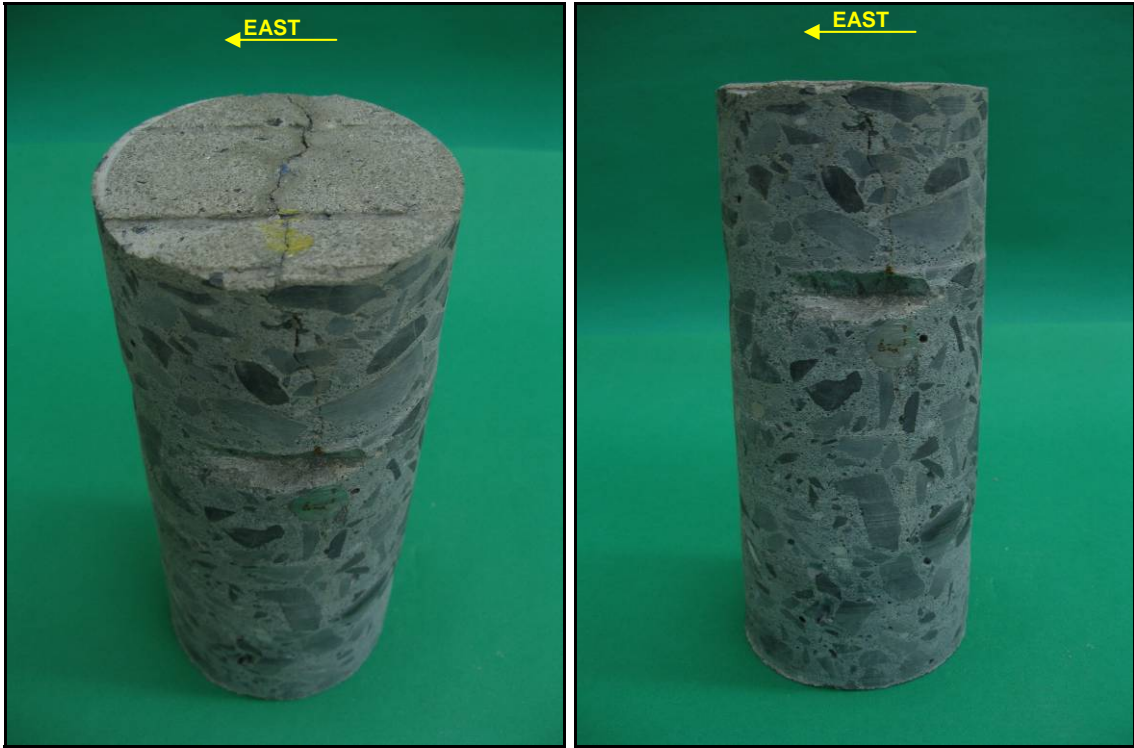
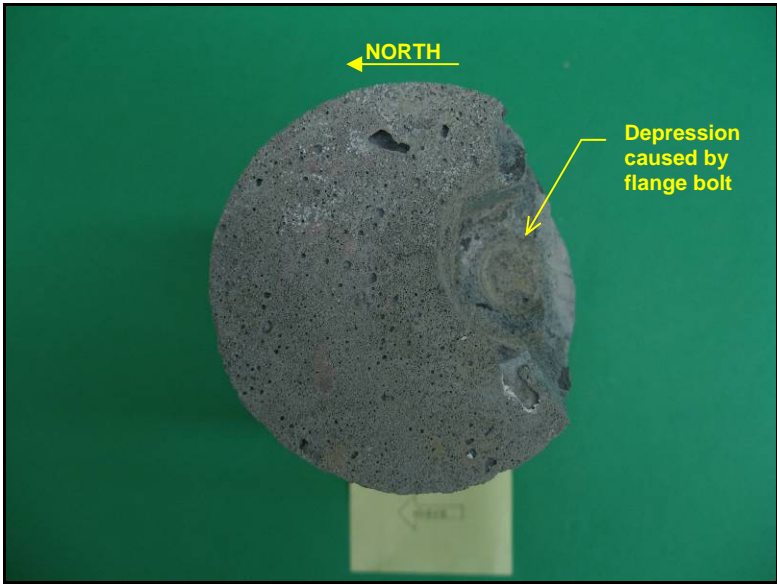
Core #3 was taken through a longitudinal crack, located within Grid 6-9, in the southbound right-hand lane. A detailed photograph of Grid 6-9 showing the location of Core #3 is presented in Figure 3.7. Finally, three photographs of Core #3 are shown in Figure 3.8.

Figure 3.8 – Photographs of Core #3; (a) overall, (b) from the north side, (c) underside

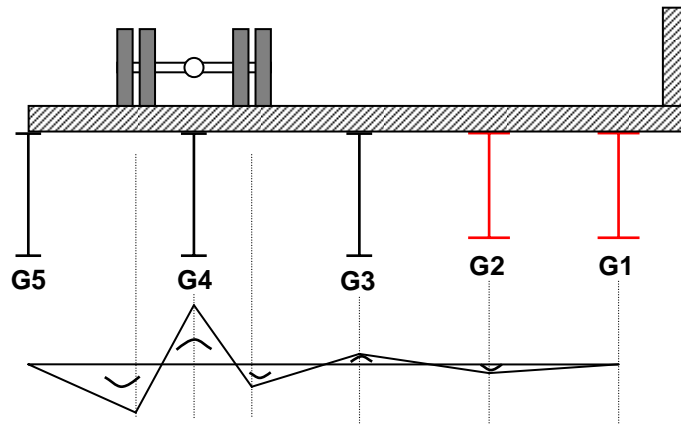
Analyses were performed to investigate whether the longitudinal cracking may be due in part to construction loads on the deck prior to completion of the bridge. Figure 4.1 is a schematic drawing showing the moment diagram resulting from the placement of a set of rear truck axles centered over the first interior girder from the longitudinal construction joint during Stage 3 or 4 of construction. This configuration of the load results in a negative moment over the girder that induces tensile stresses in the top surface of the slab. This moment is higher than the moment induced after the deck has been completed due to the fact at this location the load is in an end span. After completion of the deck, the deck would be made continuous across the construction joint. The cracking pattern shown in Figure 2.5 appears to correspond to this theory as most of the longitudinal cracking occurs over Girder G4, the first interior support.

Figure 4.1 – Stage 4 of deck placement with heavy vehicle inducing negative moment over Girder 4 causing tension stresses in the top surface of the deck (Stage 3 placement similar)

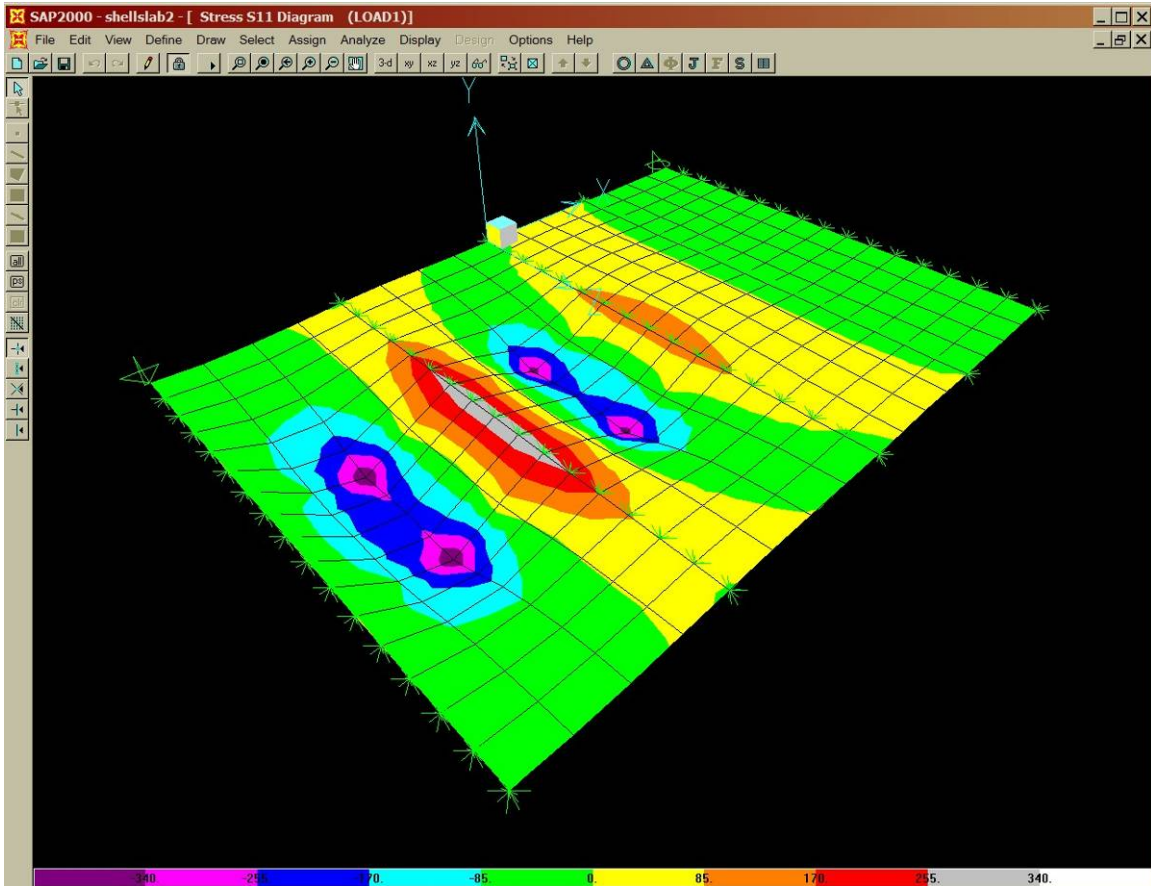
Figure 4.3 – Stress contour (in psi) for top surface X-direction stresses (transverse bridge direction)

Figure 4.3 is the transverse (X-dir) stress contour at the top surface of the deck slab for the loading described above. The slab is shown in its deformed shape. As expected the maximum transverse tensile stresses in the top surface occur over first interior girder (gray shaded area), and are equal to approximately 320 psi.

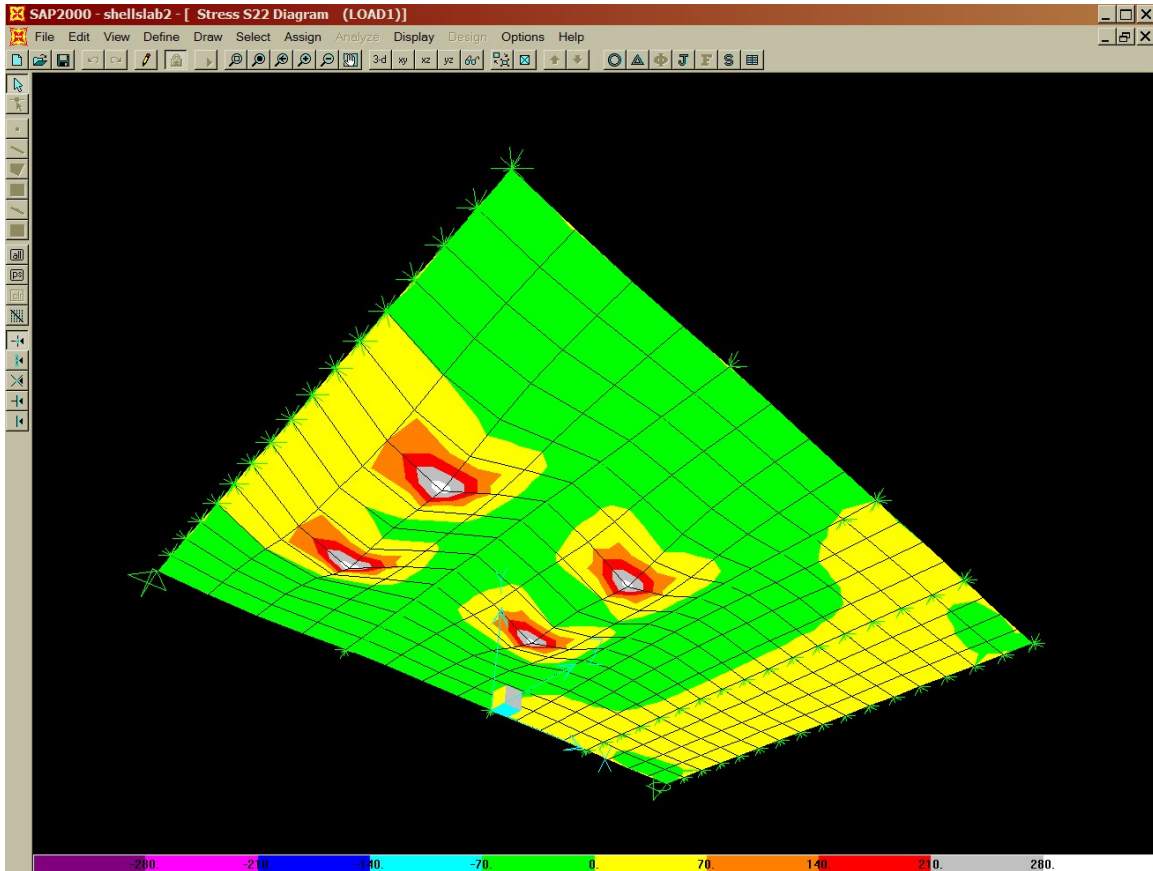
Figure 4.4 – Stress contour (in psi) for bottom surface Z-direction stresses (longitudinal bridge direction) viewed from beneath

Figure 4.4 is the longitudinal (Z-dir) stress contour on the bottom surface of the deck slab for the loading described above, viewed from beneath. The slab is shown in its deformed shape. The maximum longitudinal tensile stresses occur directly beneath the wheel loads and have a magnitude of approximately 310 psi.

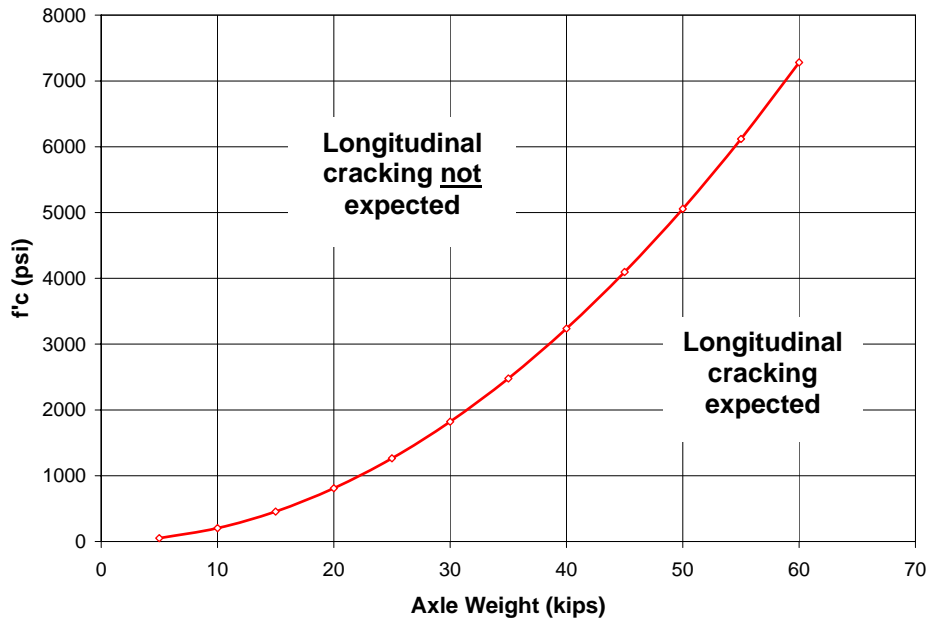
Figure 4.5 – Envelope for longitudinal cracking shown in terms of applied axle weight and concrete strength, f'_c , at time of load application for four span concrete slab with tandem axles (2 times axle weight) centered over first interior support

Where f'_c is the compressive strength of the concrete and λ is equal to 1.0 for normal weight concrete. Setting the f_r equal to the calculated stress, the compressive strength of the concrete can be solved for, which represents the strength at which cracking would occur for the given applied load. Repeating this for a number of axle loads (the calculated stress is found by scaling based on the axle load, since elastic behavior is assumed), a failure envelope is determined as shown in Figure 4.5.

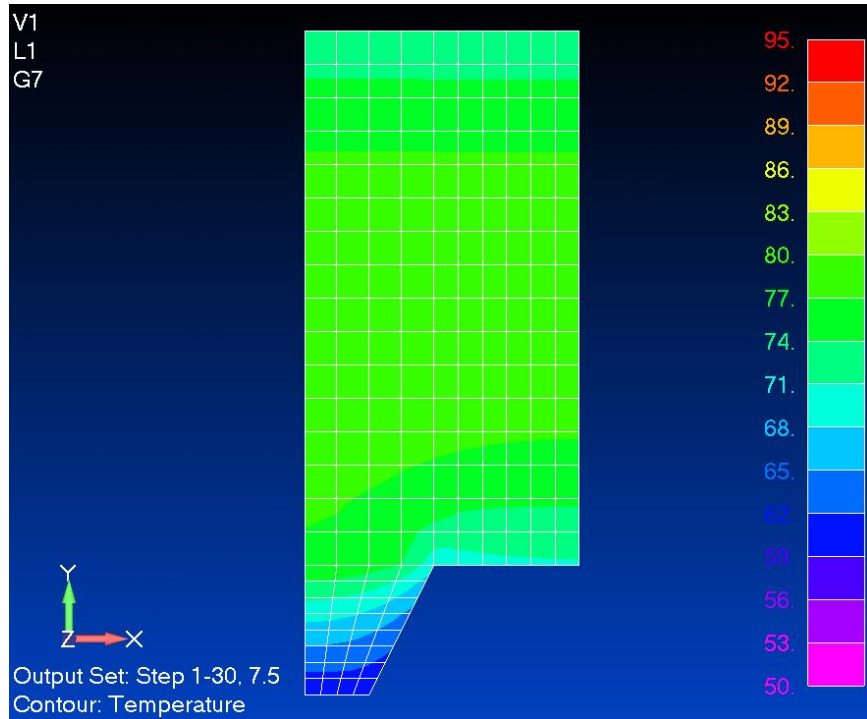
Figures 5.5 through 5.12 show, as expected, that the higher temperatures exist near the center of the slab, and relatively cooler temperatures exist near both the top and bottom surfaces of the slab. These temperature gradients through the slab thickness will give rise to tension stresses at the top and bottom slab surfaces, because the center region at a higher temperature will expand relative to the cooler top and bottom surfaces. This will place the center of the slab in compression and the top and bottom surfaces in tension.

Figure 5.5 – Model 1A (Foam filled flutes, Type I cement, standard heat generation rate) – temperature contour at 7.5 hours from placement (maximum temperature)

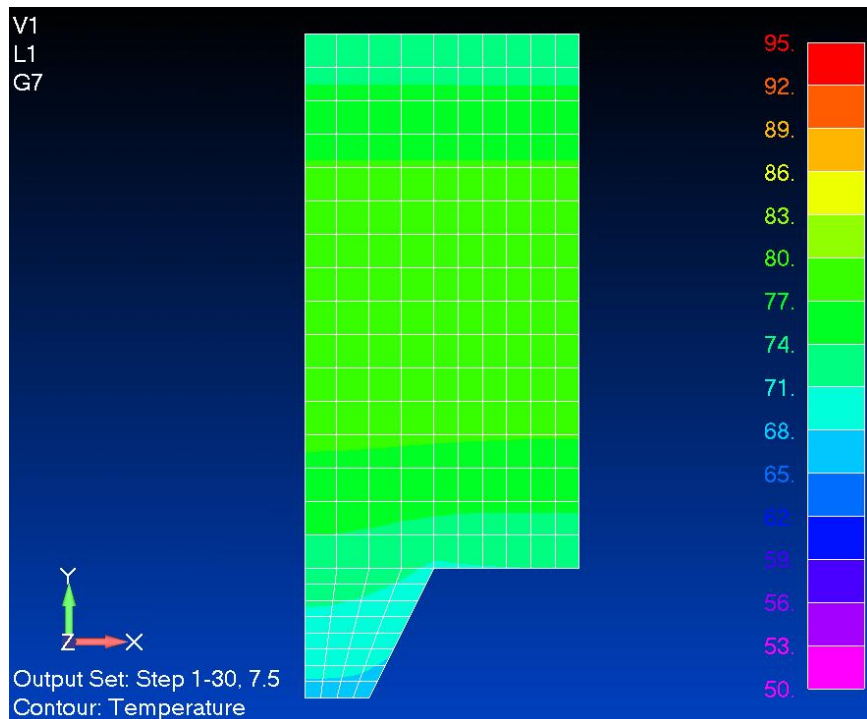
Figure 5.6 – Model 2A (Concrete filled flutes, Type I cement, standard heat generation rate) – temperature contour at 7.5 hours from placement (maximum temperature)

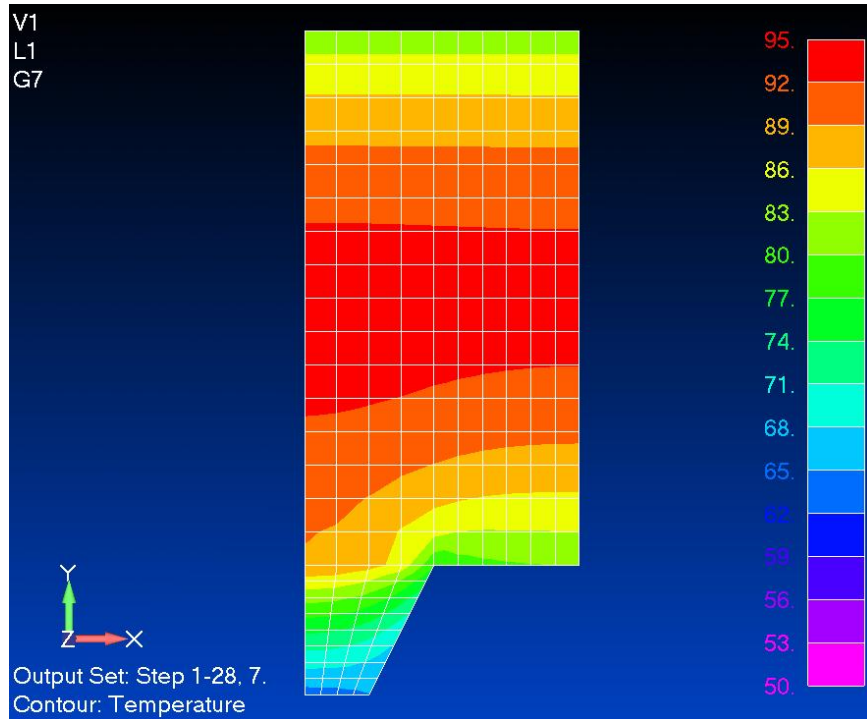
The analyses also show that modifying the rates of heat release (simulating different finenesses in the Type I cement) increase the peak temperatures in the slab and also the relative temperature differences between different regions in the slab. A more rapid rate of heat release leads to both higher peak temperature and also a higher relative temperature difference between regions.

Figure 5.9 – Model 1C (Foam filled flutes, Type I cement, 2 times standard heat generation rate) – temperature contour at 7 hours from placement (maximum temperature)

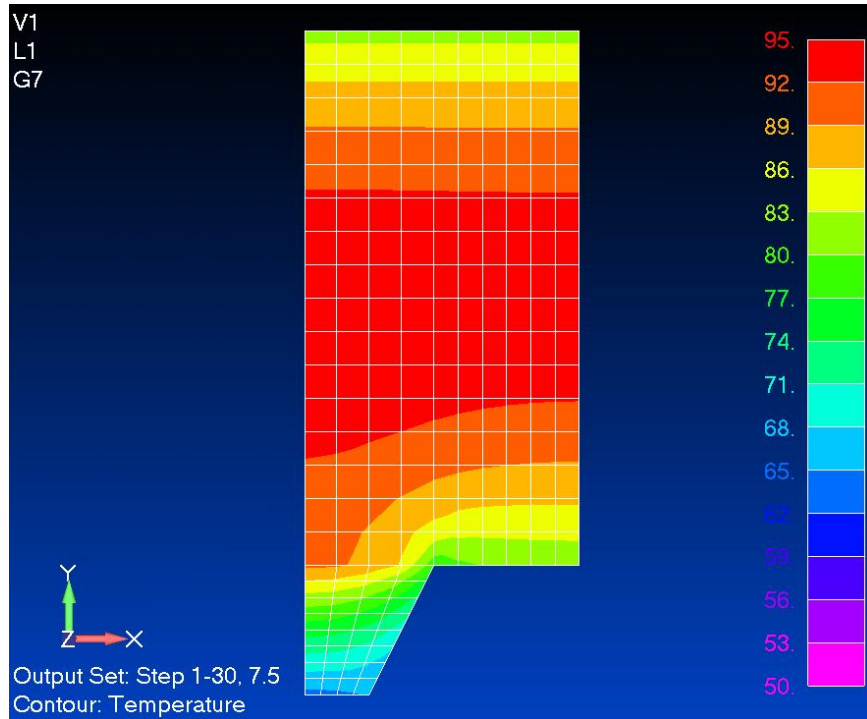
Figure 5.11 – Model 1D (Foam filled flutes, Type III cement, standard heat generation rate) – temperature contour at 7.5 hours from placement (maximum temperature)

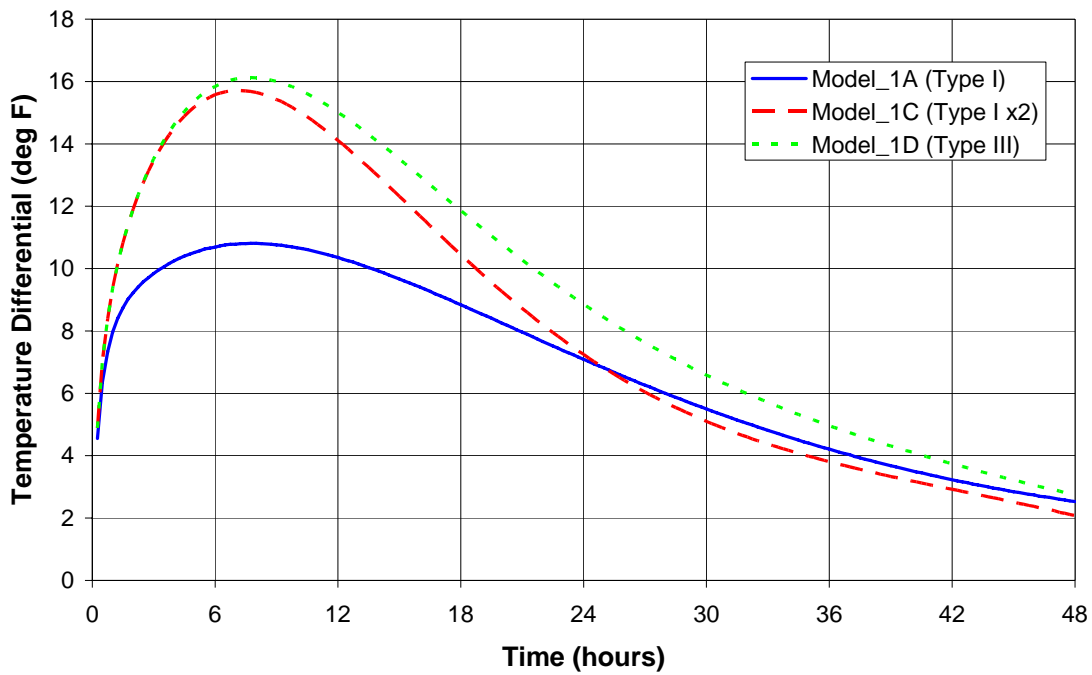
Figures 5.21 is a plot of the temperature differential between the center of the slab and the bottom surface of the slab for the Type I cement at the standard rate, the Type I cement at twice the standard rate, and the Type III cement (all for foam-filled flutes). Similarly, Figure 5.22 is a plot of the temperature differential between the center of the slab and the top surface of the slab for the Type I cement at the standard rate, the Type I cement at twice the standard rate, and the Type III cement. This figure shows that increasing the fineness of the cement (Model 1C as compared to Model 1A), or changing to a Type III cement (Model 1D as compared to Model 1A), will increase the temperature differential between the slab center and the top and bottom surfaces.

Figure 5.21 – Comparison of temperature differential between center of deck (node #735) and bottom surface of deck at the edge of the flute (node #251) for Type I and Type III cements with standard heat generation rates, and Type I with 2x heat generation rate

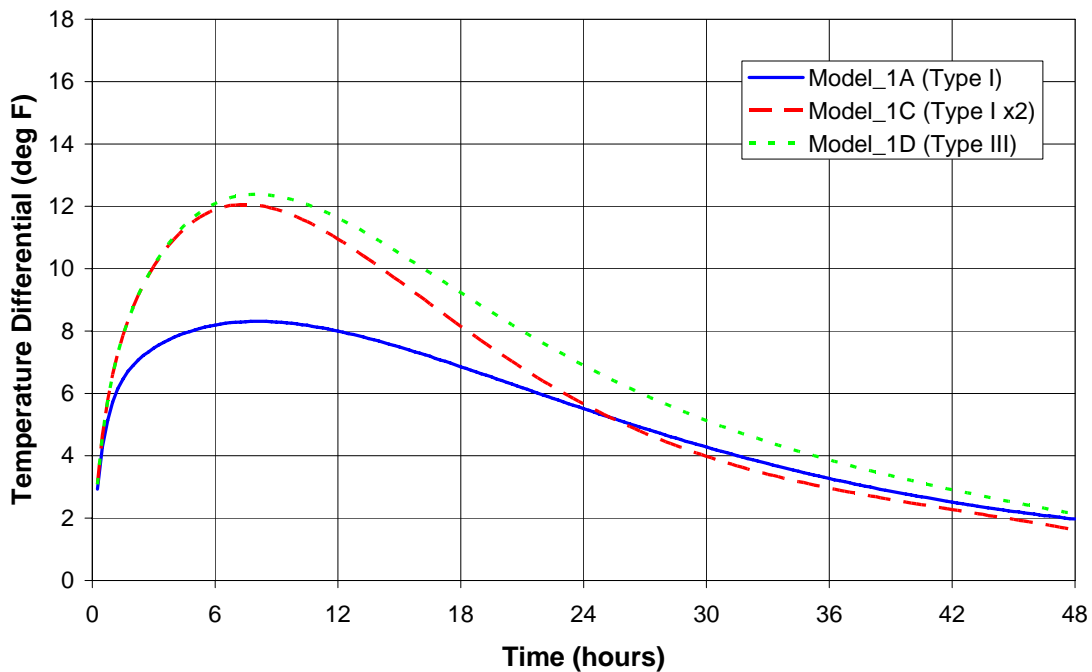
Figure 5.22 – Comparison of temperature differential between center of deck (node #735) and top surface of deck (node #1223) for Type I and Type III cements with standard heat generation rates, and Type I with 2x heat generation rate

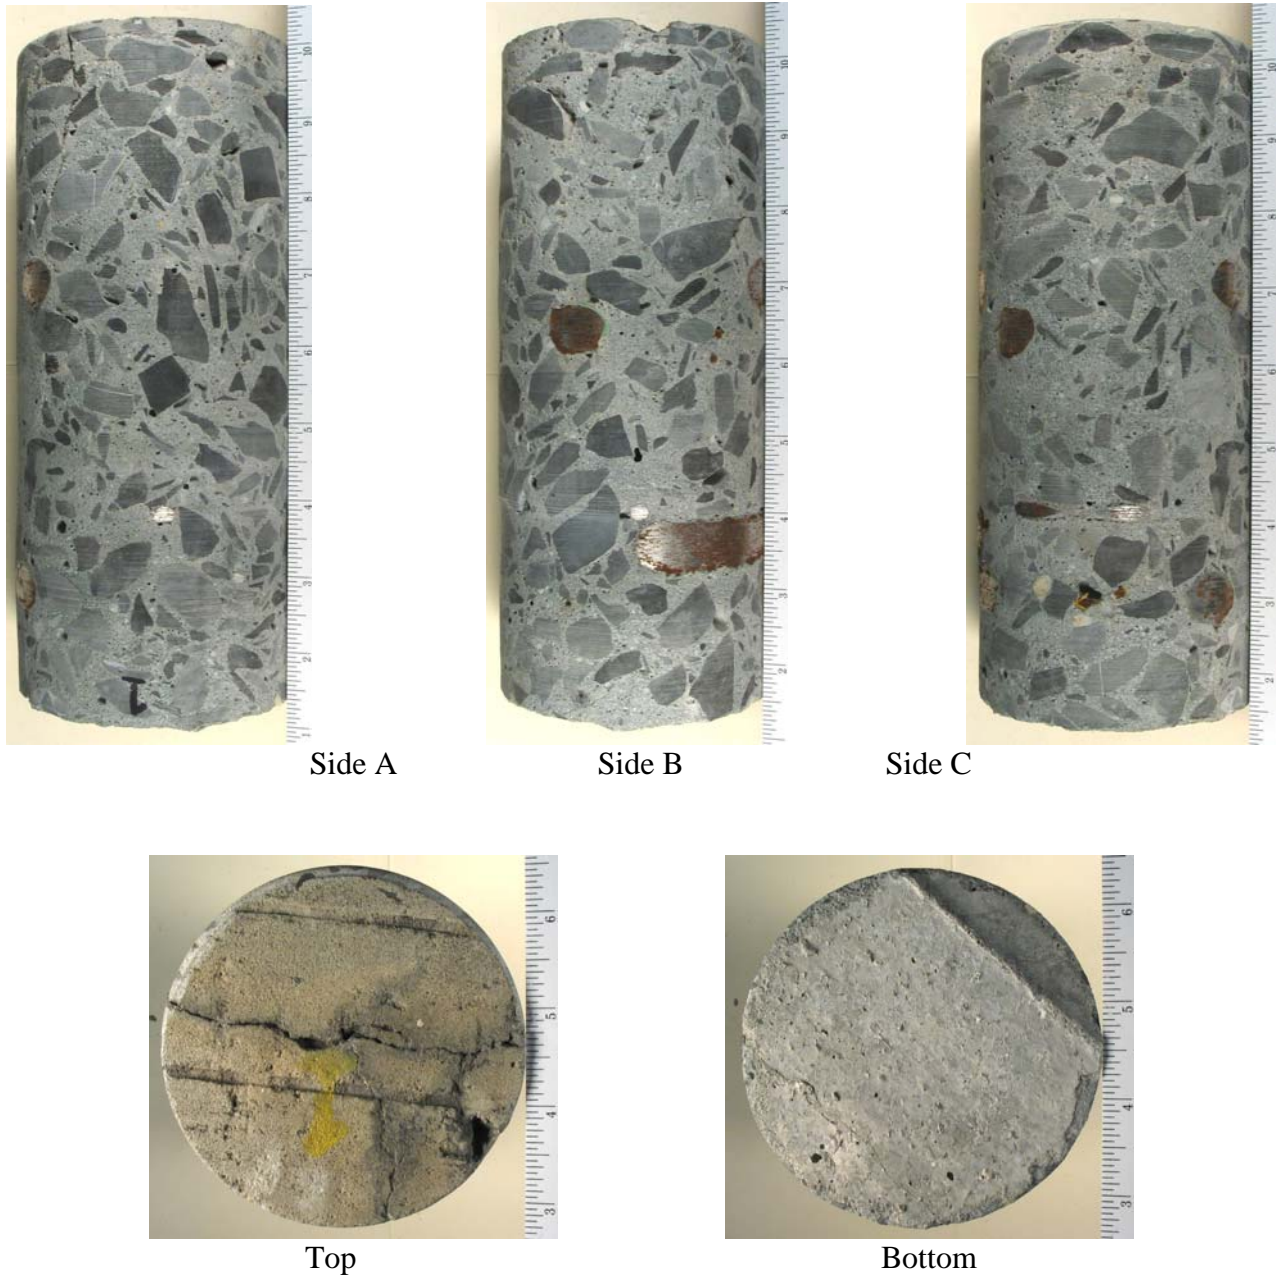
Figure 1 – Views of Core 1 as received. Scale in inches.

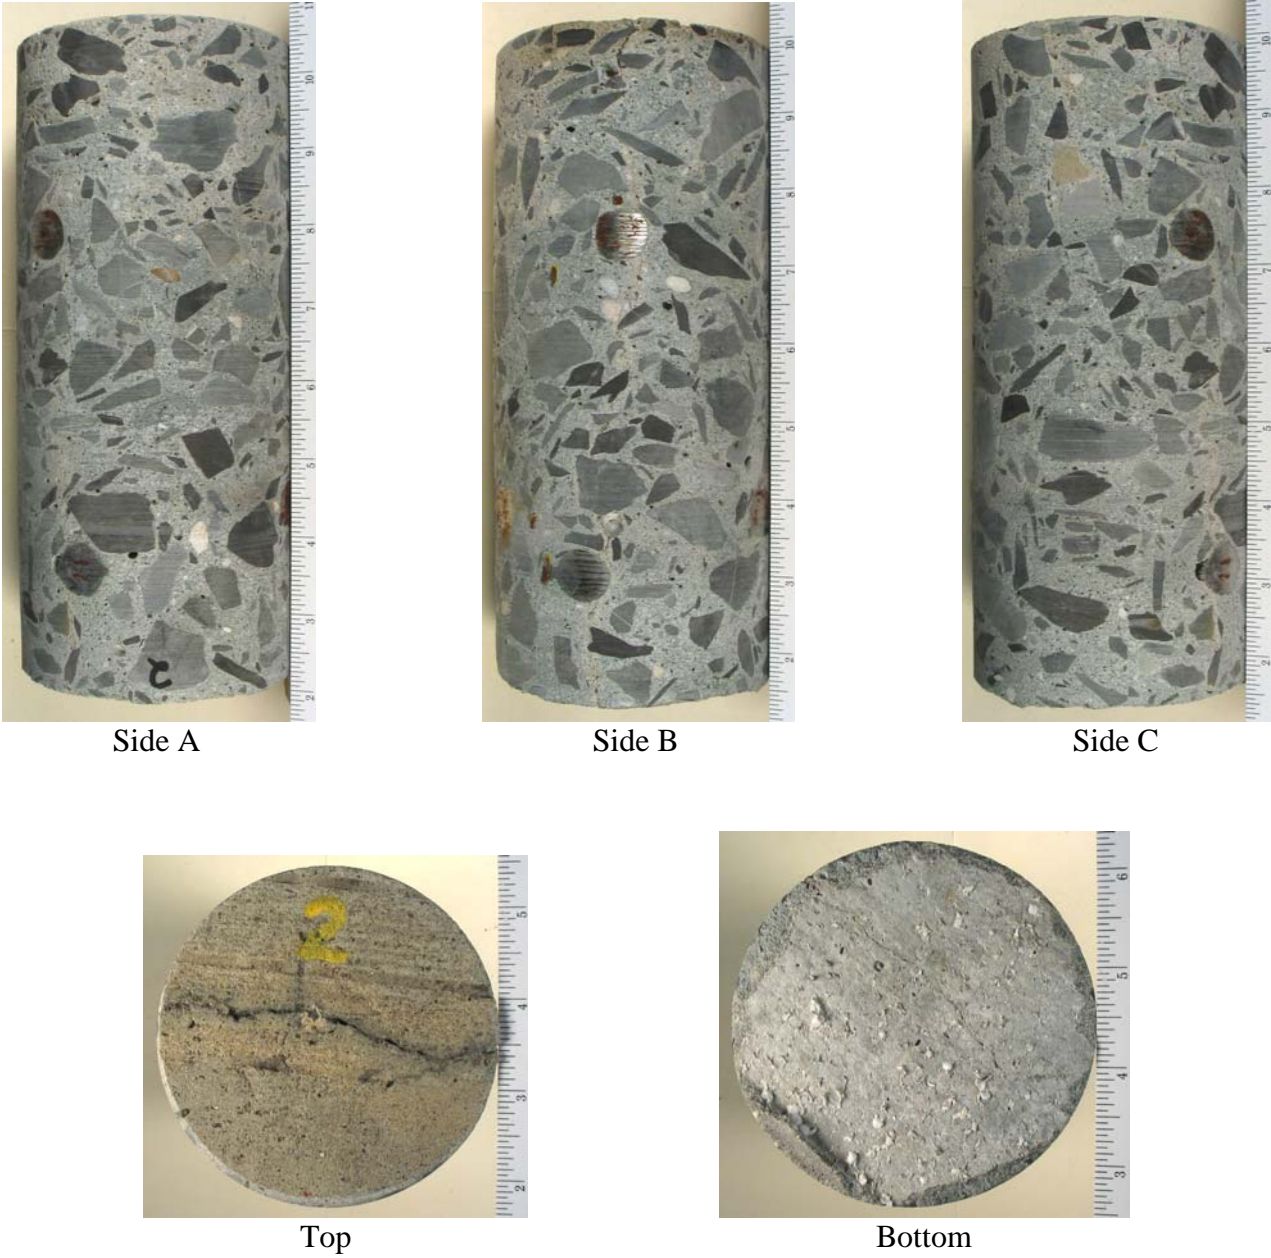
Figure 2 – Views of Core 2 as received. Scale in inches.

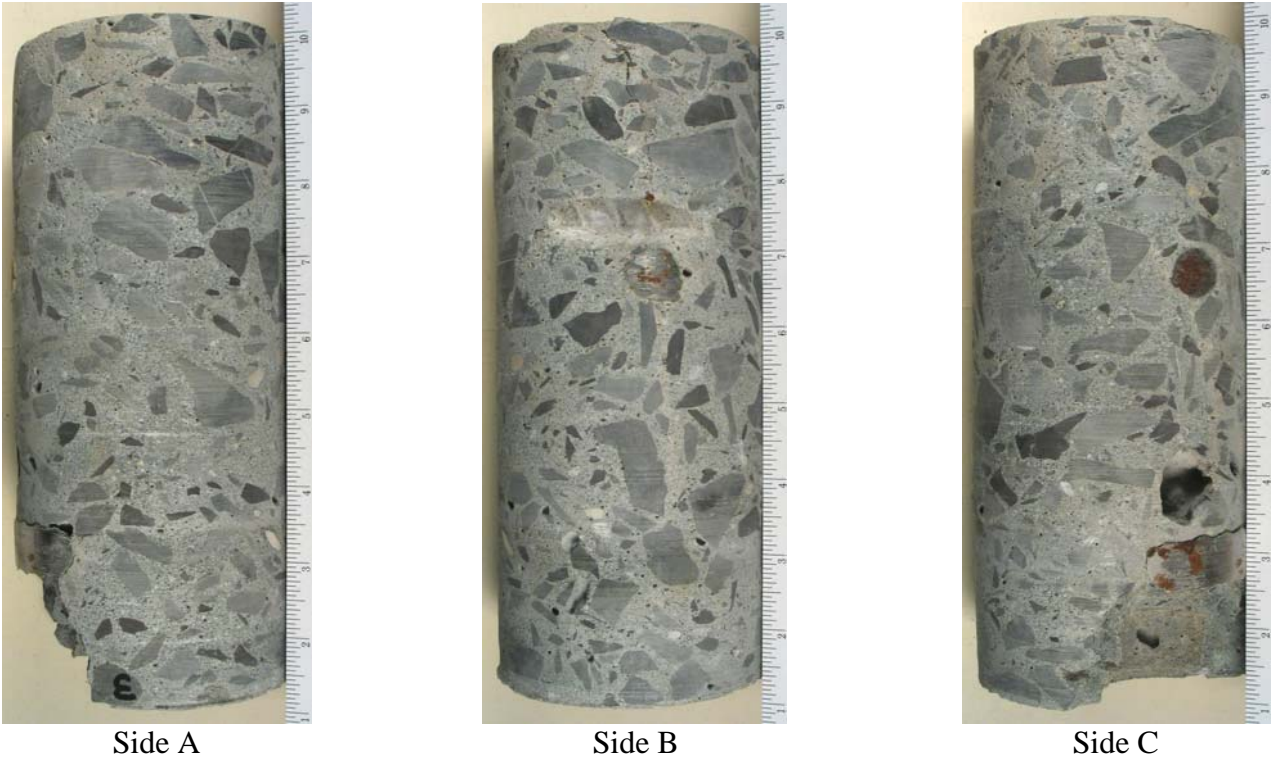
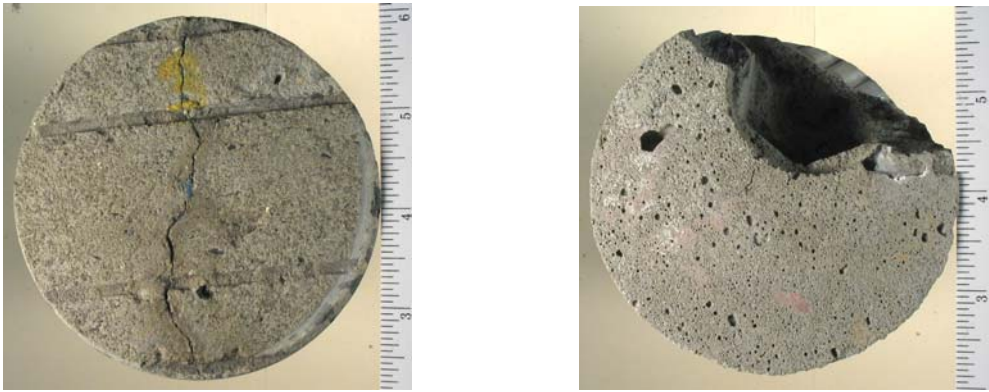
Figure 3 – Views of Core 3 as received. Scale in inches.
