Concrete Deck Cracking Investigation SR309 over Church Road, Montgomery County, PA

Final Report

ATLSS Report No. 09-07

August 2009

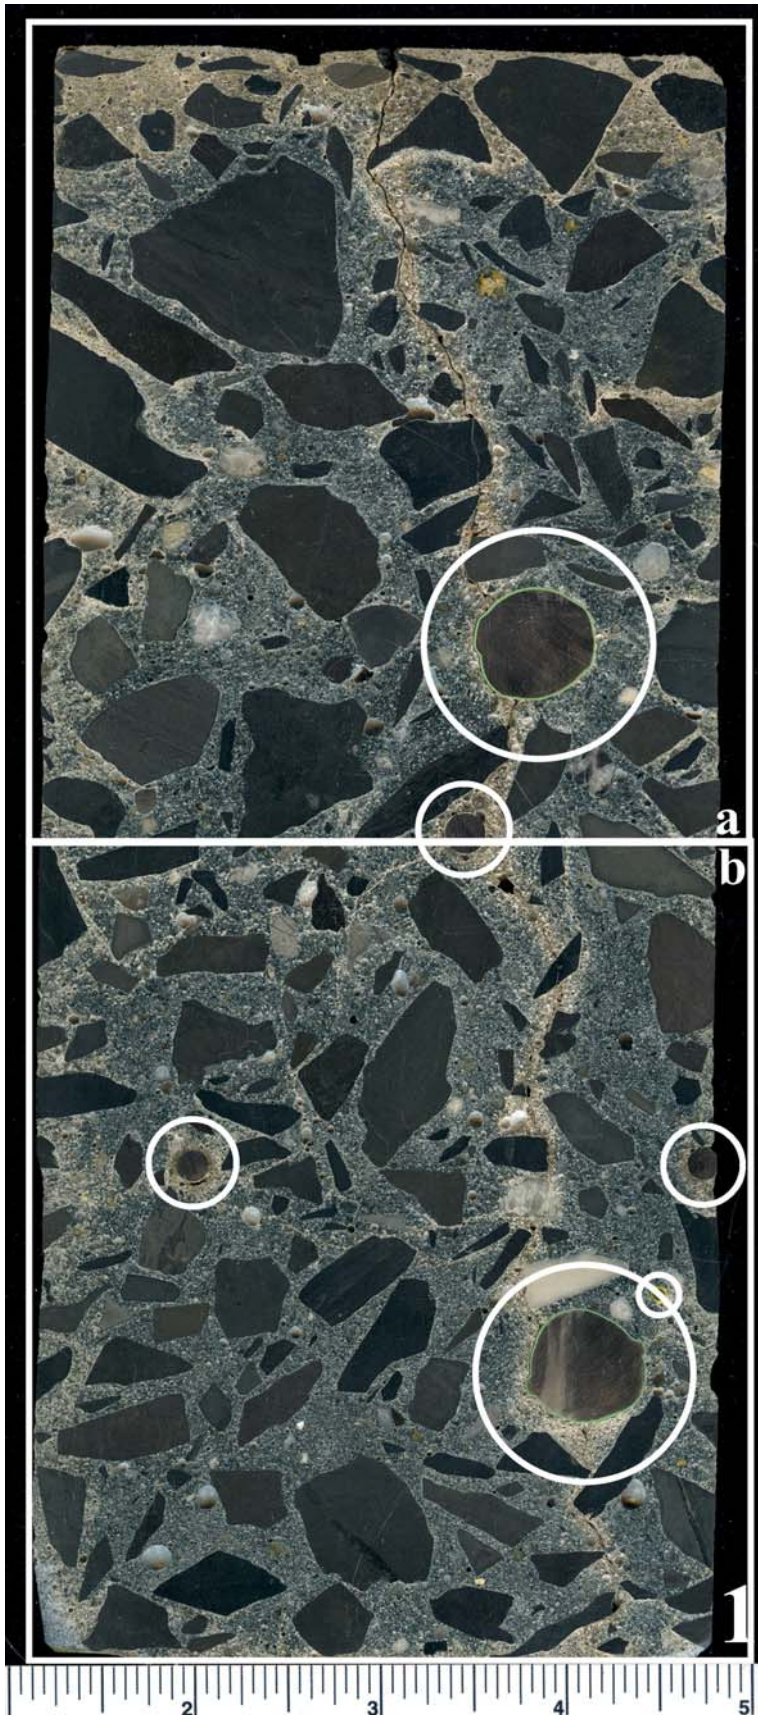
Pastes – Pastes of the cores are similar. They are dark blue-green, dense, firm, and fracture surfaces have semi-conchoidal textures. There is an apparent very slight darker to lighter color tone from bottom to top of the cores. In surface regions, to nominal depths of $1/2$ to $3/4$ inch, pastes have a warmtone brown color, a result of "atmospheric bleaching" of the slag component (Figures 4, 4A, 5, 5A, 6, 6A). That phenomenon occurs sporadically below those regions so pastes have a mottled appearance (Figures 4A, 5A, 6A), and also along cracks (Figures 4, 4A, 4B, 5, 5A, 5B, 6, 6A, 6B).

Figure 4 – Cross-section of Core 1 showing: (a) aggregate grading and distribution; (b) dark blue-green coloration typical of pastes containing ground granulated blast-furnace slag; (c) "bleaching" of the paste due to atmospheric intrusion in the surface region and along cracks; (d) a vertical crack that extends from top to bottom of the core (defined by "bleaching" along the crack path); (e) green epoxy-coated No. 5 reinforcing bars (large circles); (f) yellow epoxy-coated tie-wire (small circle); and (g) mesh sections (intermediate-sized circles). Boxed Areas "a" and "b" are shown in Figures 4A and 4B. Scale in inches.

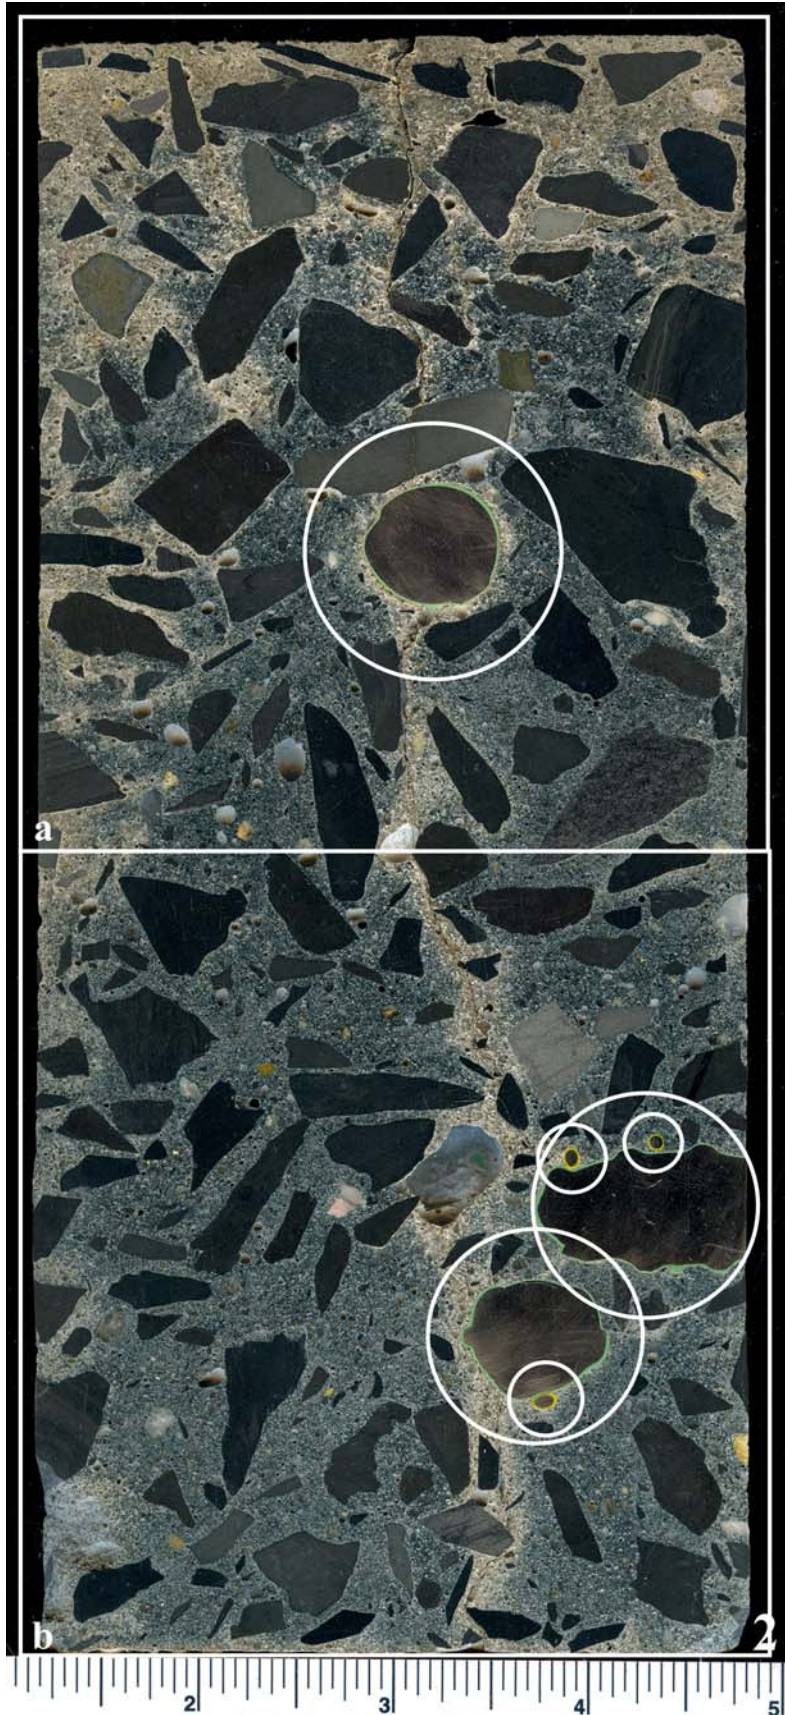
Figure 5 – Cross-section of Core 2 showing: (a) aggregate grading and distribution; (b) dark blue-green coloration typical of pastes containing ground granulated blast-furnace slag; (c) "bleaching" of the paste due to atmospheric intrusion in the surface region and along cracks; (d) a vertical crack that extends from top to bottom of the core (defined by "bleaching along the crack path"); (e) three green epoxy-coated No. 5 bars (large circles); and (f) yellow epoxy-coated tie-wires (small circles). Boxed Areas "a" and "b" are shown in Figures 5A and 5B. Scale in inches.

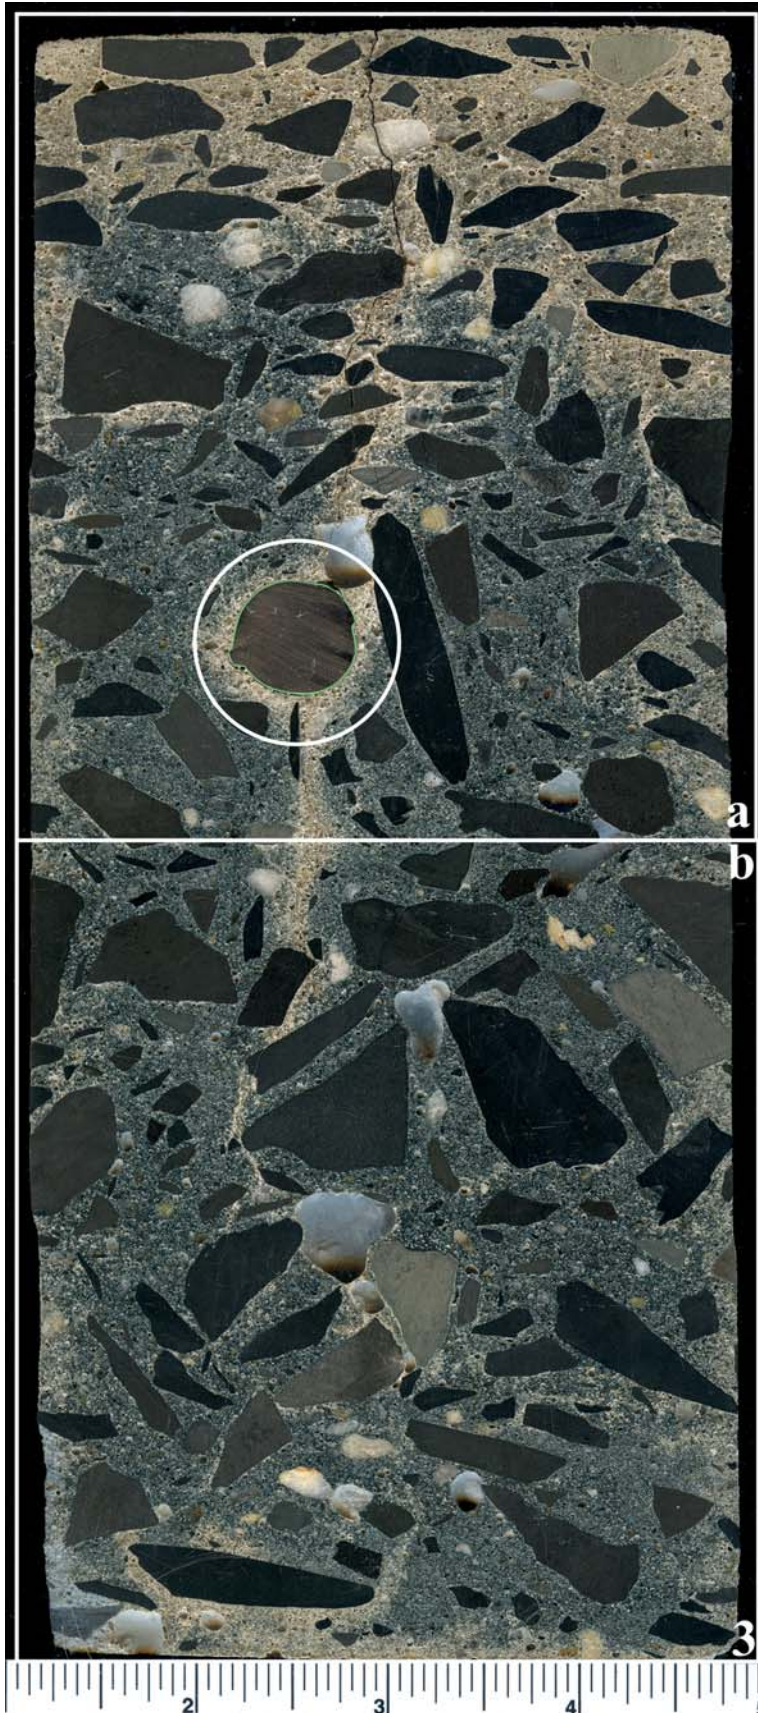
Figure 6 – Cross-section of Core 3 showing: (a) aggregate grading and distribution; (b) dark blue-green coloration typical of pastes containing ground granulated blast-furnace slag; (c) "bleaching" of the paste due to atmospheric intrusion in the surface region and along a crack; (d) a vertical crack that extends from top to 2¹/₂ inches from the core bottom (defined by "bleaching along the crack path"); and (e) an epoxy-coated No. 5 reinforcing bar (circled). Boxed Areas "a" and "b" are shown in Figures 6A and 6B. Scale in inches.

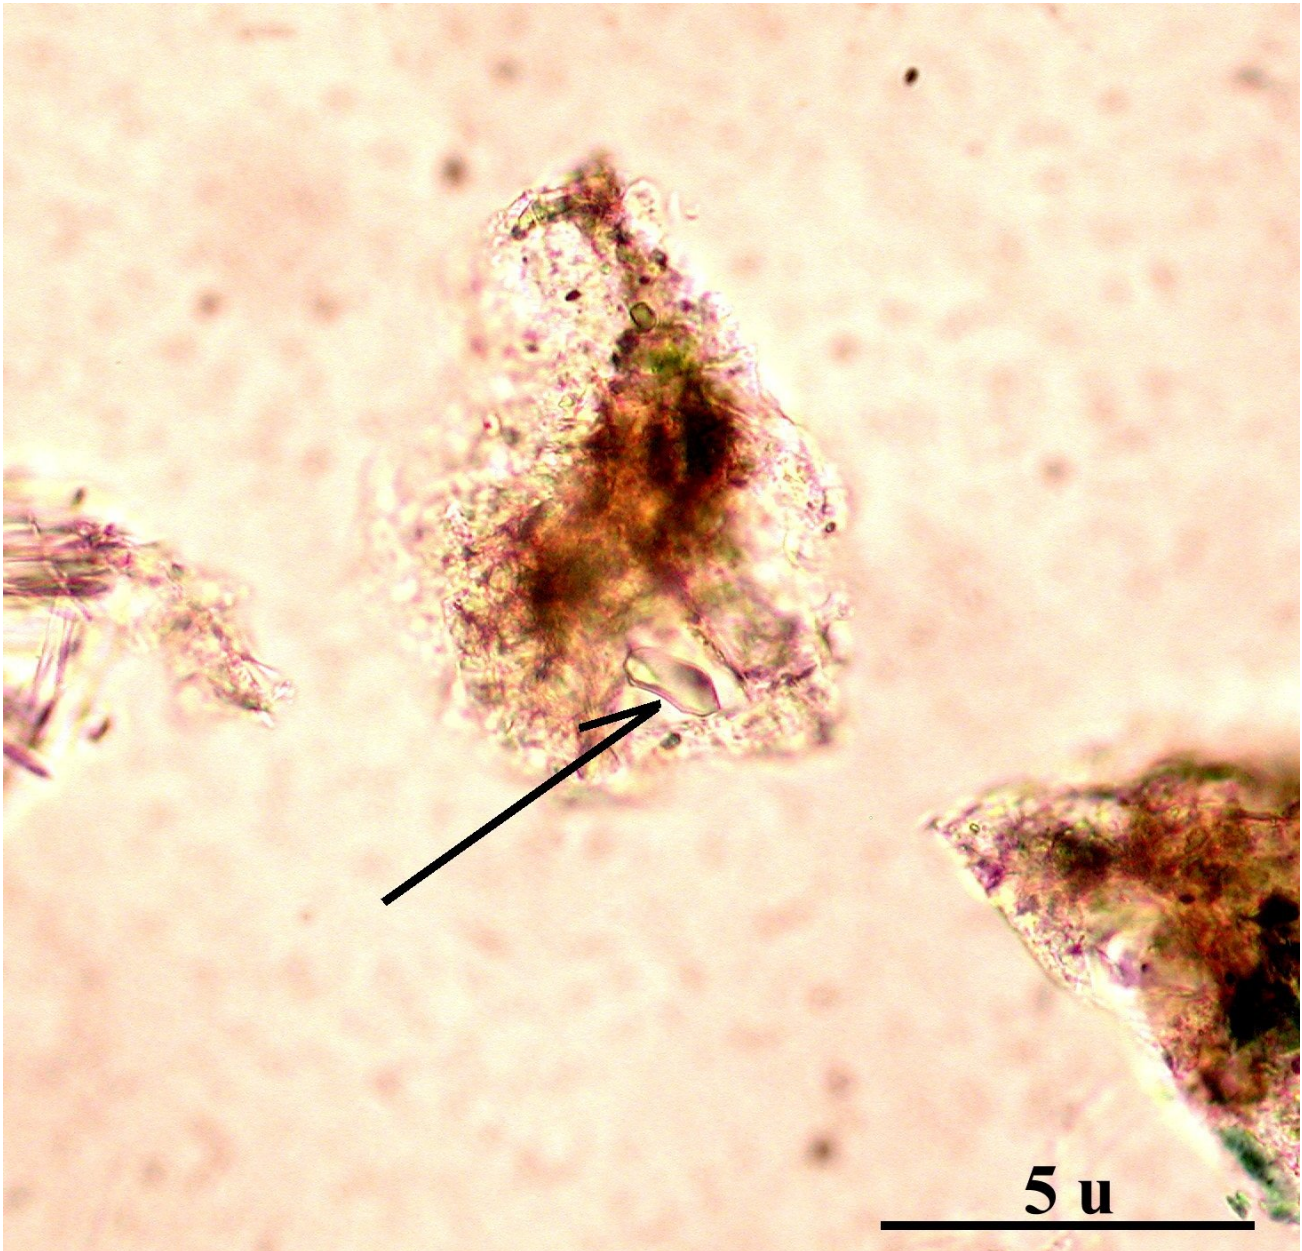
Figure 10 (Core 1) – Powder preparation observed using a petrographic microscope and plane-polarized light. The arrow points to a "core" of unhydrated ground granulated blast-furnace slag surrounded by a rim of hydrated slag. Scale in microns.

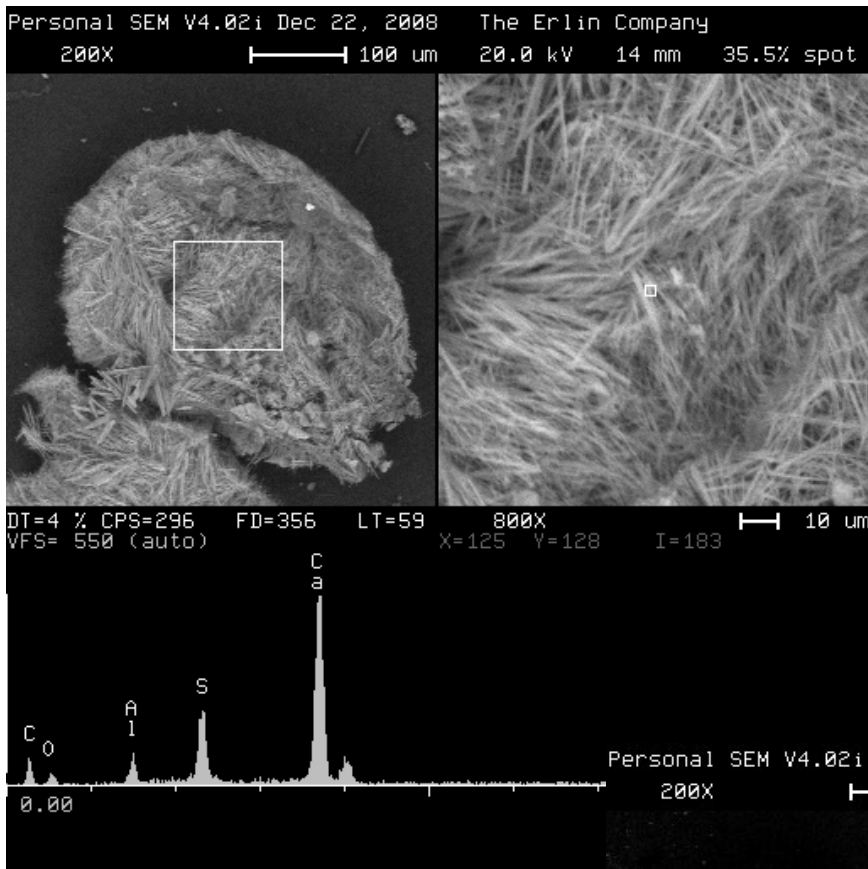
Figure 11a – Acicular ettringite picked from an ettringite-filled void.

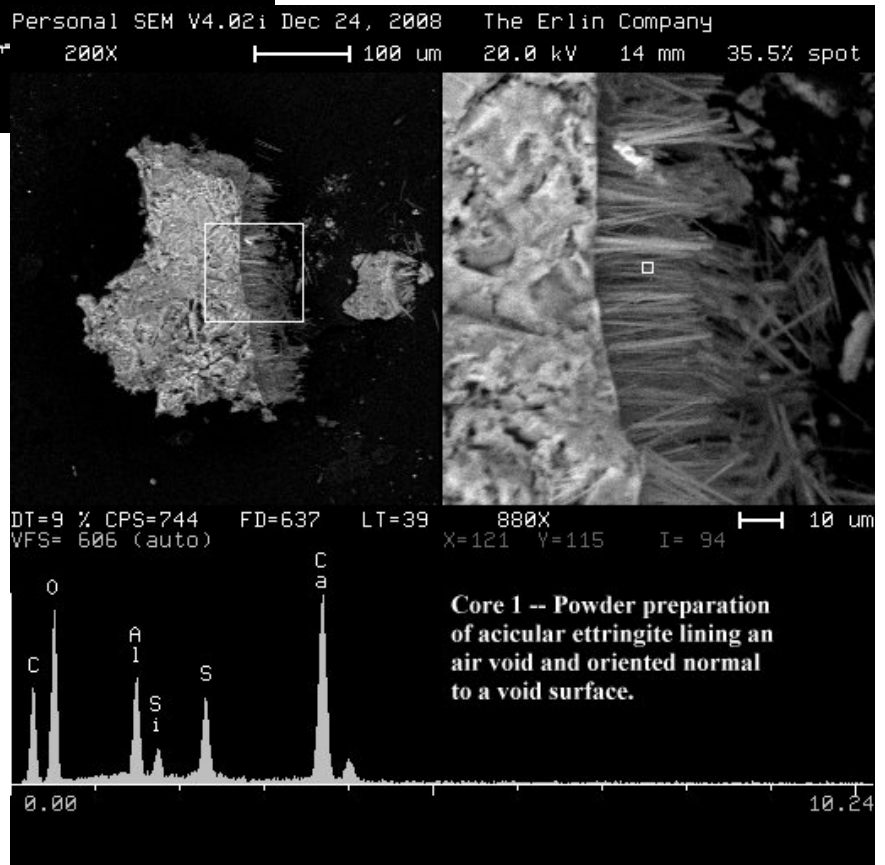
Figure 11 (Core 1) – Electron micrographs of acicular ettringite. In Figure 11a the specimen is from an air void filled with ettringite. In Figure 11b ettringite lines an air void. In each figure, the right micrograph is the box area in the left micrograph. The elemental spectra are of the small-boxed areas at about center in the right micrographs. The spectra correspond to ettringite.
