DISTORTION INDUCED CRACKING IN STEEL BRIDGE MEMBERS

ATLSS Report No. 90 - 07

August, 1990

FINAL REPORT

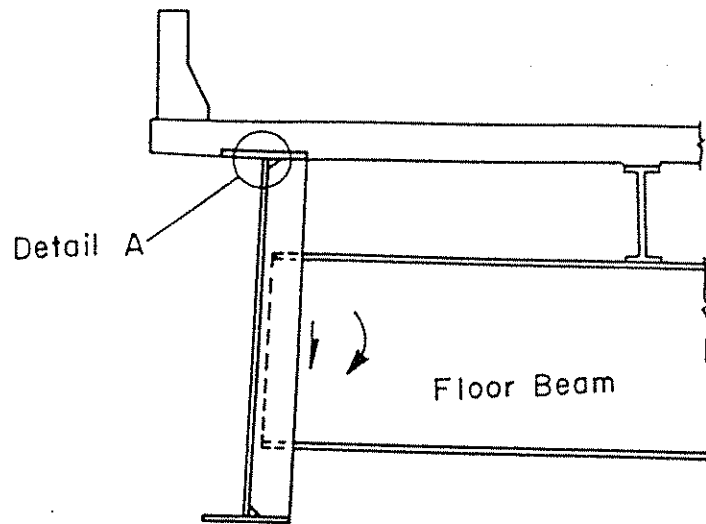
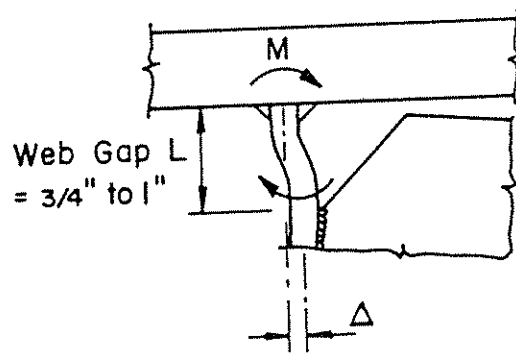
Conditions which resulted in web gap cracks have often developed because of the desire to avoid welding transverse stiffeners, that serve as connection plates, to the tension flanges. Figure 1 shows a schematic of a condition that exists in floorbeam-girder bridges. Figure 2 is typical of the cracks observed at a floorbeam web gap.

Figure 1: Schematic of distortion in web gap at end of floorbeam transverse connection plate

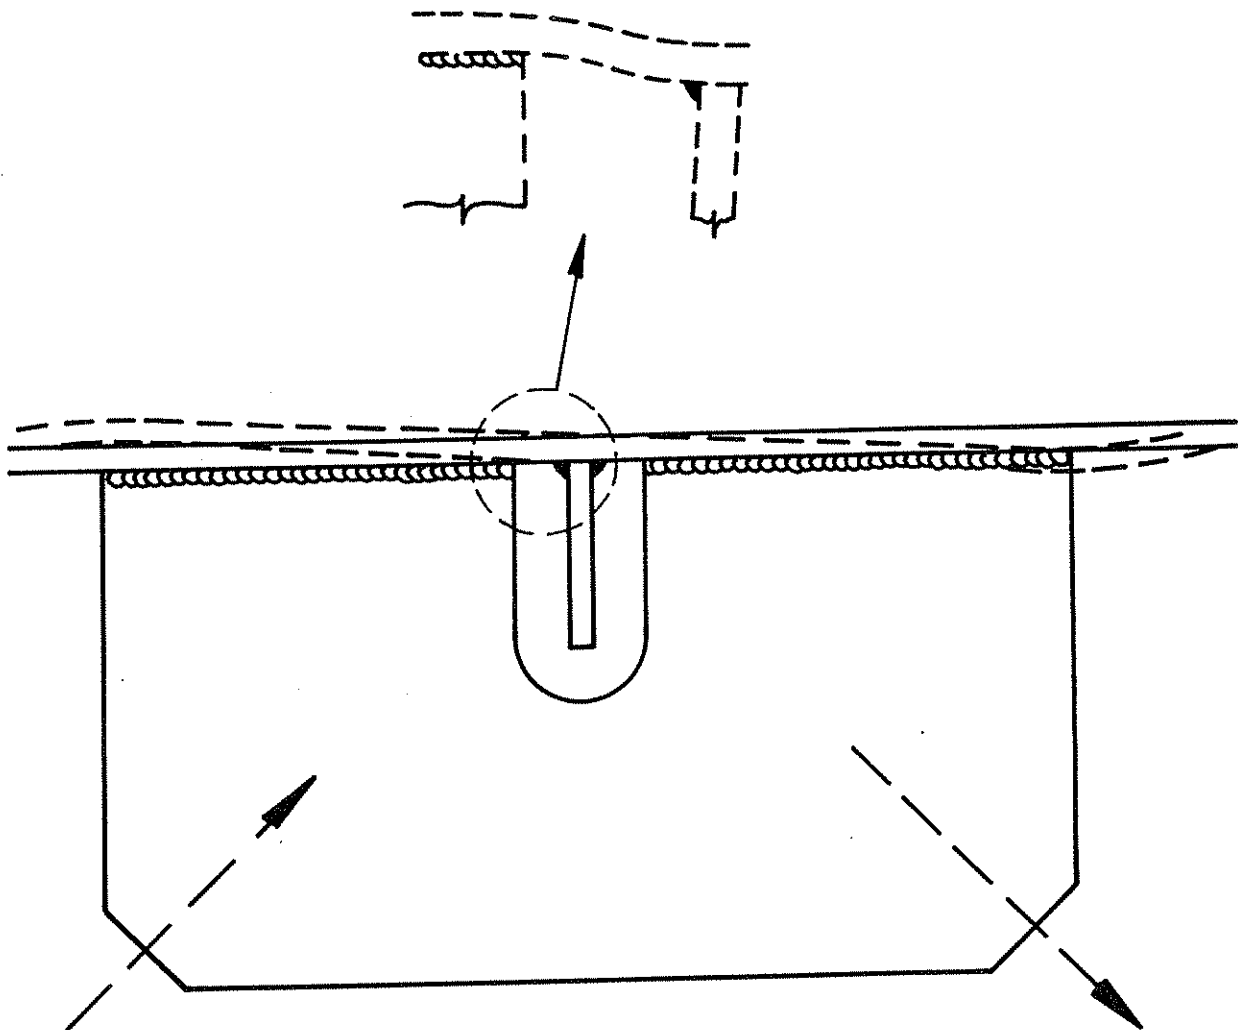
Figure 3: Schematic of distortion in web gap at lateral gusset plate

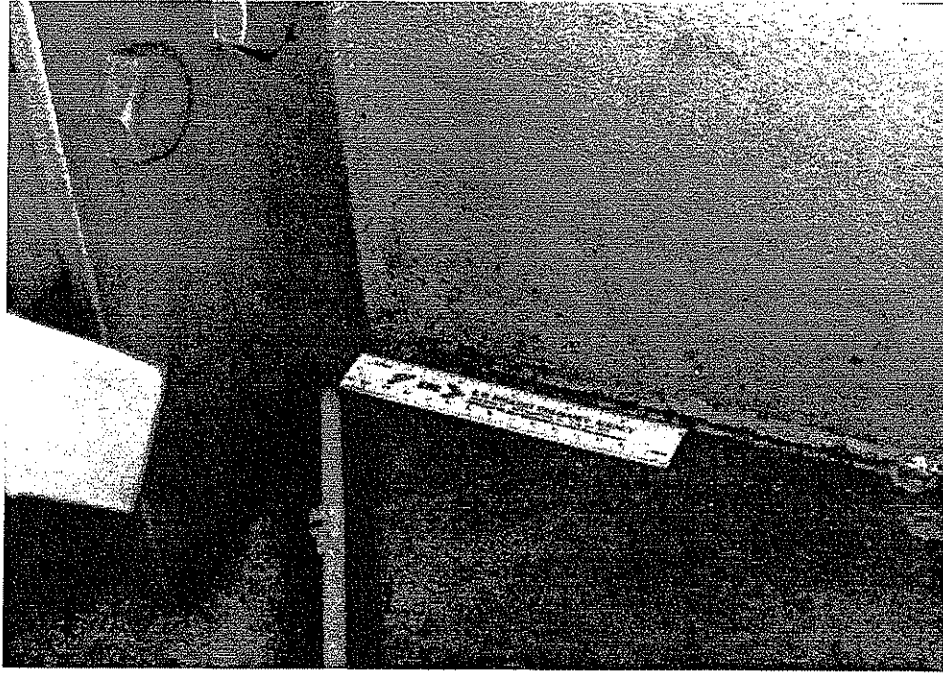
Figure 19: Lateral gusset plate detail, I-79 Bridge #2682, Reference 19

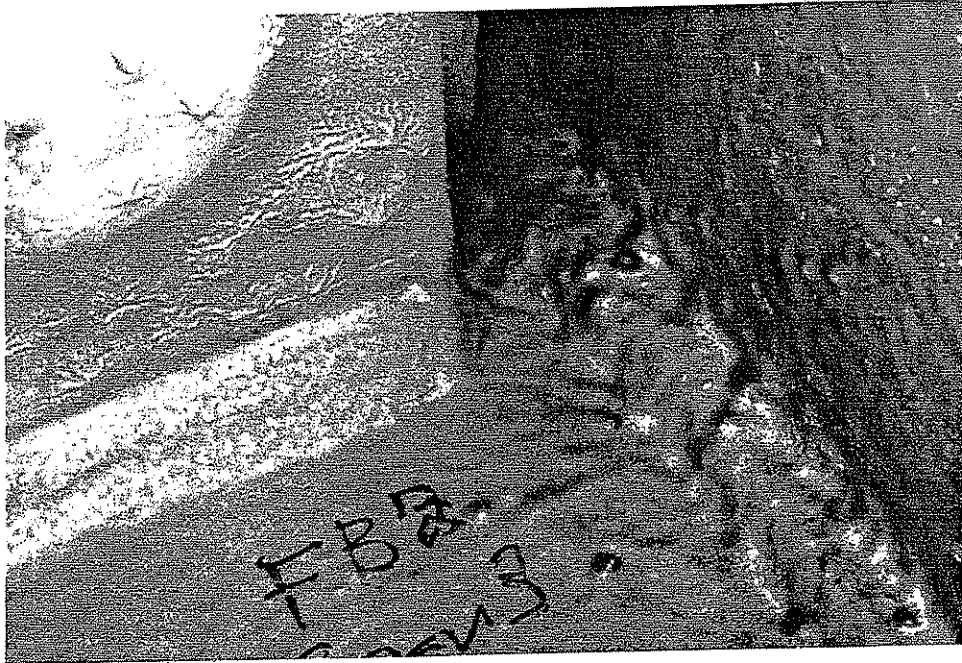
Figure 20: Lateral gusset plate detail, Canoe Creek Bridge, Reference 13

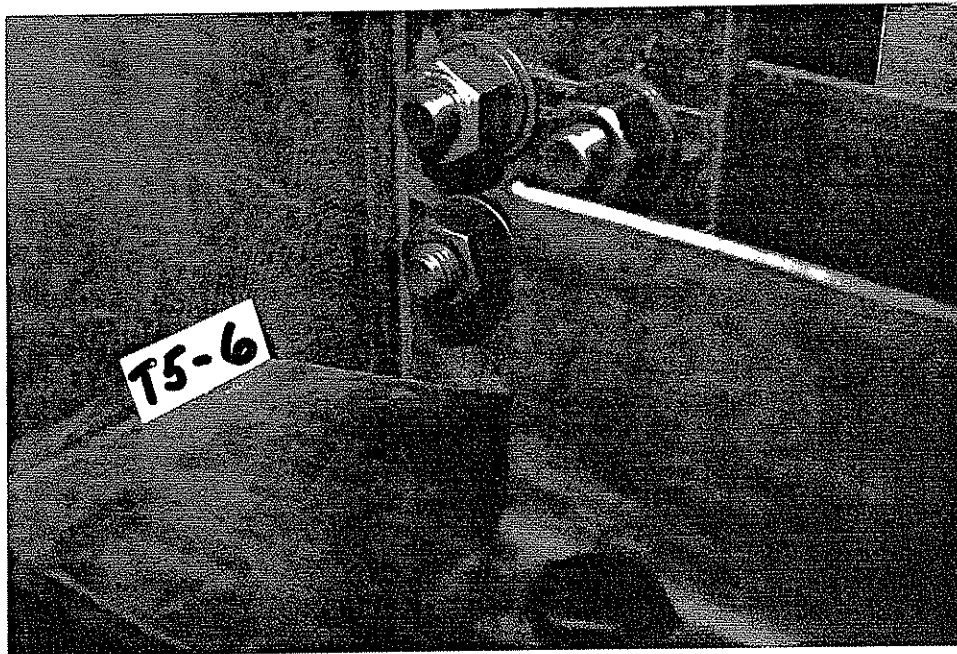
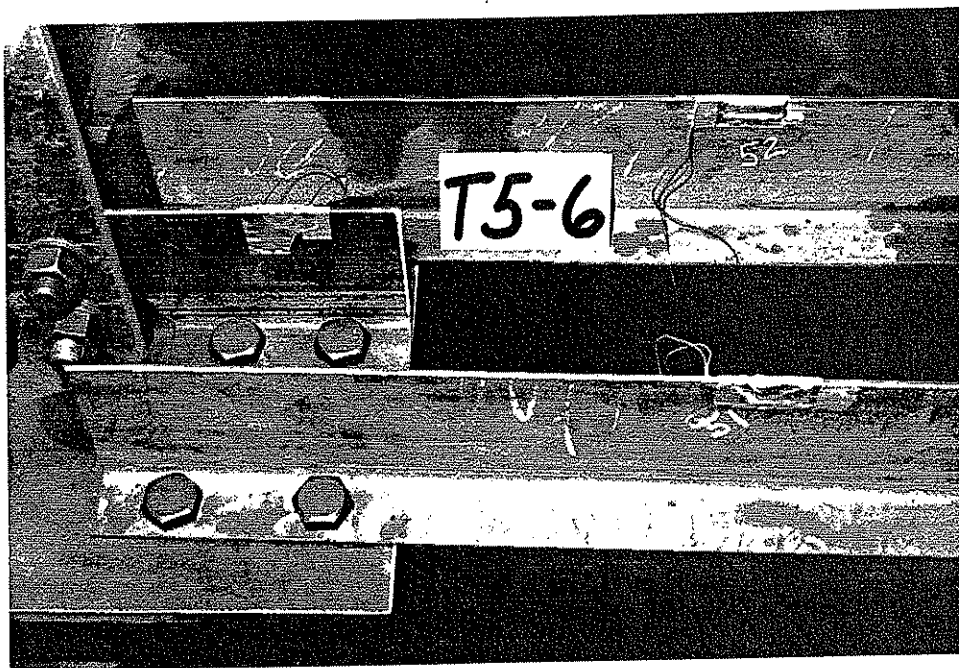
Figure 27: (a) View of web gap detail for T5-6 (Type B) with 3 in. (76 mm) gap; (b) Overview of Detail T5-6

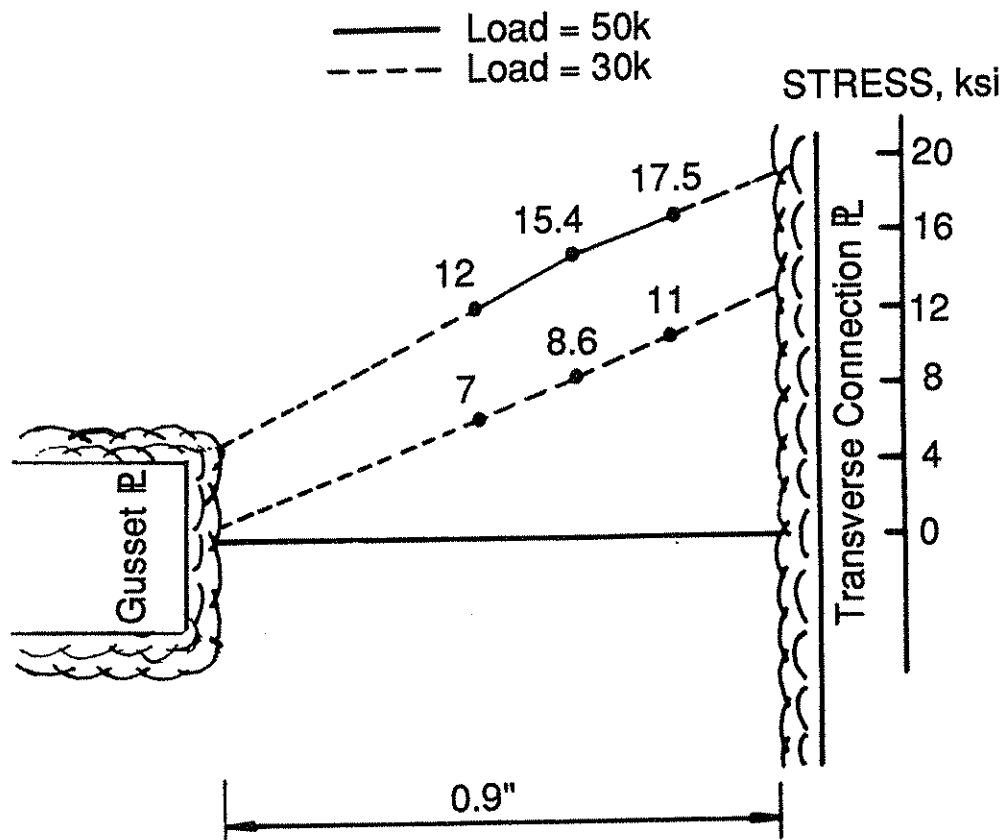
gusset plate weld end. This can be seen in Figures 28, 29, 32, and 35 for all three types of gusset plate details.

Figure 29: Stress gradient for Detail T5-5 (Type B), west web gap

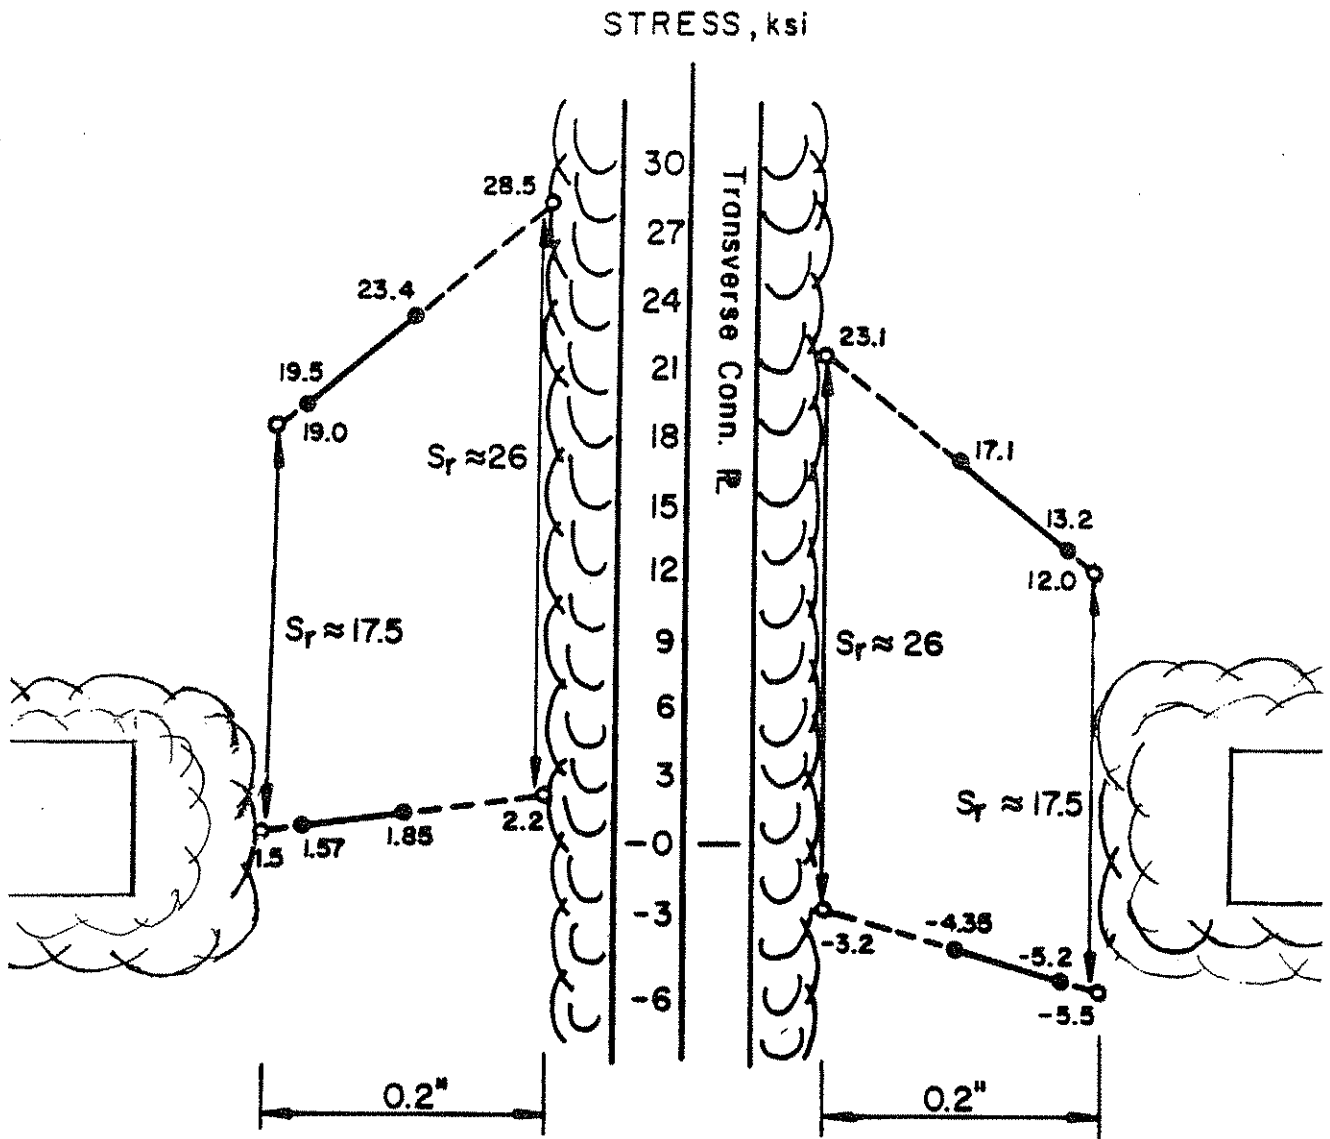
Figure 32: Stress gradients for Detail T5-10 (Type C)

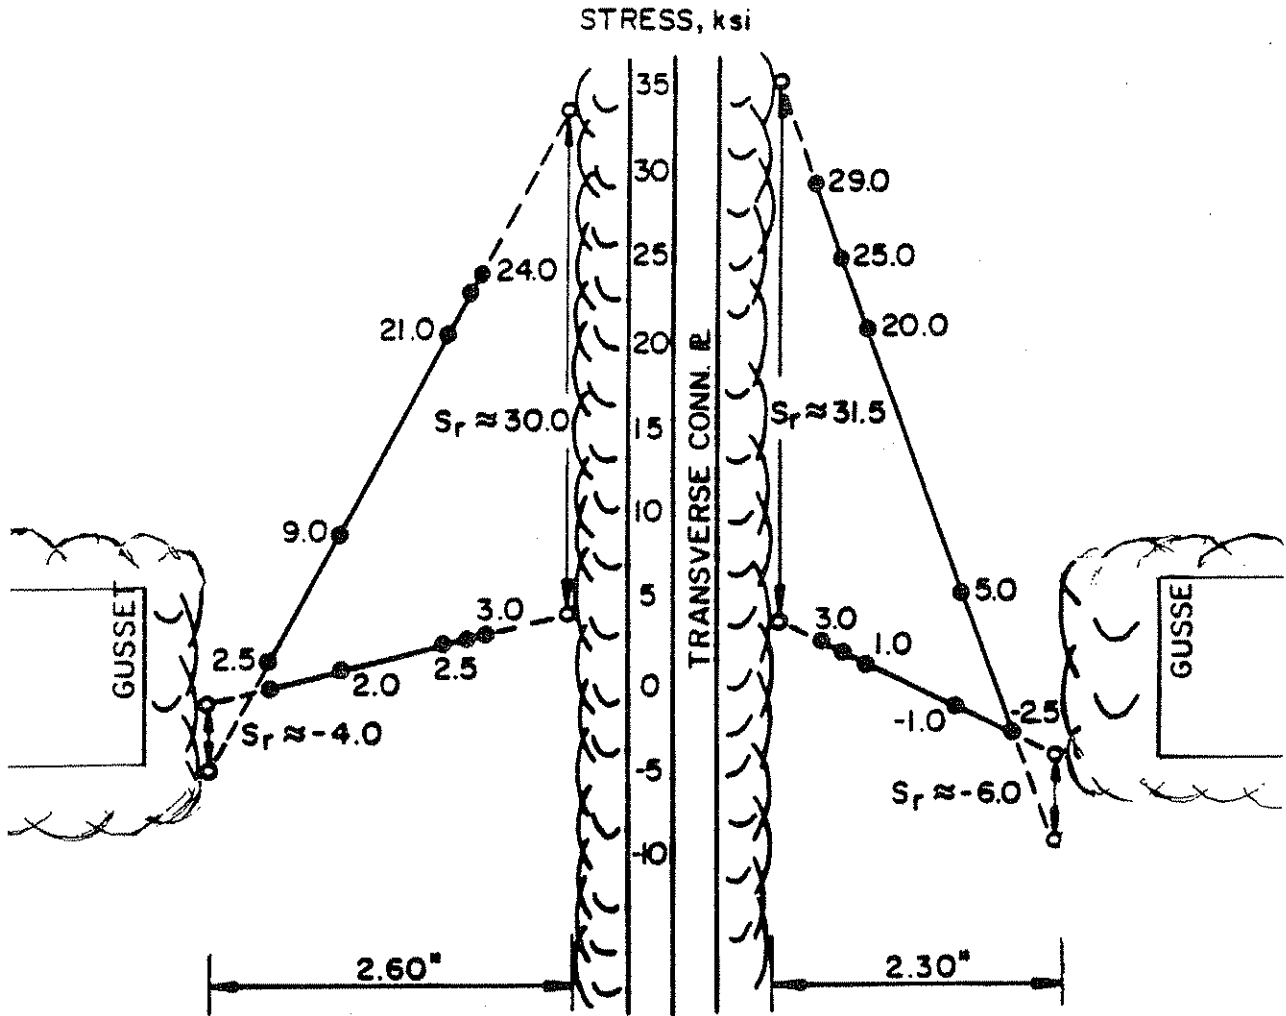
Figure 35: Stress gradients for Detail T5-12 (Type C)

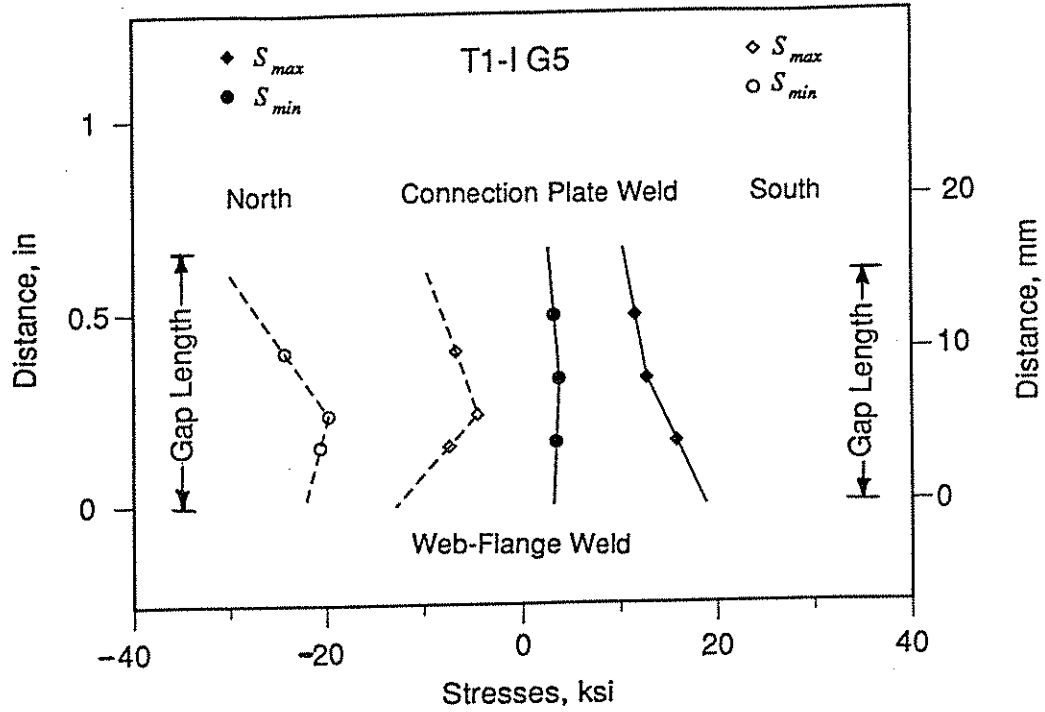
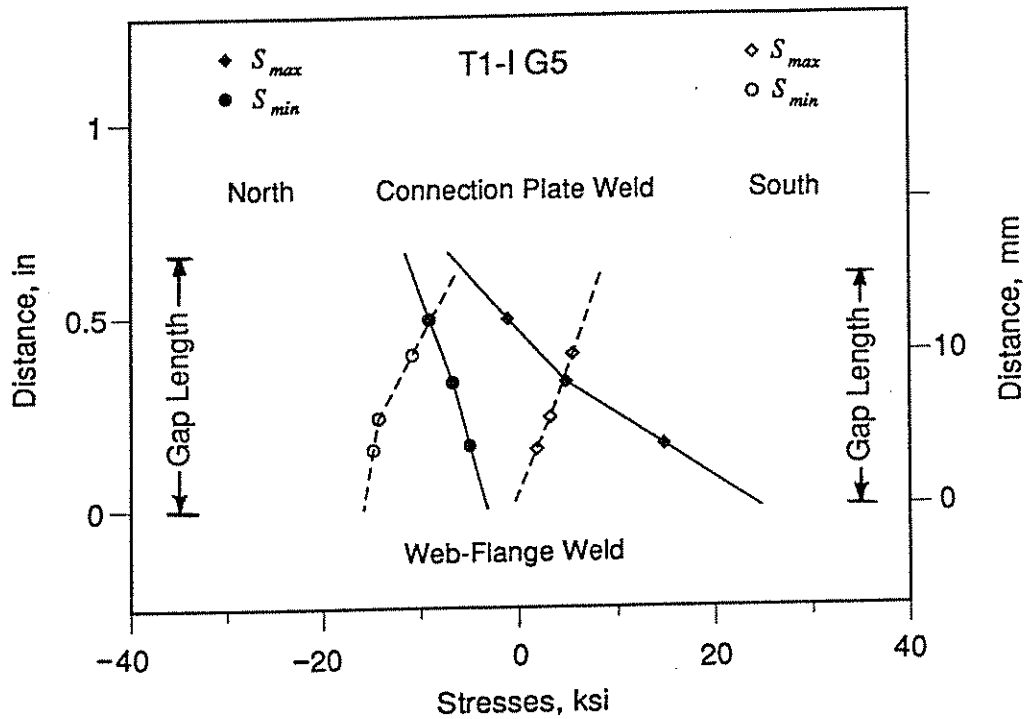
The measured web gap stresses for the 1½ in. (38 mm) details prior to cracking in general showed a single curvature response as can be seen in Figures 47 (a) to 49 (a) and 50. After cracking, the measurements generally showed a trend to double curvature and a redistribution in the web gap. The strain measurements for the smaller web gaps generally indicated a cyclic tensile stresses on one face of the web and cyclic compression on the opposite web gap face. Cracks always formed initially at the weld toe subjected to cyclic tension. Eventually, the cracks propagated through the web thickness and were observed on both sides of the web.

The web gap measurements shown in Figures 47(a) to 53(a) demonstrated the wide variability in response that can be expected at web gaps. This variability makes it difficult to model web gap behavior.

Figure 47: Stress gradients at Transverse Connection Plate Detail T1-I G5 (1 1/2 in. gap) before and after cracking at end of connection plate: (a) Prior to cracking, (b) After 10.7×10^6 cycles and visible cracking

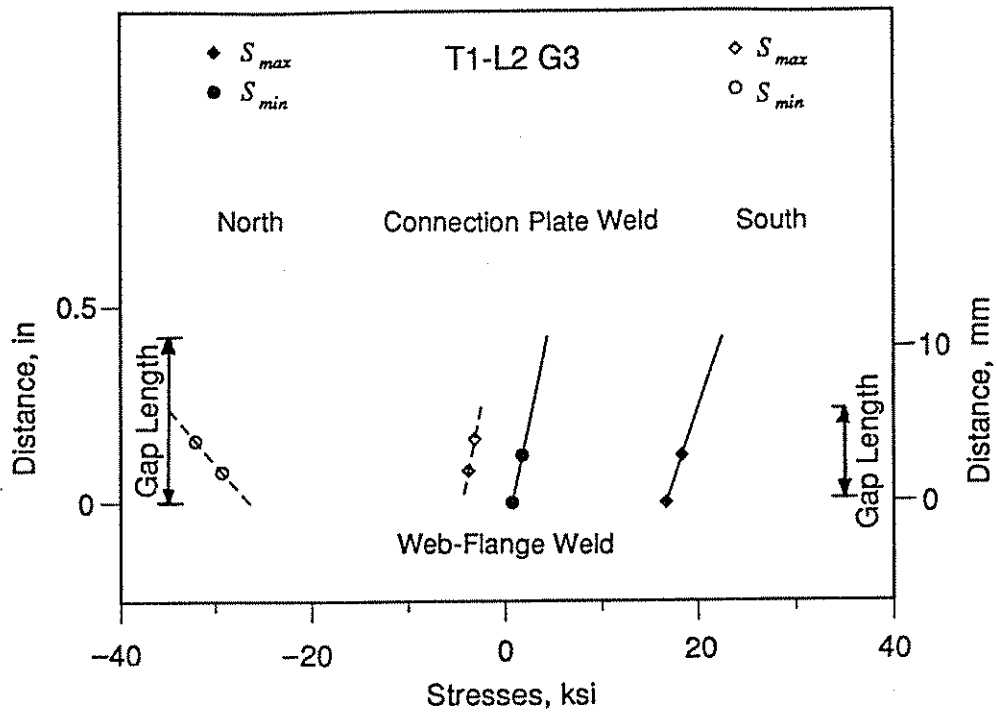
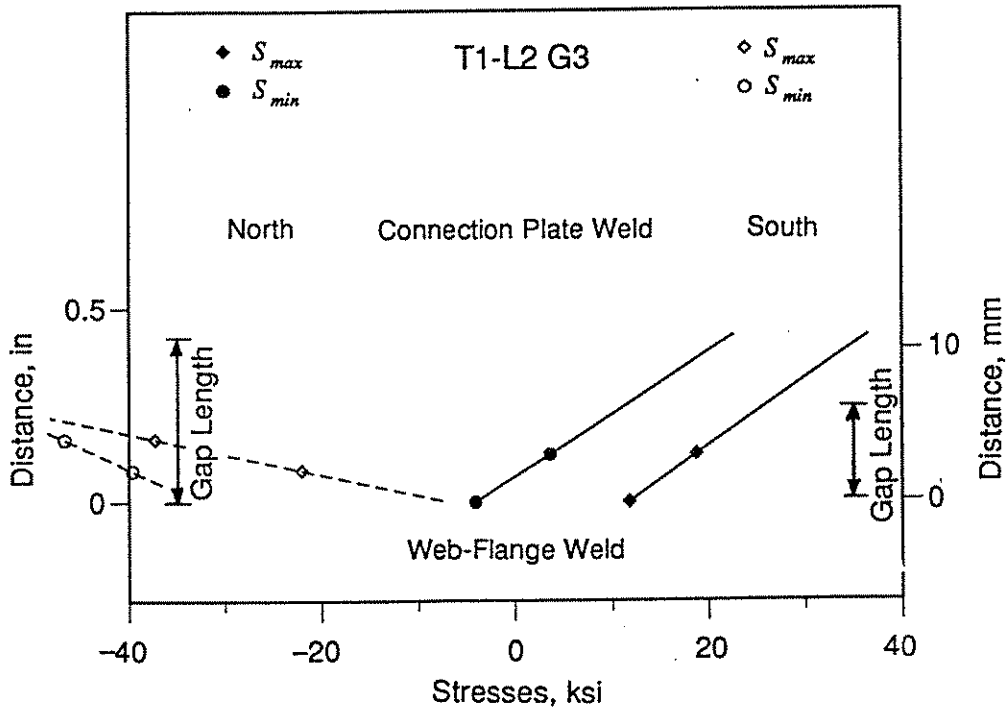
Figure 48: Stress gradients at Transverse Connection Plate Detail T1-L2 G3 (1 1/2 in. gap) before and after cracking at end of connection plate: (a) At start of test; (b) After cracking and 1.8×10^6 cycles

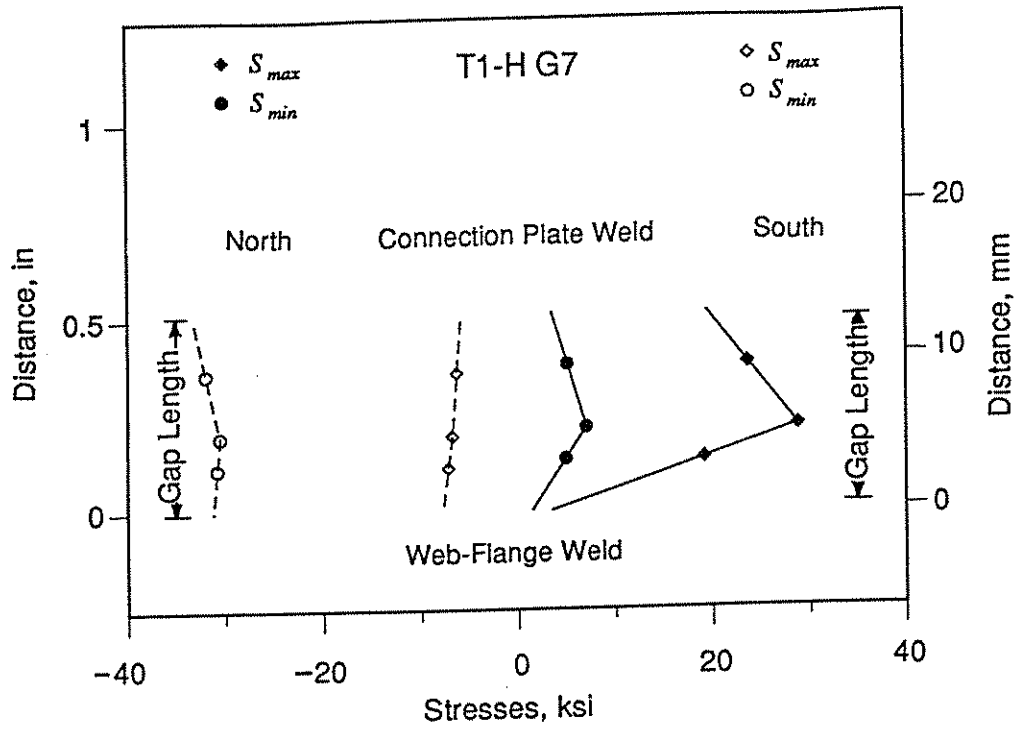
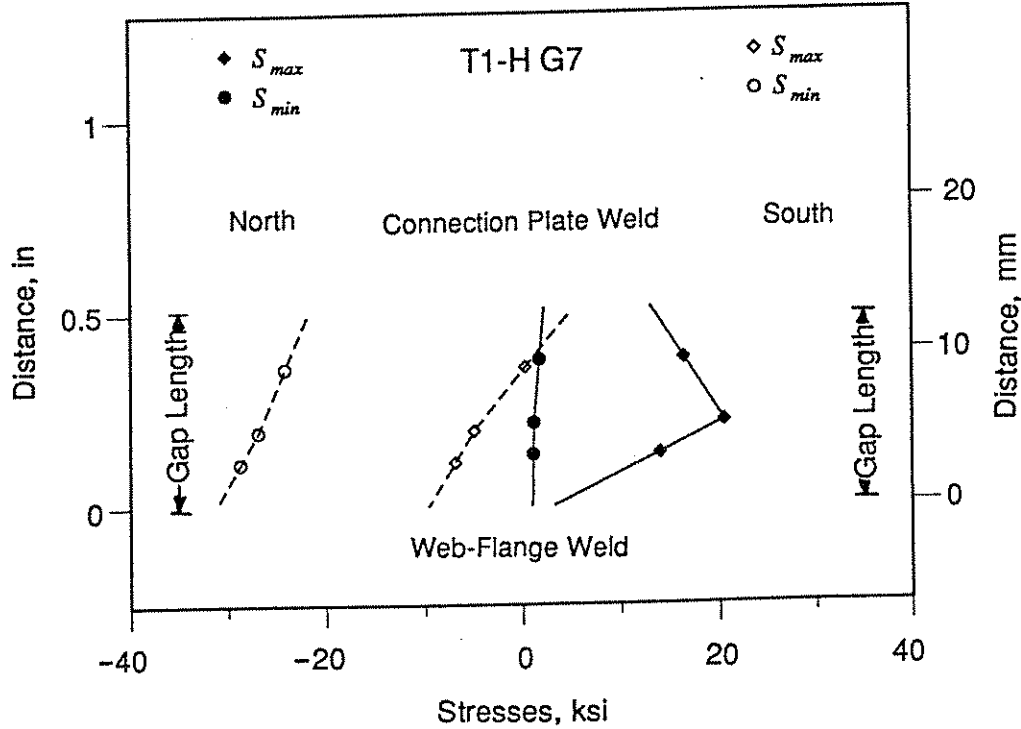
Figure 49: Stress gradients at Transverse Connection Plate Detail T1-H G7 (1 1/2 in. gap) before and after cracking at end of connection plate: (a) At start of test; (b) After cracking at 0.71×10^6 cycles

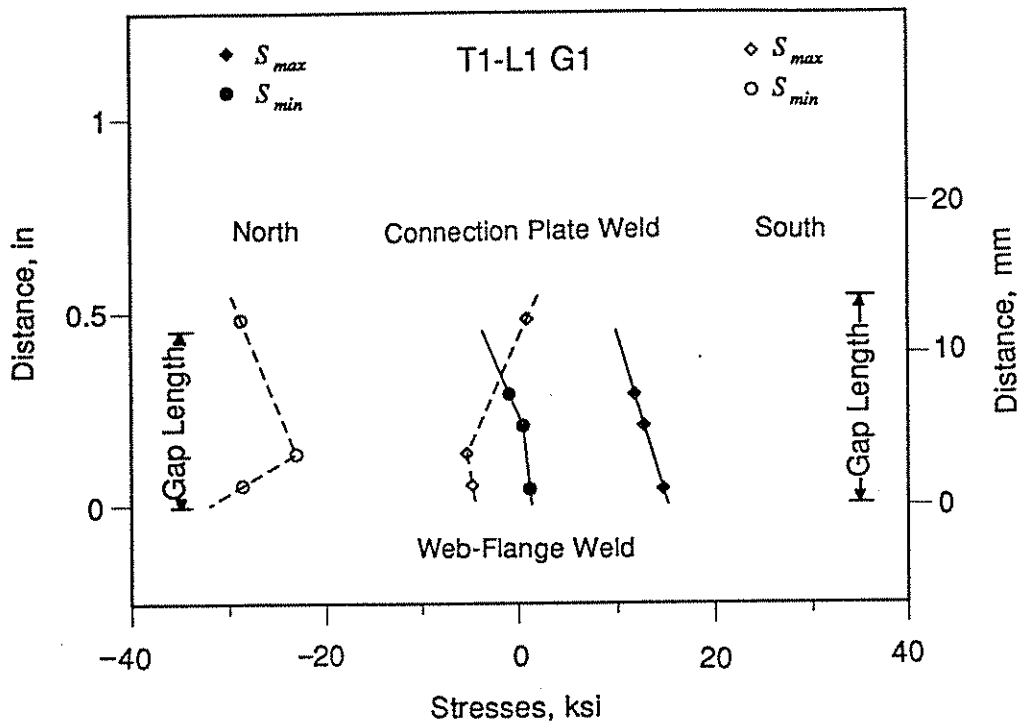
Figure 50: Distortion stresses at Transverse Connection Plate Detail T1-L1 G1 (1 1/2 in. gap) which had no detectable crack growth in web gap

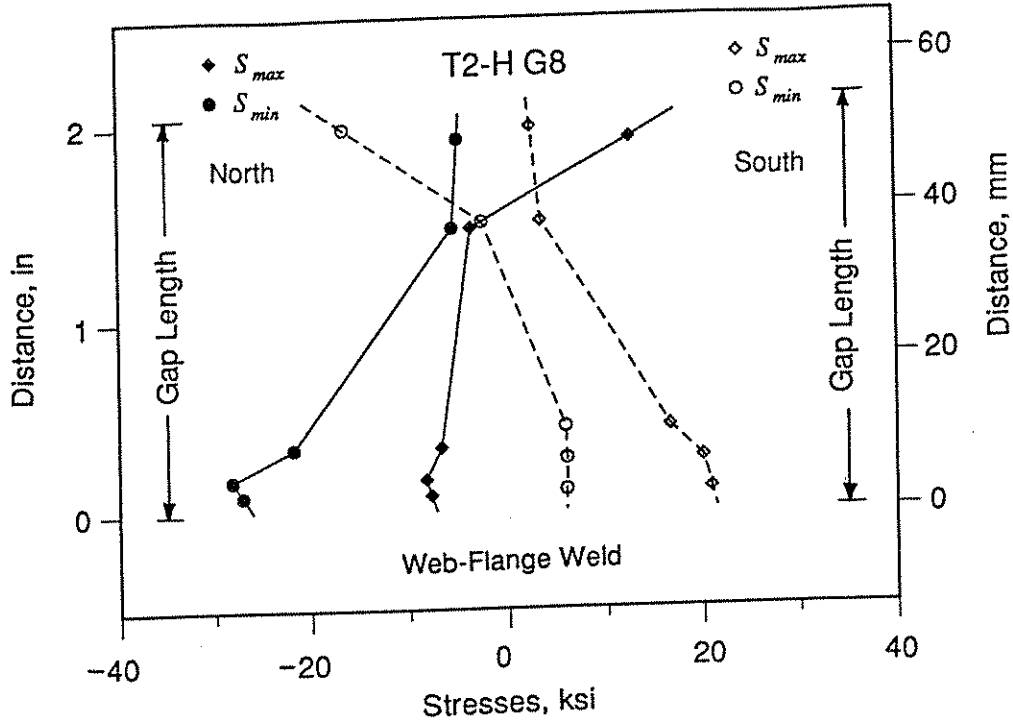
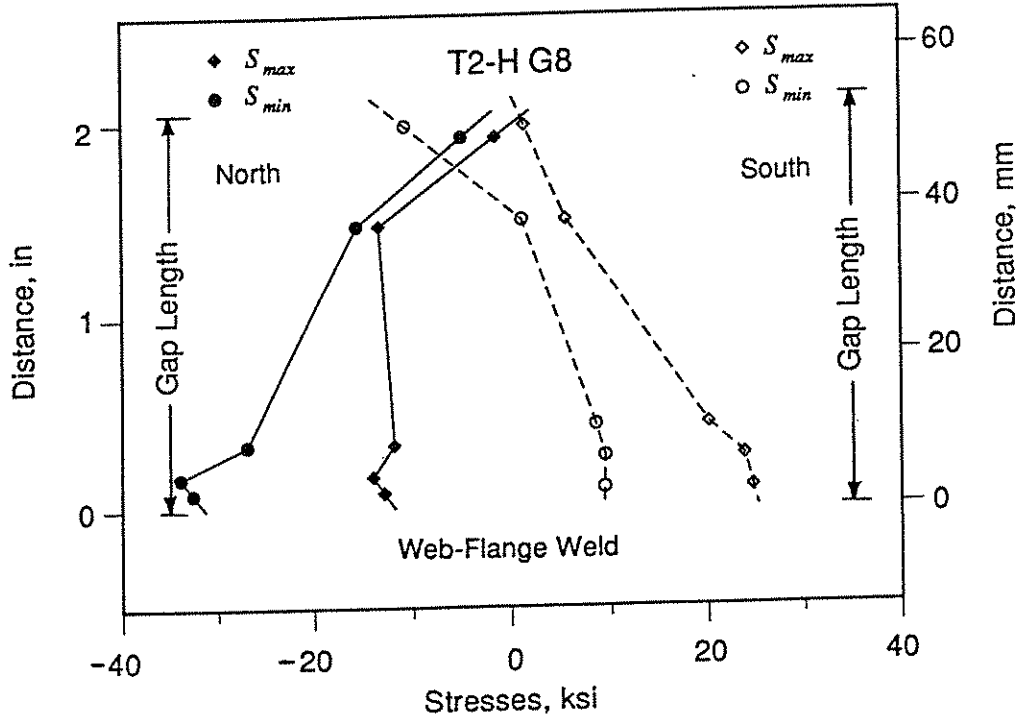
The measured web gap stresses at the larger 3 in. (76 mm) details usually exhibited double curvature as can be seen in Figures 51 (a) to 53 (a). After cracking, some details retained their double curvature characteristics whereas others developed single curvature conditions. It is also apparent that the welded toe on each side of the web was subjected to a stress reversal and hence was more susceptible to crack growth from each side of the web plate.

Figure 51: Stress gradients at Transverse Connection Plate Detail T2-HG8 (3 in. gap) before and after cracking at end of connection plate: (a) prior to cracking; (b) after 0.52×10^6 cycles and visible cracking

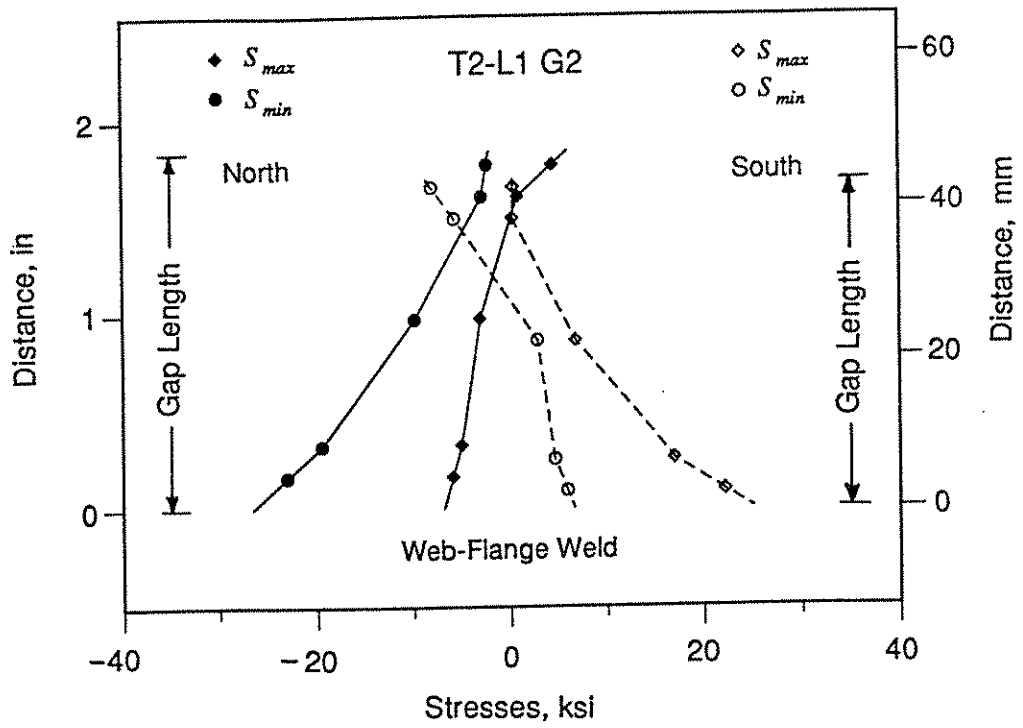
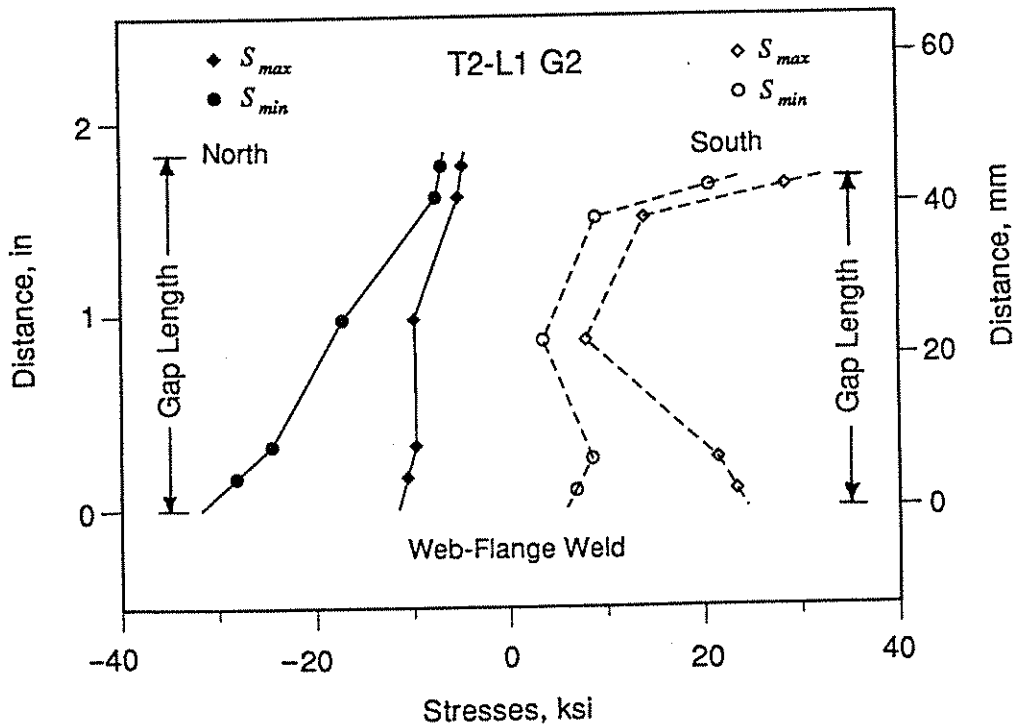
Figure 52: Stress gradients at Transverse Connection plate Detail T2-L1 G2 (3 in. gap) before and after cracking at end of connection plate: (a) At start of test; (b) After cracking at 4.5×10^6 cycles

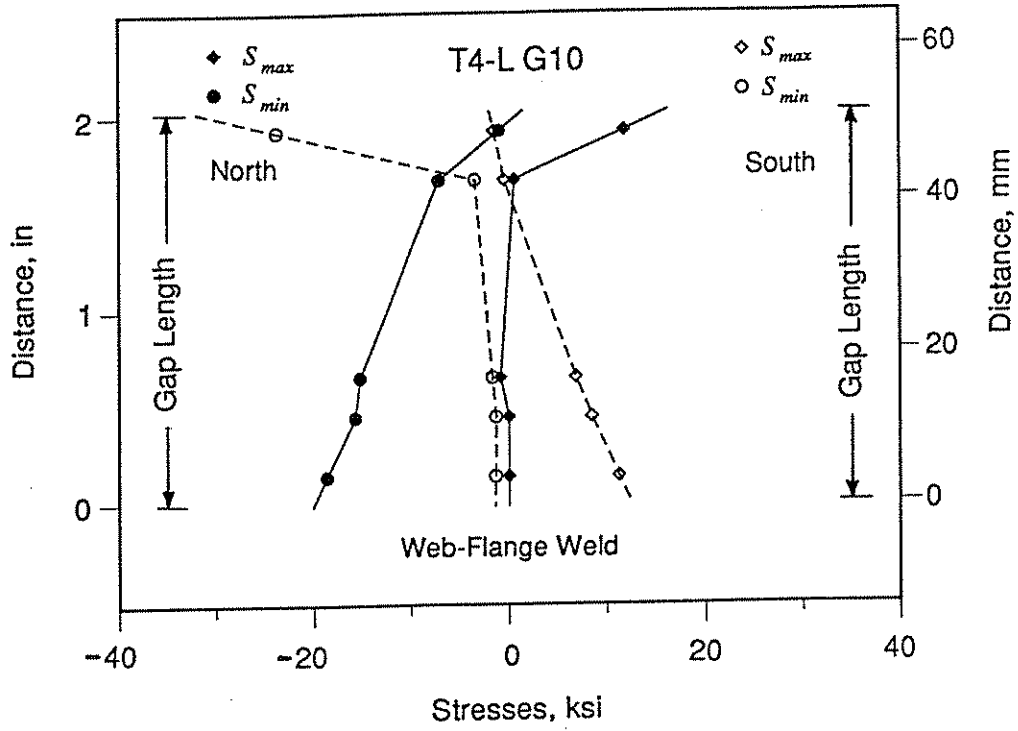
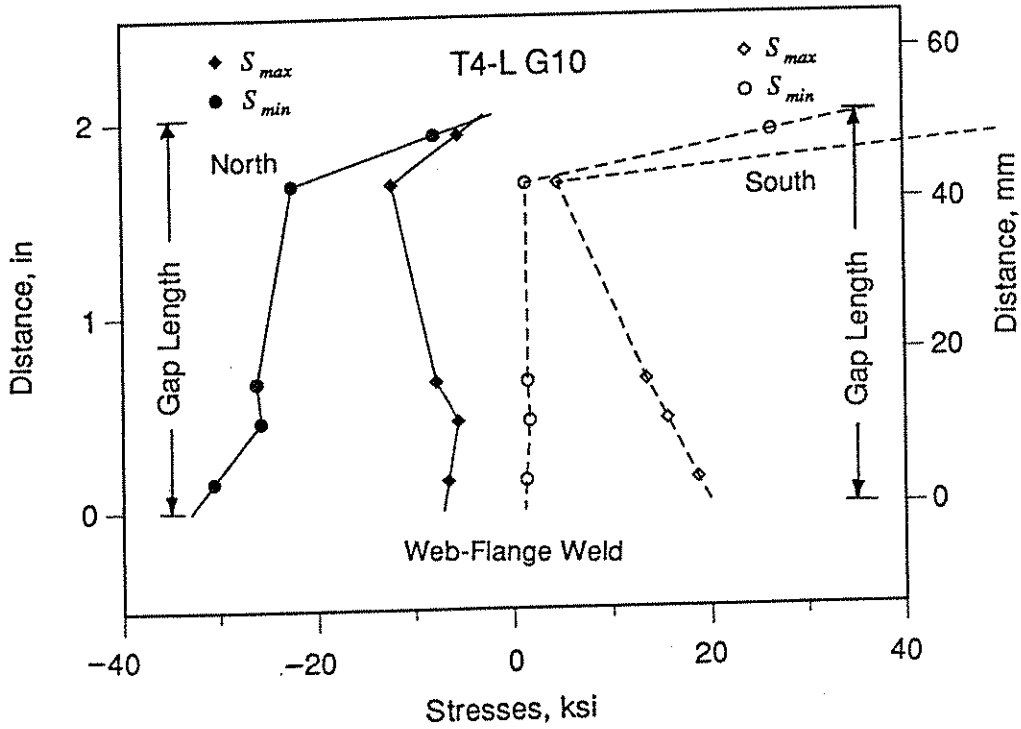
Figure 53: Stress gradients at Transverse Connection Plate Detail T4-L G10 (3 in. gap) before and after cracking at end of connection plate: (a) At start of test; (b) After 3.3×10^6 cycles and visible cracking

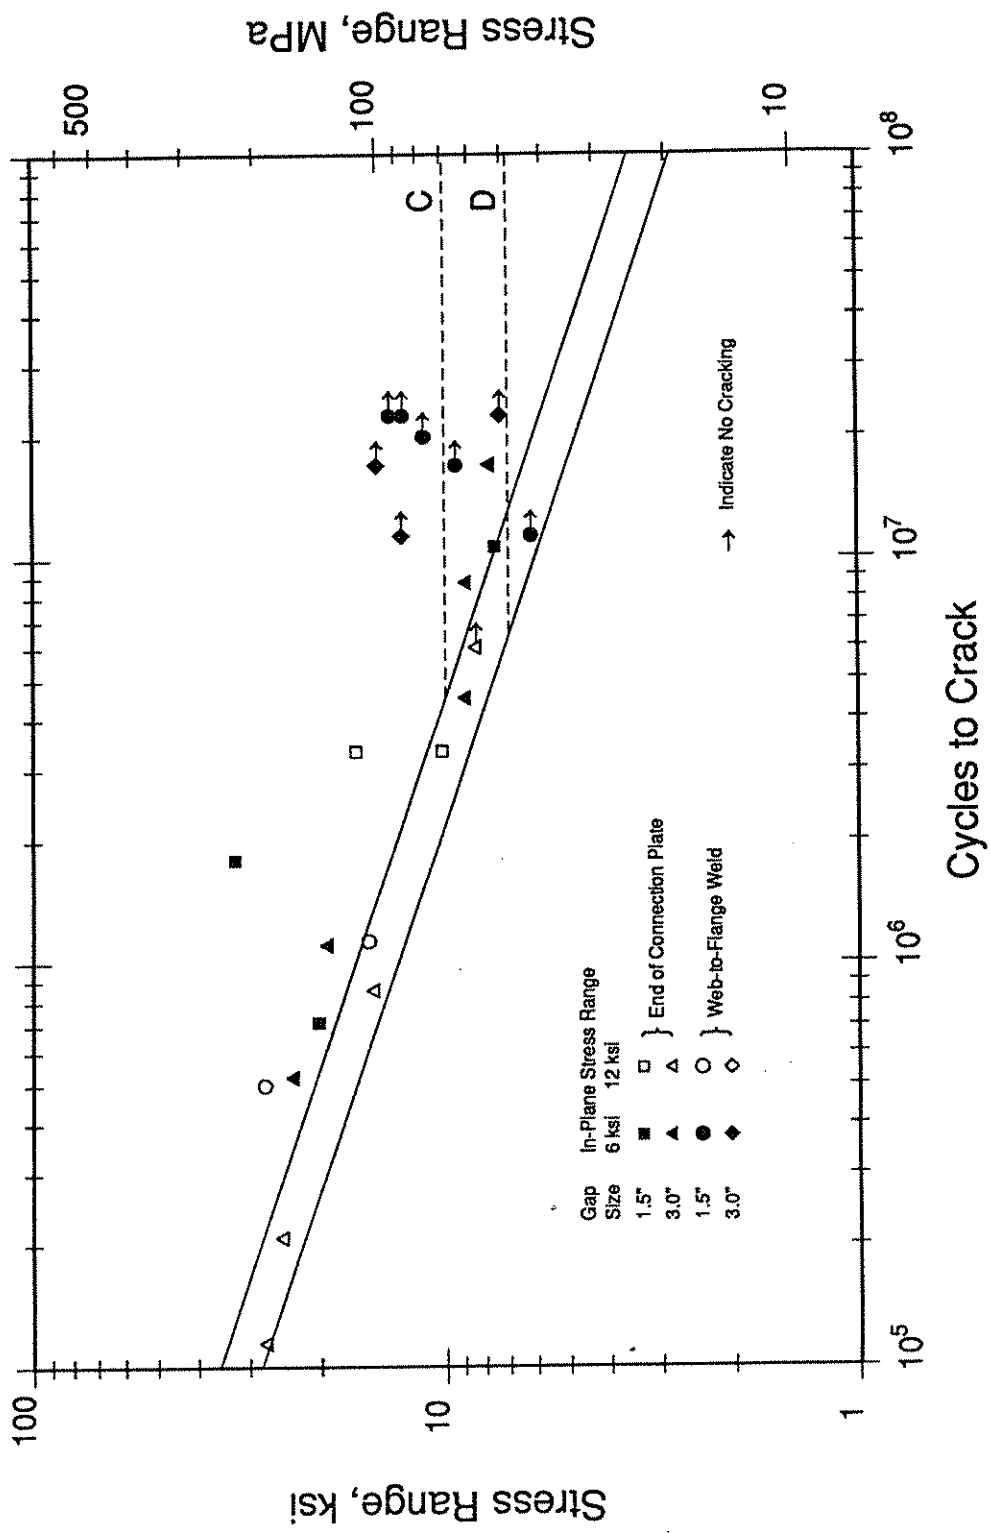
The test results at the cracked details are compared with the fatigue resistance provided by Categories C and D of the AASHTO Specifications in Figures 54 and 55. Crack detection provided a lower bound fatigue life corresponding to the Category D fatigue resistance curve as illustrated in Figure 54. This is consistent with other fatigue test data where fatigue cracks are generally observed at about 75% of their fatigue resistance. When the results were compared for cycles at the time of first retrofit, the fatigue strength generally exceeded Category C.

Also plotted in Figures 54 and 55 are the details which experienced no crack growth. When the end of the transverse connection plate were subjected to cyclic stress below 10 ksi (69 MPa) there was usually no evidence of crack growth. Many of the web gaps experienced higher stress range levels at the web-flange weld toe. The stress range had to exceed 15 ksi (105 MPa) before cracks developed at this location.

Figure 54: Cycles at which cracks were first detected at transverse connection plate details

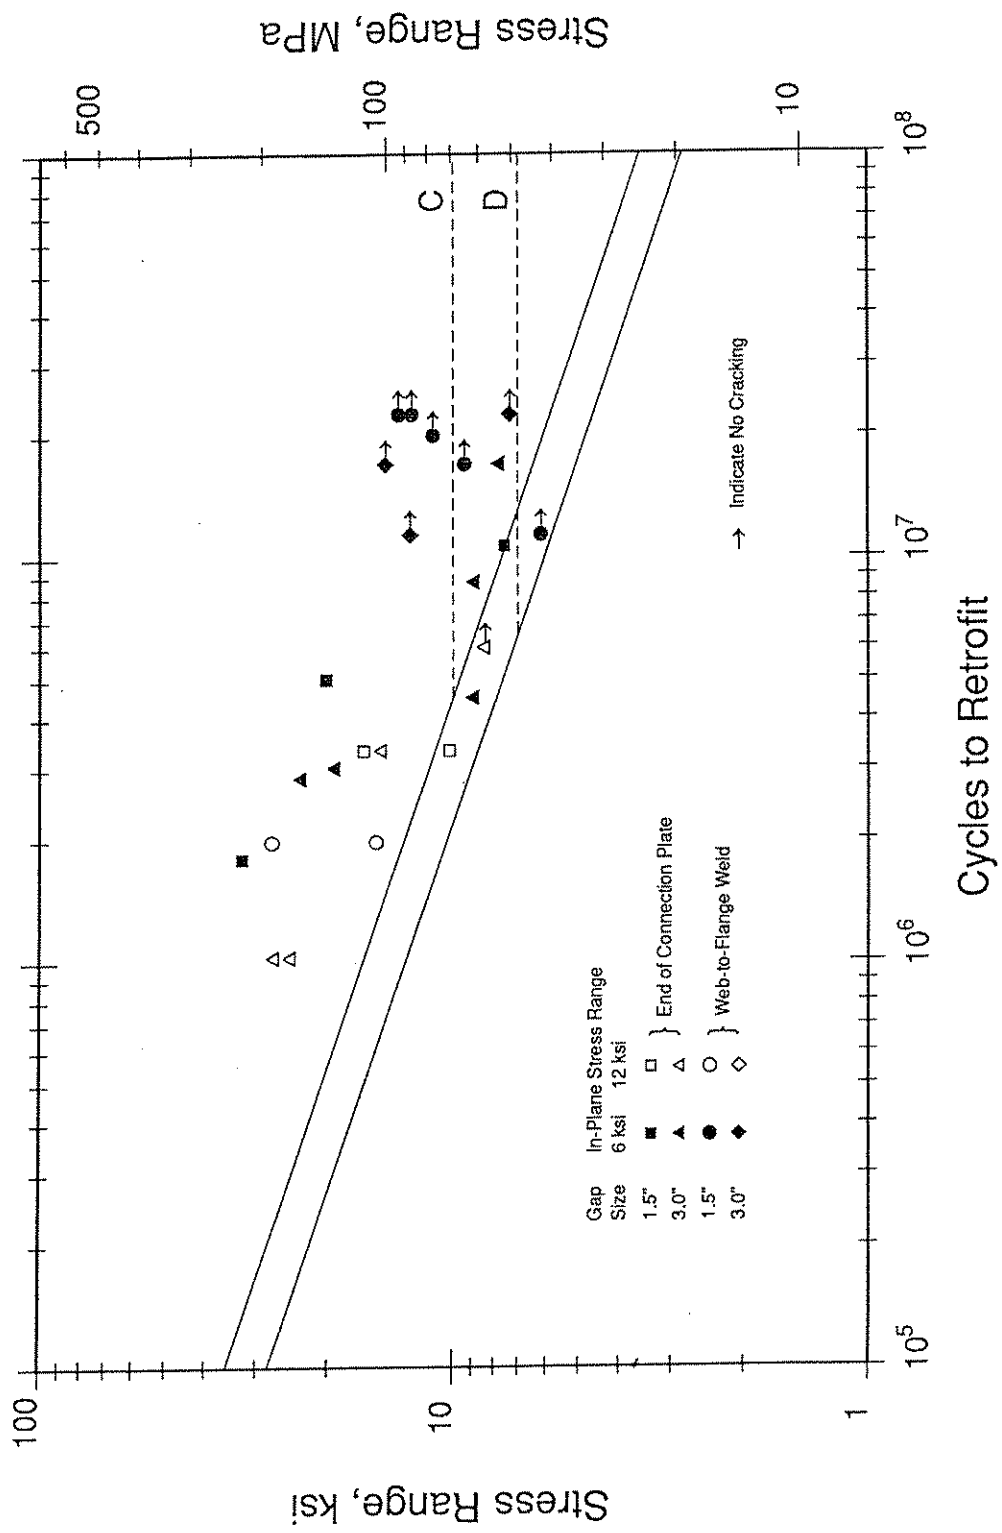
The results plotted in Figure 55 show the fatigue life at the first retrofit (usually by drilling holes) at which time the crack was through the web thickness and several inches long. At this stage of crack extension the fatigue life was comparable to other details used to define the AASHTO fatigue resistance curves. The four details that developed cracks below Category C fatigue limit were not retrofitted even though small cracks were detected. These details were subjected to an additional 10 to 17 million cycles of stress range. The cracks extended between 1 and 2 in. (25 to 50 mm) during these additional cycles. Hence, the results verify that Category C is a reasonable resistance curve for distortion induced fatigue cracking at the ends of transverse connection plates.

Figure 55: Comparison of cycle life at time details were retrofitted at transverse connection plate details

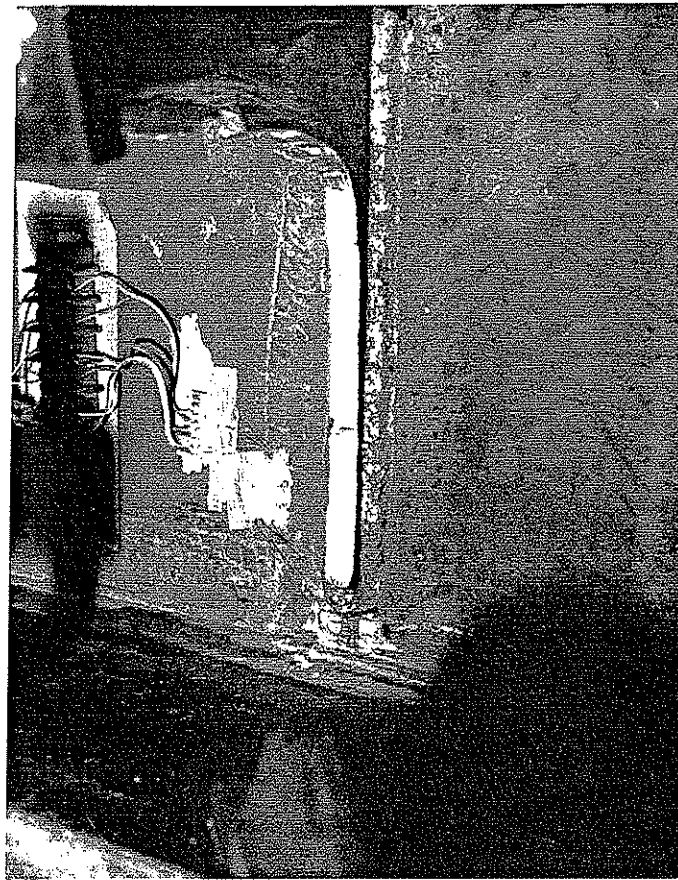
Figure 59: Partial removal of connection plate T1-G7 (1 1/2 in. detail)

The removal of a portion of the transverse connection plate as illustrated in Figure 59 was found to soften the web gap and significantly reduce the crack growth rate. The connection plate was cut away along the plate weld toe so that only the welds and a small plate segment remained. This substantially reduced the crack growth. The total crack extension was 0.5 in. (12.5 mm) after an additional 6 million cycles. The crack remained parallel to the in-plane bending stress.
