DISTORTION INDUCED CRACKING IN STEEL BRIDGE MEMBERS

ATLSS Report No. 90 - 07

August, 1990

FINAL REPORT

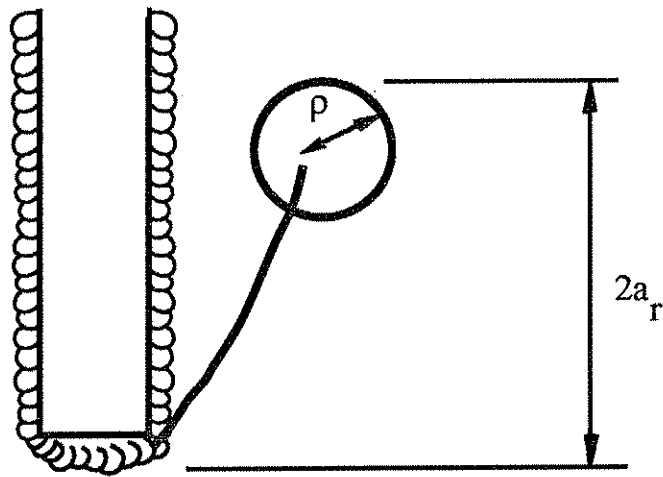
Figure 60: Retrofit hole at transverse connection plate web gap.

was satisfied. In this equation, ΔK is the stress intensity range for the in-plane stress range at the hole with radius, ρ . The crack size was taken distance from the end of the connection plate to the edge of the hole as illustrated in Figure 60. This resulted in a stress intensity range estimate of $\Delta K = S_r \sqrt{\pi a_r}$.
