**Web Cracking Repair Design for Bridge
SR 46-3020-0020-0000 on US 202 in
Montgomery County, PA**

PennDOT ECMS No. E00511: Work Order No. 10

**Field Instrumentation, Monitoring
and Analysis**

ATLSS Report No. 07-10

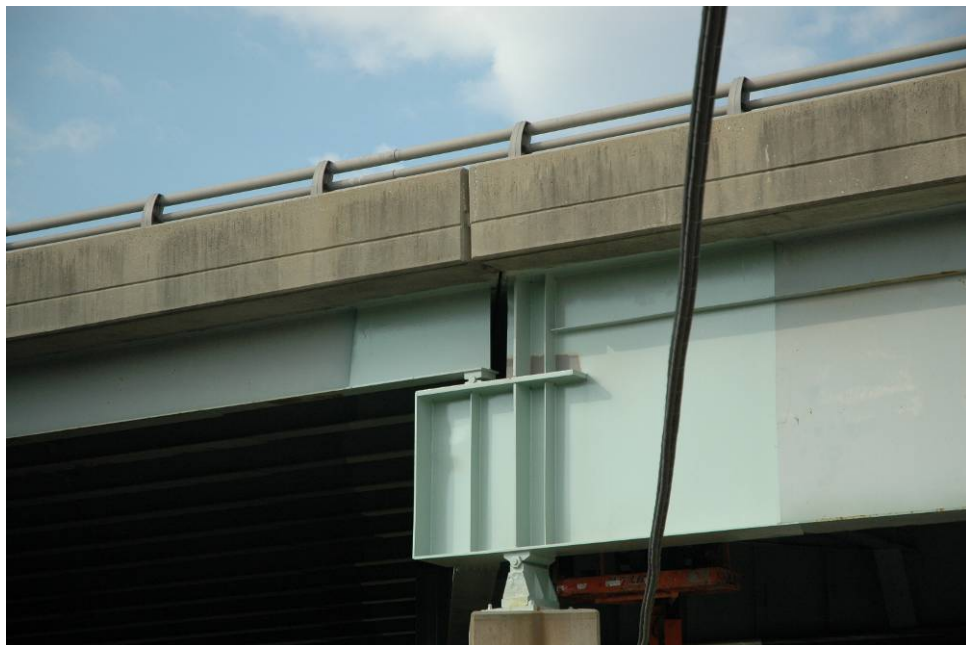
Pursuant to the Notice to Proceed (NTP), a field view of the bridge was carried out on 10/10/2006. The inspection was limited to the end of the girders in Span 2 at Pier 1, particularly of the web area near the seat for Span 1 (Figure 11).

Figure 11 Seating of Span 1 on bracket projection from girder of Span 2

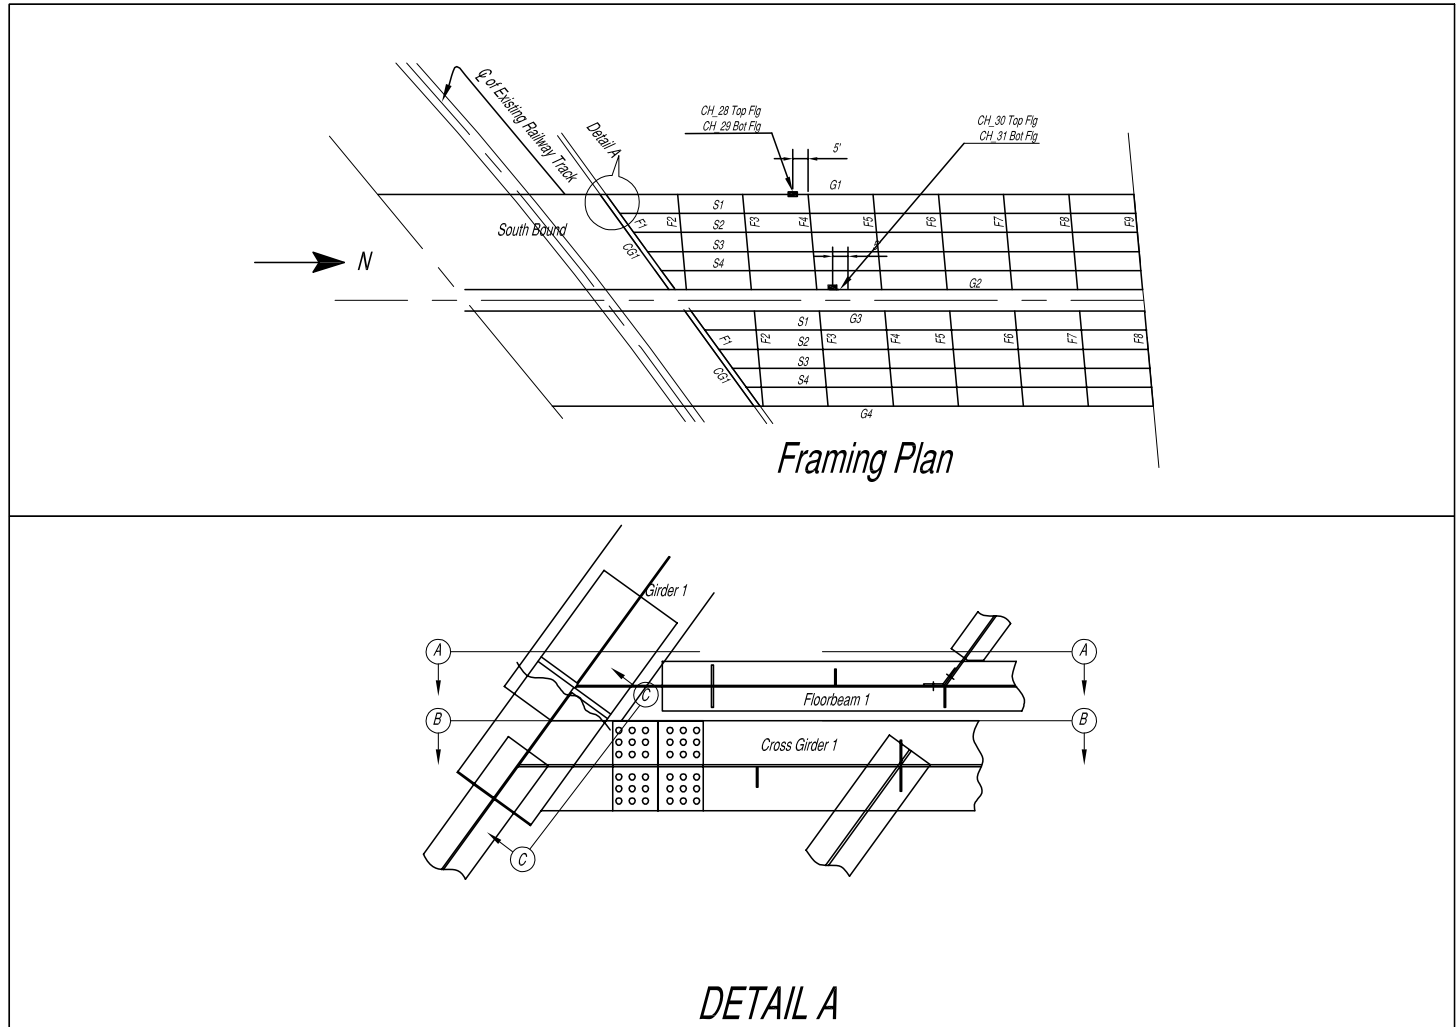
Figure 16 Instrumentation Plan (Sheet 1 of 3)

The instrumentation plan is shown in Figures 16, 17 and 18. Same instrumentation was provided for both the controlled load tests and the short term monitoring. Altogether 35 data channels were employed for 17 axial strain gages, four strain rosettes, and four LVDTs. The instruments were installed on November 13 and 14, 2006 during the day time.

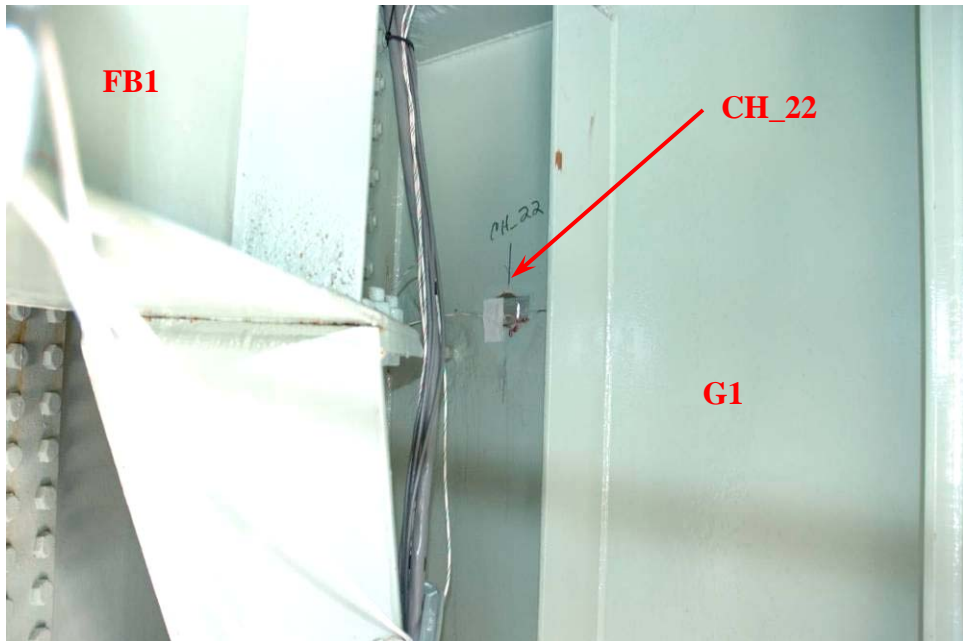
Another three strain gages were provided at a section on the main girder, two on the flanges and one on the web (CH_21 to CH_23), to determine the through depth strain distribution in the girder near the bearing stiffener and the effect of the bracket shelf plate (Figures 20 and 21).

Figure 20 Location of strain gage channel CH_22

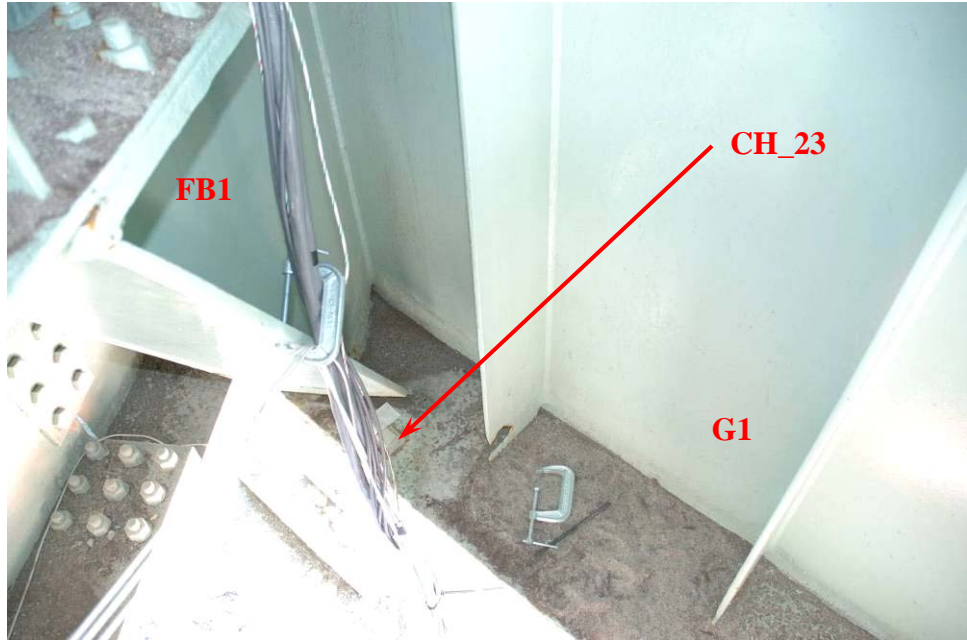
Figure 21 Location of strain gage channel CH_23

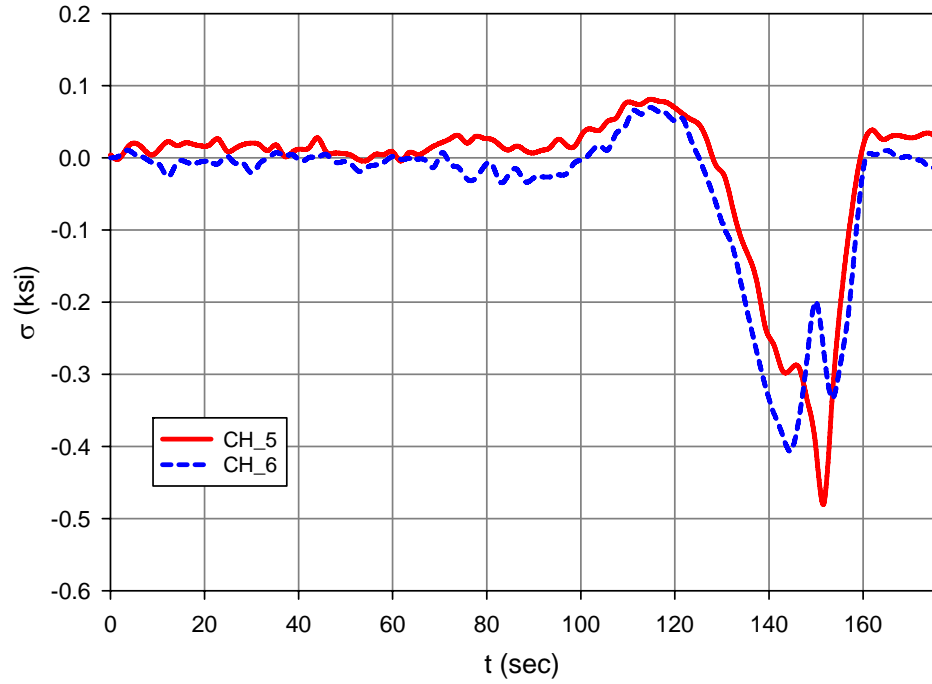
Plots of stress data from CH_5 and CH_6 are shown in Figures 27 and 28 for the crawl test CRWL_2 and the dynamic test DYN_3 respectively. These channels correspond to the vertical arms of the strain rosettes provided on both faces of the web at the span side corner of the floor beam connection plate/bearing stiffener to shelf plate junction (Figure 18). The time history plots reflect the disposition of the trucks during the tests and the bridge configuration. The two adjacent/closely spaced stress peaks noted during the crawl test resulted from the two side by side vehicles exiting the bridge at separate times due to the relatively large skew at the South End of the bridge. During the dynamic test the stress peaks were well separated since one truck first crossed the bridge followed by the other. In both loading conditions, however, the stresses on both gages located on the opposite faces of the web plate were in the order of 0.3~0.4 ksi and were compressive. The test data indicated that the live load stresses in the web plate of Girder 1 at location similar to that in Girder 3 was essentially in plane. Out-of plane bending of the web plate due to rotation of the floor beam, as expected earlier, was essentially non-existent.

Figure 27 Stresses measured at strain gage channels CH_5 and CH_6 during crawl load test CRWL_2

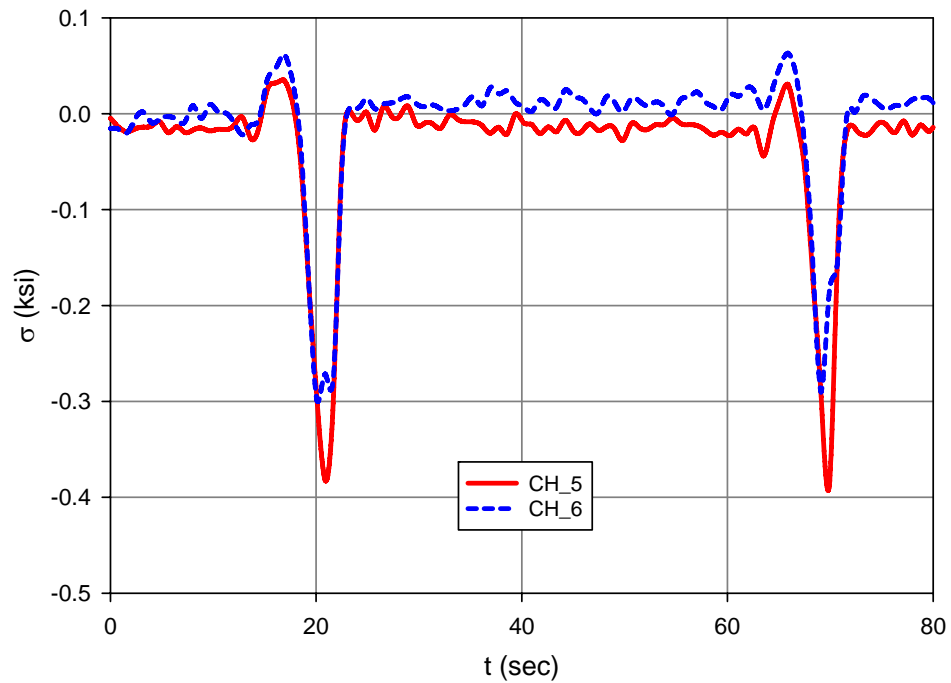
Figure 28 Stresses measured at strain gage channels CH_5 and CH_6 during dynamic load test DYN_3

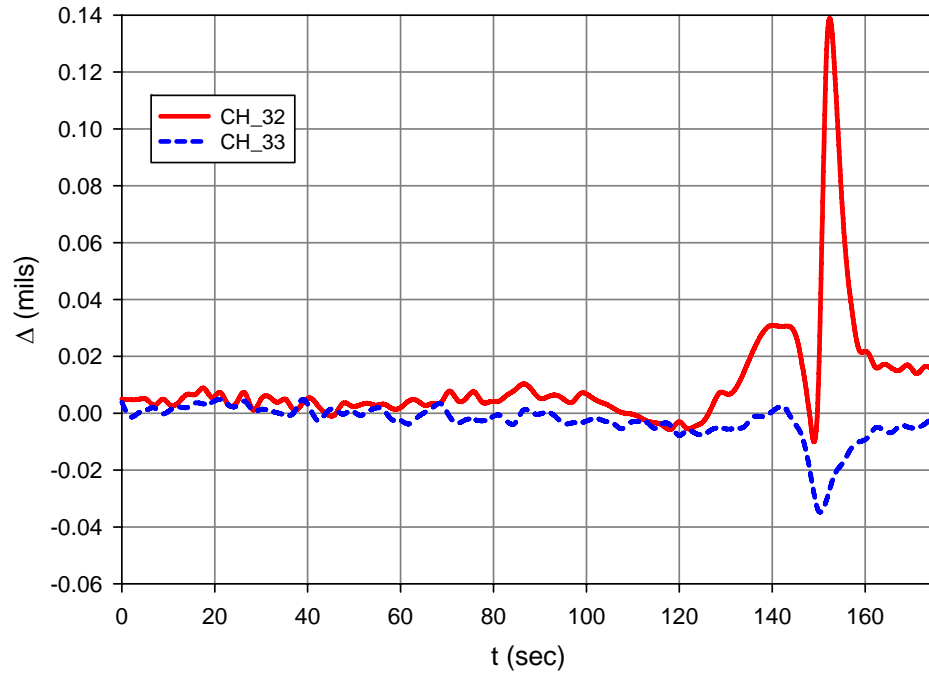
Time history of displacements measured at LVDT channels CH_32 and CH_33 are plotted in Figures 37, 38 and 39 for the same two load cases discussed above, which were the most severe among all the controlled load tests. These channels corresponded to the LVDTs located at respectively 6 in and 2 in above the shelf plate on the south side of the floor beam connection plate/bearing stiffener. The test data indicated that maximum out-of-plane deflection of the web plate was 0.14 mils. At the level of top LVDT, the displacement changed sign for both the crawl and dynamic tests as the vehicles exited the span. In fact a relatively large spike in displacement was noted in this LVDT, which suggested of some kind of impact at the expansion joint. At the level of lower LVDT, however, the displacements were always of the same sign. This LVDT was located closest to the cope at the bearing stiffener to the shelf plate junction, where cracking initiated in Girder G3. Nevertheless, the magnitude of out-of-plane displacement recorded by this LVDT was in the order of 0.03 mils, which was insignificant.

Figure 37 Displacements measured at LVDT channels CH_32 and CH_33 during crawl load test CRWL_2

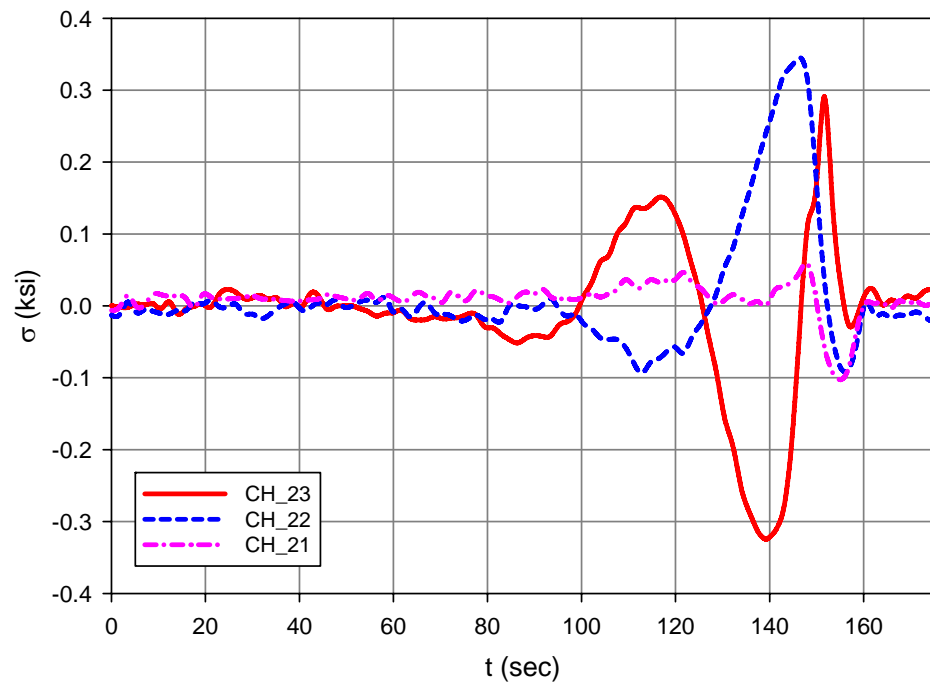
Strain gage channels CH_21, CH_22 and CH_23 were located in a section towards the span side of the floor beam connection plate/bearing stiffener. The channels CH_21 and CH_23 were located on the inner face of the top and bottom flanges respectively, whereas the CH_22 was located on the web (Figure 18). The time histories of measured stresses at these gages are shown in Figures 40 and 41 for the crawl test CRWL_2 and dynamic test DYN_3. The stress distribution through the depth of the Girder G1 at this section is affected by the presence of the bearing shelf supporting the simple Span 1. The reaction from Span 1 generates tensile stress in the bearing shelf and compressive stress in the bottom flange of the bracket projection. The compressive stress in the bottom flange of the bracket develops into Span 2 beyond the bearing center line, producing compressive stress in the bottom flange of the Girder G1 at this section. Because of the proximity of this section to the bearing center line, the reaction from Span 2 generates only small tensile stress in the bottom flange, which is insufficient to surpass the compressive stress. The stress measured at the web gage CH_22 is tensile, as the contributions from the top flange of the bracket/bearing shelf plate and Span 2 are both additive. The stresses measured in the top flange of Girder G1 (CH_21) are relatively small due to the composite action between the girder and the concrete deck. The maximum measured tensile stress at this section was about 0.35 ksi.

Figure 40 Stresses measured at strain gage channels CH_21, CH_22 and CH_23 during crawl load test CRWL_2

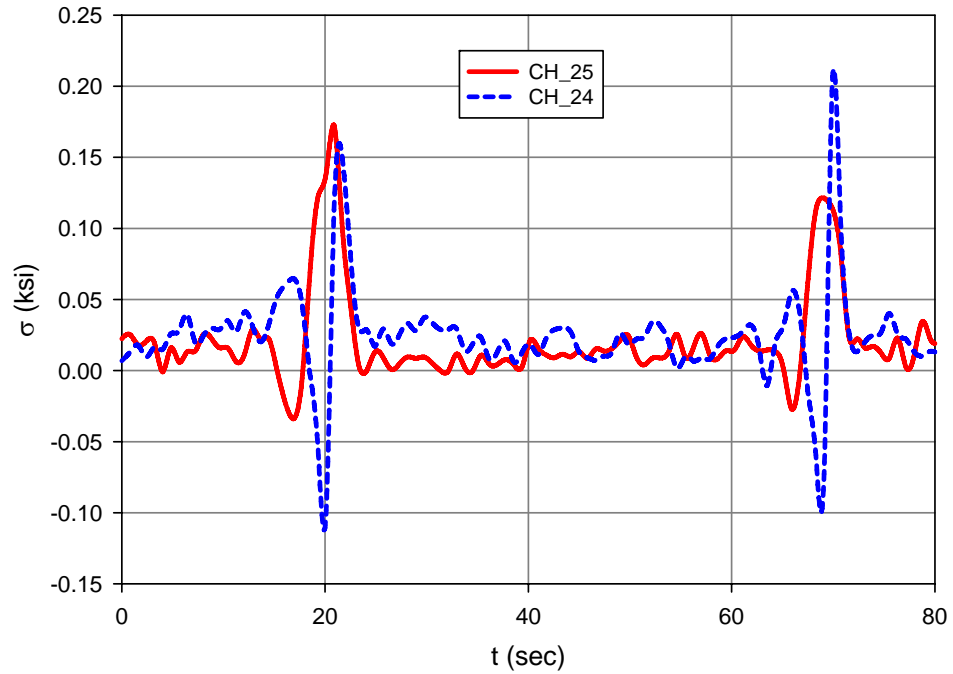
Figure 43 Stresses measured at strain gage channels CH_24 and CH_25 during dynamic load test DYN_3

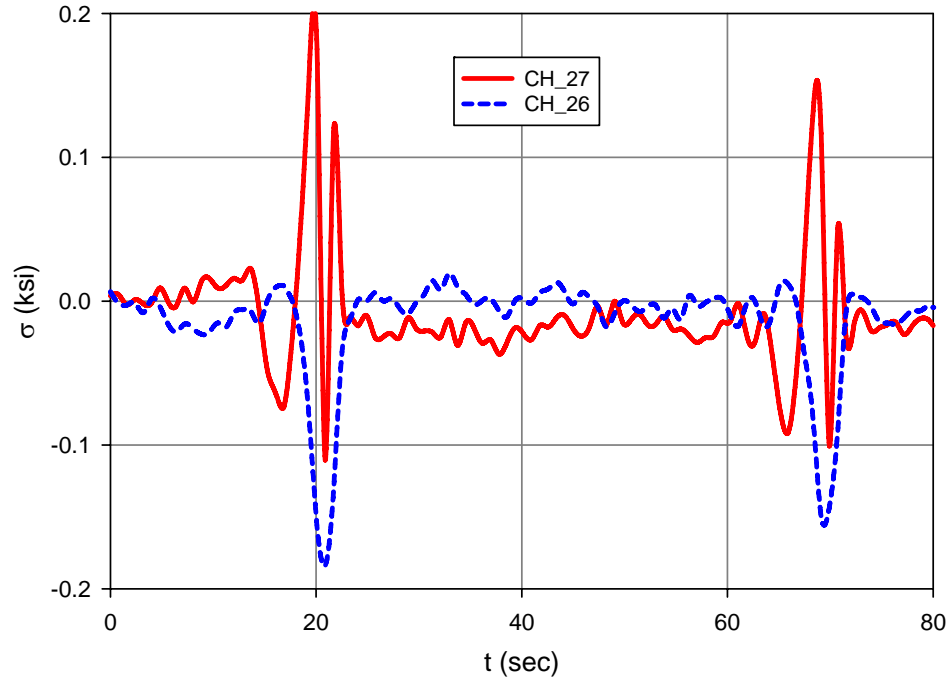
Figure 45 Stresses measured at strain gage channels CH_26 and CH_27 during dynamic load test DYN_3

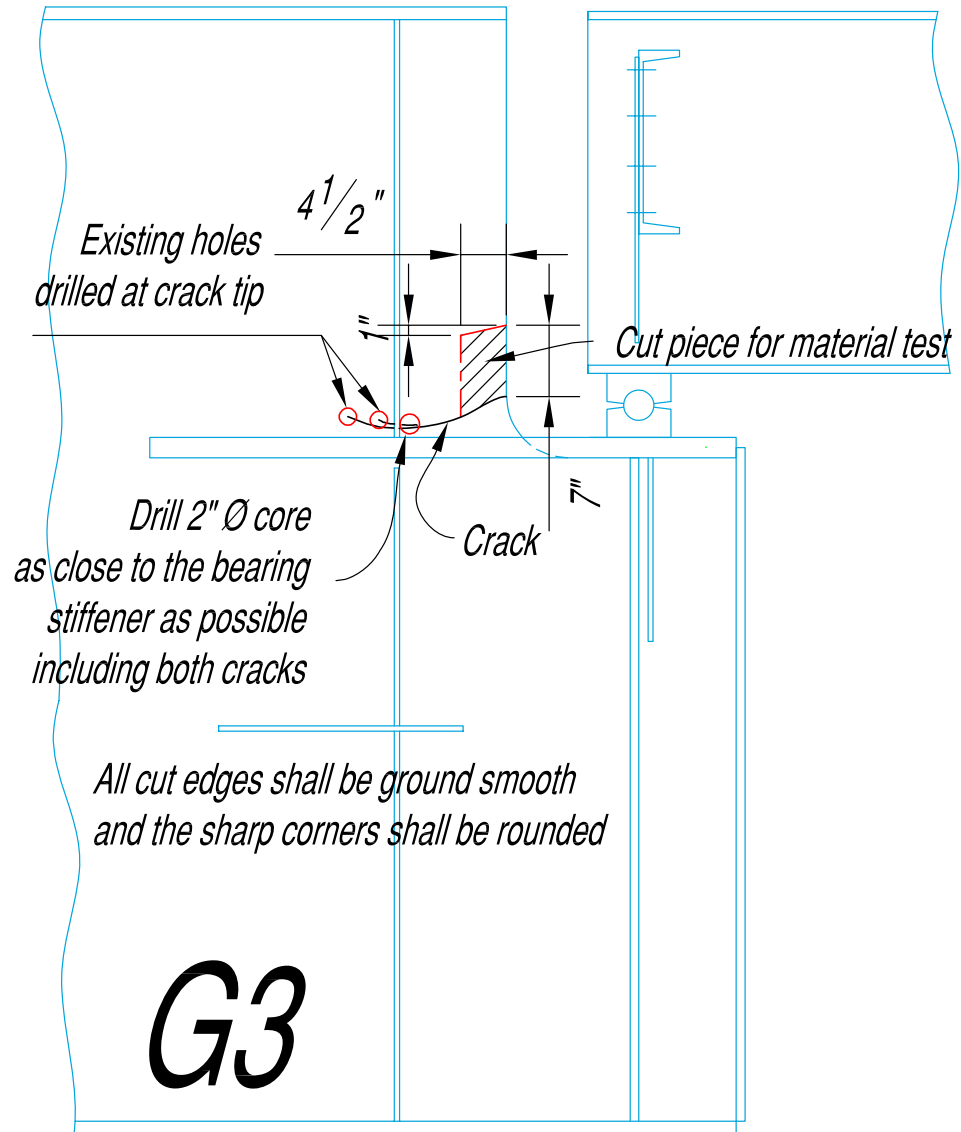
The properties of the girder web material were examined further to investigate the occurrence of cleavage fracture of Girder 3. Approximately 4.5 in × 7 in piece was cut out from the edge of the fractured web adjacent to the cracked surface. Schematic of cutting plan are shown in Figure 52. Twelve Charpy V-Notch (CVN) specimens and two tensile specimens were carved out from this cut-piece as shown in Figure 53. Chemical composition of the web steel was also determined.

Figure 52 Cut piece of girder web used for material test

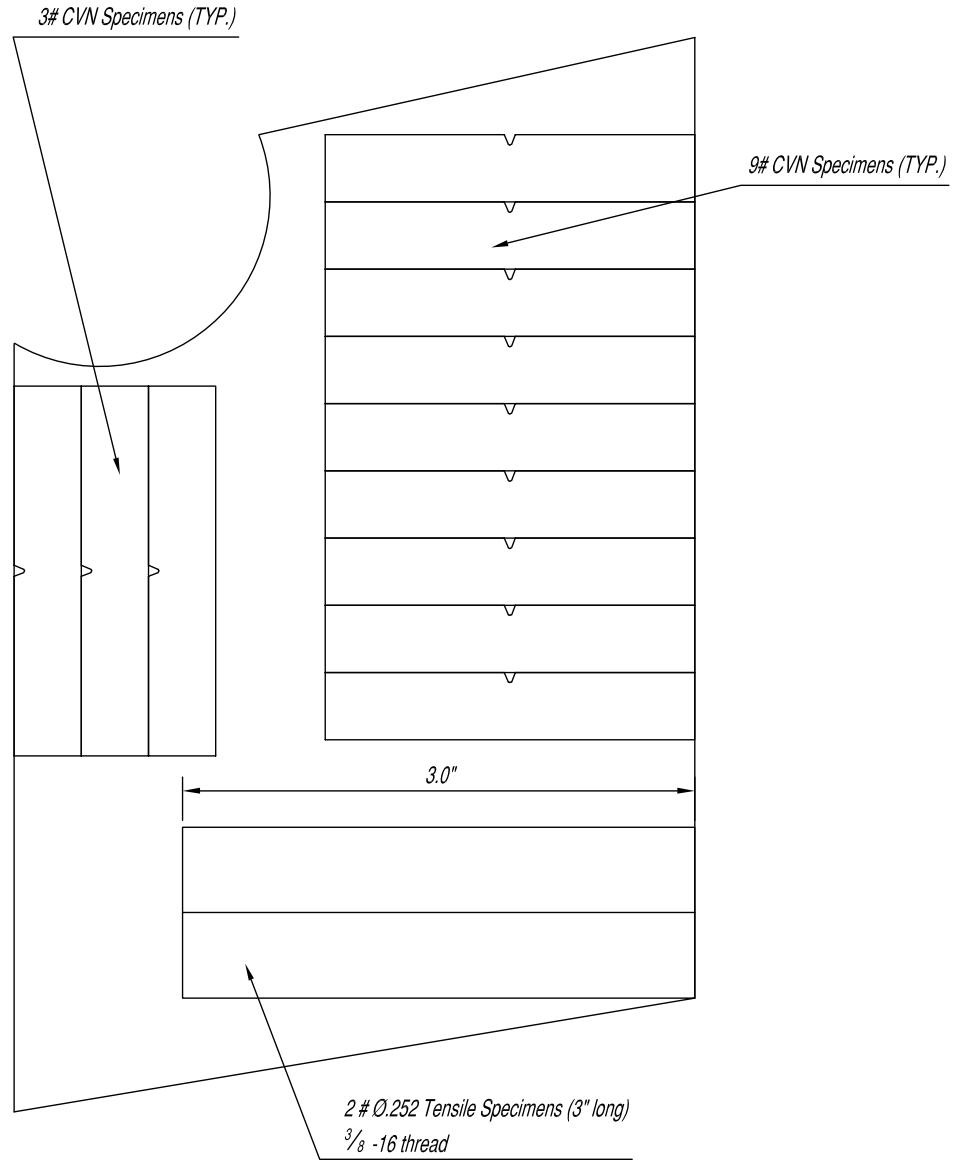
Figure 53 Cutting plan of specimens for material test

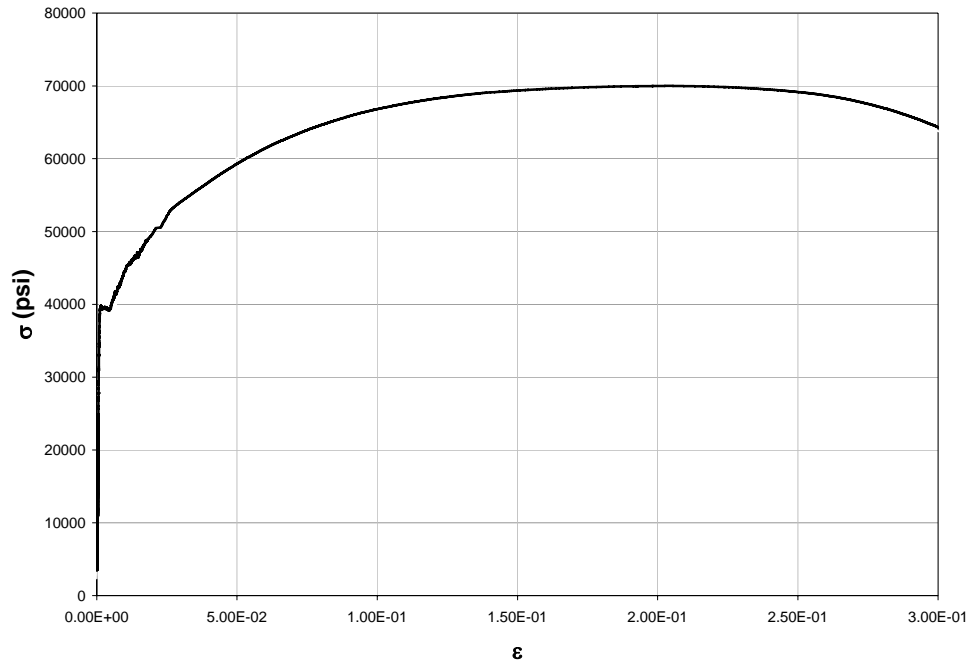
Stress-strain plots of the web steel from the tensile test are presented in Figures 54 and 55. The material demonstrated a yield and tensile strength of respectively, about 40 and 70 ksi. The stress-strain curves are typical of A36 steel, showing upper and lower yield points, yield plateau, and strain hardening.

Figure 54 Stress strain response of web steel: Specimen I

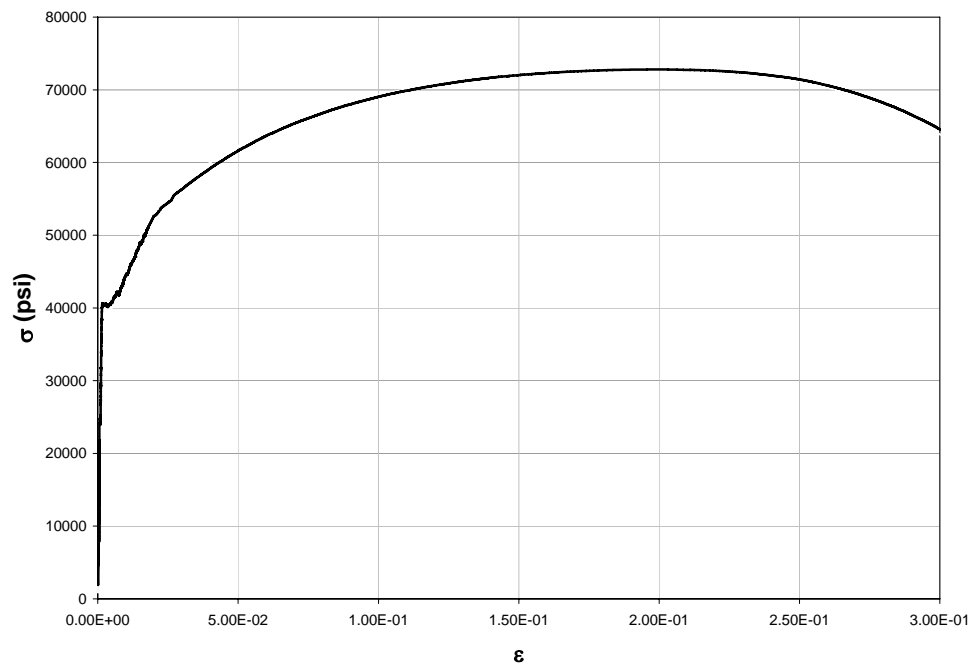
Figure 55 Stress strain response of web steel: Specimen II

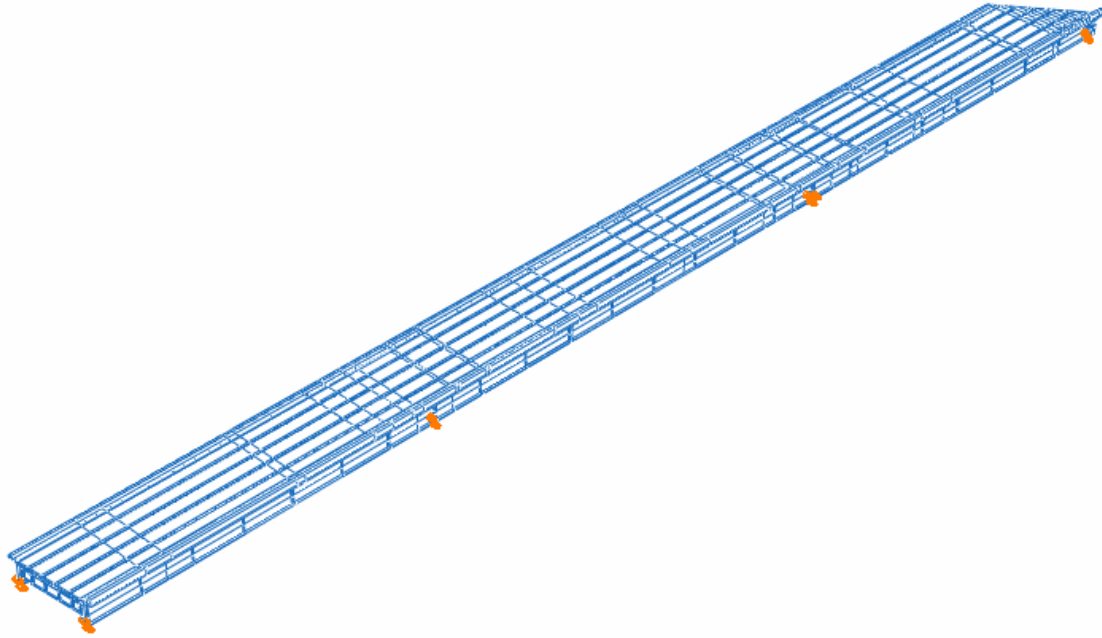
A detailed 3-D model of the continuous bridge superstructure module comprising Spans 2, 3 and 4 between Pier 1 and North Abutment was developed (Figure 58). The model consisted of all components of the superstructure including the deck, the main girders, the floor beams, the stringers, the cross girder. The bearing stiffeners, the floor beam and cross girder connection plates, the floor beam seats at connection plates and the intermediate transverse stiffeners at the floor beam connections were included in the girder models. All transverse stiffeners in the cross girders and floor beams were also included (Figures 59 and 60). However, the other transverse intermediate stiffeners and the longitudinal stiffeners in the girders, and the transverse wind bracings between the girders were excluded from the model, as these elements have little effect on the global structural response under vehicular live load. These exclusions are also unlikely to affect the stress field local to the web gap at the transverse bearing stiffener near the termination of the bearing stiffener/floor beam connection plate-to-web weld above the bracket shelf plate, which is the region of interest as the possible origin of web cracking similar to Girder G3. Similar other exclusions were the stiffeners in the stringers and the diaphragms.

Figure 58 FE model: overall bridge viewing East

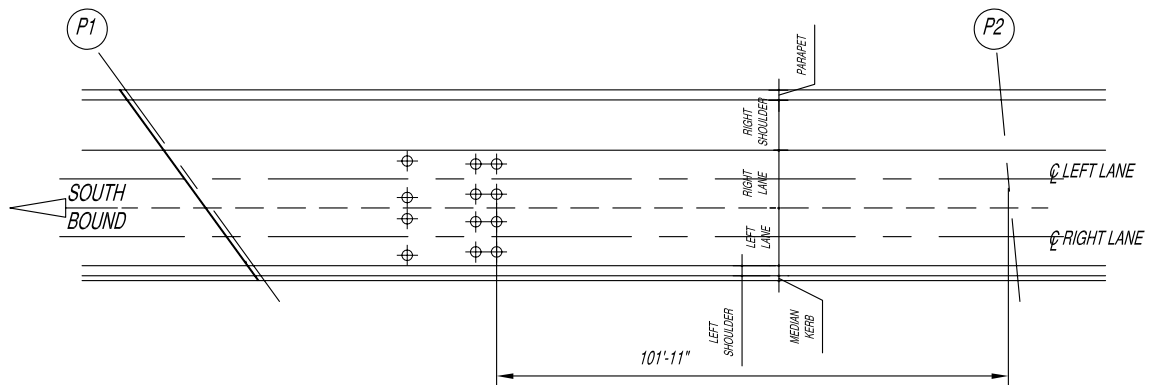
Load Case 1 – Truck positions corresponding to the maximum values at the strain gage channels CH_29 and CH_31 respectively, in the spans of Girders G1 and G2 during the crawl load test CRWL_2 (Table 3). The estimated wheel positions are shown in Figure 61.

Figure 61 Wheel load disposition in Load Case 1 – controlled load test CRWL_2

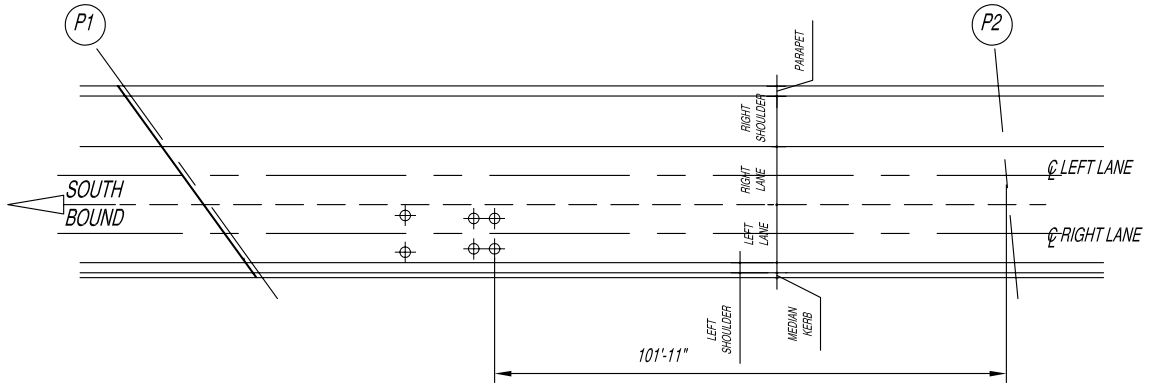
Load Case 2 – Truck positions corresponding to the maximum values at the strain gage channel CH_31 in the span of Girder G2 during crawl load test CRWL_1 (Table 3), when the truck 797-8076 was traversing the left lane. The estimated wheel positions are shown in Figure 62.

Figure 62 Wheel load disposition in Load Case 2 – controlled load test CRWL_1 left lane loaded

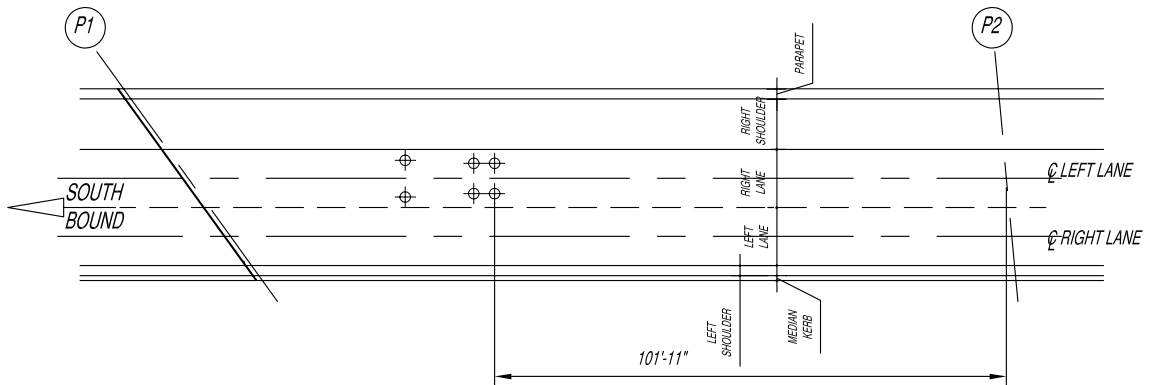
Load Case 3 – Truck positions corresponding to the maximum values at the strain gage channel CH_29 in the span of Girder G1 during crawl load test CRWL_1 (Table 3), when the truck 531-8076 was traversing the right lane. The estimated wheel positions are shown in Figure 63.

Figure 63 Wheel load disposition in Load Case 3 – controlled load test CRWL_1 right lane loaded

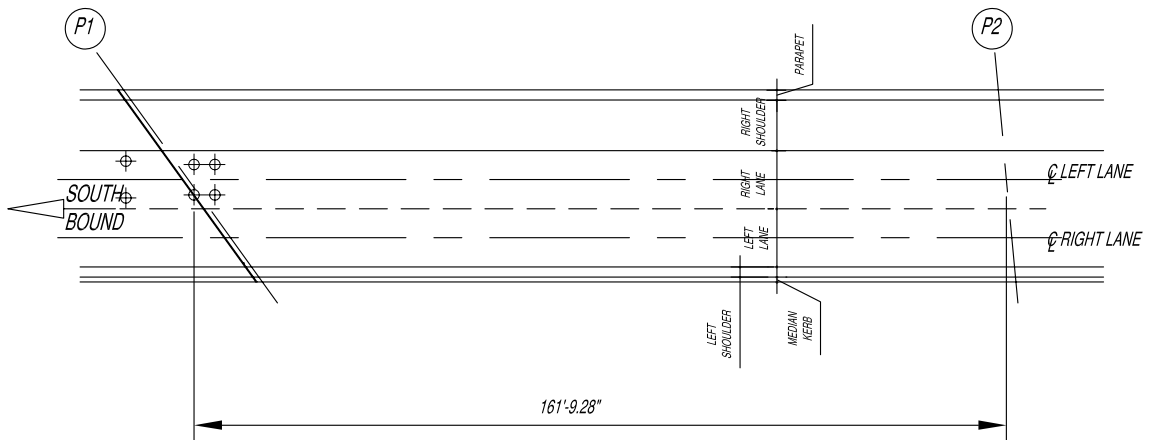
Load Case 4 – Truck positions corresponding to the maximum values at the strain gage channels CH_5 and CH_6 near the web gap at the bearing stiffener/floor beam connection plate above the bracket shelf plate in Girder G1 at Pier 1 during crawl load test CRWL_1 (Table 3), when the truck 531-8076 was traversing the right lane. The estimated wheel positions are shown in Figure 64.

Figure 64 Wheel load disposition in Load Case 4 – controlled load test CRWL_1 right lane loaded over near bearing stiffener at Pier 1

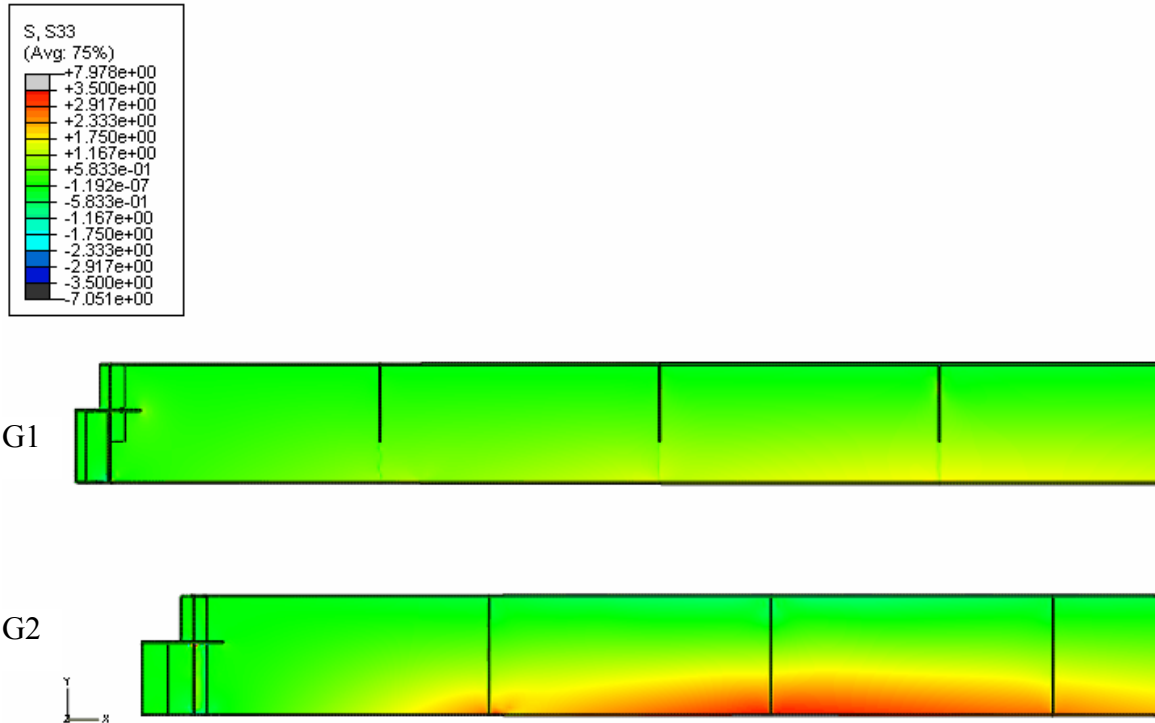
The relevant FEA results of Girders G1 and G2 are shown in Figures 65 to 73 for the analyzed load cases. Figure 65 shows the contour of longitudinal or normal stress in the Girders G1 and G2 under Load Case 1 corresponding to controlled load test CRWL_2. The stress contour is typical of the flexural response of a beam under in plane transverse loading. The neutral axis is located high up in the web near the deck soffit owing to the composite action with the deck. The stress in G2 is higher than that in G1, because of the lane disposition and the resulting placement of wheel loads closer to G2.

Figure 65 FEA result – Load Case 1: Longitudinal stress in Girders G1 and G2

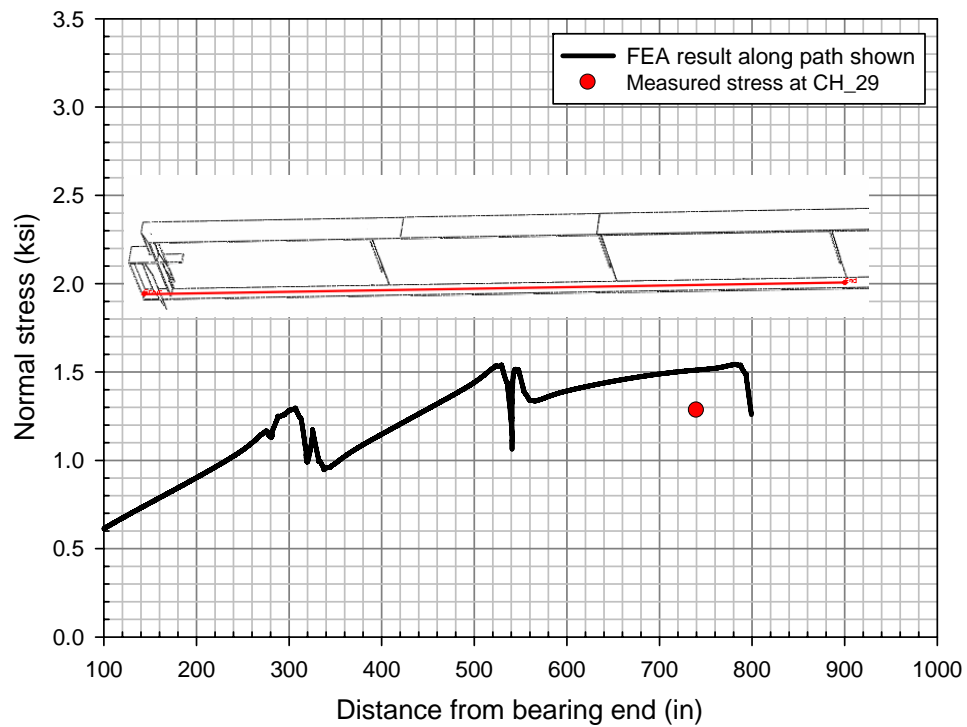
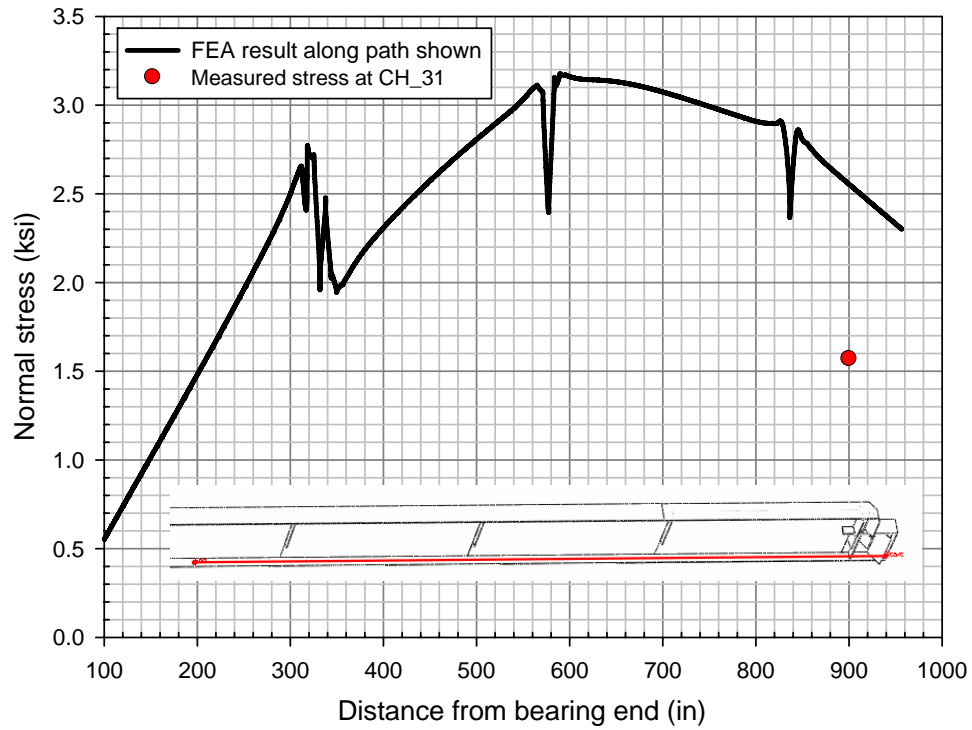
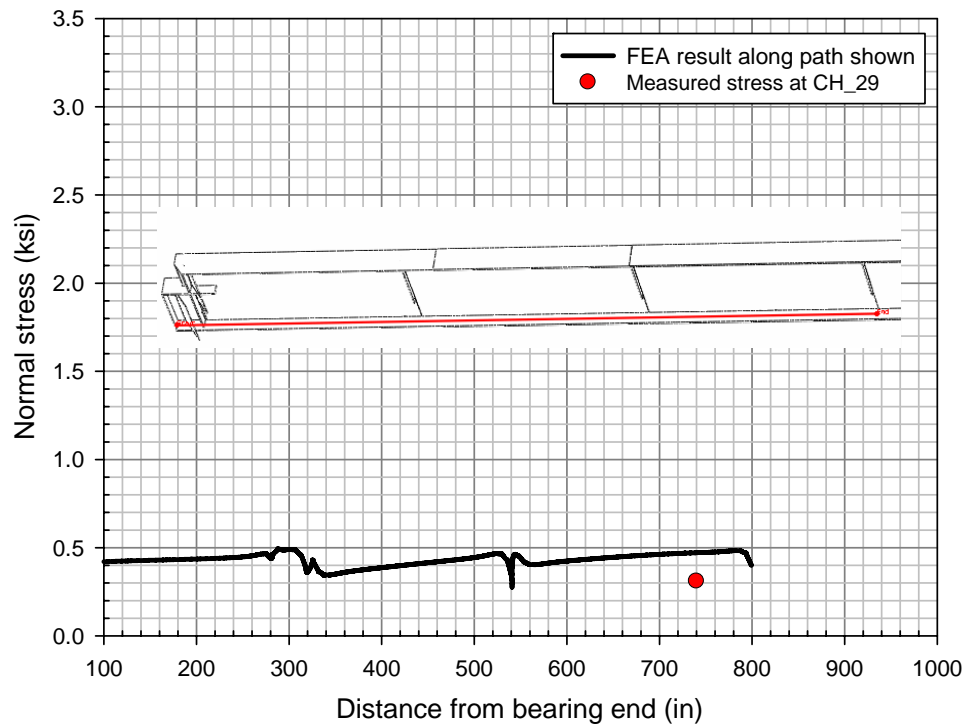
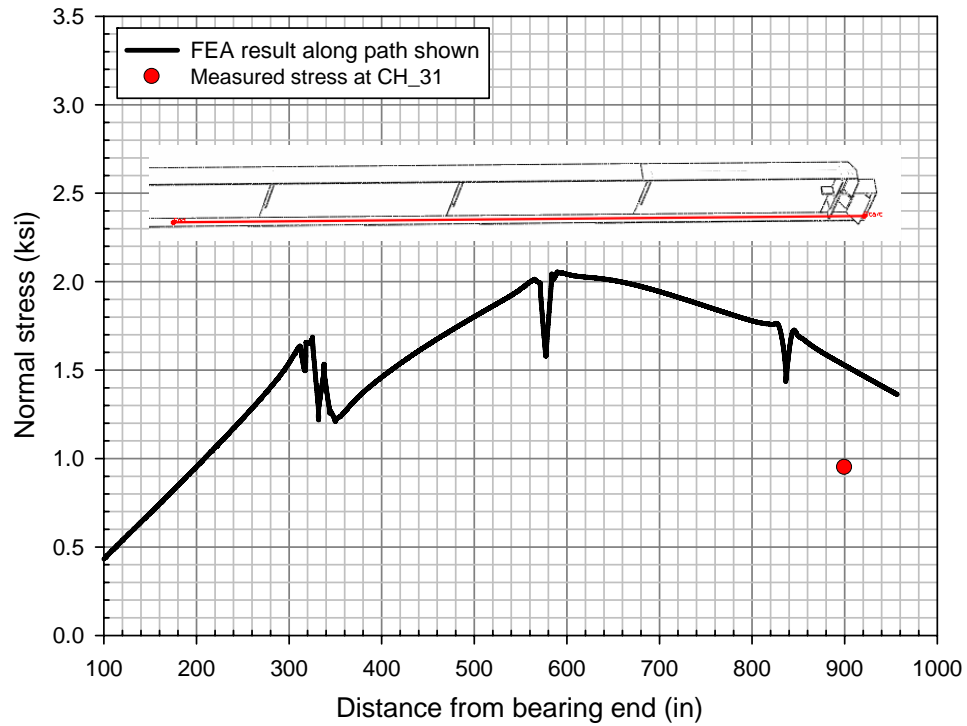
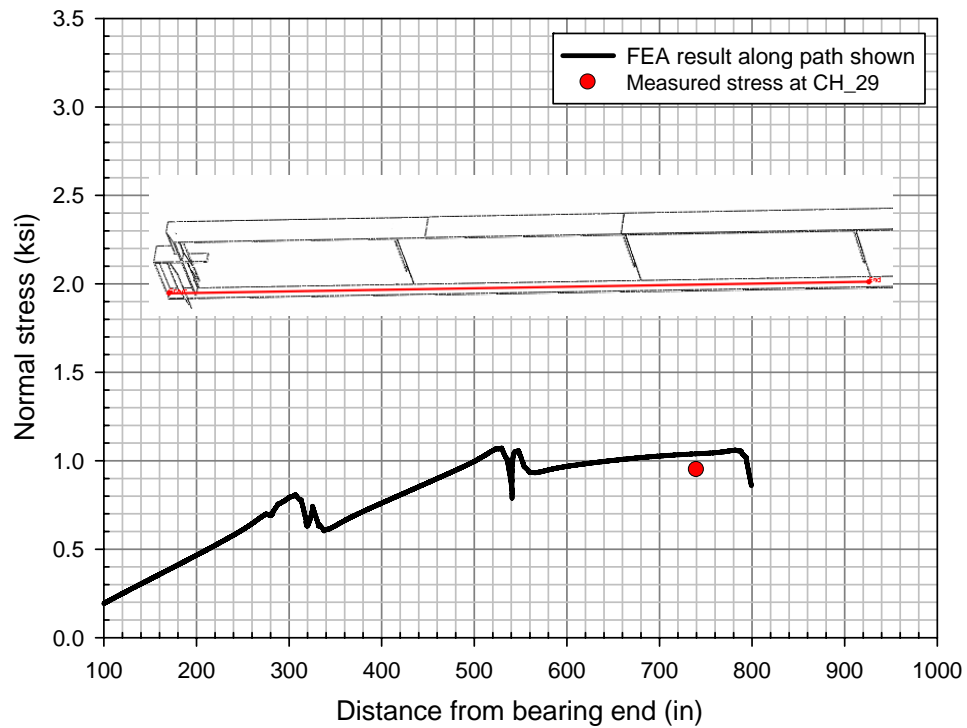
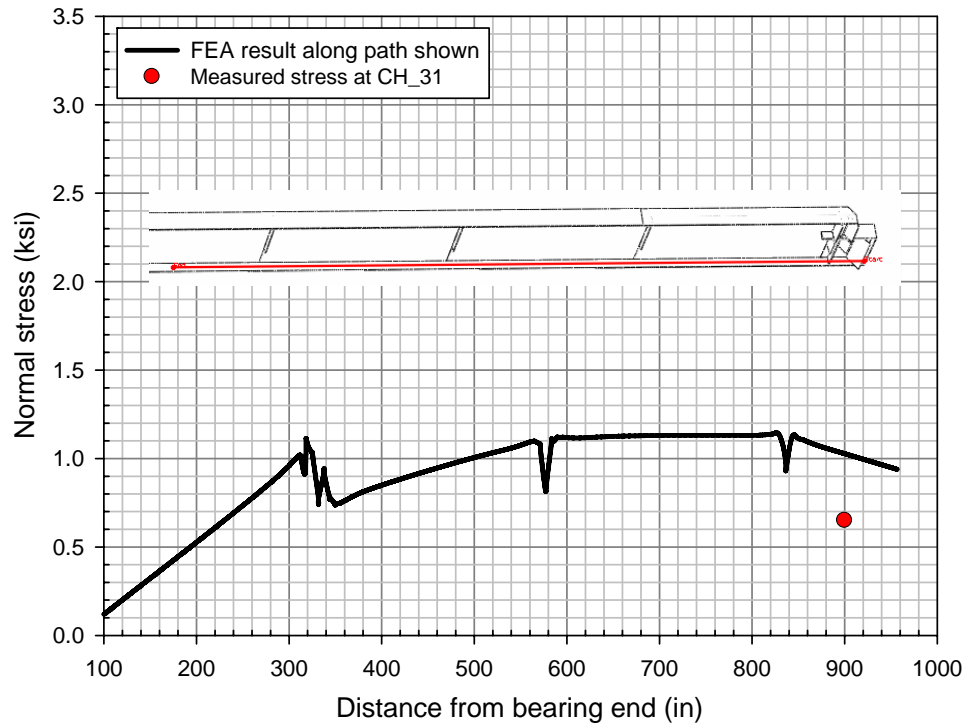
Figures 66 to 71 show the relevant part profiles of longitudinal stress at the inner face of bottom flanges of the Girders G1 and G2 along the indicated paths for the Load Cases 1, 2 and 3. The discontinuities in the stress profiles correspond to the location of floor beams, where the seats under the floor beams are connected to the bottom flange. Also plotted on these figures are the point measurements of stresses at the strain gage channels CH_29 and CH_31 as appropriate. It is evident that the FEA results consistently over predicted the stresses in the girder flanges. While the estimated stresses in Girder G1 were higher than the measured values by about 10~20%, the estimated stresses in Girder G2 were about 60~62% higher. This is not surprising, since the analysis results are known to always over predict the actual field measurements due to various reasons including, simplified assumptions in the analysis models and boundary conditions, the nonlinearities in the responses owing to complex contact interactions and load transfer among the members and component, etc. The estimated and measured stresses, nevertheless, were of the same order of magnitude.
