**Web Cracking Repair Design for Bridge
SR 46-3020-0020-0000 on US 202 in
Montgomery County, PA**

PennDOT ECMS No. E00511: Work Order No. 10

**Field Instrumentation, Monitoring
and Analysis**

ATLSS Report No. 07-10

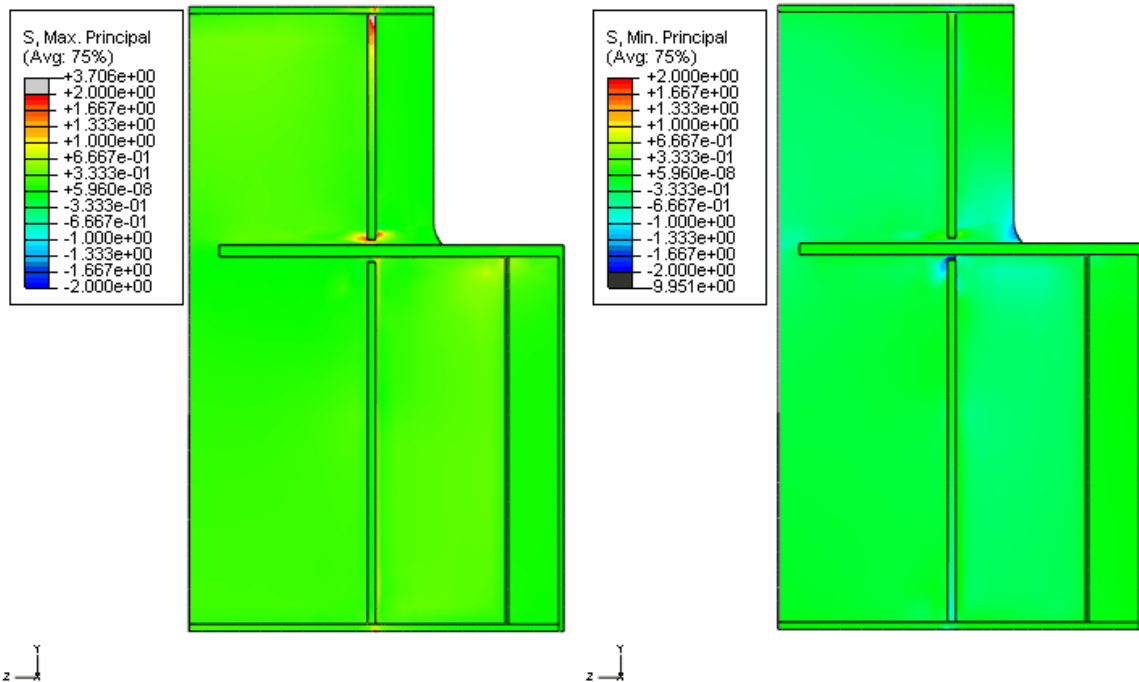
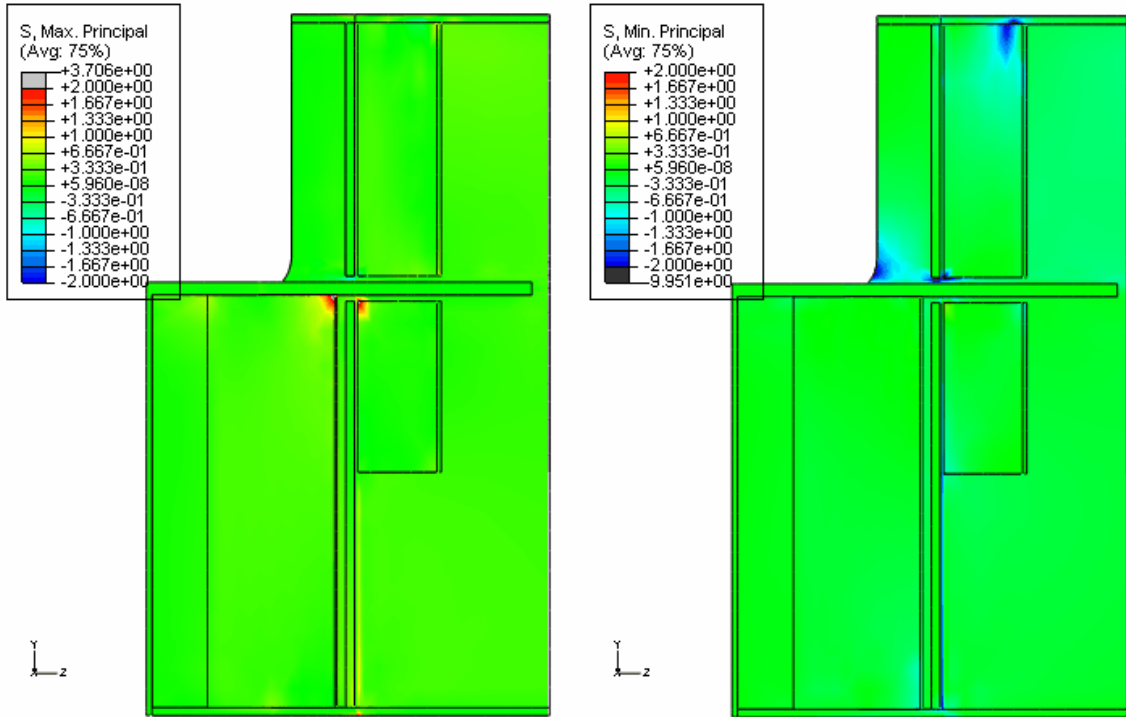
Figures 72 and 73 show the principal stress fields near the web gap in the bearing stiffener/floor beam connection plate respectively on the outer and inner faces of Girder G1 at Pier 1 under Load Case 4. The maximum and minimum principal stresses measured on strain rosette channels CH_1, CH_3 and CH_5 are respectively 0.32 ksi and -0.58 ksi. The estimated and measured stresses are of the same order of magnitude.

Figure 72 Principal stress field near the bearing stiffener / connection plate web gap in Girder G1 at Pier 1 (outer face) – controlled load test CRWL_1 right lane loaded

Figure 73 Principal stress field near the bearing stiffener / connection plate web gap in Girder G1 at Pier 1 (inner face) – controlled load test CRWL_1 right lane loaded
