Field Monitoring Prototype Retrofits of Floorbeam Connections on the I-95 Girard Point Bridge

Final Report

ATLSS Report No. 05-01

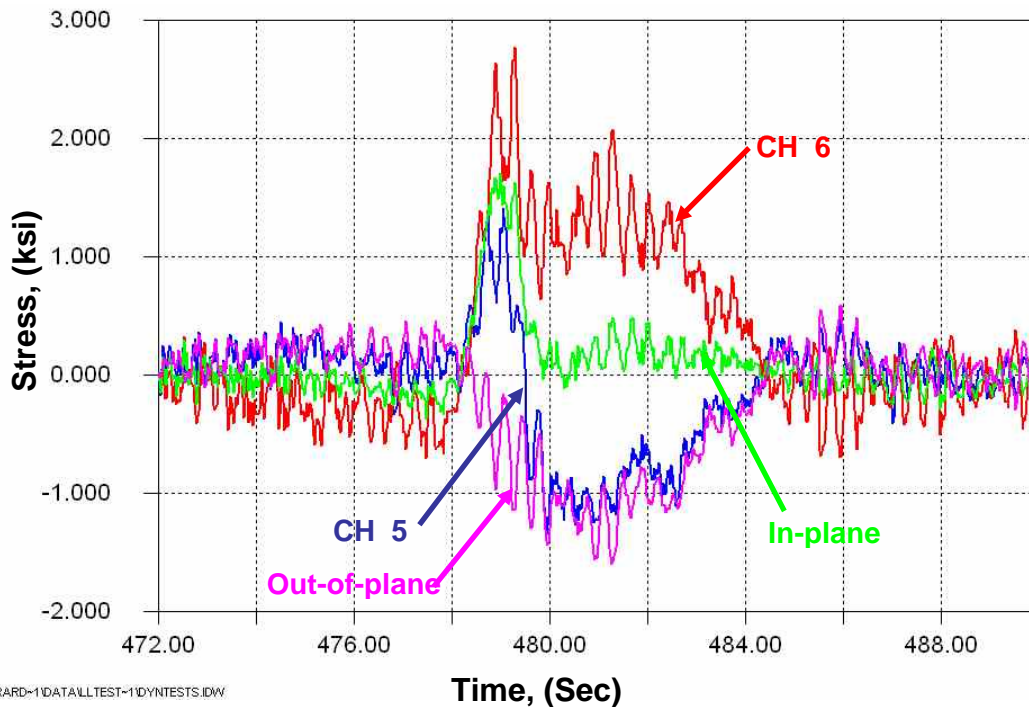
Out-of-plane bending stresses were calculated for CH_5 and CH_6 installed back-to-back on the below the cutout on the web of floorbeam FB77. The data used for generating the graphs were obtained from the dynamic test (DYN_TEST), since the crawl test results included an offset in the strain gages measurements after the test trucks passed over the details as described above. Figure 5.2 shows the in-plane and the out-of-plane components in the web below the cutout where CH_5 and CH_6 were installed.

Figure 5.2 – Response of CH_5 and CH_6 installed back-to-back and the in-plane and the out-of-plane bending stress components 1/4 inch below the cutout of floorbeam FB77 as both test trucks drove side-by-side over the west and the middle lanes in the crawl test (CRL_TEST)

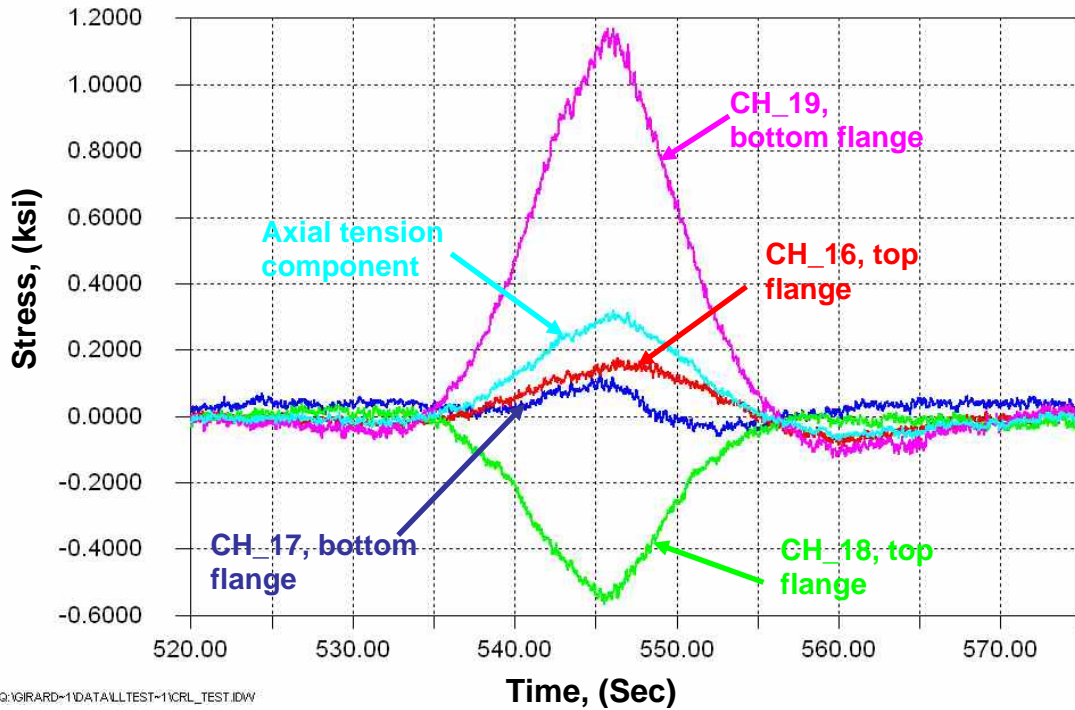
The response of the four gages during the crawl test (CRL_TEST) is shown in Figure 5.7. As expected, CH_19 installed on the bottom flange measured tensile stresses, while CH_18 installed on the top flange measured compressive stresses. Simple beam theory suggests that both measured values however, should have been equal in magnitude and opposite in sign. It is however unclear as to why the measured stress in CH_19 was twice as much to what was measured in CH_18. The difference in the magnitude between measured stresses at both channels could be attributed to axial tension stresses introduced in the top flange of the floorbeam (along with the bending stresses). This was investigated using the limited data available. As shown in Figure 5.7, the axial stress component (i.e., the average of channels CH_18 and CH_19) was calculated. As can be seen, the magnitude of this component is small. Furthermore, since the axial force component would have to be essentially constant, the axial stresses at the gages near the connection (CH_16 and CH_17) where the flange is much thinner, would be much greater, which is not the case. Hence, it is not believed that there is a significant axial stress component in the floorbeam, which is consistent with other bridges instrumented. The effect is more likely due to some level of participation between the deck and the floorbeam. Hence, the deck, though connected with flexible stringers, is somewhat composite with the floorbeam. Similar behavior has been seen on other bridges.

Positive stresses were recorded by CH_16 installed on the top flange and CH_17 installed on the bottom flange in the same cross section. Intuitively it is expected that the stresses in CH_16 and CH_17 should be of equal magnitude and opposite signs. However, near a connection where only the web is attached, the stress flow does not necessarily follow can be easily predicted by beam theory. It is likely that some level of negative moment exists as evident by the tensile stresses exhibited by channels CH_1 and CH_2 as well as other channels on the web.

Figure 5.7 – Response of CH_16, CH_17, CH_18, and CH_19 installed on the top and bottom flange of floorbeam FB77 as both test trucks drove side-by-side over the west and the middle lanes in the crawl test (CRL_TEST)

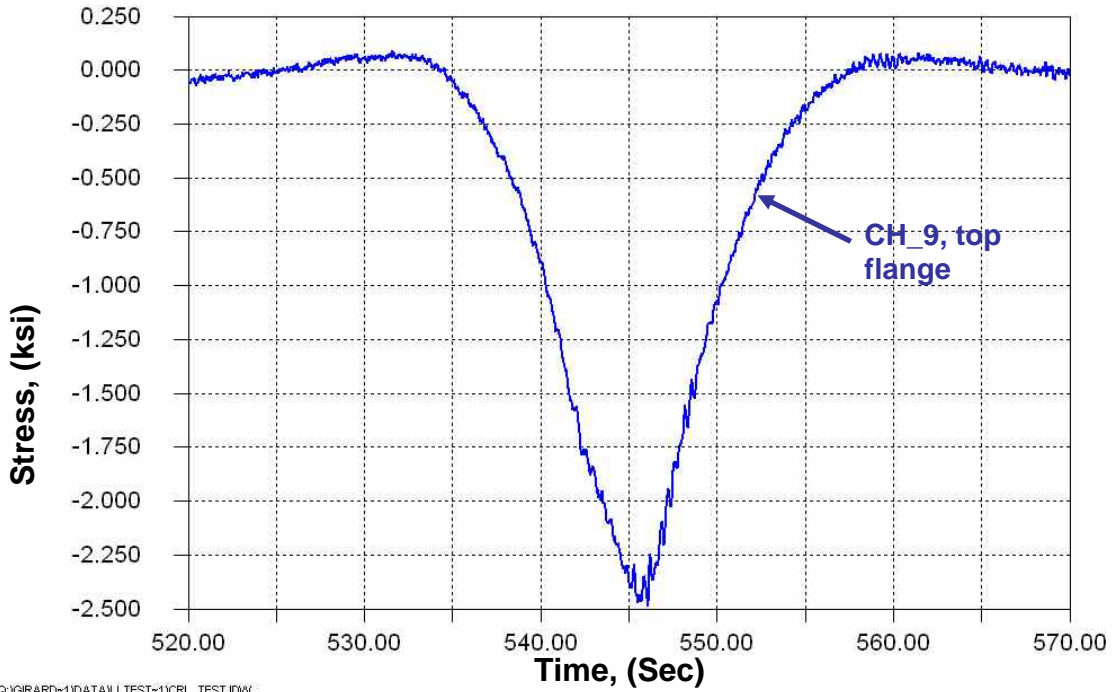
Channel CH_9 was installed on the top flange of the floorbeam approximately 1'-2 11/16" away from the edge of the angle used for connecting the floorbeam to the truss hanger. The detail is conservatively classified as category detail E. The CAFL of the detail is 4.5 ksi. Figure 5.8 shows the response of CH_9 in the crawl test CRL_TEST. The magnitude of CH_9 appears to be slightly greater than expected, at least when compared to CH_16 and CH_17. The reason for this behavior is not known. A summary of the measured maximum, minimum, and the stress range recorded by CH_16, CH_17, CH_18, CH_19 and CH_9 in the crawl test CRL_TEST is listed in Table 5.6.

Figure 5.8 – Response of CH_9 installed on the top flange of floorbeam FB77 as both test trucks drove side-by-side over the west and the middle lanes in the crawl test (CRL_TEST)

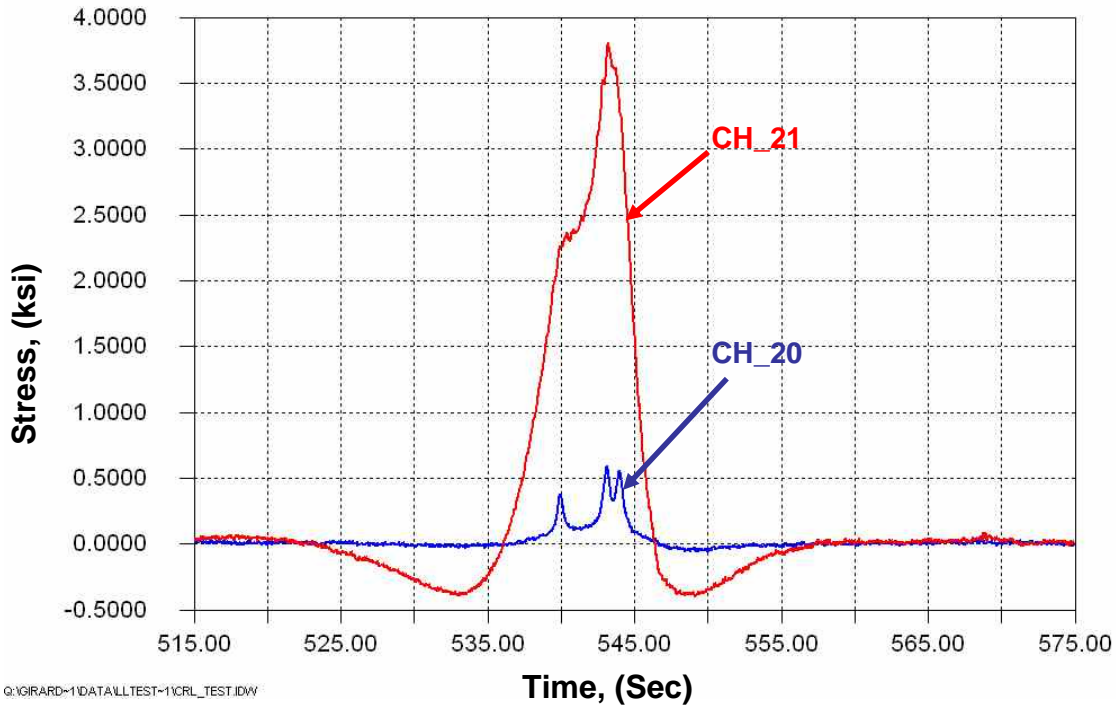
Figure 5.9 shows the response of both channels to the moving load in the crawl test CRL_TEST. The figure shows a small magnitude of stress measured by CH_20 installed on the bottom face of the top flange of the stringer and higher magnitude of stress measured by CH_21 installed on the bottom flange of the stringer. The apparent difference in the magnitude in the stresses measured by both channels and the low magnitude of stress recorded by CH_20 suggests that high level of composite action is taken place between the stringer and the bridge deck. Note the local bending effects produced in the top flange as individual axles pass above the stringer.

Figure 5.9 – Response of CH_20 and CH_21 installed on the top and bottom flange of the stringer located 25 feet east of the floorbeam to the truss hanger connection as both test trucks drove side-by-side over the west and the middle lanes in the crawl test (CRL_TEST)

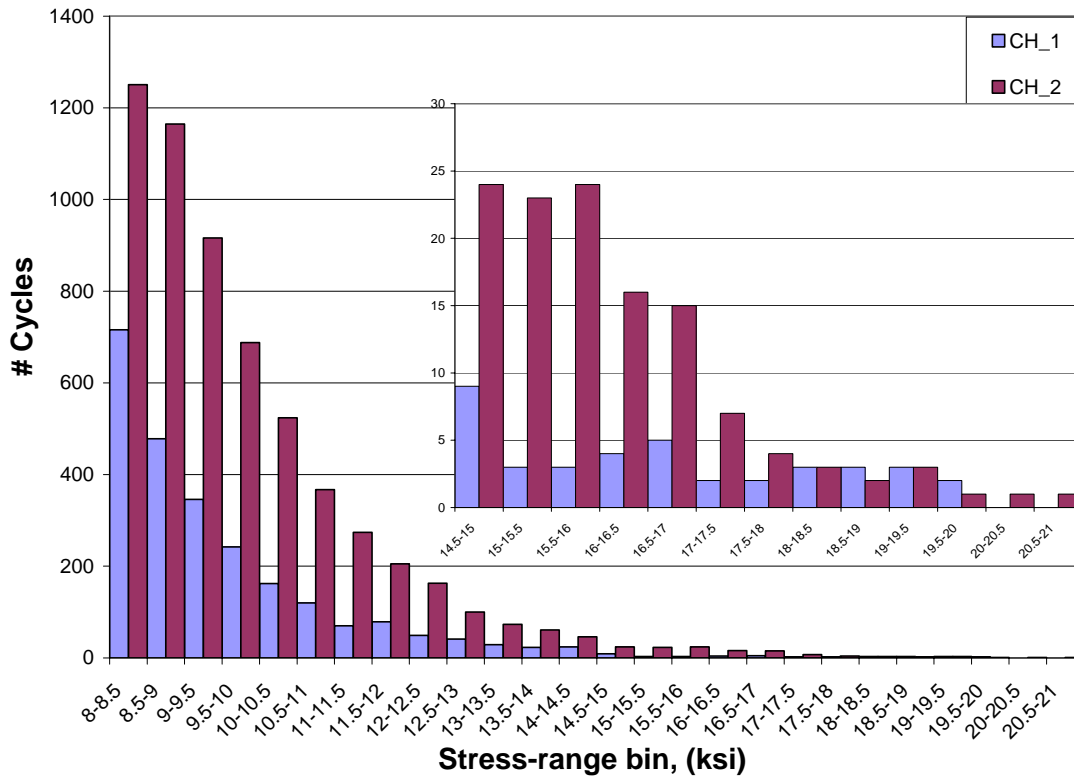
Figure 6.1 – Stress-range histogram for channels CH_1 and CH_2

As indicated in the figure, CH_2 experienced a higher count in each bin than CH_1 for a given stress range. The inset in the figure is a magnification of the last portion of the figure. Stress-range cycles as high as 19.75 ksi and 20.75 ksi were measured by CH_1 and CH_2, respectively. A lower-bound stress range truncation level of 8 ksi was selected for producing the histogram. Typically for fatigue evaluation, the truncation level is 1/4 to 1/3 times the CAFL of the detail.
