# Laboratory and Field Fatigue Investigation of Cantilevered Signal Support Structures in the City of Philadelphia

# FINAL REPORT

ATLSS Report No. 04-22

October 2004

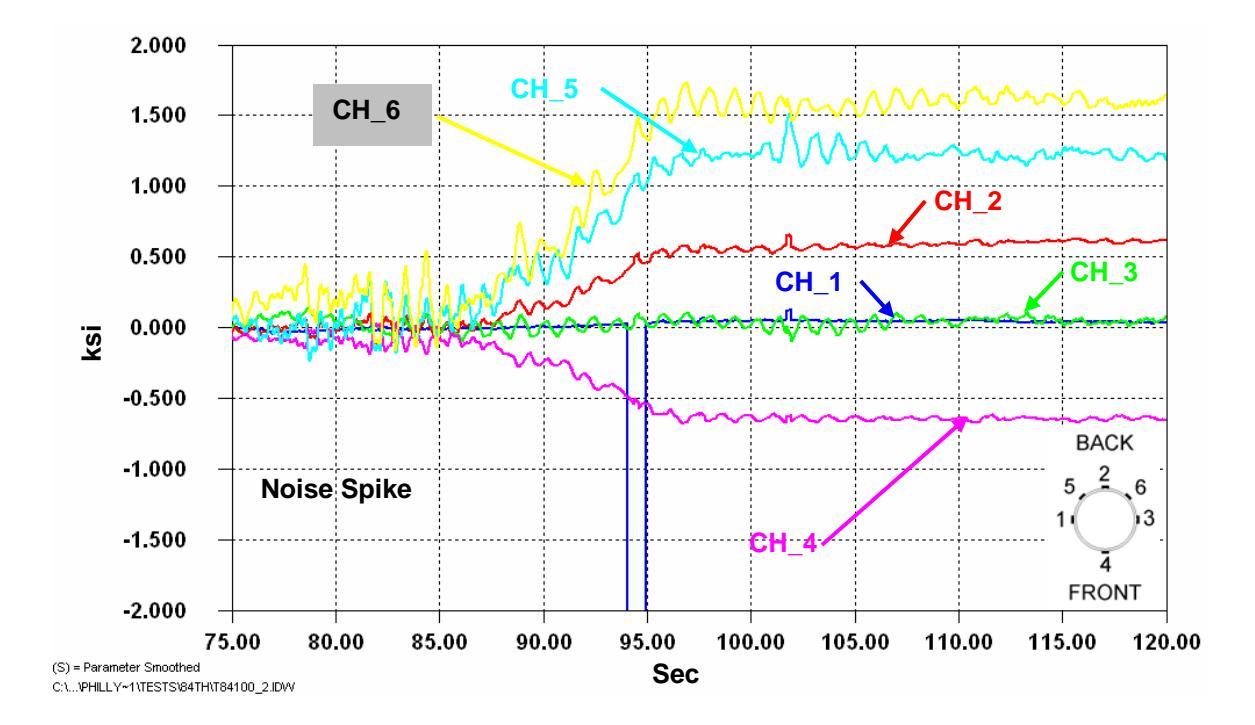
Channels CH\_2 and CH\_4 are located on the rear (tension) and front (compression) sides of the pole respectively. As expected, nearly equal and opposite stresses are measured at channels CH\_2 and CH\_4. However, note the response at channel CH\_5 and CH\_6, which are located "in-line" with the anchor rods at the rear of the base plate. The stress in these bolts is between 2 to 3 times greater than measured at channel CH\_2. The increase in stress near the bolts is primarily the result of flexibility (bending) of the base plate and shear lag. Behavior such as this has been observed in other similar structures.

Figure 4.1 - Stresses at base of pole as 100 lb load is applied at tip of mast-arm (84<sup>th</sup> and Lindbergh)

Although the base plate is mounted on grout, the tension portion of the bending moment couple in the tube must be resisted entirely by the rear anchor rods. Basic mechanics of materials calculations indicate the greatest stress is at the rear of the pole between the anchor rods (*i.e., at the position of channel CH\_2*). In reality, the base plate is very flexible between the bolts. As a result, little load can be transferred from the back of the pole to the bolts. Hence, the rear portion of the tube between the anchor rods is not as effective in transferring the bending moment in the area adjacent to the base plate as assumed. (*Current design practice assumes the base plate is infinitely rigid*) As a result, stresses are greater near the anchor rods, where most of the moment is resisted.

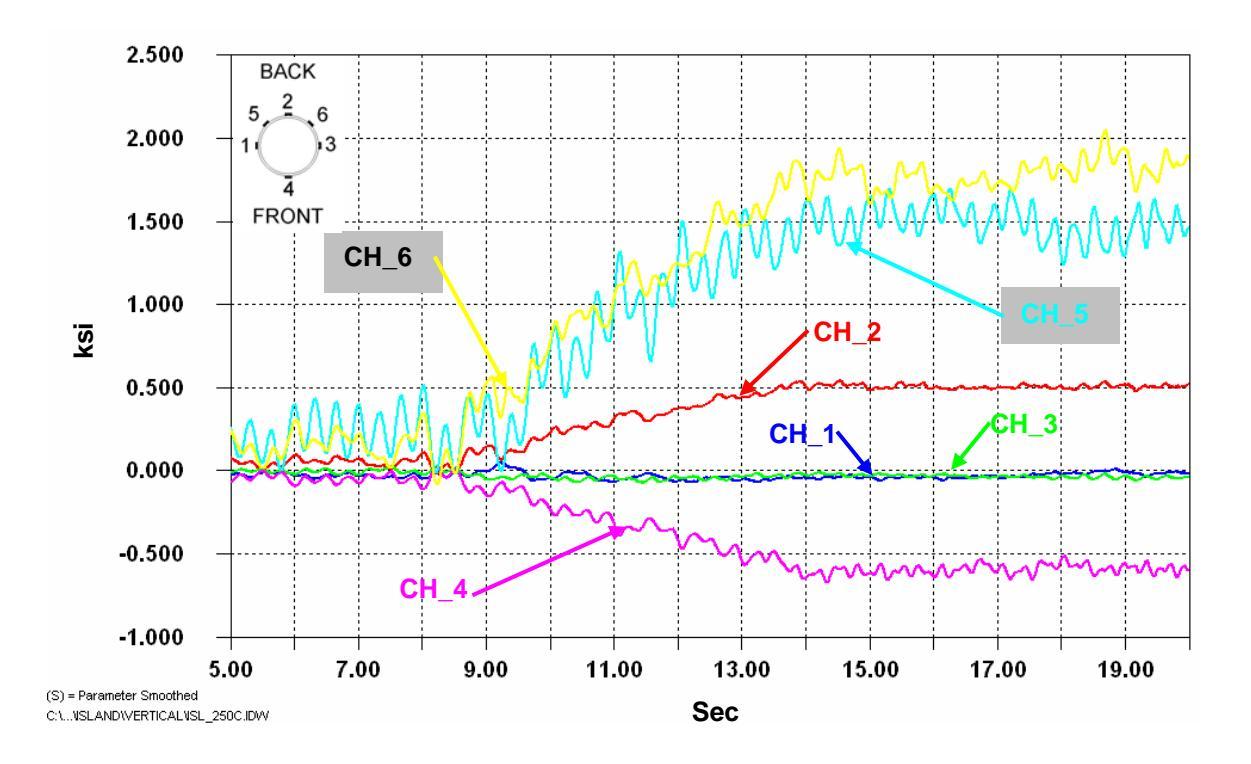
Figure 4.5 - Detail of stresses at base of pole as vertical force is applied at tip of mast-arm. (Island Ave. and SR 291))

Figure 4.5 presents the response of the pole adjacent to the base plate as a vertical load of 100 lbs was applied at the tip of the mast-arm. Comparing the results to the response with the pole at 84<sup>th</sup> street in Figure 4.1 shows nearly identical results. The most important observation is again related to the higher than expected stresses at channels CH\_5 and CH\_6. The reason for the higher than anticipated stresses at CH\_5 and CH\_6 was previously discussed.

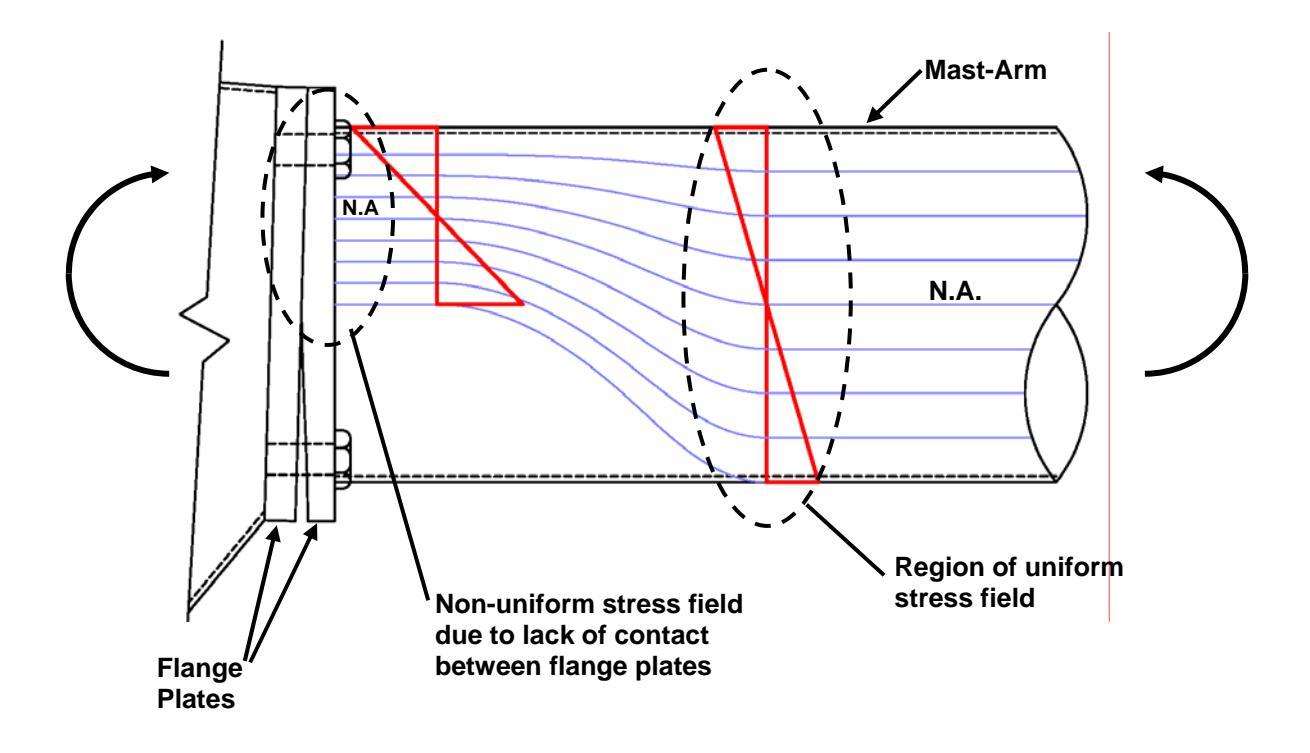
In order to establish the cause of the observed behavior, a close-up inspection was made of the upper mast-arm flange connection. The inspection revealed that the flange plates were not in full contact, especially at the lower portion of the connection. Figure 4.7 is a photograph of this detail and clearly shows the gap between the flange plates. Although all four bolts appear to be tight, the preload was apparently insufficient to close the gap.

The behavior is presented schematically in Figure 4.8 and illustrates why little to no stress was measured at channel CH\_9. Because of the gap at the Island Avenue pole, the bending moment must be resisted by a reduced section of the mast-arm near the flange plate. Hence, the neutral axis shifts upward, as shown in Figure 4.8 and gages at the mid-depth of the mast-arm (i.e., CH\_8 and CH\_10) are subjected to compression stresses.

Clearly, gaps, such as the one shown in Figure 4.8 can significantly alter the stress field in the region of the connection. As a result, traditional mechanics of materials calculations will under predict the stress range in the mast-arm and the bolts in the flange plates.

Figure 4.8 - Illustration of stress field in mast-arm due to lack of bearing between flange plates

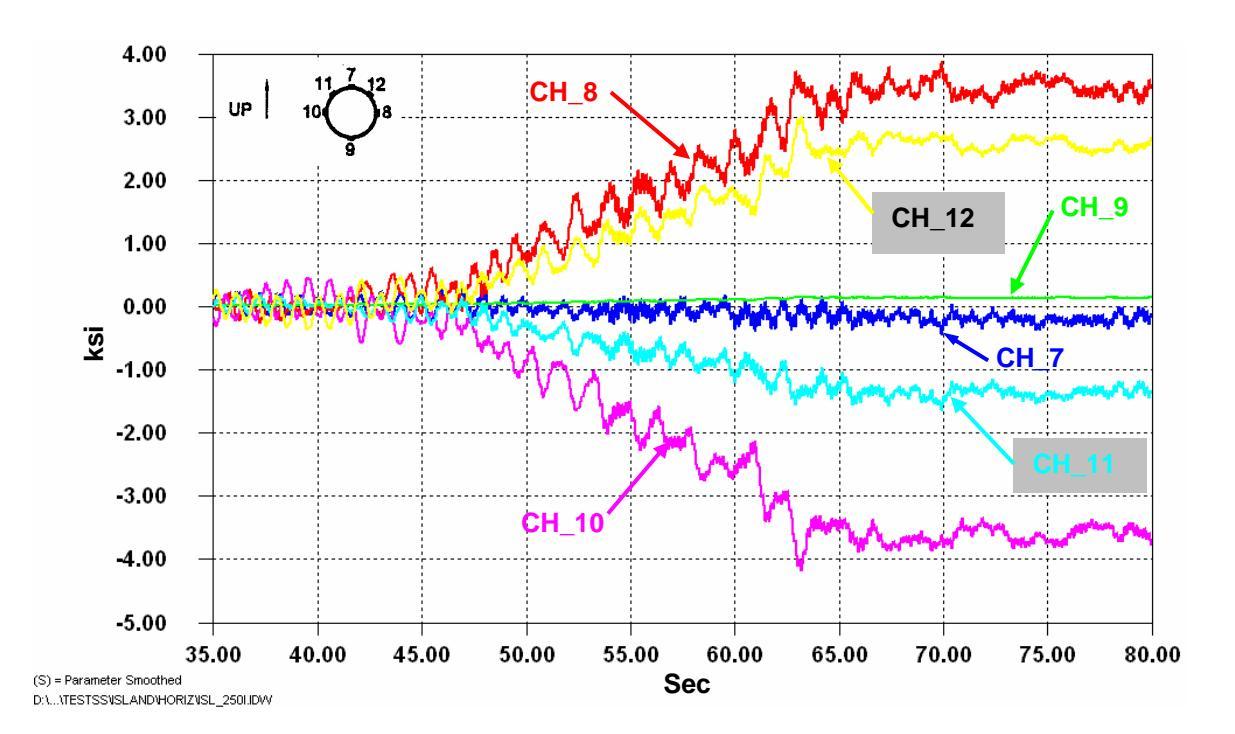
Figure 4.10 presents the response of the mast-arm subjected to the same load in Figure 4.9. As expected, channel CH\_8 and CH\_10 are exhibit the greatest stress and are approximately equal and opposite in sign. The response at CH\_7 and CH\_9 are nearly zero, as expected. Recall that the lower portion of the mast-arm flange plate was not in contact with the flange plate on the pole and a gap was observed (See Figure 4.7). Channels CH\_11 and CH\_12 would be expected to be subjected to equal and opposite stresses. However, the measurements indicated otherwise. This may be the result of the gap at the lower portion of the flange plates or some other effect, such as a loose bolt.

Figure 4.10 - Stresses in mast-arm adjacent to flange plate connection to pole as horizontal load is applied to tip of mast-arm (Island Ave. and SR 291)

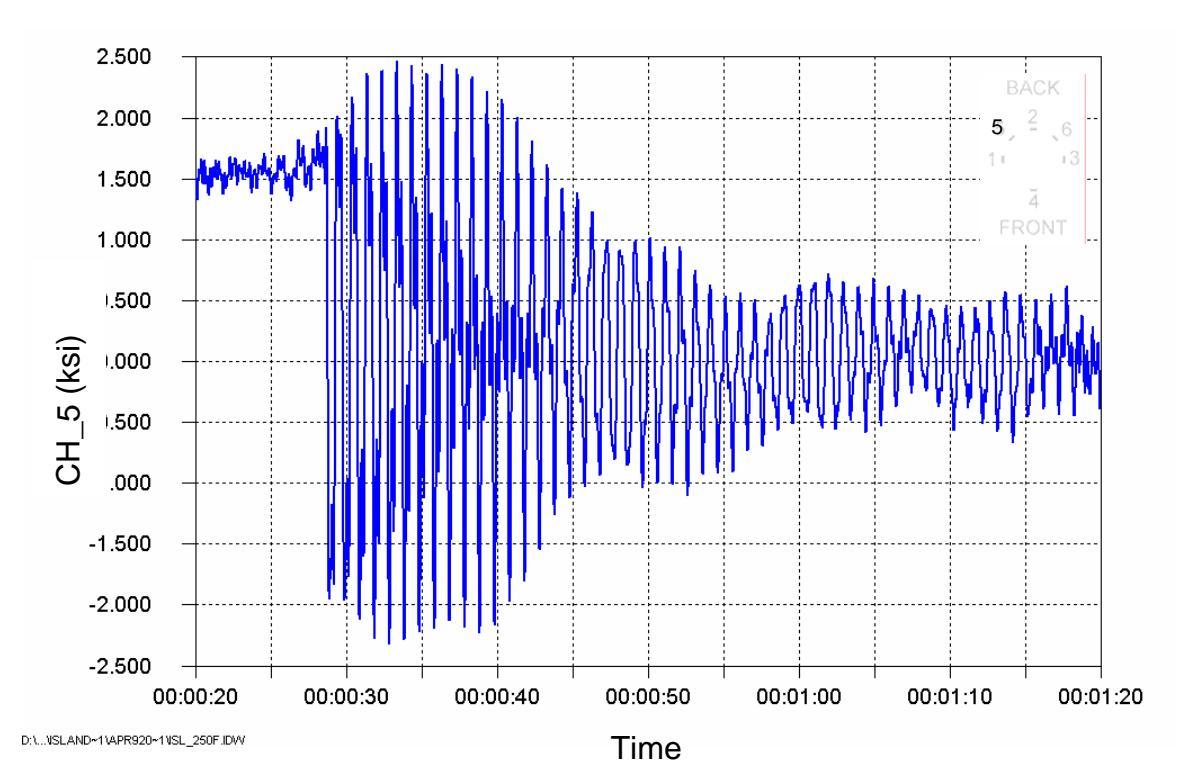
A typical stress time-history of CH\_5 during vertical free vibration of the pole is contained in Figure 5.8. The plot shows approximately 50 seconds of data after the load is released. It is interesting to note that unlike the Lindbergh site, the vibration appears to have several modes of vibration present in the strain data. Furthermore, the amplitude of the vibration attenuates more rapidly, which indicates a higher level of damping in this structure for the vertical mode of vibration.

Figure 5.8 - Stresses at strain gage CH\_5 as 100 lb vertical load is released from tip of mast-arm (Island and SR 291)

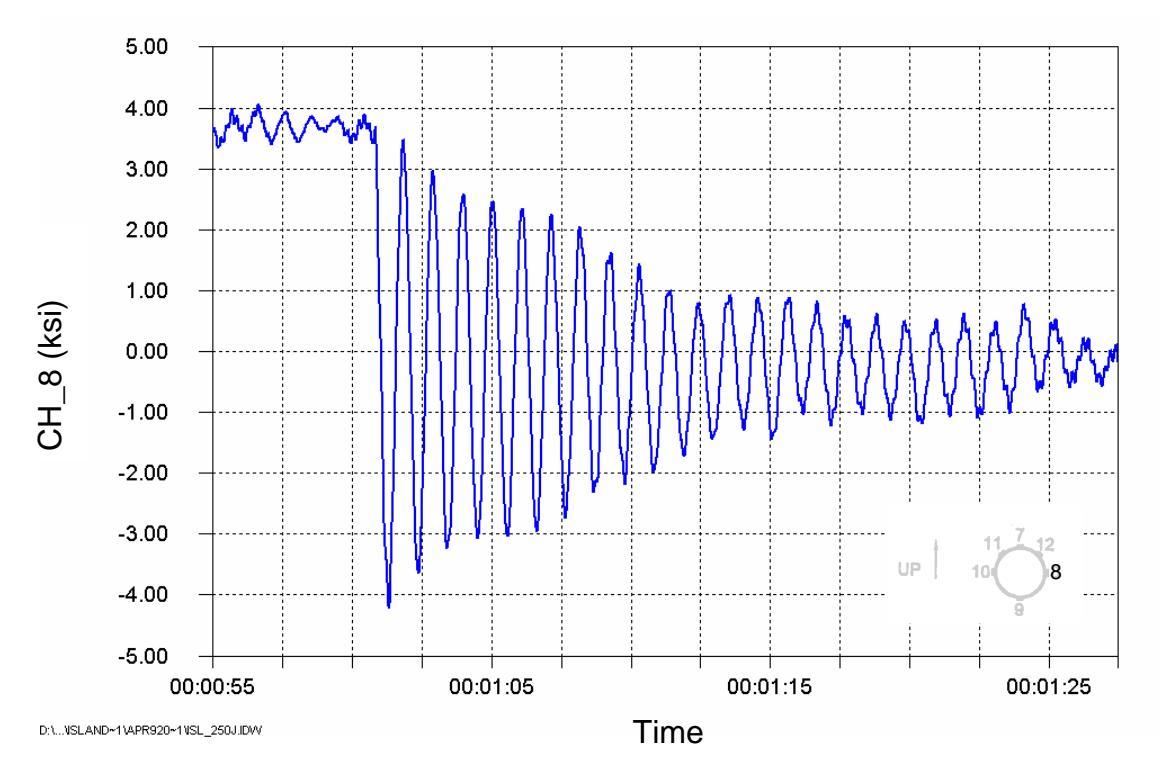
Figure 5.9 contains a similar stress time-history of strain gage CH\_8 during horizontal free vibration of the mast-arm. As shown, this plot contains about 30 seconds of free vibration response. The free vibration for this horizontal mode damps out more quickly than the vertical mode. Unlike the vertical vibration test, the horizontal response appears to be dominated by the first mode.

Figure 5.9 - Stresses at strain gage CH\_8 as horizontal load is released from tip of mast-arm (Island and SR 291)

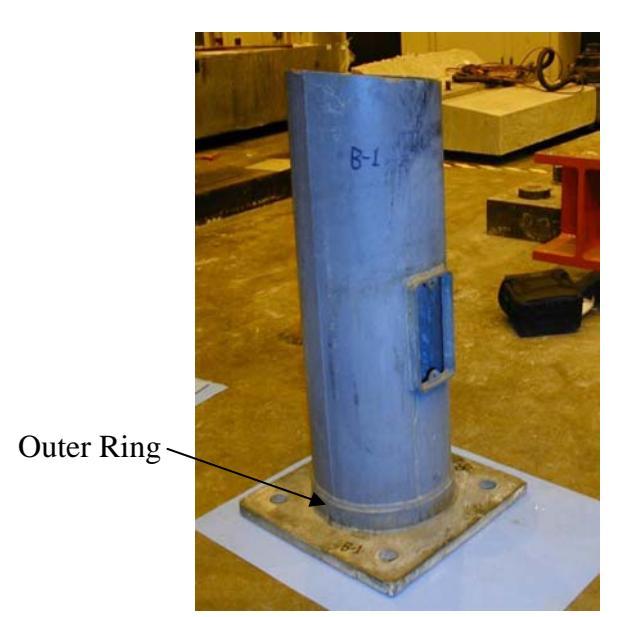
Figure 1. Baseplate Sample 1

A total of five base plate samples were received. These samples were labeled as samples B-1 through B-5 after arriving to the laboratory. These samples included the base plate to column connection and approximately 3 feet of column length, which included the hand access hole. The base plate dimensions of these 5 specimens ranged from a square 16 11/16" by 1 1/16" thick (sample B-1 seen in Figure 1), to 14" square

with a thickness of 3/4" (sample B-4). The hand access hole dimensions were typically 4" by 10", located tangent to the square base plate, approximately 12" above the base plate, as seen in Figures 1 and 2. One key feature of the base plate to column connection is the use of an outer ring to reduce the stress in the welded joints of the base plate to column connection (as seen in Figure 1).

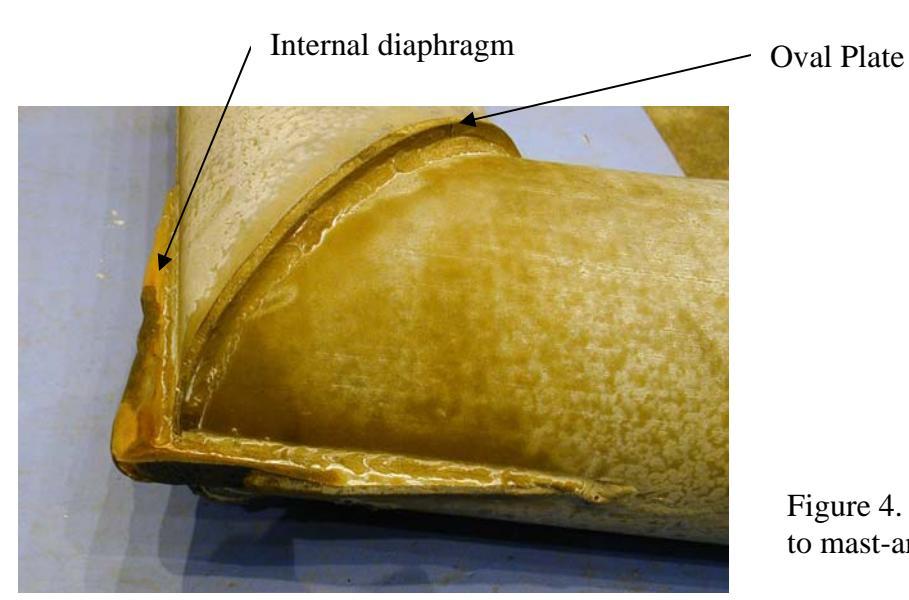
Figure 4. Corner style column to mast-arm connection detail.

Three corner or elbow style column-to-mast-arm connections were obtained. These specimens were labeled as C-6 through C-8. These connections are characterized by a complicated geometry consisting of approximately a 95° to 100° intersection of the pole and the mast-arm (Figure 3). The three dimensional geometry of these samples can be conceptualized by visualizing the column and mast-arm cut at 50° angles and joined together at an oval plate. Because both the mast-arm and column are made of thin steel tubes; this connection would be susceptible to buckling. In order to prevent this, an internal diaphragm is inserted to help transfer the vertical shear force from the mast-arm to the column and to prevent the joint from buckling.

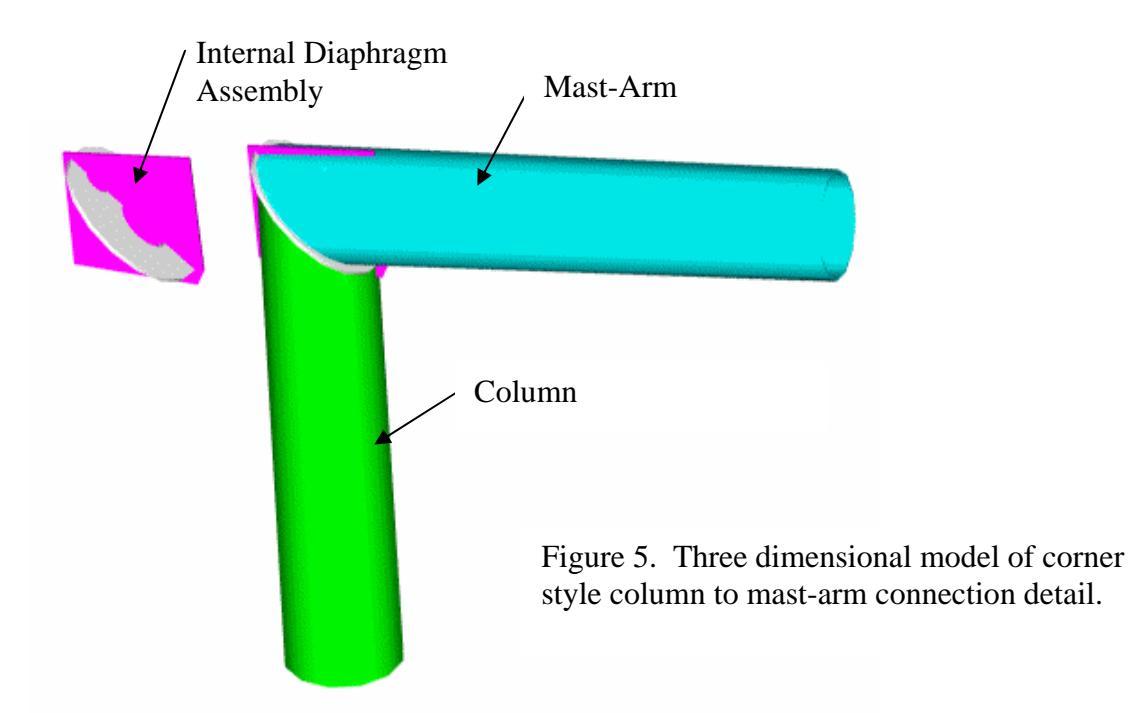
The first step in fabrication of a corner styled column to mast-arm connection is creating the internal diaphragm assembly. The internal diaphragm is constructed by bisecting an oval plate with a large central circular hole and a smaller diameter hole above and along the long direction of the oval (Approximate diameters 4" and 2" respectively as seen in Figure 5). These half ovals are then fillet welded to the "L" shaped diaphragm on each side completing the internal diaphragm. The column and mast-arm are then cut at 50° angles and slotted to allow for the portion of the internal diaphragm that will stick out. The final step is to fillet weld the column and mast-arm to both the internal diaphragm and the oval plate plate. Figure 4 is a photograph of these external fillet welds. Figure 5 is a graphic model illustrating the internal diaphragm assembly.

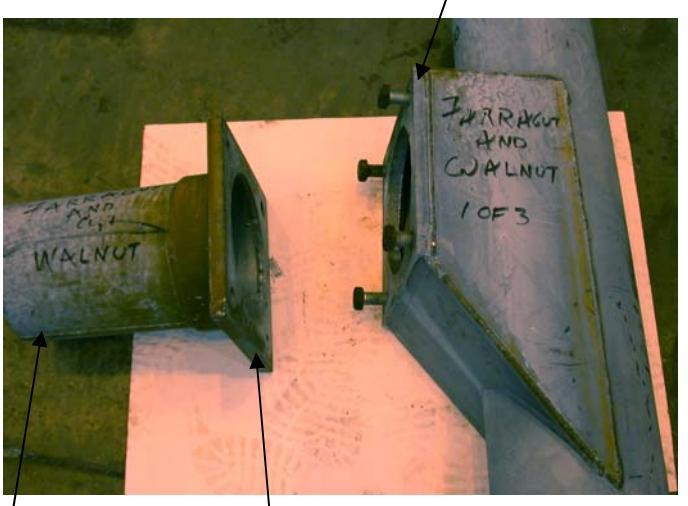
Figure 6. Bolted Flange plate style column to mast-arm connection.

One complete bolted endplate style column to mast-arm connection was obtained (See Figure 6). The endplate portion of the connection consisting of the mast-arm side of the mast-arm to column connection was labeled as specimen E-9. The large built-up box fixture, which the endplate is bolted onto, was labeled as E-10 (See Figure 6).

The built-up box is constructed of a <sup>3</sup>/<sub>4</sub>" steel plate or flange plate as shown in Figure 6. The rest of the flange box is constructed with 3/8" thick steel plates. The builtup box, which is slightly wider than the diameter of the column, is cut out to conform to the circular column. This difference in widths creates a very long vertical weld of questionable quality, as well as complicated non-perpendicular box geometry. The entire perimeter of the intersection of the column and the flange box is fillet welded as shown in Figure 6.

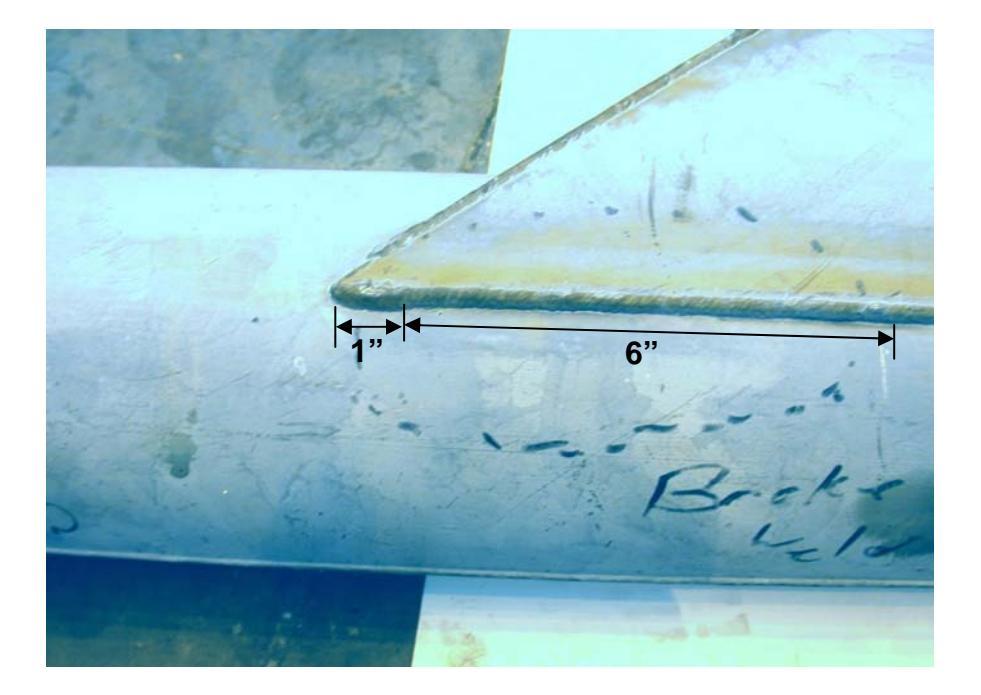
Figure 10 – Photograph of upper mast-arm connection

Specimen E-10, (the built-up box specimen) was the only specimen to have any type of visible surface weld defect. Figure 10 shows the location and length of the visible surface crack in the vertical fillet weld joining the built up box to the column. The crack was measured to be approximately six inches long originating one inch from the bottom of the vertical fillet weld.

As discussed earlier, the built-up box weld detail is difficult and awkward to fabricate. The difficulty is primarily due to the complex geometry of the assembly. The complex geometry is caused by the flange plate being approximately one inch wider than the diameter of column. The top and bottom plates of the built up box must be cut to form fit to the column. The sides of the built-up box must be fabricated as to form fit to the column also. During the fabrication of the built up box, tolerances introduced by the manual and custom-built nature of the fabrication vary. As result, there will likely be some small gaps as the built-up box will not fit perfectly to the column. The built up box is fillet welded along the entire perimeter of the built-up box, as shown in Figure 10. The two long vertical fillet welds possess a significant amount of residual stress. As the weld metal of these two vertical fillet welds cools, the weld metal is restricted from contracting due to its bond to the column. This restricted contraction of the weld metal induces the residual stress in the weld. High residual stresses as well as a poor bond between the weld metal and the column surface are the probable contributors to the crack.

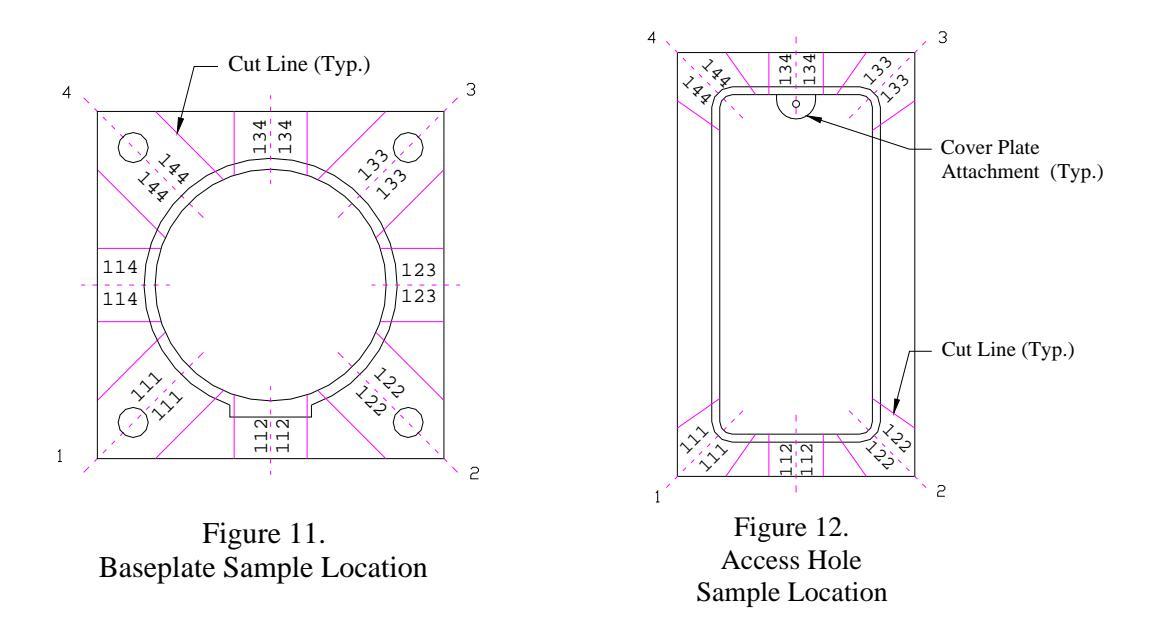
In each baseplate to column connection specimen, eight sections were made as shown in Figure 11. Specifically one cut was made through each corner and through the midpoint of each side, creating a total of 16 samples per baseplate. Because of the unknown orientation of the baseplate, sections were made in both the tensile and compression sides of the specimen. The baseplate samples were numbered using the number system also shown in Figure 11, where side 1 2 marks the tension side of the column and also the hand access hole. Baseplate specimens B-1 through B-4 were also sampled and prepared in this manner. Sampling of specimen B-5, which was significantly damaged in a car accident, was limited to the welded joints which were still intact.

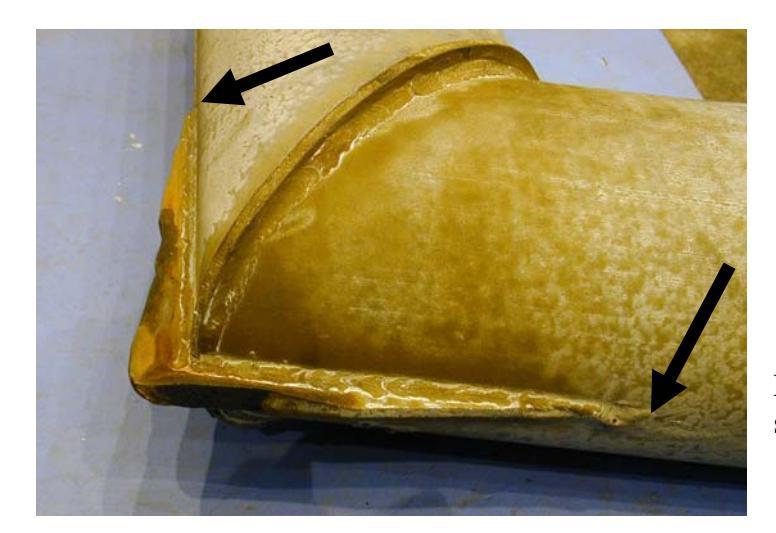
Figure 13. Section location of corner style column to mast-arm connection.

The exact location of maximum tensile stress of the complex corner style column to mast-arm connection is difficult to determine without detailed finite element analysis. As discussed earlier, the fabrication of these connections entails fillet welding both the perimeters of the slotted mast-arm and column to the oval plate and protruding internal diaphragm (Figure 4 and 5). According to simple beam theory, the portion of the fillet weld above the neutral axis will be subjected to tensile stress. The section of this weld identified to be most susceptible to fatigue crack growth was the weld between the mast-arm (as well as the column on the tension side) and the edge of the protruding internal diaphragm, marked in the photo in Figure 13.

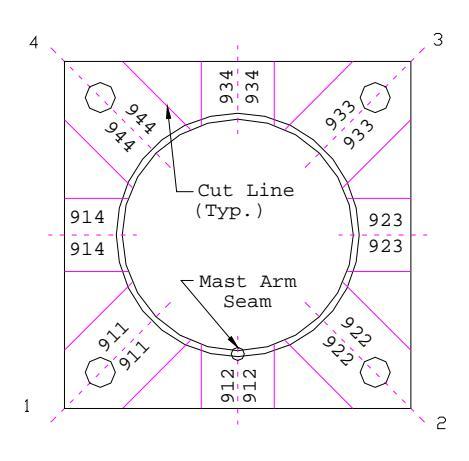
Figure 16. Endplate Sample Locations

Due to its similarity, the endplate specimen component of the endplate style column to mast-arm connection was sampled with the same exact procedure used in the baseplate specimens. The only difference was that the tension side of the endplate specimen did not have a hand access hole. The seam which identifies the bottom and hence the compression side of the mast-arm, was located on side 12, as seen in Figure 16. The endplate sections and sample numbering convention are shown in Figure 16 below also. Specimen E-9, the only endplate specimen obtained, was sampled according to this convention.

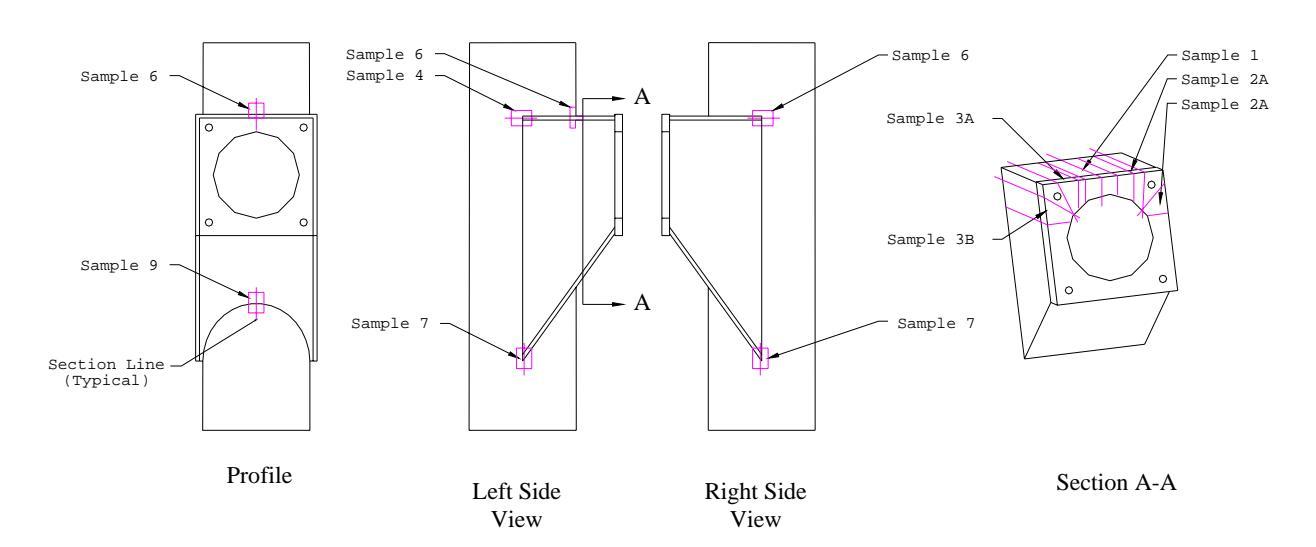
Figure 17. Sample locations of Built-up Box Specimen

The built-up box specimen, specimen E-10, was sampled as indicated in Figure 17. The welded joints of the built-up box specimen can be divided into two groups, the welded joint between the flange plate, and the built-up box (samples 1, 2A, 2B, 3A, and 3B), the welded joint between the column and the built up box (samples 4-9) Samples 2A and 2B (as well as 3A and 3B) are two different one-sided samples. Sections were oriented consistent with the locations of maximum stress in the flange plate to built-up box connection. Hence, based on field measurements, sections were also located in line with the endplate bolts. But instead of taking samples of the weld at the corner of the flange plate, samples were taken just off the corner through the top of the built up box (samples 2A and 3A) and through the side of the built up box (samples 2B and 3B). The justification behind samples 4,5,7, and 8 again was that the maximum stress acts radially in line with the endplate bolts. Samples 7 and 8 are also areas in which previously

documented fatigue investigations of cantilevered signal support structures have reported weld defects, which were suspected causes of failure. (Reference C)

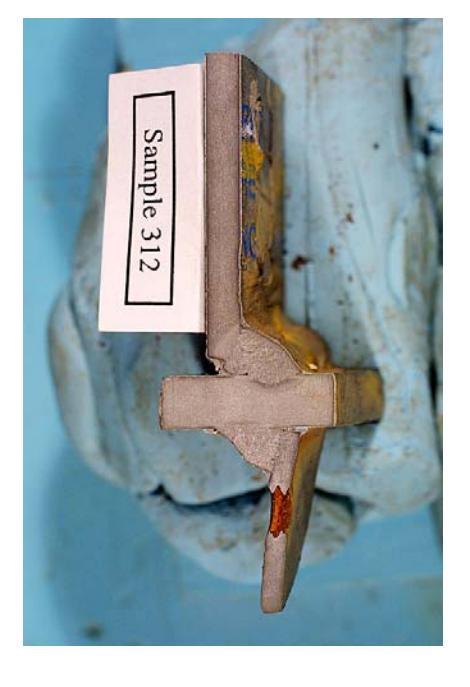
Figure 19. Hand Access Hole Sample.

The hand access hole weld details showed no signs of fatigue cracking, and good fillet weld quality. Figure 18 shows a typical cross section through the hand access hole weld. Figure 19 is a photograph showing the relative high weld quality of the hand access hole weld. Note that the bottom portion shown in figure 19, is the cover plate attachment as shown in Figure 12.

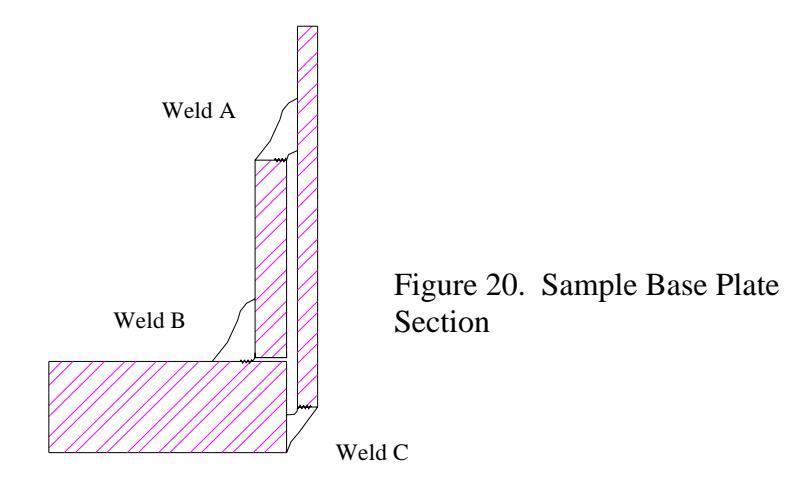
The primary weld defects encountered in the base plate and end plate weld details were as fabricated incomplete fusion and inadequate joint penetration. A typical baseplate section is shown in Figure 20, indicating the three fillet welds, Weld A, Weld B, and Weld C, which make up the baseplate to column connection. (Note that Figure 20 applies equally to the typical end plate section.) The similarity between the end plate and base plate samples is illustrated in Figures 21 and 22.
