Williamsburg Bridge Replacement Orthotropic Deck As-Built Fatigue Test

ATLSS Report No. 98-04

Interim Report on Phase II for Federal Highway Administration U.S. Dept. of Transportation, New York Dept. of Transportation and New York City Dept. of Transportation

May 1998

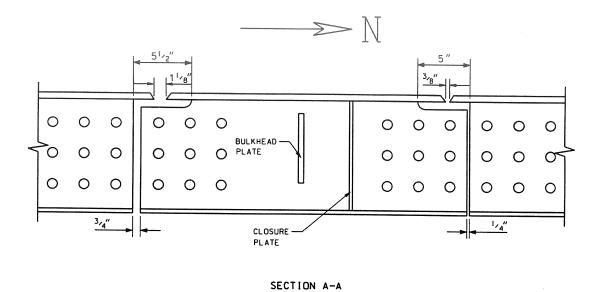
Figure 2.2 View of Trapezoidal Rib Wall Showing Deck Root Openings

length on the unsupported deck section over the rib cutouts for the backing bar, different root openings were used in the two splices between the new deck section and the existing deck sections. As shown in Figure 2.2, these two welds had root openings of 9.5 mm (0.375 in.) and 28.5 mm (1.125 in.), which were the minimum and maximum root openings allowed in the actual replacement deck.

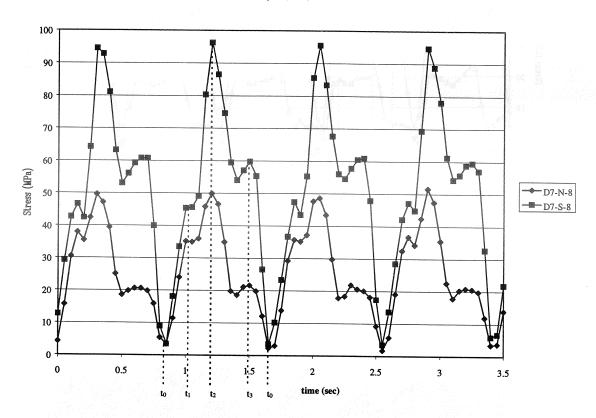
Figure 4.1 Tension Stress-Time History on Diaphragm Plate Adjacent to Rib 7

Dynamic Stress Cycle (MPa) at D7-N-8 and D7-S-8

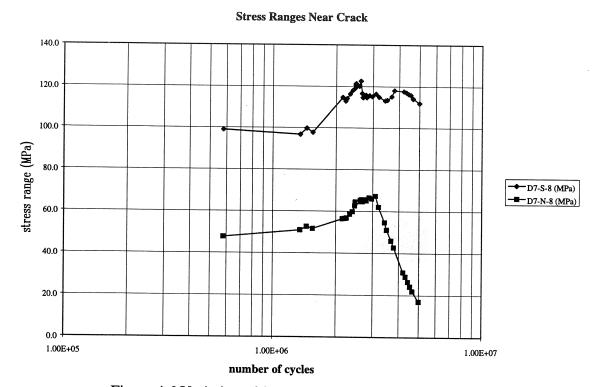
Figure 4.6 Variation of Stress Ranges Near Crack Location

4.4 Diaphragm Crack Near East Side of Rib 7

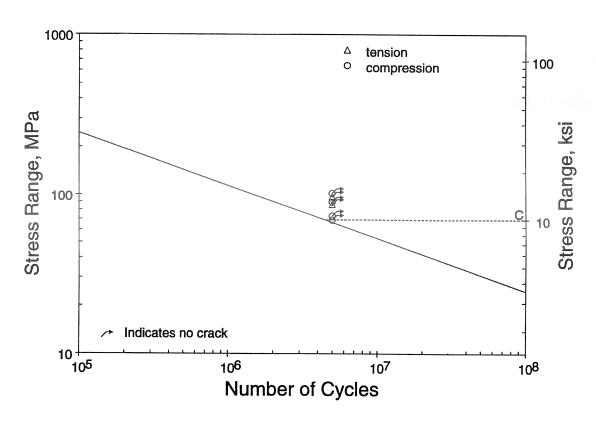
Figure 4.11 S-N Curve for Option A Rib to Diaphragm Weld

During the first five million cycles of the fatigue test, actuators will apply a carefully timed sequence of loads to produce dynamic effects equivalent to those applied in Phase I. No fatigue cracks are expected to develop under this loading condition. However, the magnitude of the loads will be increased during the final three million cycles of the fatigue test in such a manner that they correspond to roughly twice the AASHTO LRFD extreme life check. By doing so, the actual fatigue resistance of the Option "A" rib/diaphragm weld detail will be quantified.
