**RESISTANCE OF WELDED
DETAILS UNDER VARIABLE AMPLITUDE
LONG LIFE FATIGUE LOADING**

ATLSS Report No. 92 - 04

Final Report

Prepared for
National Cooperative Highway Research Program
Transportation Research Board
National Research Council

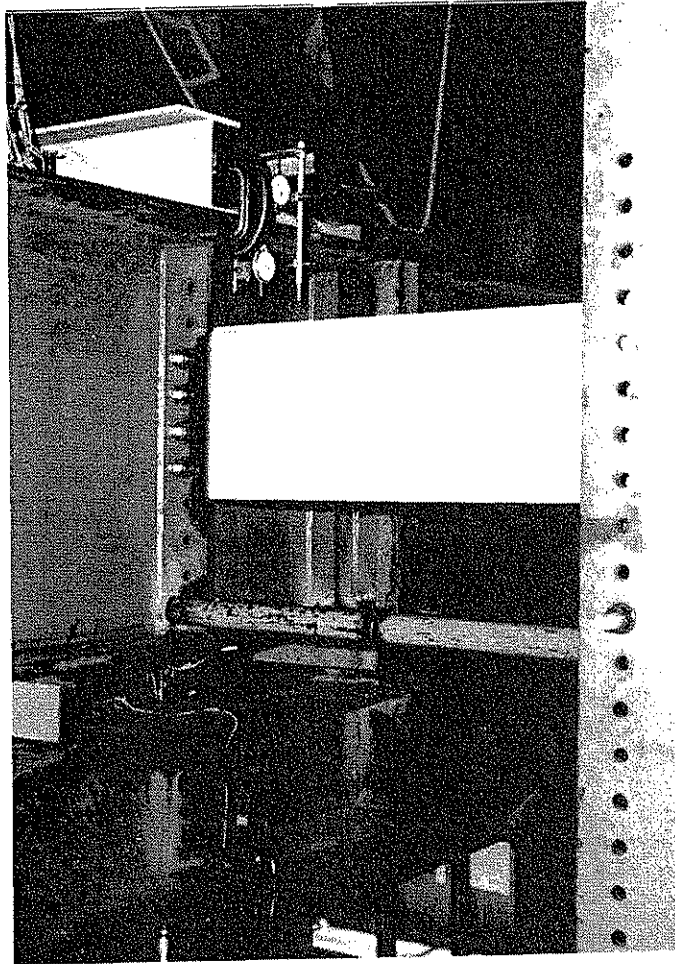
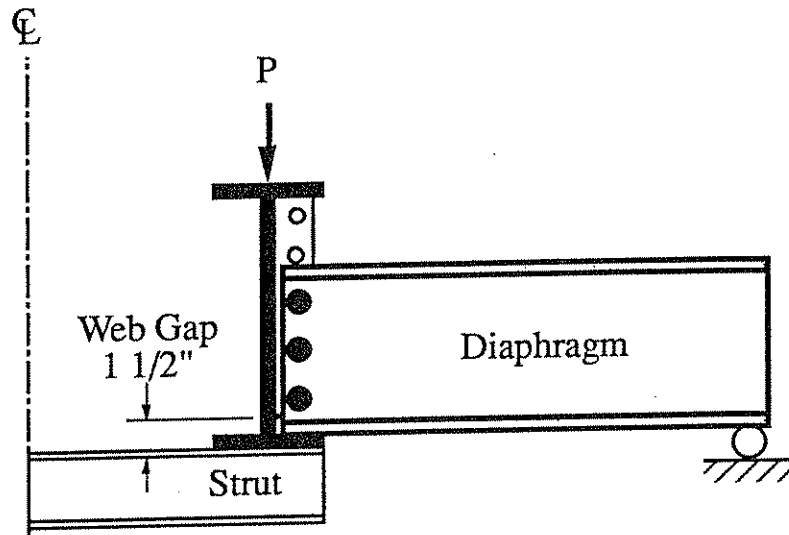
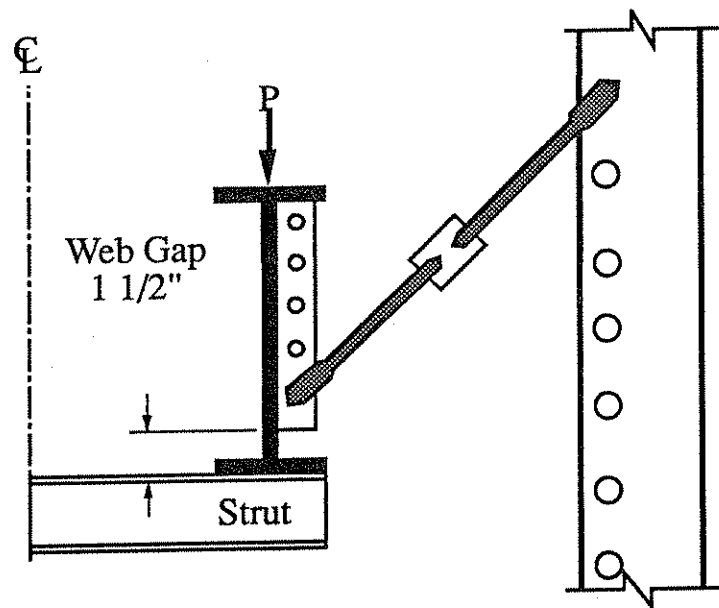
Figures 6 and 7 show the test girder and diaphragm at midspan. The connection plate was cut short of the tension flange by 1-1/2 in. for Girder Pair 1. A diaphragm consisting of W14X22 rolled section was bolted to the connection plate with its free end supported against vertical motion at the test frame column. This configuration is shown schematically in Figure 7. The bottom flange of the test girder is restrained against rotation by means of a rolled section strut, simulating a flange embedded in a concrete deck or at a support. The in-plane vertical deflection of the girder from the applied loads causes the connection plate to be forced out-of-plane by the resisting moment developed at the diaphragm connection.

Fig. 6: Diaphragm for distortion induced tests.

Test Setup for Distortion in Girder Pair 1

Test Setup for Distortion in Girder Pair 2

Fig. 7: Test Setup for Distortion Induced Web Gap Cracking for Girder Pairs 1 and 2

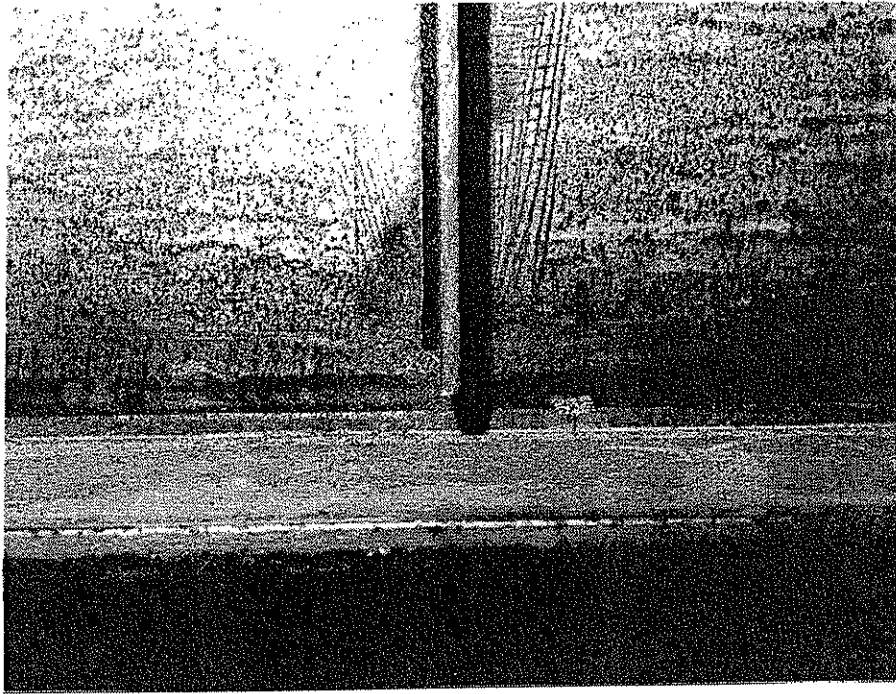
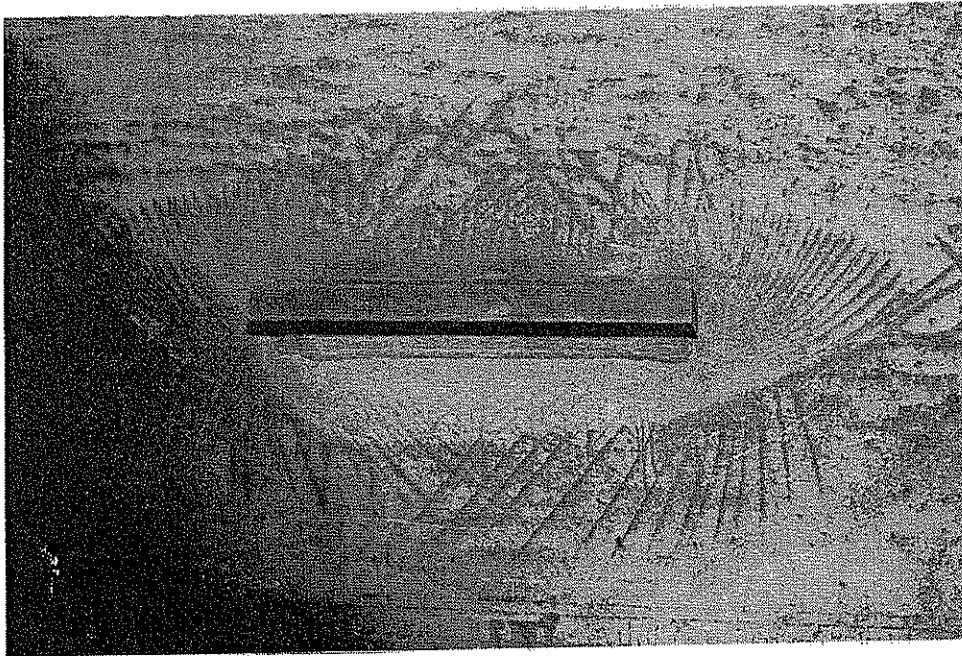
(a) Stiffener detail showing yield lines after welding.

(b) Web gusset detail showing yield lines after welding.

Fig. 10: Yield lines in mill scale adjacent to welded details confirm existence of residual stresses.

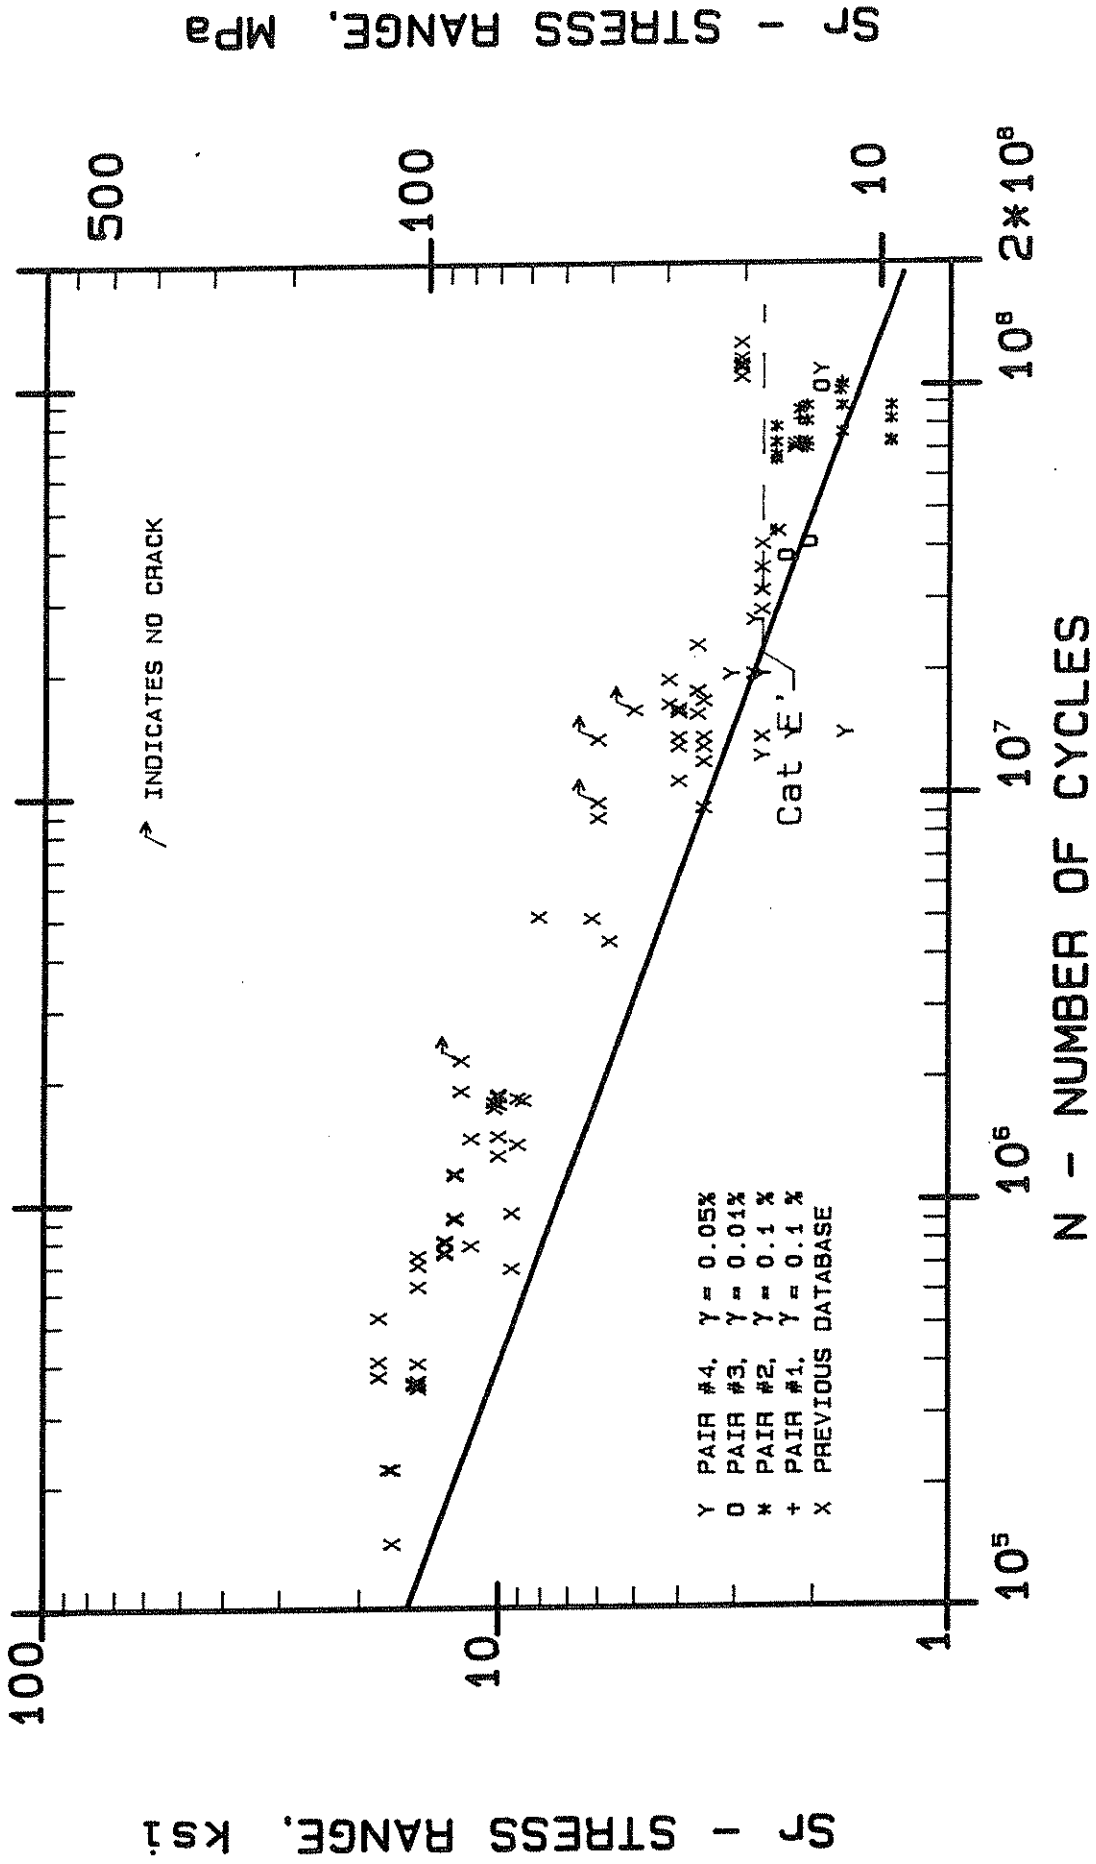
WEB ATTACHMENT DATA, FIRST CRACKING

Fig. 17: Comparison of web attachment test data at first detected cracking with category E' fatigue resistance curve.

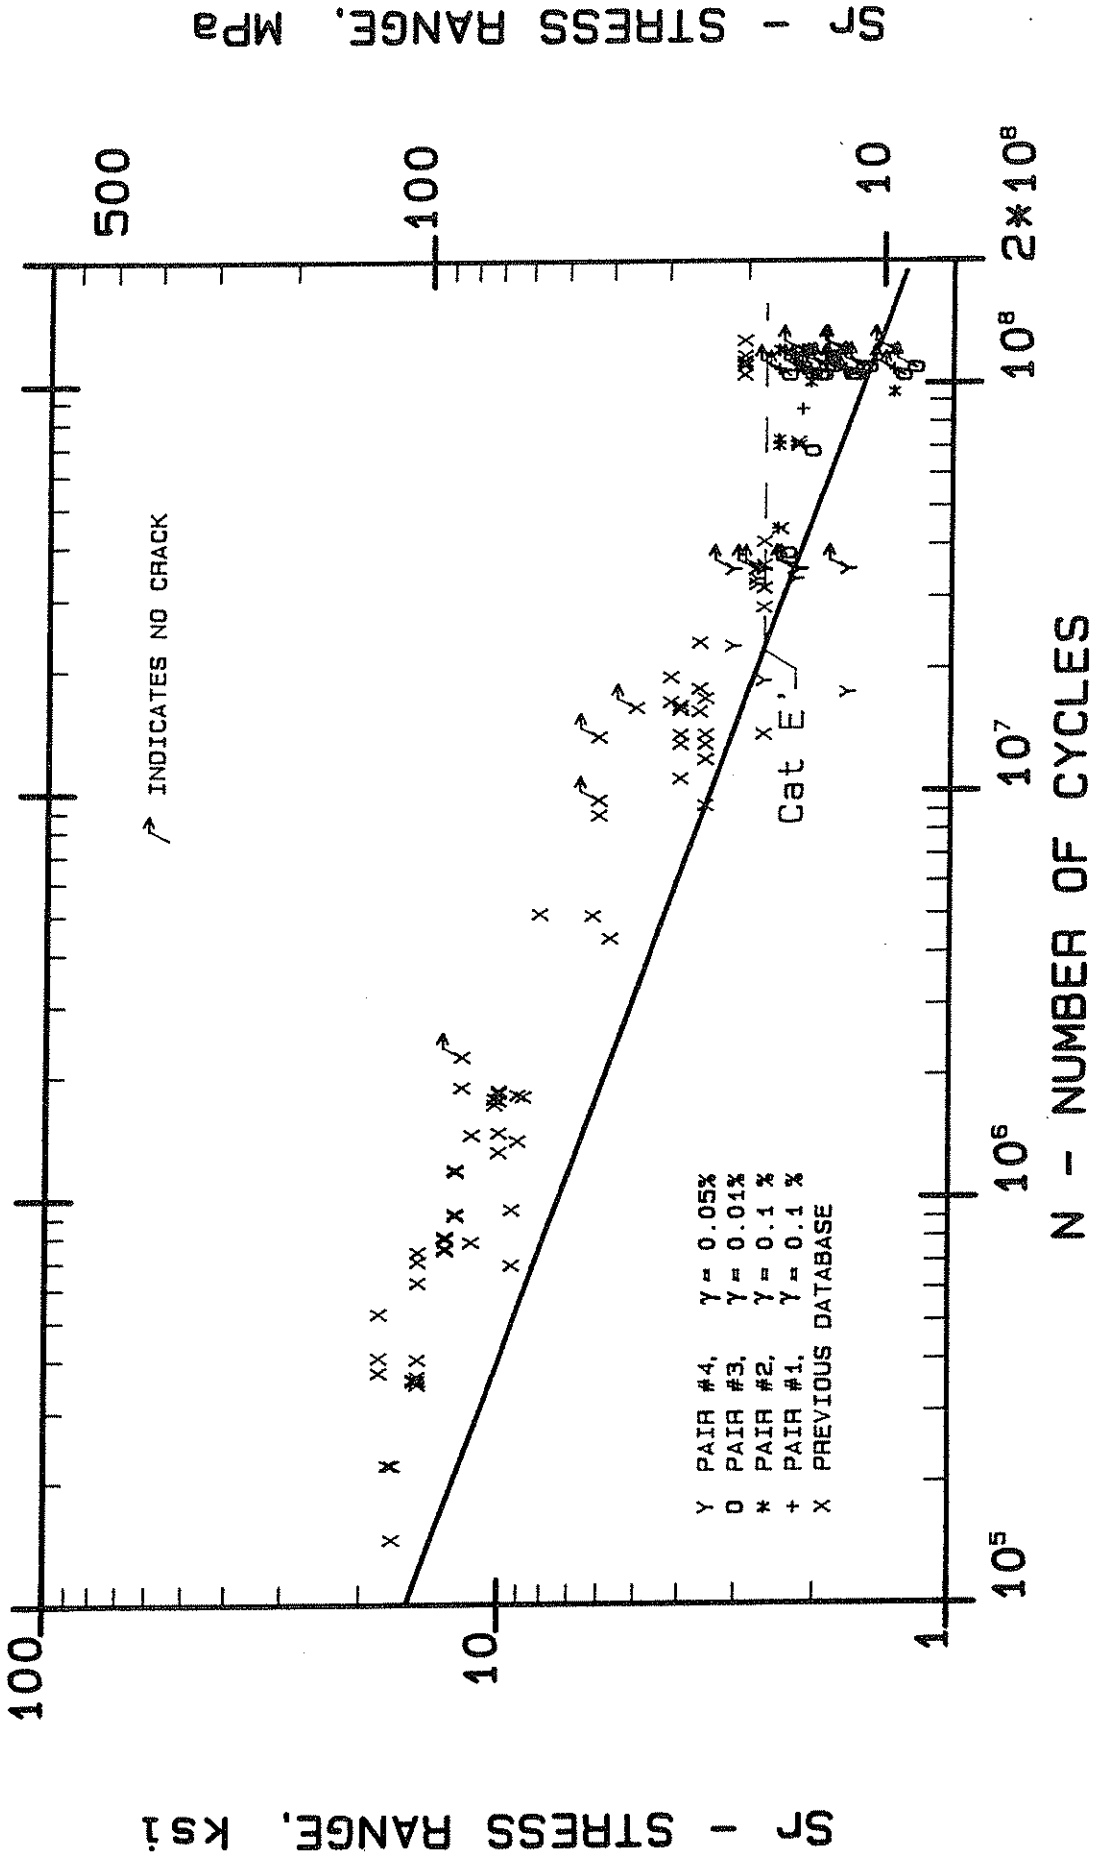
WEB ATTACHMENT DATA, FINAL CRACKING

Fig. 18: Comparison of the web attachment test data at failure or test termination with category E' fatigue resistance curve.

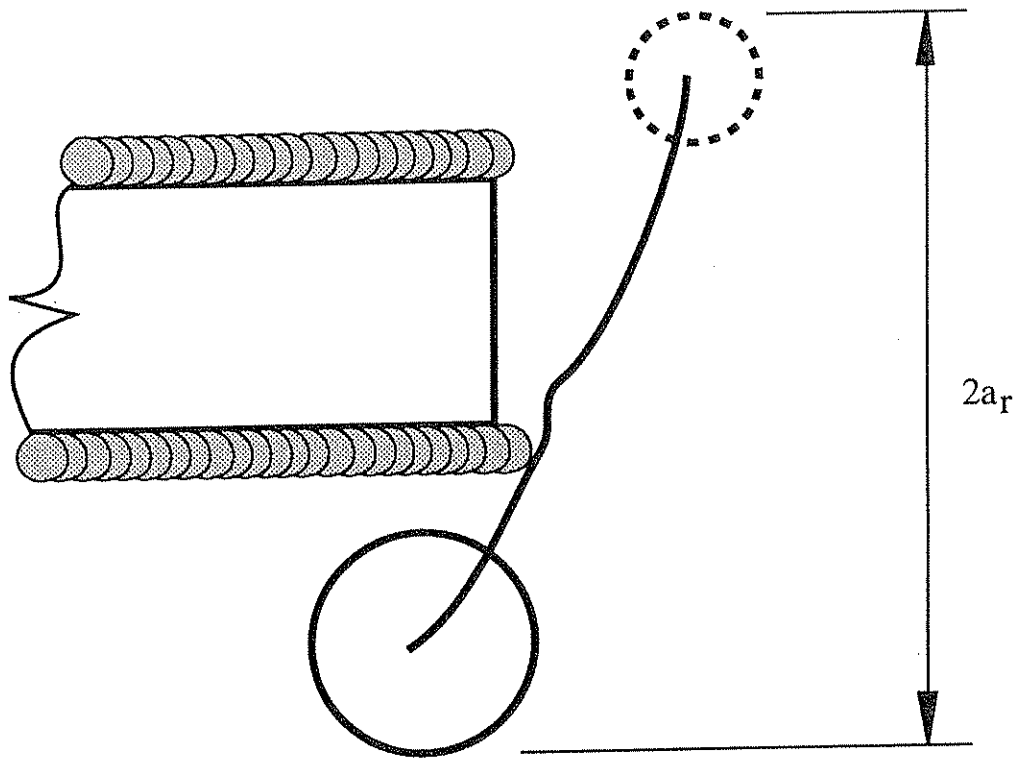
Fig. 21: Schematic showing retrofit holes and effective crack length.

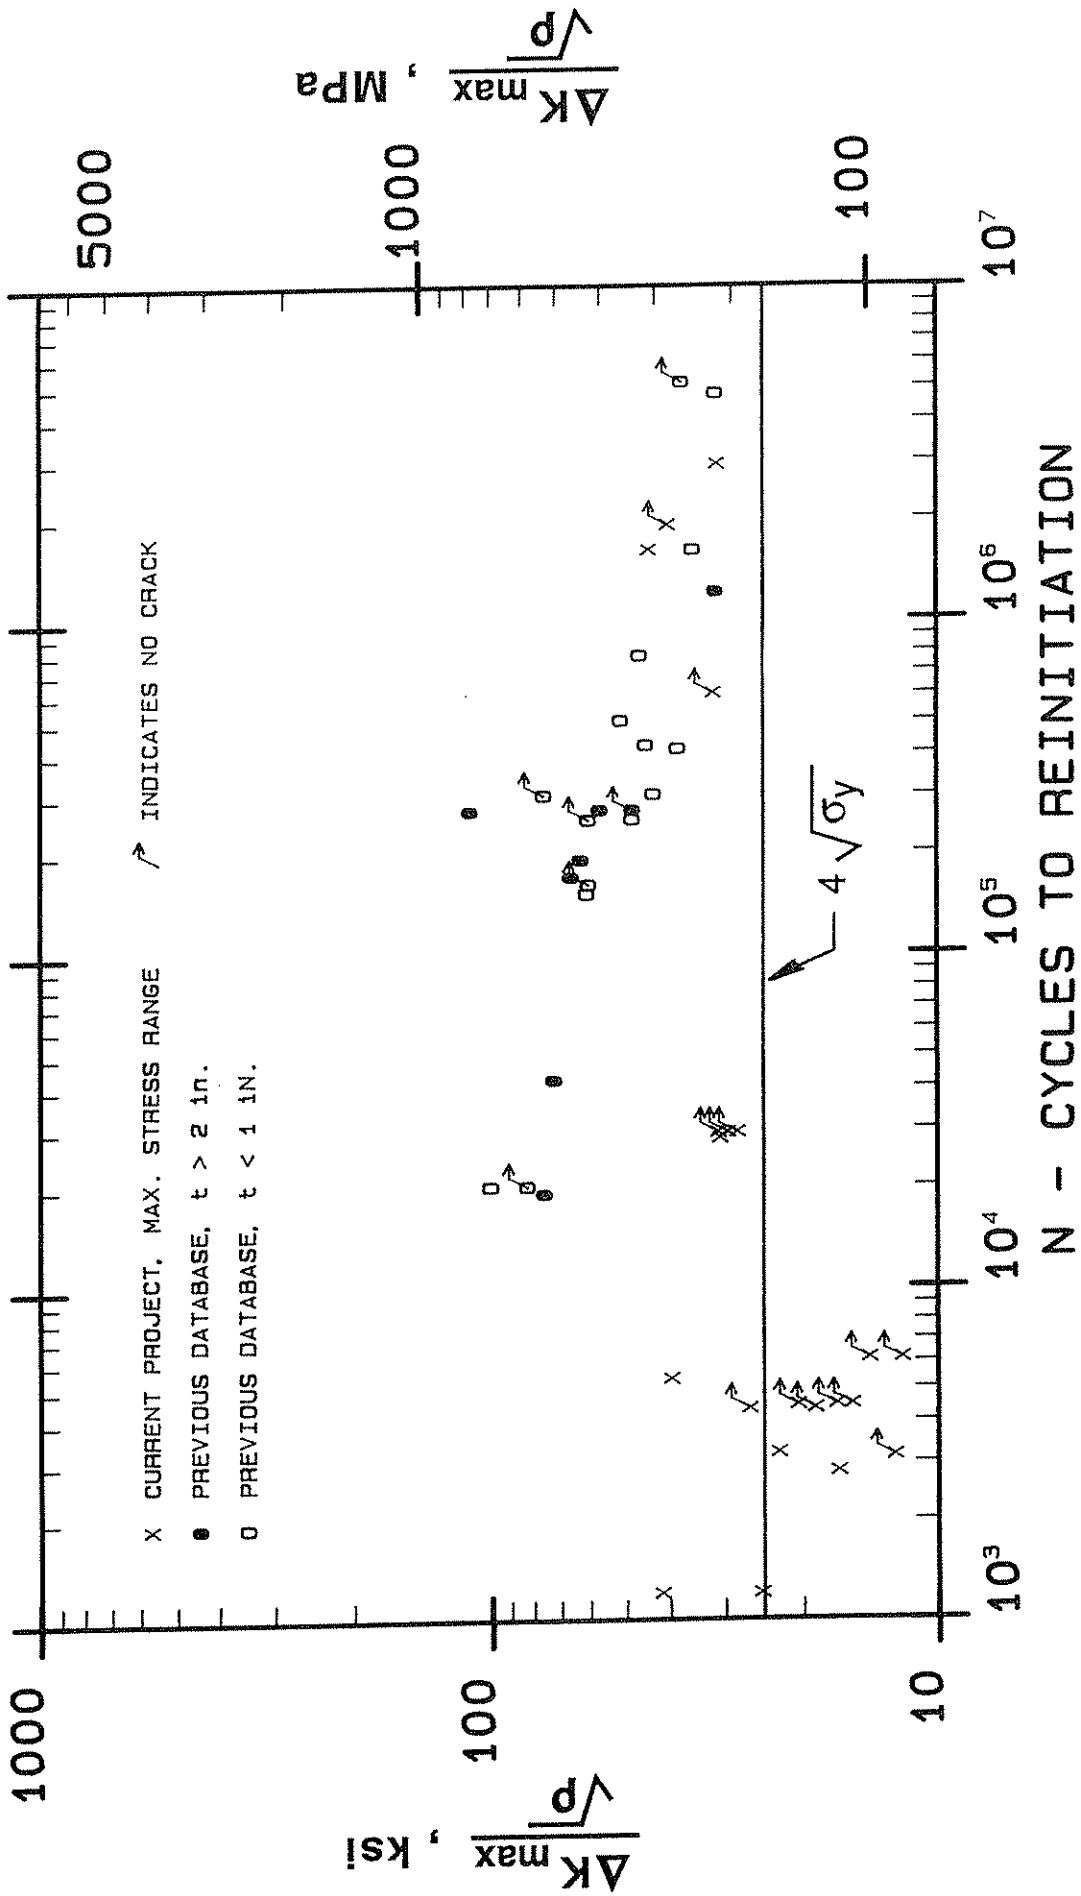
RETROFIT EFFICIENCY

Fig. 23: Retrofitted web attachments correlated on the basis of the maximum stress intensity range.

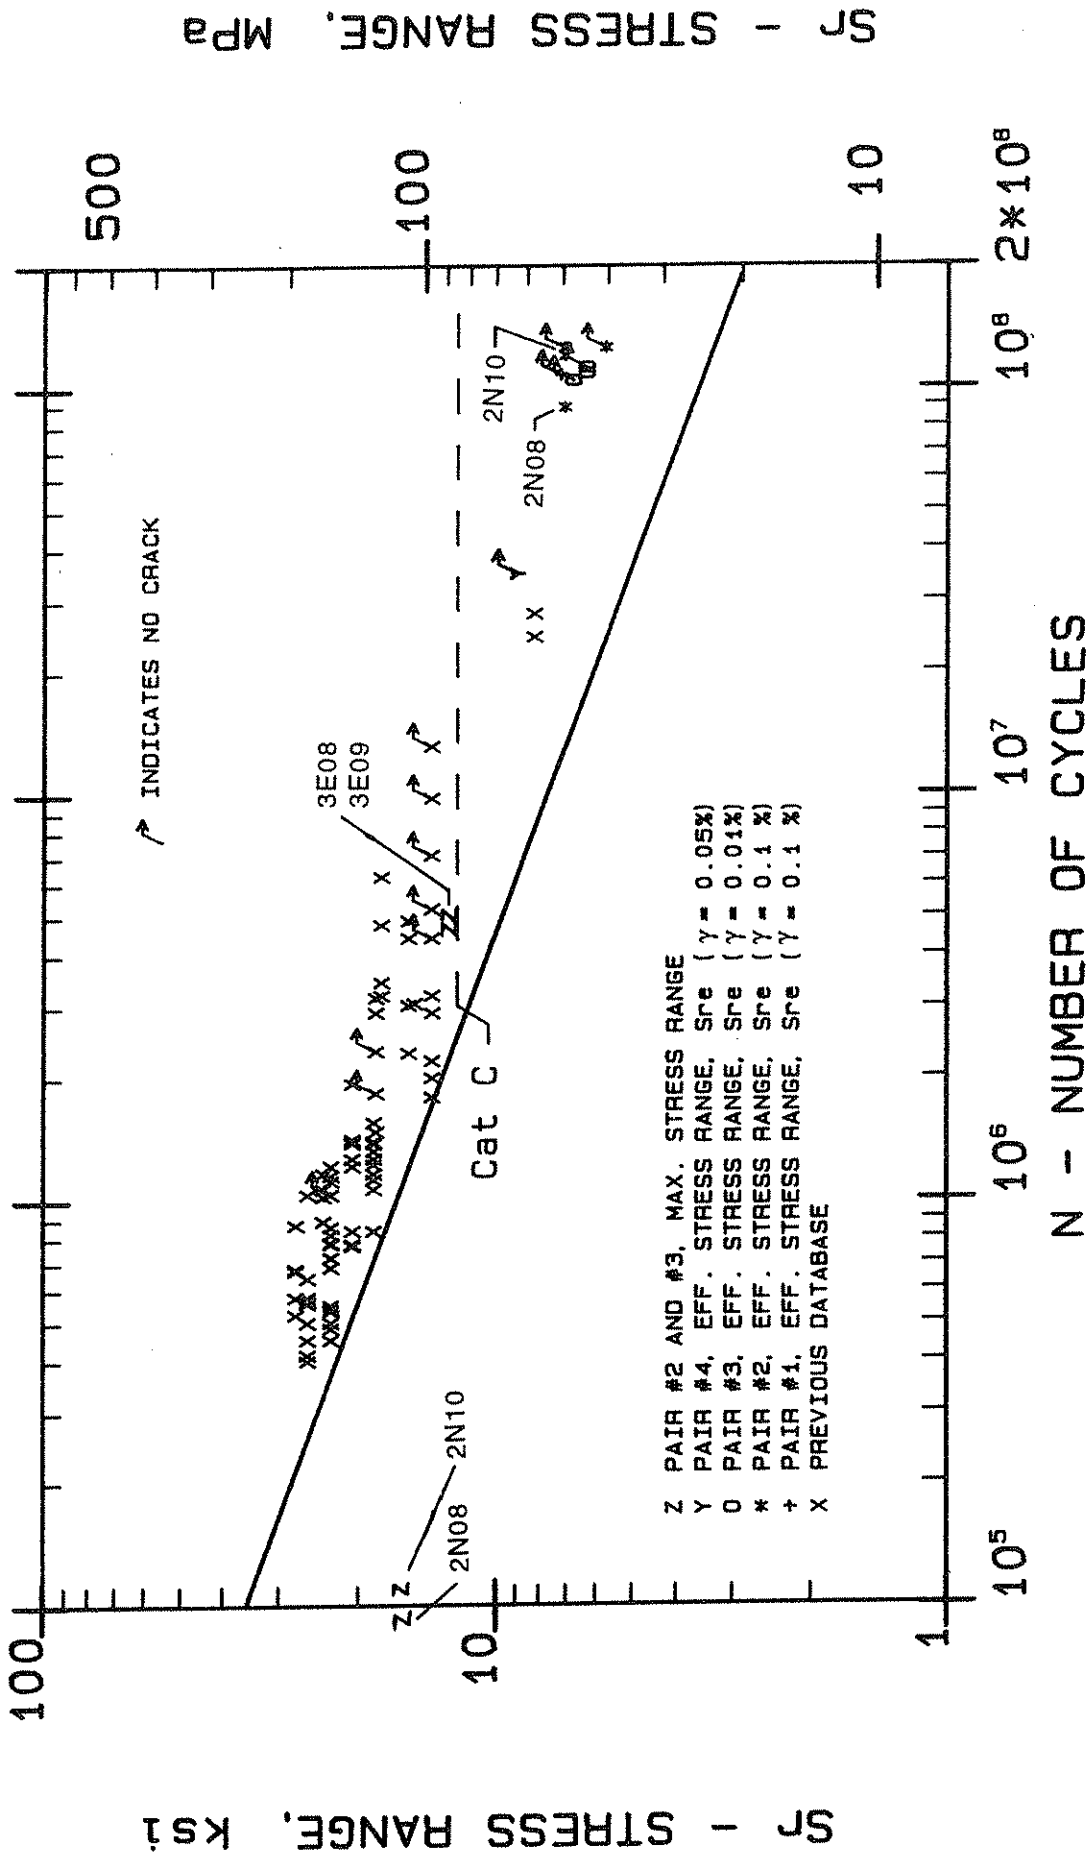
STIFFENER DATA

The stiffener details were only subjected to the overload stress cycle under the maximum load in the variable spectrum (See Figs. 2, 3 and 4). Four of the stiffeners on Beams 2N and 3E developed fatigue cracks during the test. In the case of Beam 3E, 5,000,000 constant load cycles at the maximum load level were added after the two girders were subjected to 104 million variable load cycles.

The test results are summarized in Figure 28. The test data for the four details which developed cracks are plotted two ways. The data are plotted as "z" symbol considering only the maximum stress cycle in the variable spectrum. For details 3E08 and 3E09, the test result is in good agreement with the constant cycle data. However, for details 2N08 and 2N10, there is no correlation with the constant cycle test data. All stress cycles in the variable load spectrum when plotted at the effective stress range are in reasonable agreement with the extension of the fatigue resistance curve for Category C. The test data for all test points below the assumed constant cycle stress range of 12 ksi (84 MPa), are all well beyond the lower bound fatigue resistance curve.

Fig. 28: Comparison of test data with fatigue resistance curve for category C.

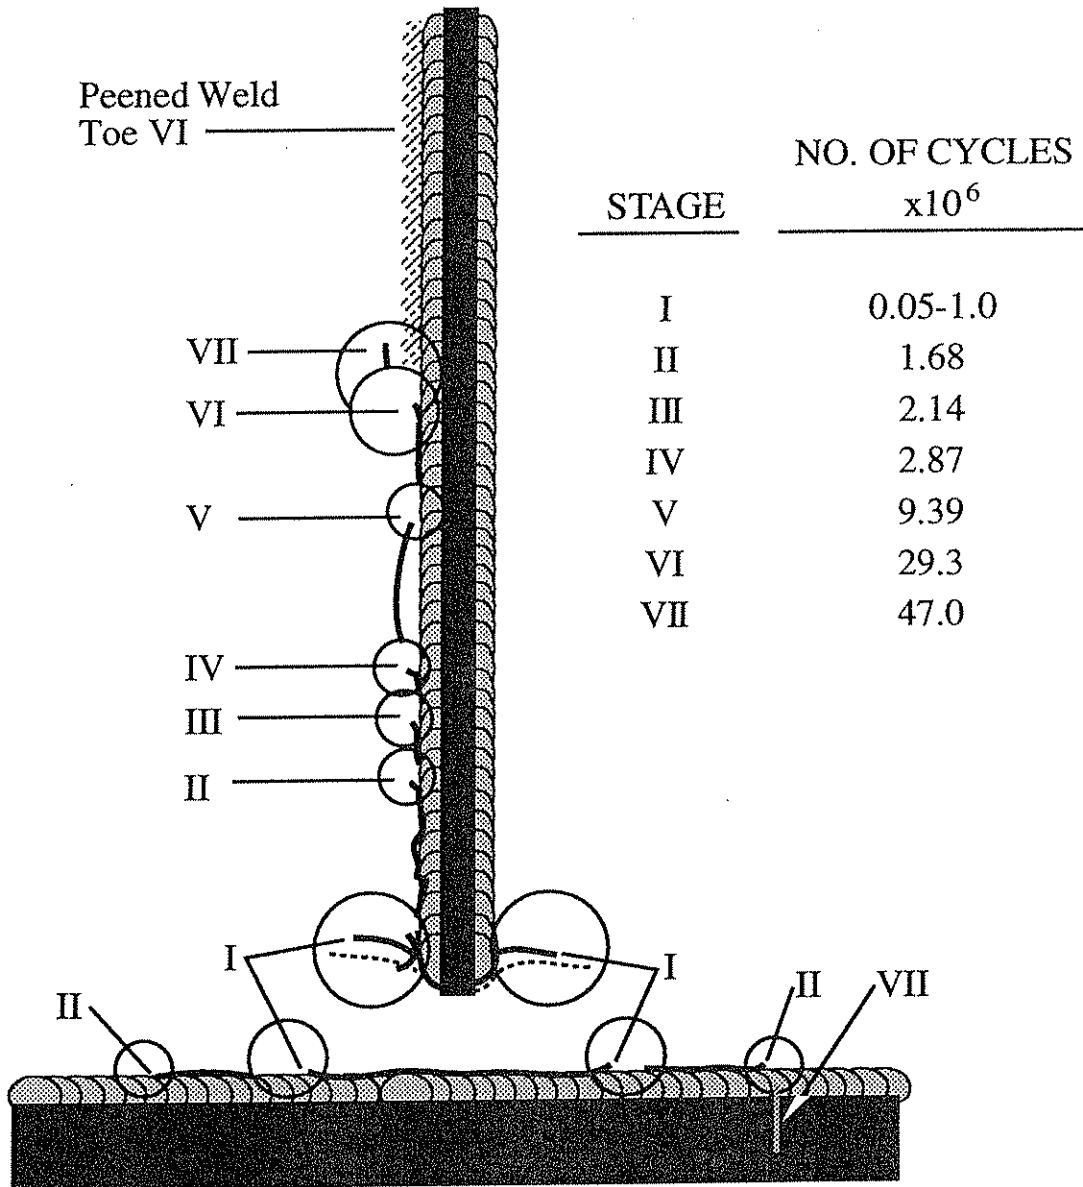
Fig. 31: Schematic history of web gap fatigue cracking.

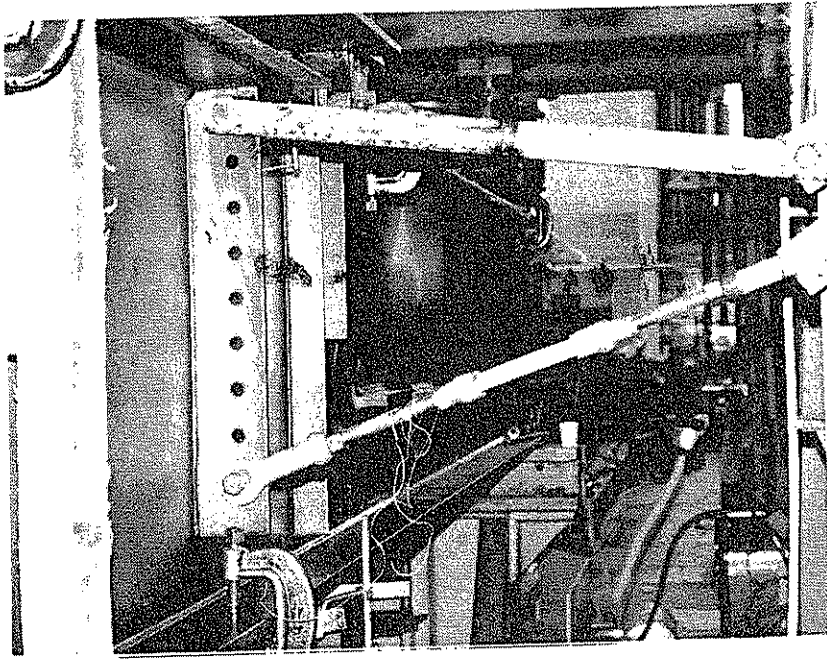
Out-of-plane distortion on the second pair of girders was not introduced until after 100 million variable load cycles. At that time distortion was introduced with a softer more controllable system, as illustrated in Figure 32. The web gap in Girder Pair 2 was increased to 4-1/2 in. (100 mm).

Fig. 32: Web gap distortion for girder pair 2.

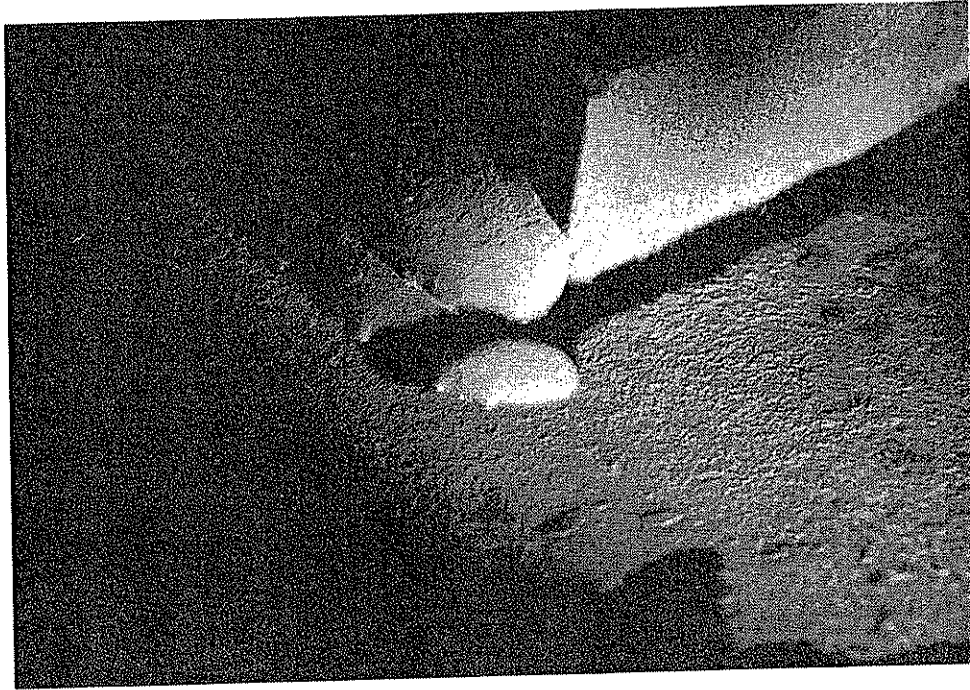
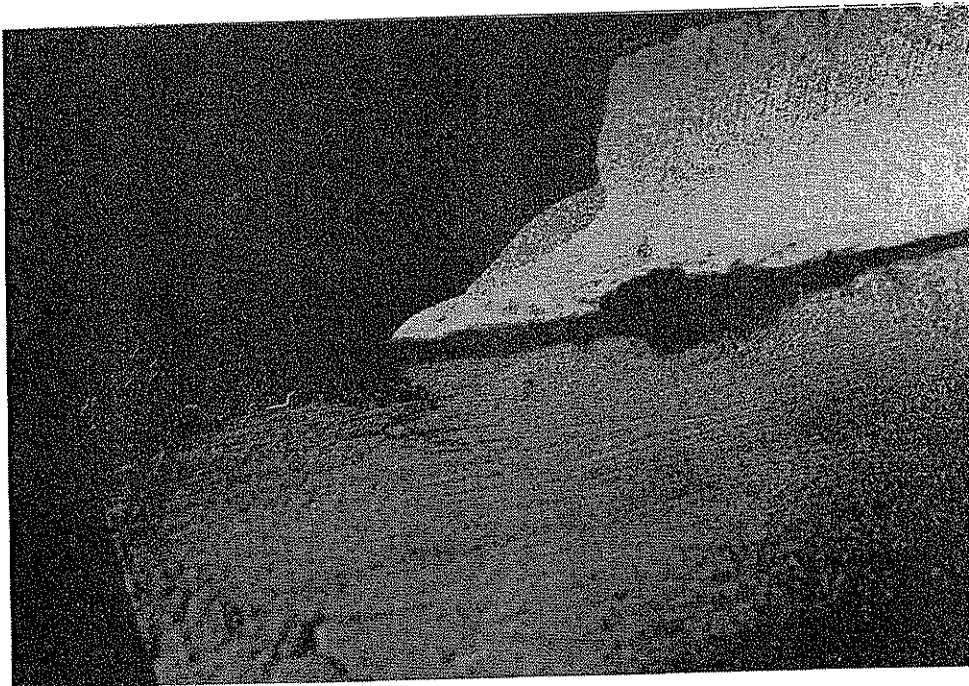
It was also noted that several of the cover plate details with no end welds had one or both longitudinal weld ends ground. Figure 34 compares the two types of weld ends. The ground end welds did not prevent cracks from developing at the weld termination. It did appear to slightly increase the fatigue life.

(a) As-welded coverplate weld termination at detail 4E17.

(b) Ground coverplate weld termination at detail 4W17.

Fig. 34: Typical coverplate weld terminations.

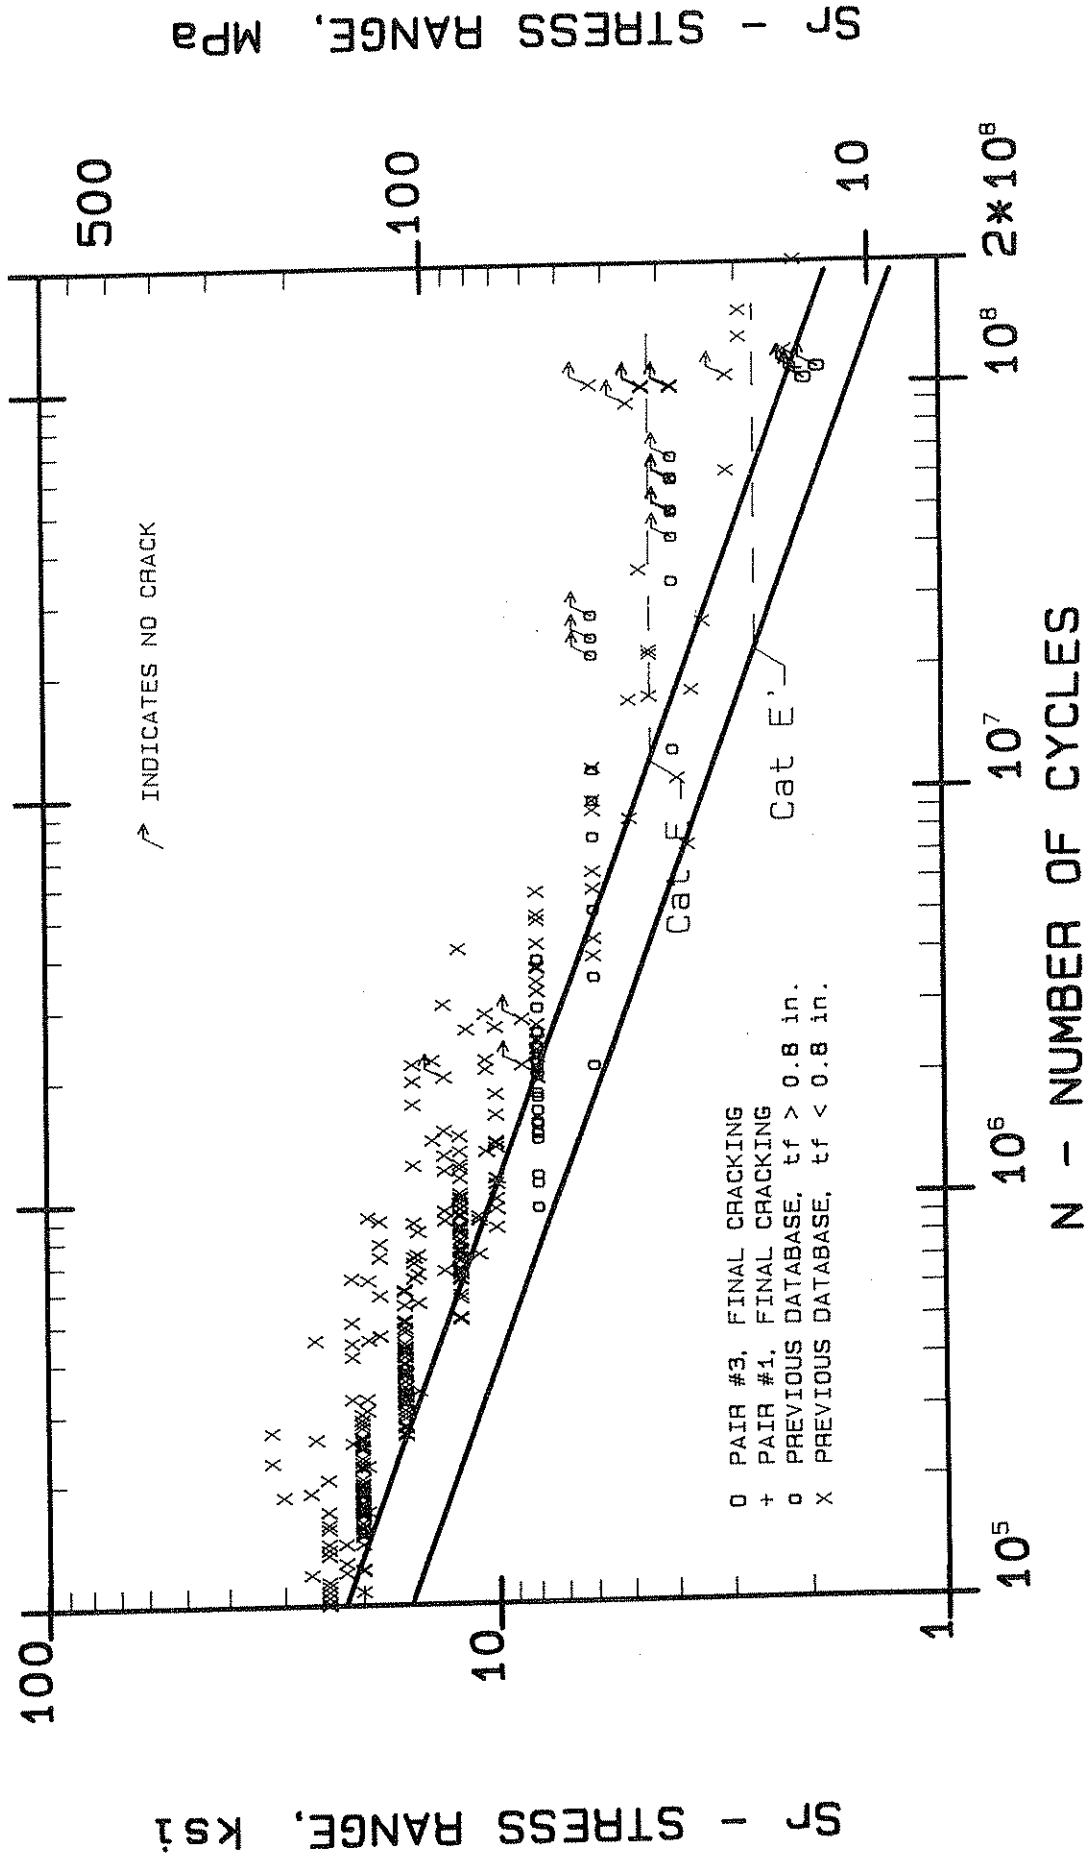
WELDED END COVERPLATE DATA

The test results for the end welded details are summarized in Figure 38. None of the test beams from pairs 1 and 3 with end welds (six details) developed detectable cracks during this study. The test results from Ref. 2 on Category E details with an exceedance frequency between 0.1% and 10.2% fall below or near an extension of the Category E fatigue resistance curve. This was true for effective stress range levels above as well as below the constant amplitude fatigue limit for Category E.

Fig. 38: Comparison of the test data on end welded coverplates with category E and E' fatigue resistance curves.

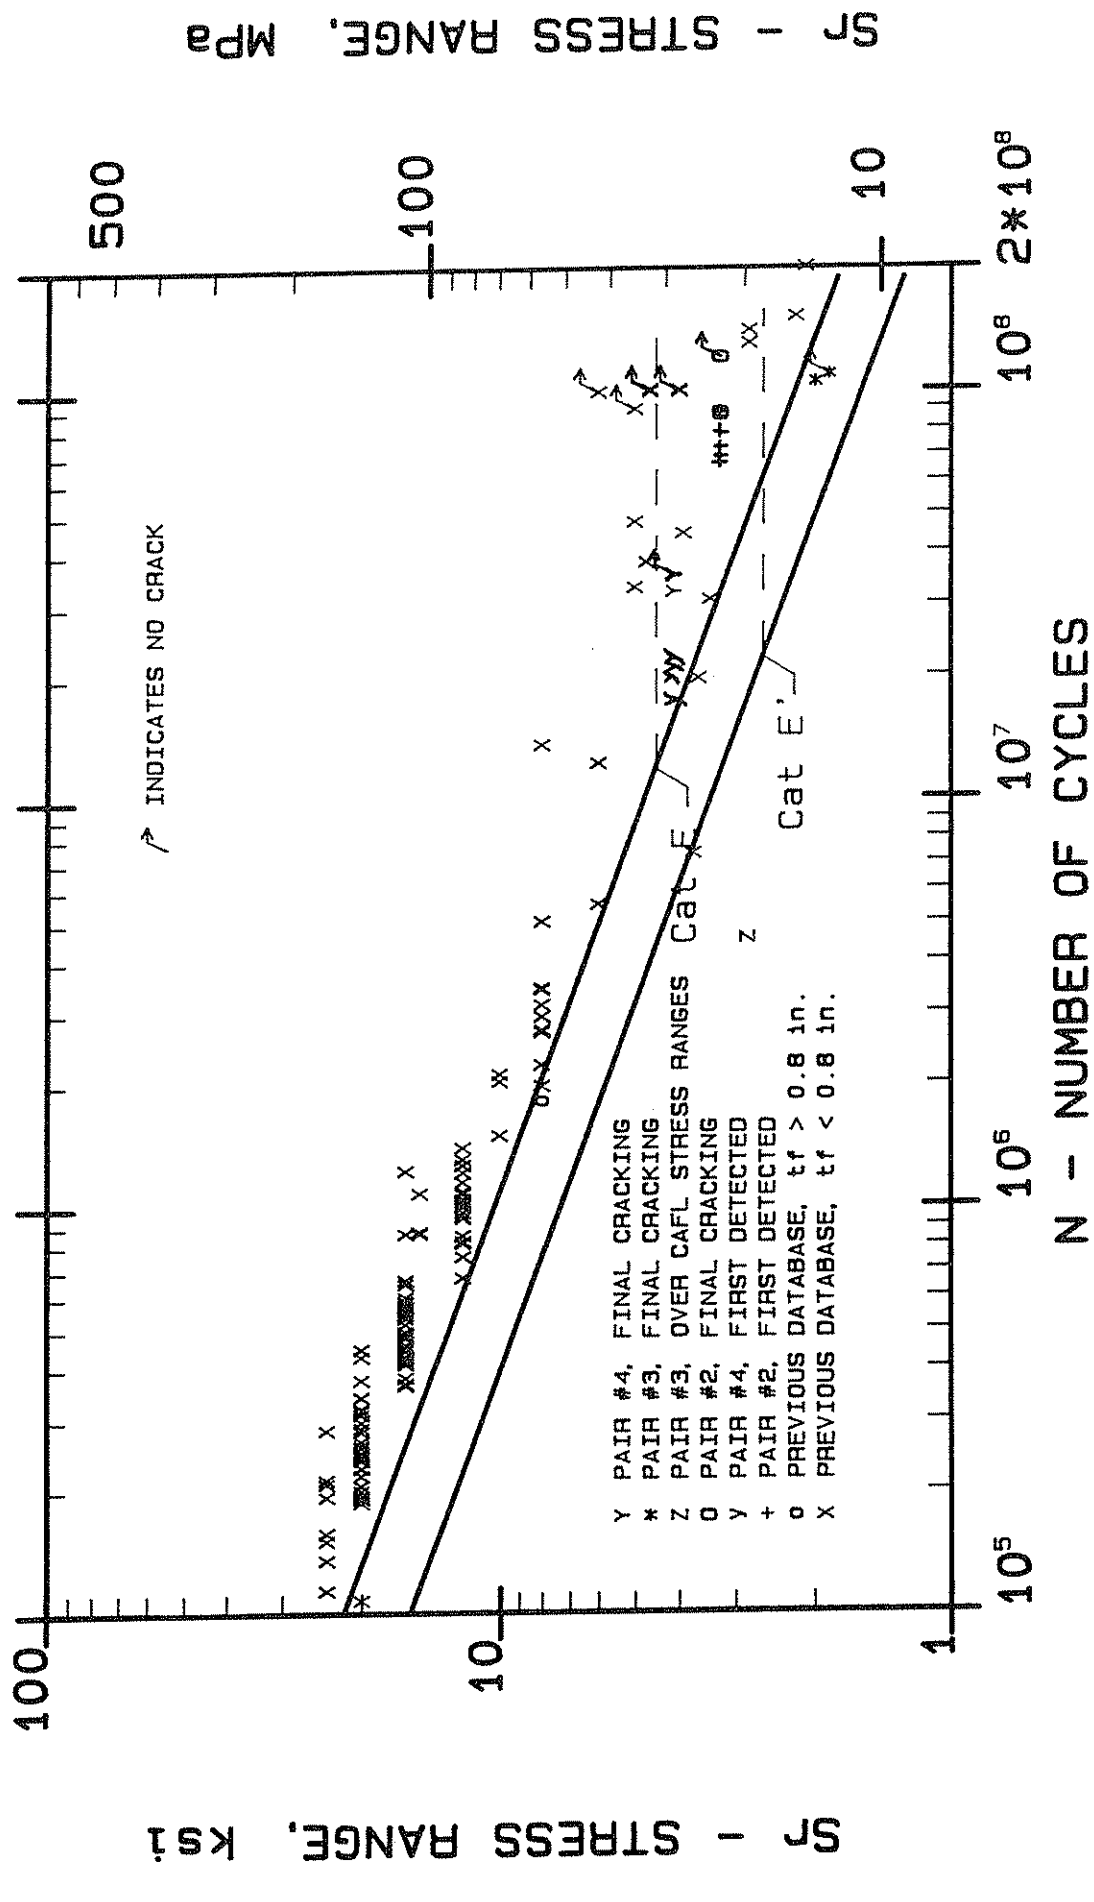
UNWELDED END COVERPLATE DATA

The test results for the cover plate details without end welds are plotted in Figure 39. Nine of the ten details developed fatigue cracks during the course of the variable loading (Beams 2, 4 and 3W). Fatigue cracks developed at exceedance frequencies between 4.3 and 100% for Category E'. The test results show that cracks were first detected near the Category E fatigue resistance curve. This was true for effective stress range values below and above the constant cycle fatigue limit for Category E'.

Fig. 39: Comparison of the test data on coverplate details without end welds with category E and E' fatigue resistance curves.
