Results of the Fatigue Evaluation and Field Monitoring of the I-39 Northbound Bridge over the Wisconsin River

Final Report

ATLSS Report No. 05-04

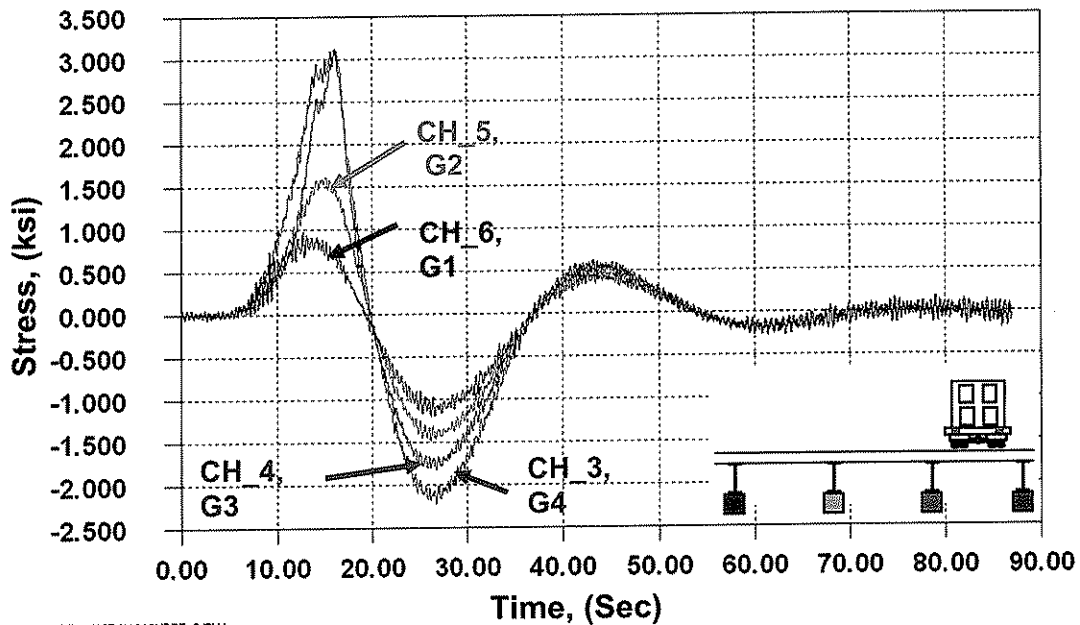
In general, the response of the bridge was as expected and typical of a continuous multi-span bridge. Figure 5.1 presents the response of CH_3, CH_4, CH_5 and CH_6 as the test truck passed over the right lane in test CNBRT_2. Channels CH_3, CH_4, CH_5 and CH_6 were installed in span 1 at P.P. 5 on the bottom flanges of girders G4 through G1, respectively. As expected, the response in all four channels is positive and maximum as the test truck passed over the first span (where the channels were installed) and becomes negative and less in absolute magnitude as it passes into the second span and subsequent spans.

The figure also shows good load distribution between the girders. The maximum response in the instrumented girders was observed when the test truck was directly located over the detail and lower response was observed in the girders further away from the test truck. This is evident as the test truck passed over span 1 and span 2. The observation becomes less clear as the test truck passed over span 3 and diminishes as the truck passes over span 4 and span 5. This is a typical behavior expected in a continuous bridge due to the substantial transverse and longitudinal load distribution which occurs as loads move further away from the instrumented section.

Figure 5.1 – Response of CH_3 through CH_6 installed in span 1 at P.P. 5 on girders G4 through G1 respectively (on the bottom flanges at the end of the cover plates) as the heavier test truck passed over the right lane in the crawl test (CNBRT_2) (View looking north)

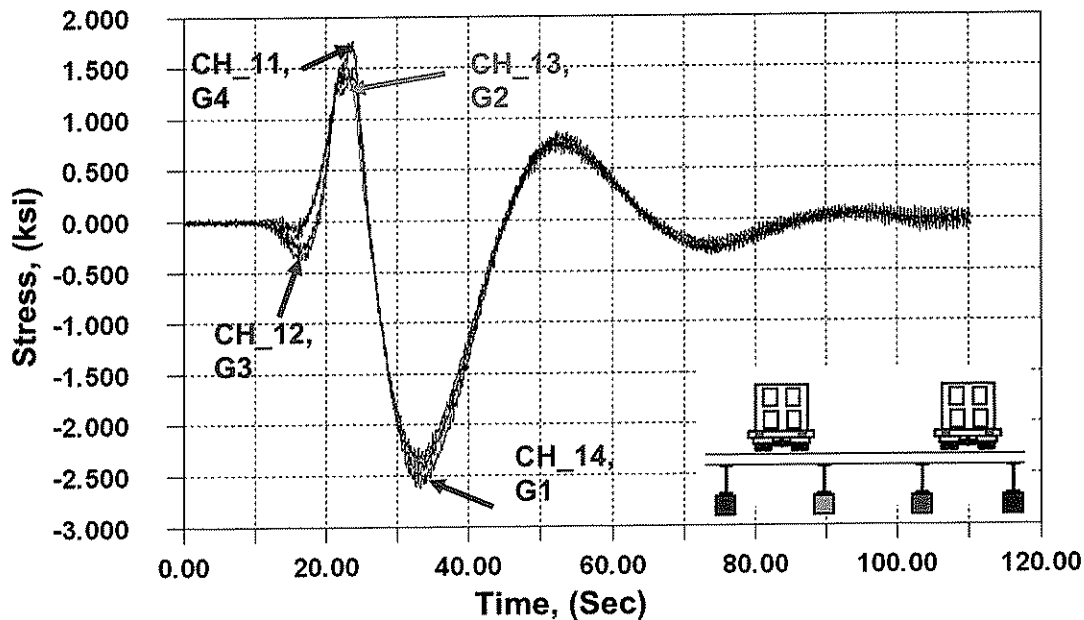
Figure 5.2 shows an evenly shared load by all girders as both test trucks passed side-by-side over the bridge. The small change in the magnitude of stress in the channels could be attributed to the slight difference in the weight between both test trucks and normal test variability. It was also observed that unlike the response shown in Figure 5.1, the first response of the channels at this cross section as the truck passes directly over them in the first span is negative and not maximum as expected. The observation confirms the fact that CH_11 through CH_14 were instrumented in the negative moment region slightly past the inflection point.

Figure 5.2 – Response of CH_11 through CH_14 installed in span 1 between P.P. 5 and P.P. 6 on girders G4 through G1 respectively (on the bottom flanges at flange splices) as both test trucks passed side-by-side over the bridge in the crawl test (CSBS_2) (View looking north)

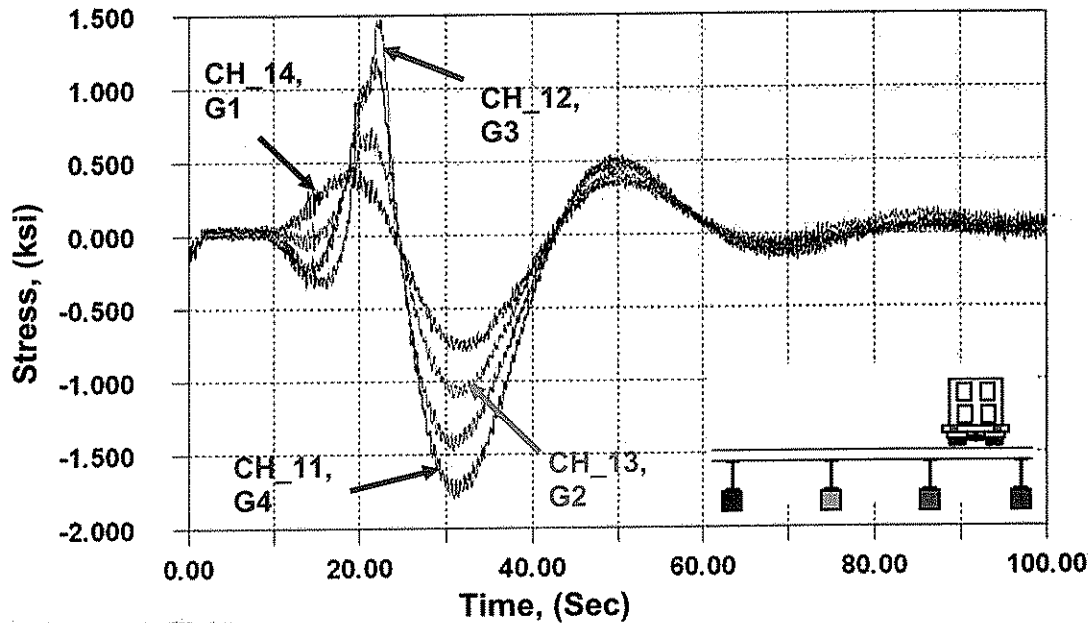
Figure 5.3 shows that unlike CH_11 and CH_12, the first response in CH_13 and CH_14 is positive when the test truck passed over the right lane. This is an indication of that composite action between the girders and the slab as girders G2 and G1 (further away from the load) are being lifted up with the slab. The response is due to torsional deformation as the load is applied eccentrically on the deck and is common in bridges of this configuration. For such torsional effects to be transferred transversely, the slab and the steel cross frames participate in spreading the load. The entire span can be idealized as a stiffened plate. That is, the slab acts as a plate while the girders can be thought of as deep stiffeners. As expected, this behavior is reversed when the test truck passed in the left lane. As indicated in the figure, the test trucks took approximately 90 seconds to cross the bridge spans (639.2 ft). The average speed is therefore, 7.1 ft/sec or 4.8 miles/hr.

Figure 5.3 – Response of CH_11 through CH_14 installed in span 1 between P.P. 5 and P.P. 6 on girders G4 through G1 respectively (on the bottom flanges at flange splices) as the test truck passed over the bridge in the right lane in the crawl test (CNBRT_1) (View looking north)

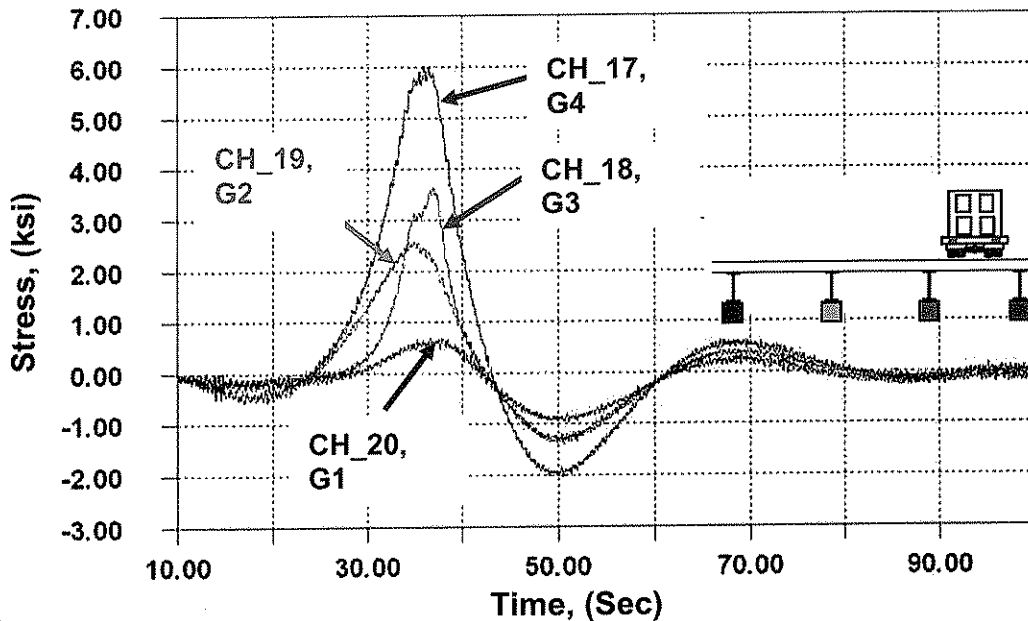
Shelf plates welded to the top face of the bottom flanges exist in many locations on the bridge. The detail is classified as category E detail with CAFL of 4.5 ksi. Six channels (CH_1, CH_2, and CH_17 through CH_20) were installed to monitor the response to live load imposed by the test trucks in the crawl and dynamic tests. Channels CH_1 and CH_2 were installed in span one at P.P. 3 on girders G4 and G3 respectively, while CH_17 through CH_20 were installed in span 2 at P.P. 13 on girders G4 through G1, respectively. Figure 5.4 shows the response of CH_17 through CH_20, with maximum response at CH_17. It is noted that the response at CH_17 is higher than that of CH_18. This is because CH_17 was installed on G4, an exterior girder. Since there is no girder to the right of G4, it cannot shed any load to the right. The load is shed from girder G3 (CH_18) to G4 (CH_17) and G2 (CH_19). Hence, the stresses are lower at CH_18. This response is different than observed from the measurements presented in Figure 5.1, but are not surprising or of concern. It is also worth noting that as the figure shows, the magnitude of the stress (negative) in CH_18 and CH_19 is the same as the test truck passes over the third span in the bridge. This observation is consistent in all crawl tests performed. As discussed, the bridge behaves more as a unit at a given section when subjected to loads applied some distance away. Table 5.2 lists the magnitude of the maximum stress, the minimum stress and the stress range of CH_1, CH_2 and CH_17 through CH_20 in the different crawl tests.

Figure 5.4 – Response of CH_17 through CH_20 installed in span 2 at P.P. 12 on girders G4 through G1 respectively (on the top face of the bottom flanges near welded shelf plates) as the test truck passed over the bridge in the right lane in the crawl test (CNBRT_1)
(View looking north)

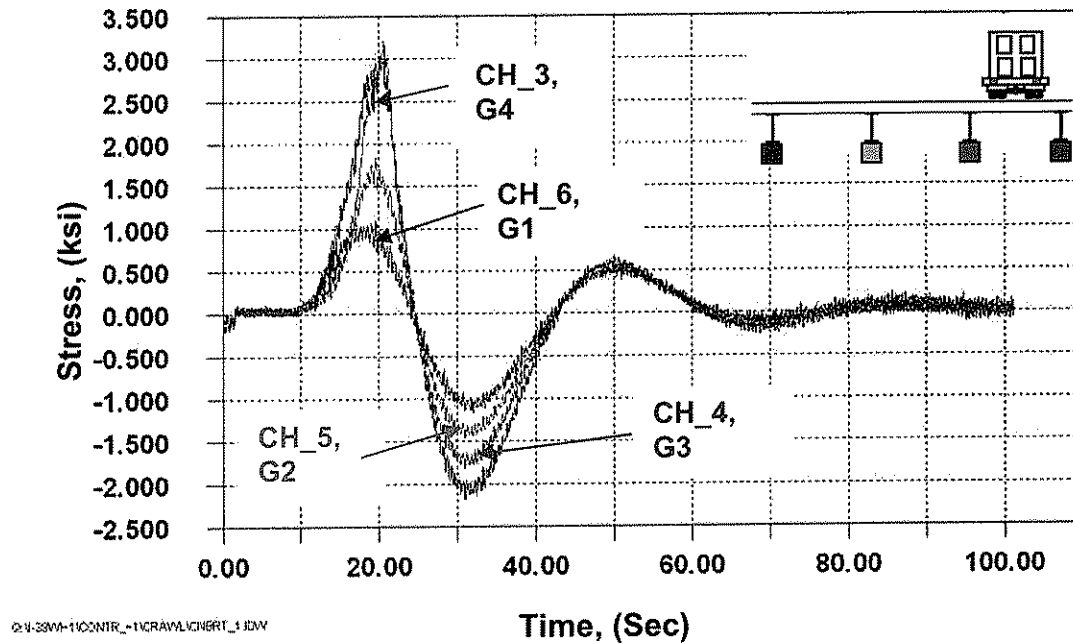
Figure 5.5 shows the response of CH_3 through CH_6 installed as the heavier test truck passed over the right lane in the crawl test (CNBRT_1). As illustrated in the figure, high stress ranges were recorded in CH_3 and CH_4. The remaining channels also experienced high magnitude of stress range cycles during the controlled load tests with various truck positions as listed in Table 5.3.

Figure 5.5 – Response of CH_3 through CH_6 installed in span 1 at P.P. 5 on girders G4 through G1 respectively (on the bottom face of the flange near welded cover plates) as test trucks # 169 passed over the right lane in the crawl test (CNBRT_1)
(View looking north)

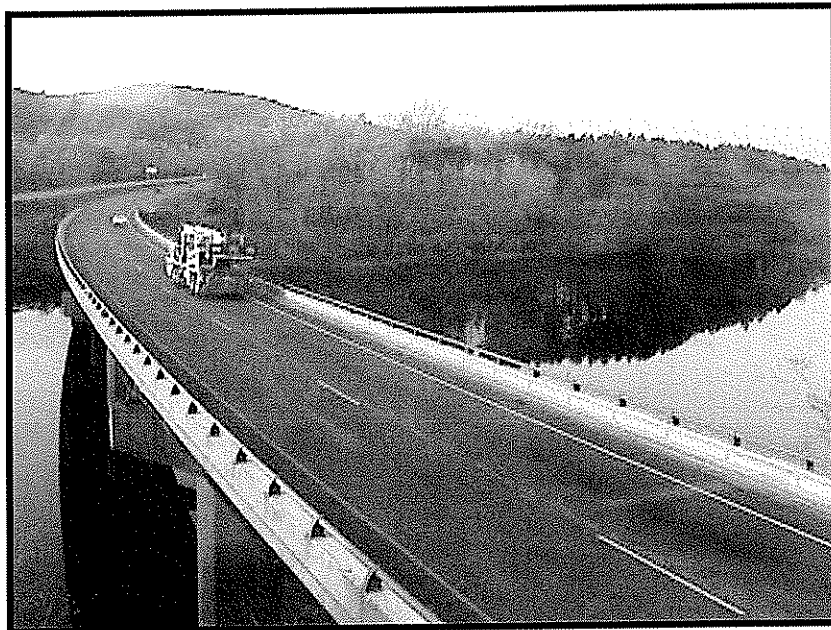
The video clips collected during the monitoring period were extremely useful in determining the configuration of the vehicles causing the triggers. High stress-range cycles were recorded at some of the channels installed on the bridge and found to be caused by either a single heavy truck crossing the bridge or multiple trucks on the bridge at the same time. For example, as shown in Figure 6.1, a trigger event in CH_17 shows a measured stress-range cycle of 12 ksi. A review of the video collected during this trigger event revealed that the response was caused by mobile crane crossing the bridge in the right lane on October 20, 2004 at 5:39 pm (Figure 6.2).

Figure 6.2 – An image from the recorded video clips during the crossing of a mobile crane on October 20, 2004 at 5:39 PM

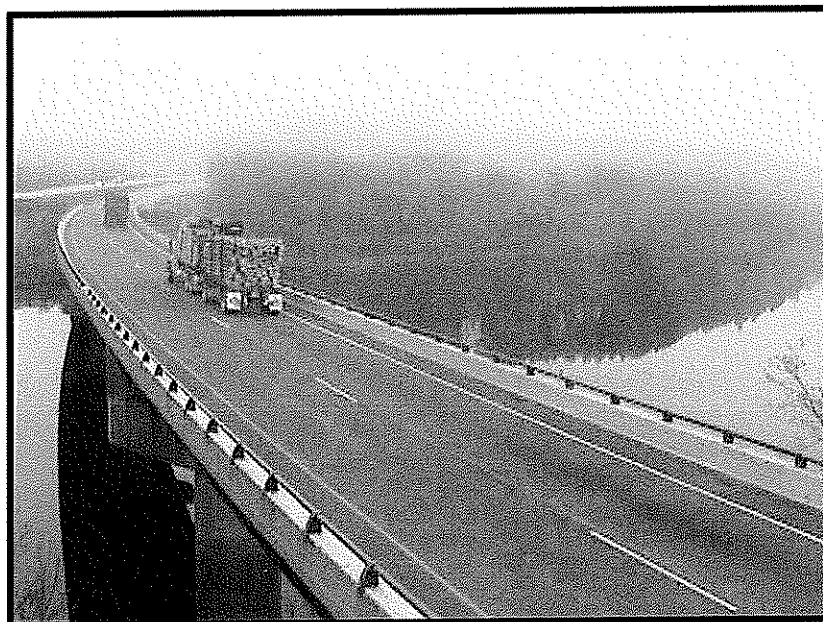
In another trigger event recorded on October 21, 2004 at 7:39 am, a stress-range cycle of 9.4 ksi was measured by CH_17 (Figure 6.3). The measured stress range was caused by a flat-bed truck loaded with logs as shown in Figure 6.4.

Figure 6.4 – An image from the recorded video clips during the crossing of flat-bed truck loaded with logs on October 21, 2004 at 7:39 AM

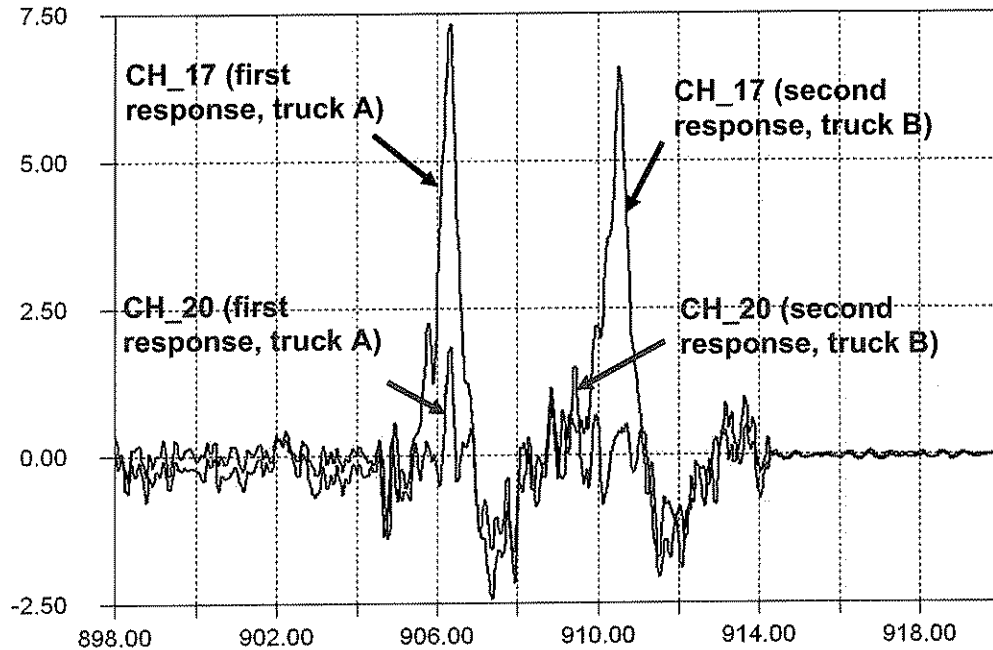
The response of CH_17 and CH_20 to two loaded back-to-back dump trucks passing over the right lane on October 21, 2004 at 3:16 pm is shown in Figure 6.5. The time history response of the channels indicates that the response of the channels to the first truck (truck A) was slightly higher than that of the second truck (truck B). The response of CH_17 and CH_20 to the first passing truck (truck A) was approximately 9.7 ksi and 3.4 ksi and to the second passing truck (truck B) was approximately 8.4 ksi and 2.3 ksi, respectively. The slight difference in the response generated by both trucks suggests that truck B was slightly heavier than truck A. It is important to note that Figure 6.5 clearly shows separate response for each truck, suggesting that truck A had approximately passed the fifth span on the bridge when truck B was passing over the first span (Figure 6.6).

Figure 6.5 – Stress time-history for CH_17 and CH_20 installed in span 2 at P.P. 13 on girder G4 and G1, respectively at a welded shelf plate detail during the passage of two loaded dump trucks (truck “A” and truck “B”) on October 21, 2004 at 3:16 PM

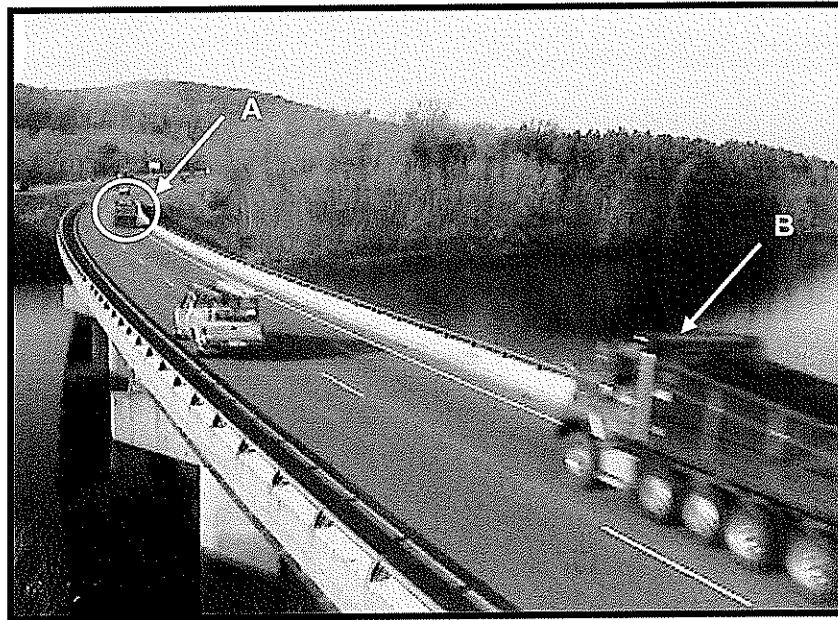
Figure 6.6 – An image from the recorded video clips during the crossing of two loaded dump trucks (truck “A” and truck “B”) on October 21, 2004 at 3:16 PM

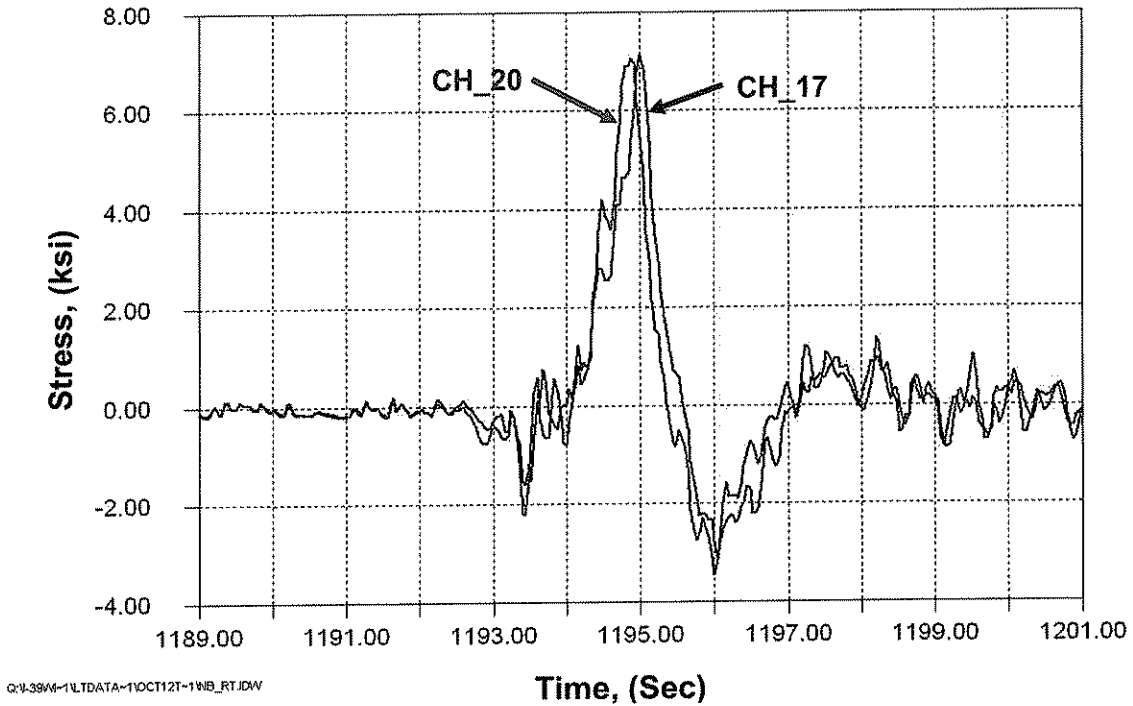
In a trigger event, which was recorded on October 28, 2004 at 7:50 am, equal response was observed by both channels (Figure 6.7) when two dump trucks were passing side-by-side (Figure 6.8). Both channels measured a stress range of approximately 10.5 ksi. The similar magnitude of response measured by both channels is an indication that both trucks were of equivalent weight and were passing over the bridge with approximately the same speed. Table 6.2 lists a summary of the above mentioned discussion and includes the stress-range cycles measured by CH_17 and/or CH_20, the type of truck, and the truck position on the bridge.

Figure 6.7 - Stress time-history for CH_17 and CH_20 installed in span 2 at P.P. 13 on girder G4 and G3, respectively at welded shelf plate during the passage of two fully loaded side-by-side dump trucks on October 28, 2004 at 7:50 AM

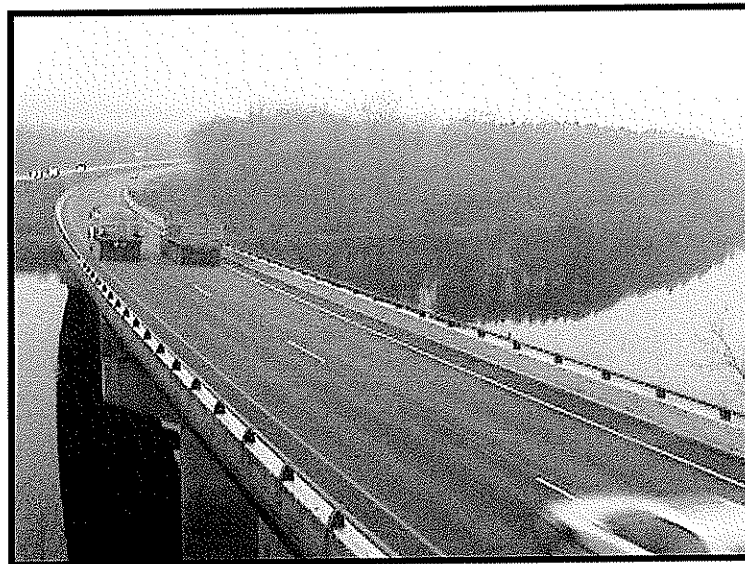
Figure 6.8 – An image from the recorded video clips during the crossing of two fully loaded side-by-side dump trucks on October 28, 2004 at 7:50 AM

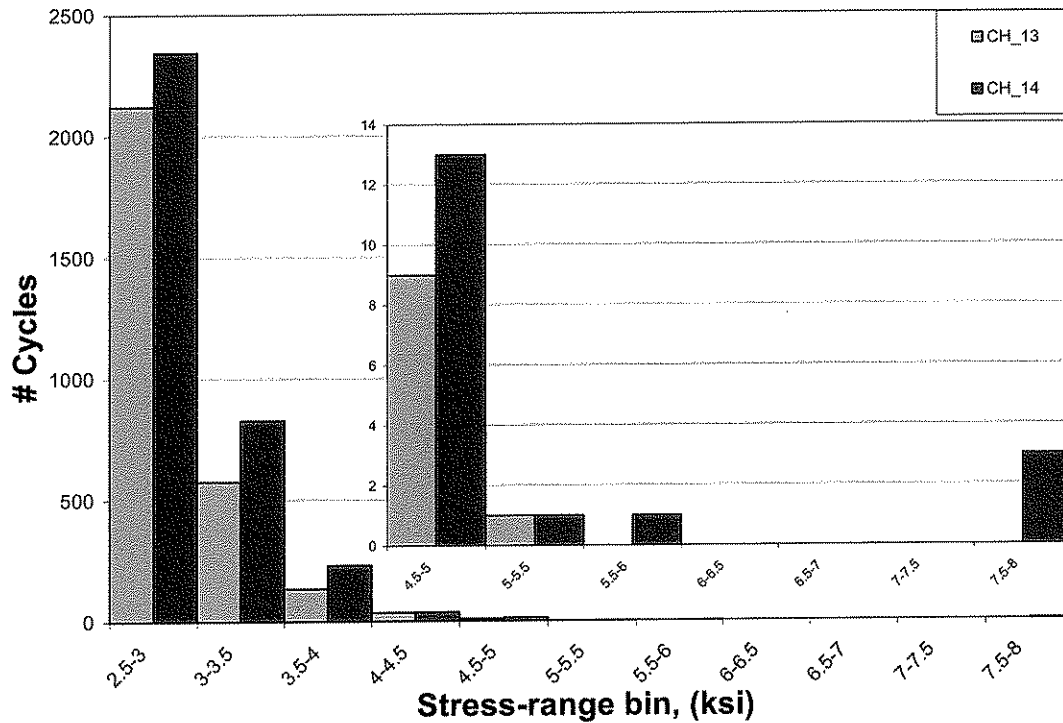
Four gages, CH_11 through CH_14, were installed on the bottom flanges of girders G1 through G4, respectively, to monitor the stresses at the welded full penetration flange splice. The detail is classified as category C per the AASHTO specifications. No stress-range cycles higher than the CAFL (10 ksi) of the detail were measured at any of the instrumented locations. The highest magnitude of stress range measured was 7.8 ksi and was recorded by CH_14, which was installed on girder G1 in span 1. Figure 6.9 shows the stress-range histogram for CH_13 and CH_14. The inset in the figure is a magnification of the right-most portion of the histogram. A lower-bound stress range truncation level of 2.5 ksi was selected for producing the histogram. Typically for fatigue evaluations, the truncation level is 1/4 to 1/3 times the CAFL of the detail. More detailed discussion on truncation levels used in fatigue evaluations could be found in Appendix B.

Figure 6.9 – Stress-range histogram for CH_13 and CH_14 installed at the welded full penetration flange splice

A summary of the magnitude of the maximum stress range, effective stress range, number of cycles measured per day, and the estimated remaining fatigue life for the details is presented in Table 6.3. As can be seen in the table, the fatigue life calculations indicate an infinite remaining life for all four instrumented welded full penetration flange splice details.

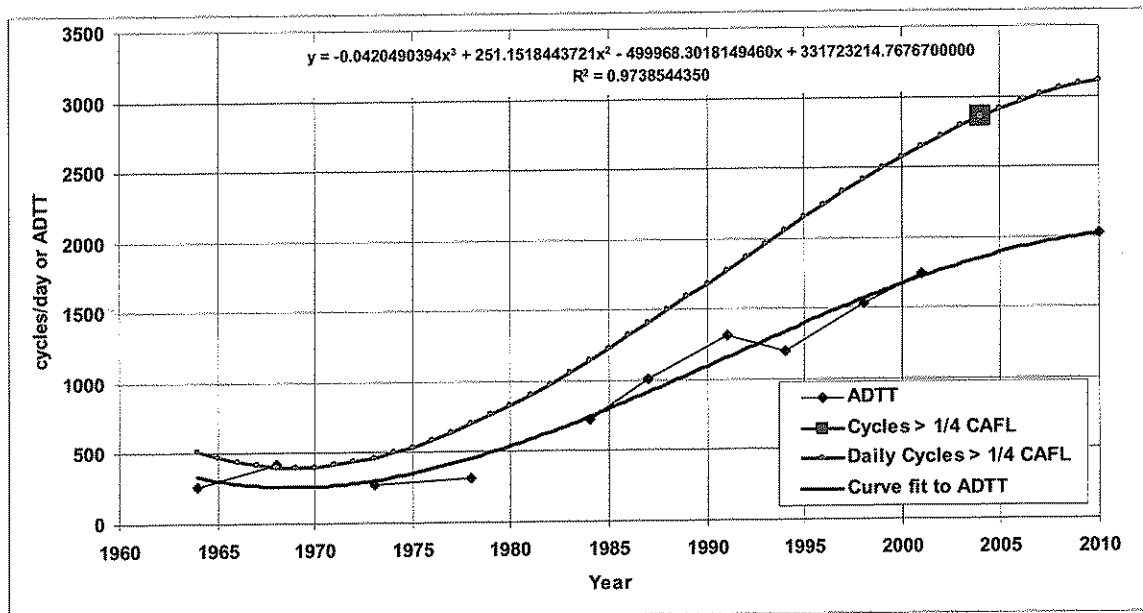
The estimated yearly cycles were then calculated by multiplying the estimated cycles/day by 365. The total number of cycles experienced by each channel is simply obtained by adding the cycles/year for every year. Table 6.6 also shows the estimated yearly cycles for selected years. It is important to note that although traffic data were not available for some of the years between 1964 and 2004, the adjusted ADTT curve was used to estimate the ADTT corresponding to that year. The graphical representation of the process mentioned above is shown in Figure 6.12 for channel CH_1.

Figure 6.12 – Graphical representation of approach used for estimating ADTT and cycles for CH_1 from 1964 through 2004

As indicated in Table 6.7, the refined approach resulted in higher estimates of remaining fatigue life in CH_1 through CH_4 and CH_17 through CH_20 installed near the weld at the lateral shelf plate detail. The positive estimated fatigue life for CH_1 and CH_17 is more realistic since no cracking was observed at either of the locations where the channels were installed.

Although Table 6.7 shows positive remaining fatigue life for the channels, it is recommended that a retrofit be implemented at the lateral shelf plate connection detail where the estimated remaining fatigue life was less than 50 years (i.e. CH_1 and CH_2, and CH_17 and CH_18). Hence, all girders may not need to be retrofit at the present time. However, considering the proposed widening, it should be prudent to retrofit all girders in a given cross section. A reasonable approach would be to retrofit all shelf plates located in positive moment regions as well as those located in regions of stress reversal (e.g. P.P. 5 in span 1). Note, it is critical that these recommendations be verified

The suggested retrofit consists of bolting a plate to the bottom flange of the girders in the area of the shelf plates. The plate will effectively act like a bolted cover plate serving two purposes. The first is to reduce stresses in this portion of the flange. Hence, the plate must be long enough and attached with a sufficient number of bolts to ensure it is fully effective across the region where the shelf plate exists. The second advantage is that in the extremely unlikely event a fatigue crack were to form in the flange, the flange is already fully spliced thereby preventing a fracture of the girder. The dimension of the plate (i.e. thickness, width, and length) should be determined using conventional methods. The suggested retrofit scheme is illustrated in Appendix C. It is important to note that the retrofit detail shown in Appendix C will have to be modified for locations where the lateral shelf plate detail is next to cover plate field splice detail. It is also important to note that size of the plate and number of bolts shown in the sketches does not reflect the actual size to be used in the retrofit. It was only used for illustrative purpose.
