Results of Field Measurements of the Pearl Harbor Memorial Bridge on I-476 over the Schuylkill River

Interim Report

ATLSS Report No. 06-07

March 2006

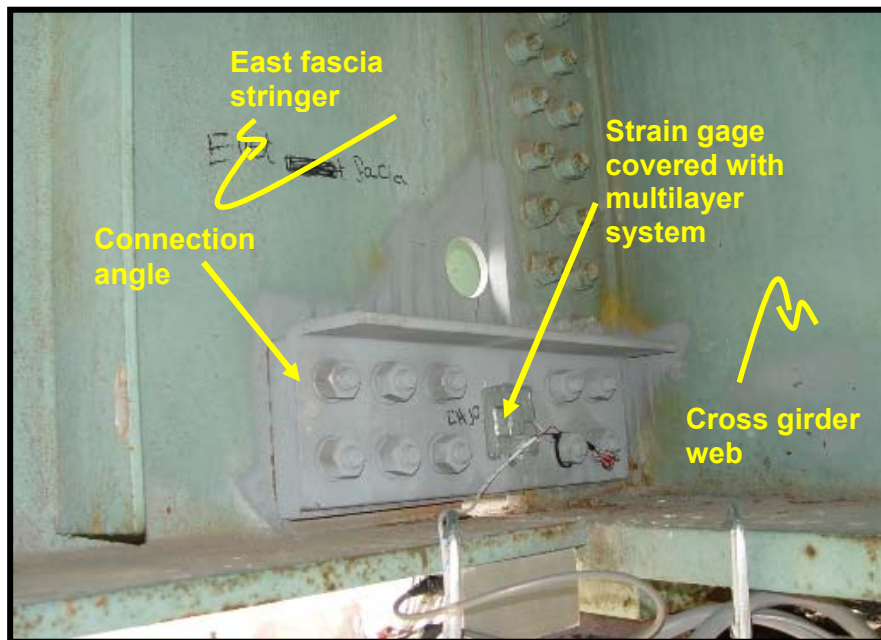
Strain gages were installed on the leg of the retrofit angles connecting the web of the east and west fascia stringer to the connection plates welded to the cross girder web. The angles were previously installed to provide positive attachment between the fascia stringers and the cross girders in an attempt to reduce the driving force responsible for fascia stringer cope cracking. Specifically, CH_10 on the angle located at the east fascia and CH_19 on the angle located at the west fascia stringer. The gages were installed at a distance of approximately 10" away from the south end of the angle and at mid height of the bolted leg. Figure 4.2 shows strain gage CH_10 installed on the retrofit angle of the east fascia stringer.

Figure 4.2 – Strain gages CH_10 installed on the retrofit angle of the east fascia

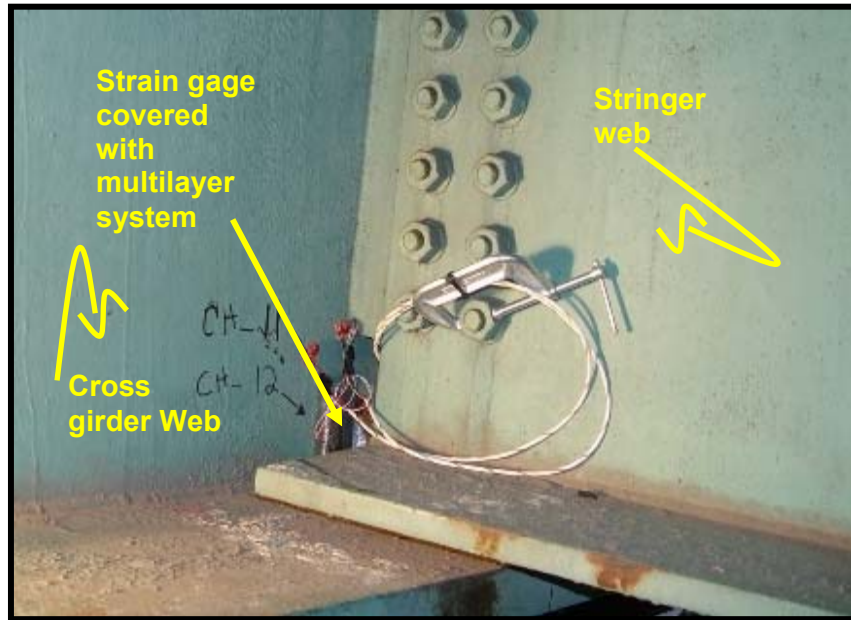
Two strain gages were installed in the web gap of the cross girder at interior stringers S3 and S6, on both faces of the cross girder web, to measure the stresses in the web gap and assess its vulnerability to develop cross girder cracks similar to those developed at the west fascia. On the north face, a large web gap of approximately 6 inches exists at the cross girder-to-stringer connection at both stringers. On the other face of the web, web gaps of approximately 5/8" exist at the transverse stiffener welded to the cross girder web. Two pairs of strain gages were installed back-to-back and directly above each other at these web gaps. The gages were first installed directly above each other on the south face of the web at the web gap of the transverse stiffener detail and fit tight against the horizontal weld attaching the web to the bottom flange of the cross girder and the vertical weld attaching the transverse stiffener to the web of the cross girder. Two gages were installed on the north face of the web at the 6 inches web gap by directly projecting the gages previously installed on south face of the web. The web gaps on the cross girder at interior stringers S3 and S6 were chosen for the installation of the gages. At interior stringer S3, strain gage CH_14 was installed in the web gap on the south face of the gross girder web and fit tight against the horizontal and vertical welds as mentioned above. Strain gage CH_13 was installed directly above strain gage CH_14. Strain gages CH_12 and CH_11 were installed on the north face of the web by directly projecting strain gage CH_14 and strain gage CH_13, respectively. At interior stringer S6, strain gage CH_23 was installed in the web gap on the south face of the gross girder web and fit tight against the horizontal and vertical welds as mentioned above. Strain gage CH_22 was installed directly above strain gage CH_23. Strain gages CH_21 and CH_20 were installed on the north face of the web by directly projecting strain gage CH_23 and strain gage CH_22, respectively. Figure 4.3 shows strain gages CH_11 and CH_12 installed on the north face of the cross girder web at the 6 inches web gap of the transverse connection plate detail at interior stringer S3.

Figure 4.3 – Strain gages CH_11 and CH_12 installed on the north face of the cross girder web at the 6 inches web gap of the transverse connection plate detail at interior stringer S3

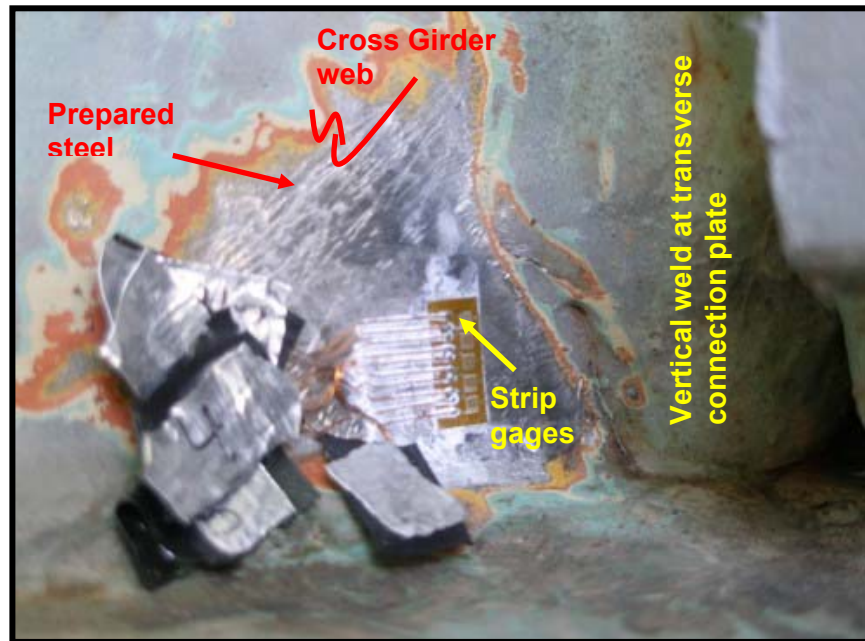
Small web gap sizes exist on the web of the cross girder at the cross girder-to-fascia stringer connection unlike those located at the cross girder-to-interior stringer connection. At the east fascia, the vertical weld used to attach the connection plate to the web of the cross girder ran the full depth of the cross girder web and there is practically no web gap. Therefore, the strip gages were installed adjacent to the vertical weld attaching the connection plate to the web of the cross girder and fit tight against the horizontal weld attaching the web and the flange of the cross girder. The gages installed adjacent to the zero inches web gap were strain gages CH_1 through CH_5 where gage CH_1 is the top gage and gage CH_5 is the bottom gage as shown in Figure 4.4.

Figure 4.4 – Strip gages CH_1 through CH_5 installed on the north face of the cross girder web adjacent to the zero inches web gap of the transverse connection plate detail at the east fascia

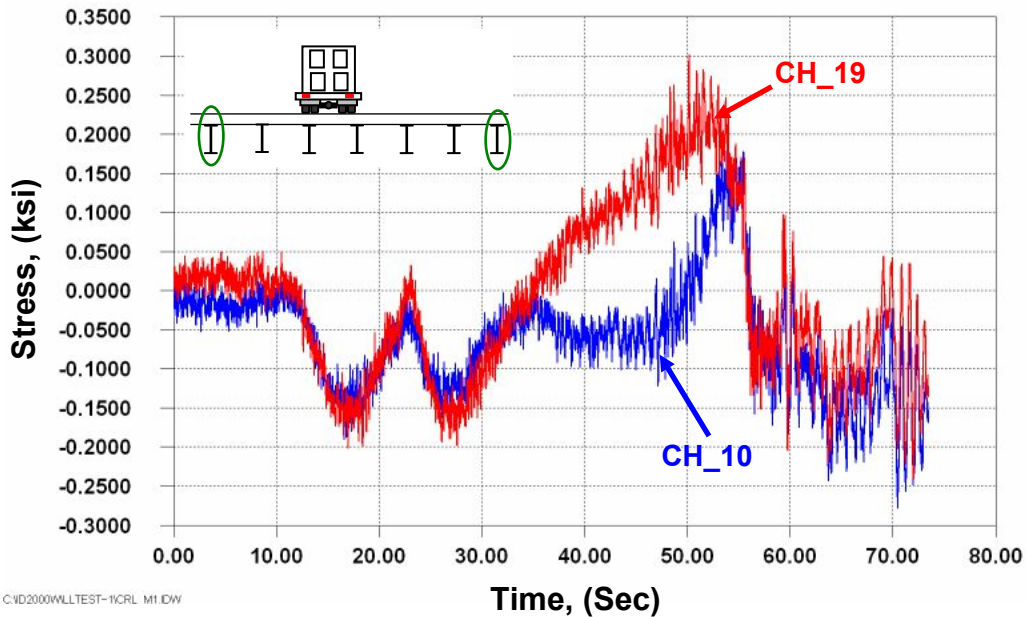
Strain gages CH_10 and CH_19 were installed on the leg of the retrofit angles connecting the web of the east and west fascia, respectively, to the connection plates welded to the cross girder web. Figure 5.3 shows the response of strain gages CH_10 and CH_19 installed on the leg of the angles at the east and west fascia, respectively, as the test truck passed over the middle lane in the crawl test (CRL_M1). The figure shows similar magnitude of stresses measured by both gages as the test truck approaches the location where the angles are located. The response differs in the angles as the test truck is near or directly above the angles. This could be associated with the existence of the cross girder cracks at the west fascia. A summary of the maximum stress, minimum stress, and stress range values experienced by the gages in the first crawl tests is presented in Table 5.3. For all three crawl tests, the angle at the west fascia stringer had higher stresses.

Figure 5.3 – Response of strain gages CH_10 and CH_19 installed on the leg of the angles connecting the web of the east and west fascia, respectively, to the connection plates welded to the cross girder web as the test truck passed in the middle lane in the crawl test (CRL_M1)

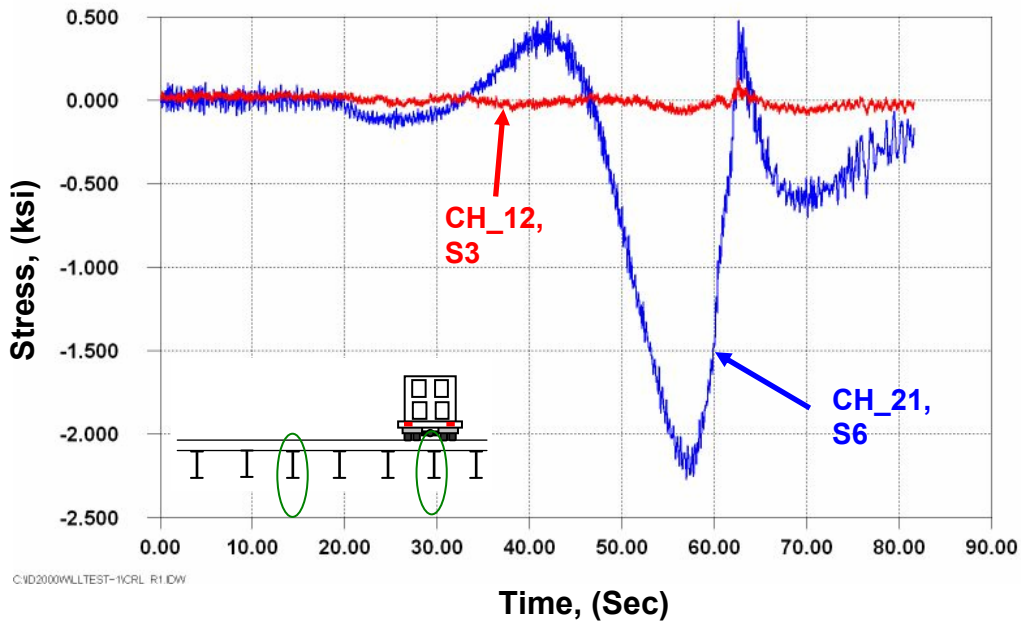
A summary of the maximum stress, minimum stress, and stress range values experienced by the gages in the first crawl tests is presented in Table 5.4. The table shows low stresses measured by the gages. As expected, the stresses measured by strain gage CH_21 installed at interior stringer S6, although low, were higher than those measured by strain gage CH_12 installed at similar location at interior stringer S3 (Figure 5.4). This is an indication of an increase in the out-of-plane distortion stresses in the web gap areas from the interior to the fascia stringer. The maximum recorded stress range at the web gap of the cross girder at the interior stringer is 2.7 ksi due to the crawl runs of the test truck.

Figure 5.4 – Response of strain gages CH_12 and CH_21 installed on the cross girder web in the web gap area of the cross girder-to-stringer connection of stringer S3 and S6, respectively, as the test truck passed in the right lane in the crawl test (CRL_R1)

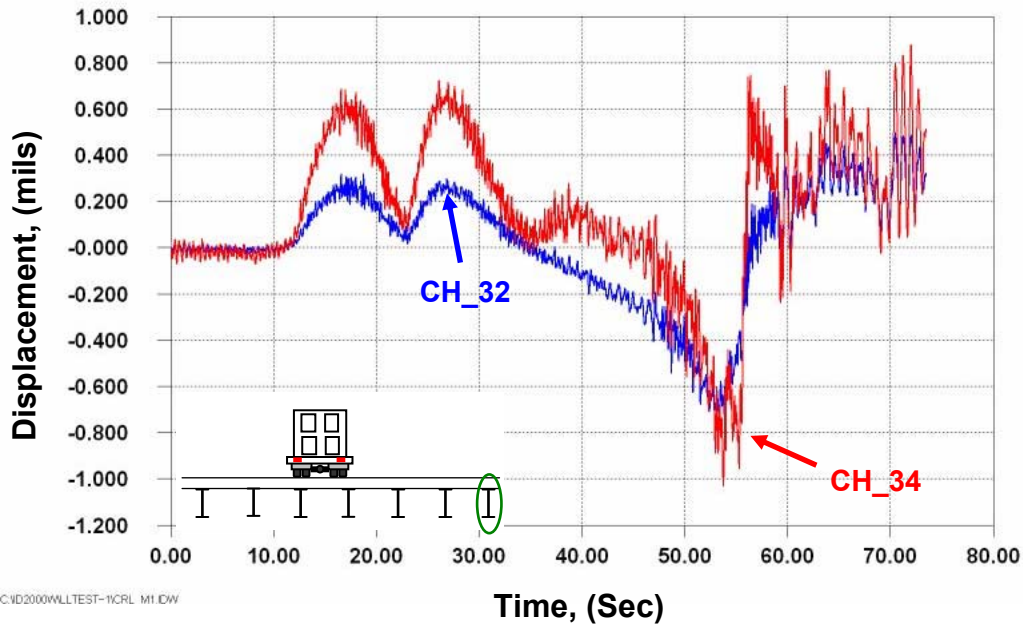
Figure 5.8 shows the response of strain gages CH_32 and CH_34 as the test truck crossed over the span in the middle lane in the crawl test (CRL_M1). As expected, the out-of-plane displacement measured by LVDT CH_34 is higher than that measured by LVDT CH_32. This is primarily due to the fact that the cracked cross girder web allows west fascia to undergo more out-of-plane displacement due to the existence of cracks in the cross girder web. A summary of the maximum and minimum relative displacement between the cross girder bottom flange and the bottom flange of the fascia and interior stringers in the first crawl tests is presented in Table 5.7.

Figure 5.8 – Response of LVDT's CH_32 and CH_34 installed to measure the relative displacement between the cross girder and the east and west fascia, respectively as the test truck passed in the middle lane in the crawl test (CRLM1)

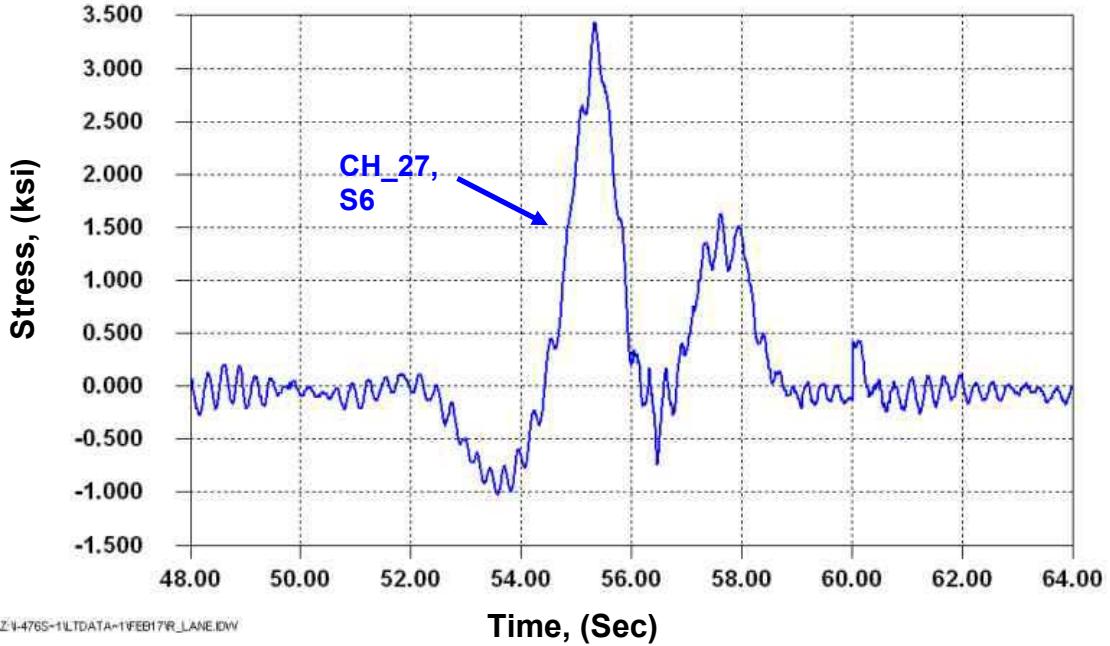
Figure 6.1 - Stress time-history for strain gage CH_27 installed on the bottom flange of stringer S6 near midspan of span 12 during the passage of a vehicle during monitoring

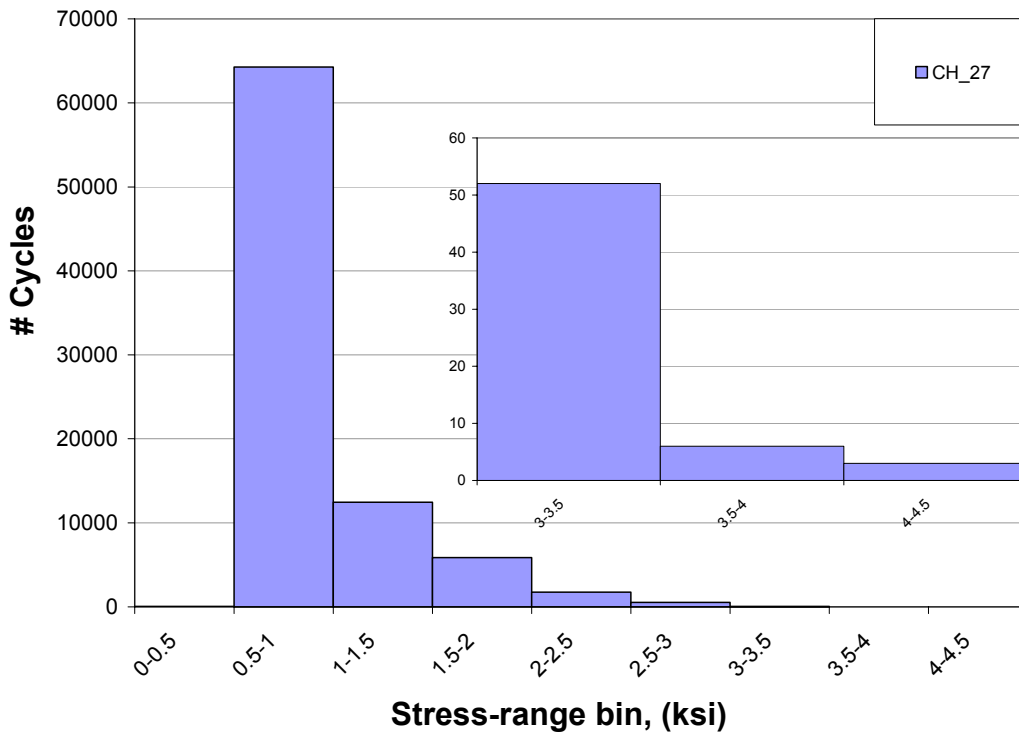
Figure 6.2 – Stress-range histogram for strain gage CH_27 installed on the bottom flange of stringer S6 near midspan of span 12

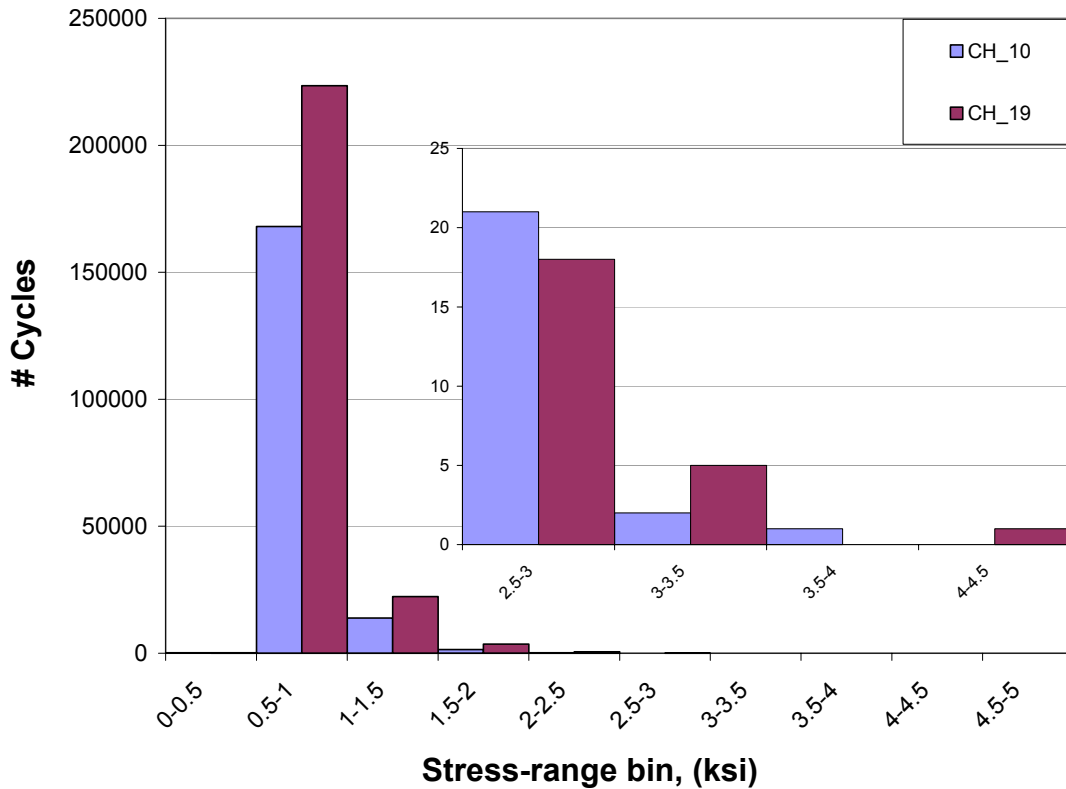
As stated earlier, strain gages CH_10 and CH_19 were installed on the leg of the retrofit angles bolted to the web of the east and west fascia stringers, respectively to measure the magnitude of stresses transmitted by the fascia stringers to the cross girder through the retrofit angles. Stresses higher than those measured during controlled load tests were recorded by both gages. Figure 6.3 shows the stress-range histogram for strain gages CH_10 and CH_19. The inset in the figure is a magnification of the right-most portion of the histogram. As shown in the figure, the maximum stress range recorded by strain gage CH_19 is higher than the maximum recorded by strain gage CH_10. This was expected since strain gage CH_19 was installed on the retrofit angle of the west fascia located below the right lane, which typically experiences heavy truck traffic than the adjacent lanes.

Figure 6.3 – Stress-range histogram for strain gages CH_10 and CH_19 installed on the leg of the retrofit angles bolted to the web of the east and west fascia, respectively

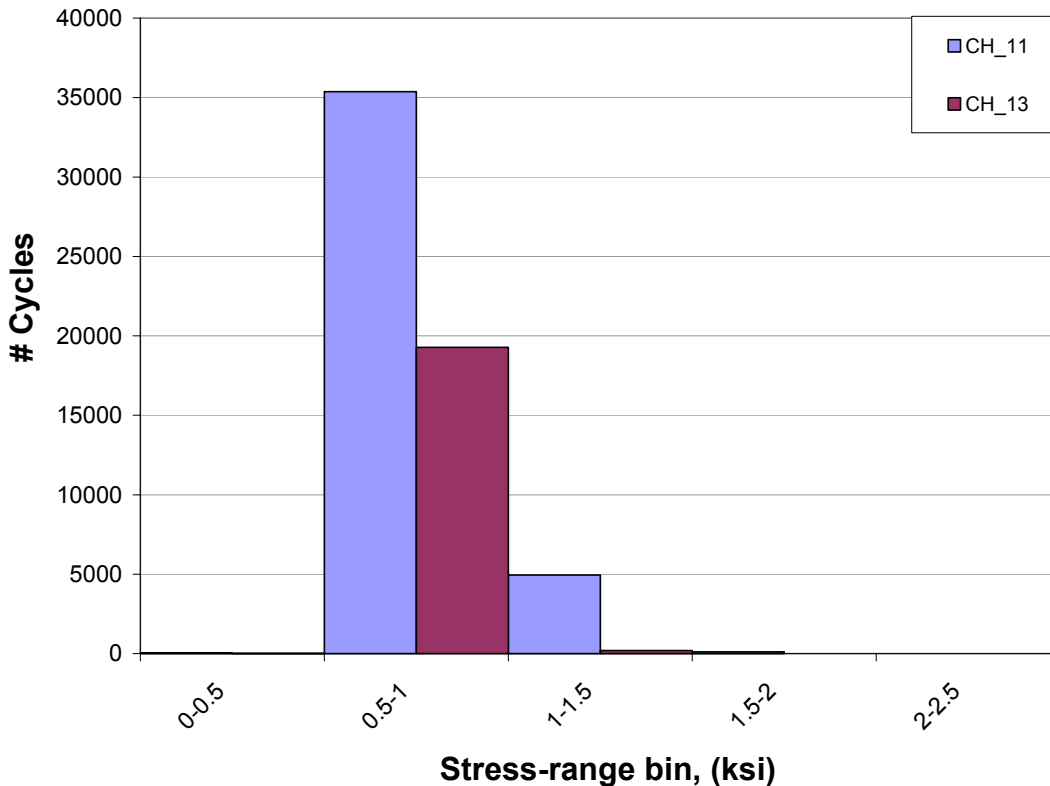
As previously mentioned in Section 4.2.2, strain gages were installed in the web gap of the cross girder on both faces of the web at interior stringers S3 and S6. At interior stringer S3, strain gage CH_14 was installed vertically in the web gap on the south face of the gross girder web and fit tight against the horizontal weld of the cross girder flange and vertical weld of the transverse stiffener. Strain gage CH_13 was installed directly above strain gage CH_14. Strain gages CH_12 and CH_11 were installed on the north face of the web by projecting strain gages CH_14 and CH_13, respectively. Similarly, at interior stringer S6, strain gage CH_23 was installed similar to strain gage CH_14, strain gage CH_22 was installed similar to strain gage CH_13, strain gage CH_21 was installed similar to strain gage CH_12, and strain gage CH_20 was installed similar to strain gage CH_11. Stresses measured at the web gap detail at interior stringer S6 were higher than those measured at interior stringer S3 and was recorded to be 9.3 ksi, 6.7 ksi, 10.7 ksi, and 6.8 ksi in strain gages CH_20, CH_21, CH_22, and CH_23, respectively. Figure 6.4 shows the stress-range histogram for strain gages CH_11 and CH_13 installed on the north and south face of the cross girder web in the web gap area at interior stringer S3. The maximum average stress range recorded by both gages was one cycle of 2.25 ksi.

Figure 6.4 – Stress-range histogram for strain gages CH_11 and CH_13 installed on the north and south face of the cross girder web in the web gap area at interior stringer S3

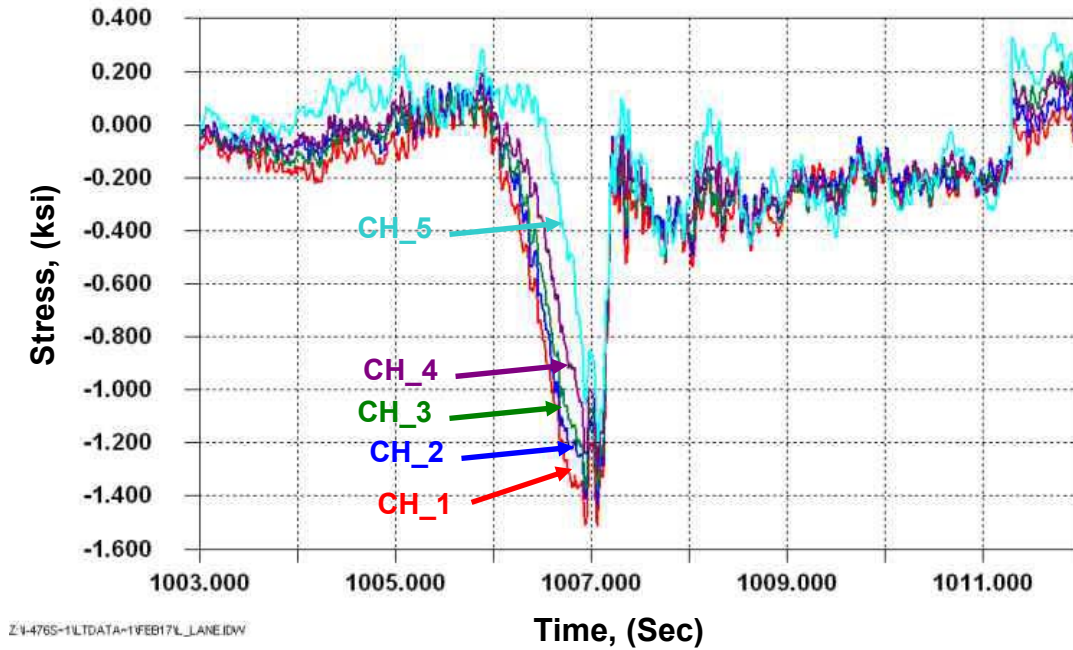
Strain gages CH_1 through CH_5 were installed on the web of the cross girder adjacent to the vertical weld in the web gap at the cross girder-to-east fascia stringer connection. The maximum stress range recorded by the gages was 1.6 ksi and was measured by strain gage CH_1. Figure 6.5 shows the time-history response of strain gages CH_1 through CH_5 during a trigger event.

Figure 6.5 - Stress time-history for strain gage CH_1 through CH_5 installed on the web of the cross girder adjacent to the web gap at the cross girder-to-east fascia stringer connection during the passage of a vehicle during monitoring
