International Conference on Case Histories in Geotechnical Engineering (2004) - Fifth International Conference on Case Histories in Geotechnical Engineering

Investigation of Structural Damage in a Corrosive Environment: A Case Study

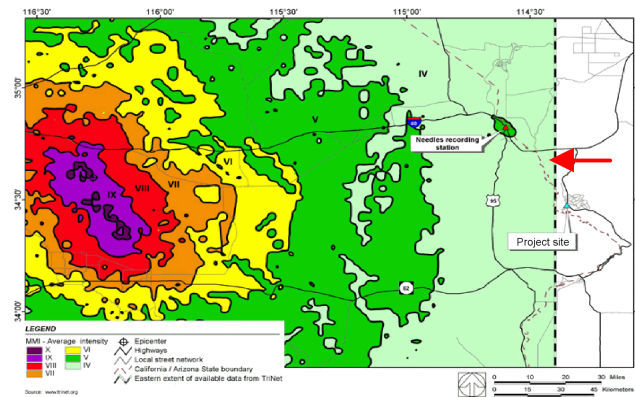
Fig. 8. Intensity distribution for the October 16, 1999 Hector Mine Earthquake (based on TriNet data). The arrow points to the eastern extent of the TriNet data.

As seen in Fig. 8, based on the TriNet data, the ground shaking intensity at the project site is estimated to be less than V (more likely IV, but conservatively using V). At Intensity V the shaking is described as *moderate* from a human perception standpoint and *very light* from a potential structural damage standpoint. TriNet also compiles a “felt intensity,” which is an intensity measure based on observations made by residents of different areas during the ground shaking. Based on 58 independent descriptions of the ground shaking for the zip code in which the project site is located, TriNet reported the ground shaking “felt intensity” to be IV. At Intensity IV shaking is described as *light* from a human perception standpoint and no structural damage is expected.

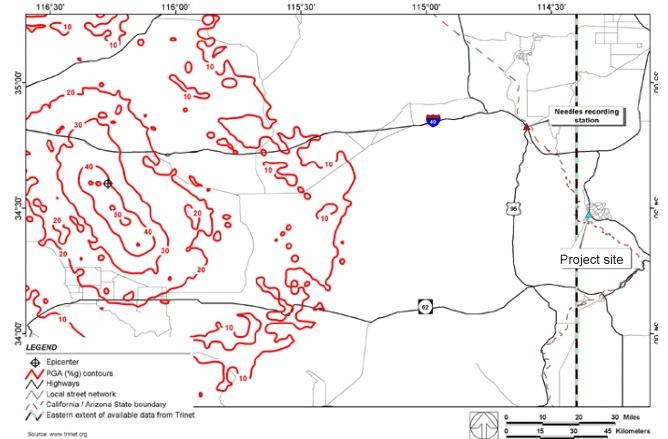
peak ground acceleration of 0.071g was recorded at the Needles station (Fig. 9). Again, the peak ground acceleration value suggests a low possibility of any structural damage.

Fig. 9. Peak acceleration map for the October 16, 1999 Hector Mine Earthquake (based on TriNet data).

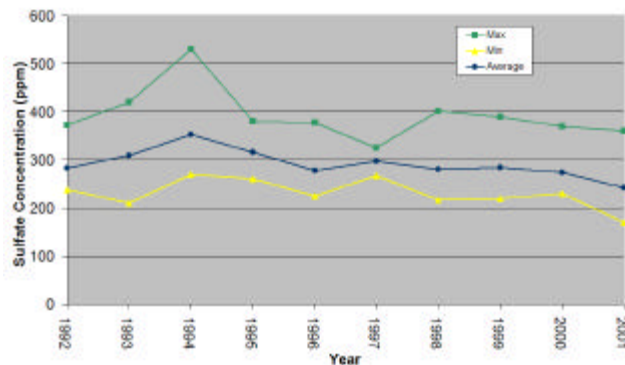
Fig. 10. Sulfate content data from the City Water Department.

Sulfate is classified under the secondary maximum contaminant level (SMCL) standards by the Environmental Protection Agency (EPA). The SMCL for sulfate in drinking water is 250 milligrams per liter (mg/l), sometimes expressed as 250 parts per million (ppm). Secondary Standards are based on taste, odor, color, corrosivity, foaming and staining properties of water. As shown in Fig. 10, the average sulfate concentration in the Lake Havasu City water exceeds the EPAs SMCL.

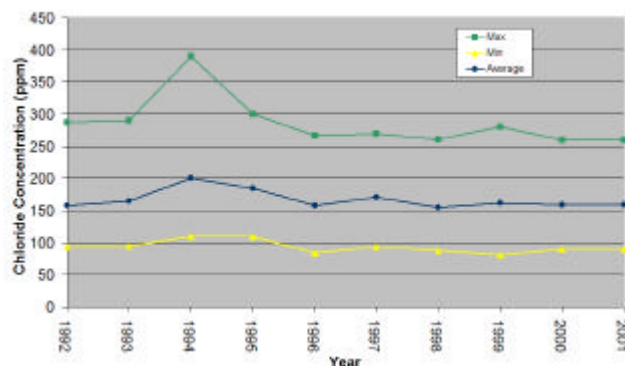
Fig. 11. Chloride content data from the City Water Department.

The SMCL for chloride in drinking water is also 250 ppm. As shown in Fig. 11, the average chloride concentration in the Lake Havasu City water is lower than 250 ppm, however maximum levels exceed the EPAs SMCL.

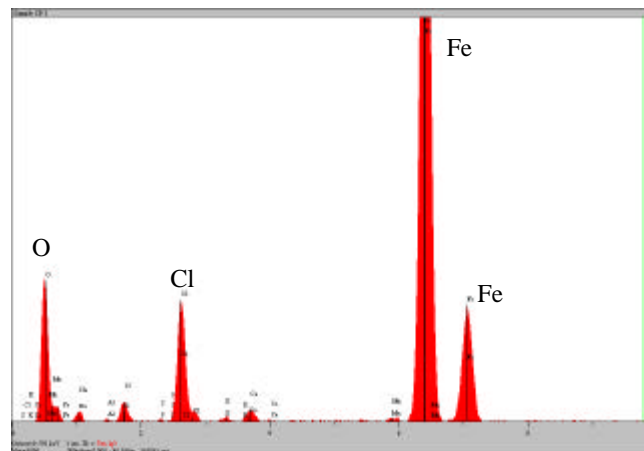
Scanning Electron Microscope (SEM) and Energy-Dispersive Spectroscopy (EDS) on three reinforcement and corrosion product samples was carried out to determine the elemental composition of the corrosion products. The results of the EDS analysis detected chloride ions on the corroded reinforcement samples and in the corrosion product (Fig. 12).

Fig. 12. Example of Electron Dispersion Spectroscopy (EDS) result for corroded reinforcement specimen
