Evaluation of Safety Performance of Fractured Joints in Steel Truss Bridge

Abstract

The Ayeyarwady bridge (Yadanarbon) spans the Ayeyarwady river linking Mandalay suburb and Sagaing city, approximately 2000 feet to the north of the old Ava bridge. It is the first longest span steel Arch bridge in Myanmar and also the gateway to Yangon, Mandalay and any other regions in the country. It comprises two units of 2*112 m continuous steel truss and one unit of 3* 224 m continuous arch truss. The main bridge is 1125.8 m long, its approach on the Mandalay side is 347 m long and on the Sagaing side is 780 m. The carriageway consists of four lanes for motorized traffic and two footpaths for pedestrians on each side of the truss. The truss is 16 m wide, and the free headroom of the carriageway is 5.5 m. The pedestrian footpaths externally on both sides of the truss are 1.8 m. It is designed by China CAMC Engineering co.ltd (CAMCE) and constructed by Public Works of Ministry of Construction in 2001. Some DG suspenders were cracked at wind velocity of 35 miles per hour during erection and its suspender design have been changed after wind tunnel test in China. The construction work was complete

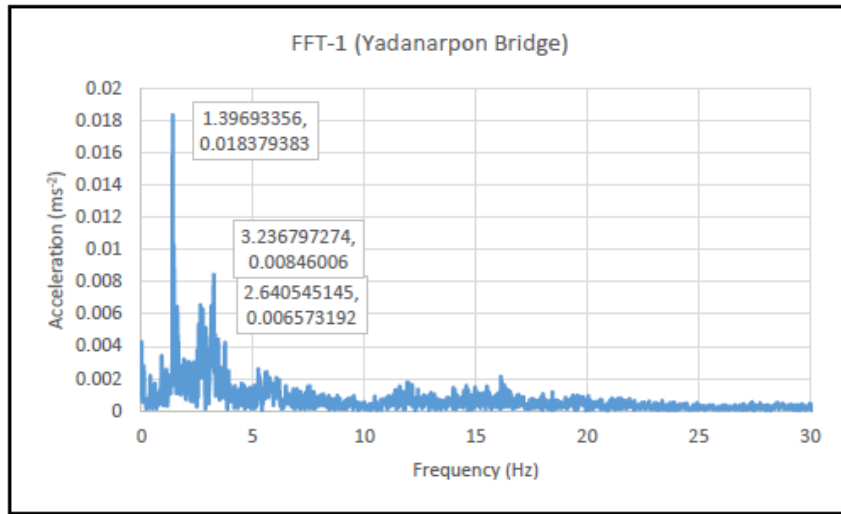
Figure 5: Example of FFT graph for Yadanarpon Bridge

- The fundamental frequencies of some modes of the bridge were found to be around 1.4 Hz, 2.6 Hz and 3.2 Hz by converting the vibration data to FFT graphs (see Figure 5).
- The average values for the wind speed, temperature, relative humidity and atmospheric pressure were measured as 1.9 m/s, 32.6°C, 62.8%, 996 hPa respectively.
- Bolt axial forces are shown in Table 5. According to the Japanese standard and AASHTO, the introduced bolt axial force for bolt of which diameter is 24mm and strength class is F10T or 10.9 should be 238kN and 257kN respectively. Bolt axial force of Bolt 3 and 4 are less than the other bolts due to corrosion (see Figure 6).

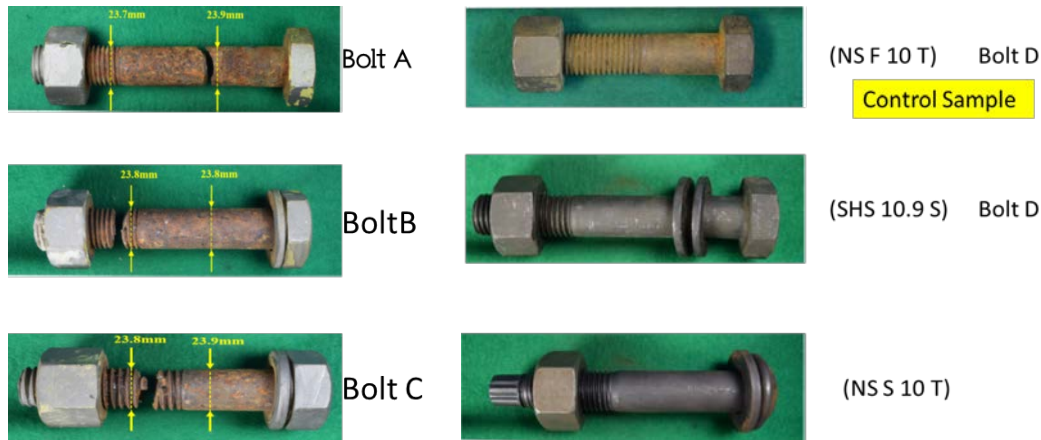
Figure 7: Samples of high strength bolts

Radial fractures occurred in the cylindrical part of Bolt A and in the thread root of Bolts B and C.

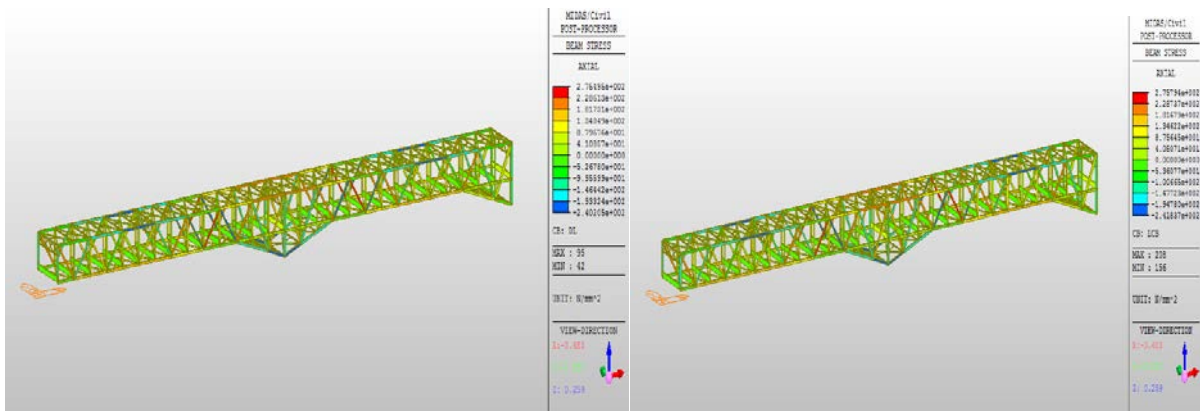
Figure 18: Stress due to dead and service load of truss bridge

Maximum stress of truss bridge (Figure 18) for dead load and that of service load is 275 MPa. For arch bridge (Figure 19) maximum stress for dead load is 158 MPa and that of service load is 248 MPa. Allowable stress is 370 MPa and stresses are within allowable limits.

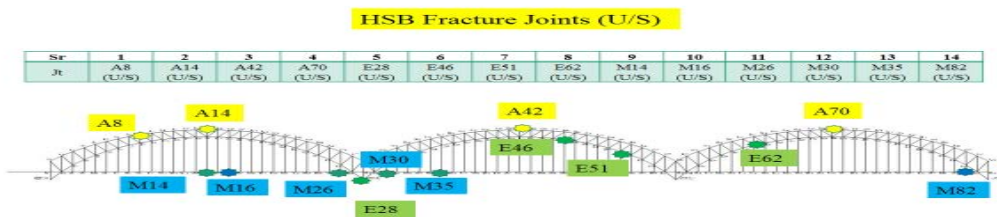
Figure 20: Considered fractured joints of arch bridge

Safety performance of fractured joints illustrated in Figure 20 are calculated based on analysis results of Midas Civil. A8, A14, A42 and A70 shown in yellow color are top chord joints. E28, E46, E51 and E62 of green color are bottom chord joints and M14, M16, M26, M30, M35, and M82 of blue color are middle chord joints. Their corresponding safety performance are shown in Table 10. Table 11 shows safety factor and percent fracture of considered joints.

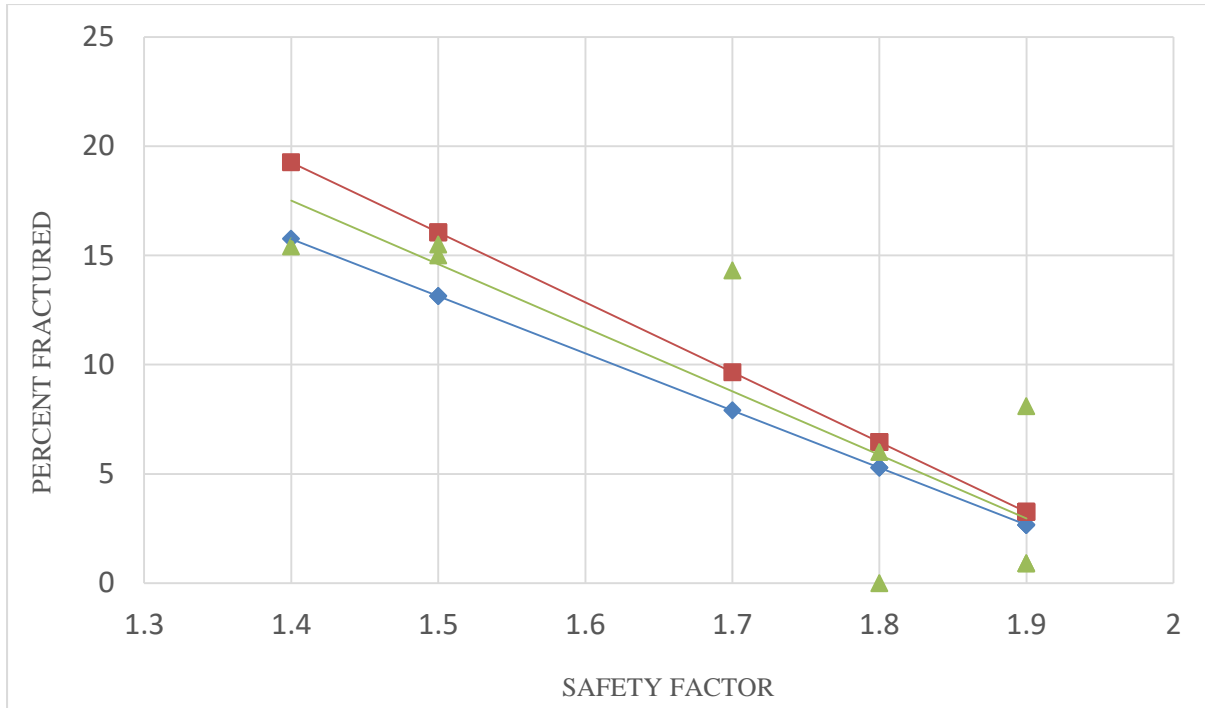
Figure 22: Safety performance of fractured joints with 10% variation

It can be seen that percent fracture decrease as safety factor increase (see Figure 21).
