DAMAGES CAUSED BY 3/11 GREAT EAST JAPAN EARTHQUAKE ON COASTAL DRAINAGE PUMPING STATIONS ALONG SENDAI BAY

H. Tanji¹, H. Kiri¹ and T. Nakaya¹

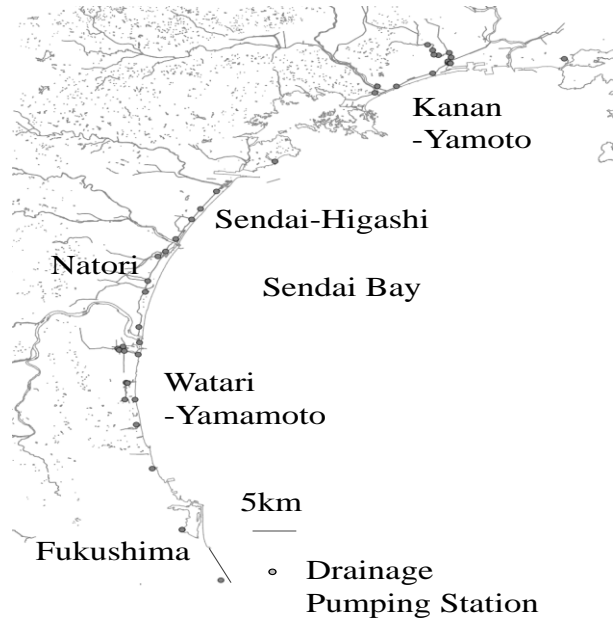
Fig. 1 Location of studied drainage pumping stations

The low-lying land along Sendai Bay was historically tidal flats and lagoons, with the land in some areas lying below sea level, particularly around the Kitakami River and reclaimed land. Figure 1 shows the Jyo River (Kanan-Yamamoto area) basin below sea level. In Fukushima Prefecture, the Yasawaura land reclamation area is below sea level. The DPS of Yasawaura is shown at the southern end in Fig. 1.

The earthquake in 2011 caused land subsidence of some low lands, of up to 100 cm. This subsidence increased the inundation damage and made drainage more difficult. In Fig. 1, the Kanan-Yamamoto area suffered land subsidence of 60 cm.

are located at the downstream end of a drainage canal or the lowest point in the basin, and so are located along rivers or on the coast. Figure 1 shows a few DPSs located along the coast: Agawanuma, Yoshida, Hanagasa 2 and Ooyachi. Typical DPSs are located along Teizanbori canal, Torinoumi lake and Ushibashiga lagoon. Because of fishing rights, direct drainage to Sendai Bay is difficult. These off coast locations may decrease the damage caused to DPSs by tsunami. Teizanbori canal is located on the coast. Although the tsunami destroyed coastal banks, the Teiaznbori canal remained. This canal helped reduce inundation by using mobile pumps. Distance is measured from the coast. DPSs are located along rivers, canals and lakes. Therefore, the distances are the lengths from the coast to rivers, canals and lakes.
