The natech events during the 17 August 1999 Kocaeli earthquake: aftermath and lessons learned

S. Girgin

European Commission, Joint Research Center, Institute for the Protection and Security of the Citizen,
TP 361, Via E. Fermi 2749, 21027 Ispra (VA), Italy

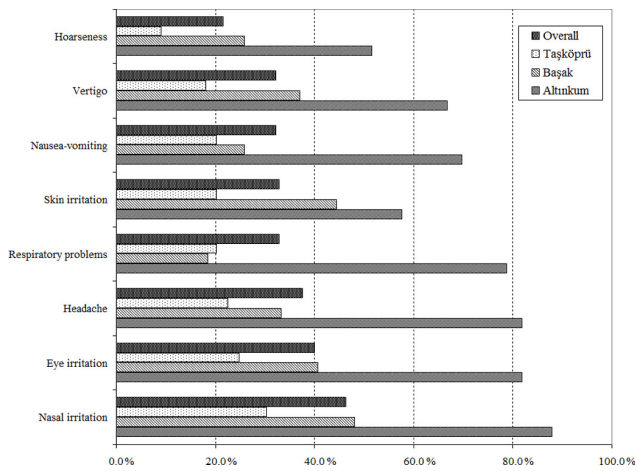
Inhabitants of settlements in the vicinity of the facility suffered symptoms of acute toxicity, such as hoarseness, vertigo, nausea, respiratory problems, skin irritation, headache, eye and nasal irritation (Şenocaklı, 2003b; Aydemir, 2010b). These health problems also hampered search and rescue operations, which were mainly conducted by the local people due to lack of professional search and rescue teams. Following the evacuation order, the settlements were started to be evacuated, but exposures up to 20 h were reported (Aydemir, 2010b). Due to the natural hazard conditions, the local hospitals and clinics were overcrowded with seriously injured people. Hence, they were not able to respond properly to the poisoned people and treat the symptoms adequately (Hürtaş, 1999). Lack of communication also prevented health officials from receiving information about the properties of AN and treatment methods of its toxic effects from the experts of the facility. A public health survey conducted by the Istanbul Chamber of Medicine two months after the incident and covering 149 residents of the closest settlements to the facility, namely Altinkum, Basak and Taskopru, revealed that acute toxicity effects were observed in the majority of the survey participants from Altinkum (Fig. 4). Toxicity effects were observed to a lesser extent among the residents of Basak and Taskopru with increasing distance to the facility (Emiroğlu et al., 2000). Altinkum is located 650 m NW of the tank farm, within the 1200 m health protection zone of the facility, whereas Basak and Taskopru are situated about 2 and 2.5 km SW, respectively. Long-term health statistics are not available, hence the long-term health impacts are not known. But it was reported that among the 189 people who prosecuted the company after the incident, 17 had died from cancer and 5 additional are being treated for cancer (Aydemir, 2010a). Among the 5 members of the military fire fighting team, which responded to the spill in the first days of the incident, one reportedly died of lung cancer and another one is being treated for it (Hürtaş, 2009).

Fig. 4. The distribution of the symptoms of toxic exposure by settlements.
