STUDY OF CORROSION OF ALUMINUM ALLOYS OF NUCLEAR PURITY IN ORDINARY WATER – PART ONE

Effects of corrosion of aluminum alloys of nuclear purity in ordinary water of the spent fuel storage pool of the RA research reactor at VINČA Institute of Nuclear Sciences has been examined in the framework of the International Atomic Energy Agency Coordinated Research Project “Corrosion of Research Reactor Aluminum-Clad Spent Fuel in Water” since 2002. The study presented in this paper comprises activities on determination and monitoring of chemical parameters and radioactivity of water and sludge in the RA spent fuel storage pool and results of the initial study of corrosion effects obtained by visual examinations of surfaces of various coupons made of aluminum alloys of nuclear purity of the test racks exposed to the pool water for a period from six months to six years.

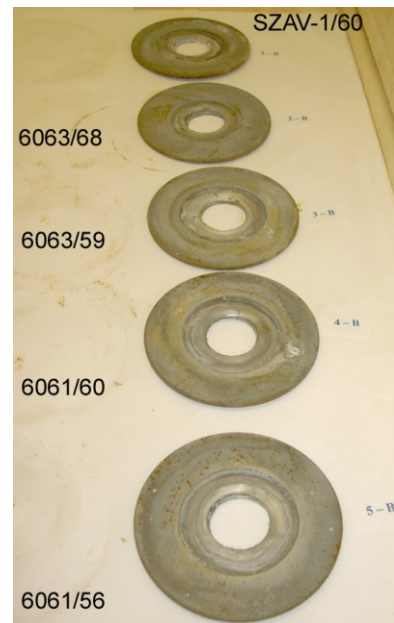
Figure 9. Front side (A) of coupon couples of disassembled Rack#1/CRP-I

Since the front side of each coupon was covered by dark-red sediment (fig. 9), effects of corrosion process could not be seen without cleaning the surfaces. Small white sediments (like jelly-mushroom type sludge) at the front side of few coupons (fig. 9) were noted. Some of these sediments were collected for further analysis. The backside of the coupons was not covered by sediment (figs. 8 and 10) and effects of the corrosion process were noted. Pitting, as a main localized form of corrosion of aluminum in water, was seen at the backside of the surfaces of all coupons. Spots of different shades of gray and black color (assumed to be aluminum-oxide) were observed at coupons too.

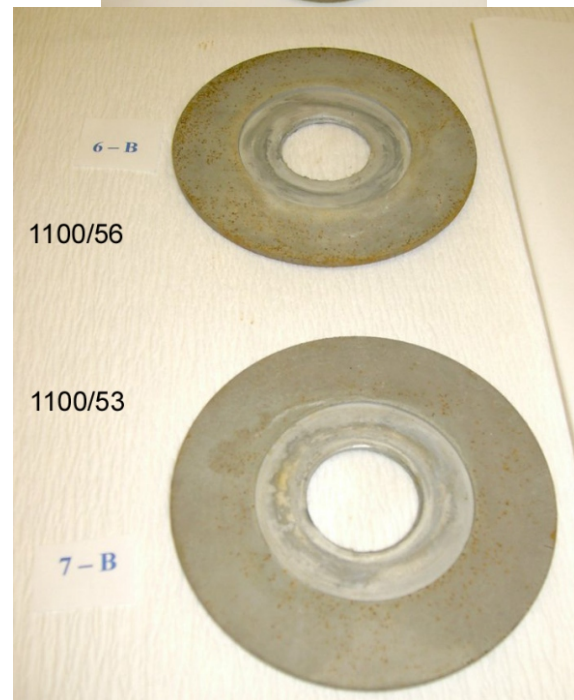
were removed from the Rack#1/CRP-I according to the IAEA Test Protocol. It was very hard to separate coupled coupons and in few cases a tool has to be applied. Photographs of the top – “the front” (fig. 9, A) and the bottom – “the back” (fig. 10, B) sides of each coupon are presented. The number beside a coupon corresponds to the type of aluminum alloy or stainless steel. The first – left number, corresponds to the upper coupon, while the second – right number, corresponds to the lower coupon of the couple. Label “SZAV”, the Hungarian spelling for SAV-1 aluminum alloy, is used at the photographs.

Figure 10. Backside (B) of coupons of disassembled Rack#1/CRP-I

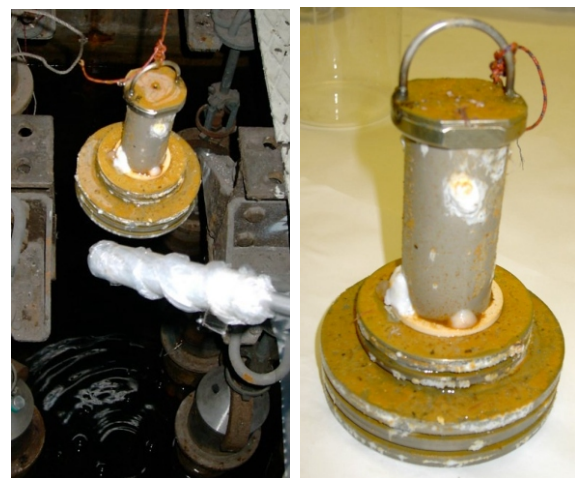
The pH factor, measured at the wet surface of the coupons, immediately after the Rack#2.1/CRP-I was with drawn, was 7.0. Gamma-ray dose rate in the vicinity of the Rack#2.1/CRP-I was about $4 \mu\text{Sv/h}$. Values of pH factor on the external surface of others coupons, determined by using pH paper, were in the range from 5.5 to 6.0. The pH factor of the water in basin No. 1 was 7.5. Initial visual examination of the

Figure 16. Rack#2.1/CRP-I after 16 months of exposition time

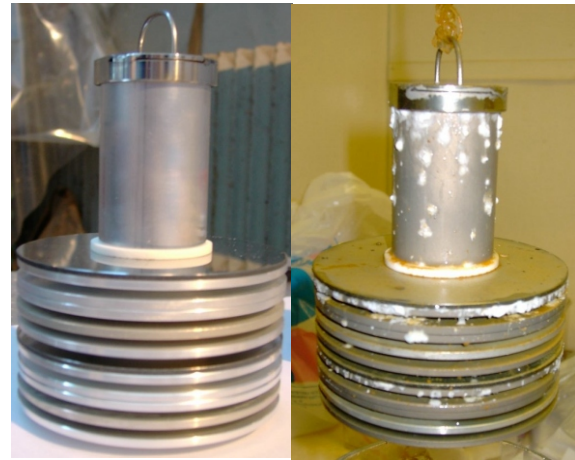
Figure 22. Rack#1/CRP-II before immersion and after 6 months of exposition time

The pH factor, measured by using pH paper just after the Rack#1/CRP-II was withdrawn at wet surfaces of the coupons, was 6.5 at the top and middle coupons and 7 at the bottom coupon. Gamma-ray dose rate measured in the vicinity of the Rack#1/CRP-II was about $3 \mu\text{Sv/h}$. The pH factor of the water in basin No. 3 was 7.5.

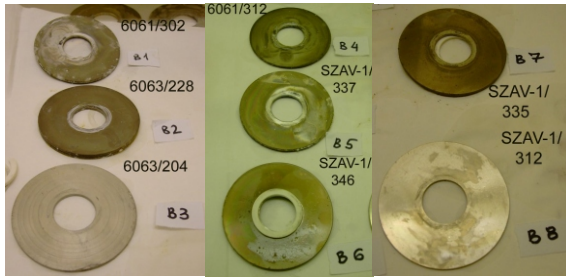
The first visual examination of the Rack#1/CRP-II showed that the front side of the coupons (fig. 23) was covered by sediments despite relatively short exposition time. There were no sediments at the backside of the coupons (fig. 24). The Rack#1/CRP-II was disassembled and all coupons were removed according to the IAEA Test Protocol. It was difficult to separate some coupled coupons, in spite of a short immersion period, and a tool had to be used. Photographs of the front (fig. 23, A) and the back (fig. 24, B) side of each coupon are presented. The number beside a coupon corresponds to the type and number of aluminum alloy or stainless steel.

Figure 24. Back side (B) of coupons of disassembled Rack#1/CRP-II

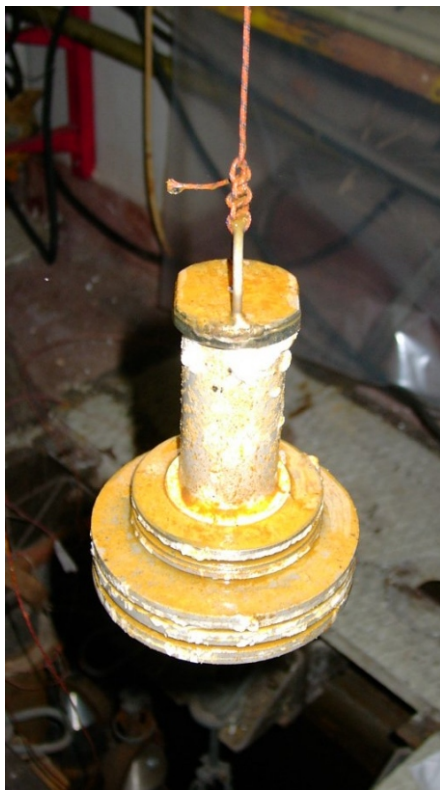
Figure 30. Rack#2.2/CRP-I after 24 months of exposition time

The pH factor, measured just after the Rack#2.2/CRP-I was withdrawn at the wet surfaces of the coupons, was from 5.6 to 5.9. Gamma-ray dose rate in the vicinity of the Rack#2.2/CRP-I was about $3.5 \mu\text{Sv/h}$. Value of pH (obtained by using pH paper) on the external front or back surfaces of the middle coupons was 6.5, while pH factor measured deep inside the rack, between coupons, was 5.3. The pH factor of water in basin No. 1 was 7.0.

Initial visual examination of the Rack#2.2/CRP-I showed the same effects noted at all racks. The backside of the coupons was not covered by sediment, as it was the case at the front sides. The Rack#2.2/CRP-I was disassembled and all coupons were removed according to the IAEA Test Protocol. It was difficult to separate coupled coupons and a tool was used. Photographs of the front (fig. 31, A) side of each top coupon (including coupons in couples) are presented. In the case of couples, the surface of the coupled side of the bottom coupon is shown. The number beside a coupon corresponds to the type of aluminum alloy or stainless steel.

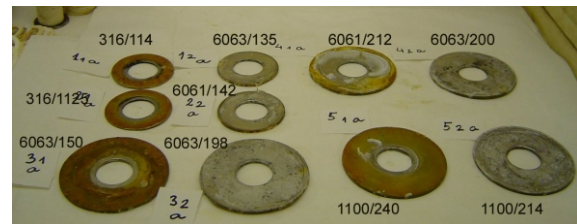
Dark-red sediments covered the front side of the coupons (fig. 32) that was exposed to water and ef-

Figure 31. Front side (A) of coupons of disassembled Rack#2.2/CRP-I

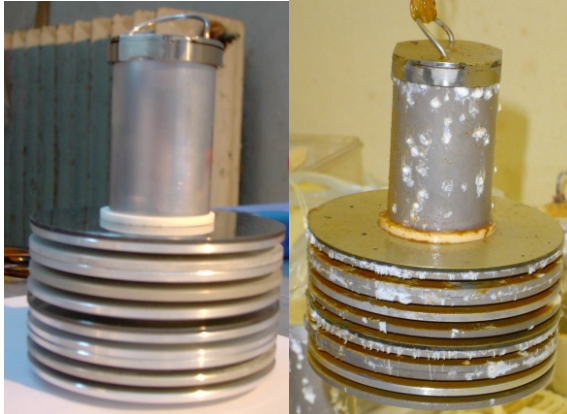
Figure 38. Rack#2/CRP-II before immersion and after 12 months of exposition time

Value of the pH factor, measured by using pH paper, immediately after the Rack#2/CRP-II was withdrawn, at wet surfaces of the coupons, was 6.5 at the top and middle coupons and 6.0 at the bottom coupon. Gamma-ray dose rate measured in the vicinity of the Rack#2/CRP-II was about $4 \mu\text{Sv/h}$. The pH factor of water in basin No. 2 was about 7.5. The first visual examination of the Rack#2/CRP-II showed that backside of the coupons were not covered by sludge deposits. Sediments covered only the front side of the coupons.

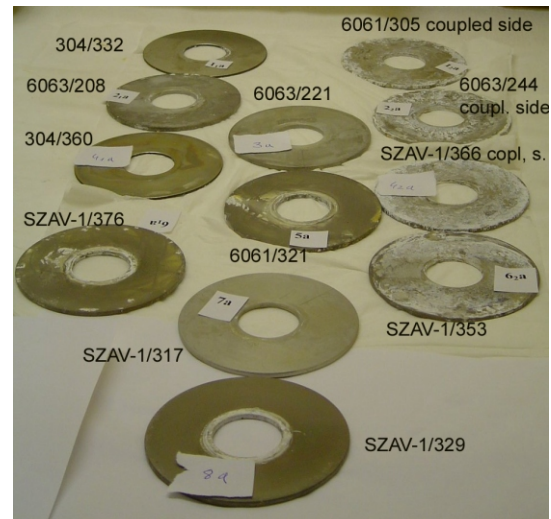
The coupons were treated by 5% phosphoric acid solution immediately according to the IAEA Test Protocol for about 3 minutes with the aim to remove sediments and clean the surfaces. After that process, the coupons were examined visually with the aim to study corrosion effects. Pitting, as the main localized form of corrosion of aluminum in water, was seen at the surface of almost all coupons. Spots of different shades of gray and black color (assumed to be aluminum-oxide) were observed at

Figure 39. Front side (A) of coupons of disassembled Rack#2/CRP-II
