*Materials* **2014**, *7*, 1866-1879; doi:10.3390/ma7031866

## Surface Characterization of Retrieved Metal-on-Metal Total Hip Implants from Patients with Adverse Reaction to Metal Debris

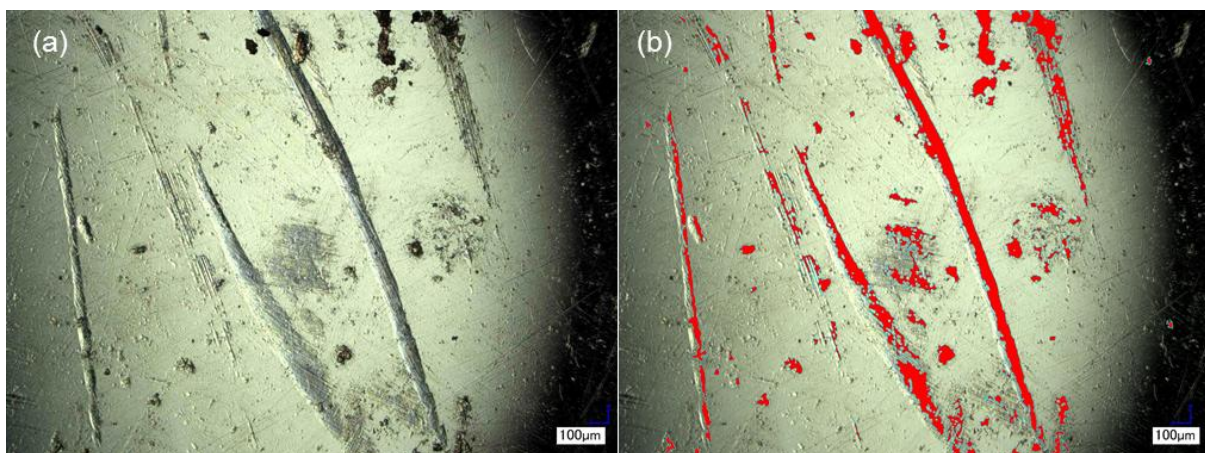
Highly scratched surfaces were detected during analysis; therefore in order to characterize and quantify the level of scratching, a 3D depth up and area measurement feature in the digital microscope software was used to make an estimate of the total scratched area (using length and depth dimensions). The 3D depth up feature allows for the capture of a full focused image across a curved plane. With this feature a set of images, with modified lighting and texture that highlighted the scratches, were obtained for each implant as illustrated in Figure 5. The scratch was defined as all slits that were deeper than  $1\ \mu\text{m}$  and thus detectable by the microscope. However, this feature offers a limitation on the level of curvature that can be brought to focus while still allowing the appropriate lighting for scratch area measurement. Due to this, only the head component of each implant was analyzed under this technique. The area measurement feature can select particular areas on an image based on the brightness and

darkness contrast or color difference in the individual image. It provides the overall area of the image and the value of the area selected. Using this feature, the highlighted scratches were selected and the percentage of the area scratched in relation to the total image area was obtained, as shown in Figure 5b. This process was repeated with all the images. The average of the different percentages for each implant was calculated and used to make an estimate of the total area scratched in the entire head interface. This measurement was then used to roughly estimate the area of material lost per year by dividing the total scratched area over the length of implantation.

**Figure 5.** Image of the curved surface of the head of one of the selected CoCr implants taken using the depth-up feature: (a) selected area for analysis; (b) example of technique used for determination of scratch areas, highlighting some of the scratches present on the surface. The actual analysis took all measurable scratches into account that were present on the surface.
