CFD simulation of multiple dust explosion occurred in a flour mill

## CFD Simulation of Multiple Dust Explosion Occurred in a Flour Mill

Paola Russo <sup>a,\*</sup>, Achraf Tabib <sup>a</sup>, Michele Mazzaro <sup>b</sup>, Enrico Danzi <sup>c</sup>, Luca Marmo <sup>c</sup>

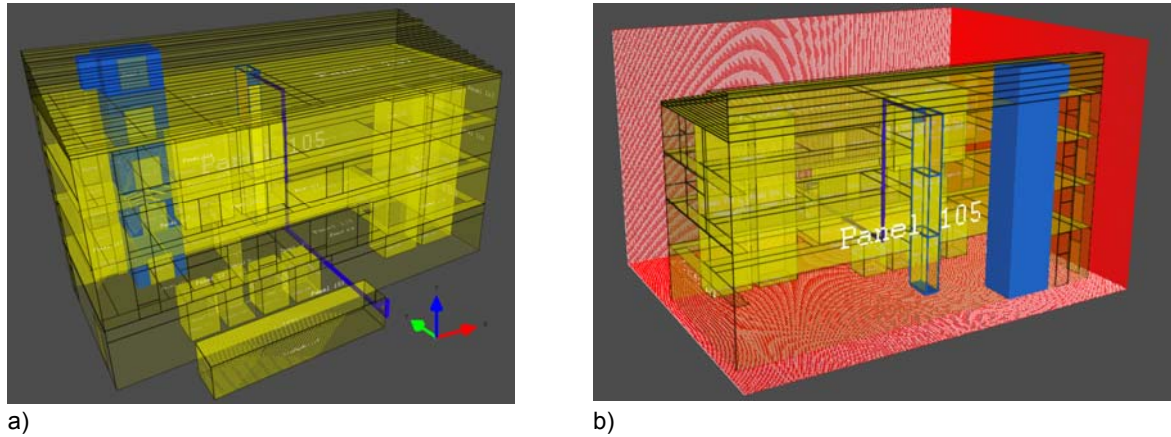
The geometry of the A area of the main building ( $28.2 \times 11.7 \times 17.0 \text{ m}^3$ ) was reconstructed in DESC with CASD code as shown in figure 3. The grid used is uniform and the cell size is 10 cm with a total of 12,217,500 cells to obtain accurate results inside the simulation volume (Figure 3). Some objects of the A area, which include the roof, the windows, the doors, some walls and the floor of the building and the walls of the silos, are represented by pressure relief panels. These devices allow to define objects with a dynamic behaviour when overpressure is detected on the surface of the panel. The characteristics of the panels (267 in total) are reported in Table 1 as obtained from NFPA 921 (2008). The fuel properties were set defining cloud volume, dust concentration, and thermodynamic and chemical data of fuel. The explosion parameters ( $P_{\max}=8.6 \text{ barg}$ ,  $K_{st}=150 \text{ bar m/s}$ ) of dust are those reported in literature for wheat flour (Mittal, 2013), as obtained in 20-L

Figure 3. Geometry of the A area of the building (a) and grid (b) used in simulations.

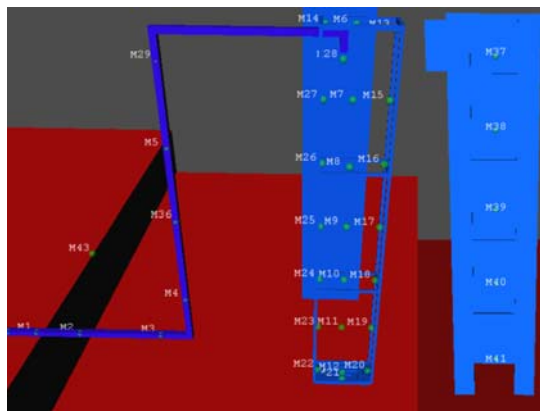
To follow the value of parameters as temperature, maximum pressure (P<sub>max</sub>), dust concentration, velocity in time and space, some monitors points were set inside the simulation volume. The monitors were located inside the pipe, the silo, the roof, the hoist and the goods receipt area as shown in Figure 4.

Monitor Point Position	
1 to 5,	Pipe
29 to 36	
6 to 28	Silo
43	Goods receipt area
42	Under-roof area
37 to 41	Hoist

Figure 4. Positions of the monitor points.
