APOLLO 12 MISSION REPORT

Mission Evaluation Team

NATIONAL AERONAUTICS AND SPACE ADMINISTRATION

March 1970

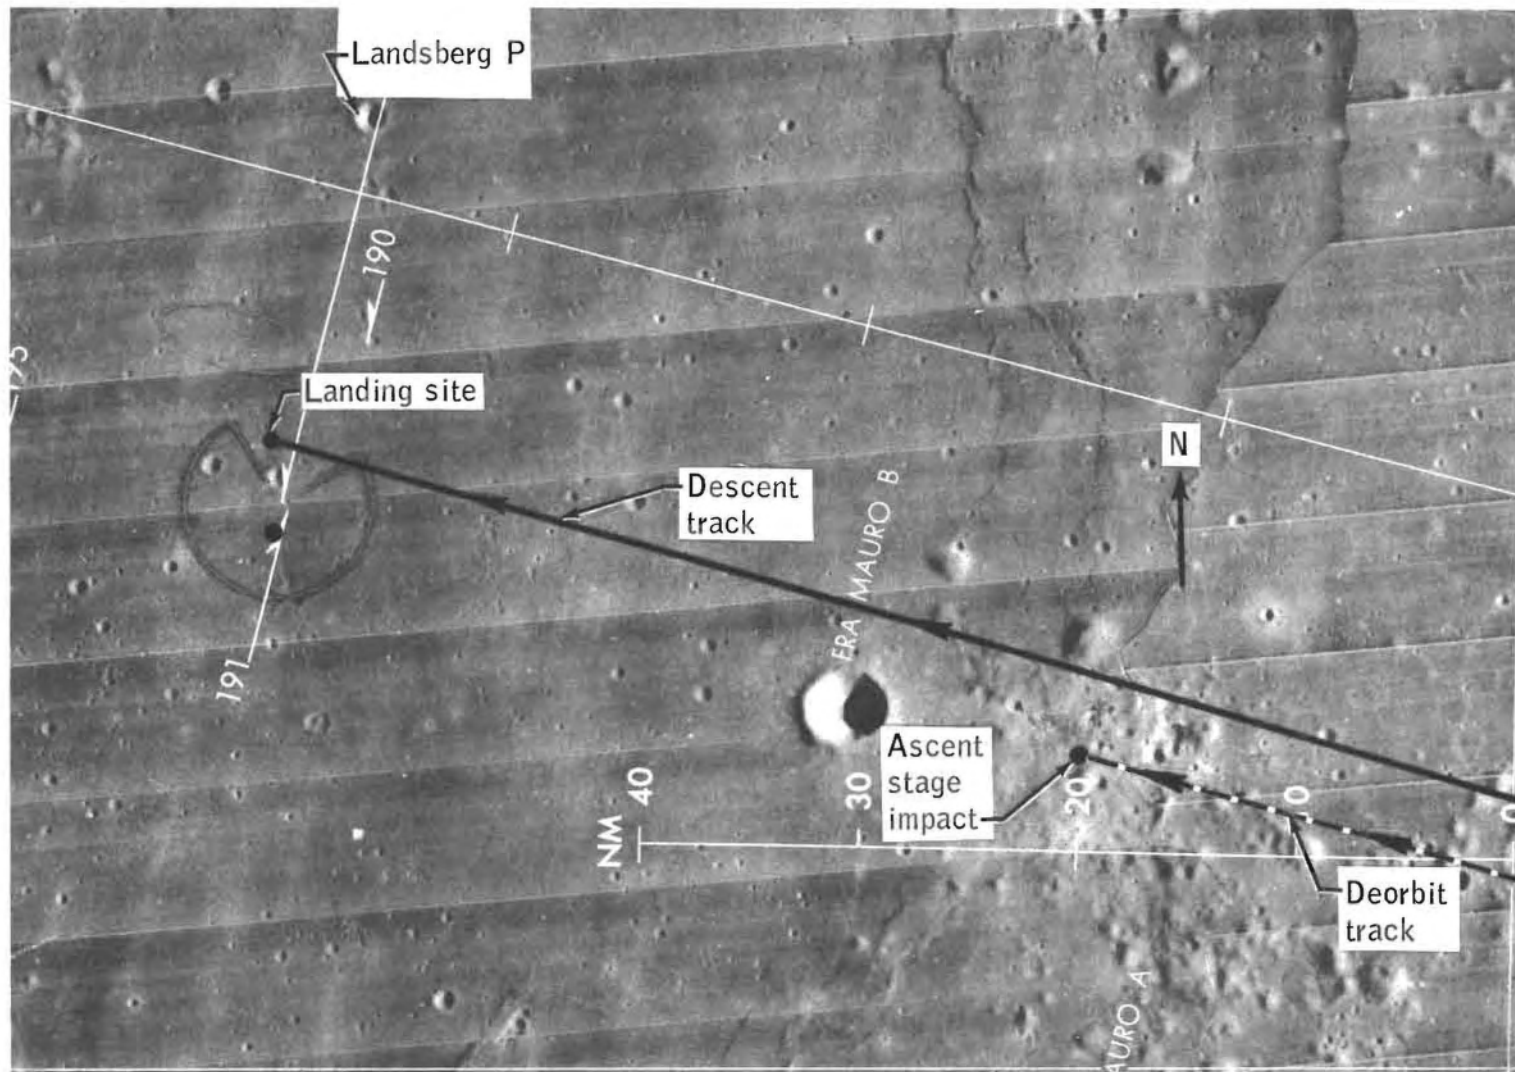
Figure 5-2.- Preliminary landing and impact locations .

The ascent stage was deorbited after jettison for a planned lunar-surface impact. A planned 200-ft/sec velocity change was provided by burning the remaining propellants through the reaction control system. The spacecraft impacted approximately 40 miles east-southeast of the Apollo landing site (fig. 5-2), as compared with an intended distance of 5 miles, primarily because of a 2-second overburn (5 ft/sec).

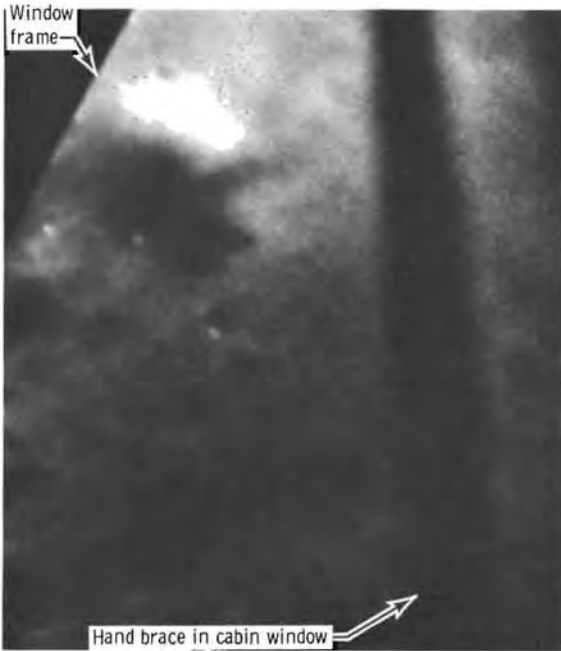
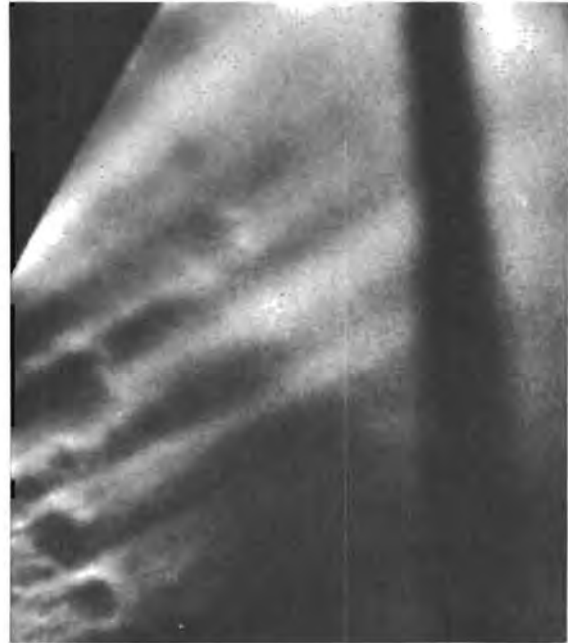
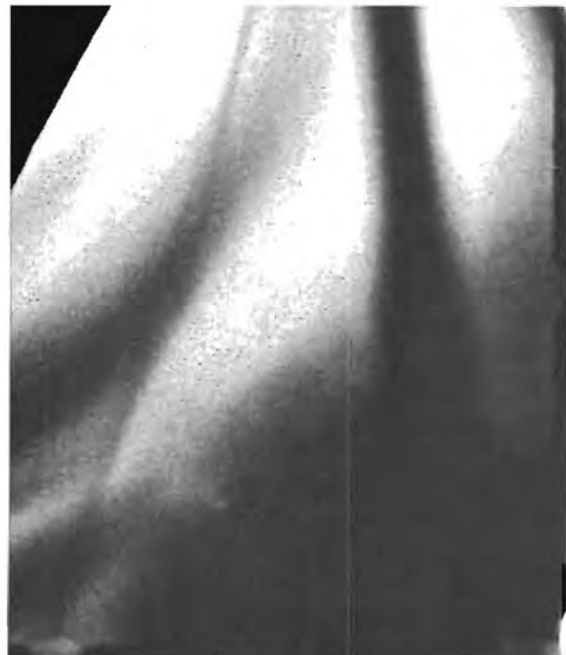
Figure 6-1. - Selected sequence photographs during landing.

Data on the degradation of visibility during landing are derived from crew observations and photographs. The photographic record is obtained from film (fig. 6-1) exposed by a 16-mm sequence camera, which is mounted

The first time that dust is detected from the photographic observations occurs 52 seconds before touchdown. This time corresponds to an altitude of about 100 feet. There is no commentary in the voice transcription relative to dust at this point, but postflight debriefings indicate the crew noticed the movement of dust particles on the surface from a relatively higher altitude. At 180 feet altitude the Lunar Module Pilot made the comment that they could expect to get some dust before long. However, the initial effect of the dust, as first observed in the film or by the crew, indicates that there was no degradation in visibility prior to about 100 feet in altitude. However, the crew stated that dust was first observed at an altitude of about 175 feet (section 9.0). Dust continued to appear in the sequence camera photographs for the next 10 or 12 seconds as the lunar module descended to about 60 to 70 feet in altitude. Visibility is seen to have degraded, but not markedly. Beyond this point, the film shows the dust becoming more dense. Although surface features are still visible through the dust, impairment of visibility is beginning. Degradation of visibility continues until the surface is completely obscured and conditions are blind. The point at which this total obscuration occurs is somewhat subjective. At 25 seconds before touchdown, the dust cloud is quite dense, although observations of the film show some visibility of the surface. From the pilot's point of view, however, visibility is seen to be essentially zero at this time, which corresponds to an altitude of about 40 feet. Therefore, the pilot's assessment that total

Compared to the Apollo 11 landing, the degradation in visibility as a result of dust erosion was much more severe during Apollo 12. During Apollo 11, the crew likened the dust to a ground fog; that is, it reduced the visibility, but never completely obscured surface features. On Apollo 12 the landing was essentially blind for approximately the last 40 feet. In order to better understand the reasons for these differences, a detailed analysis was initiated of the factors which affect erosion and visibility. The results of that analysis, although not completed, are summarized here.

analyses indicate that both of these effects contributed to the poor visibility conditions on Apollo 12. The thrust level on Apollo 12 was somewhat higher over most of the final descent and was significantly higher (about 20 percent) at about 30 feet altitude at 15 to 20 seconds before landing. This greater thrust caused a higher surface loading and therefore produced greater erosion rates. More significant, however, was the effect of the lower sun angle (5.1 degrees on Apollo 12 compared to 10.8 degrees on Apollo 11). For given dust cloud density the combined effects of light attenuation, veiling luminance, and a diffuse illumination on the surface are much more serious at the lower sun angle and can be shown analytically to produce the effects observed on Apollo 12. Analysis is continuing on a parametric variation of the factors which affect erosion and visibility. However, all these analyses are based upon certain assumptions about the optical scattering properties of the lunar dust and upon an idealized lunar model. Thus, these limitations make it impossible to conclusively prove that the effects noted can indeed be attributed to the sun elevation angle. Undeterminable differences in critical soil properties, such as cohesion, could have produced the same effects.

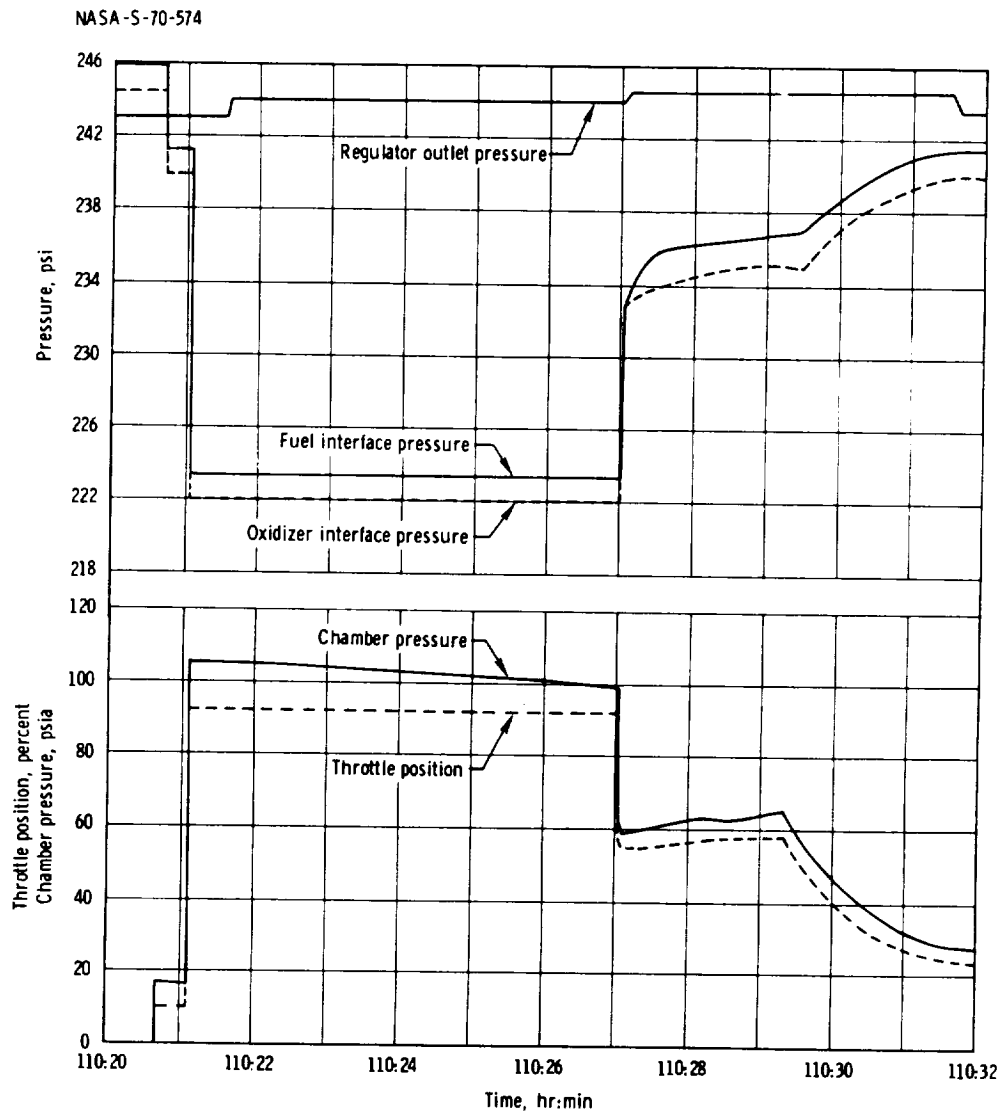
Figure 8.8-1. - Descent propulsion system performance.

The descent propulsion system performed normally during the 29-second descent orbit insertion maneuver. The powered descent firing lasted 717 seconds, and the system pressures and throttle settings are presented in figure 8.8-1. The data curve has been smoothed and does not reflect the numerous throttle changes made during the final descent. During powered descent, the oxidizer interface pressure appeared to be oscillating as much as 59 psi peak to peak. These oscillations were evident throughout the firing but were most prominent at about 55- to 60-percent throttle.

Oscillations of this type were also observed during the Apollo 11 descent. After the Apollo 11 flight, it was determined that the oscillations resulted from the instrumentation configuration and were not inherent in the system. Engine performance and operation were not affected in either flight.

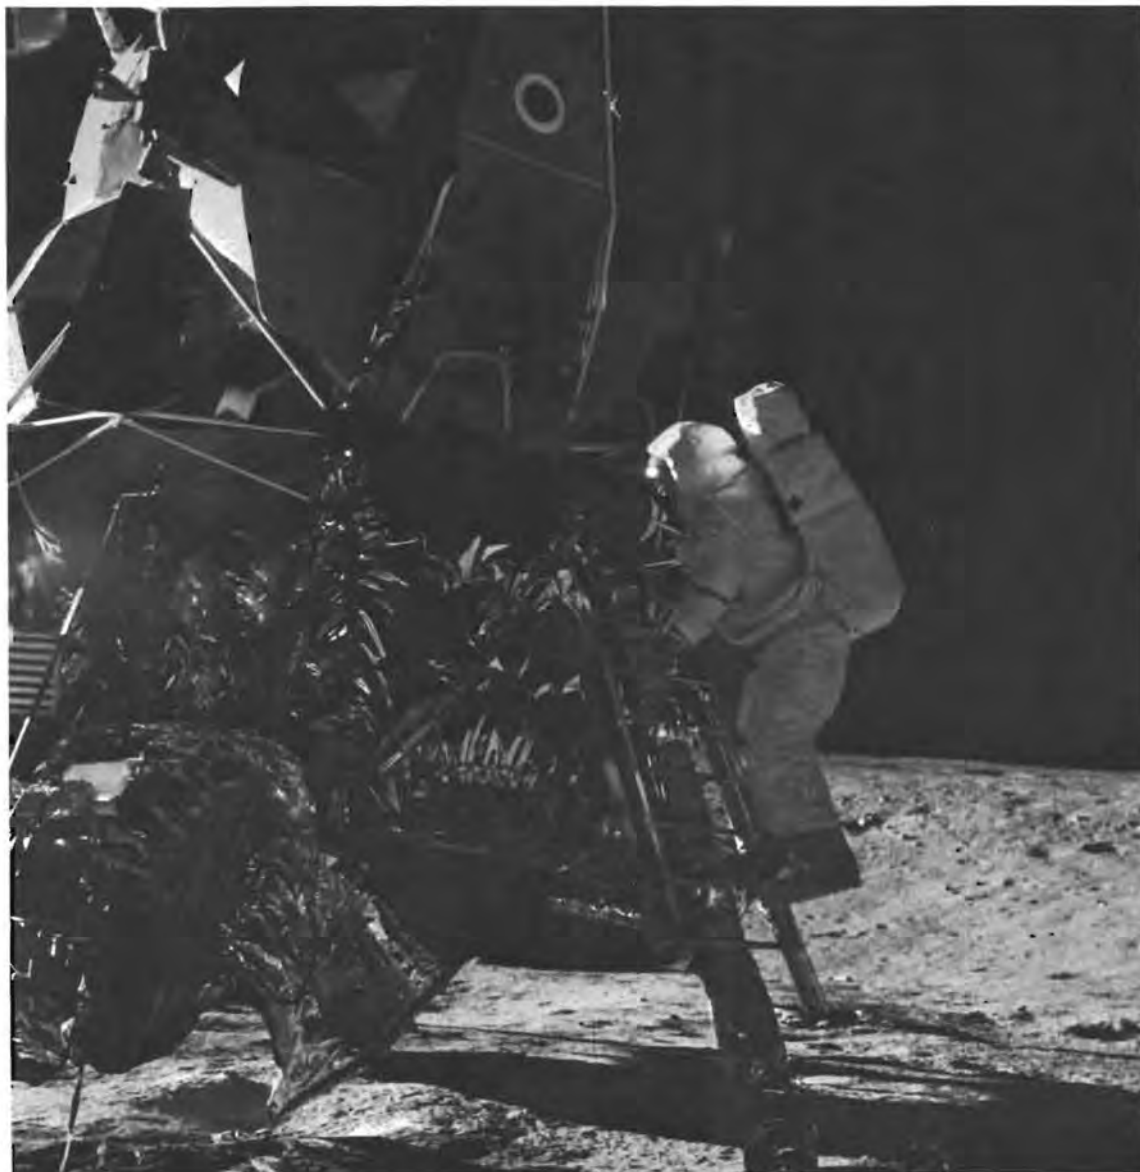
Figure 9-2.- Lunar Module Pilot descending to the lunar surface.

After the Lunar Module Pilot had egressed (fig. 9-2), he had difficulty in closing the door from the full-open to a partial position, since there is no exterior handle provided. The flap that covers the hatch lock handle cannot be reached from outside the spacecraft with the door full open, and the only other protuberance, the door covering the dump valve, is so close to the hinge line that considerable force must be used to close the door.

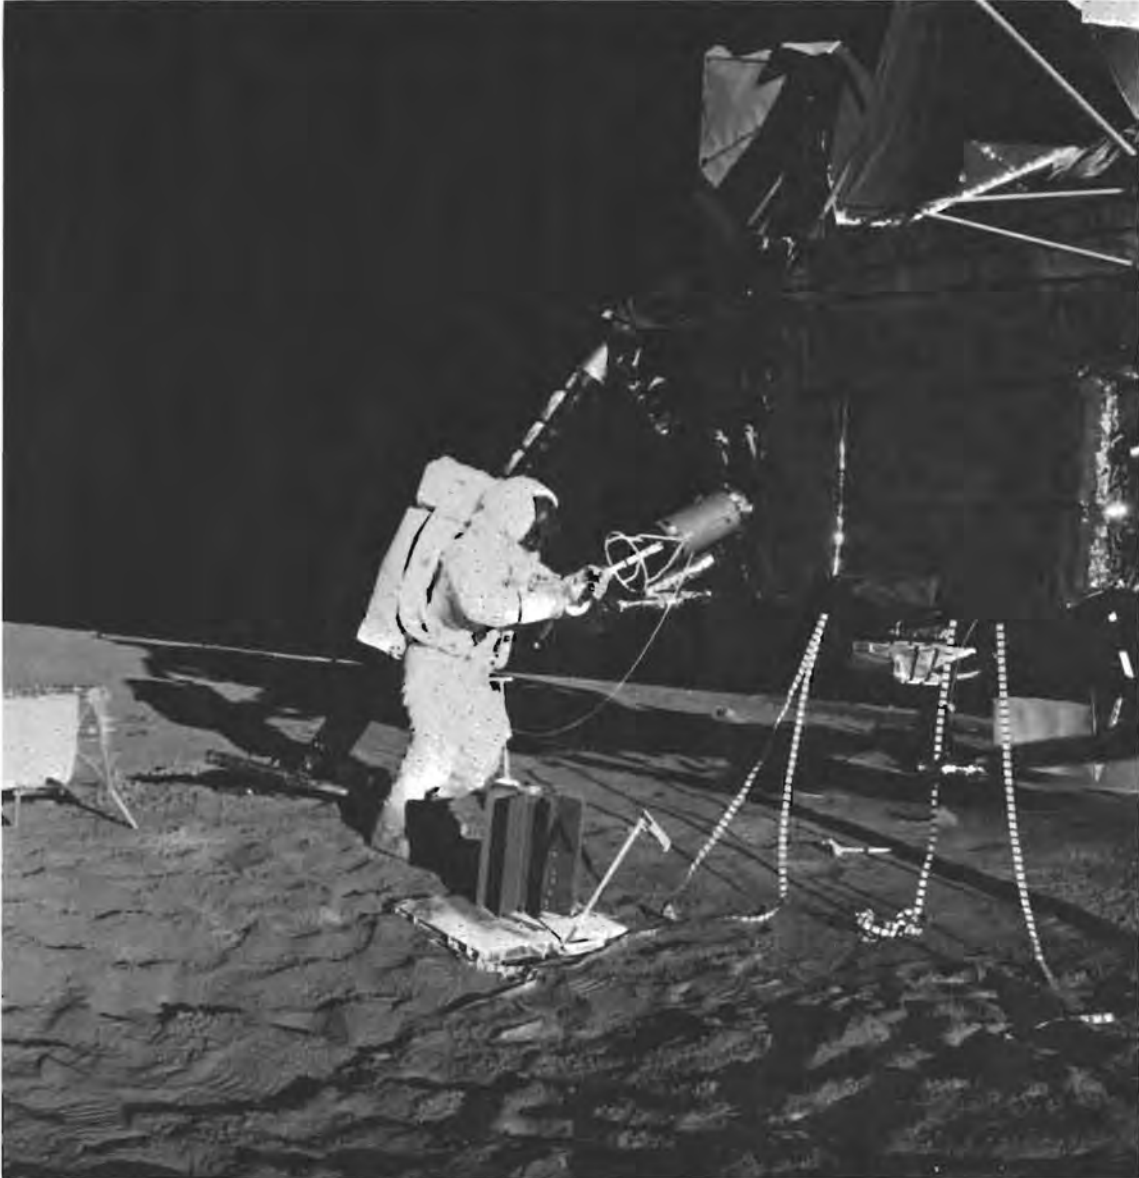
Figure 9-3.- Lunar Module Pilot extracting the fuel cask. The radioisotope thermoelectric generator is shown near the crewman.

The fuel element stuck in the cask (fig. 9-3) and could not be removed with normal force. By striking the side of the cask with a hammer

and exerting a positive pull on the element, it was possible to extend the element an additional 1/8 inch or so for each hammer blow. After the element had been extended about an inch, it became free and was removed and placed in the radioisotope thermal generator. The thermal generator was easy to fuel. Heat radiating from the fuel element was noticeable through the gloves and during the walk to the deployment site but was never objectionable.

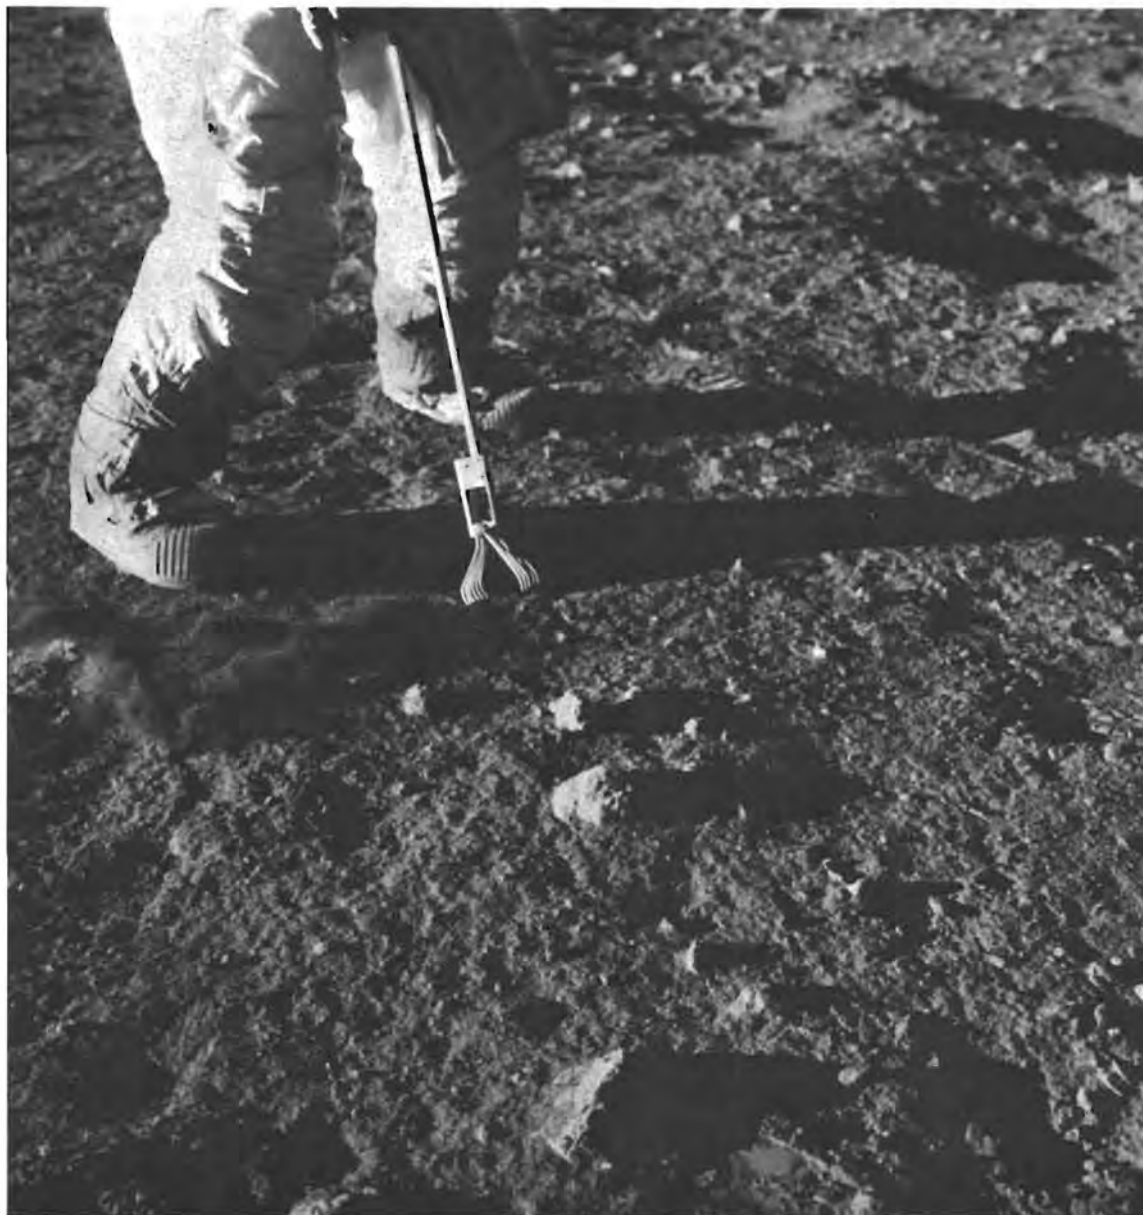
Figure 9-4.- Lunar sample collection using tongs.

The tongs are from 3 to 5 inches too short to select samples from the lunar surface easily. Further, their limited jaw size (fig. 9-4) allows selection of only very small rocks. Because of time limitations, the optimum sample size was larger than either the tongs could pick up or the sample bags would hold. The individual documented sample containers and tear-away sample bags were too small to hold the most desirable samples observed, and the tear-away sample bags were the easier of the two types to use. Furthermore, the two holding arms for the documented sample containers became bent because of interference with the suit during normal movement.

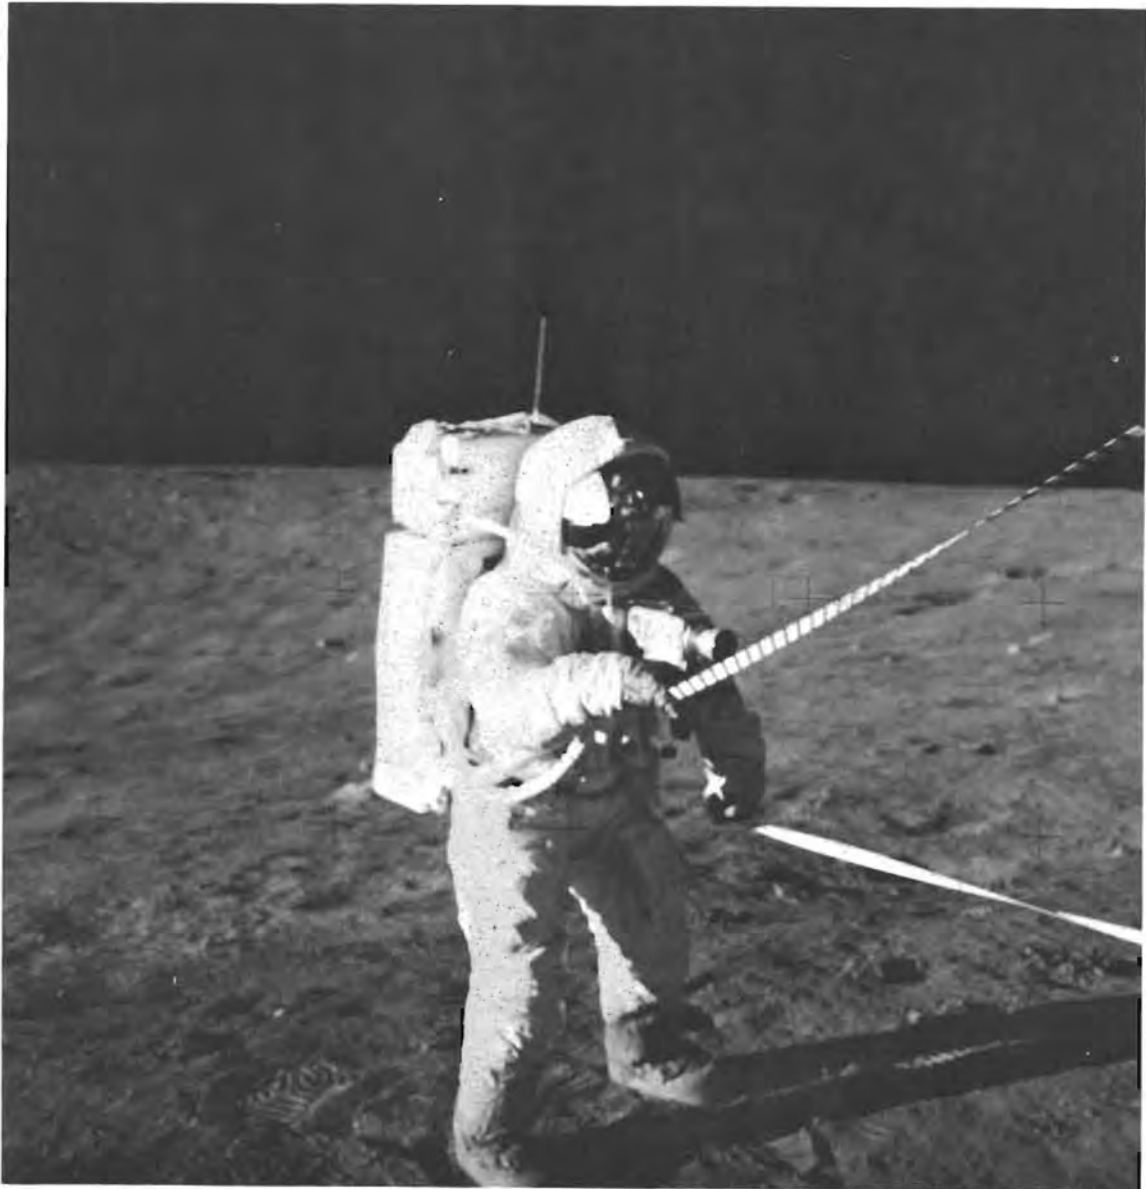
Figure 9-5.- Commander operating equipment conveyer.

The single-strap lunar surface conveyor (fig. 9-5) was easy to deploy and generally performed satisfactorily. The end of the strap resting on the surface collects dust, which is subsequently deposited on the crewmen and in the lunar module cabin. The metal pin that retains the lunar module end of the conveyor was not large enough to prevent it from slipping out of the yoke. By the end of the second extravehicular period, the lock buttons on the two hooks were extremely difficult to operate because of accumulated dust. This locking feature is not necessary.

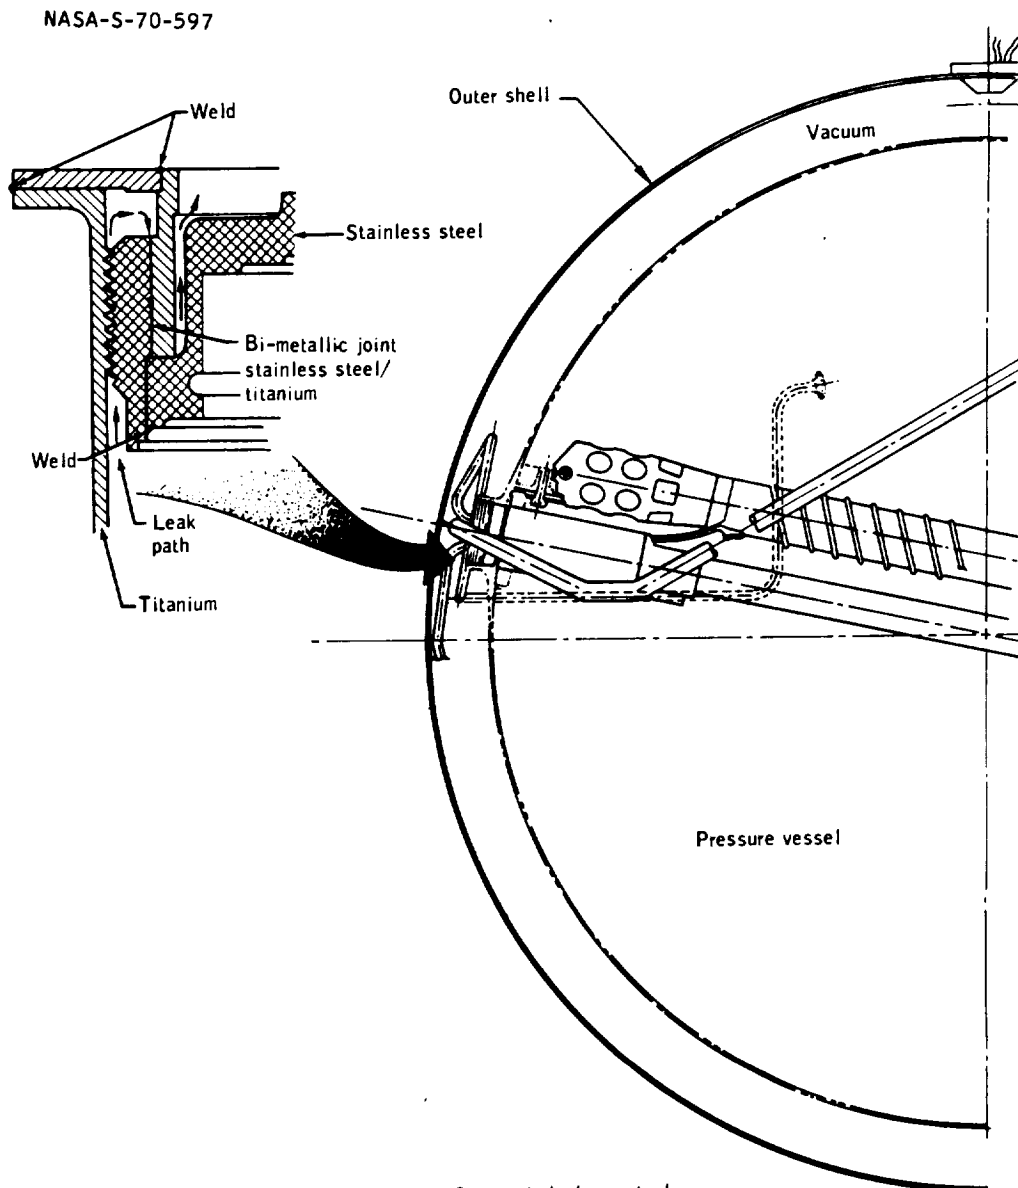
Figure 14-2.- Cryogenic hydrogen tank.

During cryogenic loading about 51 hours before launch, the heat leak of hydrogen tank 2 was unacceptable. Visual checks showed a thick layer of frost on the tank exterior, verifying an inadequate vacuum in the insulating annulus. The tank was removed and replaced. A failure analysis performed before launch identified the cause of the vacuum loss as an incomplete bond in the stainless steel/titanium bimetal joint, which permitted hydrogen to leak from the inner tank into the annulus (fig. 14-2). The bimetallic joint provides a seal between the two metals, which are not compatible for welding to each other. The joint is made from a billet such that the two metals are extruded together and machined. The machined fitting is welded in place, as shown in figure 14-2.

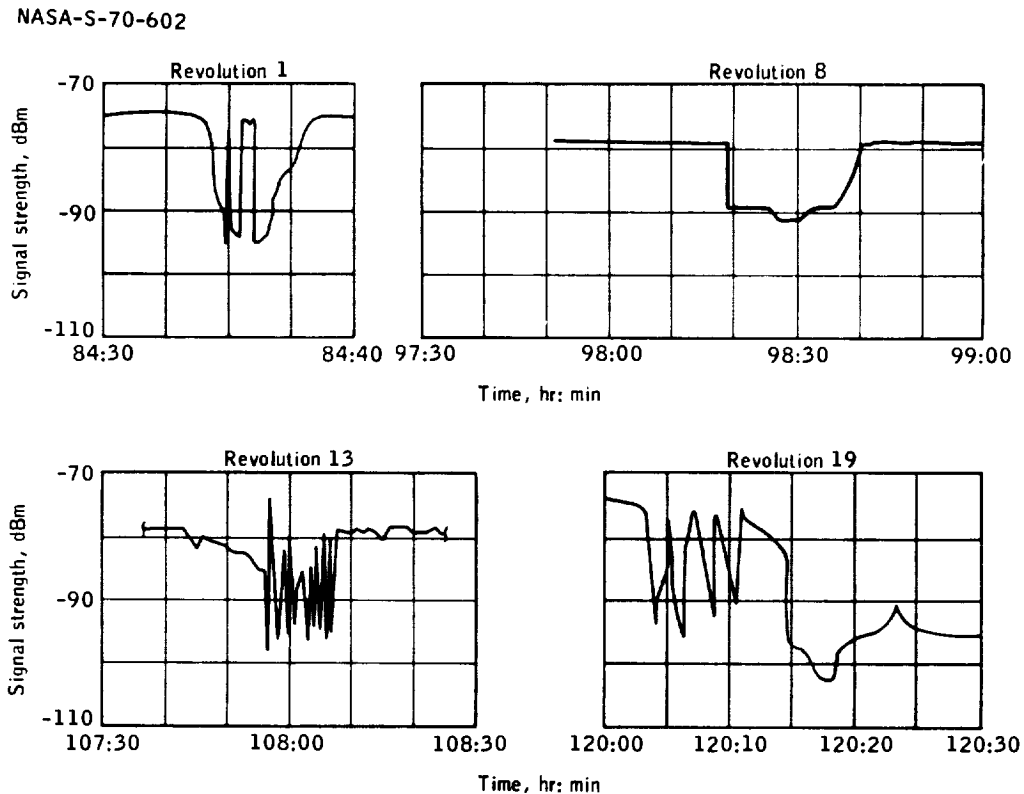
Figure 14-7.- Typical high gain antenna uplink signal strengths during abnormal operations.

Operation of the S-band high gain antenna in the narrow beam mode resulted in a decrease of approximately 10 to 12 dB in both uplink and downlink signal strength on several occasions. Illustrations of the first and other unexpected signal-strength variations are shown in figure 14-7. The first decrease occurred in lunar orbit revolution 1.

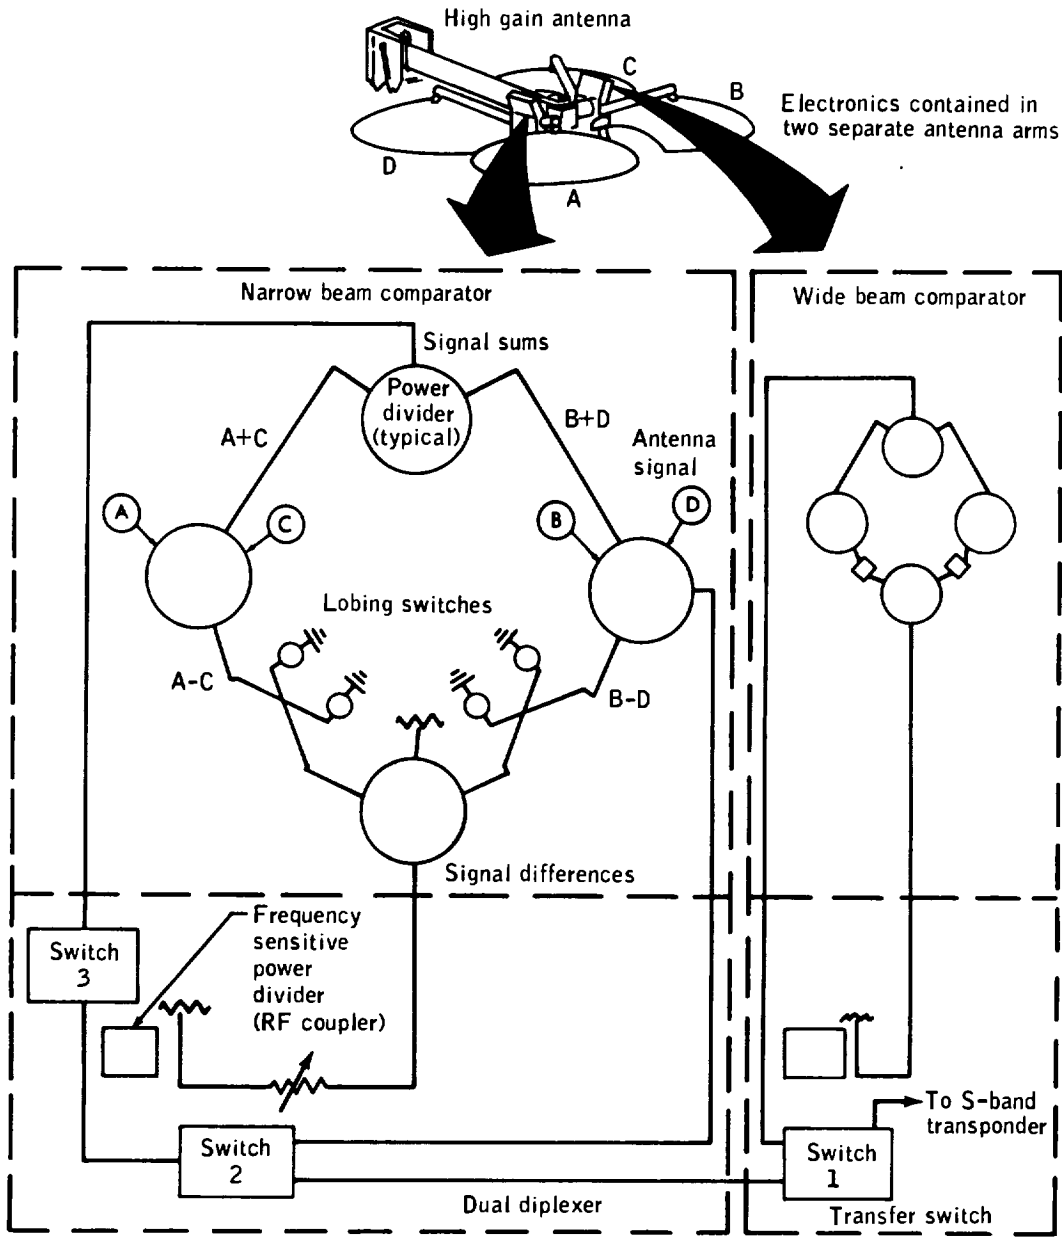
Figure 14-8.- S-band high gain antenna electronics.

There is a total of four stripline units with one contained in each of the following antenna components: narrow-beam comparator, transfer switch, and dual diplexer, as shown in figure 14-8. Based on the inflight tests, the wide beam comparator has been eliminated as a cause of the anomaly. Also, investigation of the circuitry and correlation of data has ruled out the transfer switch as being the anomaly cause. Therefore, the malfunction could only have been in the narrow beam comparator or the dual diplexer.

The narrow beam comparator combines the patterns of four dish antennas to provide the sum and difference patterns which provide the angle pointing information. Two malfunctions that could produce boresight shifts have been identified in the narrow beam comparator. Under normal operating conditions, the lobing switches function as digital phase shifters and provide either a zero or 180-degree phase shift. If a diode fault occurs that changes the phase or amplitude characteristics of either switch, tracking errors can be produced. The opening of one set of diodes would have to be intermittent to produce the observed flight anomaly, thus suggesting the presence of temperature or pressure sensitive connections in the traces that connect the diode switches. Another diode fault which can occur is a loss of the drive voltage to one of the lobing switches. In this case, the switch will provide a constant phase shift. The multiplexed difference signal for the case when the phase shift of switch 1 (fig. 14-8) is constant at 180 degrees results in unsymmetrical lobing. The antenna, in this case, will seek those pointing angles that make the elevation and azimuth angles equal in magnitude, thus suggesting that the resultant tracking error could be large and not repeatable. This condition would give the observed antenna performance characteristics. Therefore, a malfunction in the diode wiring or circuit connections is suggested. The intermittence associated with this malfunction could be explained by a temperature sensitive circuit connection (solder crack or wire break).

The major components of the dual diplexer are switches 2 and 3 and the frequency-selective power divider. The power divider is the most susceptible component for generating tracking errors. If the difference signal is attenuated by a high impedance feed-through or by incorrect phasing between the sum and difference signals, the slope of the antenna index-of-modulation curve is reduced. This decrease, in effect, reduces the total loop gain and results in an overdamped tracking system. In this case, large tracking errors would result and an antenna drift would be observed; these were the observed symptoms. Attenuation of the multiplexed difference signal can result from a trace crack or intermittent feed-through between the narrow beam comparator and the dual diplexer. Both types of failures tend to be temperature sensitive.

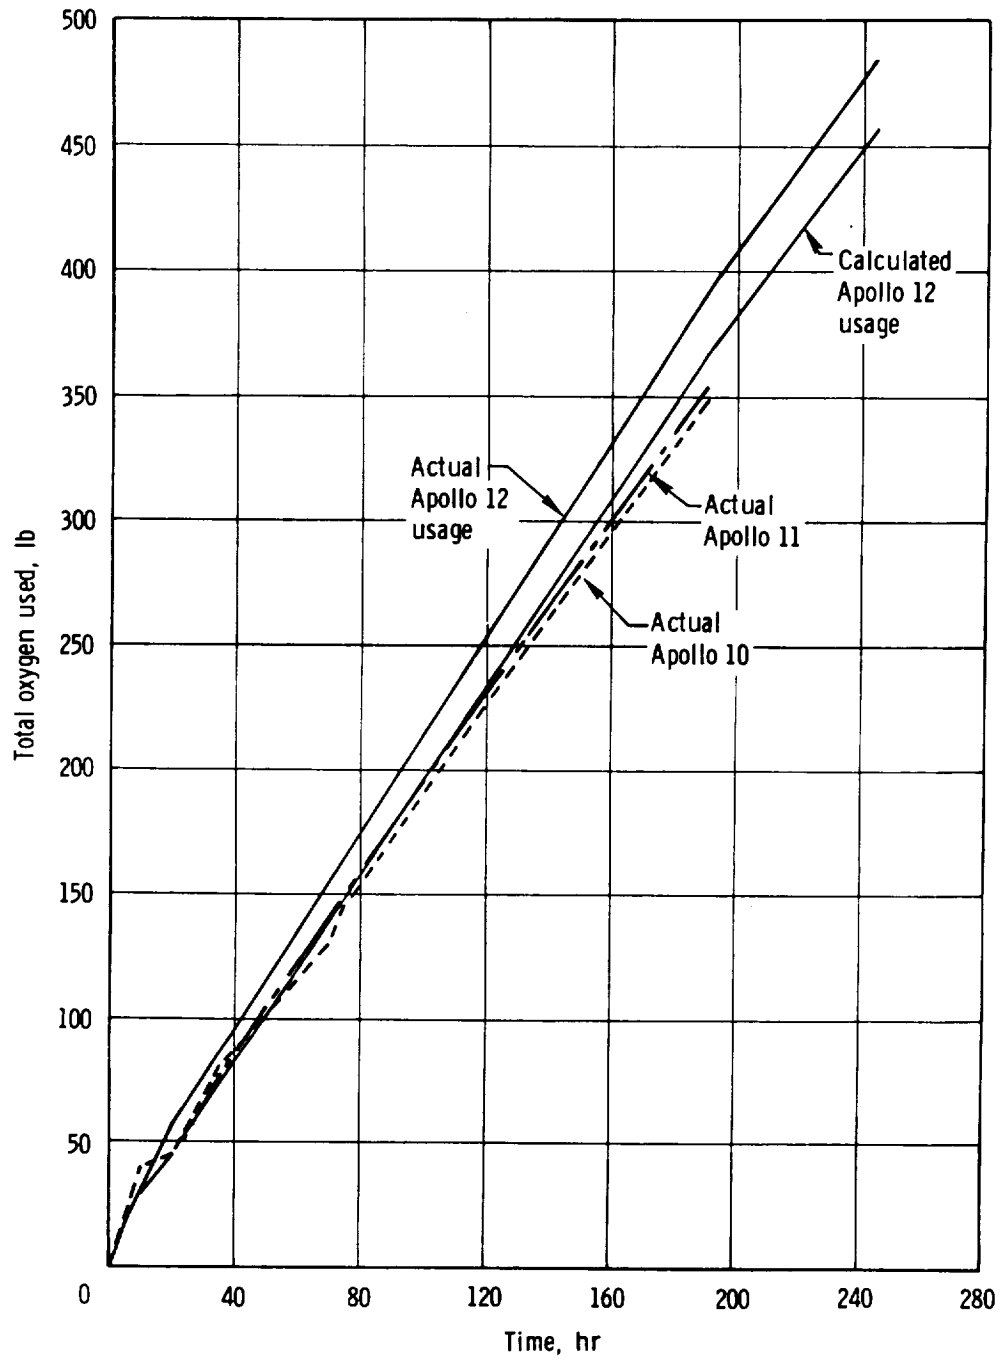
Figure 14-9. - Comparison of oxygen consumption for Apollo 10, 11, and 12.

At the end of the mission there was a discrepancy of approximately 27 pounds of oxygen between the measured total cryogenic oxygen usage and the calculated combined environmental control system and fuel cell oxygen usage, as shown in figure 14-9.

Fuel cell oxygen usage was calculated from the produced electrical current and then verified by comparison with hydrogen consumption data. Environmental control system usage is measured on a flowmeter and compared with calculated usage based on purge rates, cabin leakage rates, metabolic consumption and urine dump losses. Cabin leak rates are determined by ground tests in conjunction with flight pressure decay rates. Purge rates are calculated based on ground tests and known times for purges. Oxygen losses during urine dump operations can only be estimated. Since no excessive flow was detected downstream of the flowmeter, the source of any command module environmental control system leakage is therefore limited to the 900-psi system upstream of the meter. Figure 14-10 shows the 900-psi oxygen system and that portion of the system outside the command module that could have leaked.

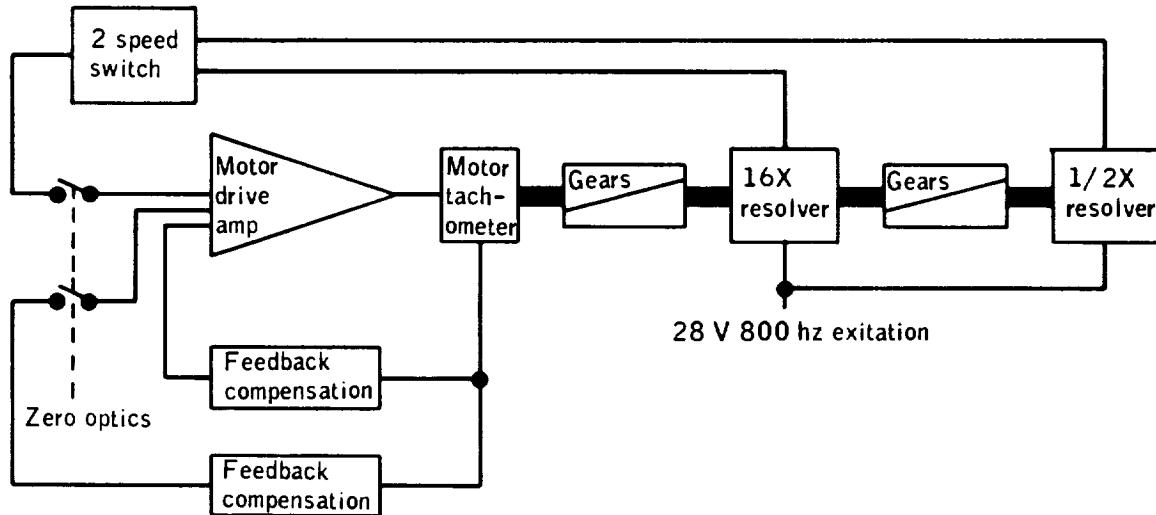
Figure 14-11.- Zero optics mode circuitry.

A number of components in the optics drive servomechanism (fig. 14-11) are used only in the zero optics mode. The optical unit and the power-and-servo assembly were removed from the spacecraft, and the servo assembly was subjected to thorough testing. The flight symptoms, however, could not be reproduced. Because of extensive sea-water corrosion, the optical unit could not be tested, but an analysis and testing of a similar unit demonstrated the cause of the zero optics anomaly to be within the power-and-servo assembly. The flight assembly was installed in a working system and has operated properly under a variety of thermal conditions. The modules associated with the optics servo were also thermally cycled in an oven, operated in a vacuum, and subjected to acceptance test vibration levels with no degradation of their performance. The modules were depotted and examined, but no cause of the anomaly could be isolated.

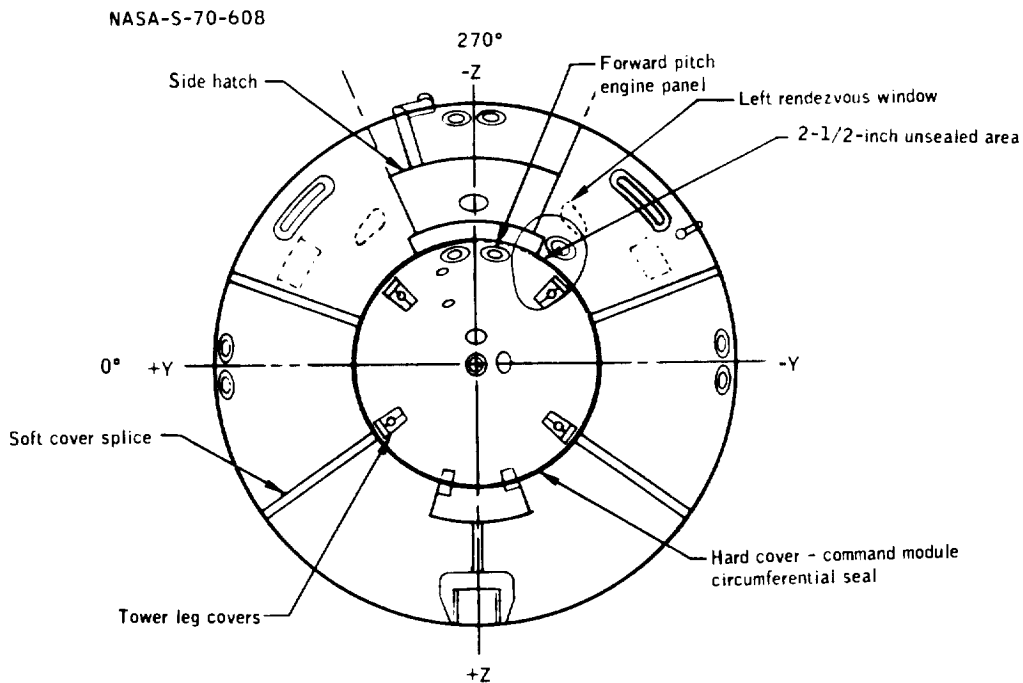
Figure 14-13.- Boost protective cover view looking aft.

The hatch, left-hand side, and both rendezvous windows of the command module had considerable amounts of contamination appearing as vertical streaks on the exterior surfaces. Before flight, gaps in the boost protective cover were noted in the hard-to-soft transition region over the left rendezvous window (fig. 14-13). A procedure requires that these gaps be sealed with a composition sealant on final installation of the boost protective cover; however, some gaps were not sealed. The crew reported that during the heavy rain just prior to launch they saw water on the exterior window surfaces and also observed water flowing over the windows at tower jettison. The water rivulets acted as collection sites for the exhaust residue during escape motor firing. After the water evaporated, the residue deposits remained on the surfaces of the windows.

For Apollo 13 and subsequent spacecraft, seals will be added to the boost protective cover to prevent leakage of rain water. Prior to flight, the hatch window cavity will be purged with a 35/65-percent mixture of dry nitrogen and oxygen to remove entrapped moisture. To further alleviate the outgassing of silicone oils, the insulation material will be removed from between the outer and inner hatch windows on future spacecraft.

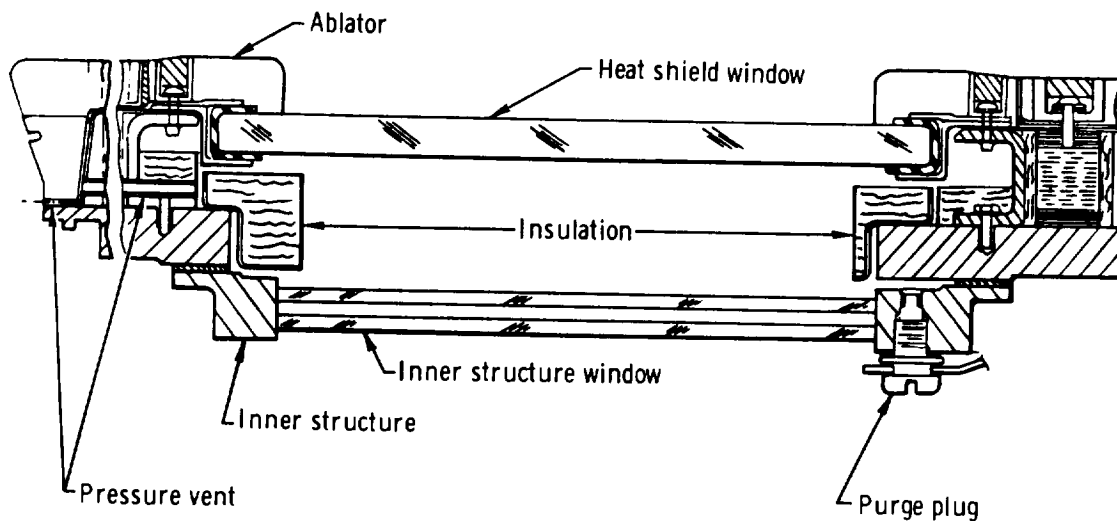
Figure 14-14. - Cross section of hatch window.

Contamination was also noted on the inside surface of the heat-shield panes on the left-hand side and hatch windows. The contamination, which disappeared on the left-hand side window after the first day, probably resulted from water entrapped between the heat shield and pressure structure in the general area of this window. The contamination on the inside surface of the hatch heat shield window remained throughout the flight and varied in size with the thermal cycles of the spacecraft. This contamination could have resulted from either entrapped moisture in the hatch area between the heat shield and the pressure structure or from outgassing of sealant materials in this area (fig. 14-14). Such outgassing has been minimal in the past three flights because the curing processes were changed to alleviate this problem. However, a chemical analysis of the contamination on the inside surface of the hatch window has shown the concentration of silicone oils to be higher than expected. These oils are the outgassed products from the material used to seal the thermal blankets near the window.

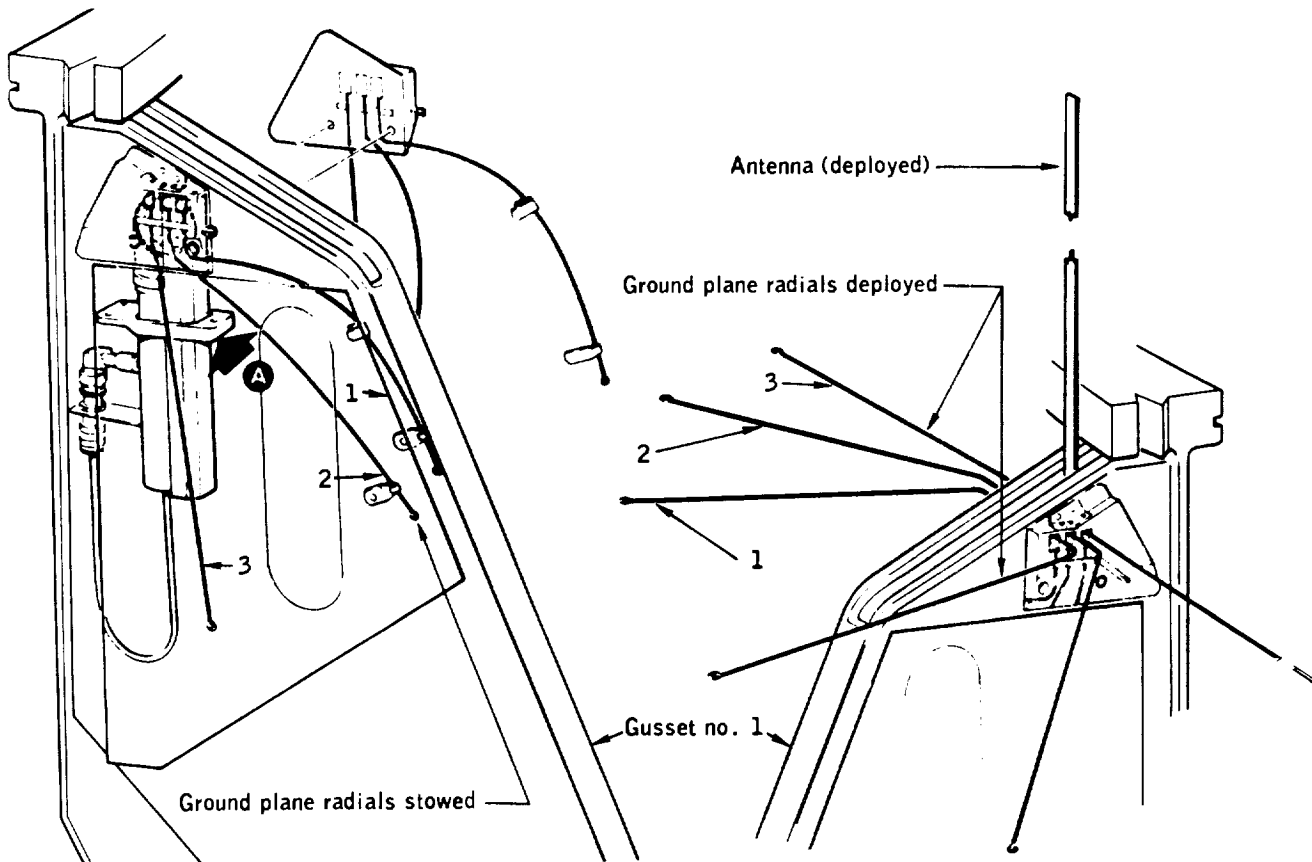
Figure 14-15.- VHF recovery antenna configuration.

During the command module descent on the main parachutes, ground plane radials 1 and 3 of VHF recovery antenna 2 (fig. 14-15) did not properly deploy. However, voice communications with the recovery forces while using this antenna were not significantly affected. Postflight examination of the antenna revealed that the cloth flap which normally covers the radials to prevent entanglement with the parachutes could be made to stick to the gusset by an adhesive substance which was inadvertently present on both the flap and the gusset. The radials would not deploy when the flap had stuck to the gusset; however, radial 1 would not always deploy, even when the flap was not stuck. A slight binding at the spring end or at the retaining clip has been experienced on radial 1.

For Apollo 13 and subsequent missions, recovery antenna 2 will be used for recovery beacon transmissions instead of voice. However, even
