APOLLO 12 MISSION REPORT

Mission Evaluation Team

NATIONAL AERONAUTICS AND SPACE ADMINISTRATION

March 1970

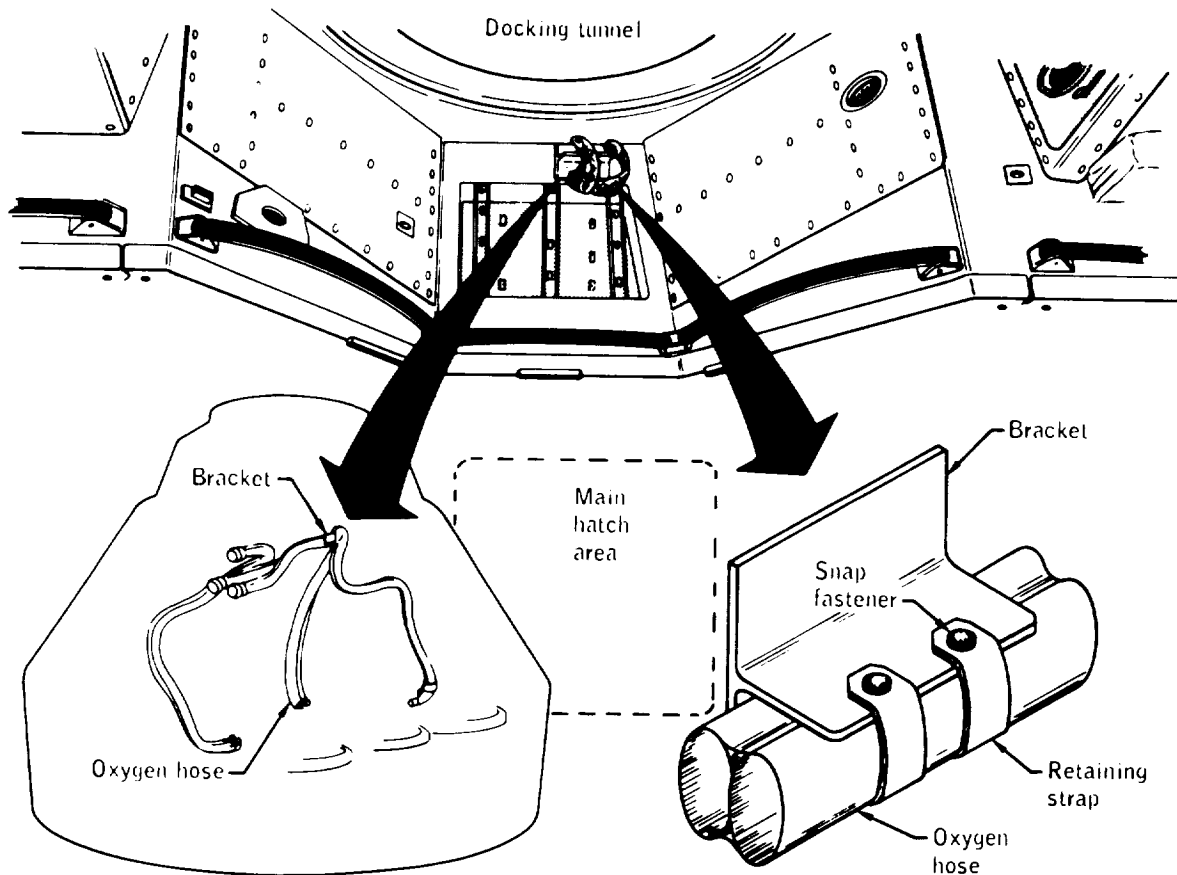
Figure 14-17.- Oxygen hose retention bracket.

At earth landing, an aluminum retention bracket for the oxygen hoses pulled loose from the main display panel (fig. 14-17). The bracket is bonded to the panel and supports four oxygen hoses, which are attached to the bracket by Beta cloth straps that snap to the panel.

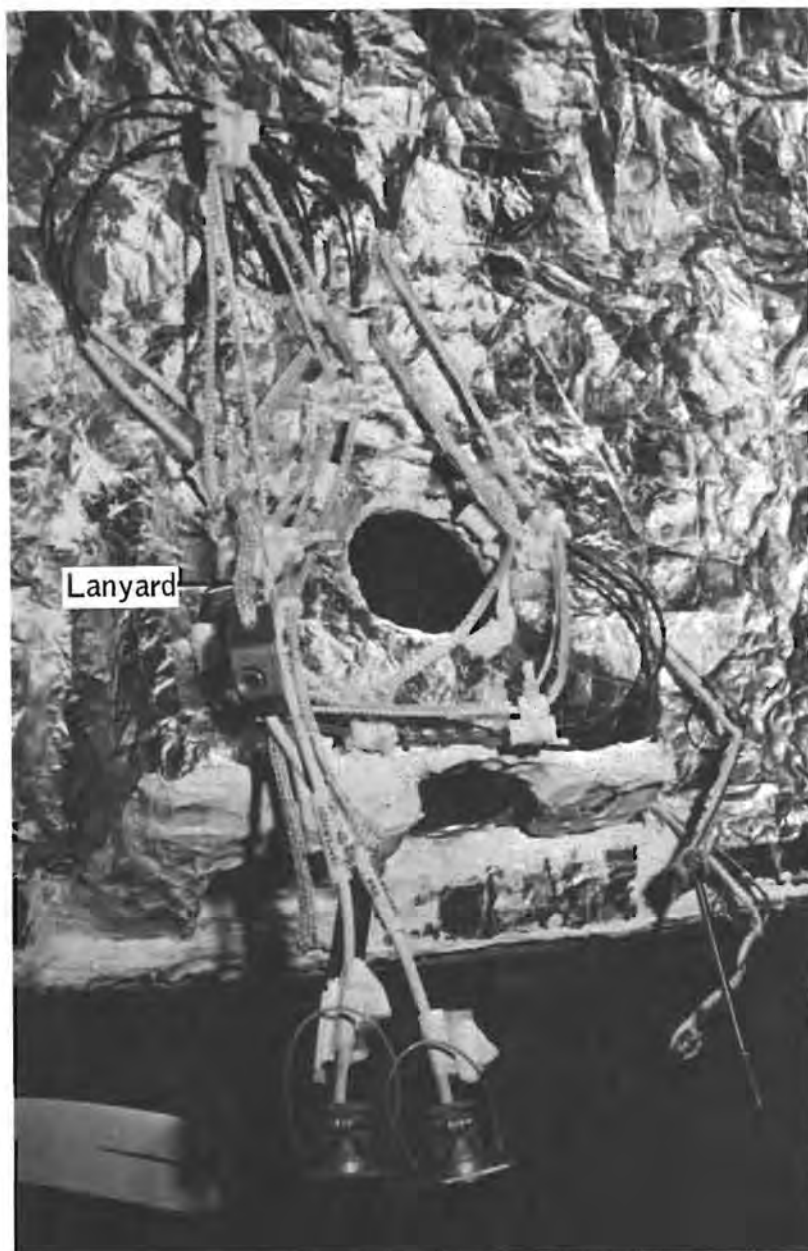
Figure 14-18.- Forward heat shield mortar umbilical.

During postflight inspection of the upper deck, the lanyard which retains the forward heat shield electrical cable had been severed, and only 18 inches of the approximately 45-inch lanyard remained. The lanyard is fabricated from natural Nomex cord with a breaking strength of approximately 600 pounds. The function of the lanyard is to provide for orderly deployment of the electrical wire bundle which connects the forward heat shield mortar cartridges and the electrical connectors on the upper deck. As the heat shield separates from the command module, the lanyard, which is anchored to the spacecraft at one end, sequentially breaks each of a series of 16- and 50-pound retainers which secure the wire bundle to the inner wall of the forward heat shield (fig. 14-18). The crew reported that parachute deployment was normal, and this is confirmed by onboard camera coverage.

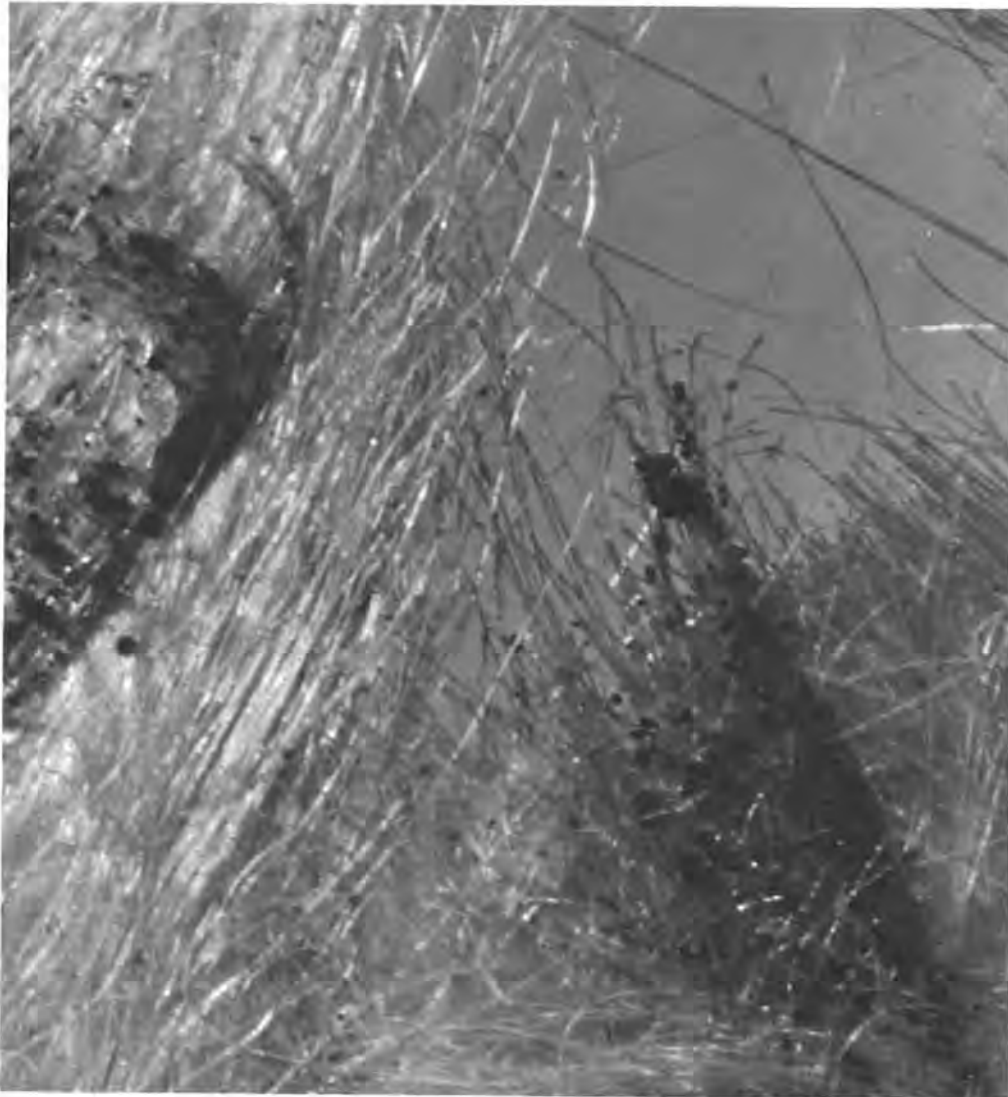
Figure 14-19.- Deposit on end of heat shield lanyard.

Examination and comparative laboratory tests on a similar type cord disclosed that the failure is nearly identical to those which occur in lanyard knots when loaded in tension. A small flake of yellow material was found embedded in the weave of the severed end of the lanyard. Comparison of the flake with yellow Mylar tape, which is used to wrap the steel drogue riser, showed a definite similarity. Foreign material removed from the lanyard and a piece of tape from a drogue riser contained significant amount of a grayish-black material (fig. 14-19), which is believed to be deposits of a dry-film lubricant used on the steel risers.

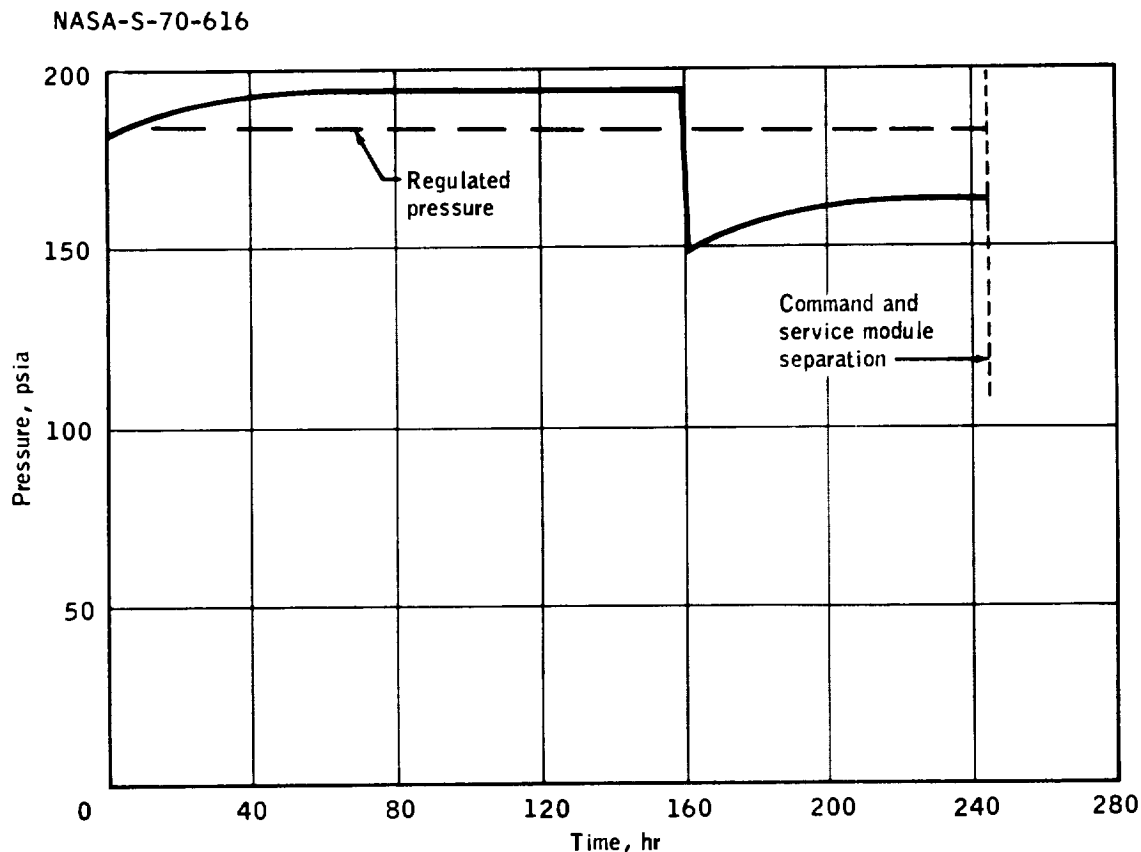
Figure 14-21.- Quad D helium manifold pressure.

Shift in quad D helium manifold pressure.- The measurement for reaction control quad D helium pressure indicated erroneous values throughout the flight. During the first 70 hours, the pressure exhibited a slow drift of about 14 psia upward. At approximately 160 hours, the measurement then shifted from 192 to 150 psia, followed by a second slow drift upward (fig. 14-21). Both the slow drifts upward and the jump shown on the figure tend to support the conclusion that the strain-gage bonding had weakened. The measurement is primarily used during preflight testing to indicate the helium manifold pressure downstream of parallel redundant pressure regulators and is not necessary for flight.

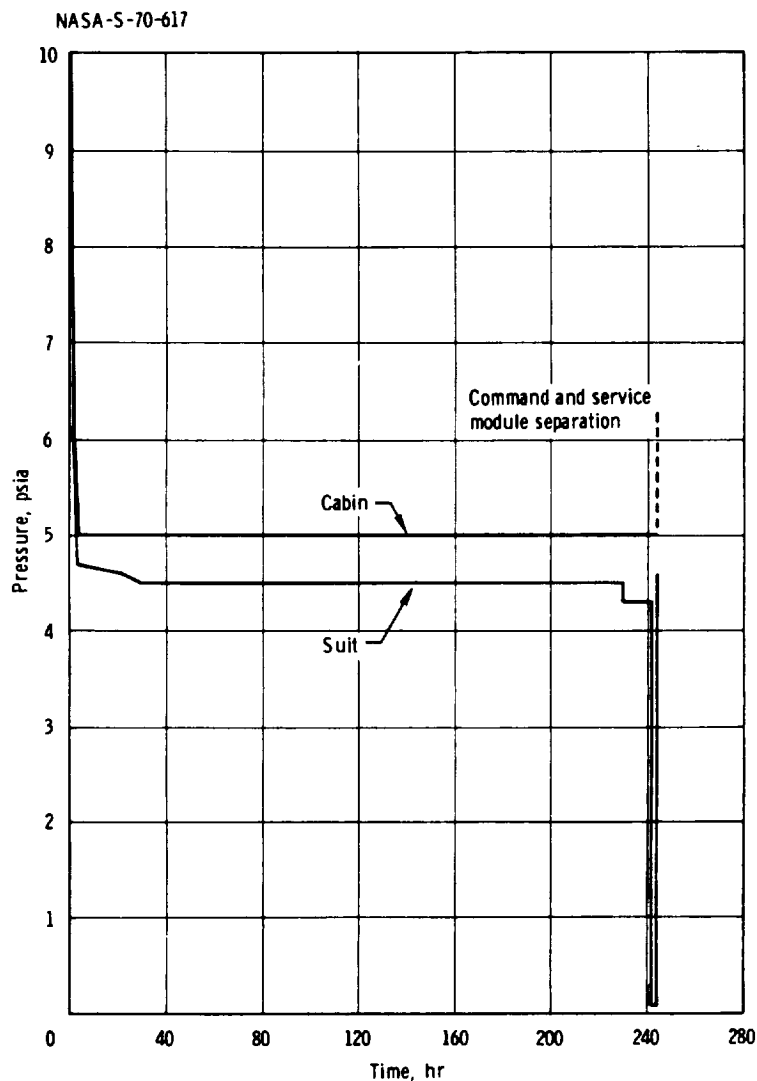
Figure 14-22. - Suit and cabin pressure history

The suit pressure transducer operated properly throughout the pre-launch and launch activities. When the helmets and gloves were removed after launch, the transducer indicated 0.2-psid less than cabin pressure and at approximately 22 hours the differential was 0.4 psid. A 0.4- to 0.6-psid disparity existed between the indicated suit loop and cabin pressures until the final hours of the mission (fig. 14-22).

At 241:41, the suit pressure transducer reading dropped to 0.1 psia, while cabin pressure was stable at 5.0 psia. About 3 hours later, at command module/service module separation, the transducer recovered to 4.6 psia. The transducer indicated a 0.4- to 0.5-psid discrepancy throughout entry. Postflight tests of the installed transducer repeated the flight anomaly. However, during subsequent tests of the removed transducer, the unit operated normally. The transducer was then returned to the manufacturer's facility, where flushing and disassembly revealed internal contamination from metallic nickel-plating particles. These particles could have caused an irregular transducer output by physically interfering with the Bourdon tube movement or by changing the inductance field of the unit. After the transducer was cleaned and reassembled, testing produced satisfactory operation. The noted contamination apparently resulted from either improper cleaning procedures or from self-generated particles within the unit.

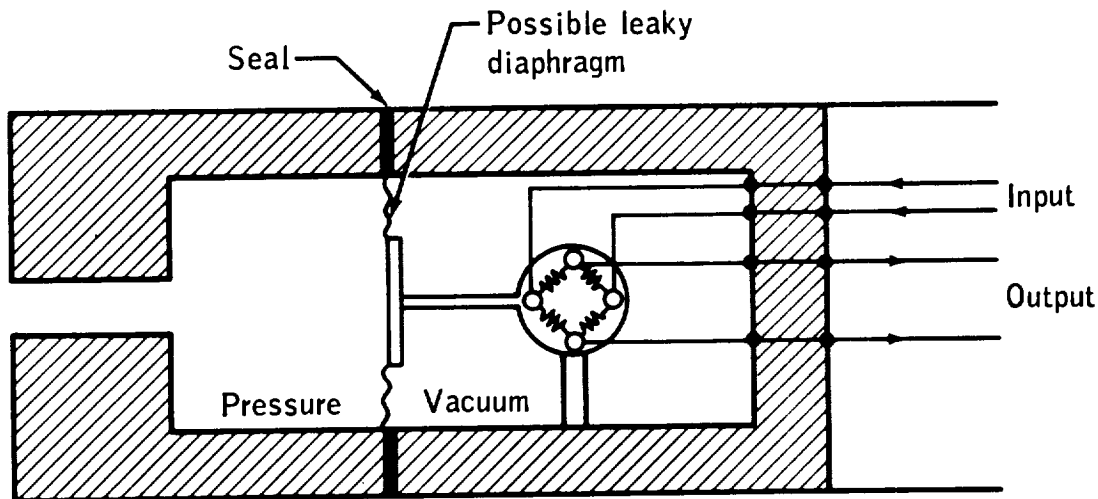
Figure 14-25.- Fuel cell 3 transducer schematic.

The apparent pressure drop has been attributed to a pressure transducer failure, with the most probable failure mode being a small leak through or around the stainless steel diaphragm in the transducer (fig. 14-25). Such a leak would allow hydrogen to enter the vacuum reference chamber of the transducer, thus destroying the normal pressure differential across the diaphragm. This reduction would result in the indicated pressure decay observed during the flight. A similar transducer failure occurred during a production fuel cell pre-test checkout.

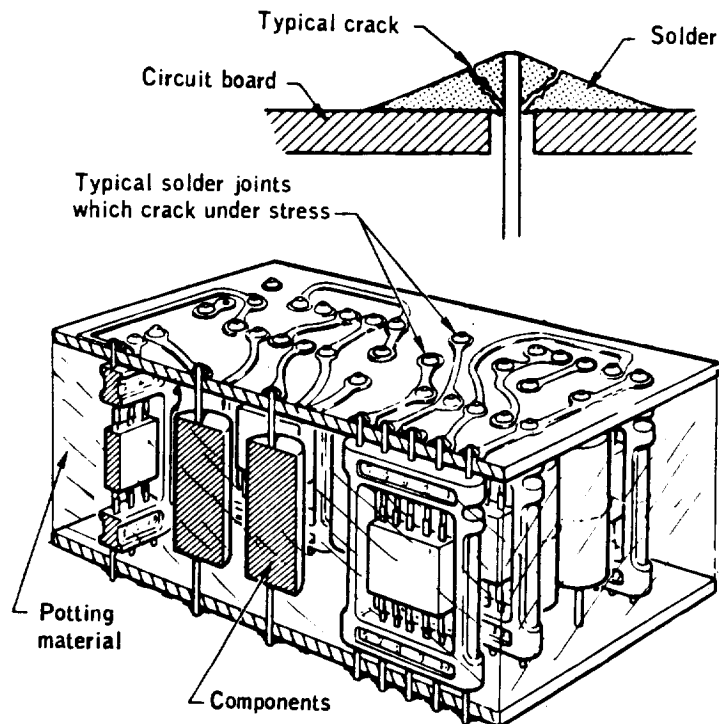
Figure 14-26.- Mission timer construction.

Based on previous mission clock failures, the most probable cause for this anomaly is a cracked solder joint in the cordwood construction. As seen in figure 14-26, electrical components (resistors, capacitors, diodes, etc.) are soldered between two circuit boards, and the void between the boards is filled with potting compound. The differential expansion between the potting compound and the component leads can cause solder joint cracks.

New mission timers, which will be mechanically and electrically interchangeable with present clocks, are being developed for Apollo 13 and subsequent spacecraft. The new clock design eliminates the cordwood construction and is less susceptible to electromagnetic interference.

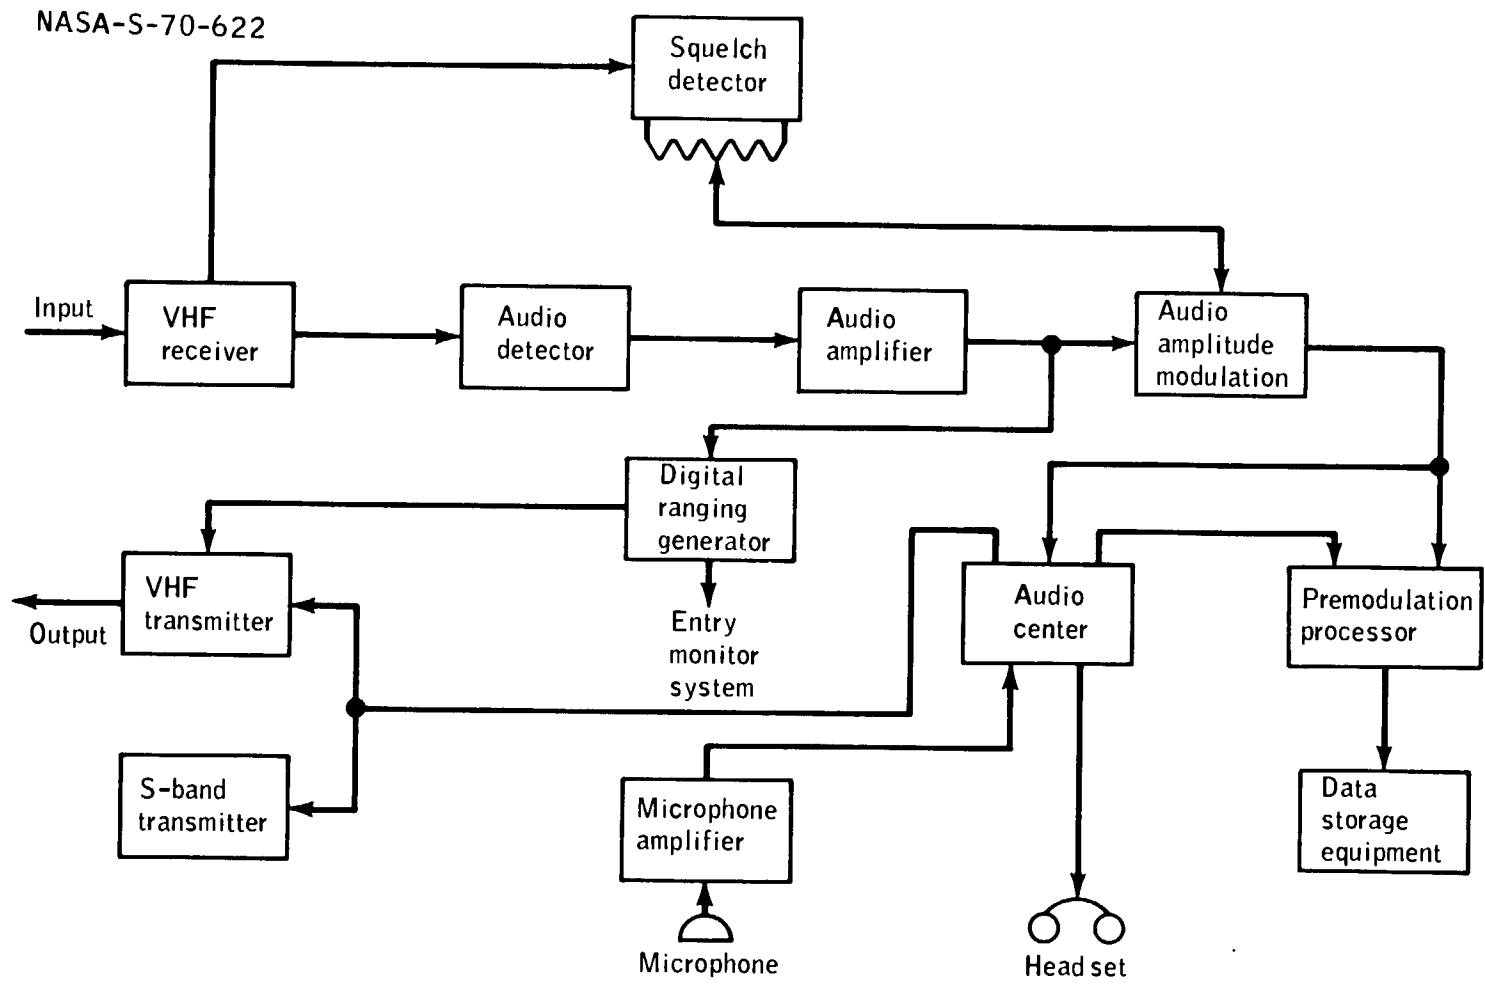
Figure 14-27.- Command module VHF communications configuration.

During ascent and rendezvous, there was a VHF communications problem between the command module and the lunar module. During this time period, there appeared to be only one problem associated with VHF voice but there were actually two separate problems. Figure 14-27 shows the VHF system as it was configured in the command module during these phases.

During ascent, there were communications from the command module to the lunar module using VHF through the lunar module aft and command module right antennas. However, beginning at 142 1/4 hours, communications from the lunar module to the command module had to be accomplished using an S-band network relay. In this case, the predicted RF signal strength (fig. 14-28) was below the sensitivity of the squelch thumbwheel setting. During the 23-minute time period following lunar module lift-off, the two vehicles had closed to a range of approximately 200 miles and the lunar module crew had switched to the forward antenna. At this point, the received signal strength at the command module improved and the Command Module Pilot began to understand the VHF voice communications.

During the time period from 142:43:00 to approximately 142:53:00, the signal strength was strong enough to maintain the squelch circuit open, as verified by flight data. During the concentric sequence initiation maneuver, the squelch was noted as dropping in and out. According to predictions, the selection of either the left or the right command module antenna did not significantly affect voice communications. During this time, the received signal strength (fig. 14-28) was approximately minus 105 dBm while using the command module right antenna and lunar module forward antenna. This figure also shows the signal strength to be minus 102 dBm or less while using the command module left antenna and lunar module forward antenna according to the flight plan. From previous tests, the squelch thumbwheel, when set at approximately 6, requires from minus 100 to 105 dBm to unsquelch the audio signal.

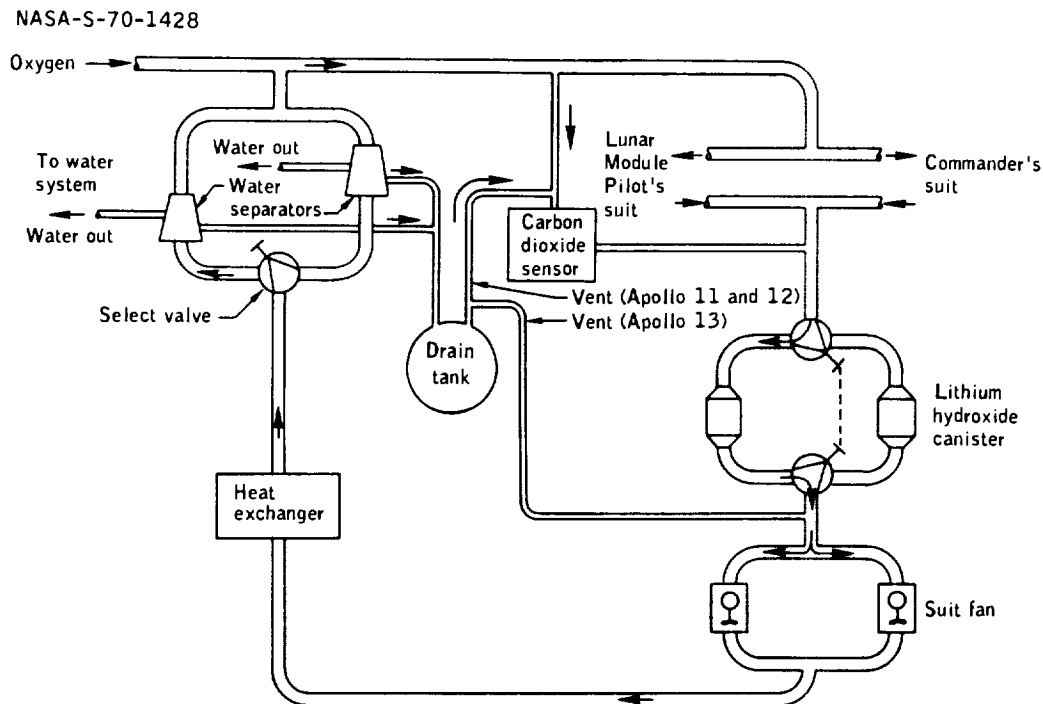
Figure 14-33.- Simplified suit loop schematic.

The carbon dioxide sensor is sensitive to free water, and the malfunction was probably caused either by water from the water separator sump tank entering the sensor or by water bypassing the water separator and entering the sensor. The water separator sump tank vent line joins the carbon dioxide sensor inlet sense line (fig. 14-33). This vent line has been rerouted for Apollo 13 and subsequent vehicles.

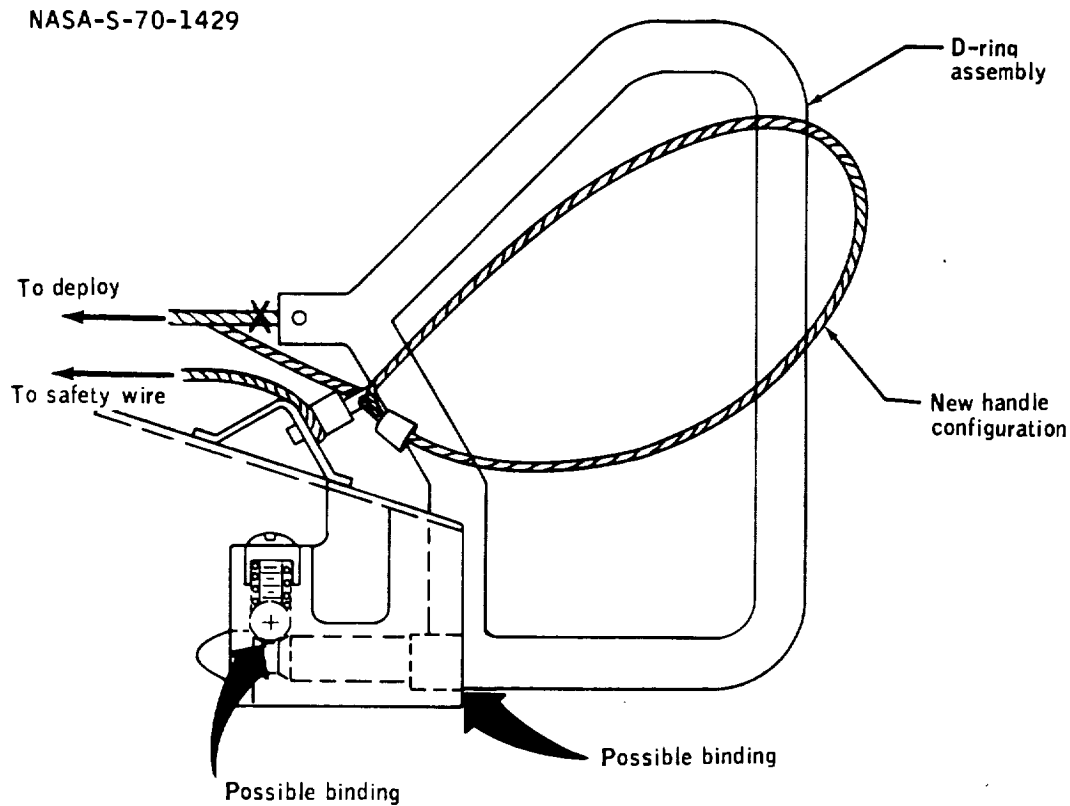
During the initial egress, the modularized equipment stowage assembly was to be deployed by pulling a special D-ring handle. Although the Commander was unable to release the handle from the support bracket, it could be rotated in its bracket. The equipment compartment was subsequently deployed by pulling on the bellcrank cable, which attaches to the center of the D-ring handle. A retention pin at the bottom of the D-ring handle plugs into a socket in the retaining bracket (fig. 14-34). This socket contains a ball detent mechanism which holds the D-ring to the bracket. Apparently, either there was binding in the ball detent or the crewman pulled on the D-ring handle at such an angle that a lateral load was applied to the retention pin, causing it to bind in the retention socket.

Figure 14-34.- Deployment handle (D-ring) on the modular equipment storage assembly.

For Apollo 13 and subsequent, the D-ring will be deleted and a loop will be clamped to the end of the deployment cable. The loop will be retained using the same type of pin presently installed to retain the safety wire (fig. 14-34).

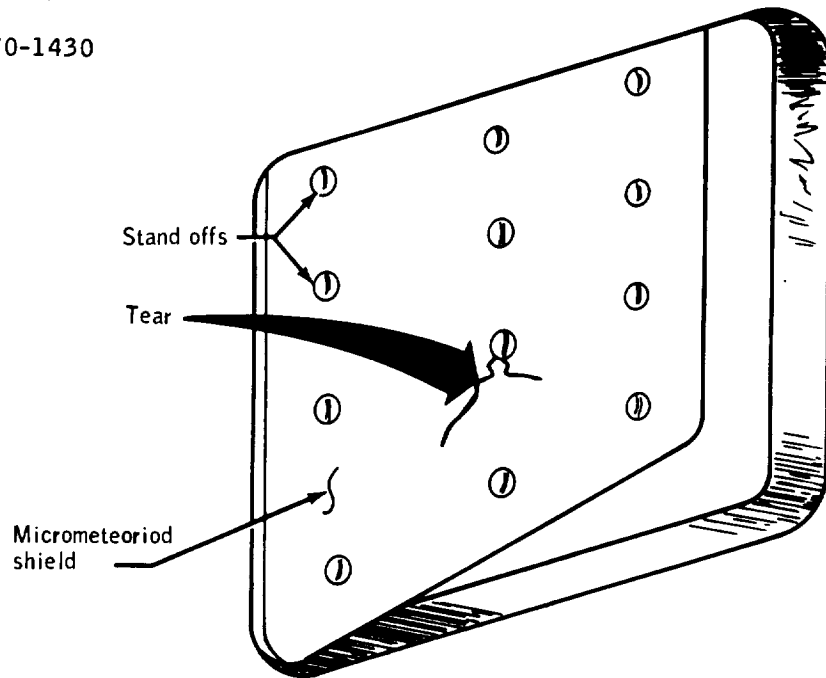
During egress, the Commander's portable life support system came in contact with and tore the hatch micrometeoroid shield (fig. 14-35). Such a tear could represent a potential hazard to the suit. For Apollo 13 and subsequent, the thermal shield thickness will generally be increased from 0.004 to 0.010 inch. At the standoff, however, the shield thickness will be increased from 0.020 to 0.040 inch. In addition, the diameter of the shield mounting holes will be increased from 0.375 to 0.5 inch (fig. 14-36). These modifications should strengthen the shield sufficiently to prevent tearing in any future contacts by the egressing crewmen.

Figure 14-35.- Tear in forward hatch outer skin.

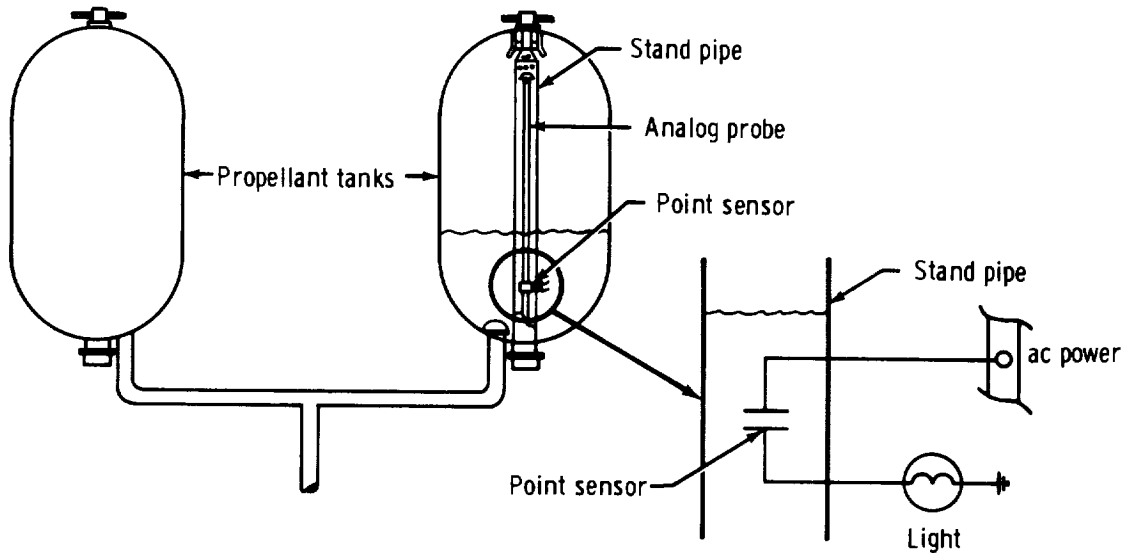
The low-level light for descent propulsion propellant quantities illuminated about 25 seconds early. The low-level light is activated and remains latched on when any one of the four low-level point sensors (one in each propellant tank) is uncovered (fig. 14-37).

Figure 14-37. - Descent propellant tank low-level sensor schematic.

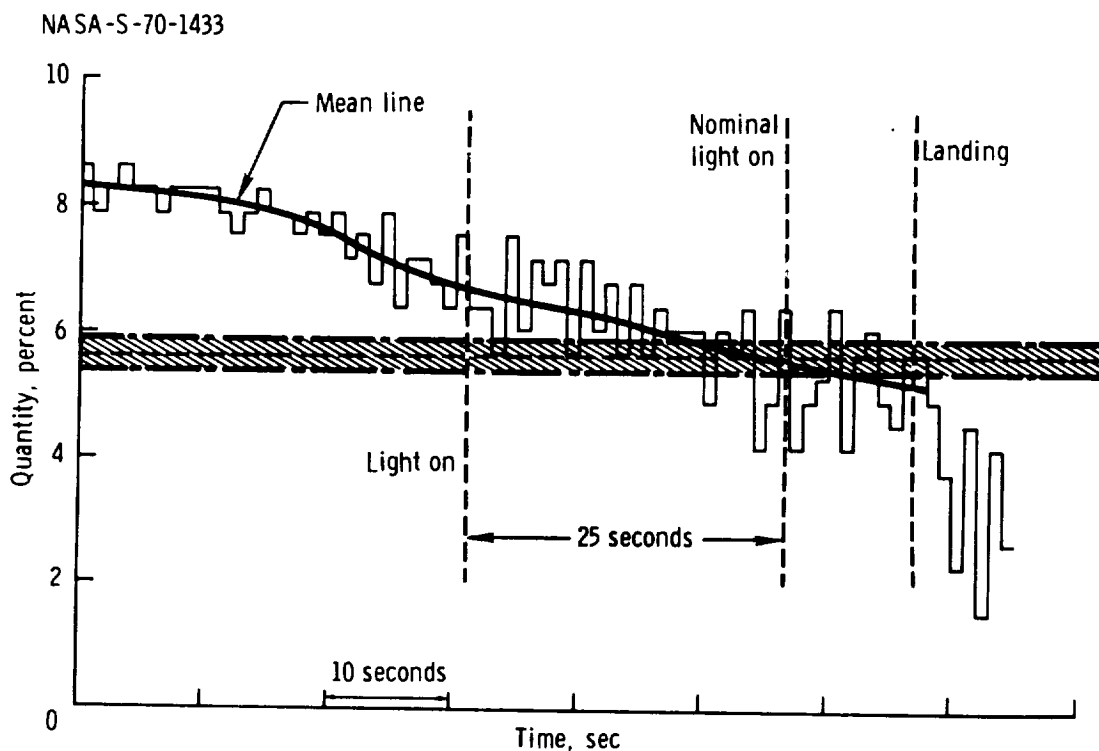
At low-level light activation, the gaging system indicated that fuel tank 2 had a mean propellant quantity of 6.7 percent. In addition, it had about a 2.3-percent peak-to-peak oscillation (fig. 14-38), probably caused by propellant slosh, which continued for some time after landing. The other three tank readings experienced similar oscillations, although at a slightly higher mean quantity level. One of the four low-level point sensors, probably fuel tank 2, uncovered momentarily because of propellant slosh, causing the low-level light to latch on.

The quantity warning light should illuminate when the lowest indicated propellant level remaining in any tank reaches a value of  $5.6 \pm 1/4$  percent. Since the light came on when the averaged quantity measurement indicated 6.7 percent with an oscillation of  $\pm 1.1$  percent, the

lowest excursion of the quantity reading was 5.6 percent and the display operated properly. The averaged propellant quantity reached 5.6 percent about 25 seconds later.

Figure 14-38. - Descent propellant quantity just prior to landing.

For Apollo 13, the quantity measurements for the four descent propellant tanks have been increased in sampling rate from 1 to 100 samples per seconds. These data will be averaged automatically and used to determine the low-level point from which the remaining firing time can be calculated. The 100 samples per second rate will provide data that will permit an understanding of the particular dynamics of the fluid in the tanks.

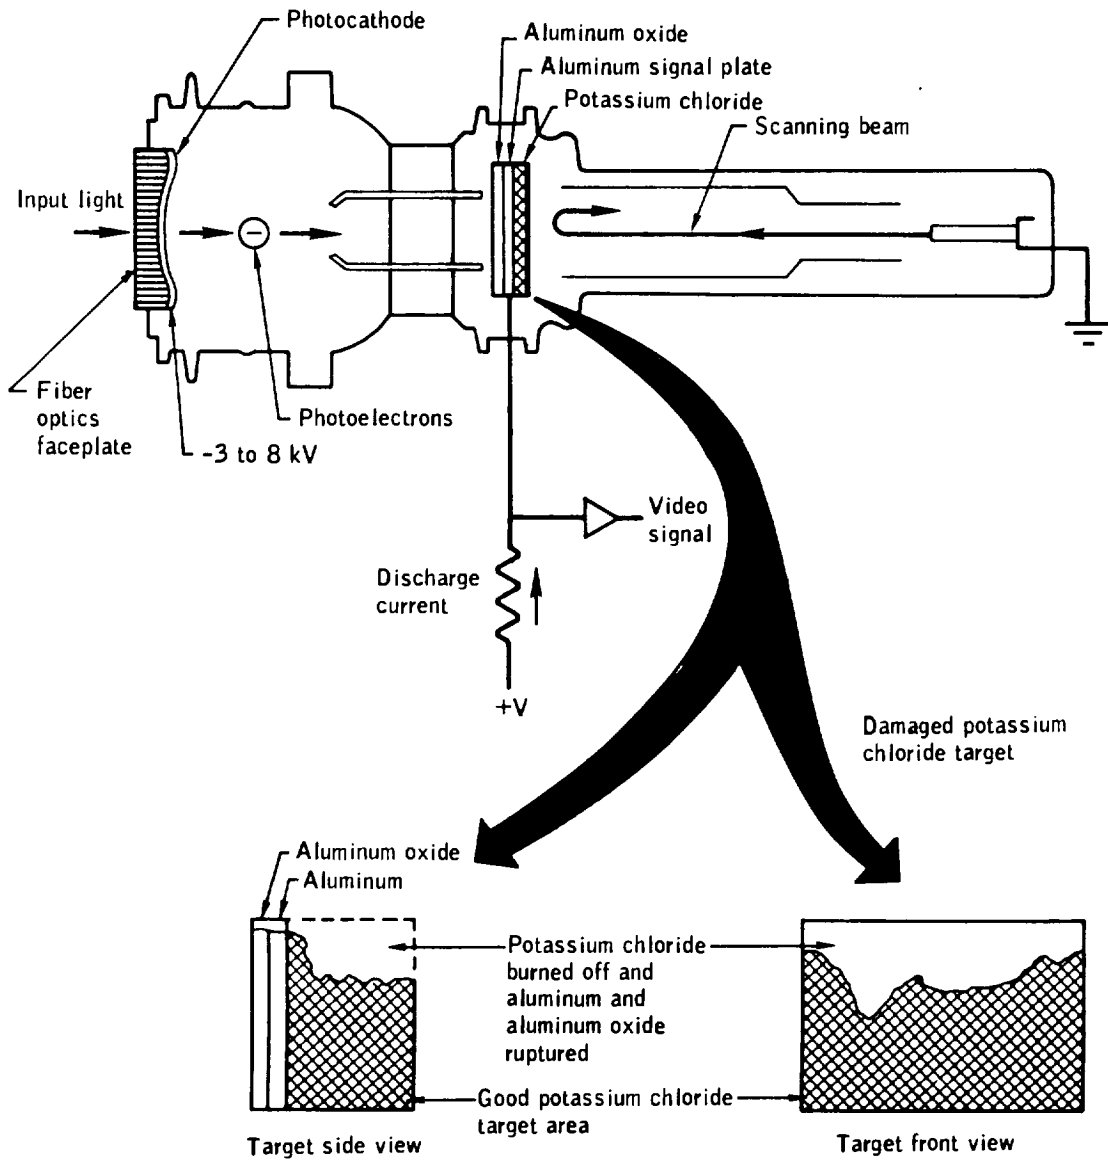
Ground tests using an Apollo-type image sensor (secondary electron conducting vidicon tube) exposed the camera system to extreme light levels. The resulting image on a monitor was very similar to that seen after the flight camera failure.

After decontamination and cleaning, the flight camera was inspected and power was applied. The image, as viewed on a monitor, was the same as that last seen from the lunar surface. The automatic light-level control circuit was disabled by cutting one wire. The camera then reproduced good scene detail in that area of the picture which had previously been black, verifying that the black area of the target was undamaged, as shown in figure 14-39. This finding also proved that the combination of normal automatic light control action and a damaged image-tube target caused the loss of picture. In the process of moving the camera on the lunar surface, a portion of the target in the secondary-electron conductivity vidicon must have received a high solar input, either directly from the sun or from some highly reflective surface. That portion of the target was destroyed, as was evidenced by the white appearance of the upper part of the picture.

Figure 14-39.- Secondary electron conductivity tube in the color television.

Training and operational procedures, including the use of a lens cap, are being changed to reduce the possibility of exposing the image sensor to extreme light levels. In addition, design changes are being considered to include automatic protection, such as the use of an image sensor which is less susceptible to damage from intense light levels.

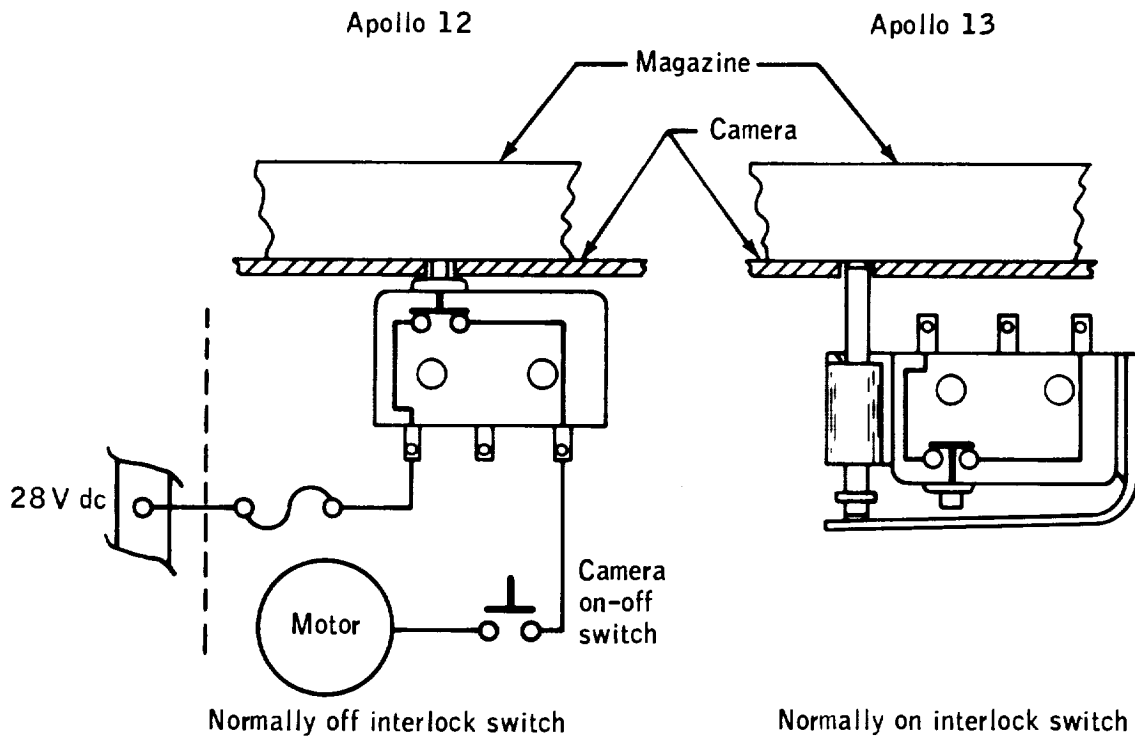
Figure 14-40.- Sequence camera interlock switch modification.

Although postflight tests showed the 16-mm camera and magazine to be in satisfactory operating condition, the characteristic sensitivity of the magazine interlock microswitch installation is such that the operating limits of the switch could cause intermittent actuation. The intermittent operation was duplicated on the flight and similar equipment by the application of pressure to the end of the magazine. The problem will be resolved by changing the interlock switch (fig. 14-40) to a configuration that is much less sensitive to variation in switch settings.

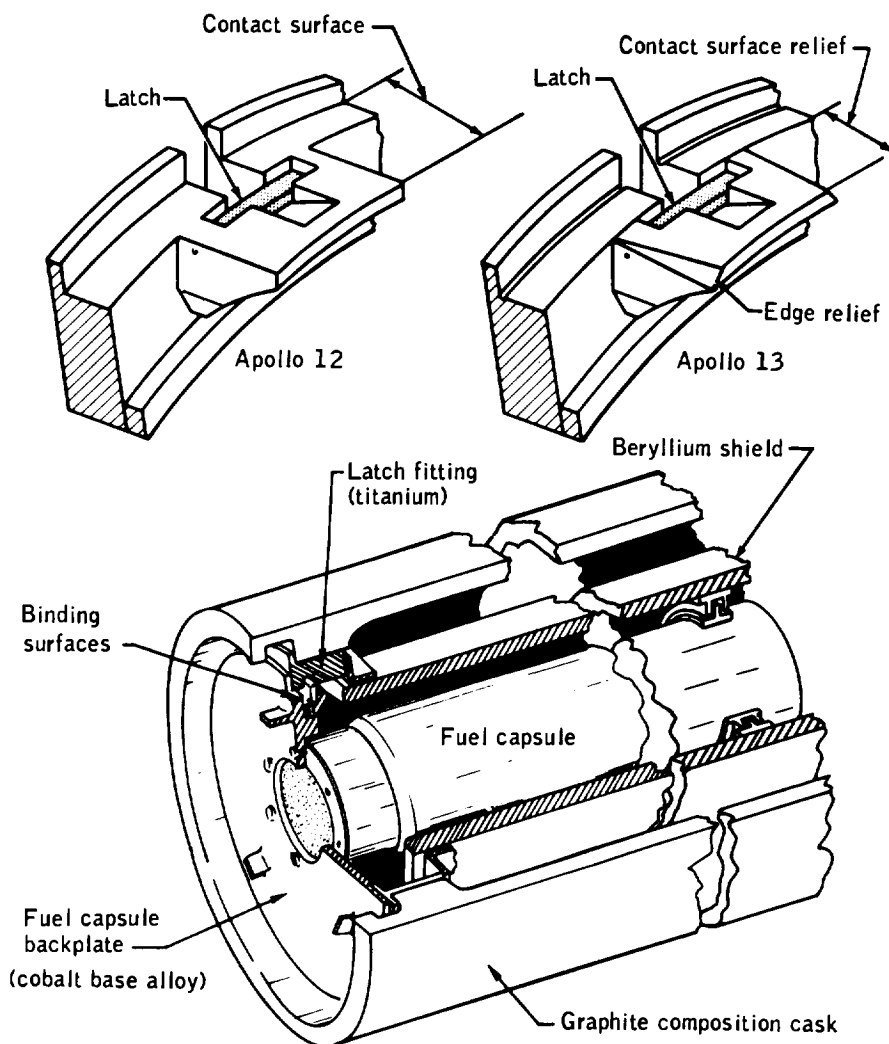
Thermal tests and analyses show that dimensional tolerances can diminish with temperature and result in binding between the latch fitting (C-ring) on the cask and the contact surface of the backplate on the fuel capsule (fig. 14-41). The longitudinal contact distance for these two surfaces is approximately 0.6 inch, and extraction was easily accomplished once this distance was negotiated.

Figure 14-41.- Radioisotope fuel capsule configuration.

As a result of the dimensional checks, the thermal tests, and analyses performed with both the qualification and Apollo 13 flight hardware, the contact surfaces of the fuel capsule backplates are being reworked as indicated in the figure. The outside diameter of the 0.10-inch long contact surface, while remaining within design limits, may be reduced as much as 0.005 inch for ease of capsule extraction. All existing capsule backplates will be reworked in this manner.

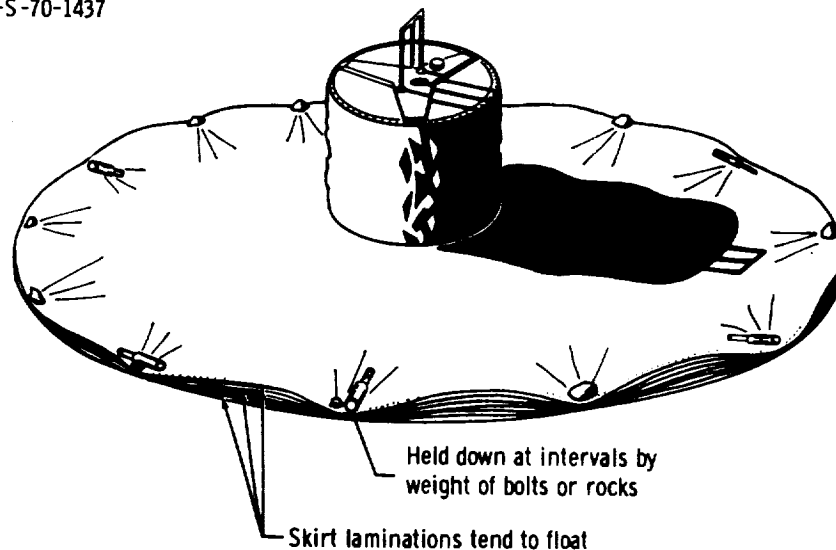
The thermal shroud tended to delaminate and rise up off the lunar surface. This condition had been anticipated, and lunar soil was placed on the periphery of the shroud to hold it down. When this operation proved difficult, tie-down bolts, which had been removed from the pallet during deployment of the experiments package, were placed on the shroud with satisfactory results (fig. 14-42).

Figure 14-42. - Passive seismic experiment deployed.

For Apollo 13 and subsequent spacecraft, the shroud laminations will be spot-sewed together at intervals around the periphery, a weight will be sewed to each of the six attach-pullout points on the shroud, and a 5-foot diameter Teflon blanket will be added for thermal control to decrease solar degradation.

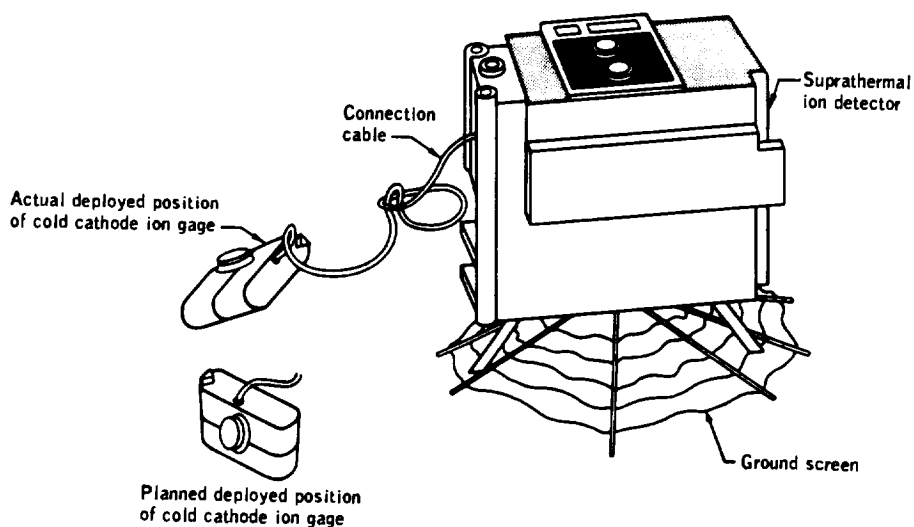
The cold cathode ion gage would not remain upright when deployed. Its final position was on its back with the sensor aperture at an angle of approximately 60 degrees from the horizontal but was satisfactory (fig. 14-43).

The cable connecting the cold cathode ion gage with the suprathermal ion detector was quite stiff. The combination of the spring effect in the cable, the reduced weight of the cold cathode ion gage under lunar gravity, and the softness of the lunar surface was apparently sufficient to cause the equipment instability during deployment. Final positioning of the equipment requires that the sensor aperture does not point directly at the surface nor directly at other experiment package components. The final positioning fulfilled this requirement.

Figure 14-43.- Cold cathode gage deployed.

The combination of the suprathreshold ion detector with the cold cathode ion gage will not be included for Apollo 13. For Apollo 14 this equipment will be flown, and the wires of the connecting cable will be tied at 6-inch intervals instead of being wrapped with heavy Mylar tape. This modification not only reduces cable stiffness by 70 percent, which decreases the spring effect, but also decreases cable bulkiness to permit easier stowage.

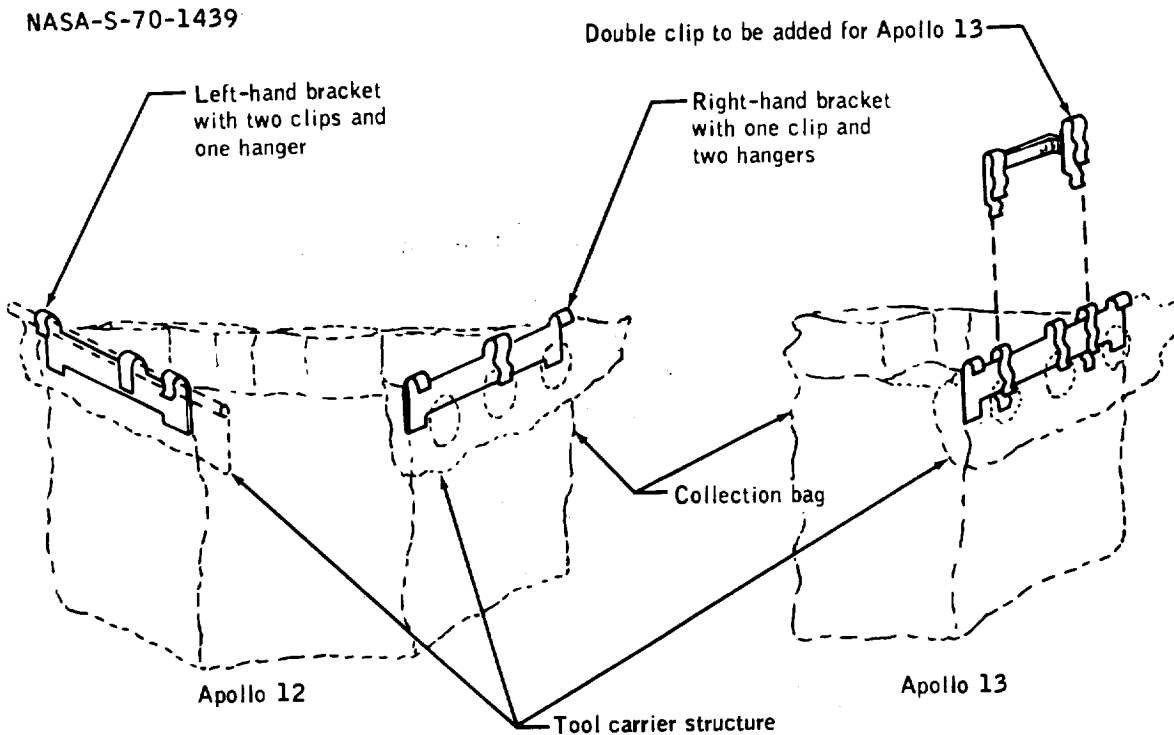
At the beginning of extravehicular activity, the empty tool carrier collection bag tended to rise out of the tool carrier until some lunar surface soil was put in to hold it down. The bag is attached to the carrier structure by three aluminum spring clips (fig. 14-44). The weight of the loaded bag is shared by these clips and three hangers. The retention force is limited so that the loaded bag may be easily lifted out of the carrier.

Figure 14-44.- Tool carrier collection bag retention.

The retention characteristics of the left side, with two spring clips over the 0.37-inch diameter rolled bead of the carrier structure, is satisfactory. However, the single spring clip over the 0.18-inch lip of the carrier on the right side did not provide sufficient positive retention. A separate double spring clip, which reaches over both the bag hanger and tool carrier structure, will be added for Apollo 13 to provide the necessary retention force as shown in the figure.

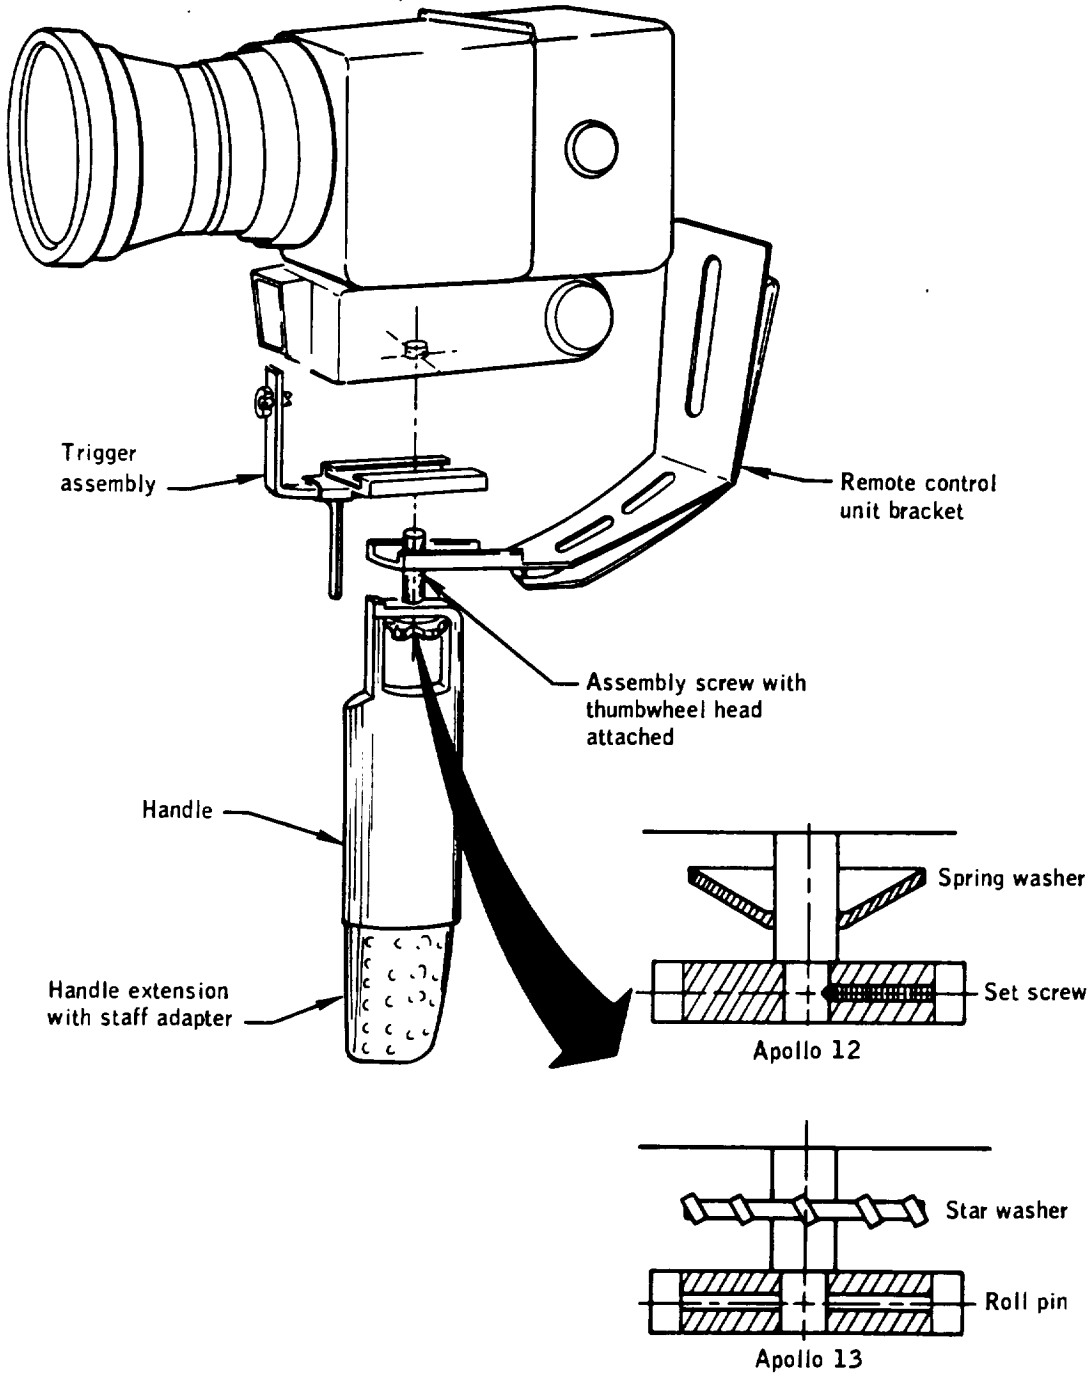
During the second extravehicular period, the Commander's camera did not advance and count every time the trigger was squeezed. Shortly afterwards, when both the camera assemblies were being removed from the remote control units in order to exchange them, both assemblies were loose, although they had been well tightened before egress. In the process of retightening on the lunar surface, the thumbwheel fell off the Lunar Module Pilot's camera assembly, making reassembly impossible (fig. 14-45). The empty camera and faulty assembly were then discarded. The Commander's camera assembly was retightened and performed satisfactorily during the remainder of the extravehicular activity.

Figure 14-45.- 70-mm camera handle assembly.

The intermittency experienced by the Commander in the shutter, counter, and film advance actions was the result of excessive trigger play caused by the loose assembly. The loss of the thumbwheel experienced by the Lunar Module Pilot was apparently the result of the improper installation of the thumbwheel setscrew.

For future missions, the cupped spring washer will be replaced by a star washer to resist rotation and loosening of the assembly screw, and the thumbwheel will be secured to the screw with a roll pin, instead of a setscrew.
