APOLLO 12 MISSION REPORT

Mission Evaluation Team

NATIONAL AERONAUTICS AND SPACE ADMINISTRATION

March 1970

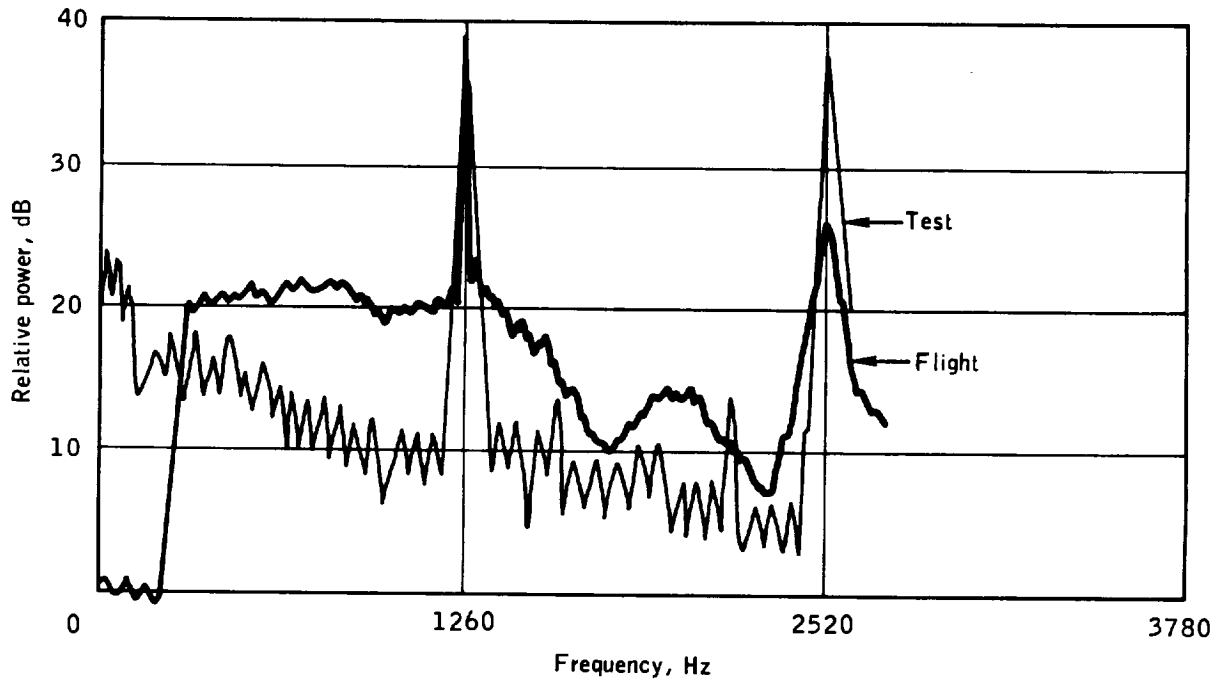
A subsequent analysis of the telemetry data transmitted from the extravehicular mobility unit did not show any degradation of data quality as a result of the noise. Power spectral density plots, however, revealed a fundamental frequency of approximately 1260 hertz and a harmonic frequency of 2520 hertz. Postflight interference tests of an equivalent extravehicular mobility unit revealed the same 1260-hertz tone on the battery-bus leads and shield which originated from the fan-motor ripple current. This condition is normal and has been noted during qualification testing of the extravehicular mobility unit. Figure 14-46 illustrates the tone interference generated by the fan motor. However, during these initial tests, the noise interference could not be made to enter the audio system such that the audio tone heard in flight was simulated.

Figure 14-46.- Tone power spectral density.

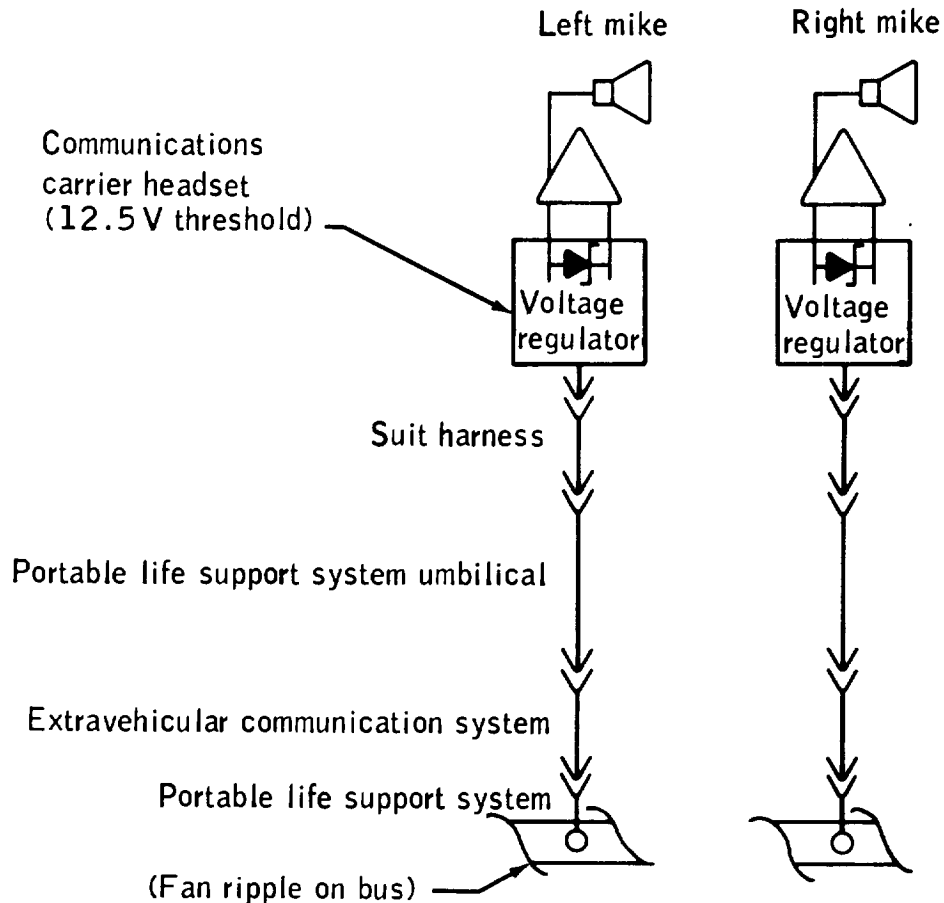
Later laboratory testing of the communications carrier headset demonstrated that lowering a microphone amplifier supply voltage below the regulator threshold of 12.5 volts caused tone interference to enter the audio system. Subsequent analysis showed that a high resistance or the failure of a regulating diode or a transistor in the microphone amplifier regulator could result in a loss of regulator filtering action. The normal operating voltage for the microphone amplifier is from 15.7 to 20.5 volts. When the microphone amplifier supply voltage is above the regulator threshold of 12.5 volts, the tone interference does not enter the audio system.

Figure 14-47.- Communications carrier headset power path.
