Proceedings of National Irrigation Seminar on Micro to Megha: Irrigation for Prosperous Nepal, 13-14 July, 2011, Department of Irrigation, Lawalakhel, Lalitpur, Nepal.

Seepage analysis underneath the headwork of Chanda Mohana Irrigation Scheme, Sunsari, Nepal

Santosh Kaini, MSc¹, L.G.Hayde, PhD², Bart Schultz, PhD³, Miroslav Marenc, PhD⁴

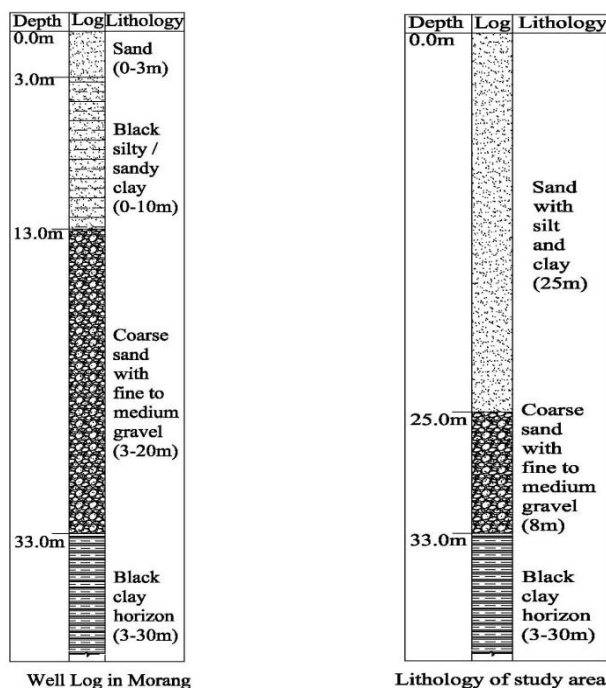
Figure 5: Lithological sections

Earlier studies carried out in Morang district (near to Sunsari district) show that it is also underlain by alluvium. As shown in Figure 5, the thickness of the top soil ranges from few centimetres to 3 m. Black silty to sandy clay of thickness few centimetres to 10 m is encountered below the top soil. The clay content is decreasing towards the North. Below this there is a layer of 3 m to 20 m consisting of coarse sand with fine to medium gravel. Shallow tube wells tap the water from this zone in the local areas. A black clay horizon of 3 m to 30 m is encountered below this layer. Further below this black clay horizon, 5 m to 40 m thick gravel and coarse to fine sand was observed (Bhattarai, 1988).

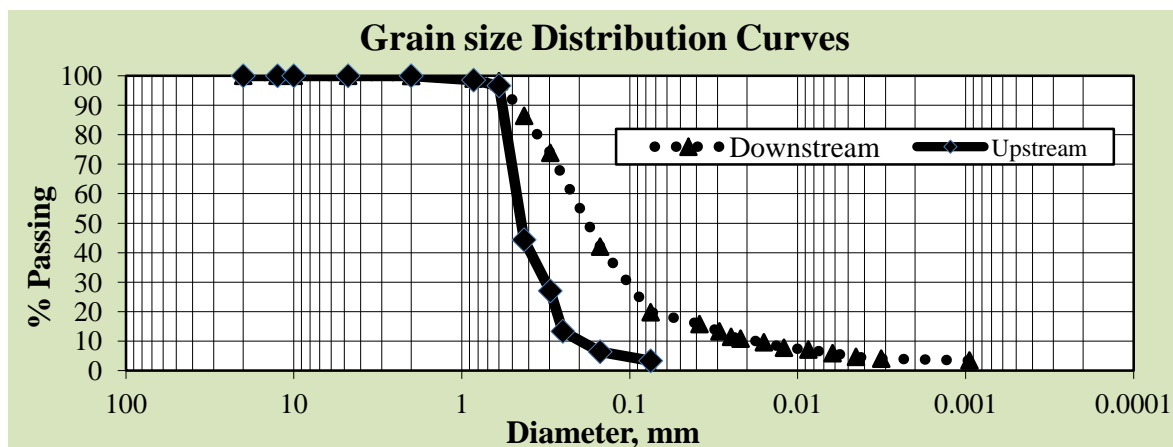
Figure 6: Grain size distribution curves

The Grain size distribution test: The grain size distribution curves of upstream and downstream samples are shown in Figure 6.

As per USDA soil classification system, upstream sample belongs to sand while downstream sample belongs to loamy sand. The D60, D50 and D30 of both samples are given in Table 2. The D60 means particle size such that 60% of the soil is finer than this size.

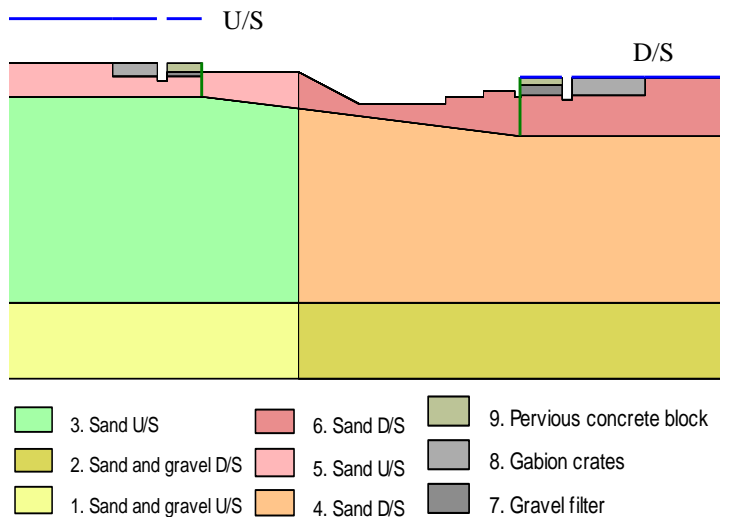
Figure 8: Schematization for under-sluice portion without lateral flow for Scenario-I

The model was run for sections of under-sluice portion and weir portion separately for the flow from upstream to downstream without considering lateral flow. Exit gradients for each section were calculated. The schematization for under-sluice portion without lateral flow is shown in Figure 8. The schematization for weir portion is shown in Figure 9. Different types of materials are shown in different layers. Each layer has its own colour as shown in legend in respective figure. The sheet piles are denoted by vertical green lines. Water levels at upstream and downstream are denoted by horizontal blue lines.

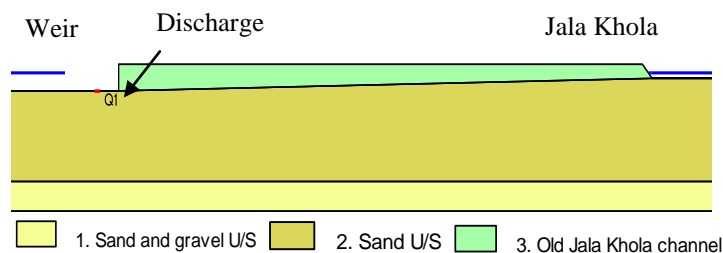
Figure 10: Schematization for lateral flow consideration for Scenario-I

For the lateral flow consideration, section along weir portion - under-sluice portion - abutment wall - Jala Khola was considered in upstream weir crest line. The potential (residual head) obtained above from weir portion at the line of weir crest beneath the upstream floor is used for the boundary condition for the seepage analysis along

weir portion - under-sluice portion - abutment wall - Jala Khola. The river bed and water level in Jala Khola were the boundary condition for Jala Khola end. The schematization for lateral flow consideration is shown in Figure 10.

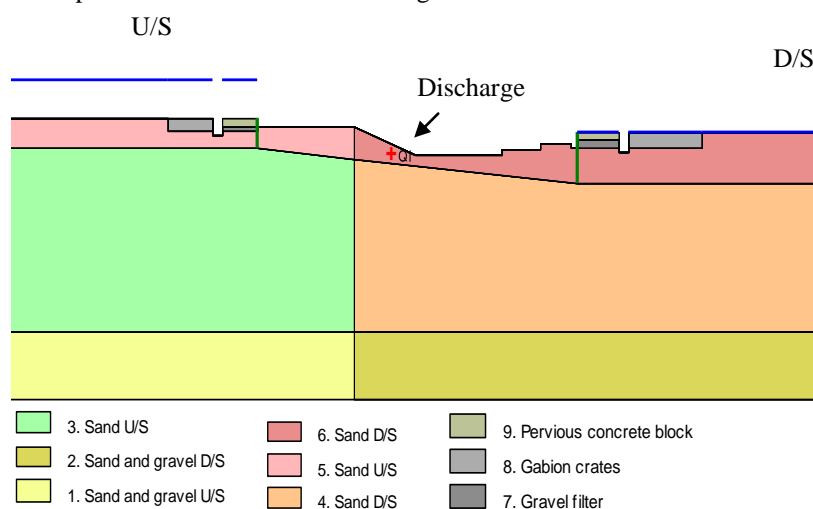
Figure 11: Schematization for under-sluice portion with lateral flow for Scenario-I

This seepage discharge was added at the point at beneath weir crest at under-sluice portion for the flow from upstream to downstream along the under-sluice portion. When a discharge point is added in MSeep, this discharge goes all around the point (even in to upstream of the point). In reality, it does not go to upstream. So, the discharge point is given in sloping portion of weir to reduce this effect. From this, exit gradient at the under-sluice portion was obtained considering lateral flow. The schematization is shown in Figure 11.

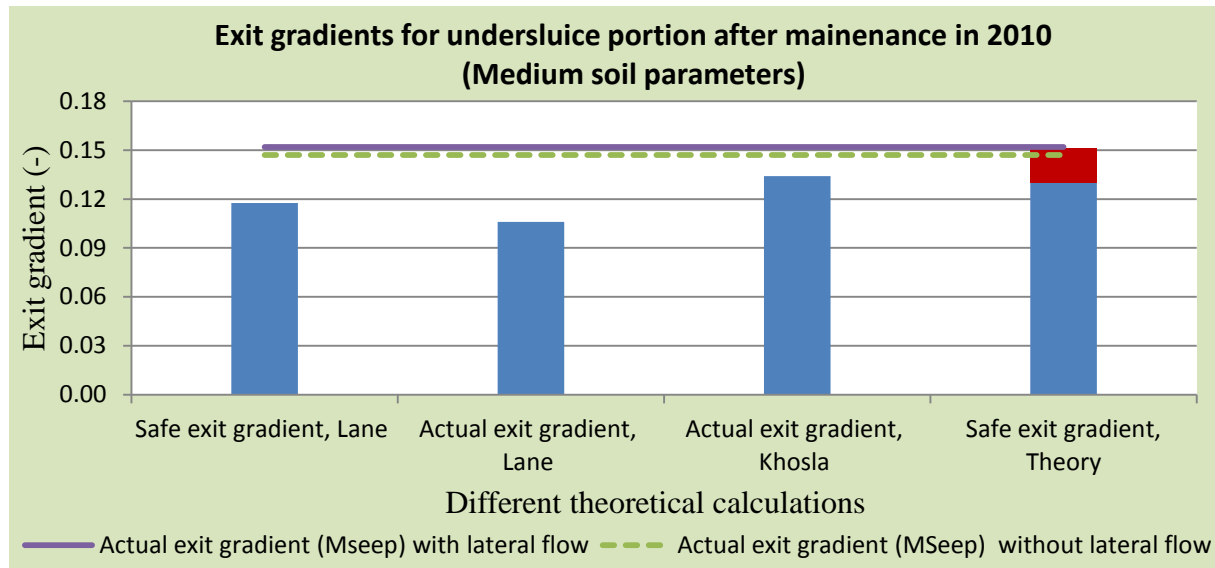
Figure 20: Comparison of exit gradients for under-sluice portion for Scenario-IV (Medium soil parameters)

The comparison of exit gradients for under-sluice portion is shown in Figure 20. As new soil parameters were considered in modelling, the exit gradient without later seepage is much higher than exit gradient by Khosla. The structure seems to be safe from Khosla exit gradient. But, it has not considered the lateral flow as well as effect of change in values of soil parameters. The vertical distance of sheet piles in inner sides is taken to calculate the lane's exit gradient though the stream line do not reach up to floor level in between the downstream sheet piles which can not be known from Lane's theory. It tells us that the exit gradient by Lane is less than the recommended which is safe for structure. The exit gradient including seepage flow is slightly above the maximum theoretical permissible limit. This shows that the structure is still at the verge of failure.

Although major maintenance works were carried out three times after the completion of the headwork, the results show that it is still not safe. If the higher safety factor than that recommended by Khosla had taken for seepage analysis during the design, the structure would not have failed.

It is difficult and quite expensive to control the quantity of seepage that occurs after construction (Uromeihy *et al.*, 2007). The repeated maintenance works due to lower safety factor cost more than one time construction cost resulting from higher safety factor. As the structure is not fully safe even after maintenance in 2010, further additional maintenance works are recommended under Scenario V.
