# Liquefaction Incidents of Mineral Cargoes on Board Bulk Carriers

**Michael C. Munro and Abbas Mohajerani**

Liquefaction is a frequently occurring problem taking place when transporting wet granular solid bulk cargoes on board bulk carriers. Liquefaction of a solid bulk cargo can occur when excessive dynamic loading, induced by rough seas and vessel vibrations, is transmitted to the cargo. From 1988 to 2015, there have been 24 suspected liquefaction incidents reported, which resulted in 164 casualties and the loss of 18 vessels. The objective of this study is to investigate the collective causes of liquefaction of solid bulk cargoes on board bulk carriers in order to make recommendations to prevent future incidents from occurring. This was achieved by analysing the seven available investigative reports relating to the incidents, focusing on the key findings and exploring the effect of excess moisture within the cargo. This study has placed significant emphasis on the importance of preventing ingress of water into the cargo during transportation, loading, and storage. Recommendations have been given, based on the key findings from the reports, to reduce the potential for liquefac

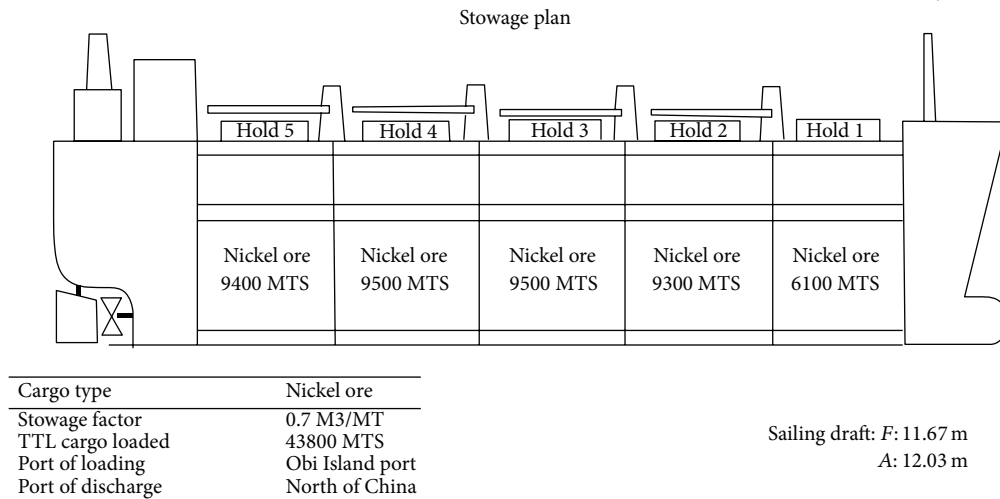
FIGURE 11: Stowage plan for the Jian Fu Star [23].

The stowage plan for the Jian Fu Star for this voyage can be seen in Figure 11.

The vessel loaded 23,800 tonnes of nickel ore continuously depending on the inflow of barges and halting during periods of occasional showers. After the Master noted that the moisture content of the nickel ore was less than the shipper's earlier declaration, the Jian Fu Star departed Obi Island, Indonesia, on the 20 October at approximately 1800 bound for Lazhou, China [23].

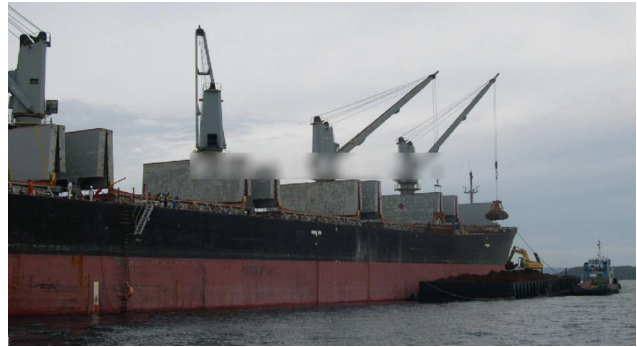
FIGURE 14: Loading operation at Kolonodale, Indonesia, similar to that of the Nasco Diamond and Hong Wei [26].

**2.4.1. Summary of Incident.** On 18 October 2010 at 2130, the Nasco Diamond arrived at Kolonodale, Central Sulawesi, Indonesia, seen in Figure 13, to begin loading a cargo of nickel ore from shore barges, similar to what is seen in Figure 14. Loading operations commenced at 2245 on 19 October. The same day, the flow table test was carried out on a sample of the cargo that was to be loaded on the Nasco Diamond.

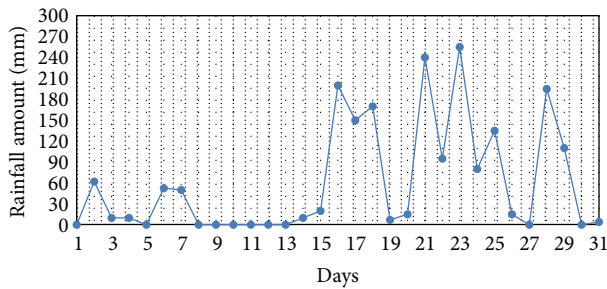
FIGURE 25: December rainfall at the Port of Kuantan, Malaysia [28].

The east coast of Malaysia had endured record-breaking rainfall over the month of December, recording the highest monthly rainfall in the history of Kuantan at 1806.4 mm over a 22-day period, as seen in Figure 25. The loading operations continued for an extended period of time due to heavy rain

and technical delays. During periods of rain, vessels generally close their hatch covers to prevent any moisture from entering cargo holds and maintain the cargo in a dry condition. However, any cargo left on the quayside is left uncovered and therefore exposed to the elements. It is very likely that the moisture content of the bauxite increased during this time [28].

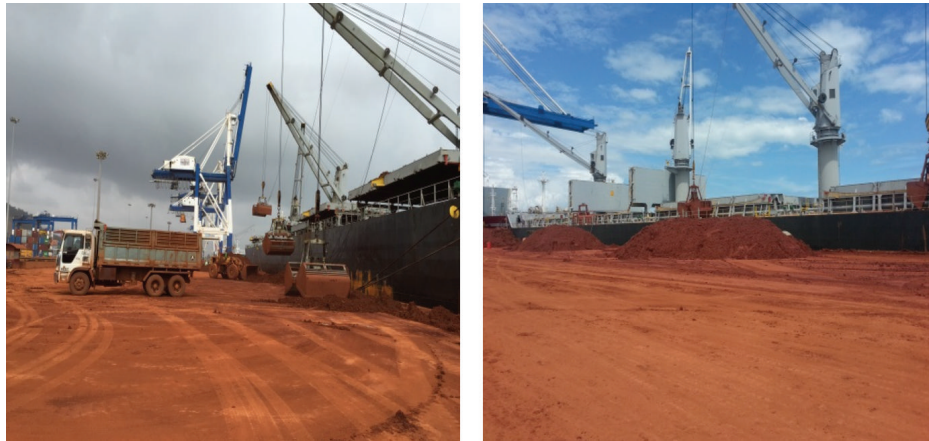
FIGURE 26: Cargo being loaded onto a bulk carrier from the quayside at the Port of Kuantan, Malaysia [28].

Figure 26. The bauxite is transported to the port on load trucks where they either store the cargo in stockpiles or storage facilities or transport the bauxite directly to the quayside. Noted in the investigation was that during transport and storage the bauxite is generally not covered to protect it from rain [28].

- (4) In total 186.55 hours of loading was lost due to rainfall, the equivalent of 7 days of loading over the period. The infrastructure available to adequately store and transport bauxite in Kuantan increased the exposure of the bauxite to the elements. Despite the crew’s diligent response to the rain by continually opening and closing the hatch covers to reduce the ingress of water, the cargo remained exposed while on the quayside, in stockpiles, and in the trucks.

measures to protect the cargo on shore from further rain were not effective in preventing further wetting. The absence of an independent inspection resulted in the cargo being loaded without its physical properties and moisture content being verified against the parameters of the IMSBC Code schedule or the cargo declaration form.
