# ASSESSMENT AND EVALUATION OF THE REPAIR OPTIONS FOR THE TORROJA INSTITUTE WINTER GARDEN

O. Río & J Mateo  
CSIC-UPM  
CISDEM  
Serrano Galvache, 4  
28033-Madrid  
Spain  
[rio@ietcc.csic.es](mailto:rio@ietcc.csic.es)

**KEYWORDS:** crack repairs, masonry shell, unreinforced brickwork, Torroja, FE analysis

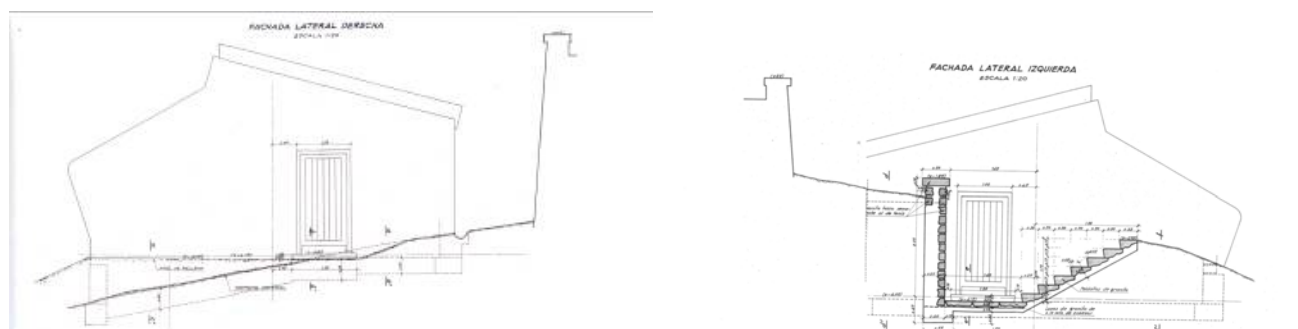
Figure 5: Level of earth between West and East façades of actual winter garden as it is shown in the original IETcc plans

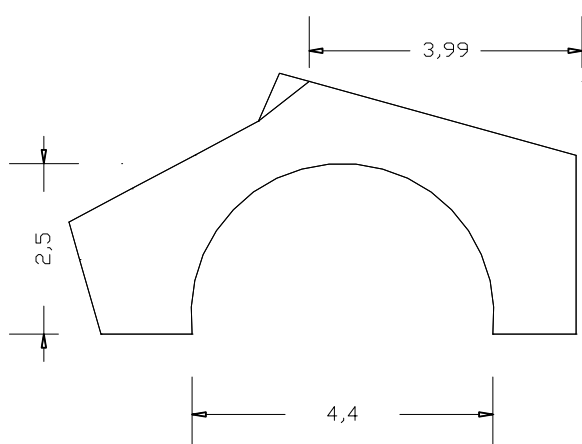
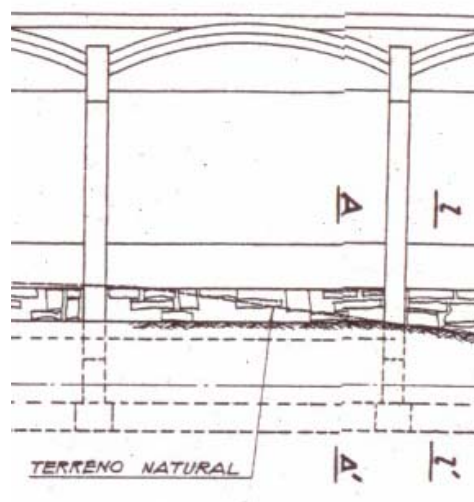
Figure 6. Aspect and geometry of the arches and cross section of the vaults

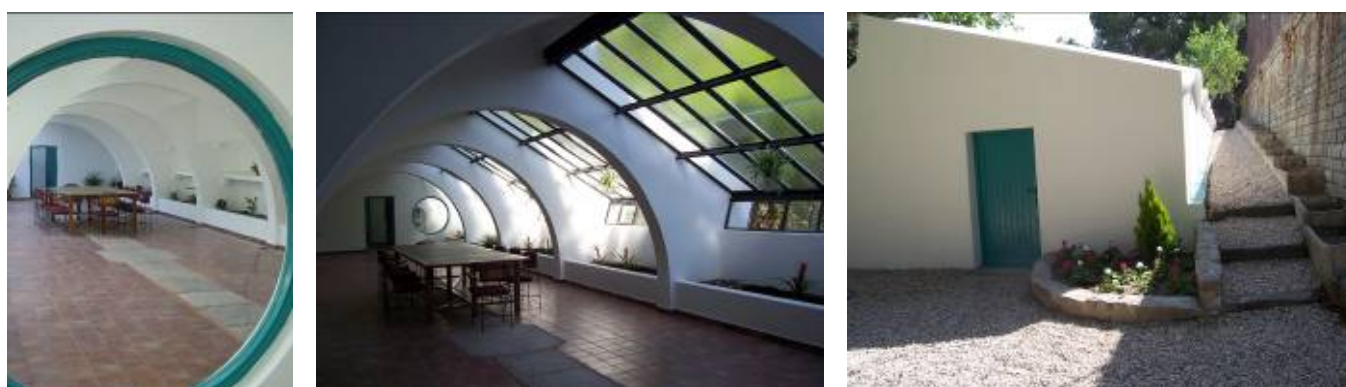
Figure 15: The winter garden at present

The surrounding areas were cleared from overgrowth and the planting bays close to the wall were removed, while all drainage was refurbished. Once the integrity of the structure was restored, thermal insulation and a waterproofing screed was applied on the vaults. In the interior, a new single-coat render was applied. So far as the metal frame of the windows is concerned, all the mullions were cleaned and the

glass panels that had not been damaged were placed once again. The damaged ones were replaced with reinforced glass that was distinct from the original panels and for this reason two entire bays were glazed this manner. In addition, the most damaged metal mullions were protected from the ingress of water. Eventually, the building at the end of the works is the very pleasant multi-functional space that was planned (Fig. 15).
