## 1            **Structural integrity monitoring of onshore wind turbine concrete foundations**

### 7            **Abstract**

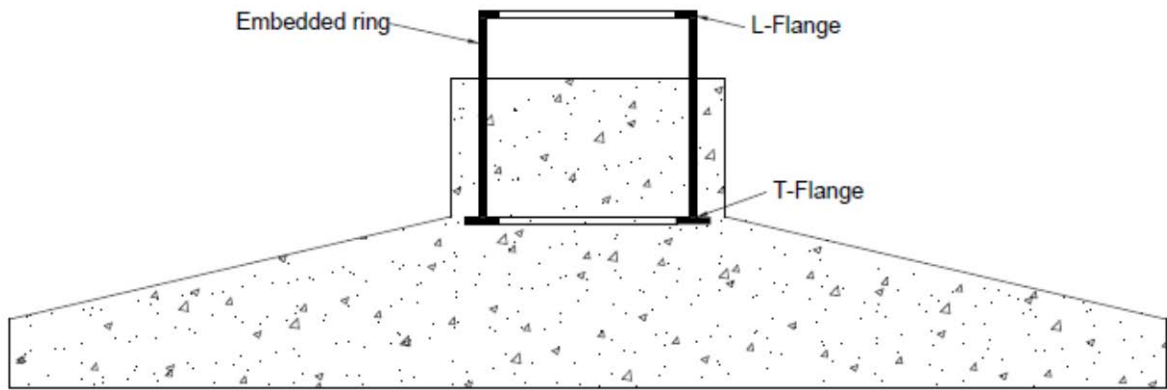
76 The onshore wind turbine concrete foundations with embedded ring shown in Fig. 1 are widely  
77 used around the world. These types of foundations are the subject of this study with respect to  
78 vertical movement. Several wind farms were visited to identify the main cause of this vertical  
79 movement using Endoscopic filming through boreholes created in the foundations. The  
80 Endoscopic filming showed significant voids filled with water under the flange of the embedded  
81 ring. Significant erosion was also observed on the upper side of bottom flange due to the uplift  
82 forces placed on the foundation by the rotor. These voids have caused excessive vertical  
83 movement of the ring, leading to concrete cracking (Fig. 2) and failure of the water proofing  
84 system.

Fig.1: Typical onshore wind concrete foundation with embedded ring

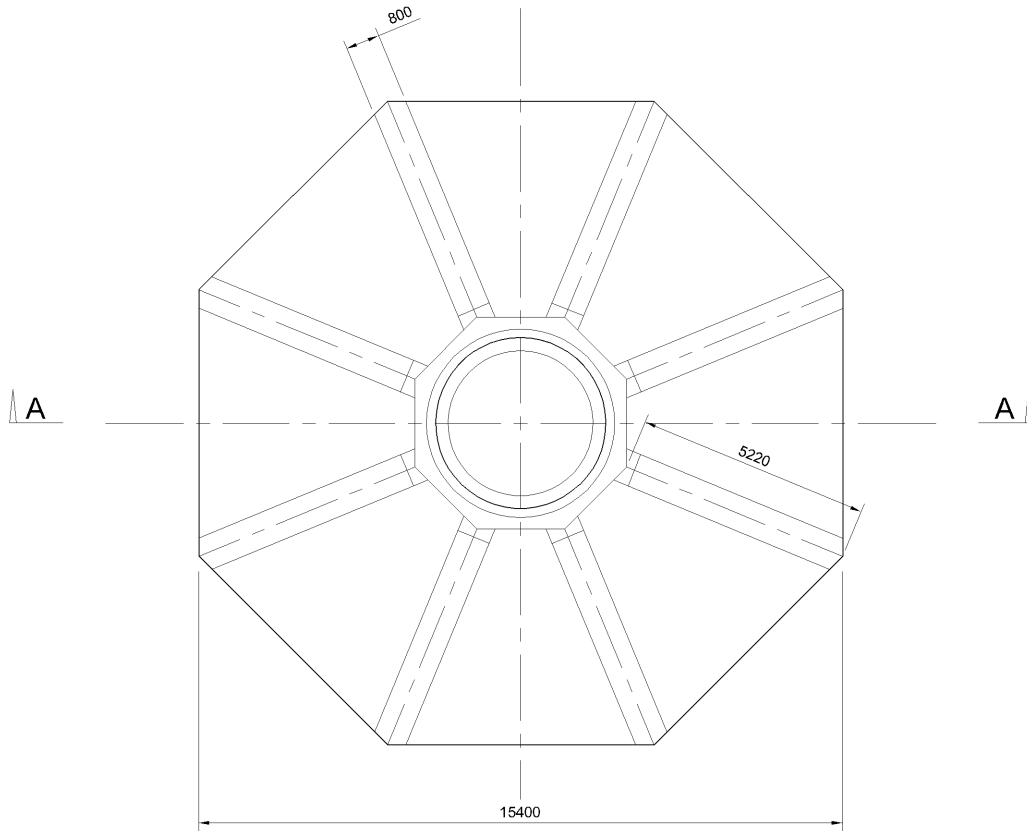
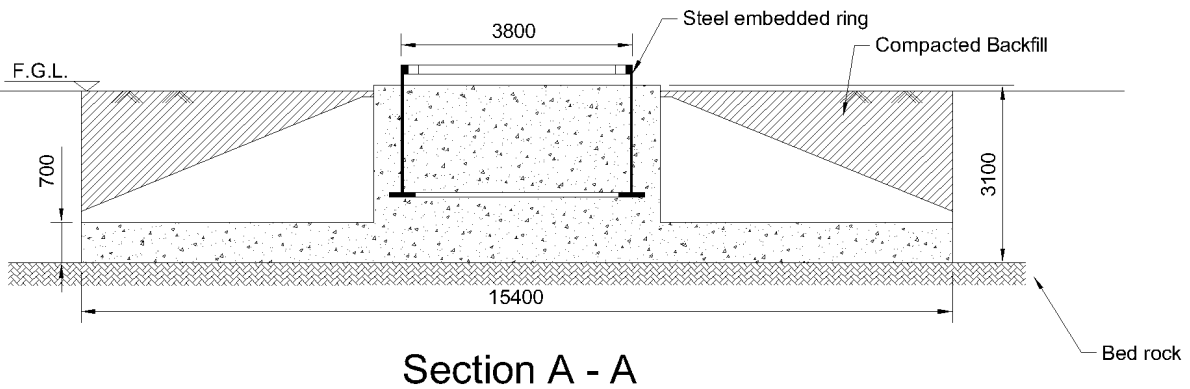
91 The wind turbine test bed used in this investigation was a modern 2.0 MW pitch regulated  
92 variable speed machine and in operation for at least five years. The exact location and turbine  
93 model are confidential due to a non-disclosure agreement with the operator. The foundation  
94 consisted of an octagonal reinforced concrete slab with an embedded steel ring connection  
95 system. Fig. 3 shows the geometry of the foundation. The foundation was designed to support a  
96 67 m-hub tower equipped with a rotor of 80 m in diameter.

Fig. 3. Layout of the wind turbine concrete foundation (dimensions in mm)

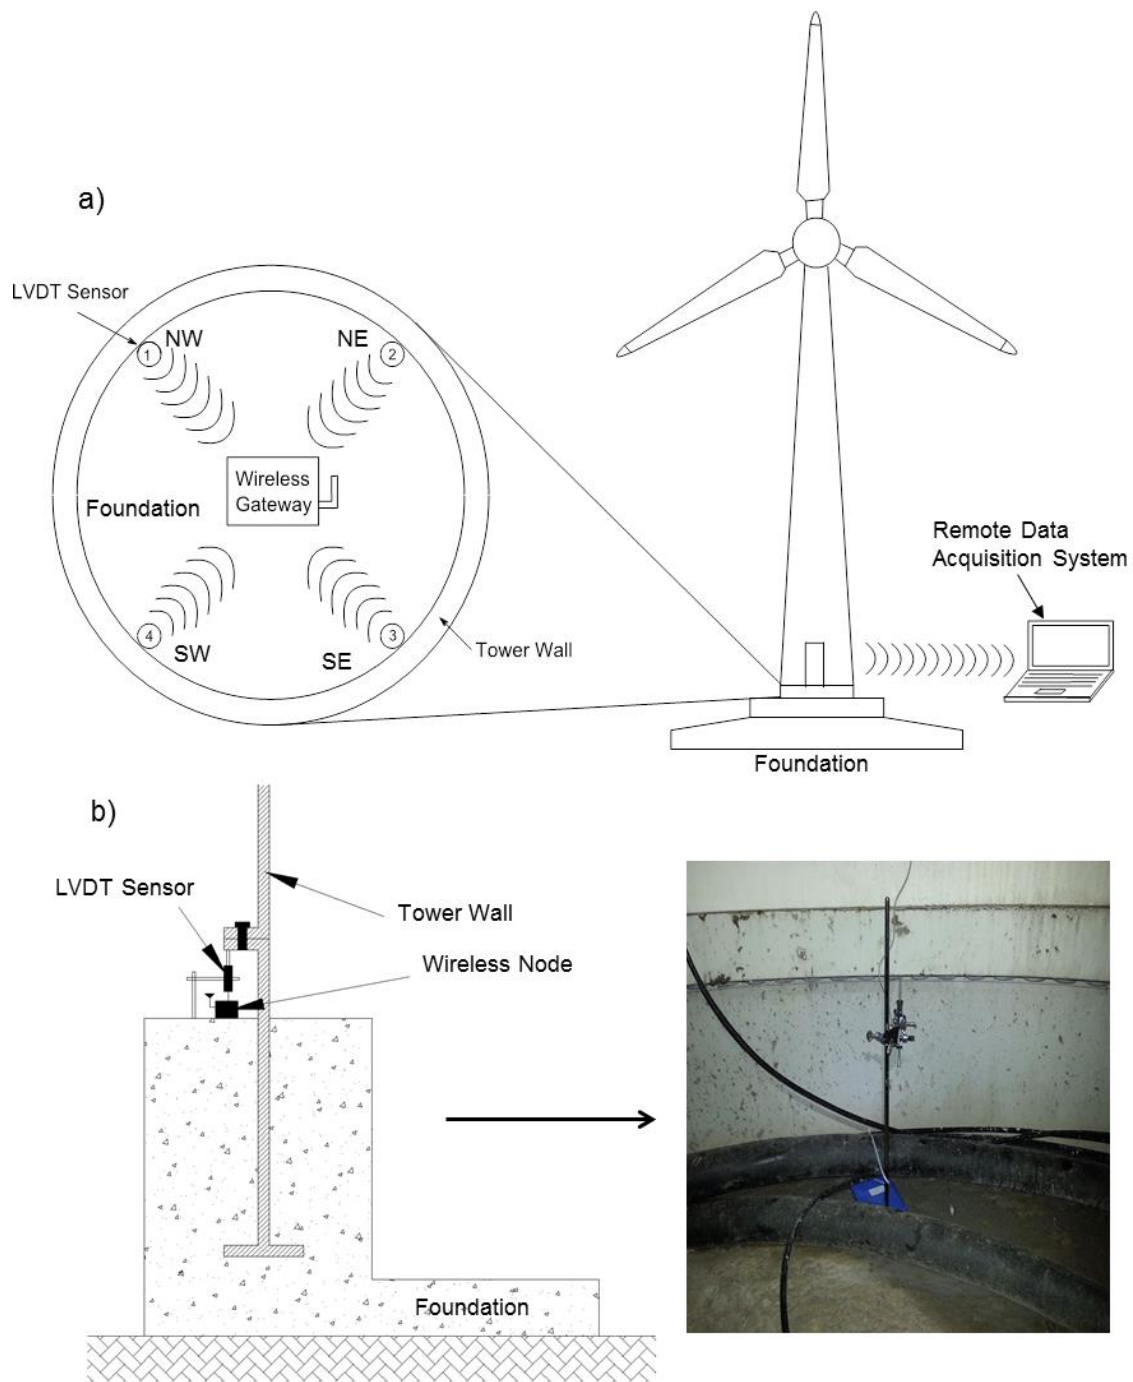
113 As shown in Fig. 4a, four LVDT sensors were installed under the top flange of the embedded  
114 ring. Each LVDT was equipped with an off-the-shelf wireless communication node set to  
115 measure displacement at a frequency of 1Hz. This rate was deemed to be sufficient for the  
116 relatively slow movement of the turbine tower. The nodes were equipped with a 2.4 GHz  
117 CC2420 wireless radio chip from Texas Instruments, which is IEEE 802.15.4 compliant. The  
118 transmission power was set at 0 dBm while the receiver sensitivity of radio chip is -95 dBm.  
119 The wireless gateway device consisted of an off-the-shelf low cost Raspberry Pi microcomputer,  
120 a standard 4GB SD memory card and a small size battery pack, which acts as a UPS.

121 The sensors were positioned equidistant around the foundation (see Fig. 4a). The measurement  
122 points are numbered on the figure as 1 NW (North West), 2 NE (North East), 3 SE (South West)  
123 and 4 SW (South West). These points were selected because the prevailing wind conditions on  
124 the site were south-westerly in nature. Using these measurement points, the sensor array would  
125 capture the displacement on planes parallel and perpendicular to the prevailing wind. The LVDT  
126 sensors were installed to measure the displacement between the static concrete foundation and  
127 the embedded ring. It was essentially measuring the movement of the embedded ring at the  
128 connection with the tower. Retort stands were used to keep the sensors with a heavy weight base  
129 and the attachments were locked in position using thumbscrews, preventing any movement  
130 during operation. The LVDTs were set half compressed, allowing vertical upwards and

131 downwards movements to be recorded. The LVDT installed in the foundation had a maximum  
132 stroke of 50 mm; hence they were installed at a set position of 25 mm. Fig. 4-b shows the sensor  
133 location along with the method of anchoring the sensor.

Fig. 4. a) SIM architecture and b) sensor installation.
