NASA/TM-2016-219217

# Emergency Locator Transmitter System Performance During Three Full-Scale General Aviation Crash Tests

*Justin D. Littell and Chad M. Stimson  
Langley Research Center, Hampton, Virginia*

July 2016

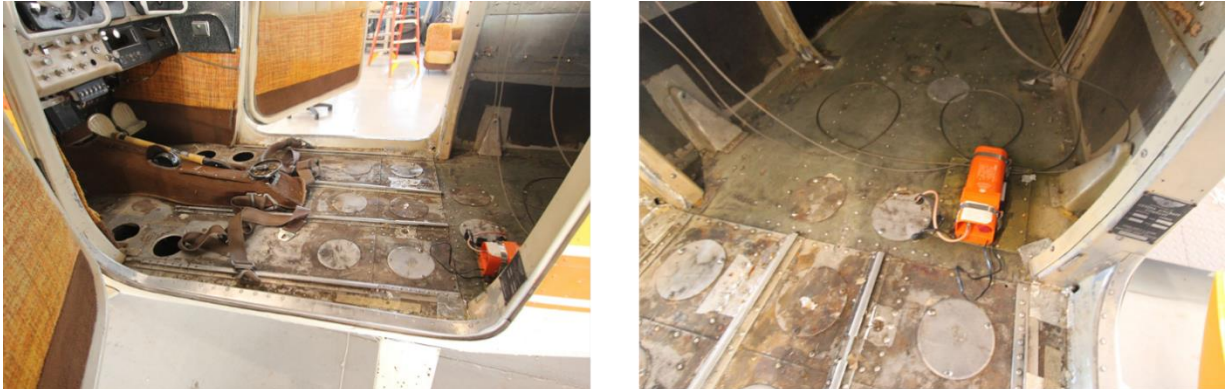
Figure 6 - Test 1 original airplane ELT beacon installation as viewed from the pilot door (left) and pilot seat looking aft (right)

The original ELT for the Test 1 airplane was still present when the airplane was delivered to LaRC. The beacon was floor mounted beneath the rear bench seat on the pilot side of the cabin and the antenna cable was routed through an access hole in the cabin subfloor and into the external antenna located in the tail, directly behind station 108. The beacon was mounted onto an aluminum doubler plate, which was riveted into the subfloor support channels. Figure 6 shows the original ELT installation after removal of the aircraft interior components.

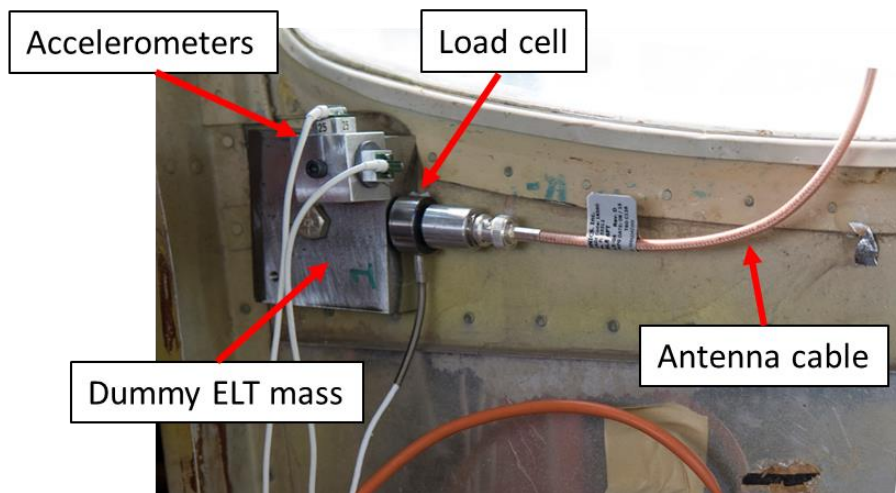
Figure 8 - Dummy ELT beacon installation for Test 1 (pilot side shown)

The two dummy ELT beacons were mounted just forward of the station 90 frame section, beneath the rear window on both the pilot and co-pilot side with the BNC/load cell connection facing forward, as shown in Figure 8.

This scenario is plausible because the antenna cable was attached into the BNC end which was attached to the load cell, which then attached to the dummy ELT weighted block. This configuration created a long moment arm extending from the load cell. Referring to Figure 8, both the load cell and BNC end were pointed forward, as they would be in a typical ELT beacon configuration. The antenna cabling attached to the dummy beacon, and then made a 180 degree change in direction turn after which it was subsequently routed under the assembly to an antenna in the tail of the airplane and pulled taught. During the crash when the airplane experienced the tail fracture, the subsequent hinging relative motion between the tail and cabin created tension on the cable, which pulled down on the dummy ELT 2 fixture. This downward motion created a bending moment at the load cell to dummy mass attachment location, and caused the load cell to register a negative reading. Dummy ELT 1 also experienced signs of cable pullout; however, during the timeframe of data collection, the pullout load was not able to be measured.

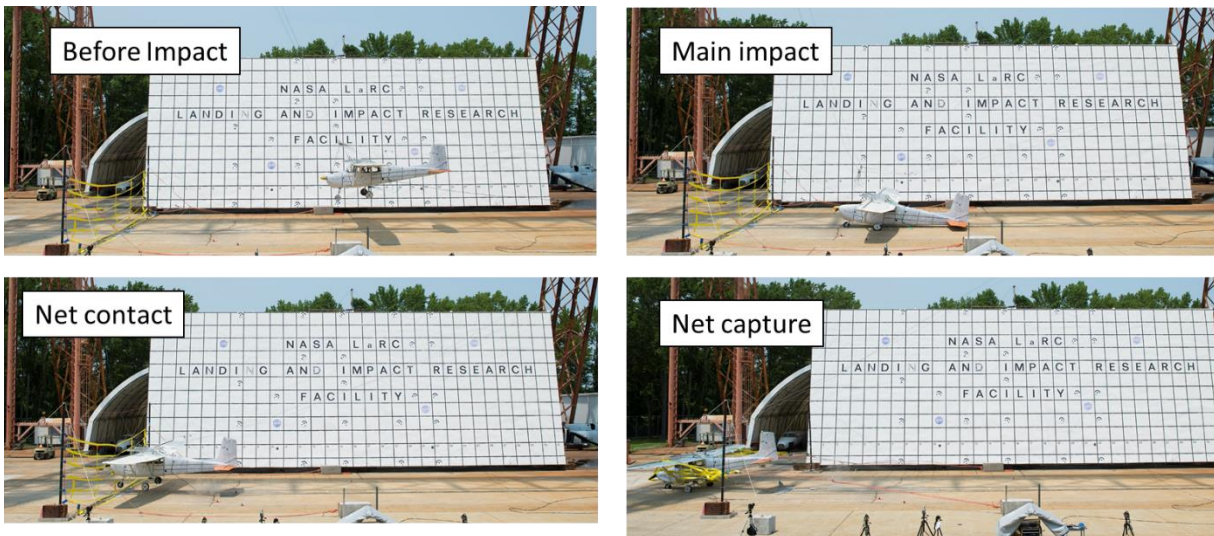
Figure 10 - Test 1 impact sequence

Test 1 occurred on July 1, 2015. The airplane impacted the concrete surface at a flight path velocity of 64.4 ft./sec. at an Angle of Attack (AoA) of 1.5 degrees nose high. The main landing gear compressed enough to allow the tail to strike the surface approximately 0.125 sec. after initial impact. The airplane rebounded with a large amount of residual horizontal velocity, which was

then stopped by the catch net. The time between the initial impact and the first catch net contact was 0.475 sec., however the net capture occurred at approximately 0.800 sec. after initial impact. At a point during the net capture, the airplane tail impacted the ground a second time, causing a small portion of the lower tail to break free from the airplane. The airplane came to rest approximately 5.85 sec. after initial ground impact. Figure 10 shows the impact sequence.

Other than minor damage in the nose gear mounting location and rear tail piece which broke free, the airplane appeared to be largely undamaged after the impact. Visual inspections confirmed that all ELT beacons remained seated in their mounting trays, with no structural failures detected on the mounting tray, aircraft attachment plates or beacons due to the ground impact or net capture events. Acceleration data captured from accelerometers mounted directly to the beacons are plotted in Figure 11. Accelerations for all beacons and aircraft attachment plates presented in this report are filtered at a SAE Channel Filter Class (CFC) 60 low-pass filter [15].

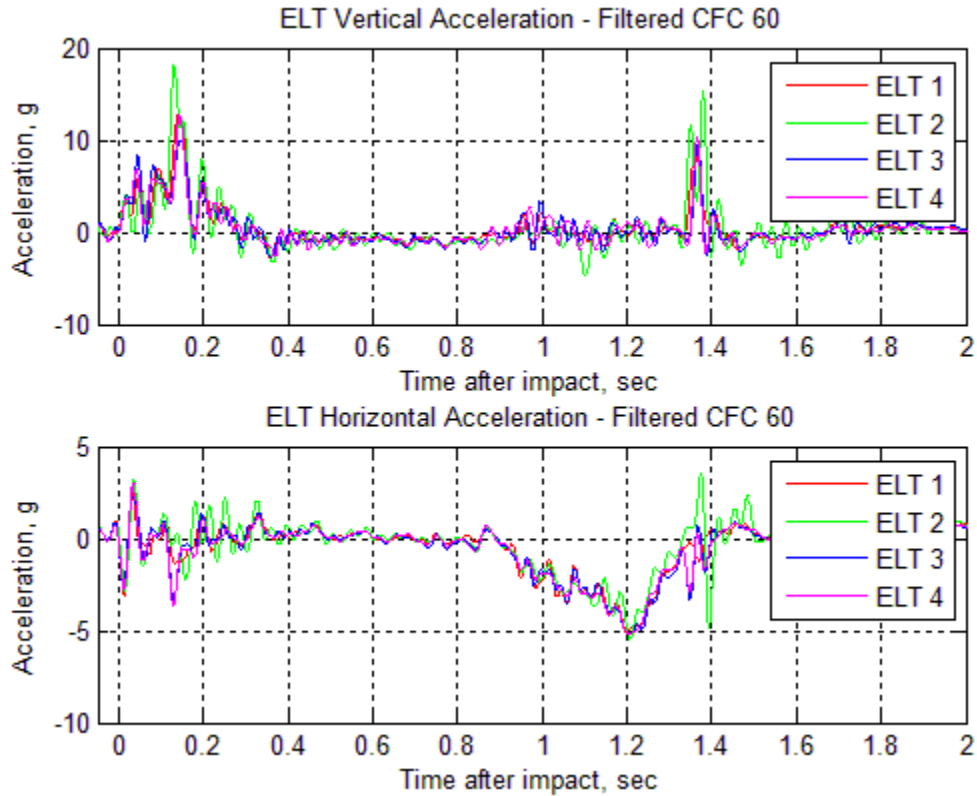
Figure 11 – ELT beacon accelerations from Test 1

Vertical accelerations during the ground impact event reached peak values of 12.7, 18.1, 10.1 and 12.7 g for ELT beacons 1, 2, 3 and 4, respectively. The maximum values occur 0.125 sec. after impact, and are due to the tail strike condition. ELT beacon 2 is closest to the tail and has the highest maximum peak accelerations. All peaks resemble a trapezoidal pulse shape with a sharp spike at the end. The duration of the pulse was 0.300 sec. with rise and fall times of 0.050 sec., and a sustained time of 0.200 sec. Another spike in acceleration occurs at 1.36 sec. after impact. This spike is due to a second tail strike which occurred during the net catch. The duration of this impact was approximately 0.030 sec. with maximums close to 10 g for ELT beacons 1, 3 and 4, and 15 g for ELT beacon 2.

Horizontal accelerations, which are shown in the lower plot in Figure 11 are mainly concentrated between 0.800 and 1.600 sec. There are short spikes which occur during the ground contact portion of the impact event, and oscillate between -3 and 3 g initially. The main portion of horizontal acceleration is evidenced from the net capture. The ground impact event is complete by 0.475 sec. after impact, after which the airplane makes contact with the net. Little acceleration is seen between 0.475 and 0.800 sec. after impact, mainly due to the net breaking away from the supports and beginning to wrap around the airplane. The actual capture begins 0.800 sec. after impact where the net tension begins to pull the drag weights in order to decelerate the airplane. The deceleration reaches maximums of 5.1, 5.5, 5.1 and 5.2 g for ELT beacons 1, 2, 3, and 4, respectively. The pulse is triangular in shape.

Change in velocity, which is simply the integrated acceleration signal from the plots show in Figure 11 is presented in Table 3. Data are computed in the vertical direction at ground contact between times 0.000 and 0.400 sec., and computed in the horizontal direction during net contact and catch, between times 0.800 and 1.600 sec. For reference, peak accelerations described above are also included. It should be noted that these delta-v results are substantially higher than what is required for automatic activation of the ELT [4].

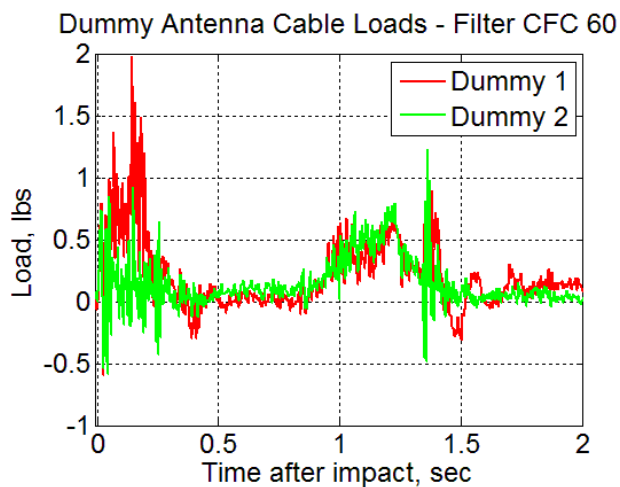
Figure 14 - Test 1 dummy antenna cable loads

Cable loads were minimal in the dummy antenna cables due to the large amount of slack present in both of the dummy cable lengths. Since cables were slack, maximum loads developed were less than 2 lb. for both cables. No antenna cabling showed signs of damage or pullout from the attachment points. Figure 14 shows the results.

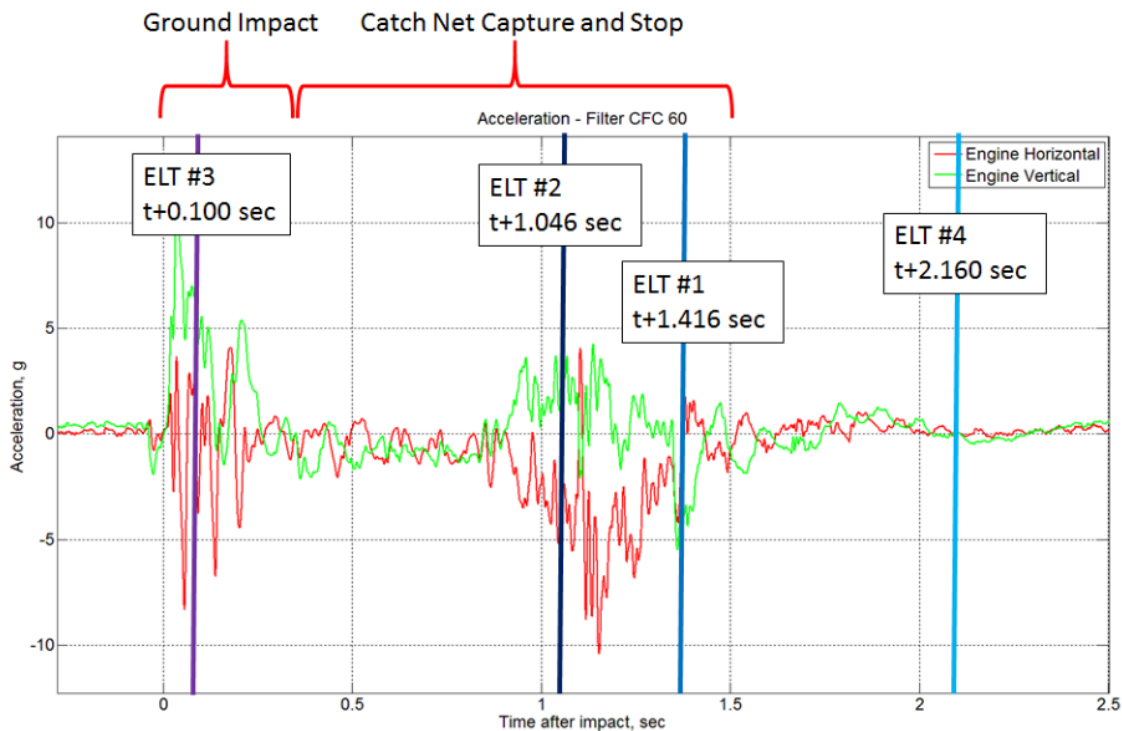
Figure 16 - Test 1 LED illumination timing

All four of the ELTs activated automatically and transmitted during the test. Since Test 1 was comprised of two major separate impact events, ELT beacon activation timing is critical to determining whether ground impact or net capture led to the distress signal transmissions. A sequence of events was reconstructed by examining when the visual status indicator lights on the beacons and remote switches illuminated. The analysis included the utilization of timing data, frame rate information and the common DAS/camera time-code from each of the cameras to reconstruct a complete timeline. The timeline showing the first indicated illumination is overlaid onto the aircraft engine acceleration data in Figure 16.

ELT beacon 3 was the only beacon that clearly sensed the initial ground impact event, consisting of the high vertical (cross-axis with respect to the sensitive direction of the crash sensor) acceleration. The light illumination occurred at 0.100 sec. after impact, which is in the middle of the ground contact acceleration pulse. ELT beacon 3 was a single axis sensing beacon which had undergone vibration tests, which are described in more detail below, prior to being used for the crash test. The other three ELT beacons showed LED illumination occurring more than 1 sec. after impact, either during or after the net capture.

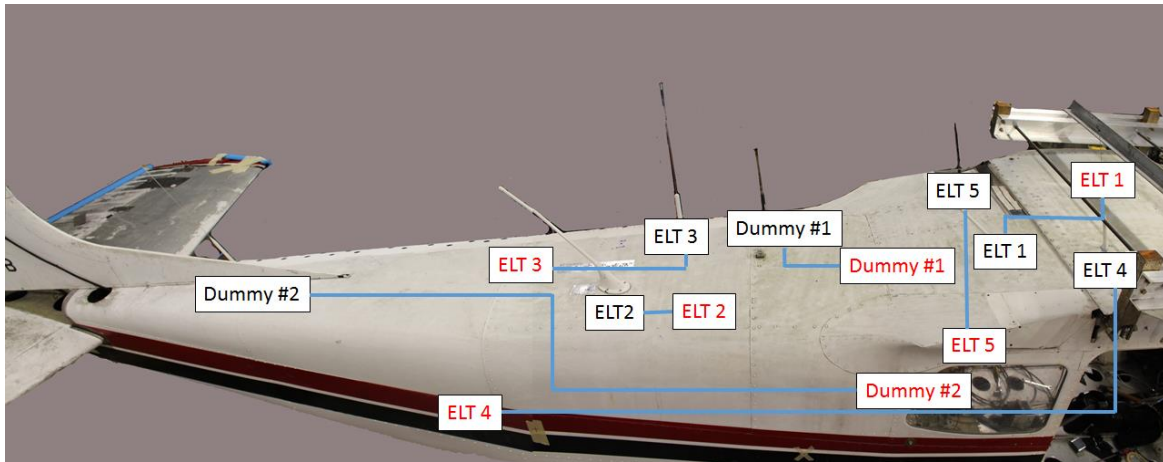
Figure 19 - Antenna locations for Test 2 with cable runs annotated

A combination of rod and whip antennas were used for Test 2. For the two helicopter ELT installations (ELTs 1 and 2), rod antennas were used per typical practice, and the remainder used whip antennas. Figure 19 shows the antenna locations, in black, on the rear cabin and forward tail, with approximate beacon interior locations also identified in red. The blue connecting line is an illustration to show the cable run between the beacon and antenna. ELTs 1, 2 and 3 all used best practice guidelines in trying to keep the antenna as close to the beacon as possible and without crossing airframe production breaks. Since beacons 1 and 2 were both ceiling mounted, the cable was a short 24-in. in length. The longest cable was used on the installation of ELT 4. This cable spanned four production breaks, connecting the ELT near station 140 to the antenna near station 65.

Unlike Test 1, the dummy ELT 1 antenna was very short. Dummy ELT 2, however, ran from the side window location at station 90 to the rearmost antenna near station 205. The antenna at station 205 was the rearmost mounted antenna amongst all three tests. As with Test 1, all cabling was secured via tie wraps to frame sections.

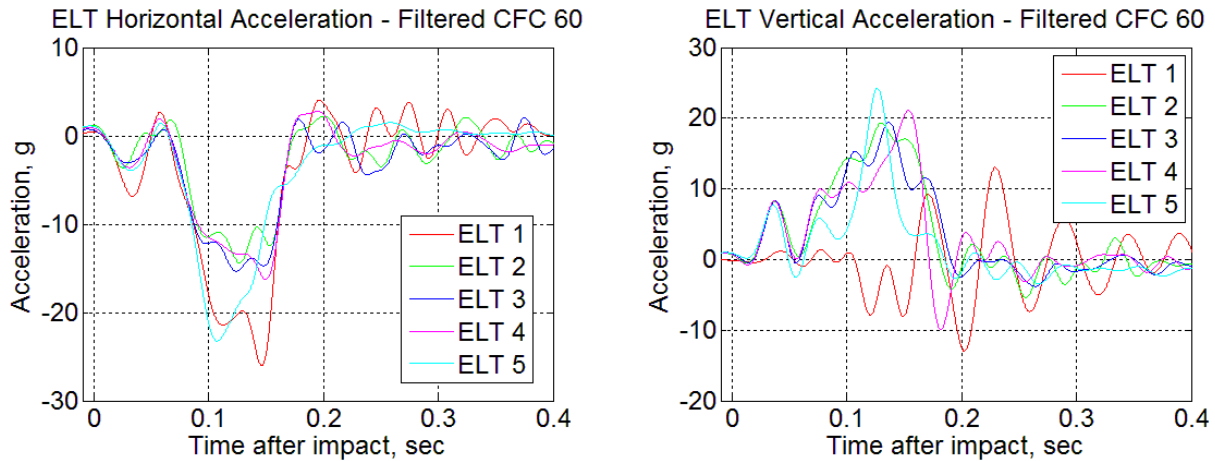
Figure 21 – ELT beacon accelerations from Test 2

As shown in Figure 21, ELT beacons 1 and 5 show the highest horizontal accelerations during the impact, with peaks of 26.1 and 23.2 g, occurring at 0.145 sec. and 0.107 sec. after impact. It should be noted that both ELT beacons 1 and 5 were mounted in the cabin of the airplane, on the ceiling for ELT beacon 1 and on the floor for ELT beacon 5. ELT beacon 1 was the only ELT used in all tests which did not follow instrumentation orientation consistent with the airframe coordinate system. Instead, the two accelerometers mounted on ELT beacon 1 were mounted in the ELT beacon sensing direction and perpendicular to the ELT beacon sensing direction, respectively. For purposes of reporting, the ELT beacon accelerations are not transformed into the airplane coordinate system because it is important to show the accelerations experienced by the ELT in the beacon sensing direction. Therefore, the results from ELT beacon 1 shown in Figure 21 do not follow the acceleration traces acquired from the other ELT beacons.

ELT beacons 2, 3, and 4 show similar results, both in magnitude and in shape of horizontal accelerations from the impact. The accelerations are presumably similar due to the close proximity of mounting locations of the beacons in the tail. These accelerations approximate a trapezoidal shaped pulse, with a sustained acceleration duration of 0.63 sec. at average values of 10.3, 12.0 and 10.7 g, for ELT beacons 2, 3 and 4, respectively.

Vertical accelerations, as shown in Figure 21, from the test closely matched between ELT beacons 2 through 5. The vertical accelerometer orientation on ELT beacon 1 was oriented at a 45 degree angle. Combined with a 12.2 degree nose down impact angle, the vertical accelerometer mounted on ELT beacon 1 was actually measuring accelerations at a 57.2 degree angle from the vertical, relative to the ground. It is because of this angle offset that the vertical accelerometer was measuring the complementary angle of acceleration relative to the flight path angle of 21.6 degrees, and thus, not registering high accelerations.

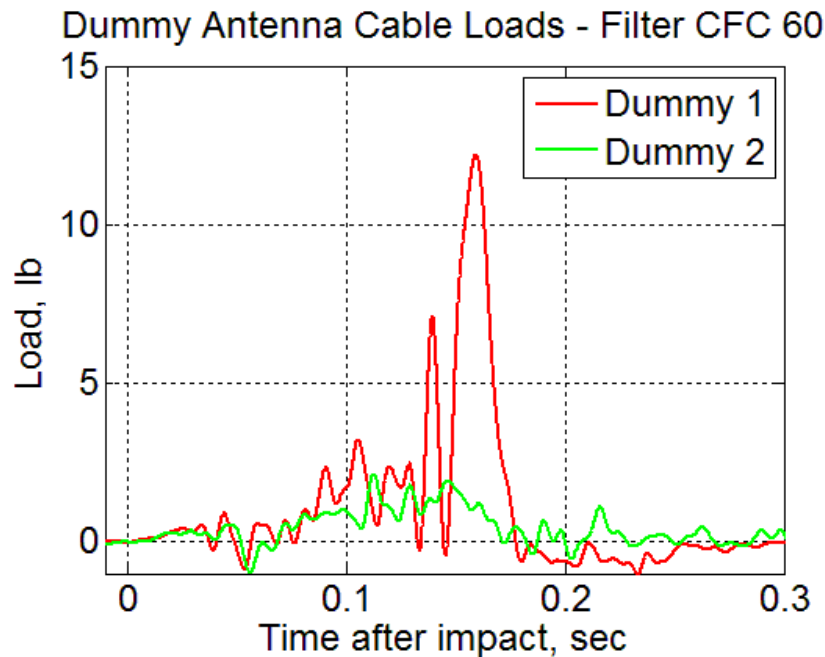
Figure 23 - Test 2 dummy antenna cable loads

The cable loads developed in the dummy ELT cables are shown in Figure 23. As with Test 1, the loads measured in the dummy cables were very low, reaching peaks of 12.2 and 2.1 lb. for dummy 1 and 2, respectively. These loads occur in the first 0.200 sec. of the crash, which follows when the ELT beacons saw the acceleration pulses from the crash.

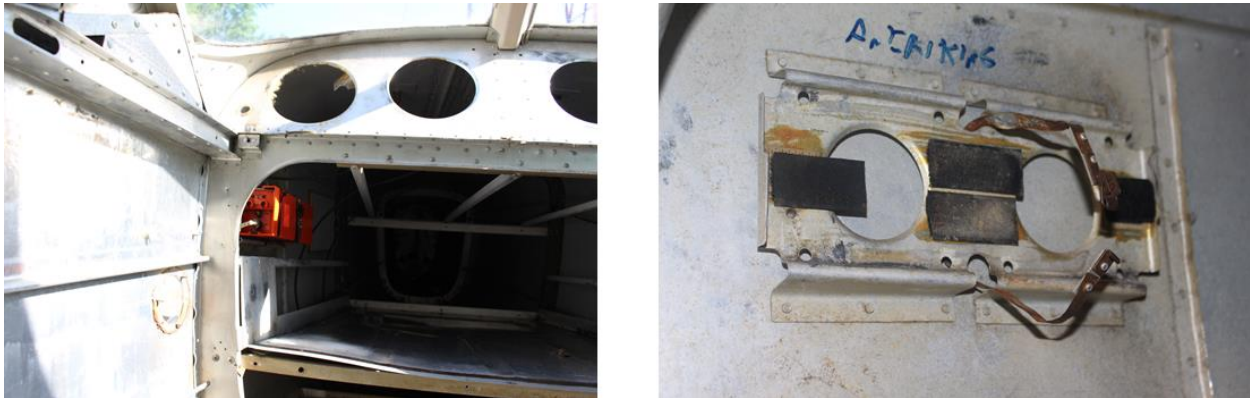
Figure 25 - Test 3 original airplane ELT location (left) and aircraft attachment plate (right)

As with the Test 1 aircraft, the Test 3 aircraft arrived at LaRC with the original ELT installation present. As shown in Figure 25, the beacon was installed on the co-pilot side, in the forward tail section, directly behind the cabin-to-tail transition area. The aircraft attachment plate did not follow current installation standard [4], and was riveted directly onto the skin, and not attached to any primary structural elements. The beacon was secured in its mount via a tie wrap located at the forward end and a leather buckle in the middle. The antenna was located near the beacon, centered on the tail at the same approximate station location. Note the tie wrap has been removed from the aircraft attachment plate view.

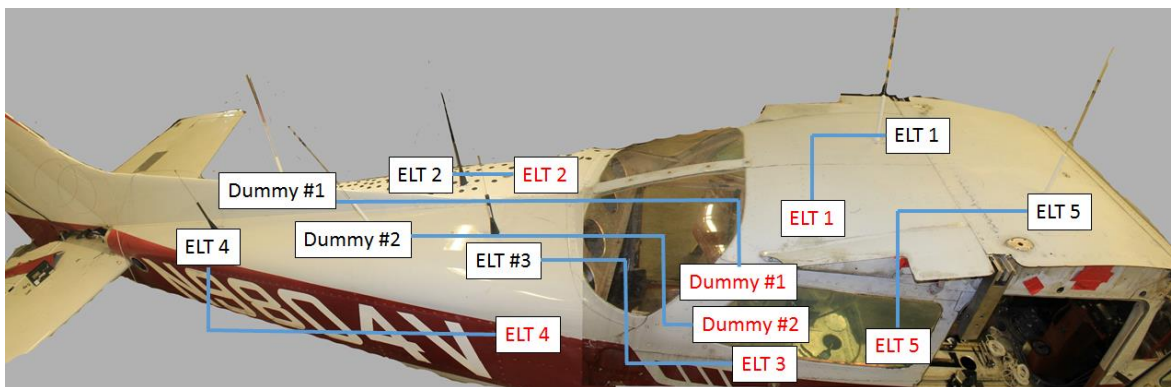
Figure 27 – Antenna locations for Test 3 with cable runs annotated

For ELTs 1, 2 and 5, the shortest cable run distance was implemented. The ELT 4 cable originated at the beacon location just aft of station 108, ran through frames at stations 140 and 172, and terminated at an antenna located aft of station 172. ELT 3 antenna cabling crossed frames located at stations 90 and 108. The longest runs were the two dummy ELTs. Dummy ELT 1 cabling ran under the floor of the cabin, crossed frames at stations 108, 140 and 172 and terminated at an antenna aft of station 172. The cable length was chosen such that the cable developed significant tension when attached to the beacon and antenna. Dummy ELT 2 included an antenna located forward of station 140. The cable, while having more slack than Dummy ELT 1, was purposely chosen to be almost the exact length as the run needed, causing very little slack to be present. Figure 27 shows an illustration of the ELT beacon (in red) and antenna locations (in black), with the cable runs noted.

When examining the cabling layout diagram in Figure 27, the three connections that failed are the only ones that had crossed a production break between the cabin and tail of the airplane. The connections failed due to the large amount of deformation which occurred in the tail after the fracture initiated during the crash sequence. The long length of these connections was intentional, and specifically made in an attempt to magnify the failure response exhibited in Test 2. All other cable runs were made as short as practical, with one exception made for ELT 4. The cable spanned the entire tail length, originating from the beacon in the forward tail to the antenna in the rear tail. The loads measured from the dummy ELT cables are plotted, and shown in Figure 31.

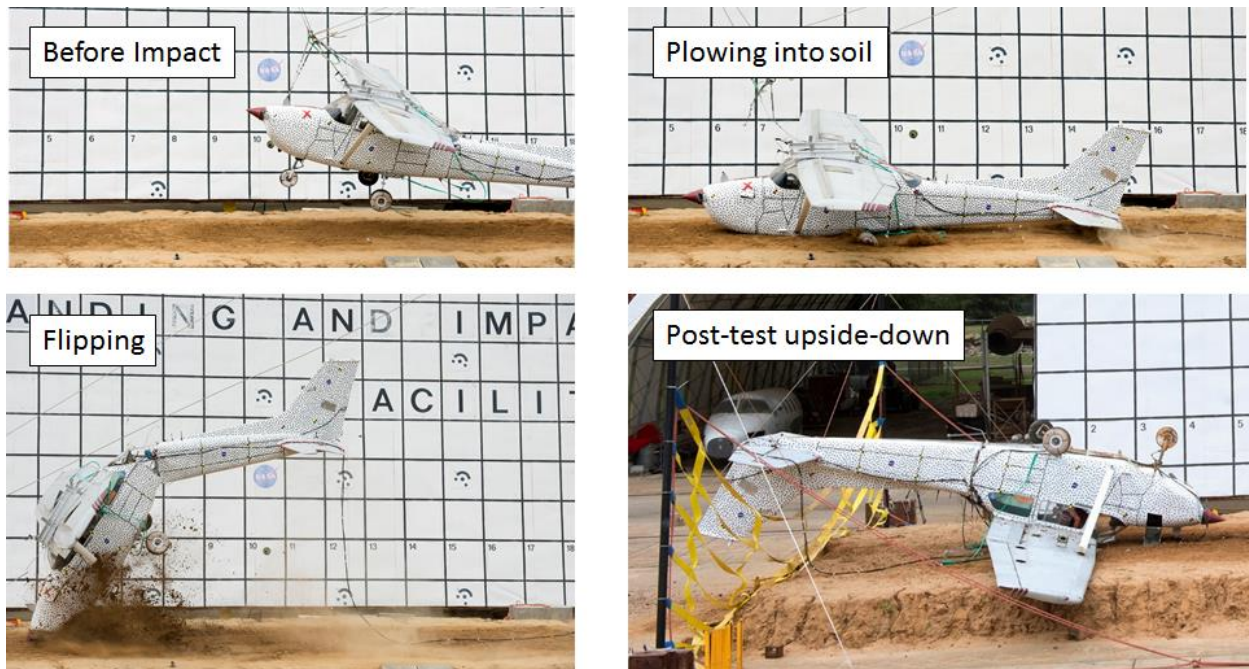
Figure 28 - Test 3 impact sequence

There was a slight amount of roll (co-pilot high) and yaw (nose left) at impact. Due to these conditions, the pilot main gear impacted the soil initially. The tail contacted the soil 0.030 sec. after initial gear impact and the nose contacted the surface 0.116 sec. after impact. Similar to Test 2, the nose gear penetrated the soil surface and acted as a pivot point for the airplane to rotate around. The airplane started to exhibit noticeable rotation shortly after nose contact. At 0.138 sec. after impact, tail failure occurred, causing a large fracture at the tail-cabin junction to appear. The airplane landed upside-down 1.53 sec. after impact and rocked back and forth for an additional 3 seconds. The airplane came to rest approximately 5 sec. after initial impact. This sequence is depicted in Figure 28.

The airplane sustained major damage from the impact. Large amounts of deformation were seen in the engine area by the nose and firewall. The most noticeable failure that occurred was the tail separation from the cabin section. A fracture occurred at the tail-to-cabin transition area in the skin of the aircraft, causing the skin to fail on three sides. The only material holding the tail onto the rest of the airplane was a small section on the bottom of this area, and the tail hinged about this section. This fracture occurred very early in the crash event, during the time the airplane was plowing into the soil. During the flip over, the hinging caused the tail to become oriented at a 90 degree angle perpendicular to the fuselage creating a large opening at what would be the top of the tail/cabin connection.

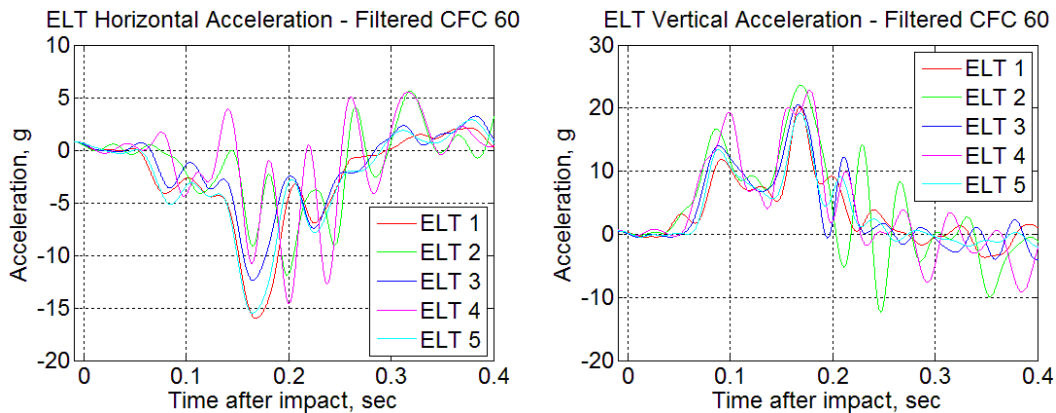
Figure 29 ELT beacon accelerations from Test 3

As shown in Figure 29, horizontal accelerations were triangular in shape, with a pulse duration of 0.300 sec. The peak acceleration values occurred for ELT beacons 1, 2, 3, and 5 at approximately 0.168 sec. after impact, with the peak for ELT beacon 4 occurring a short time later at 0.200 sec. ELT beacon 4 showed more oscillations than the other ELT beacons, which affected its peak value. Visual inspections of the ELT beacon-to-mounting tray and aircraft attachment plate connections post-test revealed nothing unusual or loose regarding the instrumentation. The noise was attributed

As shown in Figure 29, the vertical accelerations resembled a trapezoidal shape of approximately 0.250 sec. in duration, with two defined peaks at the beginning and end of the plateau. The first peak occurs between 0.085 and 0.98 sec. after impact, depending on which ELT beacon is examined. The second peak occurs at an average time of 0.167 sec after impact. The first peak is due to the initial impact of the fuselage structure with the soil. The airplane rotation in which the nose finally impacts the soil causes the second peak a short time later. Maximum accelerations for the first peak range between 11.9 g for ELT beacon 1 and reach 19.4 g for ELT beacon 4. For the second peak, accelerations are more uniform but slightly higher, ranging between 19.2 g for ELT beacon 5 and 23.7 for ELT beacon 4.

Note that ELT beacons 2 and 4 are in symmetric arrangement in the forward tail, but experience large differences in the first peak of vertical accelerations. This finding is likely due to the slight amount of roll at impact. For the second peaks, which occur during the nose contact and plowing, the accelerations are more closely matched.
