NASA/TM-2015-218987

Crash Tests of Three Cessna 172 Aircraft at NASA Langley Research Center's Landing and Impact Research Facility

Justin D. Littell
Langley Research Center, Hampton, Virginia

November 2015

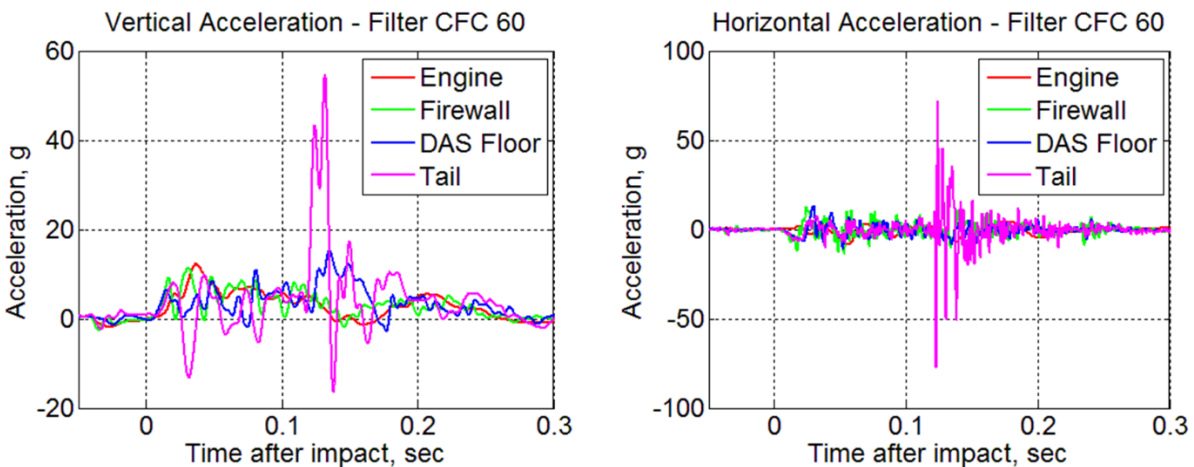
Figure 10 – Test 1 airframe accelerations during ground impact

At a high level, the test can be discussed in terms of two distinct impact events. The first event is the airplane impacting the concrete surface simulating a crash or emergency landing. In this event, which occurs for the first 0.300 sec, the landing gear deforms and the plane rebounds with minimal loss in its original horizontal velocity. As shown in Figure 10, the vertical acceleration shows a roughly trapezoidal shaped pulse resulting from the landing gear deflecting. Examining the plateau in acceleration occurring between 0.015 sec (start of plateau) and 0.200 sec (start of airplane rebound) after impact, the average sustained acceleration varies between 4.1 g in the engine to 5.9 g in the tail. The large 54.7 g peak in the tail is due to the tail strike, which occurred at 0.125 sec after the impact. The horizontal acceleration is minimal with the exception of the noise seen in the tail accelerometer, which is due to the tail strike.

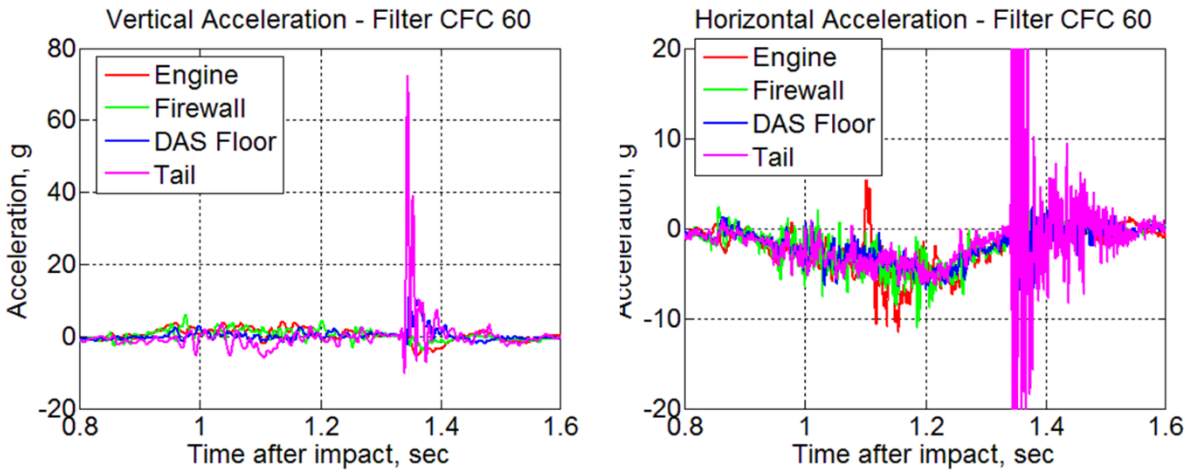
Figure 11 – Test 1 airframe accelerations during net contact

The second event is the airplane interacting with the catch net. The net was necessary to the test due to the constraints of the LandIR facility and not originally thought to be a part of the test. However, when investigating the results, the net can simulate a real scenario such as an airplane impacting brush, berm or other obstruction after the initial emergency/crash landing. Thus, it should be included in the data analysis in terms of its effect on the loading on the airframe and occupants. As shown in Figure 11, the horizontal acceleration in the airplane resulting from the catch net was a triangular pulse shape, lasting 0.5-sec and reaching average peak accelerations ranging between 4.0 g in the tail to 5.3 g on the engine. The large spike at the end of the net contact in the tail data is a second tail strike onto the concrete.

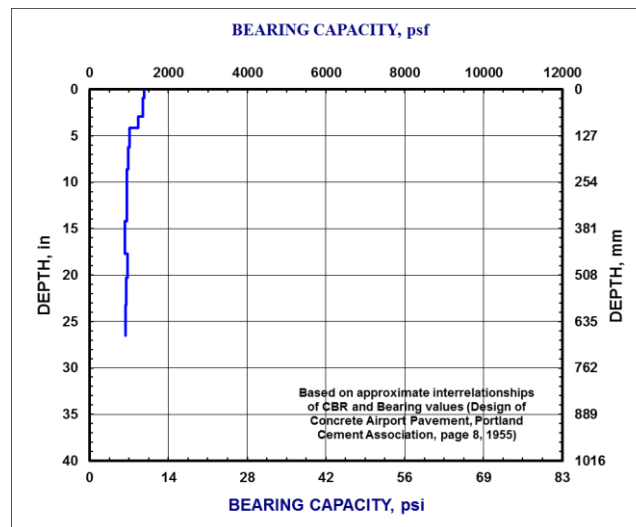
Figure 17 - Bearing capacity of the soil in Test 2

The surface of the soil was wetted using a hose approximately one hour before the test. The moisture content for Test 2 varied between 8.8% and 22.6% by weight. Density of the soil varied between 108 lb/ft^3 and 127 lb/ft^3 . The bearing capacity at one particular location is shown in Figure 17.

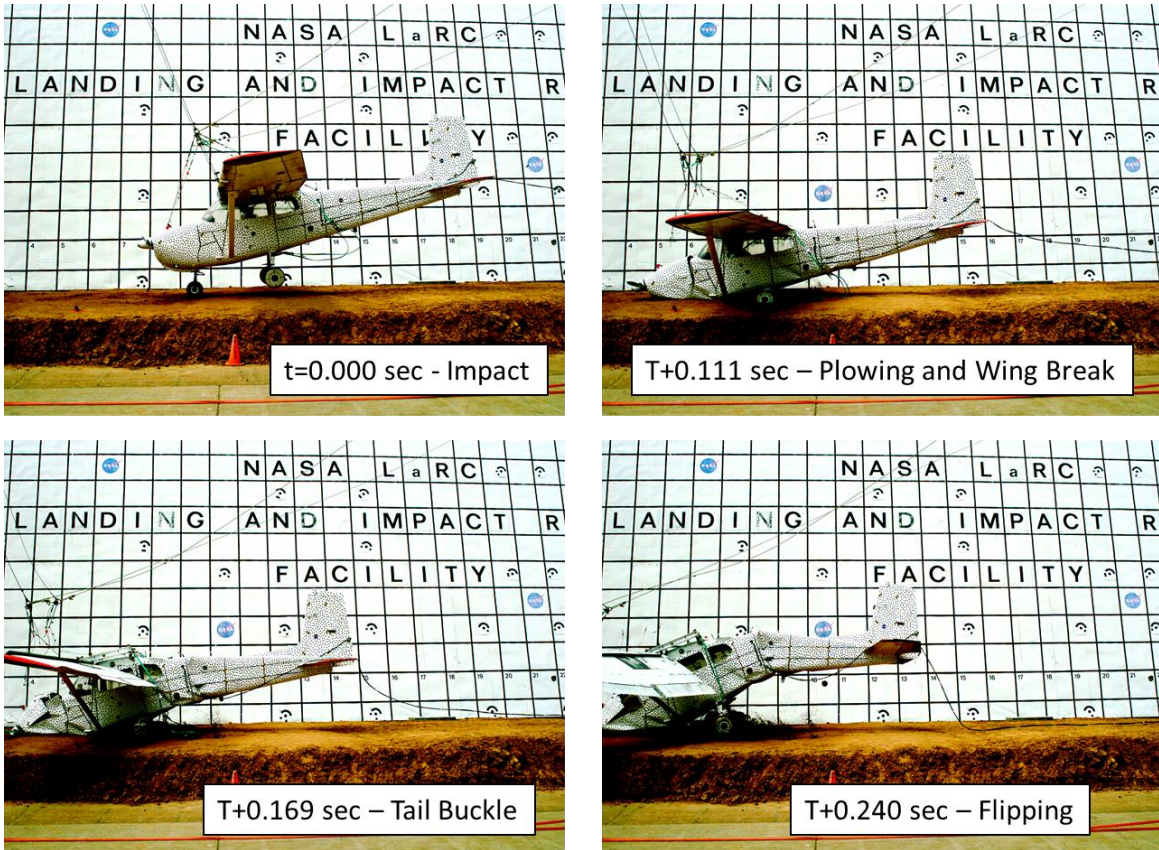
Figure 18 - Test 2 impact sequence - side view

The airplane nose gear impacted the soil first and began to plow into it. The nose of the airplane impacted the soil approximately 0.070 sec after initial nose gear contact with the soil. The nose and nose gear plowing into the soil continued to occur until the left wing broke away from the fuselage at 0.111 sec after impact. At 0.169 sec after impact, the plowing caused the tail to buckle, and at 0.240 sec after impact, the airplane

started to flip over. The flipping occurred due to the penetration of the nose gear into the soil. While the soil stopped the nose gear's motion, it also created a pivot point for the rest of the airplane to rotate around. At some point during the rotation, the nose gear broke away from the rest of the airplane. This sequence is captured in Figure 18.

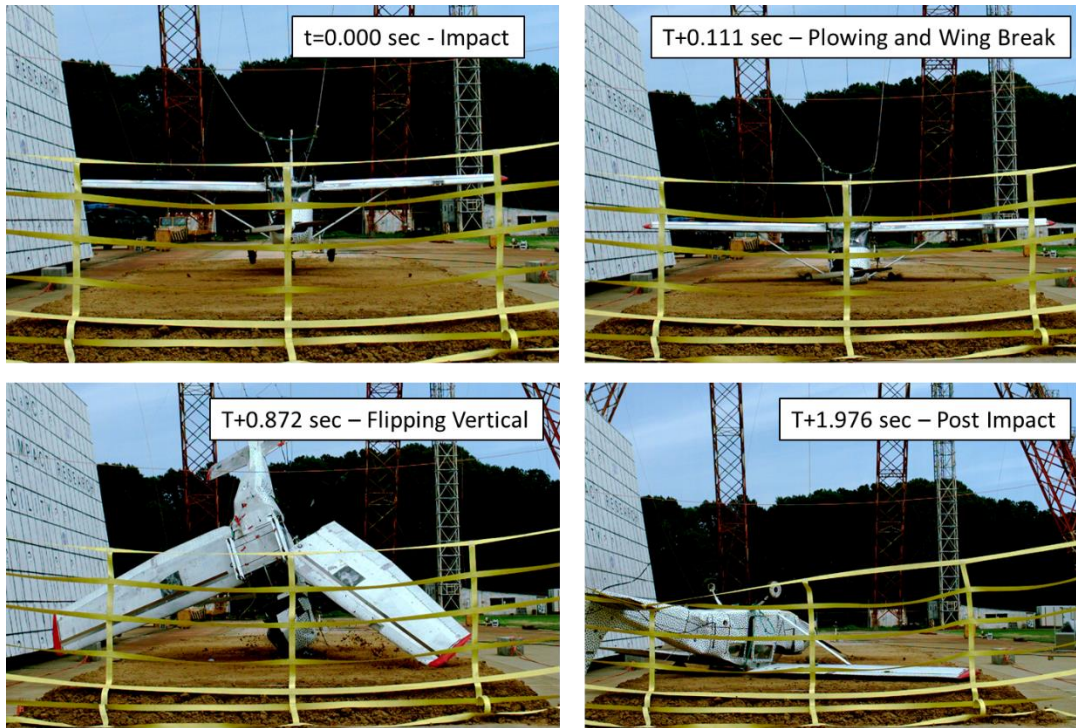
Figure 19 - Test 2 impact sequence - end view

The rest of the impact was captured from an end view camera. The rotation of the airplane continued to occur until the airplane landed upside-down approximately 1.976 sec after impact. It continued to rock back and forth until it came to final rest 6.790 sec after impact. Figure 19 shows the continuation of the impact sequence.

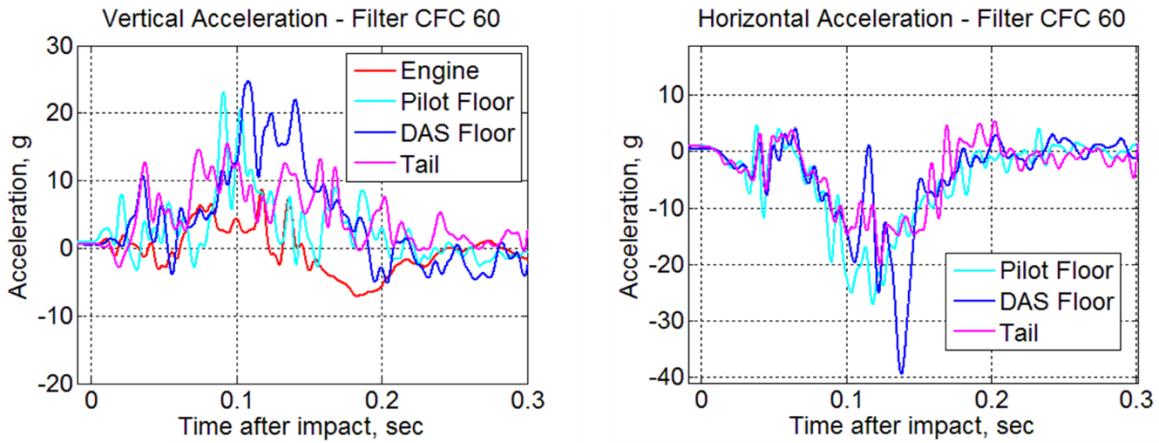
Figure 20 - Test 2 airframe accelerations

Vertical accelerations from the different portions of the airplane are different in magnitude, duration and shape, as shown in Figure 20. The engine experiences a peak acceleration of less than 9 g, which occurred 0.118 sec. after impact, after which, the engine experiences negative accelerations for the next 0.100 sec. The cabin of the airplane experiences maximum accelerations. The pilot floor accelerometer, located in the forward cabin, and the DAS floor accelerometer, located in the rear cabin, show peaks of 23.2 and 24.7 g, respectively. The tail acceleration starts negative, but then resembles a 0.130-sec plateau shape at +8.1 g mean acceleration.

Horizontal accelerations, shown in Figure 20, exhibit similar responses for both shape, magnitude and duration for all locations, with the exception of a large spike in the DAS floor. Engine acceleration is not plotted due to a severed cable which resulted in signal loss from that location, and the firewall location is also not plotted due to a small signal to noise ratio. The horizontal acceleration resembles a 0.135-sec triangular pulse with negative peaks of 27.1 g, 39.5 g and 19.9 g for the pilot floor, DAS floor and tail,

respectively. The average acceleration for the pulse shape is 18.7 g, 18.4 g and 13.5 g for the pilot floor, DAS floor and tail, respectively.

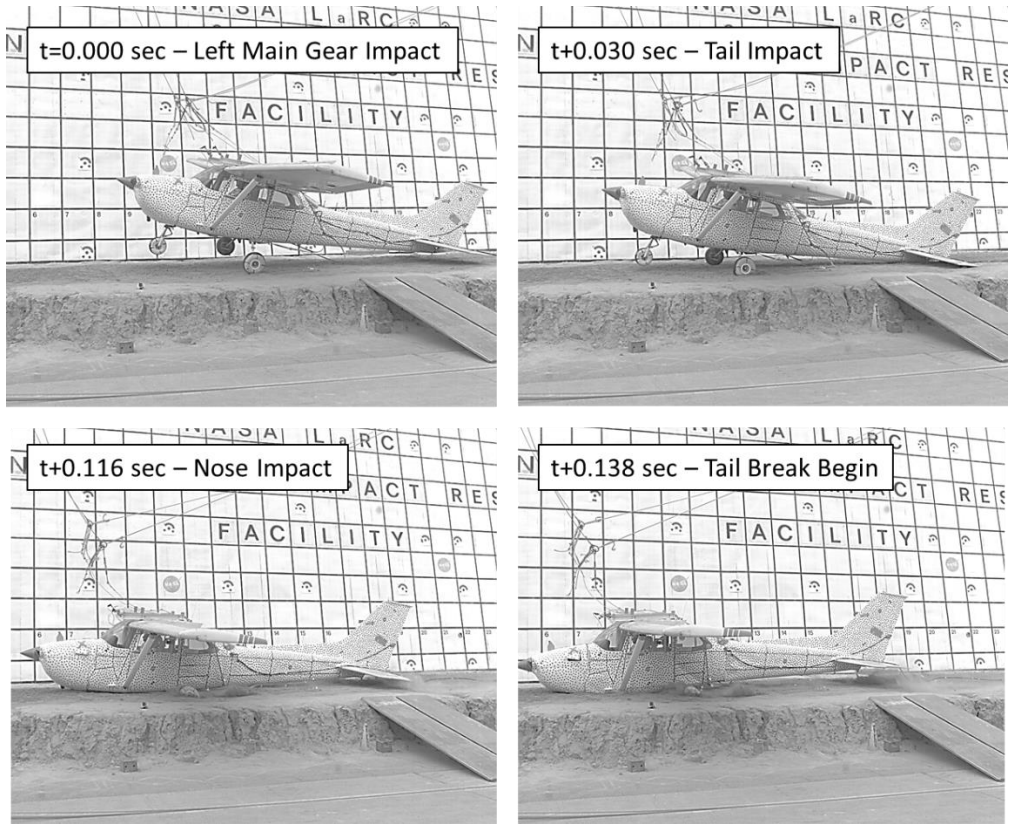
Figure 28 - Test 3 impact sequence - side view

Due to the slight amount of roll and yaw, the airplane left main gear impacted the soil first. As the tire and the gear deformed, the tail contacted the surface at 0.030 sec after impact. The nose gear, along with the nose of the airplane contacted the surface at 0.116 sec after impact. As with Test 2, it was after the nose gear penetrated into the soil surface that the airplane started to exhibit a rotation around the nose. Unlike Test 2, however, the tail developed a fracture aft of station 108 at 0.138 sec after impact. This fracture caused the tail to peel away from the fuselage, acting much like a hinge. A small portion of skin on the bottom of the aircraft retained the tail to the rest of the airplane during the rotation. The rotation of the aircraft lasted until approximately 1.53 sec after impact, at which time the ceiling of the airplane contacted the soil. The airplane rocked for a few seconds before finally coming to rest at almost 5 sec after initial impact. A time sequence is depicted in Figure 28, as captured from one of the black and white side view cameras and Figure 29, as captured by the end view camera.

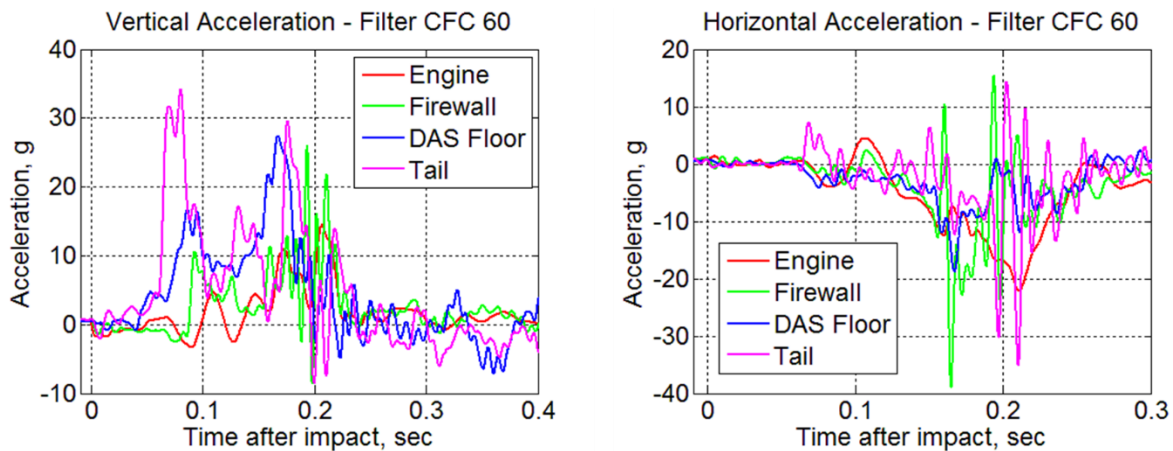
Figure 30 - Test 3 airframe accelerations

Figure 30 shows the airframe accelerations. A slap down effect can be seen in the vertical acceleration plots. The tail strike is first captured by the instrumentation approximately 0.080 sec after initial impact and reaches a peak of approximately 32 g. The peak accelerations from locations going from aft to forward then occur in sequence. These accelerations reach their peaks of 27.5 g, 26.0 g, and 15.5 g, at 0.165 sec, 0.193 sec and 0.206 sec after first contact for the DAS floor, firewall and engine, respectively. The vertical acceleration pulse duration for all locations is approximately 0.240 sec.

The horizontal accelerations resemble either a triangular or trapezoidal pulse shape, depending on the location under investigation. The engine acceleration peaks at -22.1 g at 0.210 sec after impact, shaped over a 0.180-sec triangular pulse. The firewall, exhibited a peak acceleration of -38.9 g; however, this peak is likely due to the increased noise in the signal from the firewall location. The peak occurs at 0.165 sec after impact and the shape also resembles a 0.180-sec triangular pulse. The DAS floor and tail are more representative of a trapezoidal pulse, having a 0.050-sec sustained acceleration and a total pulse width of 0.250 sec. The DAS floor sustained peak acceleration is approximately -8.7 g, while the tail reaches a sustained peak acceleration of -8.1 g. The accelerations are caused from the dragging of the airplane through the dirt before rotation around the nose gear tire begins, and they occur mainly in the rear portions of the airplane due to the tail strike condition.

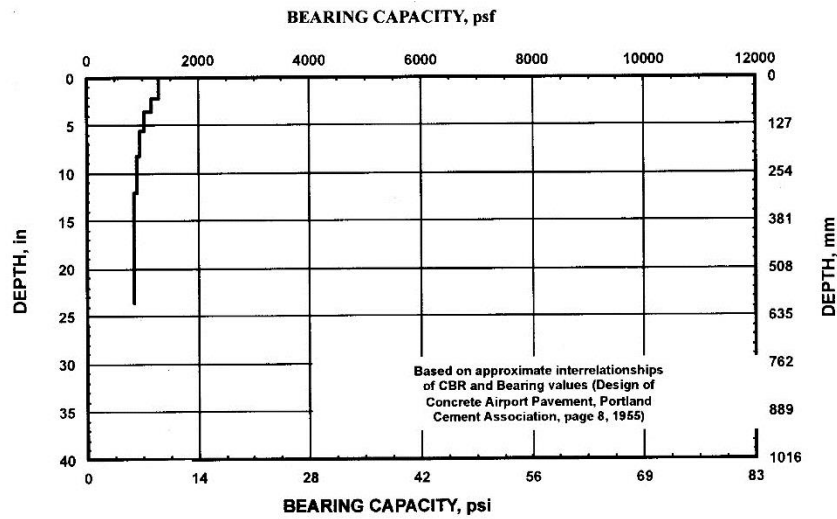
Figure 31 - Bearing capacity of the soil for Test 3

The moisture content for Test 3 varied between 11% and 14% by weight. Density of the soil varied between 138 lb/ft³ and 152 lb/ft³. The bearing strength of the soil at the surface was about 1300 lb/ft³, which dropped

to approximately 800 lb/ft³ at a depth of 1 foot, and sustained this strength to the bottom depth of 2 feet. The bearing capacity as a function of depth is shown in Figure 31.
