The Evolution of Failure Analysis at NASA's Kennedy Space Center and the Lessons Learned

Failure in LEO: the Solar Alpha Rotary Joint (SARJ):

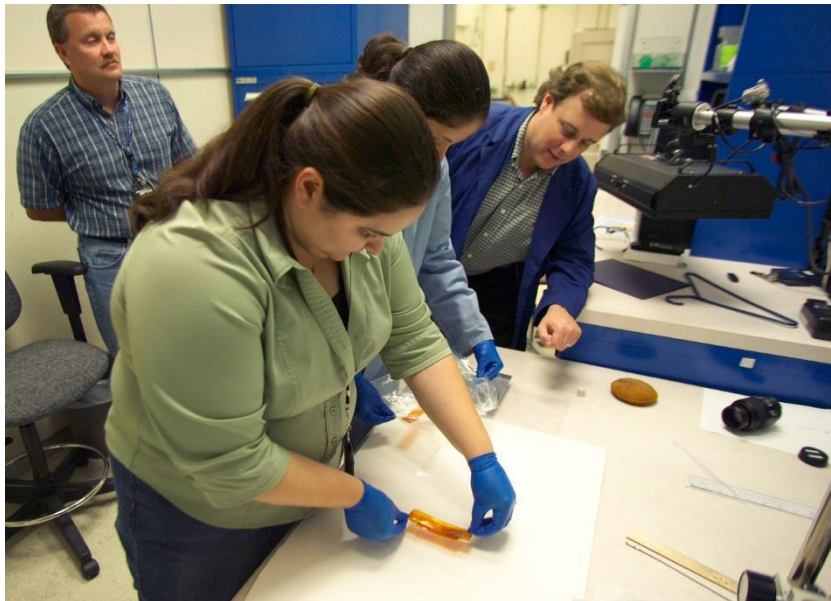
Figure 5. Meticulous handling of the starboard SARJ samples was carried out by the team during the investigation. Credit: P. Marciniak/NASA KSC

The three pieces of polyimide tape collected by astronaut Tani and returned to Earth were photodocumented and initially observed in a stereomicroscope. The particles sizes for the debris ranged from very fine particulate less than 100 μm up to approximately 1 mm. The first significant observation was apparent machine markings still present on the surface of some of the larger fragments and fracture features visible on other fragments (Figure 6). Additionally, the debris was classified as fine particulates, flattened agglomerations, and large chips. The debris had a slight magnetic response [13].
