# Dynamic Open-Rotor Composite Shield Impact Test Report

*Silvia Seng and Charles Frankenberger  
Naval Air Warfare Center Weapons Division, China Lake, California*

Use of advanced composites in fuselage structures may address airplane threats from uncontained blade failures. This report documents results of testing to validate the effectiveness of composite panels for shielding the fuselage from debris.

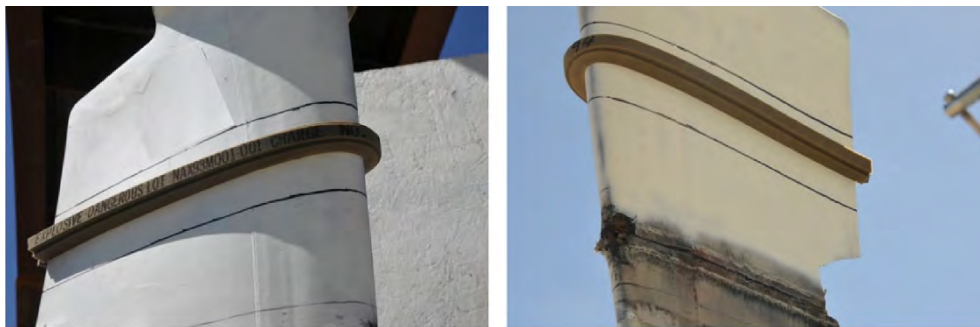
Figure 8.—Blade with shape charge around full circumference.

Because the shape charge did not completely sever the blade, the test was repeated with the shape charge cord around the full circumference of the blade (Fig. 8). The second test was performed on the same blade, several inches above the location of the first test. The blade was completely severed by the linear shape charge cord around the full circumference of the blade. The spars appeared to have visibly delaminated some on either side of the linear shape charge. A large piece of the blade trailing edge (aft of the carbon spars) separated from the remaining blade section; however, this appears to be a result of damage from the first test.

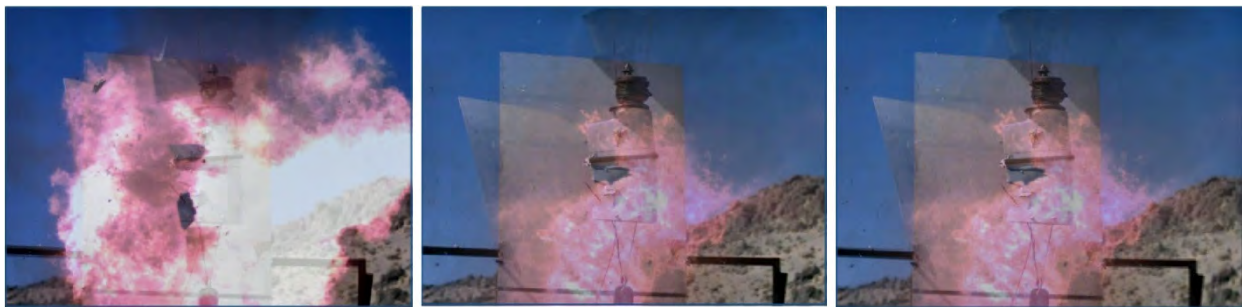
Figure 9.—Shape charge detonation, full-circumference configuration.

Test instrumentation was limited to one high-speed video camera, a safety video, and a firing line. The shape charge resulted in a significant fire ball, but it did not impart significant force on the blade. Figure 9 shows the blade root section rotating as a result of the blast, but does not propel the blade vertically. Likewise, the outer span of the blade merely falls away from the cut. Review of the severed blade section reveals a relatively clean cut with composite delamination reaching approximately 1 in. away from the cut line (Fig. 10).
