# Lessons Learned during the Refurbishment and Testing of an Observatory after Long- term Storage

John Hawk, Sharon Peabody, and  
Richard Stavely  
NASA Goddard Space Flight Center

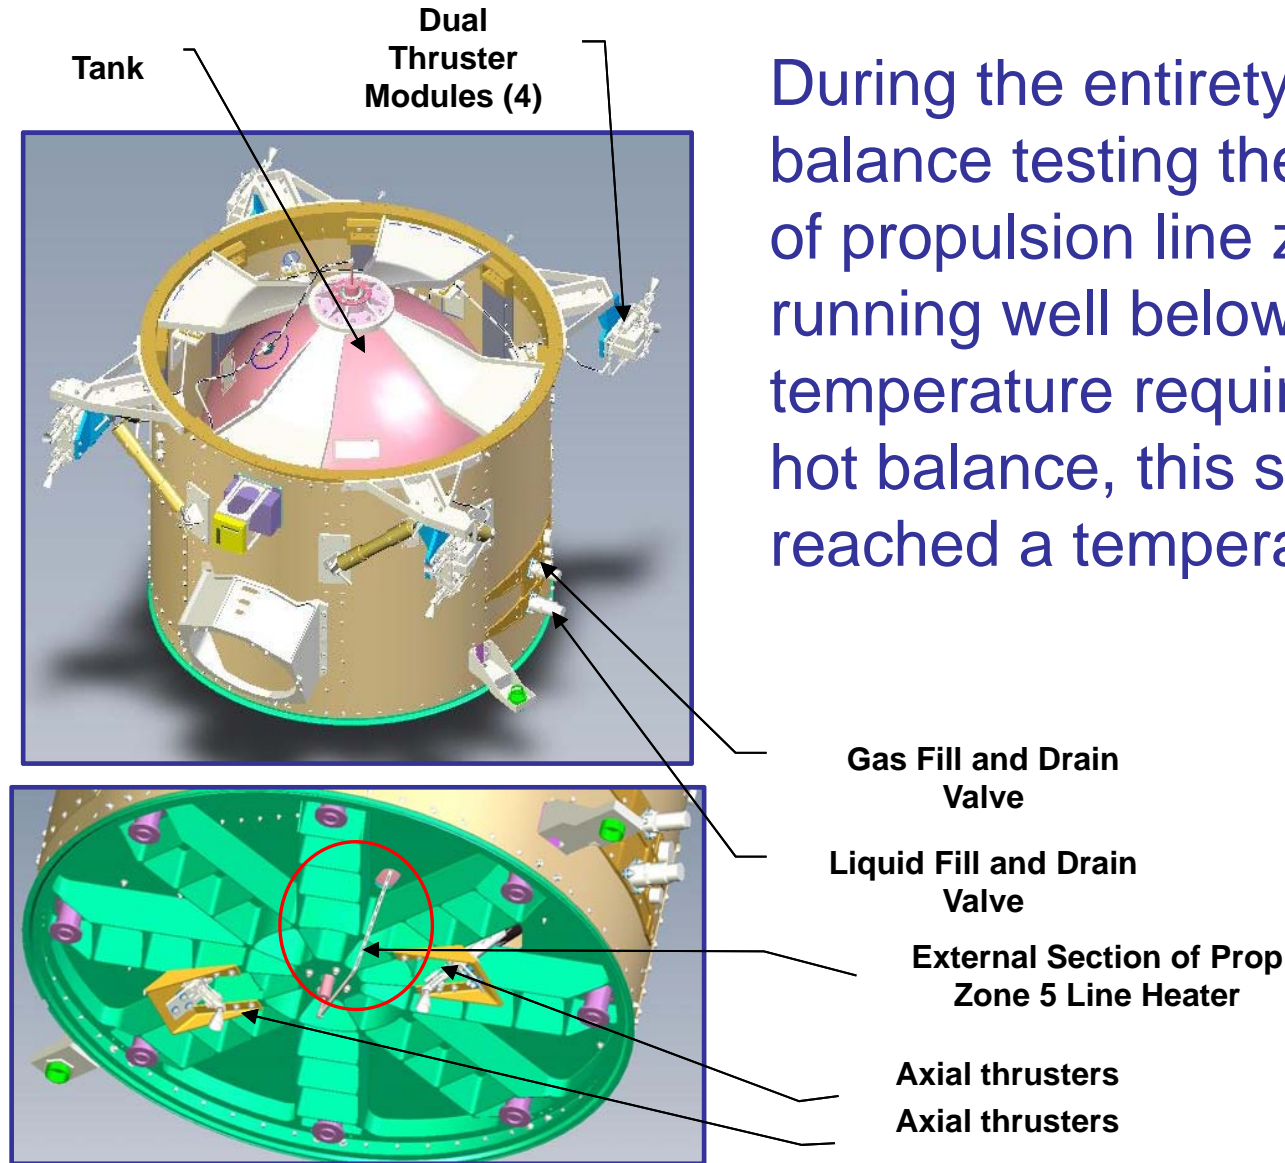
# Propulsion - Module Hardware

During the entirety of the thermal balance testing the external run of propulsion line zone 5 was running well below the minimum temperature requirement. During hot balance, this section of line reached a temperature of +2.3°C.
