NASA/TM-2014-218538 (Corrected Copy)
NESC-RP-14-00957

A Comprehensive Analysis of the X-15 Flight 3-65 Accident

October 2014

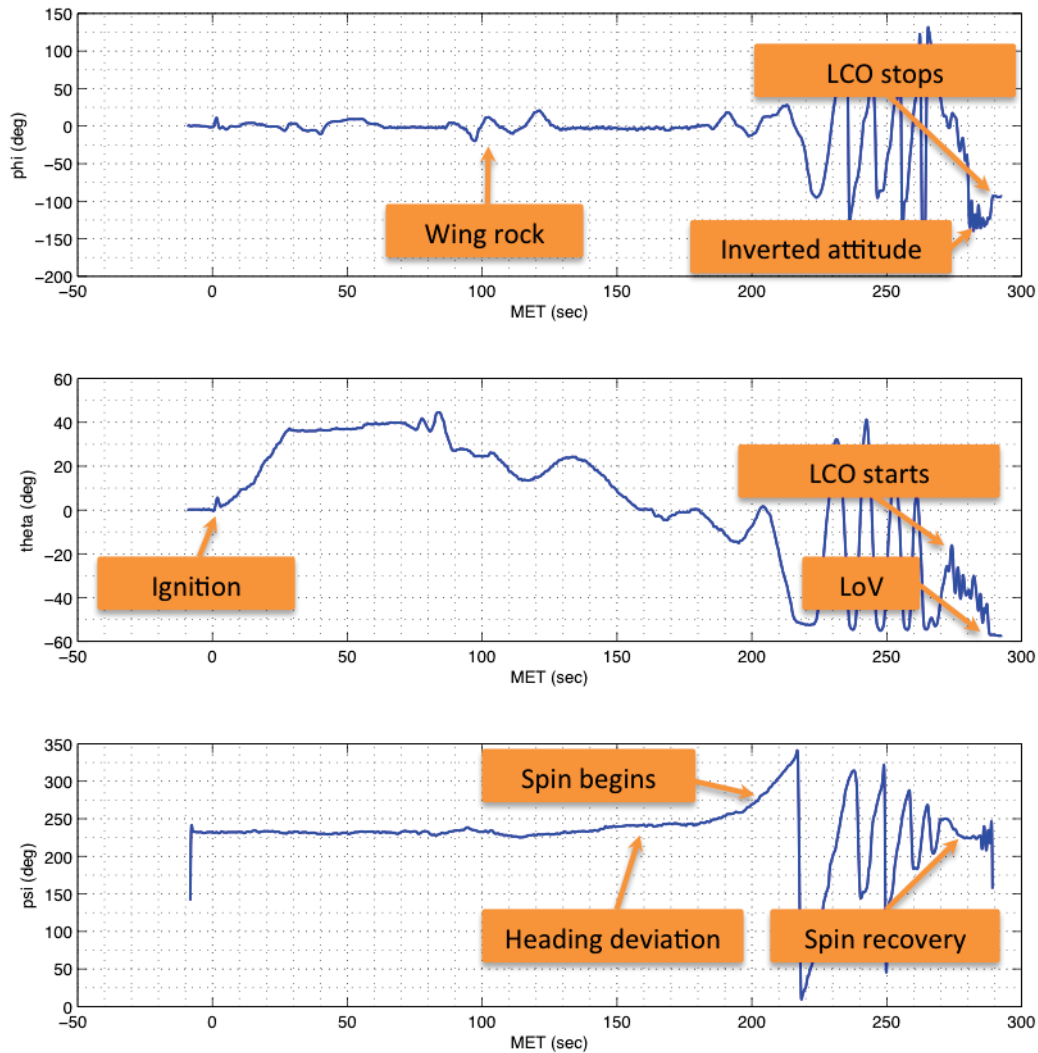
Figure 7.3-1. X-15 3-65 Reconstructed Flight Data (attitude angles⁹)

Reconstructed flight data depicting key events with respect to the aircraft attitude angles are shown in Figure 7.3.1. These data were derived from filtered measurements of the IMU resolver angles recovered from the original stripchart recordings. The correctness of the IMU angle data was verified by the post-accident investigation team via correlation of the estimated attitude with a known solar angle in recovered film footage from onboard cameras [ref. 3]. The remaining trajectory data appear in Appendix B.

In Figure 7.3-1, MET is referenced to ignition, which occurred at 10:30:08 PST. The onset of spin entry at approximately 10:33:30 PST (MET + 202 seconds) was based on the rapid increase in yaw rate and the observation of the first traversal of the sun across the instrument panel as seen from the cockpit camera. Note that the aircraft was tumbling after approximately MET + 215 seconds, and the attitude resolver angles wrap through 360 degrees, but are masked by noise filtering.

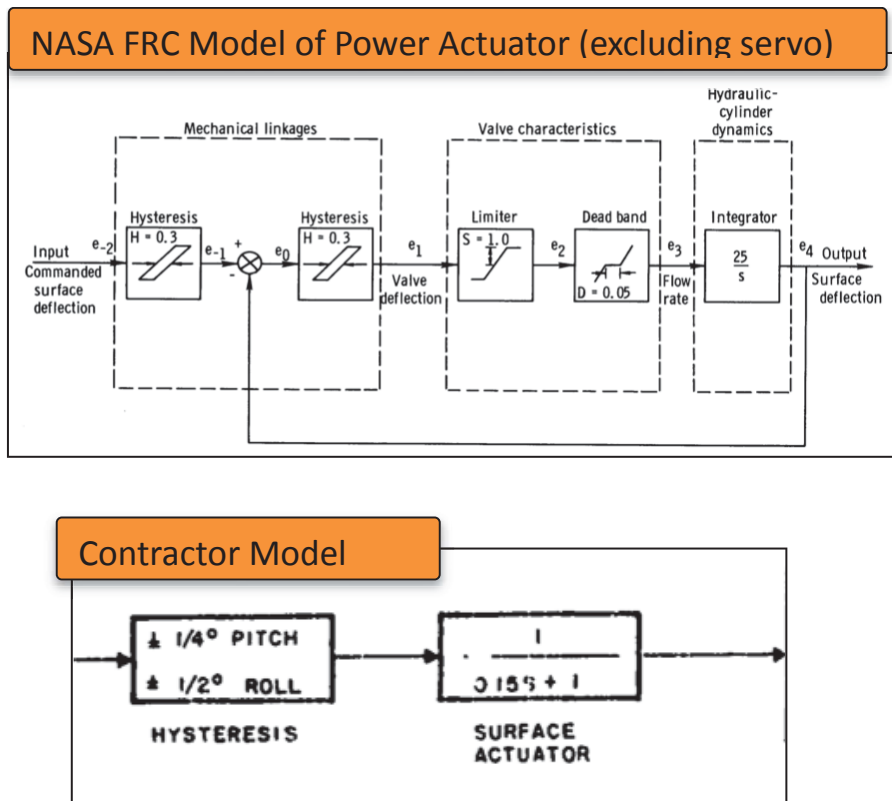
Figure 8.5-1. Surface Actuator Models Used in Design [refs. 34 and 35]

However, while NASA FRC had used a nonlinear model of the servo and power actuator with more extensive HWIL simulation to verify the filter design, the contractor apparently did not have access to the same type of model data and used a simple first-order lag model with hysteresis only (Figure 8.5-1). As such, a latent design sensitivity was introduced into the inner loop of the MH-96 SAS that would allow the SAS rate loop to become unstable in the presence of actuator rate saturation.

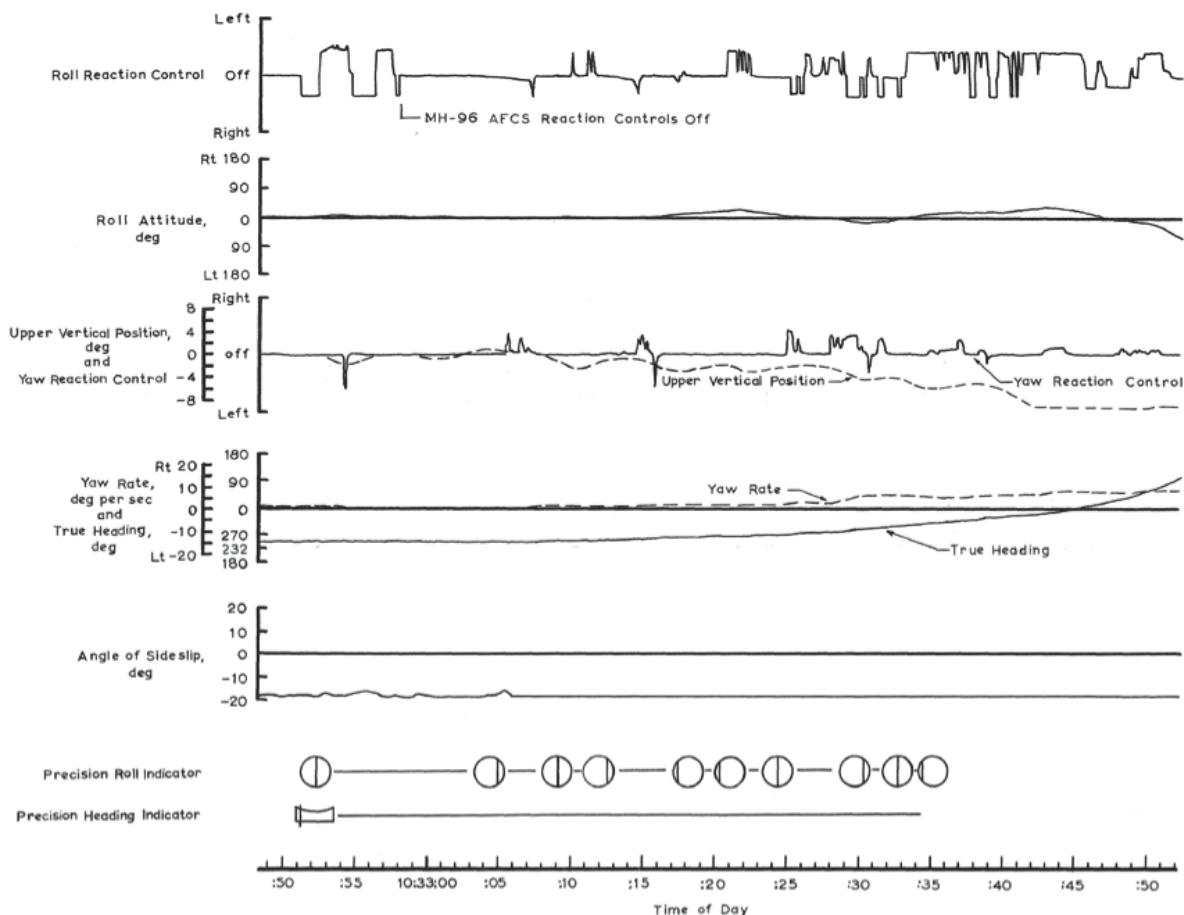
Figure 9.2-1. Time History of Precision Attitude Tracking Task at Peak Altitude [ref. 3]

The evidence suggests the pilot forgot he was in the PAI mode when he switched to the left-hand stick RCS control. However, at the moment he switched control, he was performing the precision attitude-tracking task (Figure 9.2-1) and he continued to try to complete that task after he switched hands. It is difficult to believe that the pilot would have forgotten that he was in the PAI mode while he was in the process of performing the very maneuver for which the PAI mode was specifically designed.

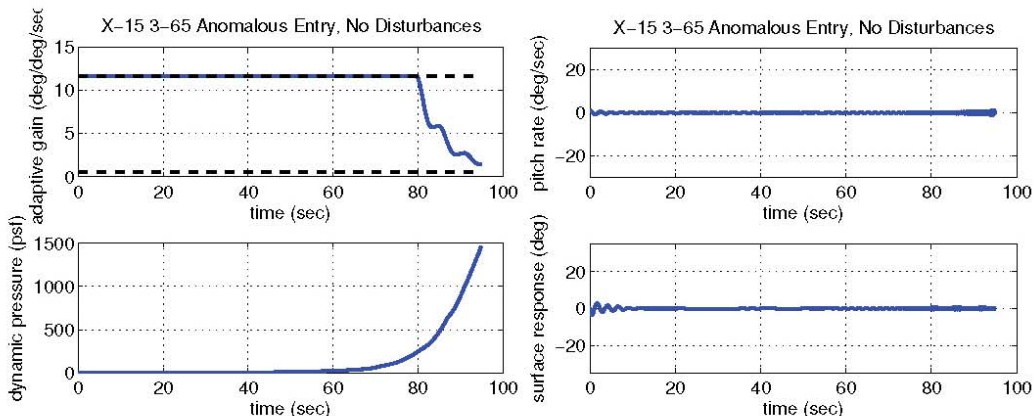
Figure A.14: MH-96 3-65 entry, no disturbances

profile, the adaptive law is successful in establishing the desired servoactuator limit cycle and modulating the forward gain to the proper value (Figure A.14). This analysis result contradicts the author's early hypothesis that the adverse LCO was precipitated by a dynamic pressure rate-of-change exceeding the capability of the MH-96 gain changer.

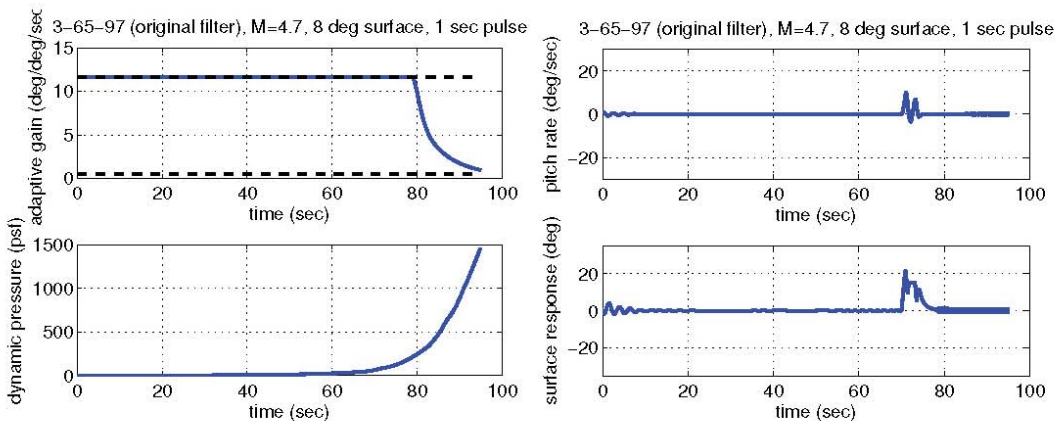
Figure A.17: 3-65 entry, large pilot input, original filter

It is illustrative to consider that the introduction of lag due to the implementation of the structural notch filter may be related to the apparent rate-limit divergent limit cycle oscillation. Under the time-varying 3-65 entry conditions, the system is simulated with an identical pilot input but with the original loop filter design (Eq. A.7). Although rate limiting is induced for a short time, the actuator does not couple with the short-period mode and thus no divergent oscillation is induced (Figure A.17).

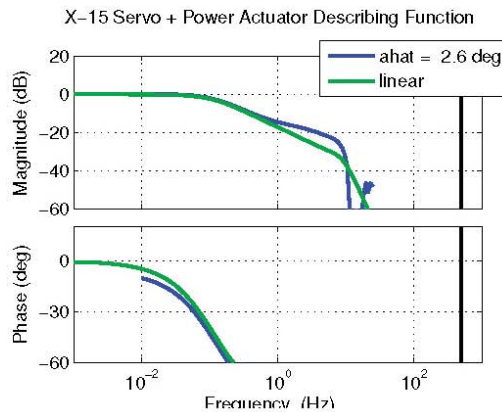
Figure A.19: X-15 servoactuator small-amplitude describing function

A DF approximation of the servoactuator with these parameters is computed and compared with the nominal linear model of the servoactuator. As can be seen in Figure A.19, the response of the actuator matches well at low frequencies but exhibits slightly more phase lag.

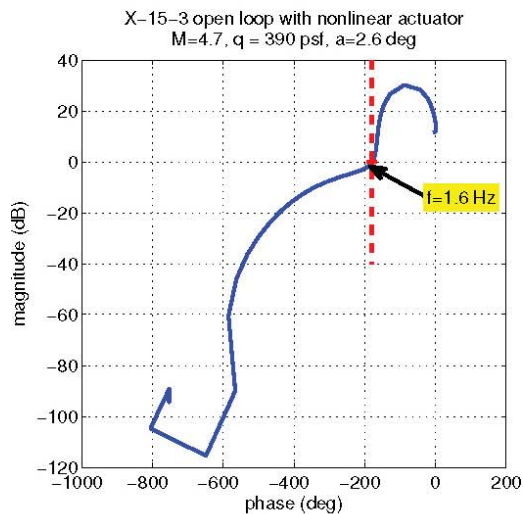
Figure A.21: X-15 servoactuator small-amplitude LCO prediction

Using the servoactuator DF in-the-loop at the stated forward gain condition, the small-amplitude LCO is accurately predicted by the numerical analysis. Since the forward gain in the DF analysis matches the converged gain, the system intercepts the critical point. The $-\pi$ phase line is shown for comparison. It should be noted that the short period mode, appearing at approximately 0.4 Hz, has relatively little equivalent phase margin at this condition at stable values of the forward gain.

It was noted before in the analysis of the high-frequency desired LCO that the short-period mode had very little phase margin when operating at the critical gain (Figure A.21). In the design of the MH-96, an implicit assumption was that the system phase shaping (via filters in the rate feedback path) provided for a linear phase margin that was approximately invariant with respect to the forward gain. Based on a comparison of the original system response with the flight configuration using the structural notch filter, it appears that the introduction of the notch filter substantially degraded the phasing of the short period mode due to the introduction of additional low-frequency lag (Figure A.23). Even under these conditions, the original design maintains more than 30 degrees of phase margin for the short-period mode.

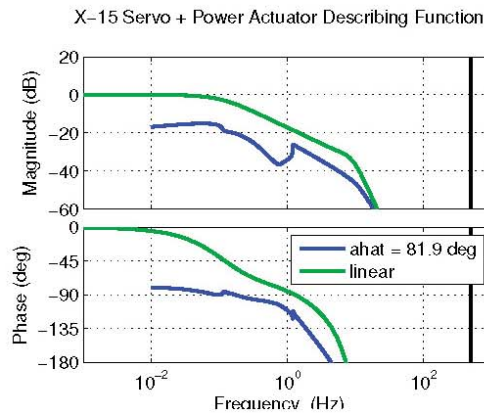
Figure A.22: X-15 servoactuator large-amplitude describing function

Based upon the time-domain analysis, it was observed that the large-amplitude LCO tended to be precipitated by large inputs causing actuator rate saturation coupled with an excitation of the short-period pitch mode. In order to determine the possible transition amplitude for the adverse LCO, the amplitude-frequency parameter space was searched for a DF such that the short-period mode would approach critical stability when at the 3-65 entry conditions (maximum forward gain, 390 psf). The transition amplitude for this condition consists of a large servo command of approximately 80 degrees peak equivalent, or a command-to-authority factor of about 6:1. Large servo commands exceeding the servocylinder limit of 1 inch (15 degrees equivalent) will cause saturation in the servo, the power actuator, or both. The effects of saturation on the actuator frequency response are shown in Figure A.22. Near the short-period frequency, the effective phase lag is increased by approximately 25 degrees.

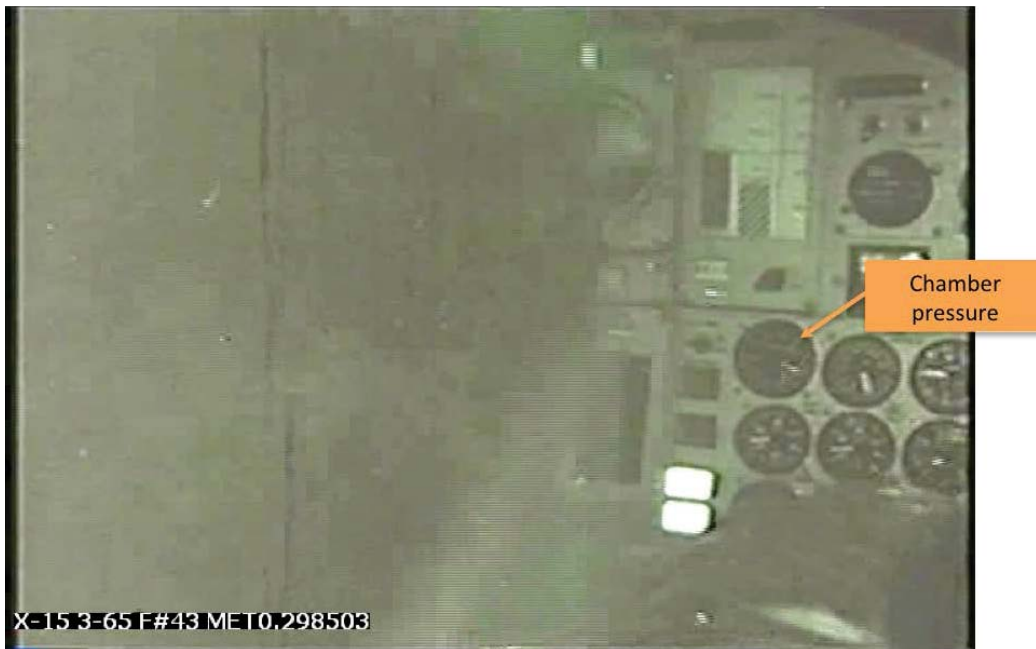
Figure B-8. Cockpit Film – Ignition Indicated by Increasing Chamber Pressure (MET = 0 seconds, 10:30:08 PST)

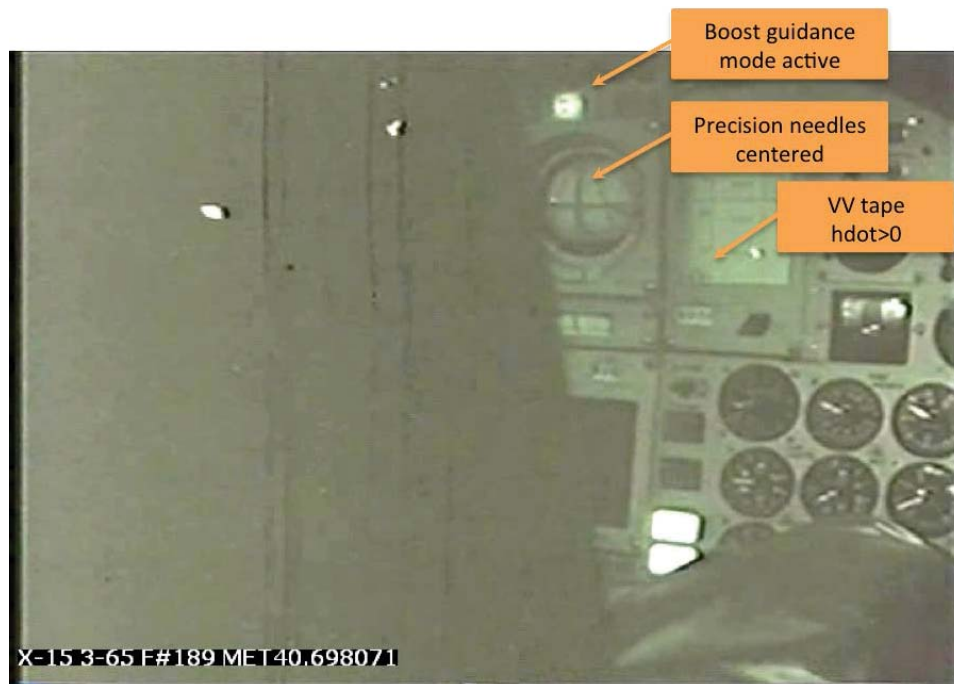
Figure B-9. Cockpit Film – Boost Phase (MET = 41 seconds, 10:30:49 PST)

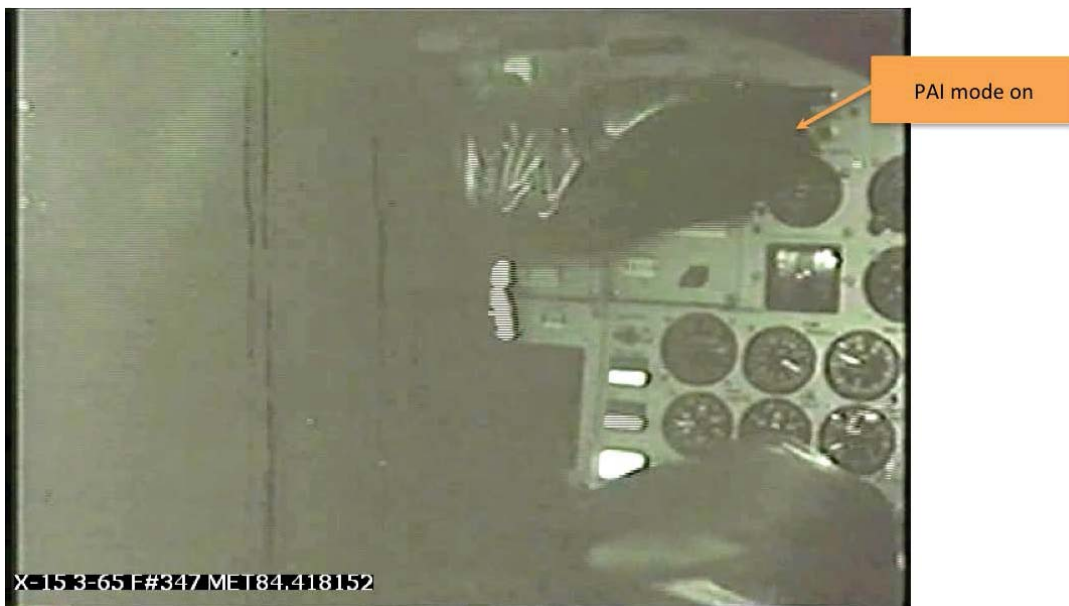
Figure B-11. Cockpit Film – Pilot Engages PAI (MET = 84 seconds, 10:31:32 PST)

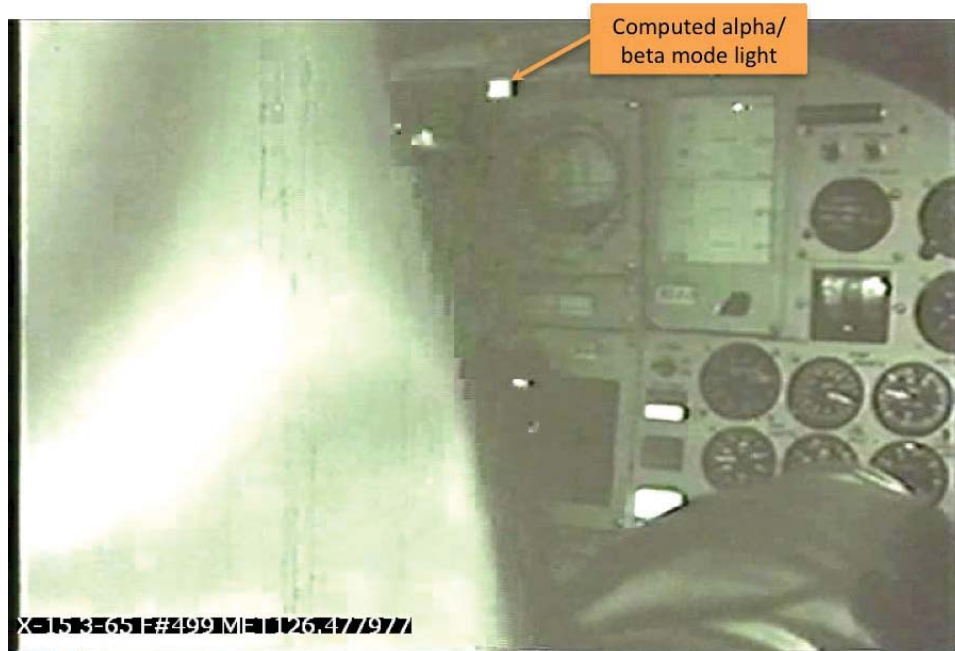
Figure B-13. Cockpit Film – Pilot Selects Computed IFDS Aerodynamic Angles <50 psf (MET = 126 seconds, 10:32:14 PST)

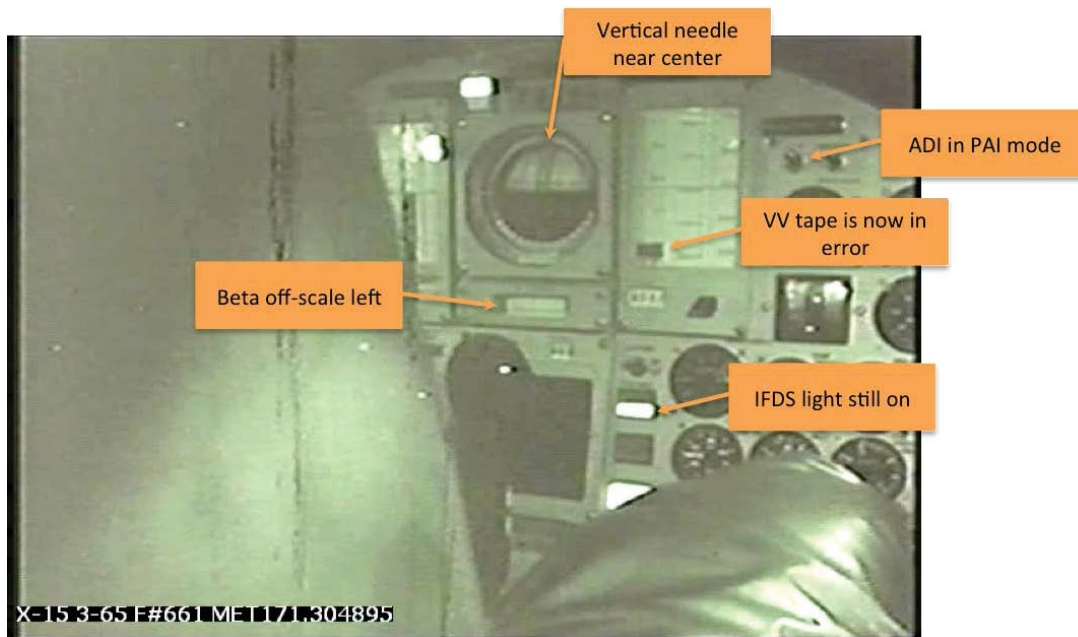
Figure B-15. Cockpit Film – Near Peak Altitude (MET = 171 seconds, 10:32:59 PST)
