# DETERMINE ISS SOYUZ ORBITAL MODULE BALLISTIC LIMITS FOR STEEL PROJECTILES HYPERVELOCITY IMPACT TESTING

Hypervelocity Impact Technology Group (HVIT)  
Astromaterials Research and Exploration Science (ARES) Directorate  
Human Exploration Science Office, KX

July 2013

Prepared for the  
**ISS Systems Engineering and Integration Office**

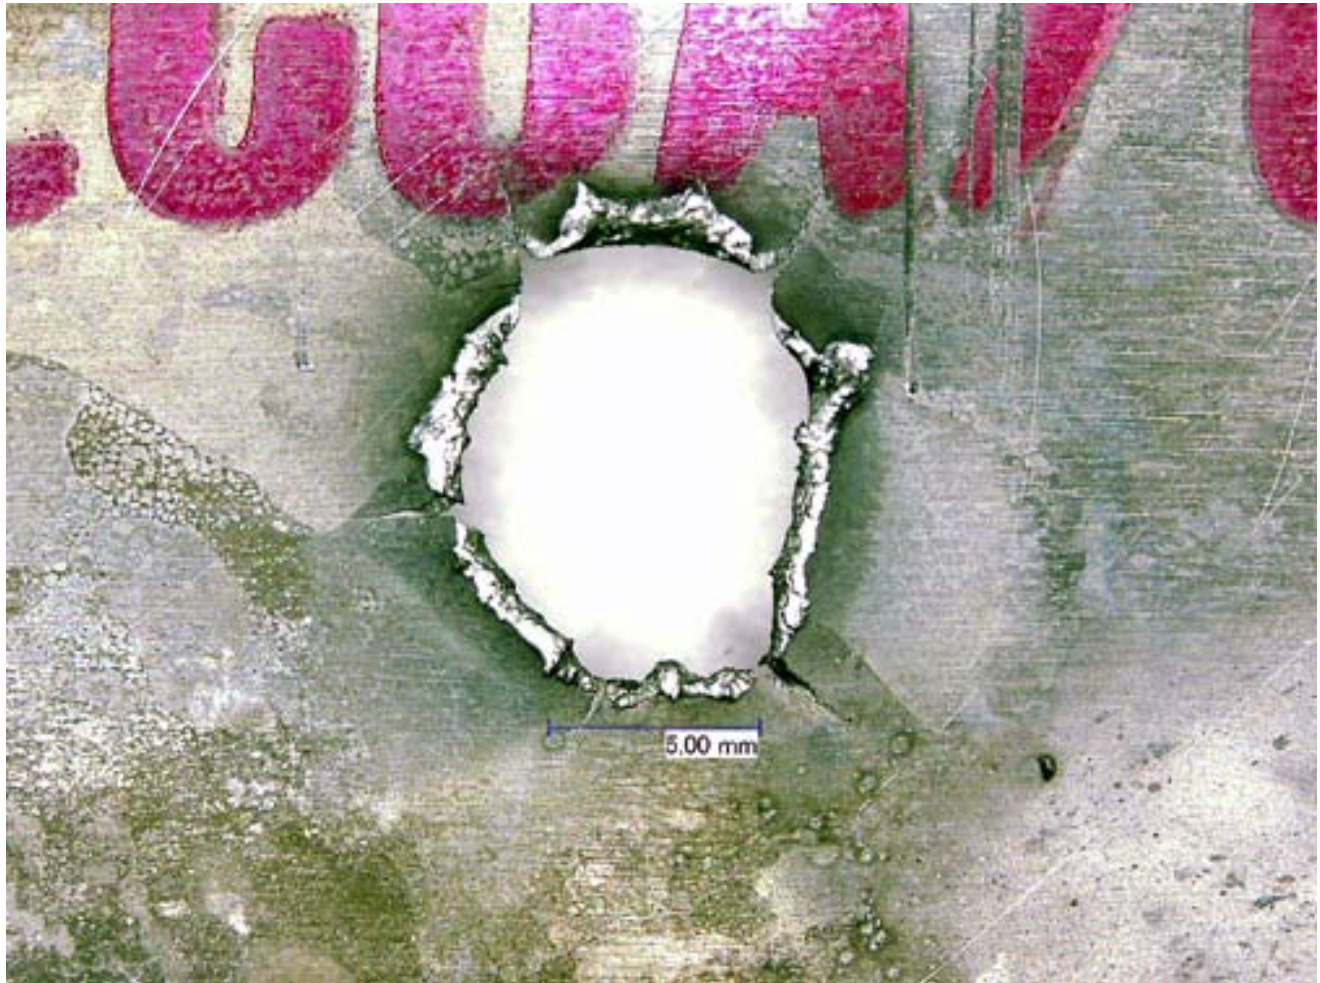
## Test #1, HITF12257

Test No.	Actual Projectile Diameter (mm)	Actual Projectile Mass (g)	Actual Impact Velocity (km/s)	Impact Angle (deg)	Results
1 <a href="#">HITF12257</a>	1.79	0.02310	7.18	30	<p><b>Fail</b></p> <p>Beta cloth entry damage = 1.77mm x 1.96mm hole  Mylar Film damage = 45.97mm x 33.08mm hole  Fiberglass entry damage = 10.81mm x 13.44mm hole  Al 6061 Foil damage = 8.64mm x 8.26mm hole  Fiberglass exit damage = 12.89mm x 15.04mm hole  MLI exit damage = 7.71mm x 9.88mm hole  Al 6061-T6 plate damage = 8.14mm x 10.21mm hole  Al 5456-0 RW damage = 3 holes largest is 2.45 x 3.09mm  Al 2024-T3 WP damage = 0.198mm x 0.218mm x 0.051mm  deep crater &amp; many smaller</p>
2 <a href="#">HITF12258</a>	1.59	0.01610	4.99	30	<p><b>Fail</b></p> <p>Beta cloth entry damage = 1.54mm x 1.95mm hole  Mylar Film damage = 13.43mm x 9.34mm hole  Fiberglass damage = 2.87mm x 3.87mm hole  Al 6061 Foil damage = 6.04mm x 5.06mm hole  Fiberglass damage = 8.47mm x 12.48mm hole  MLI exit damage = 7.01mm x 7.80mm hole  Al 6061-T6 plate damage = 4.42mm x 6.33mm hole  Al 5456-0 RW damage = 2 holes largest is 6.57mm x 8.95mm  Al 2024-T3 WP damage = 0.58mm x 0.97mm x 0.275mm  deep crater &amp; many smaller</p>

**Figure 25: Al 6061-T6 Layer 7 Back of ISS Soyuz OM Test #1  
(Keyence 3D Microscope Image)**

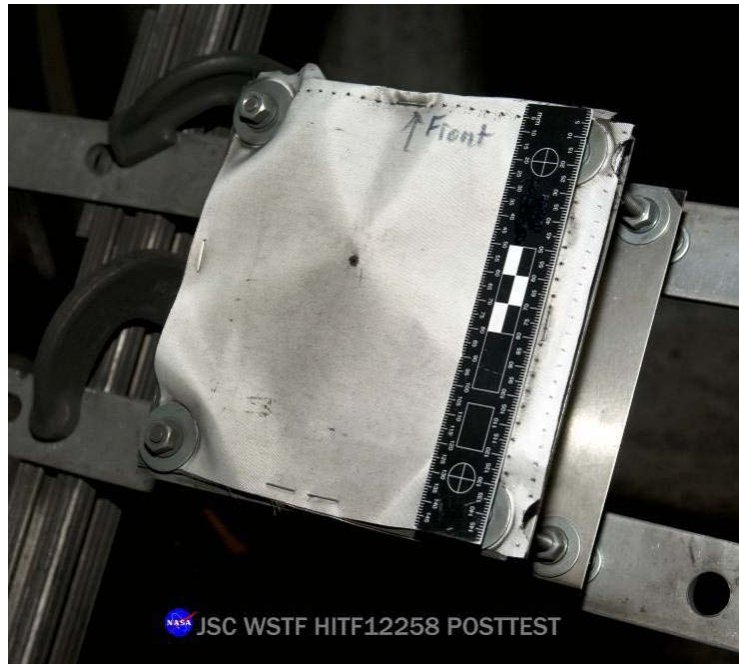
Test #2, HITF12258

**Figure 33: Post-test of ISS Soyuz Orbital Module Test #2 (HITF12258) article mounted in 0.50-caliber target tank.**

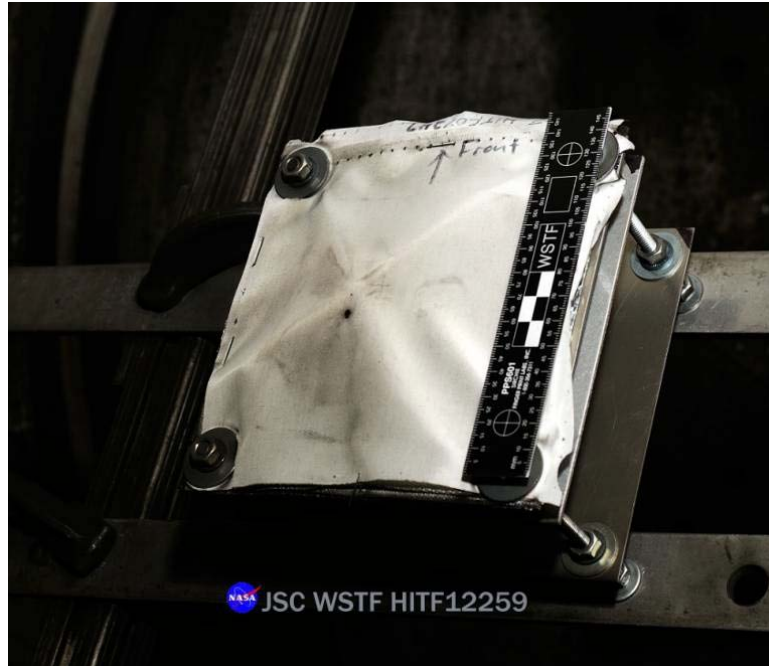
Test #3, HITF12259

3 <a href="#">HITF12259</a>	1.72	0.02046	5.78	30	<p><b>Fail</b></p> <p>Beta cloth entry damage = 1.61mm x 2.11mm hole  Mylar Film damage = 9.83mm x 13.76mm hole  Fiberglass damage = 5.69mm x 7.78mm hole  Al 6061 Foil damage = 6.09mm x 5.58mm hole  Fiberglass damage = 8.24mm x 14.03mm hole  MLI exit damage = 6.38mm x 10.22mm hole  Al 6061-T6 plate damage = 7.38mm x 9.42mm hole  Al 5456-0 RW damage = 4.97 x 4.53mm hole  Al 2024-T3 WP damage = 0.140mm x 0.187mm x 0.034mm  deep crater &amp; several smaller</p>

Figure 50: Post-test of ISS Soyuz Orbital Module Test #3 (HITF12259) article mounted in 0.50-caliber target tank.

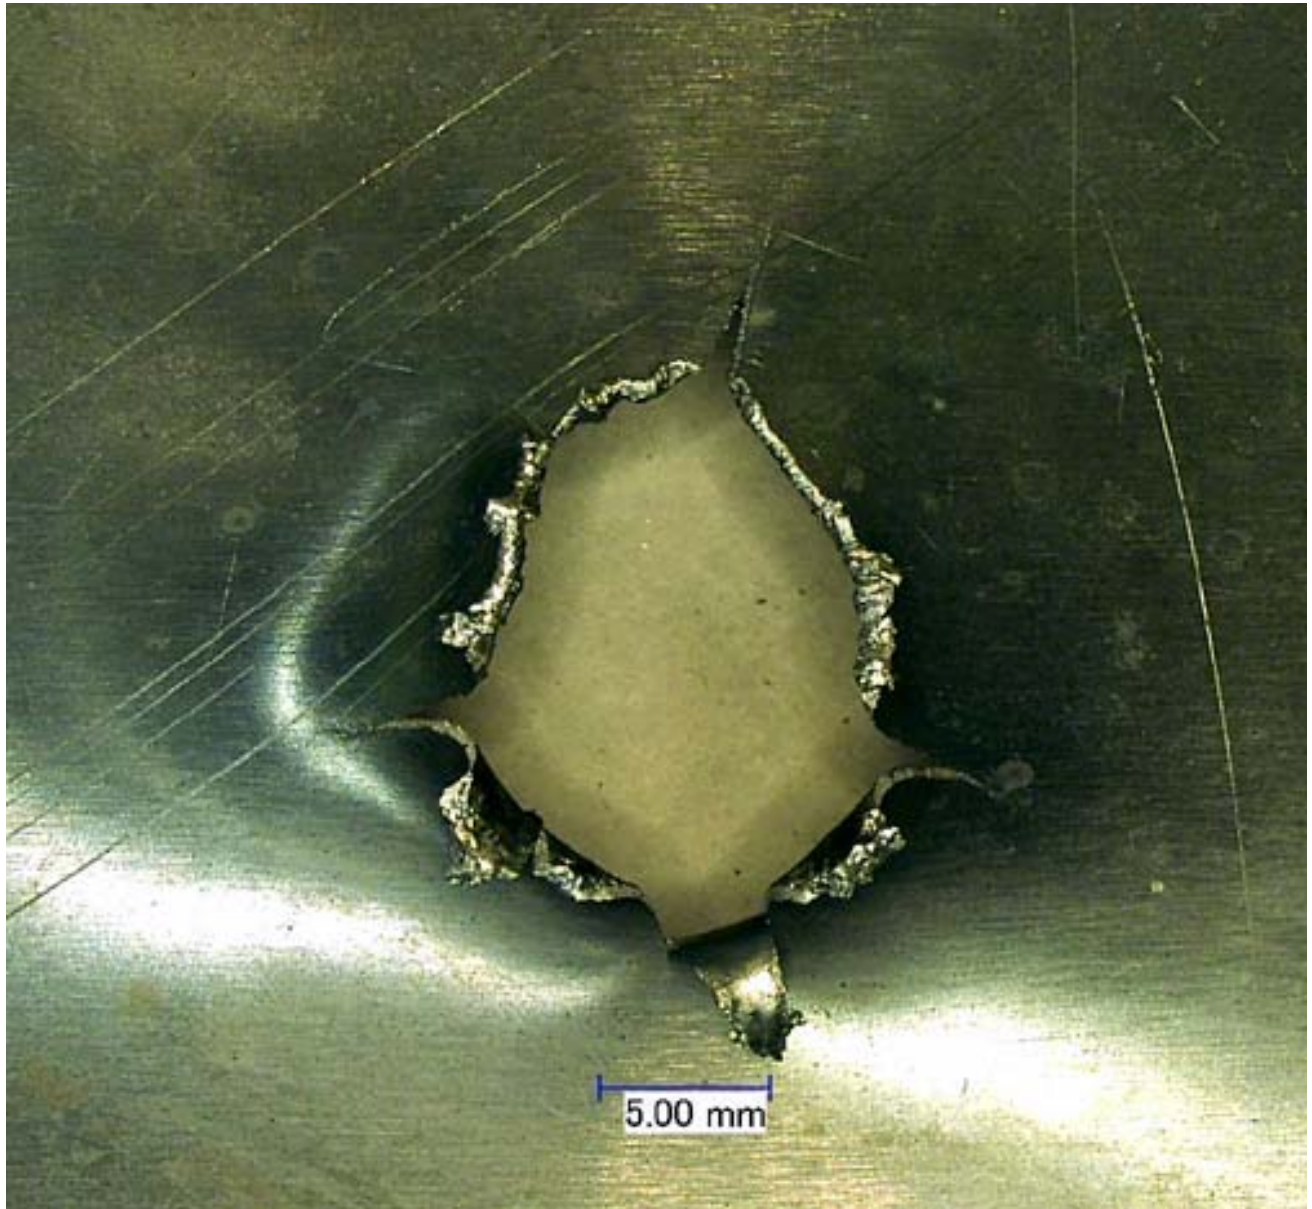
Test #4, HITF12260

Figure 76: Al 6061-T6 Layer 7 Back of ISS Soyuz OM Test #4  
(Keyence 3D Microscope Image)

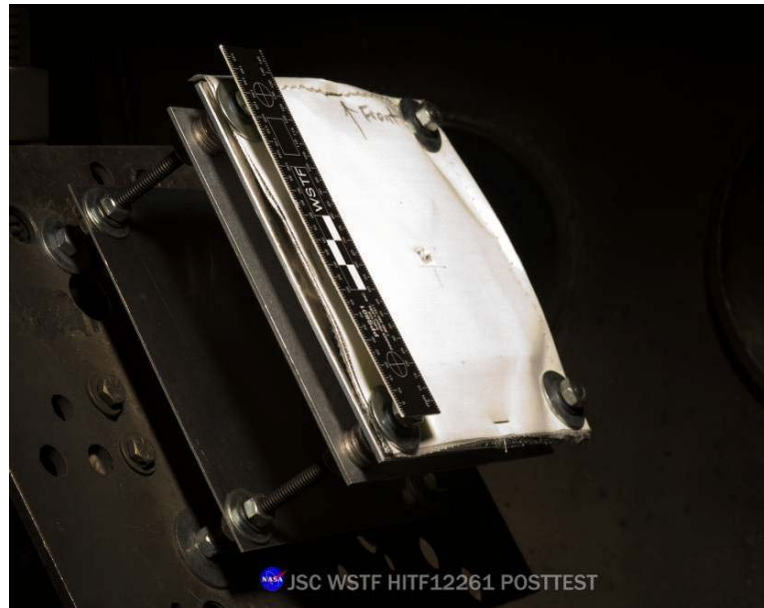
Test #5, HITF12261

**Figure 83: Post-test of ISS Soyuz Orbital Module Test #5 (HITF12261) article mounted in 0.17-caliber target tank.**

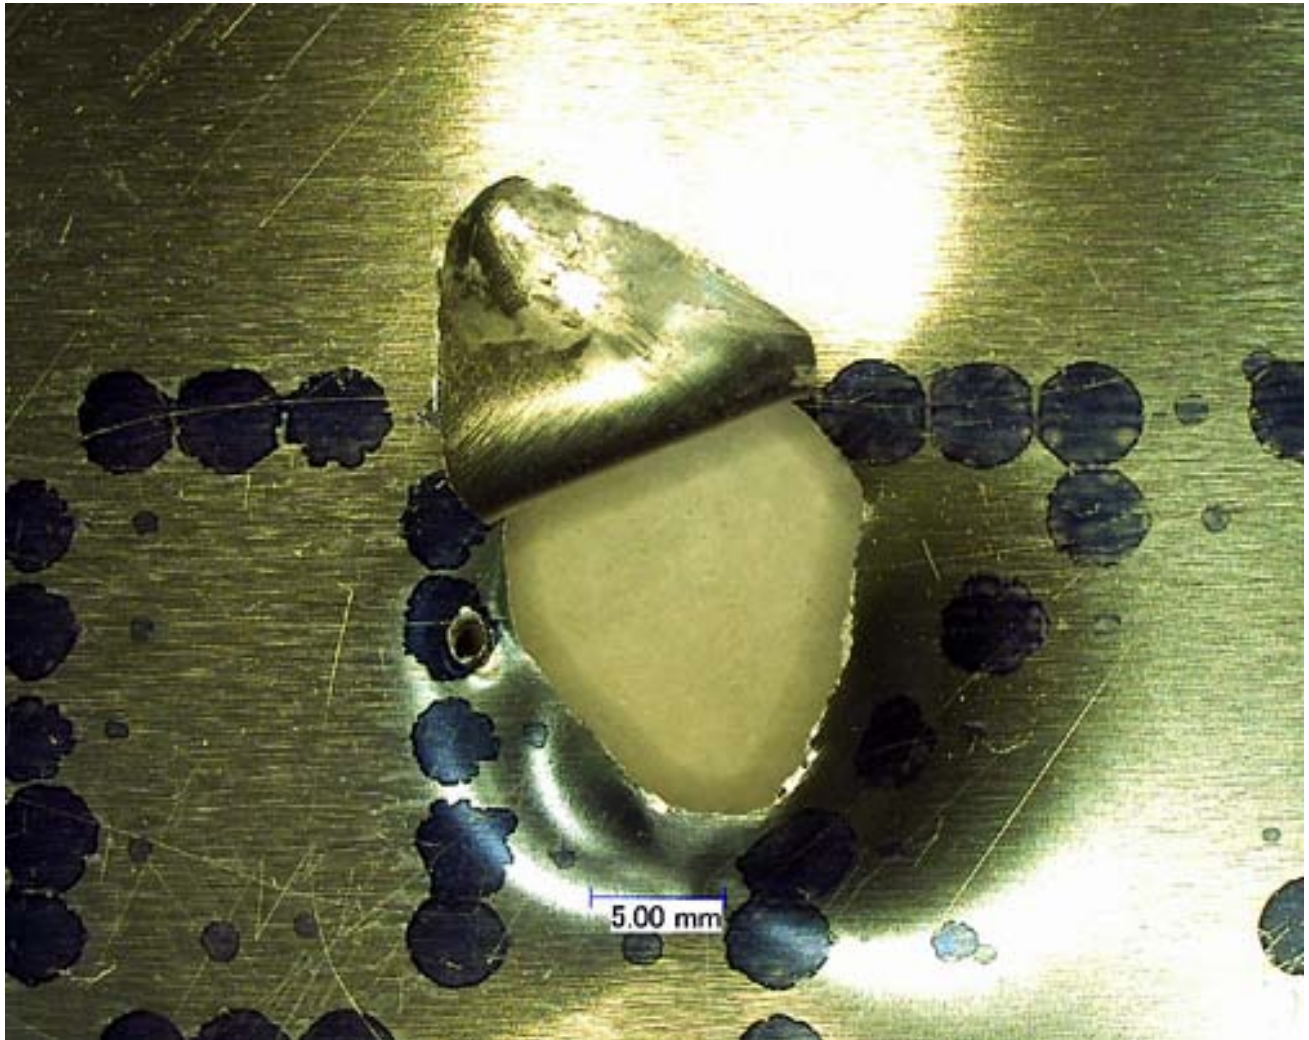
Test #5, HITF12261

Figure 92: Al 6061-T6 Layer 7 Front of ISS Soyuz OM Test #5  
(Keyence 3D Microscope Image)

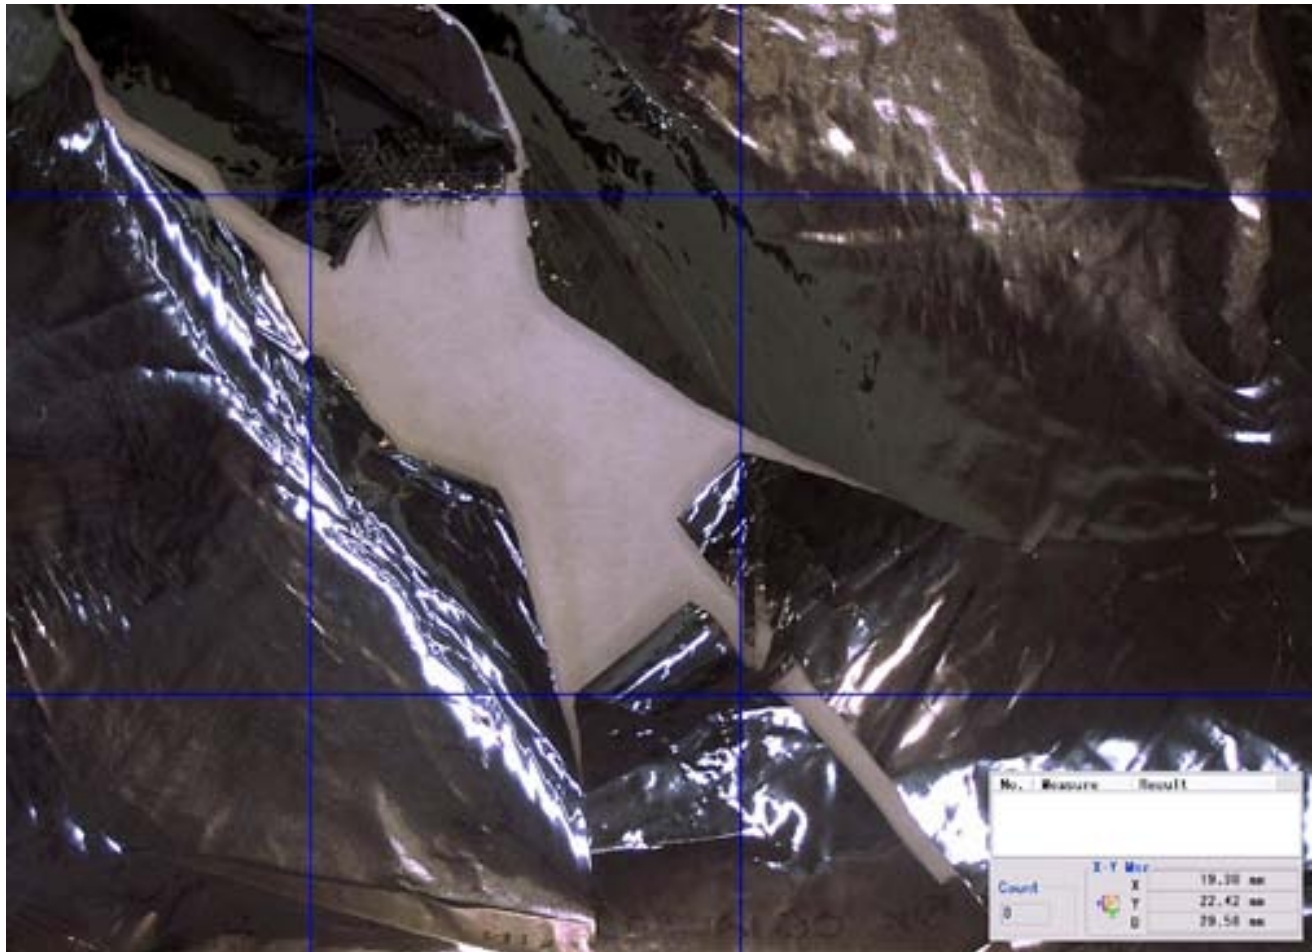
## Test #8, HITF12264

Figure 135: Mylar Film Layer 2 of ISS Soyuz OM Test #8  
(Keyence 3D Microscope Image)

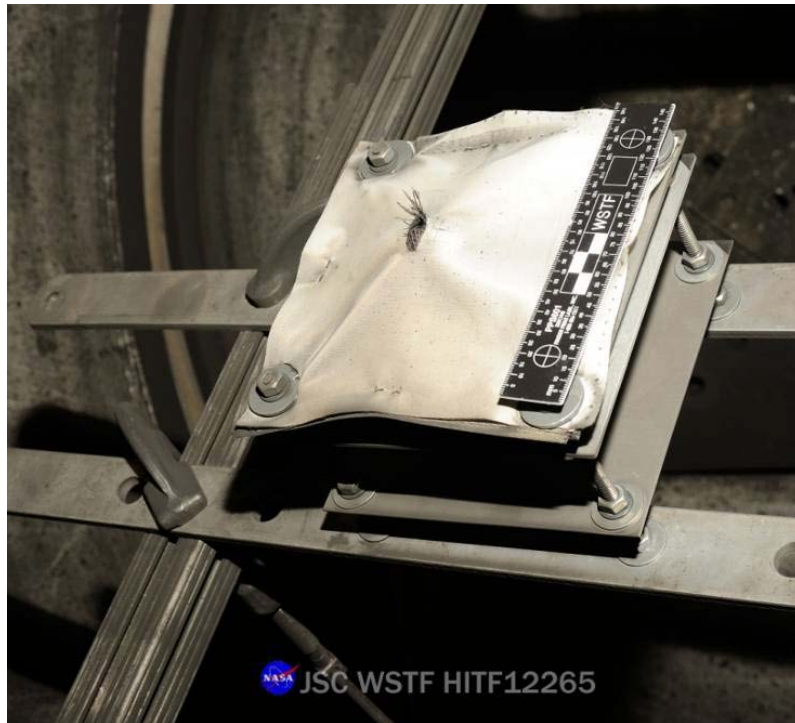
Test #9, HITF12265

9 <a href="#">HITF12265</a>	1.6	0.01615	7.14	45	<p><b>Fail</b></p> <p>Beta cloth entry damage = 5.49mm x 17.51mm hole  Mylar Film damage = 35.16mm x 19.19mm hole  Fiberglass damage = 13.55 x 14.32mm hole  Al 6061 Foil damage = 9.50 x 14.24mm hole  Fiberglass damage = 14.57 x 16.36mm hole  MLI exit damage = 8.51mm x 11.30mm hole  Al 6061-T6 plate damage = 8.93mm x 9.57mm hole  Al 5456-0 RW damage = 1.50 x 2.39mm hole  Al 2024-T3 WP damage = 31mm x 30mm area of aluminum specks</p>
10 <a href="#">HITF12266</a>	1.39	0.01075	3.19	30	<p><b>Fail</b></p> <p>Beta cloth entry damage = 1.56mm x 1.50mm hole  Mylar Film damage = 13.80mm x 15.43mm hole  Fiberglass damage = 2.67 x 2.27mm hole  Al 6061 Foil damage = 2.50 x 2.74mm hole  Fiberglass damage = 2.45 x 2.93mm hole  MLI exit damage = 3.83mm x 4.66mm hole  Al 6061-T6 plate damage = 2.53mm x 2.92mm hole  Al 5456-0 RW damage = 2.84 x 3.09mm hole  Al 2024-T3 WP damage = 1.48mm x 1.93mm x 0.089mm deep crater &amp; many smaller</p>

Figure 147: Post-test of ISS Soyuz Orbital Module Test #9 (HITF12265) article mounted in 0.50-caliber target tank.

Figure 148: Side View of ISS Soyuz Orbital Module Test #9

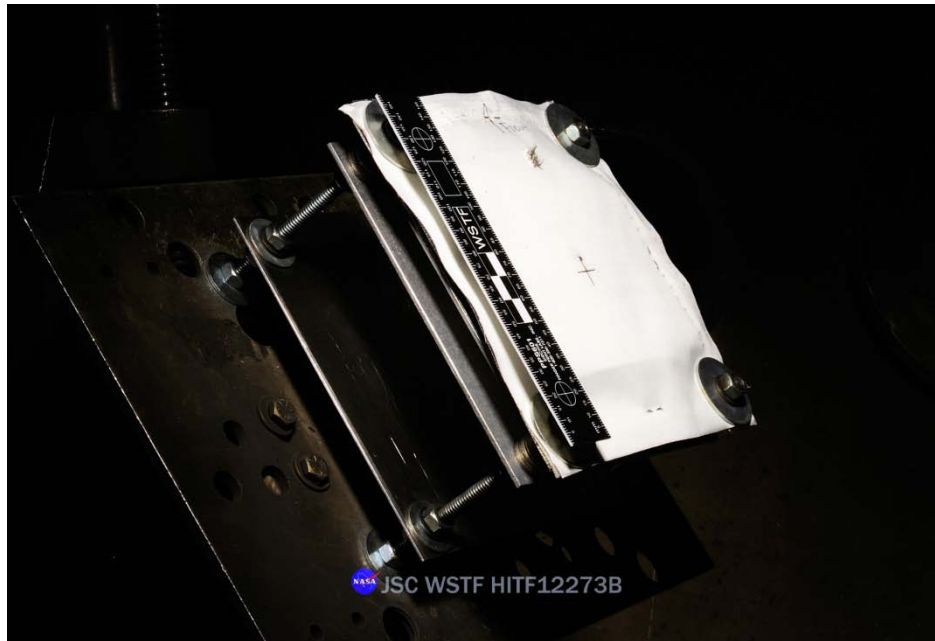
Test #13B, HITF12273

13B <a href="#">HITF12273</a>	1.29	0.00863	2.87	30	<p><b>Fail</b></p> <p>Beta cloth entry damage = 1.39mm x 1.35mm hole  Mylar Film damage = 6.54mm x 5.89mm hole  Fiberglass damage = 2.42mm x 2.98mm hole  Al 6061 Foil damage = 2.53mm x 2.50mm hole  Fiberglass damage = 2.84mm x 2.95mm hole  MLI exit damage = 3.03mm x 4.17mm hole  Al 6061-T6 plate damage = 2.05mm x 2.48mm hole  Al 5456-0 <a href="#">RW damage</a> = 2.23mm x 2.33mm hole  Al 2024-T3 WP damage = 0.64mm x 0.74mm x 0.1mm deep crater &amp; several smaller</p>
6B <a href="#">HITF12262</a>	1.49	0.01332	7.14	30	<p><b>Pass</b></p> <p>Beta cloth entry damage = 1.97mm x 1.72mm hole  Mylar Film damage = 24.76mm x 31.83mm hole  Fiberglass entry damage = 7.66mm x 11.22mm hole  Al 6061 Foil damage = 8.67mm x 6.48mm hole  Fiberglass exit damage = 12.33mm x 11.26mm hole  MLI exit damage = 8.01mm x 8.64mm hole  Al 6061-T6 plate damage = 6.66mm x 5.18mm hole  Al 5456-0 <a href="#">RW damage</a> = 0.97mm x 1.11mm x 1.09mm deep crater of many with a 0.94mm high bump on back  Al 2024-T3 WP damage = no damage</p>

Figure 214: Post-test of ISS Soyuz Orbital Module Test #13B (HITF12273) article mounted in 0.17-caliber target tank.

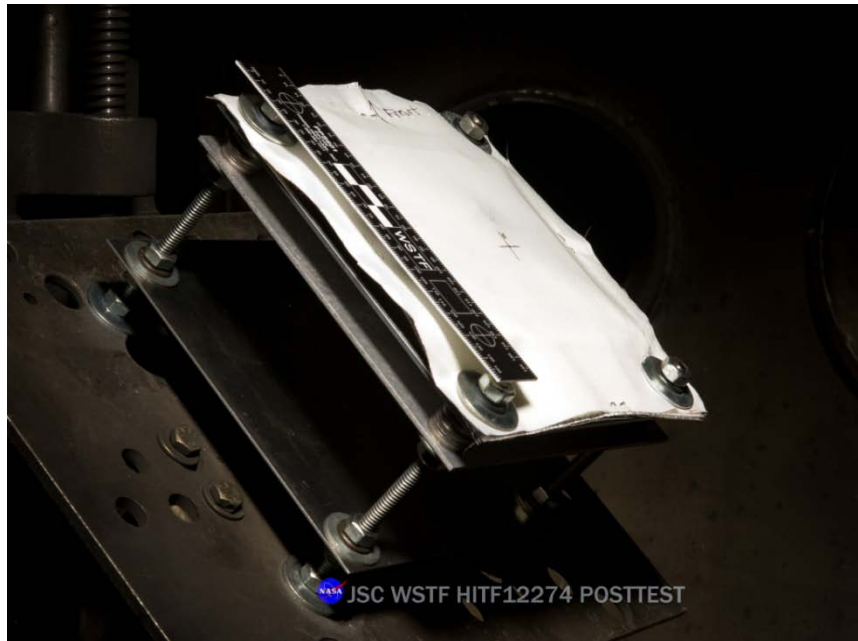
14 <a href="#">HITF12274</a>	1.3	0.00864	4.18	45	<p><b>Fail</b></p> <p>Beta cloth entry damage = 1.43mm x 1.87mm hole  Mylar Film damage 33.26 x 22.20mm hole  Fiberglass damage = 3.10 x 5.92mm hole  Al 6061 Foil damage = 2.95 x 4.06mm hole  Fiberglass damage = 3.46 x 4.32mm hole  MLI exit damage = 5.07mm x 6.72mm hole  Al 6061-T6 plate damage = 3.05mm x 5.04mm hole  Al 5456-0 RW damage = 0.87mm x 0.99mm hole  Al 2024-T3 WP damage = 0.50mm x 0.85mm x 0.056mm deep crater</p>
15C <a href="#">HITF12275</a>	1.0	0.00400	3.93	45	<p><b>Pass</b></p> <p>Beta cloth entry damage = 1.23mm x 1.68mm hole  Mylar Film damage 24.03 x 20.59mm hole  Fiberglass damage = 1.72 x 2.52mm hole  Al 6061 Foil damage = 2.23 x 3.04mm hole  Fiberglass damage = 2.20 x 3.15mm hole  MLI exit damage = 4.10mm x 5.64mm hole  Al 6061-T6 plate damage = 2.70mm x 3.95mm hole  Al 5456-0 RW damage = 1.10mm x 1.21mm hole  Al 2024-T3 WP damage = no damage</p>

Figure 232: Post-test of ISS Soyuz Orbital Module Test #14 (HITF12274) article mounted in 0.17-caliber target tank.

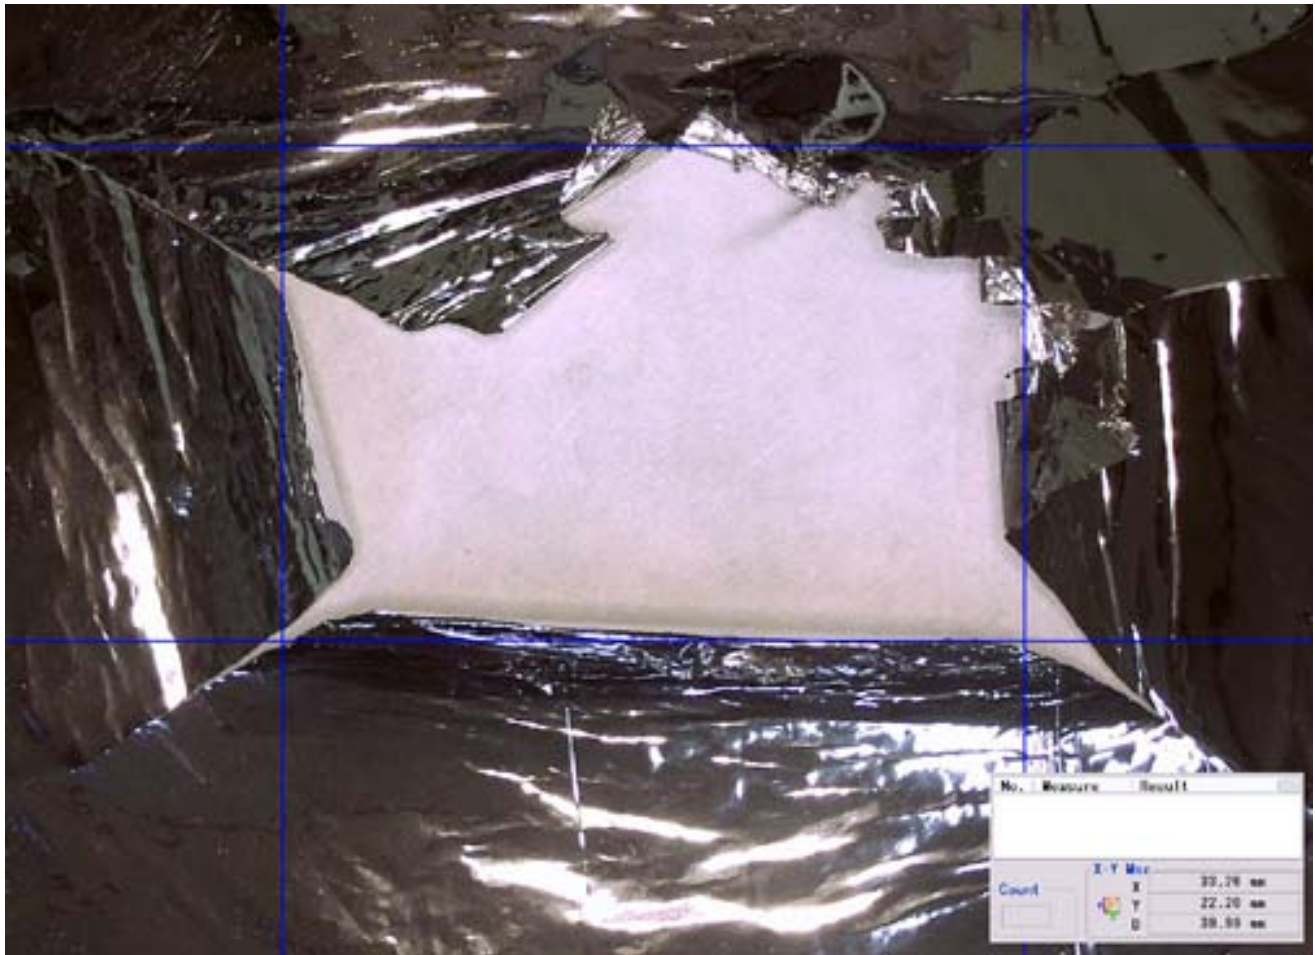
Figure 236: Mylar Film Layer 2 of ISS Soyuz OM Test #14  
(Keyence 3D Microscope Image)

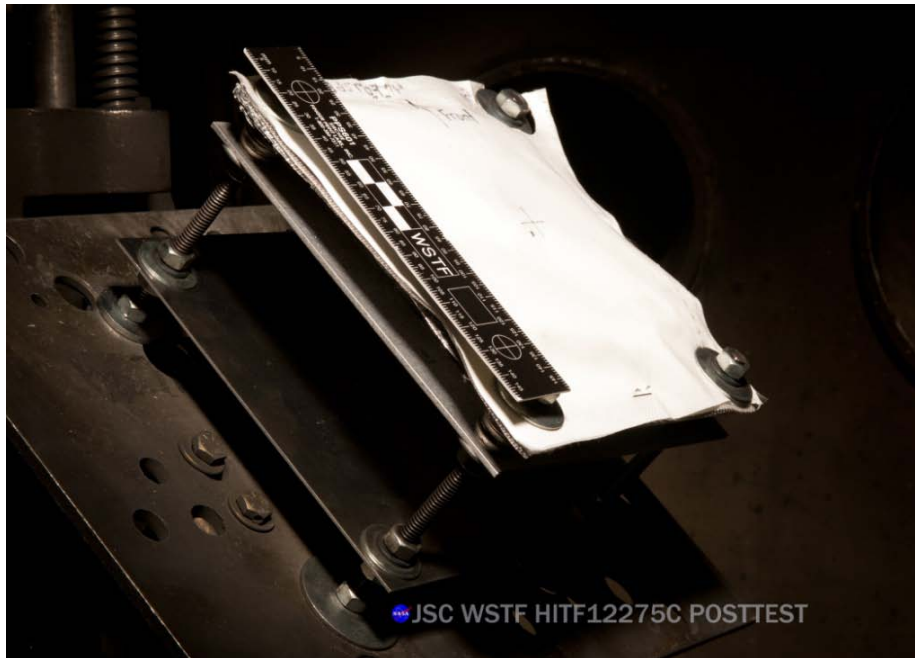
Figure 250: Post-test of ISS Soyuz Orbital Module Test #15C (HITF12275) article mounted in 0.17-caliber target tank.

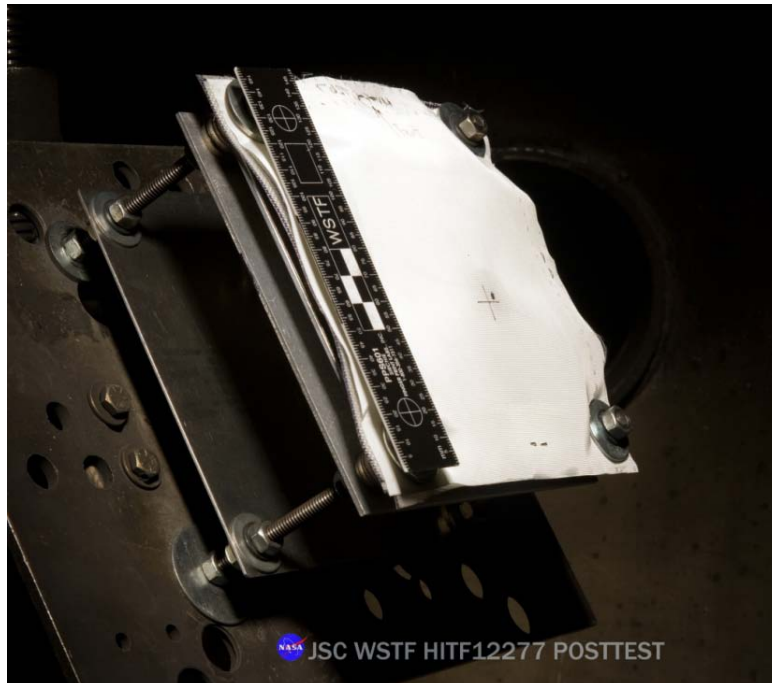
Test #17, HITF12277

Figure 280: Post-test of ISS Soyuz Orbital Module Test #17 (HITF12277) article mounted in 0.17-caliber target tank.
