NASA/TM—1999-209077

Aerospace Mechanisms and Tribology Technology: Case Study

K. Miyoshi
Glenn Research Center, Cleveland, Ohio

CASE STUDY: GALILEO SPACECRAFT AND HIGH-GAIN ANTENNA DEPLOYMENT ANOMALY

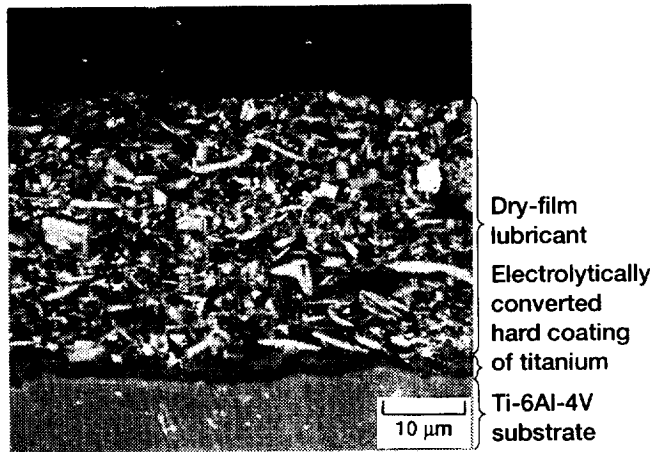
Figure 5.—Tapered cross section of dry-film-lubricated Ti-6Al-4V pin at angle of 45°.

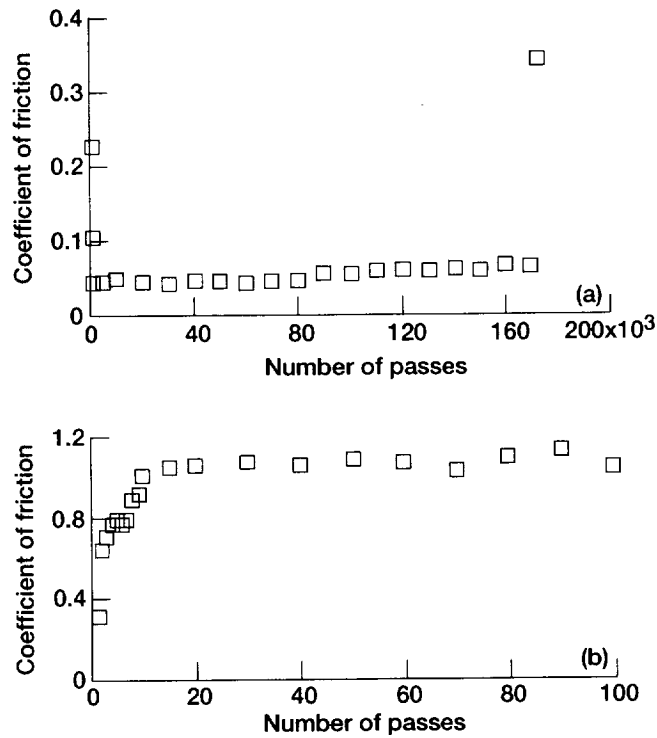
Effect of dry-film lubricant: The coefficient of friction for the dry-film-lubricated Ti-6Al-4V in contact with the bare high-nickel-content superalloy started at 0.23 but rapidly decreased and reached an equilibrium value of about 0.04 (fig. 6(a)). It remained constant at 0.04 for a long period of time. The friction trace fluctuated slightly with no evidence of stick-slip behavior. The sliding action finally caused the coefficient of friction to rapidly increase at 172 370 passes. Wear damage (i.e., local removal of the dry-film lubricant and consequent exposure of the substrate surface), which will be discussed later, caused the high friction at this stage.

The coefficient of friction for the unlubricated, bare Ti-6Al-4V in contact with the bare high-nickel-content superalloy started at 0.31. The friction force traces for the first few sliding passes were characterized by random fluctuation, with only occasional evidence of stick-slip behavior. The presence of oxides and contaminants on the surfaces of the bare Ti-6Al-4V pin and the bare high-nickel-content superalloy disk contributed to the low initial coefficient of friction. Stick-slip behavior became dominant after a few sliding passes. The coefficient of friction rapidly increased with an increase in the number of passes. Also, the higher the number of passes, the greater the stick-slip behavior. At ~ 10 passes and above, the coefficient of friction reached an equilibrium value of about 1.1 and remained constant for a long period of time (fig. 6(b)). The traces for 10 passes and above were primarily characterized by a continuous, marked stick-slip behavior. This type of friction is anticipated where strong metallic

Comparing figures 6(a) with (b) shows that the adhesion and friction in equilibrium conditions for dry-film-lubricated Ti-6Al-4V were less than those for unlubricated, bare Ti-6Al-4V by a factor of 28. Thus, the dry-film lubricant on the Ti-6Al-4V pin surface was effective and greatly reduced adhesion and friction.

Self-healing of dry-film lubricant.—At 172 370 passes of sliding contact in vacuum (fig. 6(a)) the sliding motion was stopped because of high friction (0.36 or greater) caused by the wear damage. After holding conditions for about 18 hr the sliding was restarted. The result is presented in figure 7(a). The coefficient of friction after restart became much lower than 0.36, generally decreasing to about 0.05 with increasing number of passes. This result suggests that the wear damage occurring in vacuum, which caused high friction at 172 370 passes, can self-heal when rerun in vacuum after a period of hold time.

Figure 6.—Coefficients of friction for dry-film-lubricated and unlubricated Ti-6Al-4V pins sliding against high-nickel-content superalloy disks as function of number of passes in vacuum. (a) Dry-film-lubricated pin at 8.5-N load. (b) Unlubricated pin at 4-N load.

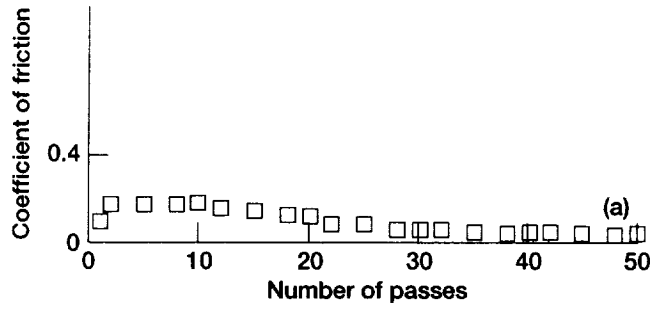
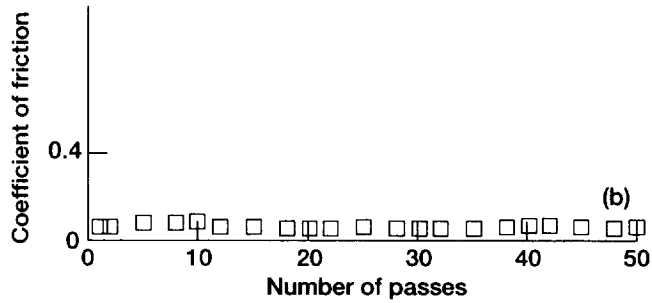
After 50 passes of sliding contact in the rerun process, the sliding motion was stopped, and the load was decreased from 8.5 to 2.5 N. Contact was maintained for 30 sec and then sliding was begun at the new load. Decreasing the load from 8.5 to 2.5 N did not affect the coefficient of friction, as shown in figure 7(b).

Figure 7.—Coefficients of friction for surfaces previously worn in vacuum of dry-film-lubricated Ti-6Al-4V pin sliding against high-nickel-content superalloy disk as function of number of passes when rerun in vacuum. (a) Load, 8.5 N; rotating speed, 40 rpm. (b) Load, 2.5 N; rotating speed, 1 rpm.

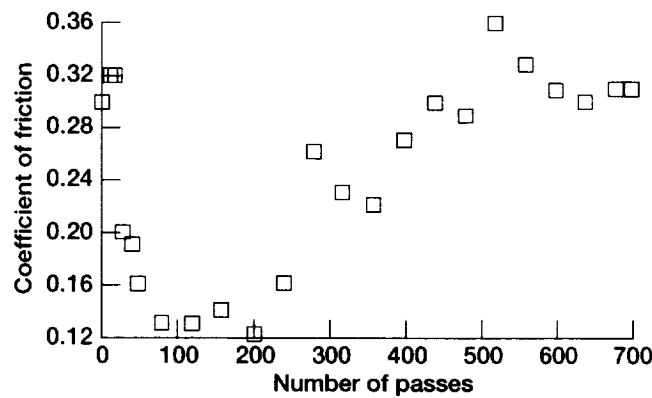
Sliding friction in humid air : In humid air the coefficient of friction for an MoS₂ dry-film-lubricated Ti-6Al-4V pin sliding on a high-nickel-content superalloy disk started high (~0.30) in the first 23 passes but then decreased to an equilibrium value of about 0.13 (fig. 8). Continued sliding caused the coefficient of friction to increase at 270 passes. When the coefficient of friction then reached an equilibrium value of about 0.32 at 700 passes, the experiment stopped.

When compared with the coefficients of friction obtained in vacuum (fig. 6(a)), the coefficients of friction obtained in humid air (fig. 8) were much greater. The coefficient of friction for the dry-film lubricant in vacuum was one-third of the value in humid air. Further, the endurance life of the dry-film lubricant in vacuum (the number of passes before the onset of a marked increase in friction) was about three orders of magnitude longer than that in humid air.

Figure 8.—Coefficients of friction for dry-film-lubricated Ti-6Al-4V pin sliding against high-nickel-content superalloy disk at 8.5 N in humid air as function of number of passes.

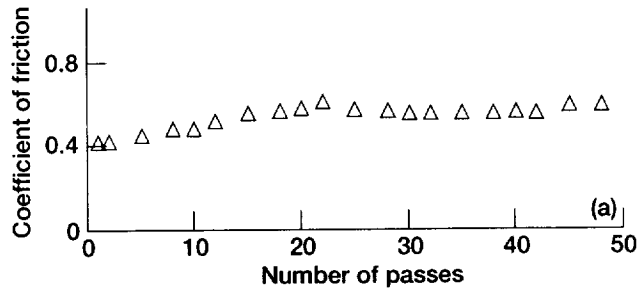
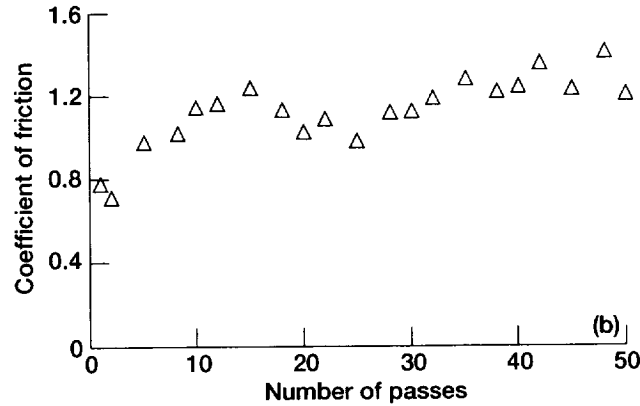
Seizure when rerun in vacuum: After 700 passes in humid air (fig. 8) the worn surfaces were at rest, and large wear particles loose on the disk surface were blown off. Then the vacuum chamber was evacuated to 10⁻⁷ Pa. After ~18 hr in contact the sliding motion was restarted. The coefficients of friction, ~0.5, as shown in figure 9(a), for the pin and disk previously worn in humid air were much higher than those (0.05 in fig. 7(a)) for the pin and disk previously worn in vacuum.

After 50 passes of sliding contact in the rerun process the sliding motion was stopped, and the load was decreased from 8.5 to 2.5 N. Contact was maintained for 30 sec and then sliding was begun at the new load. The coefficient of friction continued to increase to 1.4 with increasing number of passes, as shown in figure 9(b). Therefore, seizure between the pin and disk did occur due to wear damage to the dry-film lubricant (i.e., local removal of the dry-film lubricant and exposure of the substrate).

Figure 9.—Coefficients of friction for surfaces previously worn in humid air of dry-film-lubricated Ti-6Al-4V pin sliding against high-nickel-content superalloy disk as function of number of passes when rerun in vacuum. (a) Load, 8.5 N; rotating speed, 40 rpm. (b) Load, 2.5 N; rotating speed, 1 rpm.
