RESULTS OF A CYCLIC LOAD TEST OF AN RB-47E AIRPLANE

MEMORANDUM 3-15-59L

By Wilber B. Huston

SUMMARY

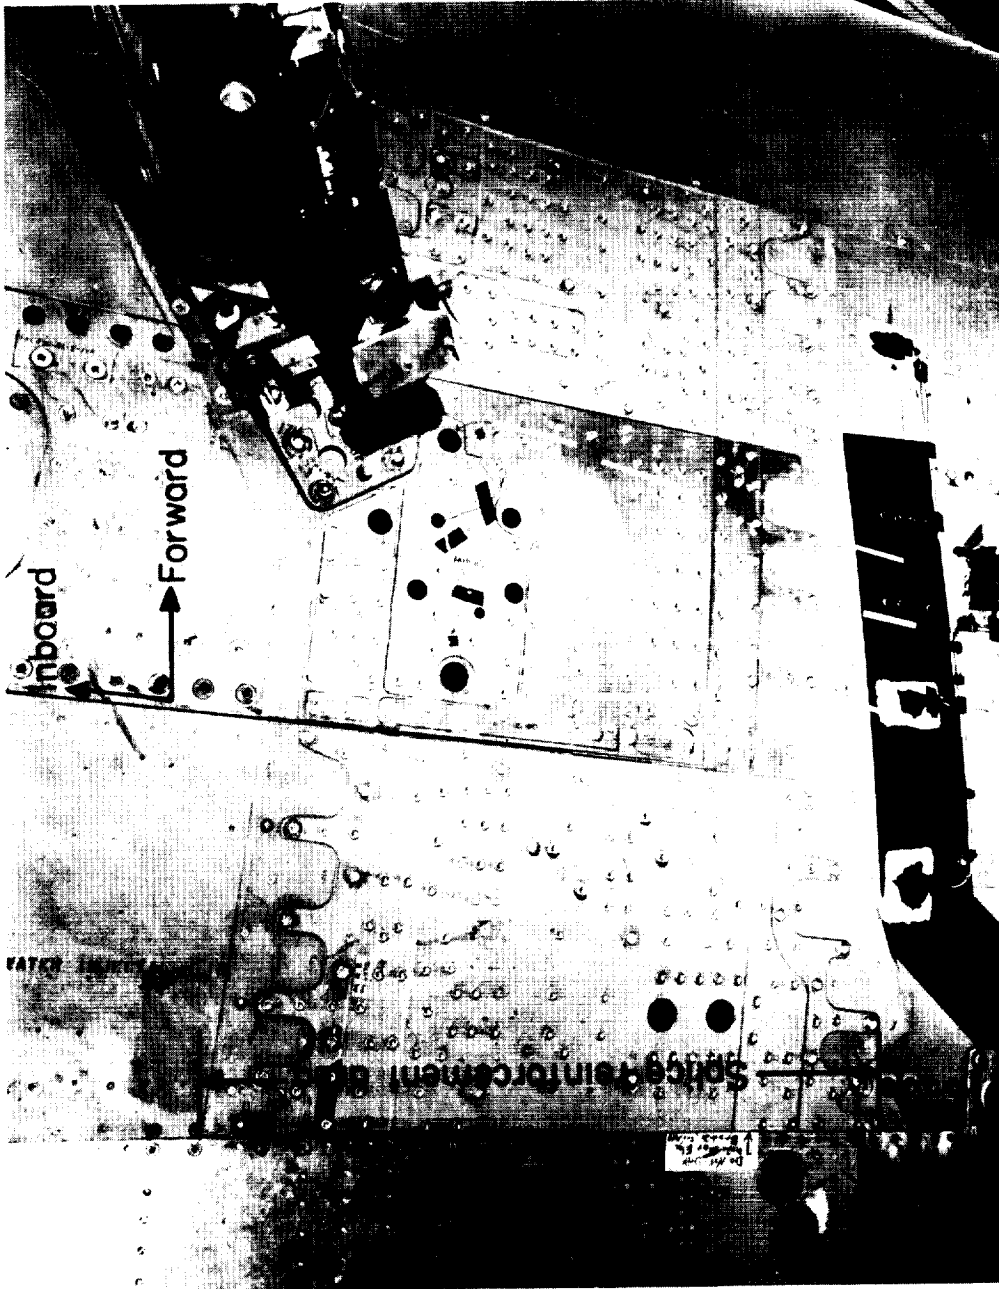
(a) Wing station 354. L-58-1309a.1

Figure 1.- Wing-splice reinforcements on lower surface.

The airplane was stripped of nonstructural items, such as fuel tanks and navigational, communication, and reconnaissance equipment, and was thoroughly inspected for fatigue cracks in accordance with the procedures specified in reference 2. Two cracks were found in the W.S. 354 splice area on the left side. The wing-splice reinforcements at W.S. 354 and B.L. 45 were then installed; these reinforcements are described in reference 3 and photographs are given in figure 1.
