NASA MEMO 3-3-59E

PERFORMANCE OF TWO BORON-MODIFIED S-816 ALLOYS IN  
A TURBOJET ENGINE OPERATED AT 1650° F

By William J. Waters, Robert A. Signorelli,  
and James R. Johnston

Lewis Research Center  
Cleveland, Ohio

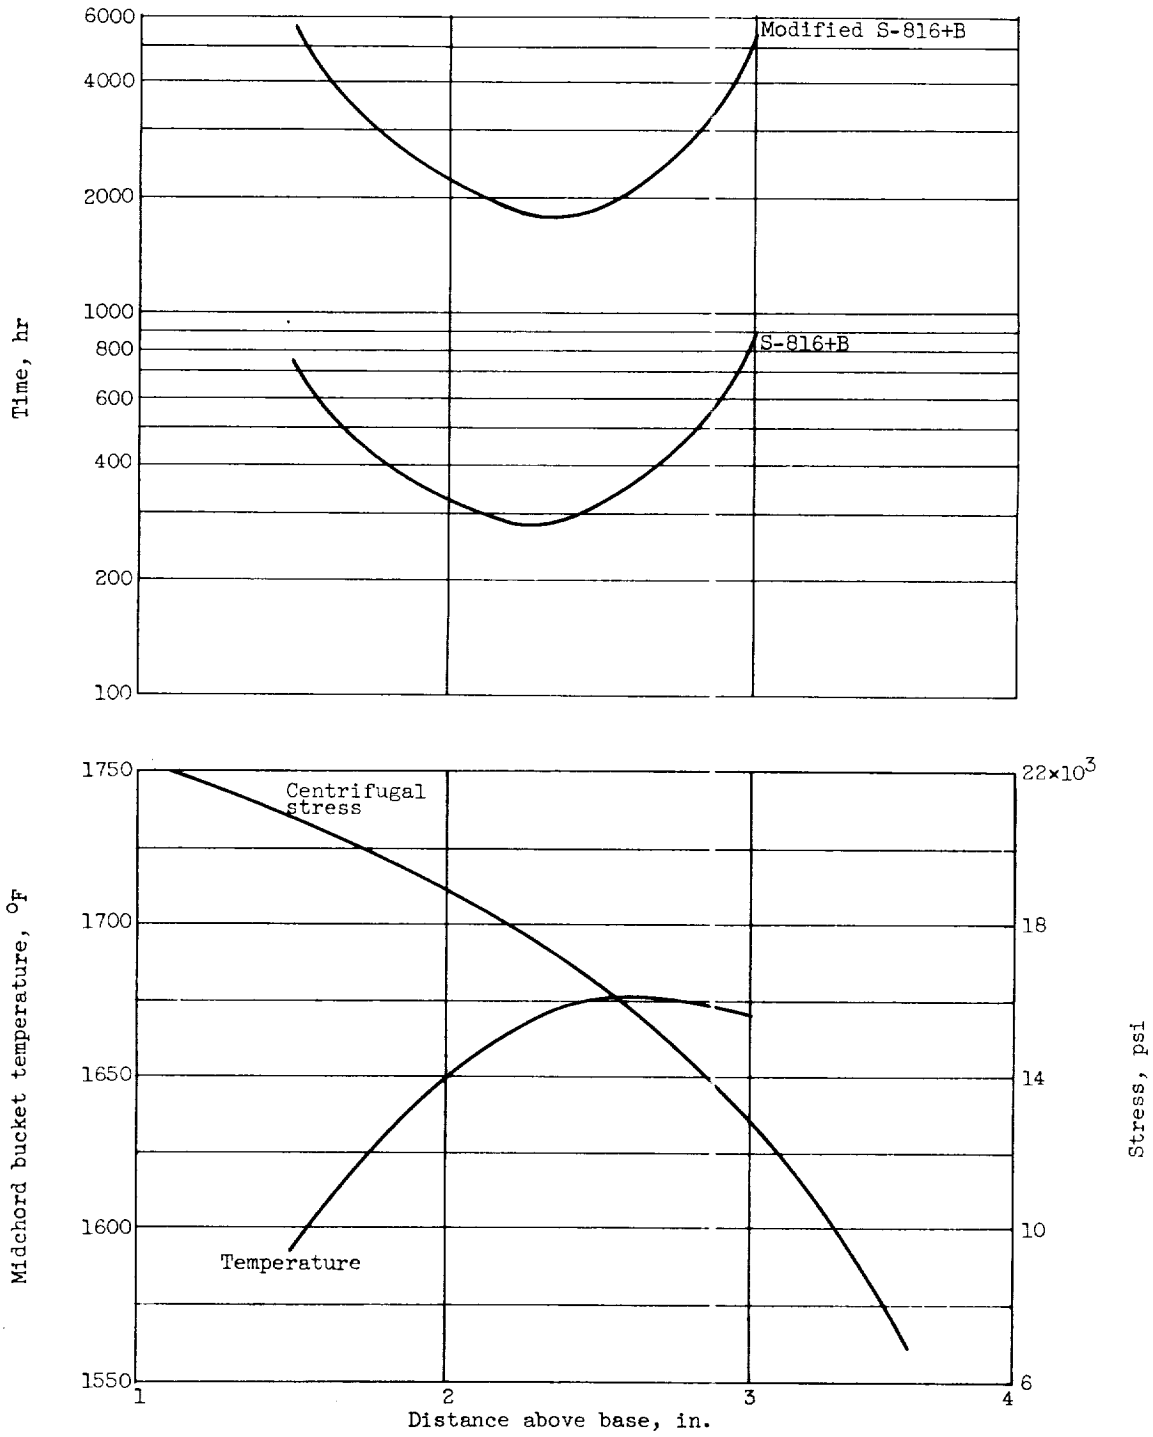
The distributions of centrifugal stress and temperature in bucket airfoils during engine operation at rated speed are shown in figure 1. The centrifugal stresses were calculated by the method described in reference 3 and represent average stresses over the entire airfoil cross section. To obtain the bucket airfoil temperature distribution prior to evaluating the S-816+B and modified S-816+B buckets, a full turbine wheel of standard S-816 buckets was operated in the engine for a few minutes. The temperatures were obtained from thermocouples installed in the buckets at midchord and connected to a recording device through sliprings, using the methods described in reference 4.

Figure 1 also shows the predicted-engine-life curve for buckets of each alloy if failure results solely from a combination of centrifugal stress and temperature. These curves were constructed using analytical and graphical extrapolation of stress-rupture data to determine the potential stress-rupture life at various spanwise stations along the airfoil. The most important portions of these curves are those which indicate the location of minimum bucket life. These portions of the curves were

Figure 1. - Nominal temperature-stress distribution and minimum stress-rupture lives of bucket airfoils.

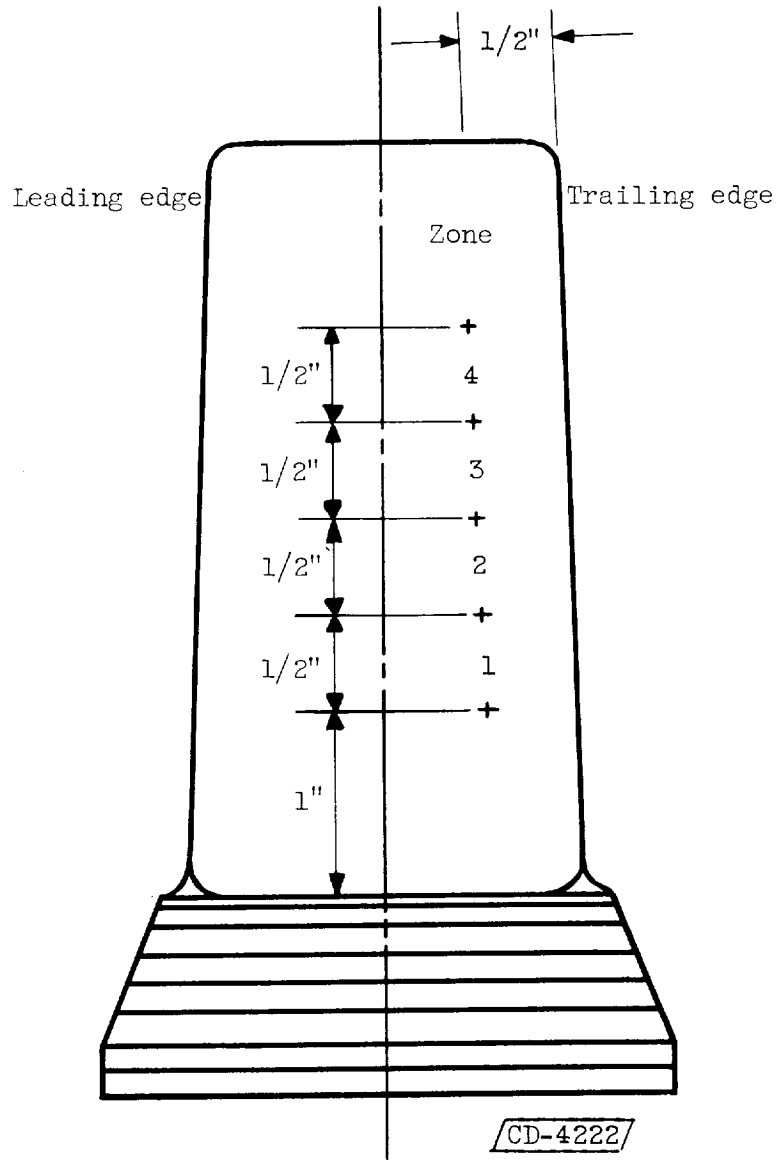
Three buckets of each alloy were scribed as shown in figure 2. The elongation of the various sections of the scribed airfoils was measured with an optical extensometer after completion of 10, 55, and 106 hours of engine operation. Elongation readings were taken to the nearest 0.0001 inch in each 1/2-inch gage length. However, because of the width of the scribed marks, bowing of bucket airfoils, and human error, elongation readings were sensitive to  $\pm 0.001$  inch or  $\pm 0.2$  percent of the gage length.

Figure 2. - Scribed bucket for elongation measurements.

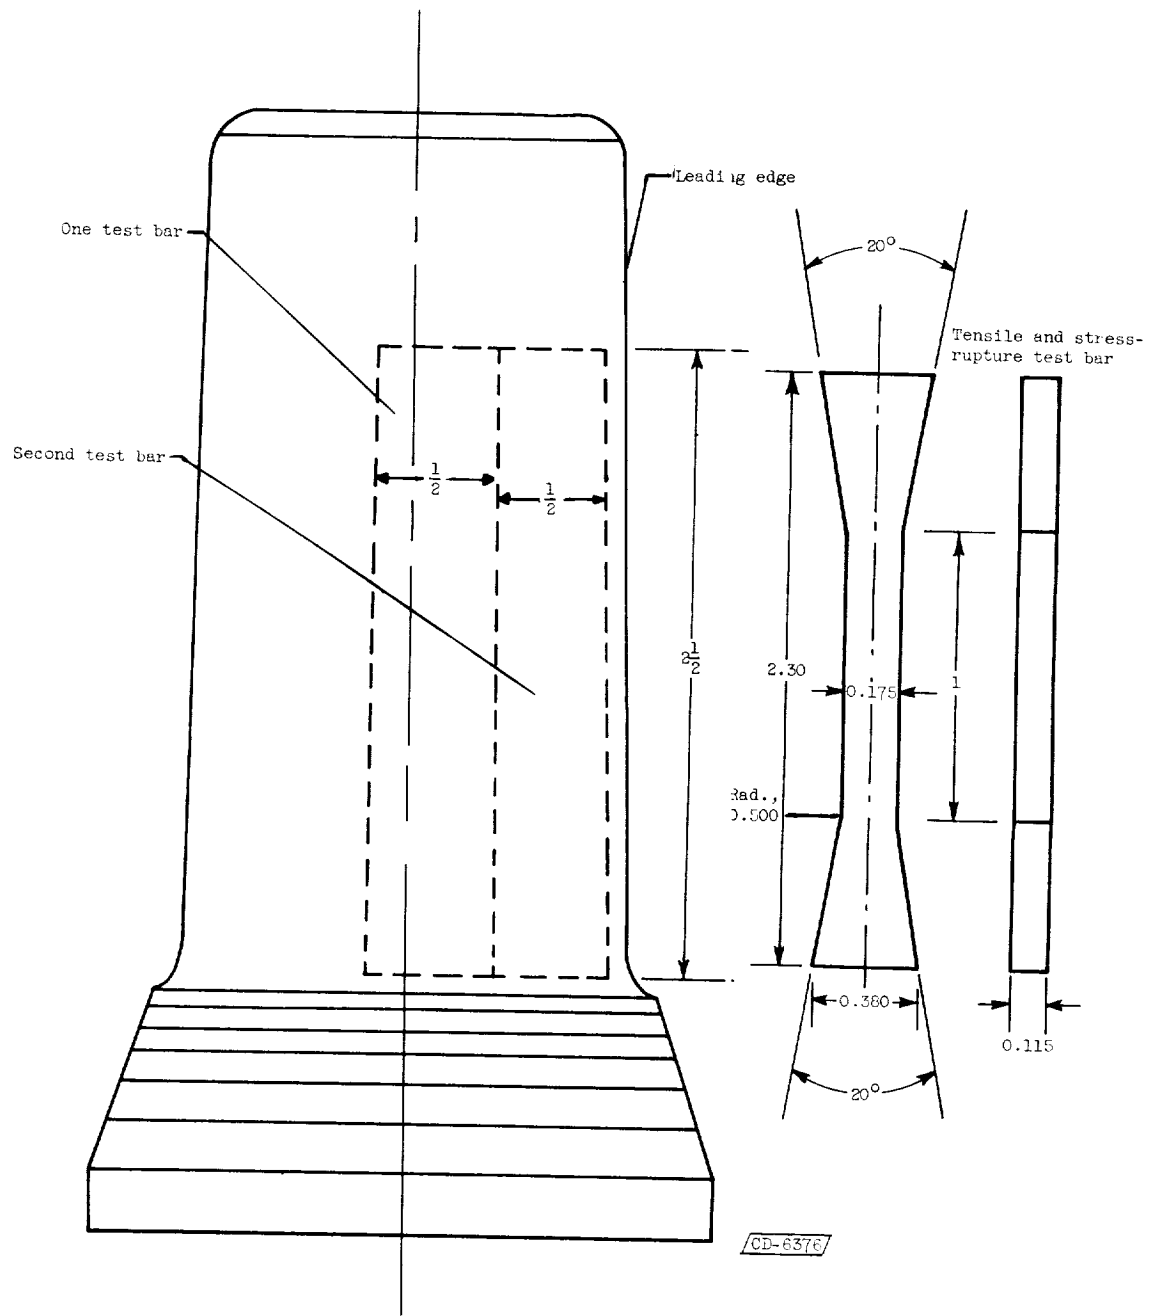
Stress-rupture and tensile tests were run on specimens obtained from randomly selected turbine buckets of each alloy in the as-cast condition. Figure 3 shows the test bar and that portion of the airfoil from which the test bars were obtained. Two test bars were obtained from each bucket. Stress-rupture lives for S-816+B and modified S-816+B were established at 1650° F for a range of stress from 18,000 to 40,000 psi. Two tensile tests were performed at 1650° F for each alloy.

Figure 3. - Stress-rupture and tensile bars and zone from which they were obtained. (Dimensions in inches.)

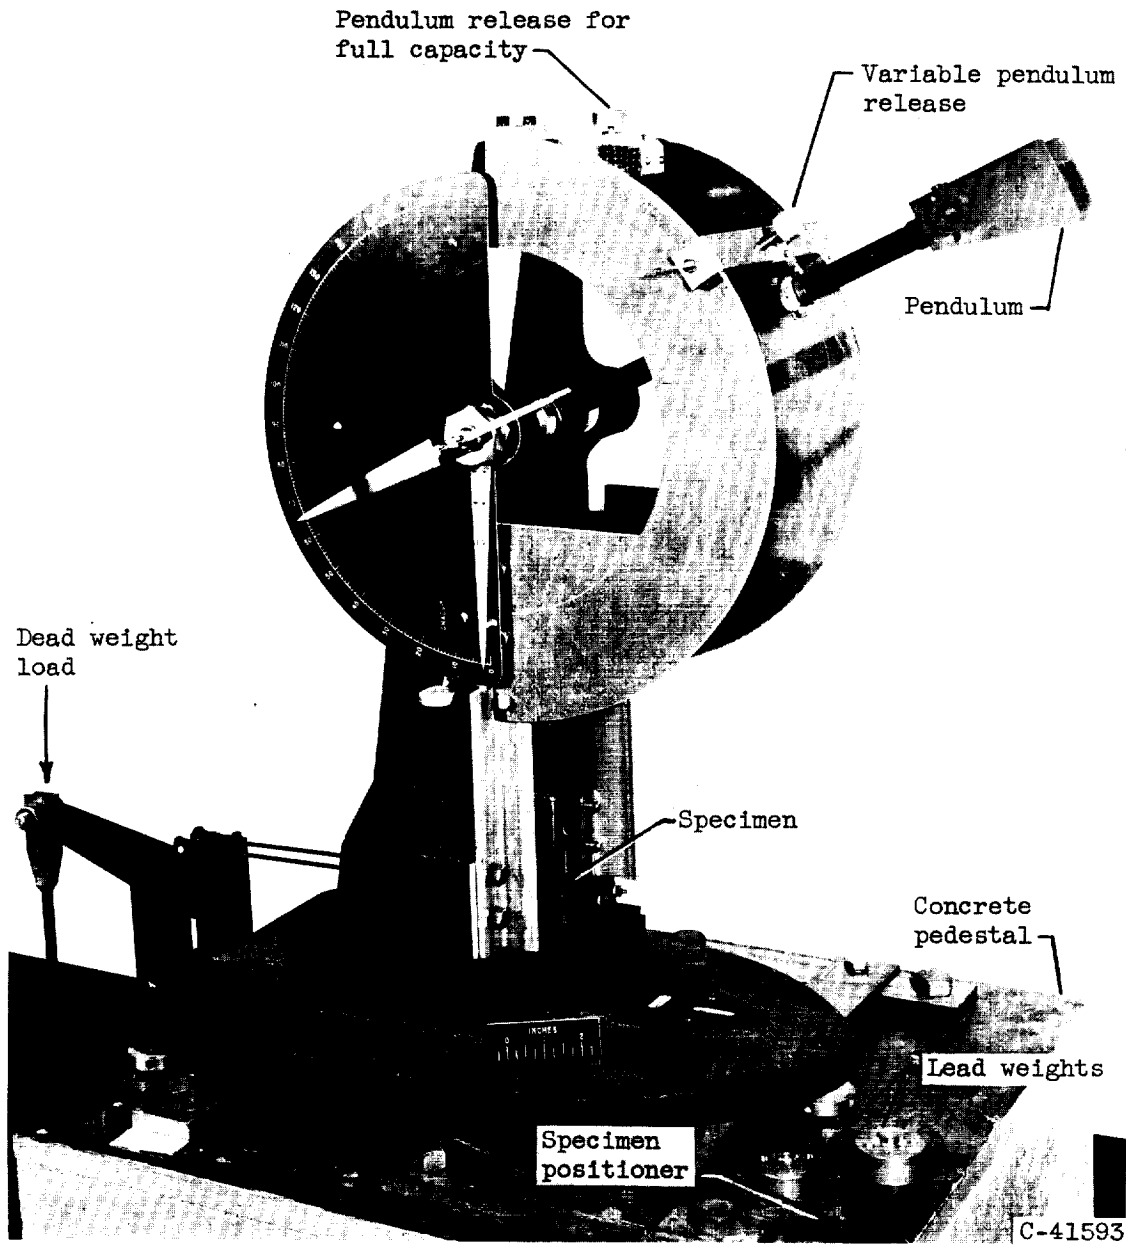
Laboratory impact studies. - Laboratory impact tests were performed for both alloys and for Guy alloy (as a standard for comparison) in the as-cast condition, using a low-capacity Izod impact tester. The tester is shown in figure 4 and is described in reference 5. Tests were performed at room temperature and at 1650° F with 3/16- by 3/16- by 1/2-inch unnotched impact bars machined from the base section of buckets. The test bars were inserted in the gripping device to a depth of 1/2 inch, and the point of impact of the pendulum was 1/8 inch from the free end of the bar. The total capacity of the pendulum was 25.5 inch-pounds, and the striking velocity was 135 inches per second.

Figure 4. - Modified Izod impact-test apparatus.

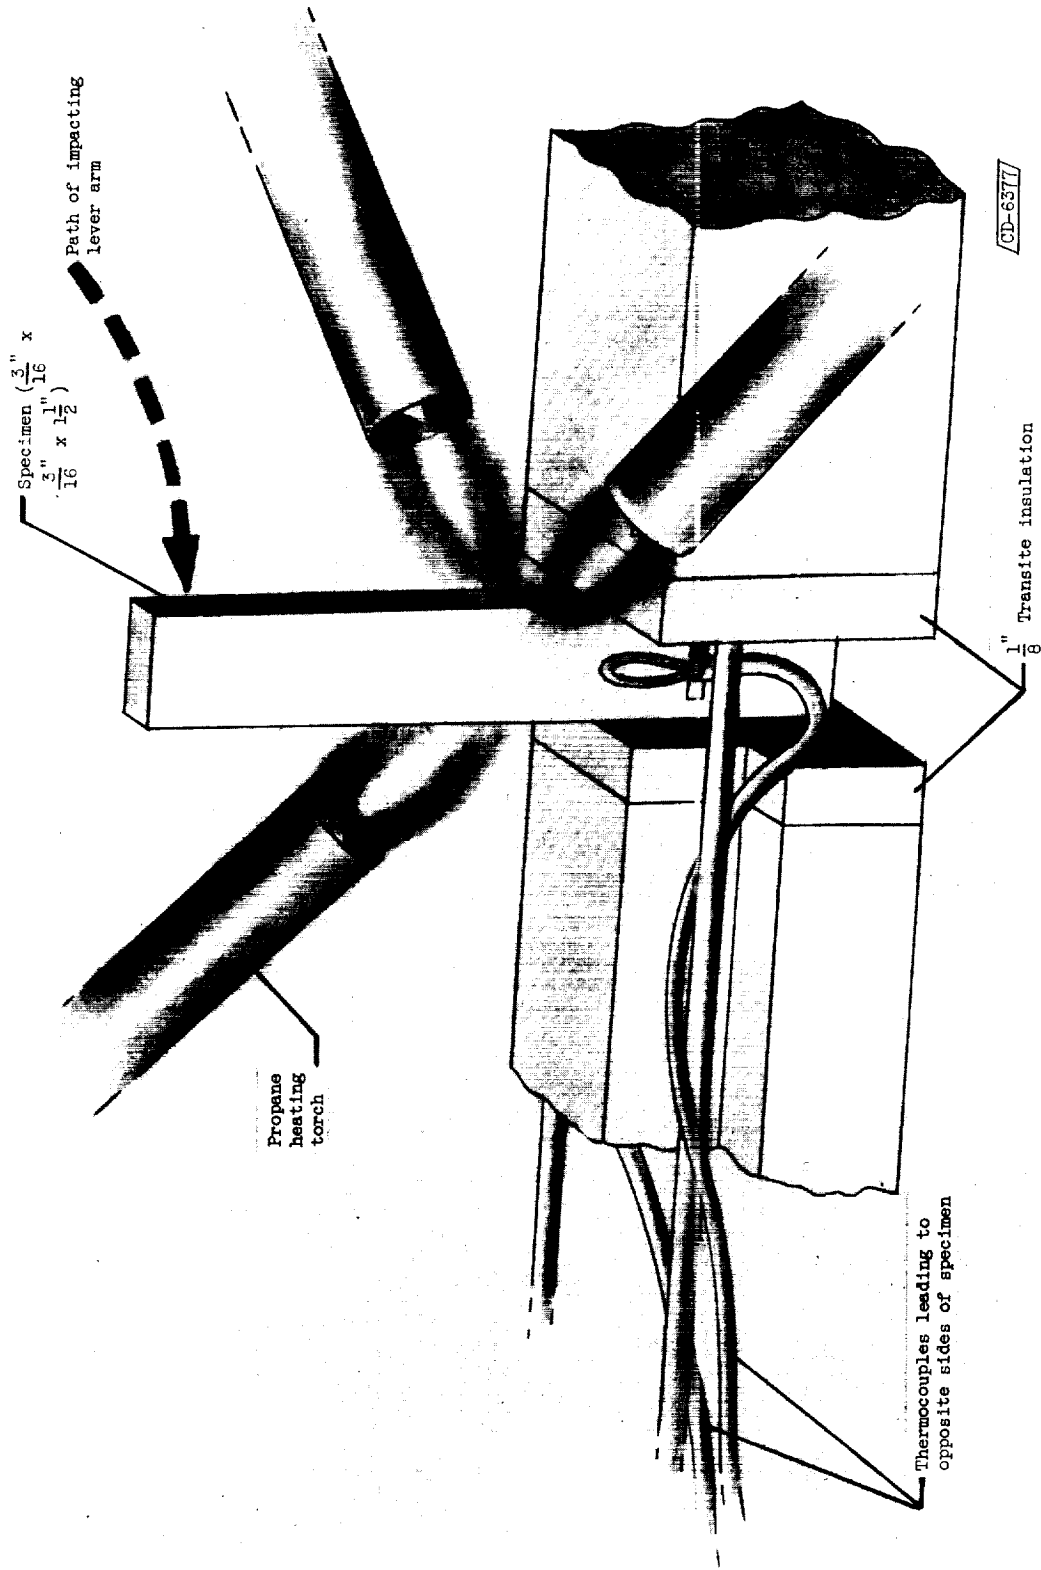
Figure 5 shows the heating and gripping arrangement used in the impact tests at 1650° F. A battery of three propane torches was manually directed at the free length of the test bar. Two thermocouples were attached on opposite sides of the test bars, as shown in figure 5. The thermocouples were located where the specimen was expected to break, at a point just above the gripping device. When the temperature reached 1650° F, the torches were removed and the pendulum was released. To minimize heating of the steel vise jaws, sections of Transite were inserted between the specimen and the jaw faces. While the Transite was not needed in room-temperature tests, the same procedure was used to avoid possible variables in gripping.

Figure 5. - Sketch of high-temperature impact test apparatus.

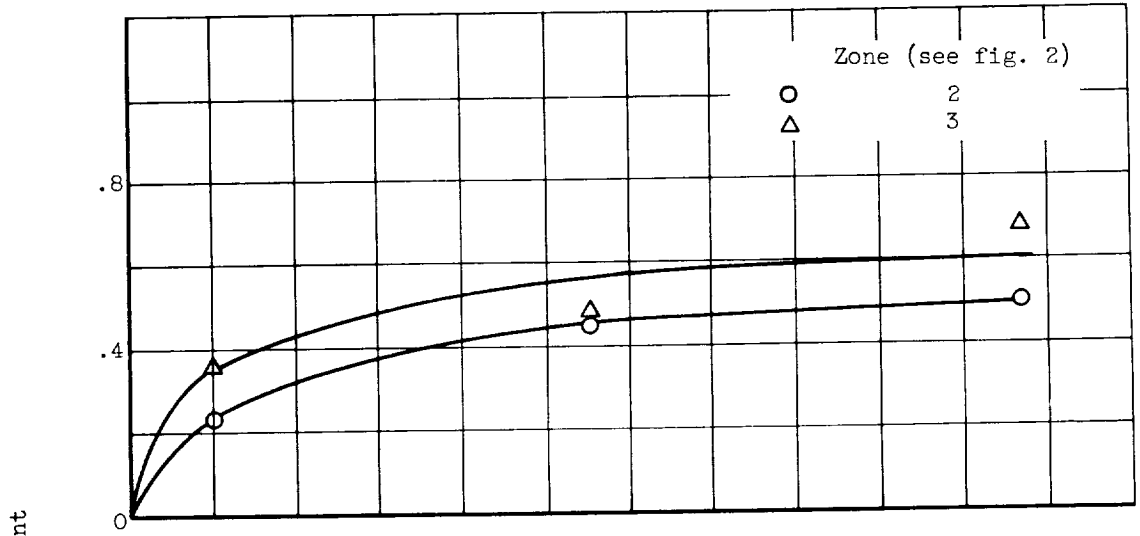
(a) Modified S-816+B.

Figure 10. - Elongation rate of midchord section of bucket airfoil.

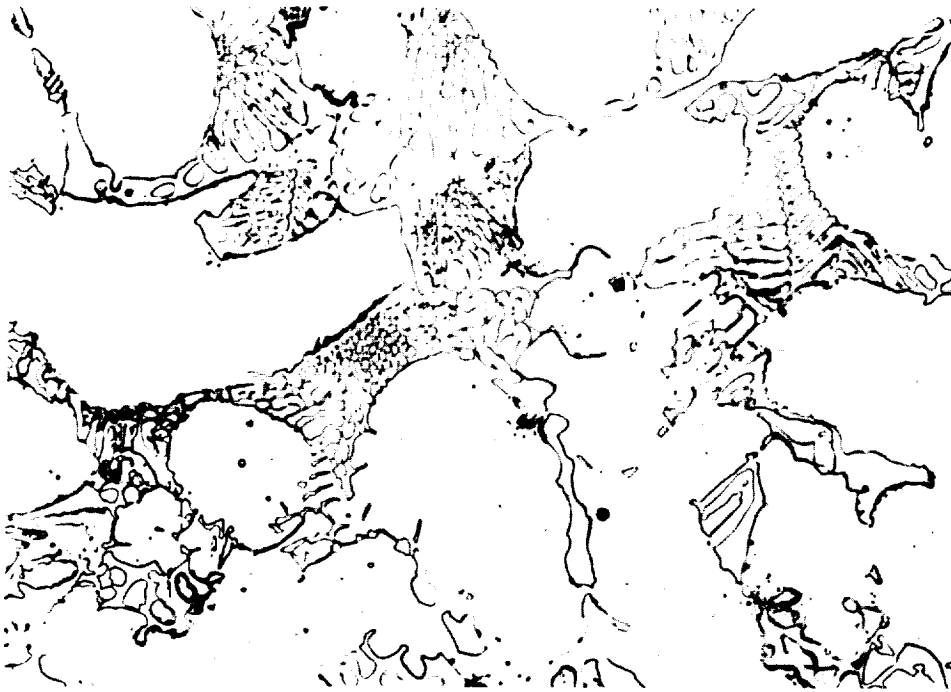
(a) S-816+B.

Figure 11 . Typical as-cast structures of alloys. Etchant, 20 cc water, 20 cc glycerine, 10 cc nitric acid, and 5 cc hydrogen fluoride.

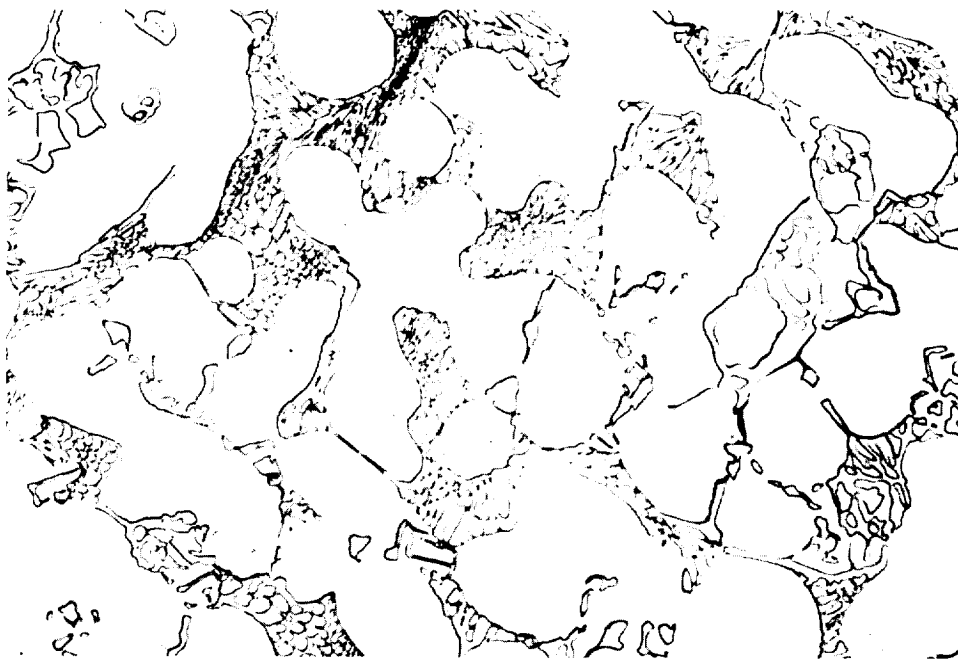
Figure 11. - Concluded. Typical as-cast structures of alloys. Etchant, 20 cc water, 20 cc glycerine, 10 cc nitric acid, and 5 cc hydrogen fluoride.

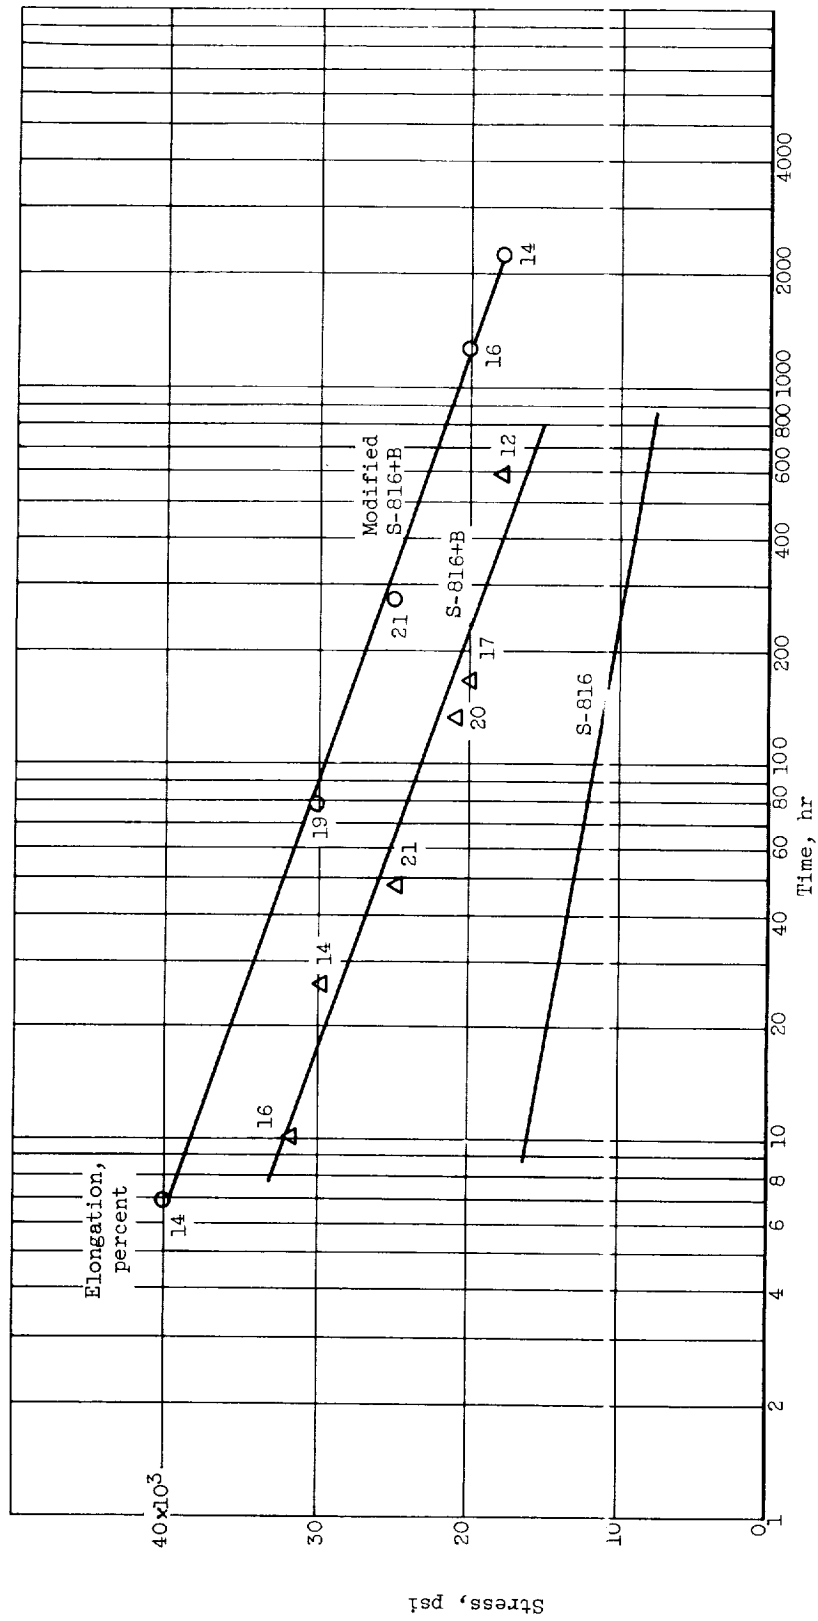
Figure 13. - Stress-rupture lives and elongation at 16500 F for alloys.
