NASA MEMO 4-7-59E

ENGINE OPERATING CONDITIONS THAT CAUSE THERMAL -  
FATIGUE CRACKS IN TURBOJET -ENGINE BUCKETS

By James R. Johnston, John W. Weeton, and Robert A. Signorelli

Lewis Research Center  
Cleveland, Ohio

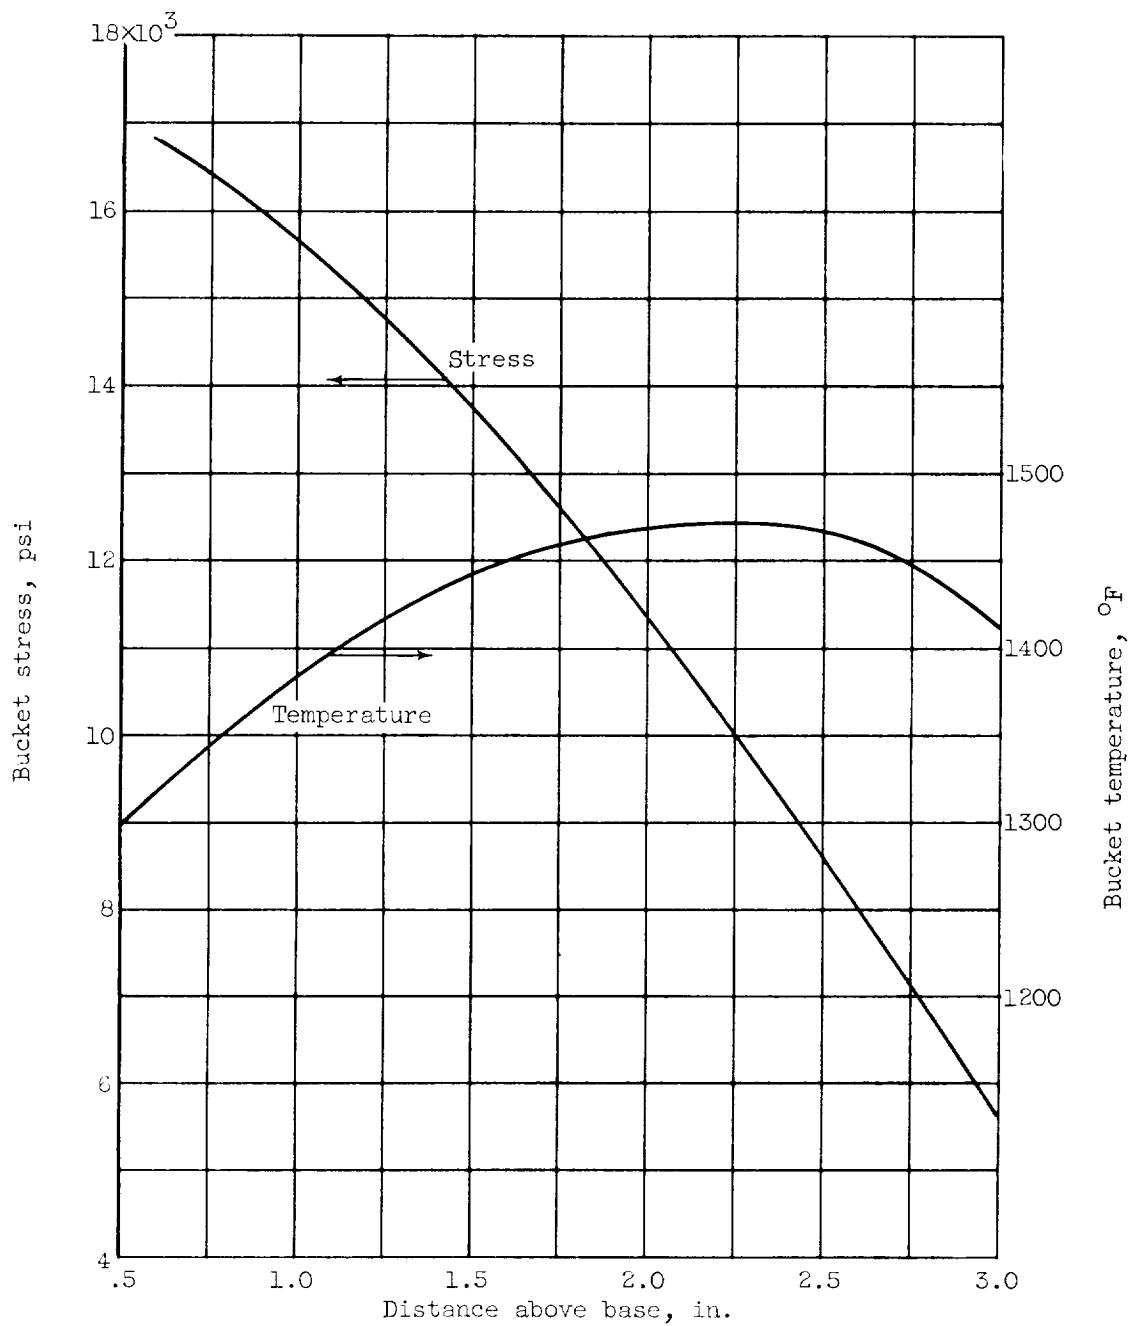
The centrifugal stress and temperature distributions in the bucket airfoil at rated engine conditions are shown in figure 1. The stress calculations were made using rotational speed, material density, and bucket geometry (ref. 3). The temperature distribution in the test engine was obtained with a spare turbine wheel prior to the installation of the test wheels. Six thermocouples were imbedded in the bucket airfoils to provide the spanwise temperature profile. By using the stress and temperature distribution in the bucket and stress-rupture data for the material, expected failure time can be computed for various sections along the airfoil span. The point with the lowest expected life is the critical zone; that is, the zone where fracture would occur if temperature and centrifugal stress were the only factors contributing to failure. The critical zone was given (for similar stress and temperature data) in reference 1 as centered at approximately 1.5 inches from the base of the airfoil. The expected life in the critical zone was greater than 10,000 hours.

Figure 1. - Distribution of centrifugal stress and temperature in J47 turbine bucket at rated-speed conditions.

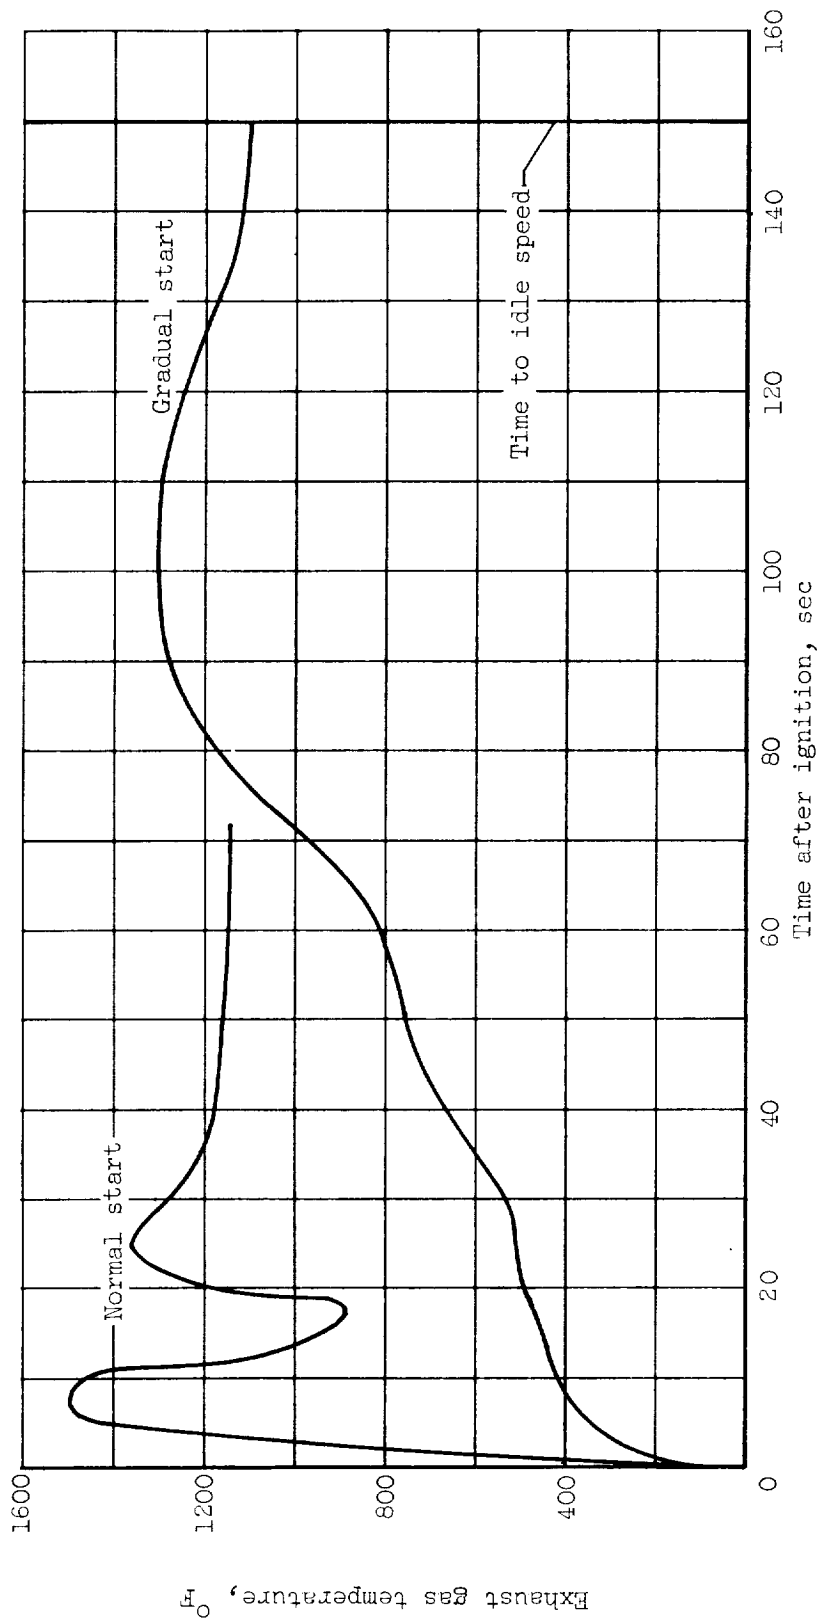
In the standard-engine fuel system, duplex fuel nozzles in all eight combustors are supplied by two common manifolds. In the standard engine, fuel is supplied only to the small slots while starting in order to limit the fuel flow in each combustor. However, the fuel flow necessary to sustain combustion causes the engine temperature to rise very rapidly. To prevent this rapid temperature rise, a distributing valve was designed to supply fuel to each combustor nozzle in sequence. This permitted the engine to ignite on one combustor and the engine temperature to increase gradually as each succeeding nozzle was supplied with fuel. A comparison of the exhaust gas temperatures for the gradual start and a normal start is shown in figure 2.

Figure 2. - Exhaust gas temperature during normal and gradual starts of J47 engine.

Another significant result of the series of engine tests was the demonstration that leading-edge cracking was prevented by reducing the severity of the engine starts. It was shown, by incorporating a simple distributing valve into the fuel system and by permitting an additional 90 seconds for starting, that the engine could be started without a rapid rise in gas temperature (fig. 2). It appears that this reduction in the rate of gas temperature rise reduced the thermal stresses in the buckets sufficiently to preclude failure by thermal fatigue. The simplicity of this remedy suggests that it might be considered for use on jet engines in applications where the slight extra time could be tolerated. It should be possible to do this in commercial types of aircraft and in some military vehicles such as bombers and trainers.

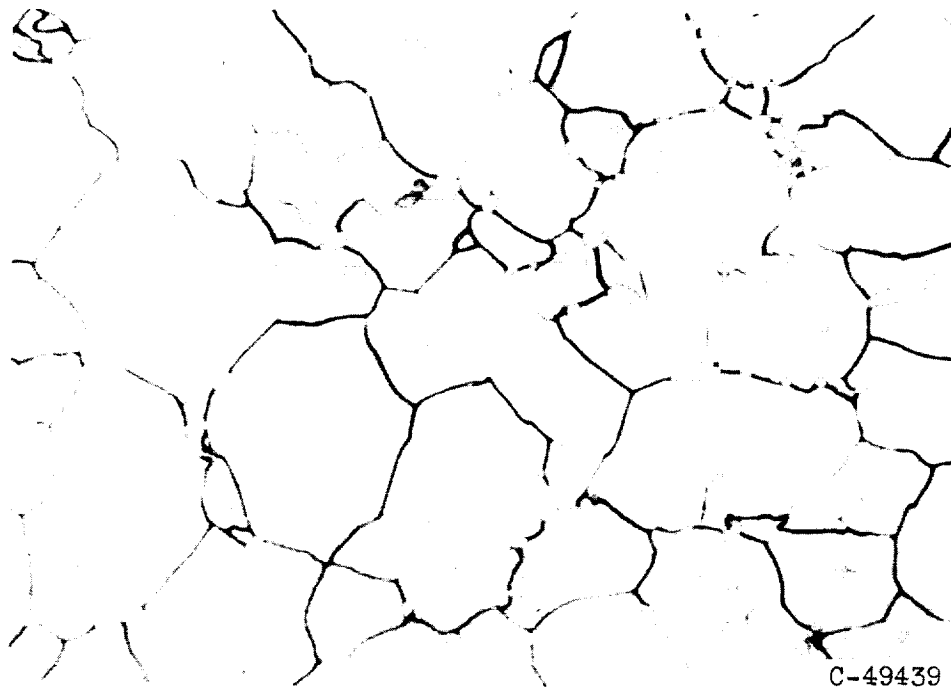
(b) S-816. Etchant, aqua regia plus glycerol.
