NASA/TP-97-206257

The Characteristics of Fatigue Damage in the Fuselage Riveted Lap Splice Joint

Robert S. Piascik
Langley Research Center, Hampton, Virginia

November 1997

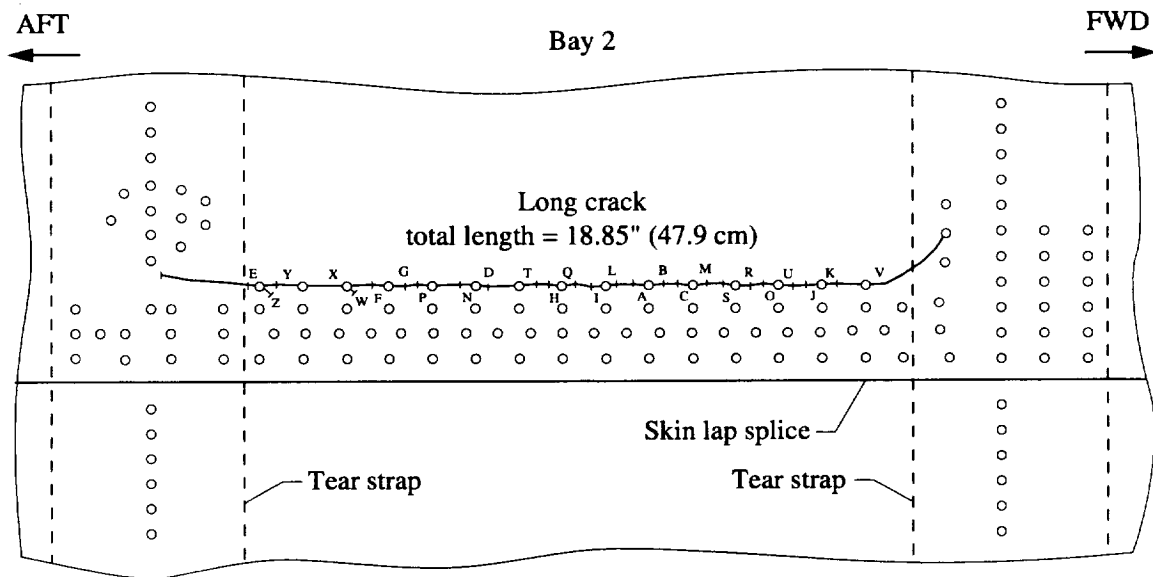
Figure 3.1 shows a schematic of bay 2 detailing the locations of the lap splice rivet holes, the tear straps and the 18.85 inch (47.9 cm) upper rivet row crack. It should be noted that the schematics shown in this section are used to show general features; the drawings (not drawn to scale) show the approximate rivet hole locations. More accurate drawings of the rivet hole spacings are found in Sections 6.0 through 11.0. As fatigue cracks were visually observed during the pressurization test, the sequence of outer skin fatigue cracking was identified alphabetically. The letters A through Z shown in Figure 3.1 therefore identify the chronology of fatigue cracking within the bay. Figures 3.2 and 3.3 are photographs showing the appearance of the outboard skin surface of bays 1 and 2, respectively. Open holes remain where rivets were removed after pressure testing and prior to receipt of the panel. The numbers located above each of the upper rivet holes are used to identify specific rivet locations within each bay. The large crack is easily visible along the entire upper rivet row in bay 2 and extending into both tear straps. Figures 3.4, 3.5 and 3.6 are more detailed photographs of the large upper rivet row crack observed in bay 2. Each fatigue crack segment is identified per the chronological code (A through V) shown in Figure 3.1.³ From Figures 3.4, 3.5 and 3.6, the following observations are made.

Figure 3.1 The schematic shows bay 2 and two adjacent tear strap regions. Dashed lines mark the location of the tear straps. The "tic" marks locate the approximate location for fatigue cracks A through Z prior to link-up. The long crack is shown along the upper rivet row.

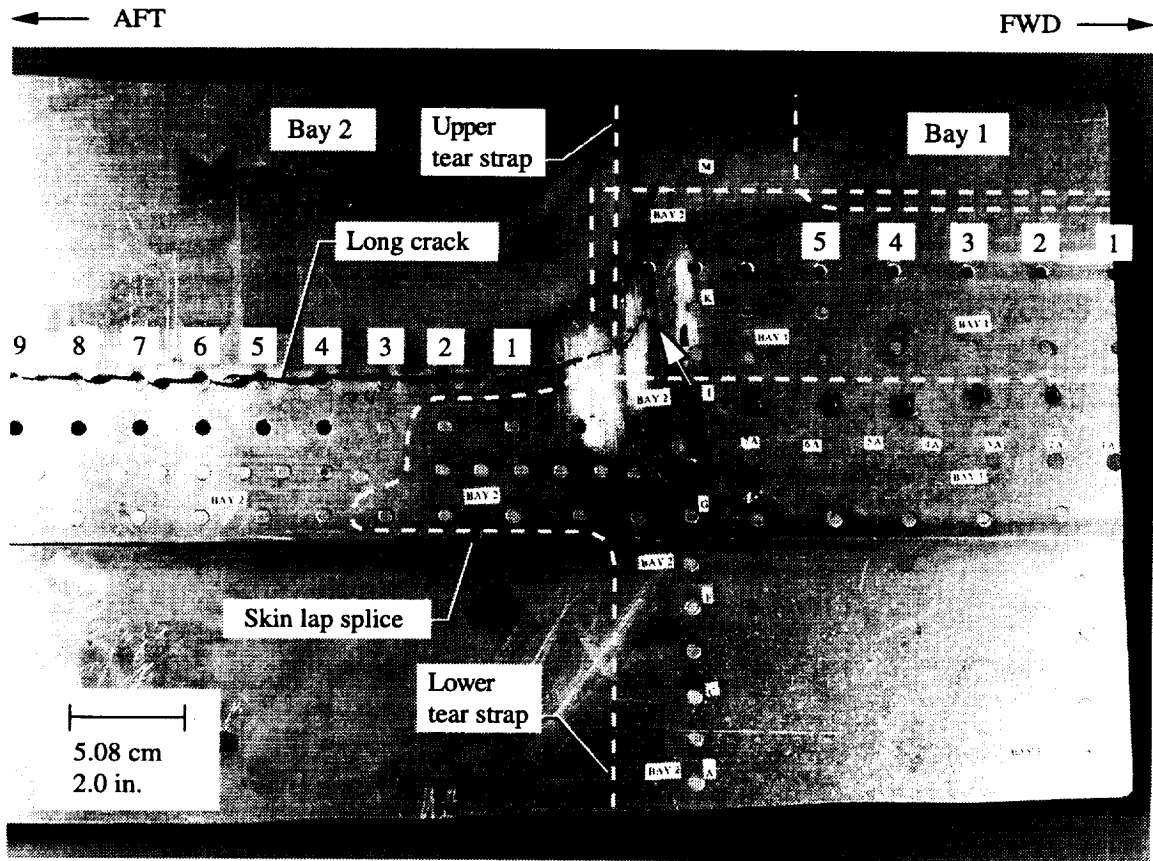
Figure 3.2 The photograph shows the bay 1 tear strap region and a portion of bay 2. The complex shape of the bay 1 tear strap is shown by the dotted lines. The bay 2 long crack is clearly visible along the upper rivet row of the midbay section. Growth of the forward portion of the bay 2 crack terminated at a rivet hole in the bay 1 tear strap region (arrow). Rivet rows are labeled with letters (bottom to top) and rivet holes are numbered from forward to aft (right to left). Note: A number of rivets were removed for visual and within hole eddy current inspection prior to receipt of the panel.

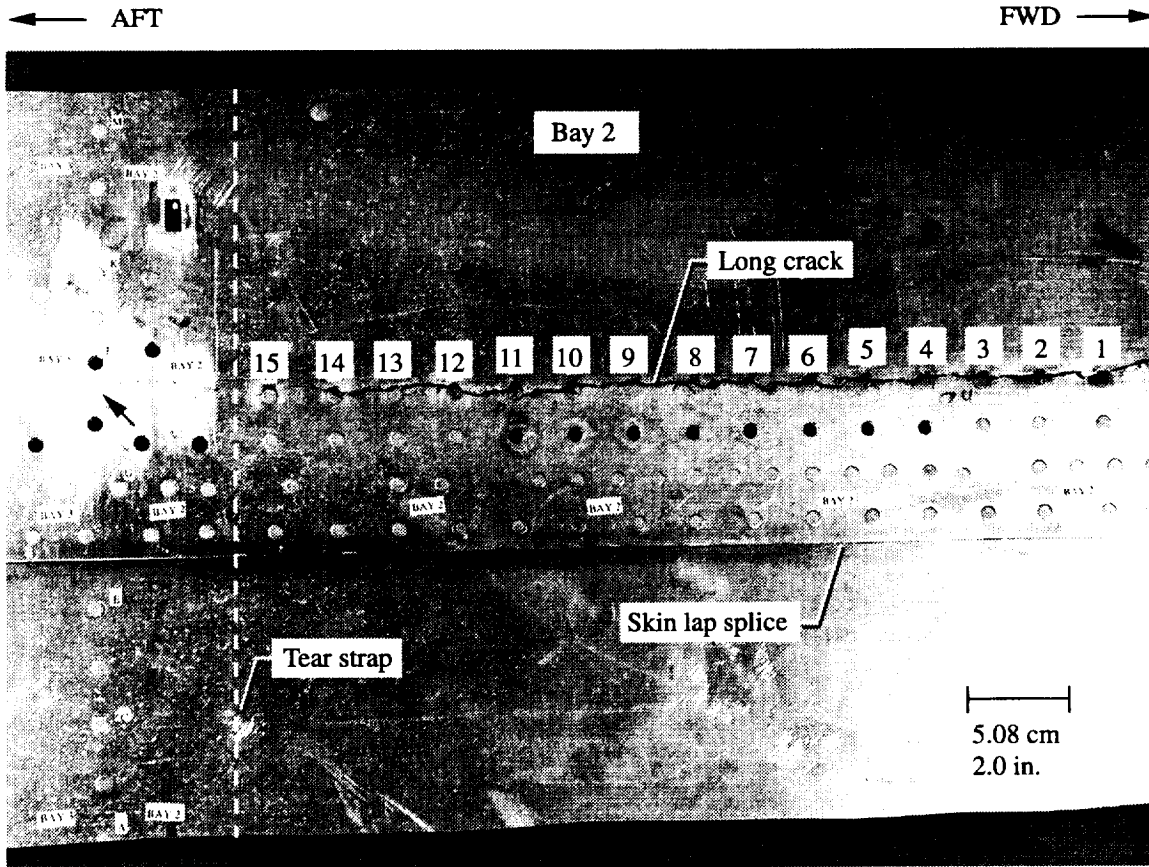
Figure 3.3 The photograph shows bay 2 and the bay 2/3 tear strap region (left of the dotted line). The long bay 2 crack is visible along the upper rivet row. Growth of the aft portion of the bay 2 crack terminated in the 2/3 tear strap region. Rivet rows are labeled with letters (bottom to top) and rivet holes are numbered from forward to aft (right to left). Note: A number of rivets were removed for visual and within hole eddy current inspection prior to receipt of the panel.

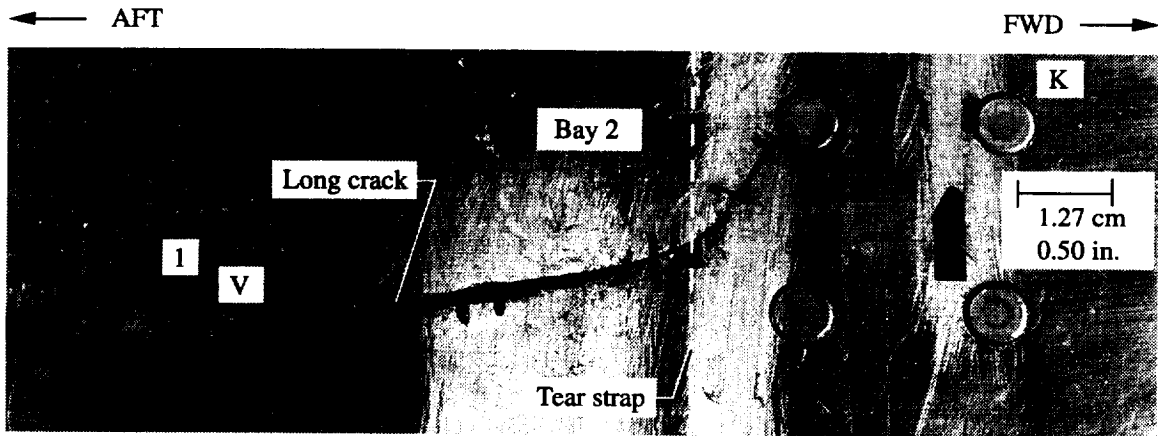
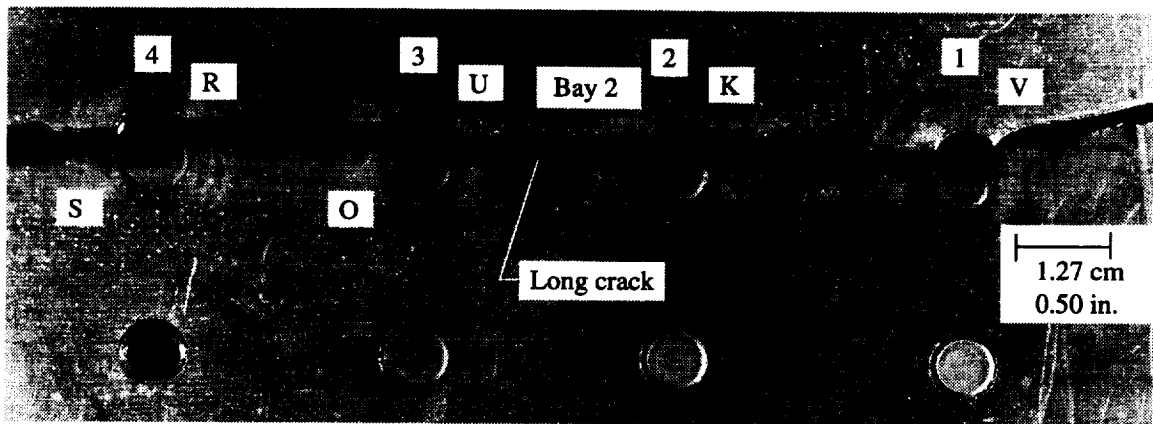
1. All visible fatigue cracking was contained in the upper rivet row.
2. Each fatigue crack initiated at or above the mid plane (centerline) of the rivet hole.

Figure 3.4 a) The photograph shows the forward end of the long bay 2 crack. Growth of the forward end of the crack terminated in a row K rivet hole contained in the bay 1 tear strap region (dashed line). The position of the fatigue crack front, detected by *in situ* visual observation, is noted by the arrow at position V. b) The photograph shows upper rivet holes 1 through 4 and a portion of the long bay 2 crack. Arrows mark the position of fatigue crack fronts detected by *in situ* visual observations at positions S, R, O, U, K, and V.

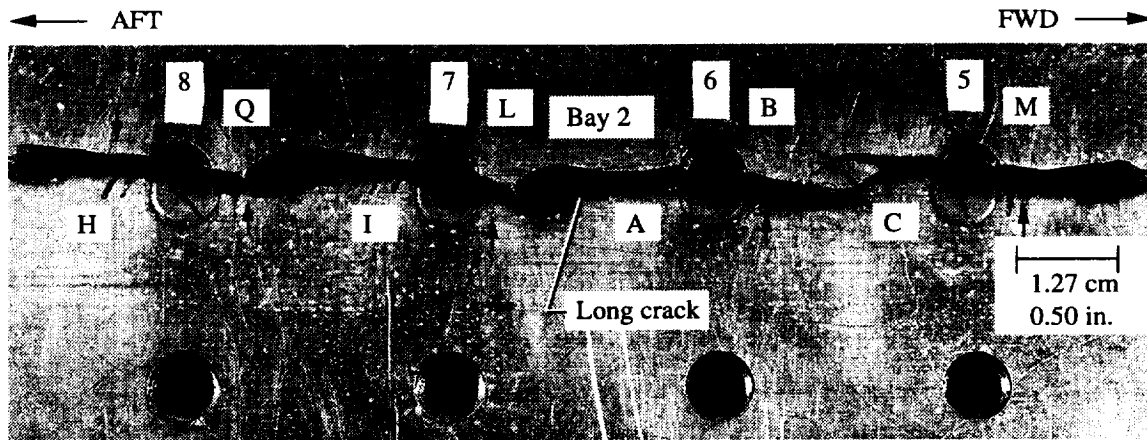
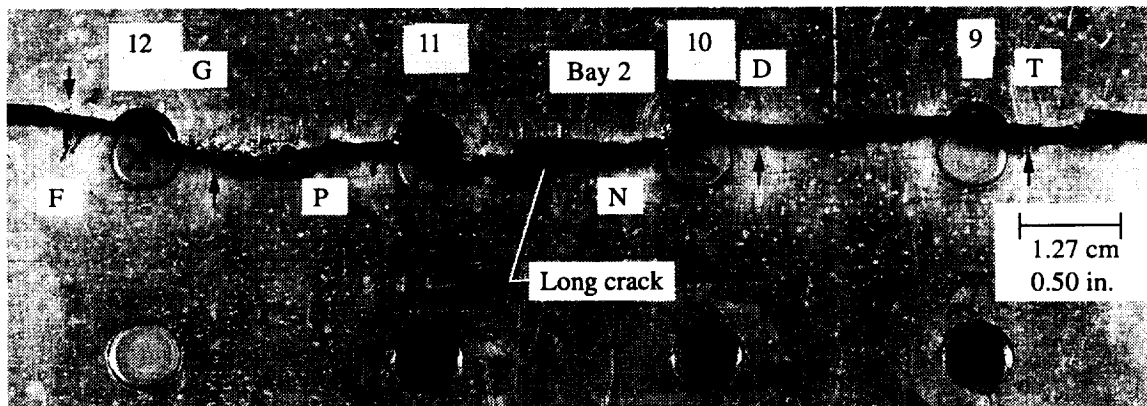
3. The region of fatigue cracking between rivet holes 5, 6, and 7 in Figure 3.5 was the first region of crack link-up in bay 2, refer to Figure 2.1. These fatigue cracks exhibit a characteristic curved crack path that resulted in an oblong shaped crack link-up configuration. Cracking at other bay 2 rivet hole locations exhibited a straighter crack path.

Figure 3.5 a) The photograph shows upper rivet row holes 5 through 8 and a portion of the long bay 2 crack. The position of fatigue crack fronts, detected by *in situ* visual observations, are noted by arrows at positions H, Q, I, L, A, B, C, and M. b) The photograph shows upper rivet holes 9 through 12 and a portion of the long bay 2 crack. The position of fatigue crack fronts, detected by *in situ* visual observations, are noted by arrows at positions F, G, P, N, D, and T.

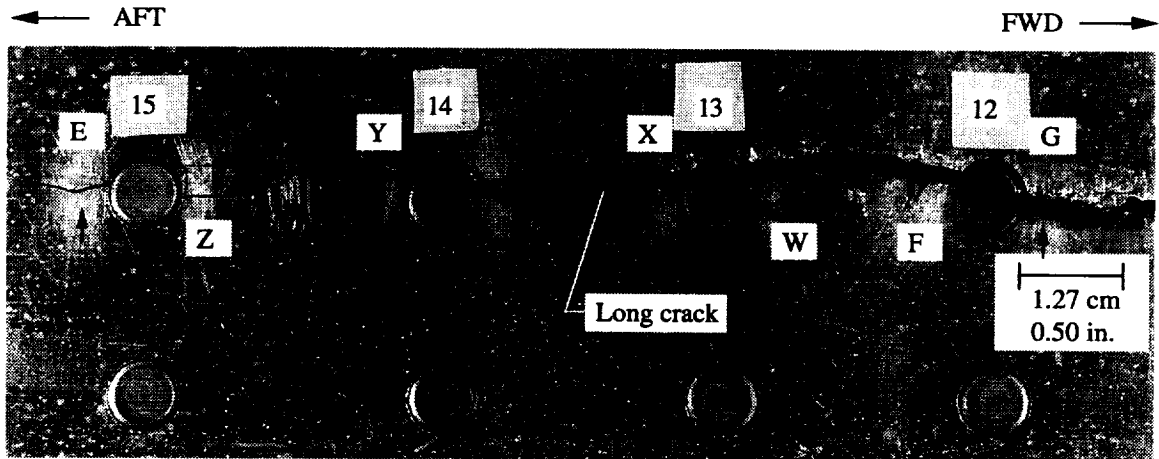
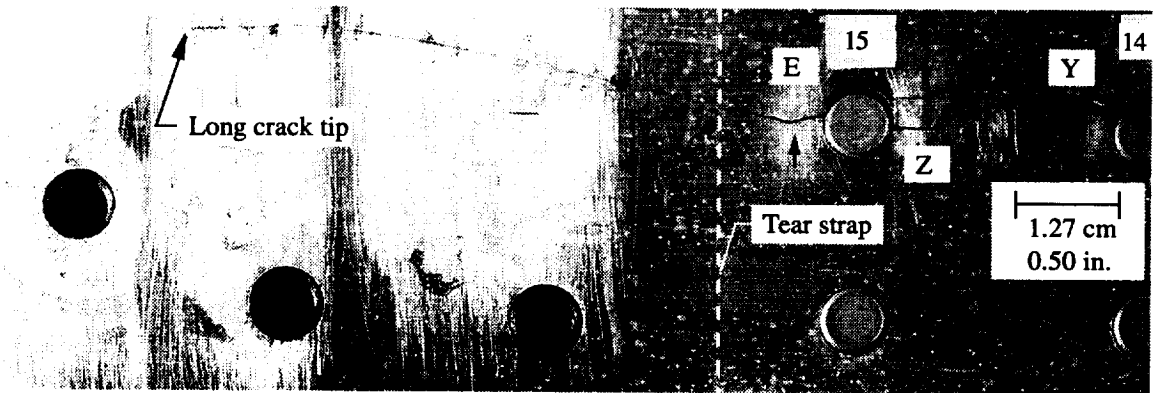
Figure 3.6 a) The photograph shows upper rivet holes 12 through 15 and a portion of the long bay 2 crack. The position of fatigue crack fronts, detected by *in situ* visual observations, are noted by arrows at positions E, Z, Y, X, W, F, and G. Secondary cracks can be seen at locations Z and W. b) The photograph shows upper rivet holes 14 and 15 and a portion of the long bay 2 crack. Growth of the aft end of the crack terminated in the center of the bay 2/3 tear strap (to the left of the dashed line). The position of fatigue crack fronts, detected by *in situ* visual observations, are noted by arrows at positions E, Z and Y.

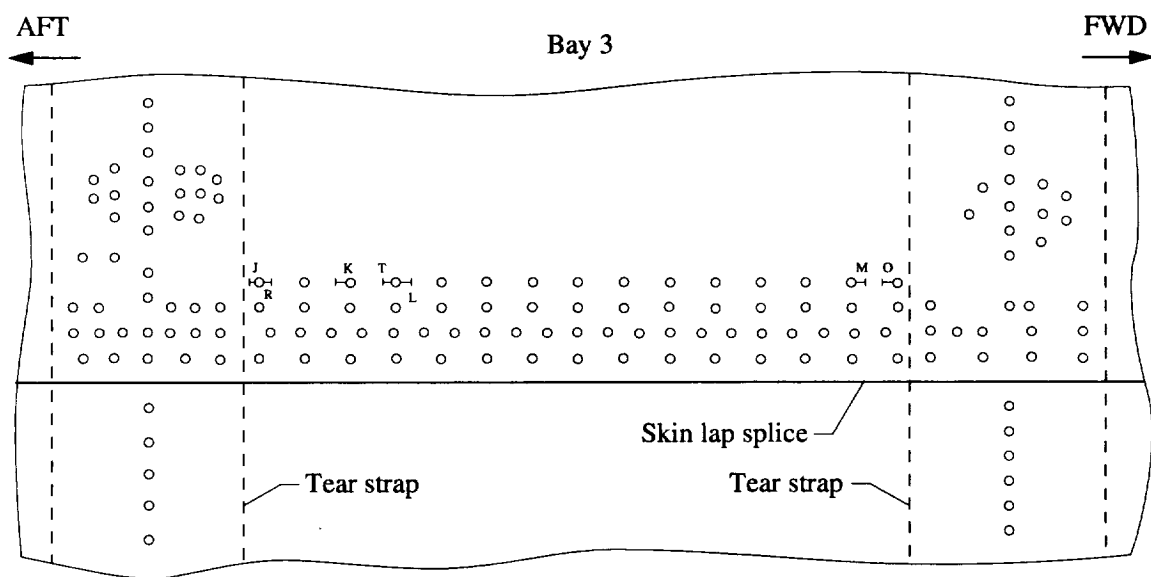
Figure 3.7 The schematic shows bay 3 and the two adjacent tear strap regions. Dashed lines show the location of the tear straps. Shown are the locations of fatigue cracks, J, K, L, M, O, R, and T.

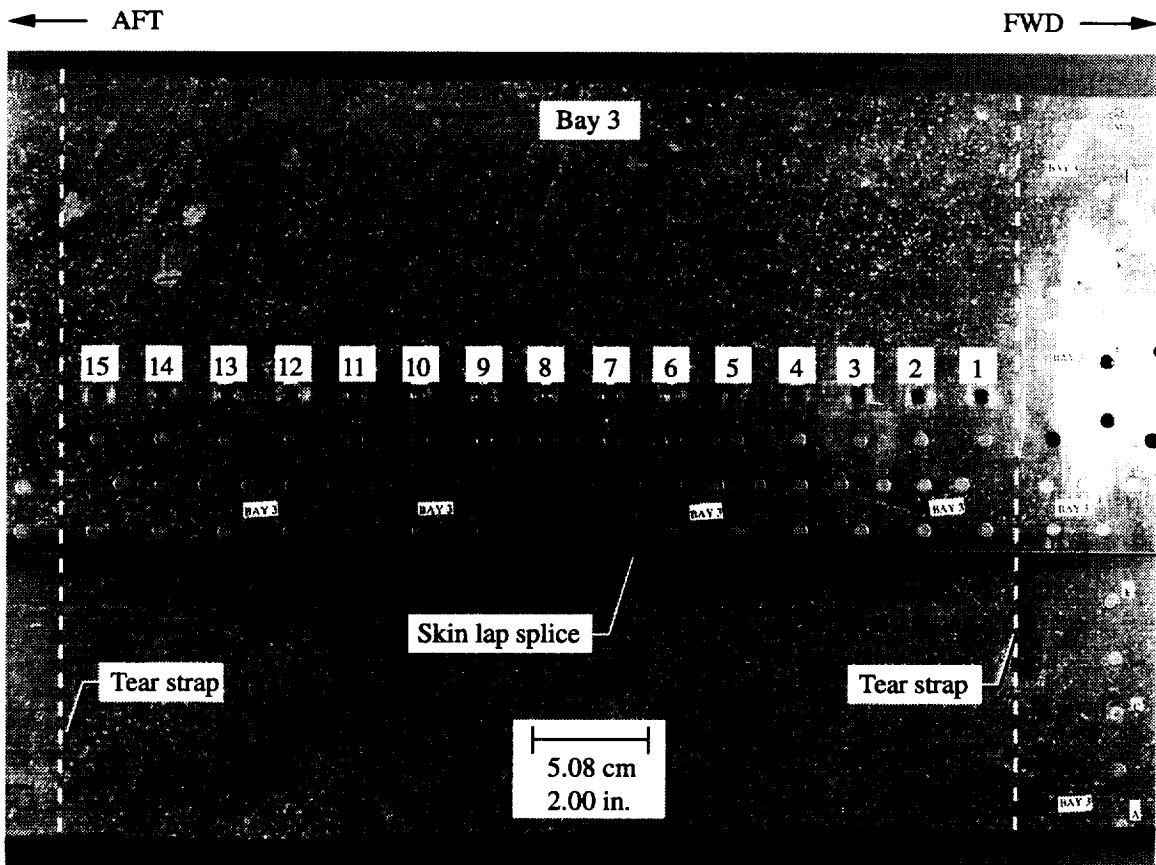
Figures 3.7 and 3.8 show the configuration and overall condition of bay 3 outer surface. Note that all top row and six second row rivets were removed prior to receipt of the panel. Figure 3.9 shows the outer skin surface region that contain visible fatigue cracks adjacent to upper rivet holes 1 through 4 and 12 through 15. Visible fatigue cracks were observed at locations J, K, L, M, O, R, and T. No crack link-up was visible in bay 3. Figure 3.10 is a photograph of the tear strap region that separates bays 3 and 4. No visible evidence of outer skin cracking was observed with the bay 3/4 tear strap.

Figure 3.8 The photograph shows bay 3 and portions of the bay 3/4 and bay 2/3 tear strap regions (marked by dashed lines) to the left and right of the photograph, respectively. Rivet rows are labeled with letters (right) from bottom to top (A through M) and rivet holes are numbered from forward to aft (right to left).

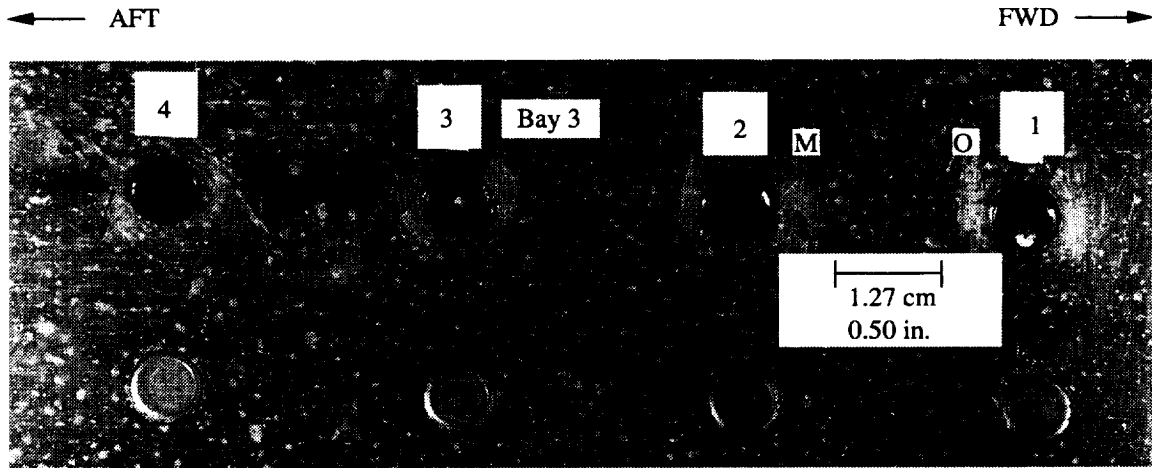
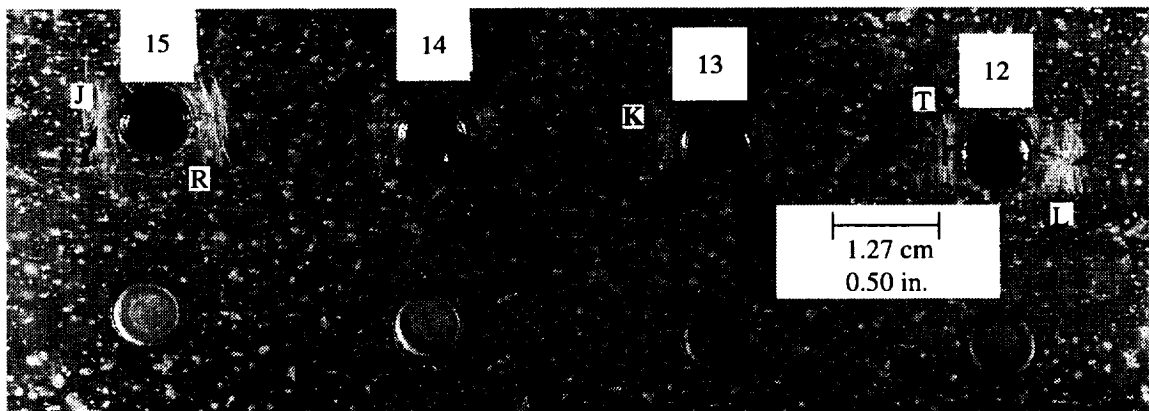
Figure 3.9 a) The photograph shows bay 3 upper rivet row holes 1 through 4. The position of fatigue crack fronts, detected by *in situ* visual observations, are noted by arrows at positions M and O. b) The photograph shows bay 3 upper rivet row holes 12 through 15. The position of fatigue crack fronts, detected by *in situ* visual observations, are noted by arrows at positions J, R, K, T and L.

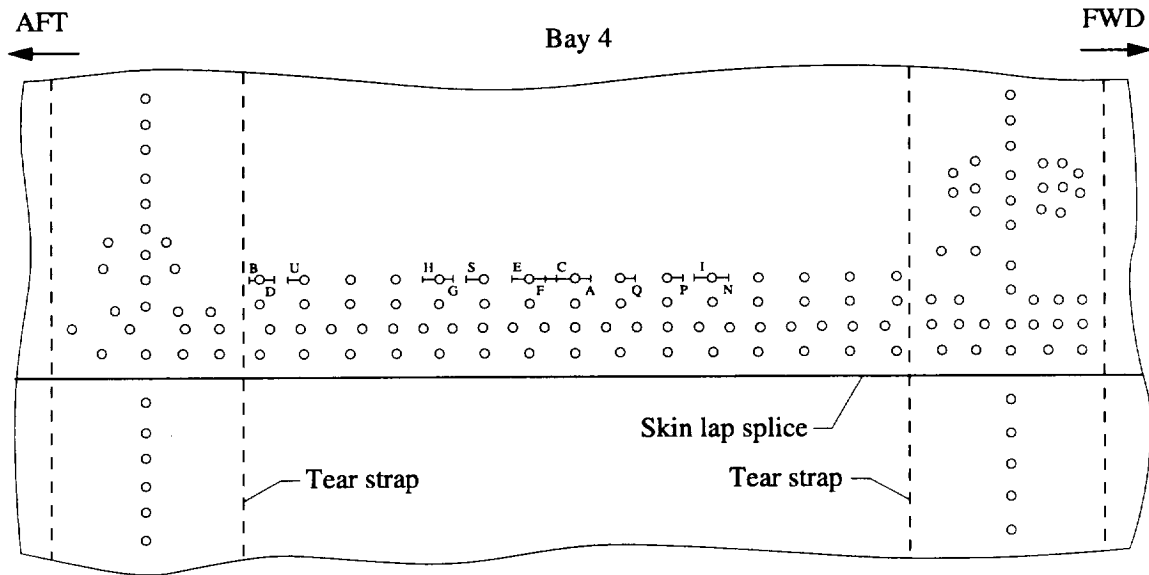
The schematic in Figure 3.11 and the photograph in Figure 3.12 show the location of fourteen fatigue cracks contained in nine upper rivet row holes. Crack link-up occurred in the middle of the bay between upper rivet row locations 8 and 9. Figures 3.13 and 3.14 are photographs of the outer surface showing the visible fatigue cracks along the upper rivet row. Figure 3.13b details the region of crack link-up, cracks F and C. Crack C propagated within a plane slightly elevated with respect to crack F. Link-up occurred at a point located nearly mid-distance between the rivet holes 8 and 9. Final link-up occurred by the failure of the small ligament located between the two fatigue cracks C and F, producing a crack at an angle nearly 30° from vertical.

Figure 3.11 The schematic shows bay 4 and two adjacent tear strap regions. Dashed lines show the location of the tear straps. The location of thirteen fatigue cracks are noted at A, B, C, D, E, G, H, I, N, P, Q, S, and U. Crack link-up occurred between fatigue cracks C and F.

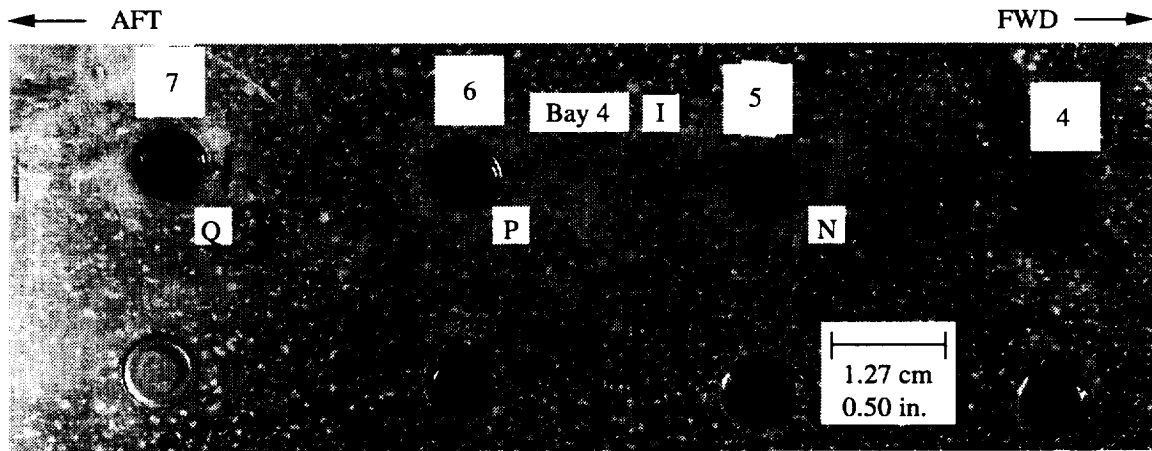
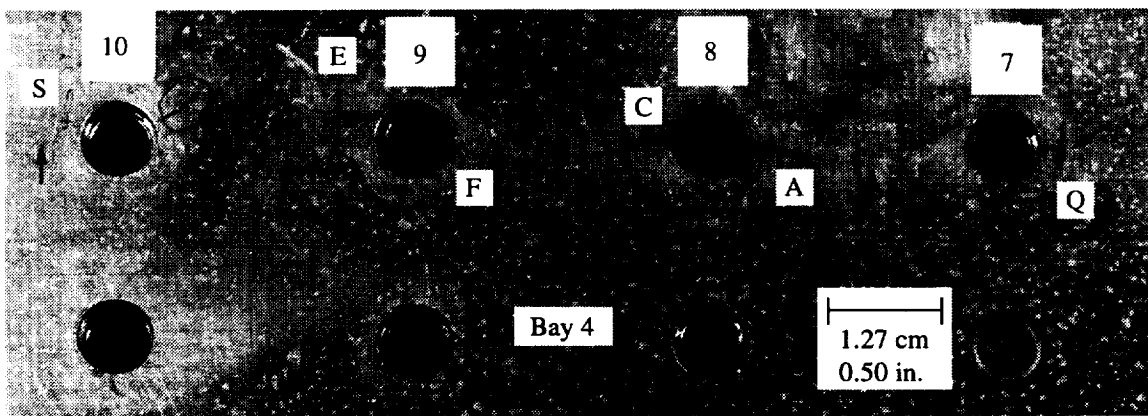
Figure 3.13 a) The photograph shows bay 4 upper rivet row holes 4 through 7. The position of fatigue crack fronts, detected by *in situ* visual observations, are noted by arrows at positions Q, P, I, and N. b) The photograph shows bay 4 upper rivet row holes 7 through 10. The position of fatigue crack fronts, detected by *in situ* visual observations, are noted by arrows at positions S, E, F, C, A, and Q. The cracks between rivet holes 8 and 9 have linked-up.

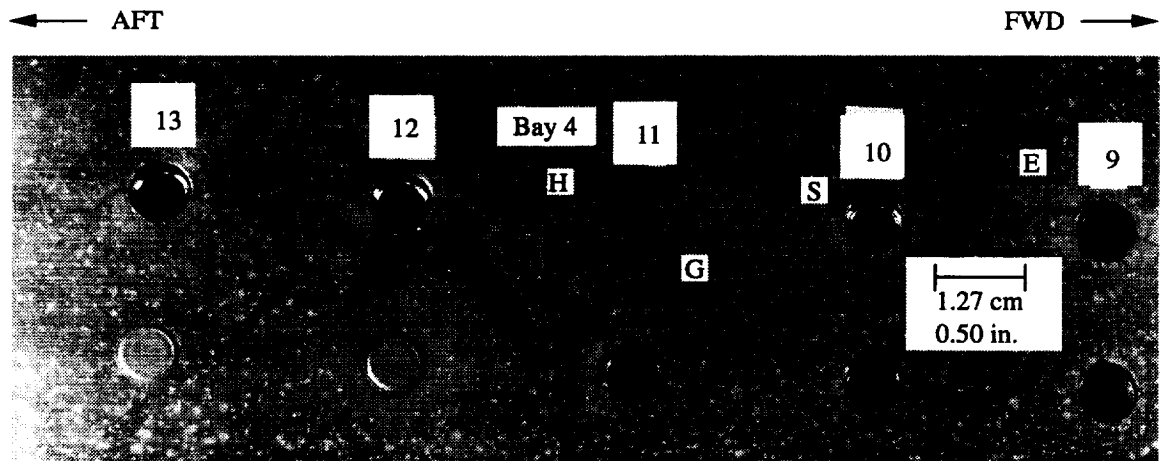
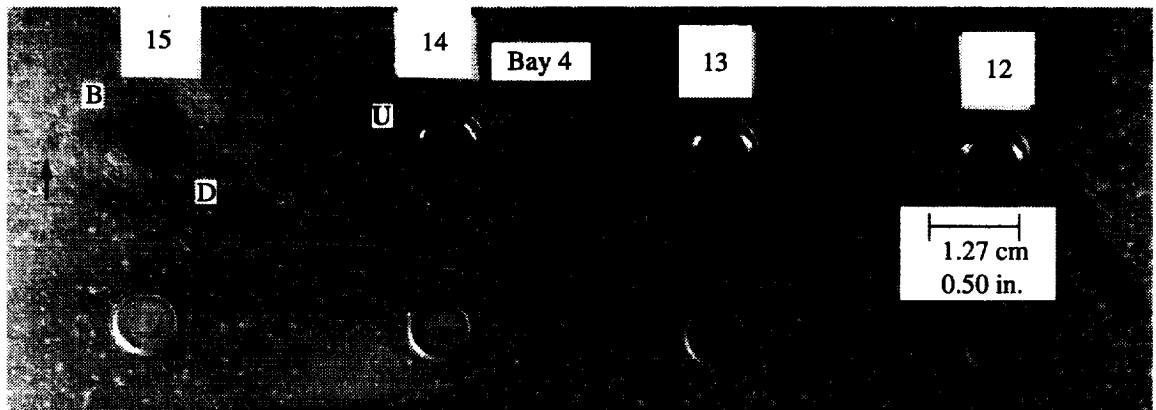
Figure 3.14 a) The photograph shows bay 4 upper rivet row holes 9 through 13. The position of fatigue crack fronts, detected by *in situ* visual observations, are noted by arrows at positions H, G, S, and E. b) The photograph shows bay 4 upper rivet row holes 12 through 15. The position of fatigue crack fronts, detected by *in situ* visual observations, are noted by arrows at positions B, D, and U.

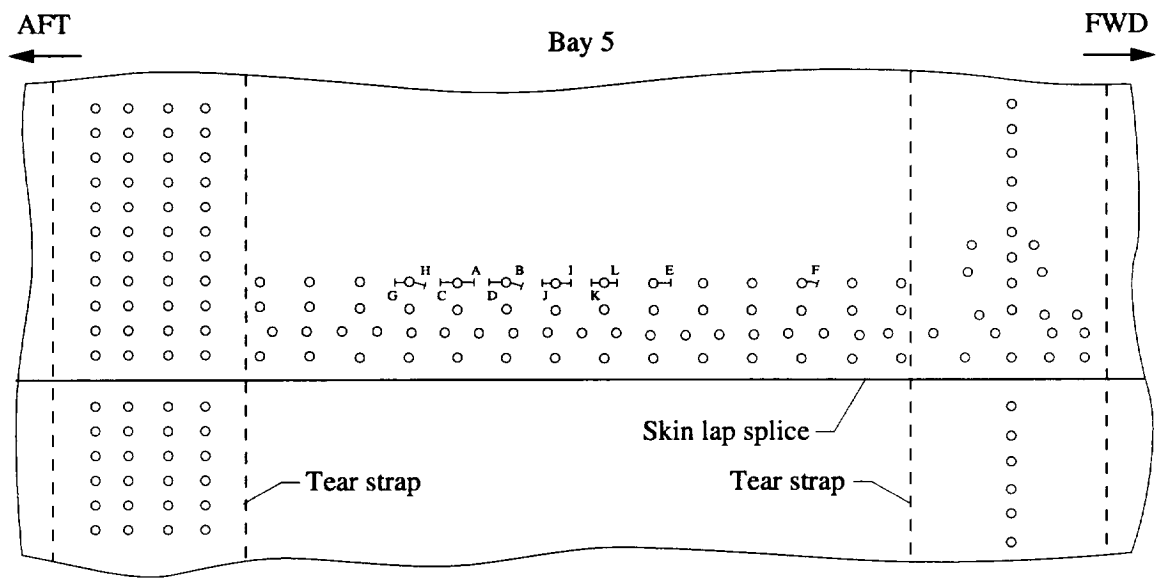
Figure 3.15 shows the rivet hole configuration for bay 5. Here, seven upper rivet holes contained a total of twelve visible fatigue cracks. No visible fatigue crack link-up was observed in bay 5. The photographs in Figures 3.16 and 3.17 shows the outboard surface of bays 4 and 5 and the tear strap regions bordering bays 5 and 6, respectively. Figures 3.18 and 3.19 are photographs detailing the visible cracks found in bay 5 upper rivet row. Figure 3.19 shows the crack path between upper rivet holes 7, 8, 9, and 10. All fatigue cracks that propagated in the forward direction exhibited a curved crack path slanted upwards and fatigue cracks that grew in the aft direction curved downwards. Many of the fatigue cracks shown in Figure 3.19 extend close to the adjacent rivet hole without crack link-up. A number of the aft fatigue cracks, i.e., crack C in hole 10, initiated below the mid plane of the rivet holes. This crack path configuration differs from that observed in bays 2, 3, and 4 and suggest the possible influence of complex loading created by nearby structure.

Figure 3.15 The schematic shows bay 5 and two adjacent tear strap regions. Dashed lines highlight the location of the tear straps. Shown are the locations of fatigue cracks A through L.

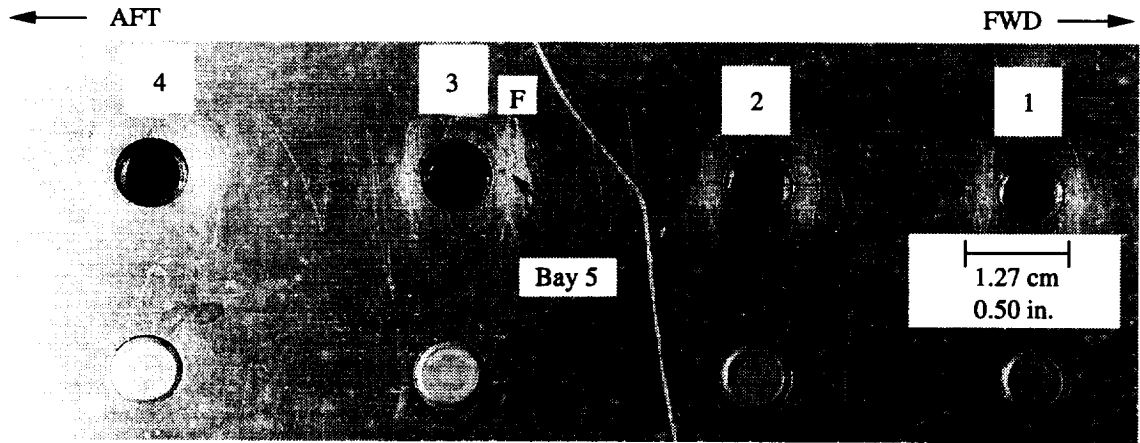
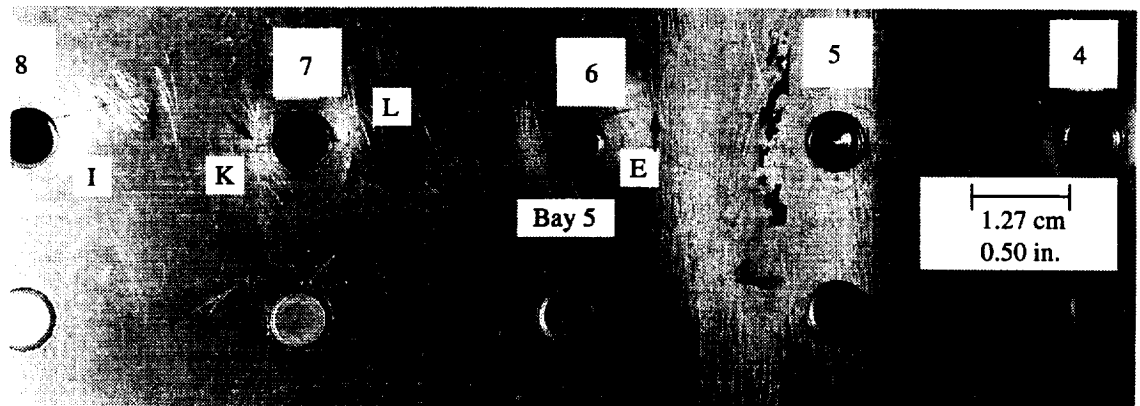
Figure 3.18 a) The photograph shows bay 5 upper rivet row holes 1 through 4. The position of the fatigue crack front, detected by *in situ* visual observation, is noted by an arrow at position F. b) The photograph shows bay 5 upper rivet row holes 4 through 8. The position of fatigue crack fronts, detected by *in situ* visual observations, are noted by arrows at positions I, K, L, and E.

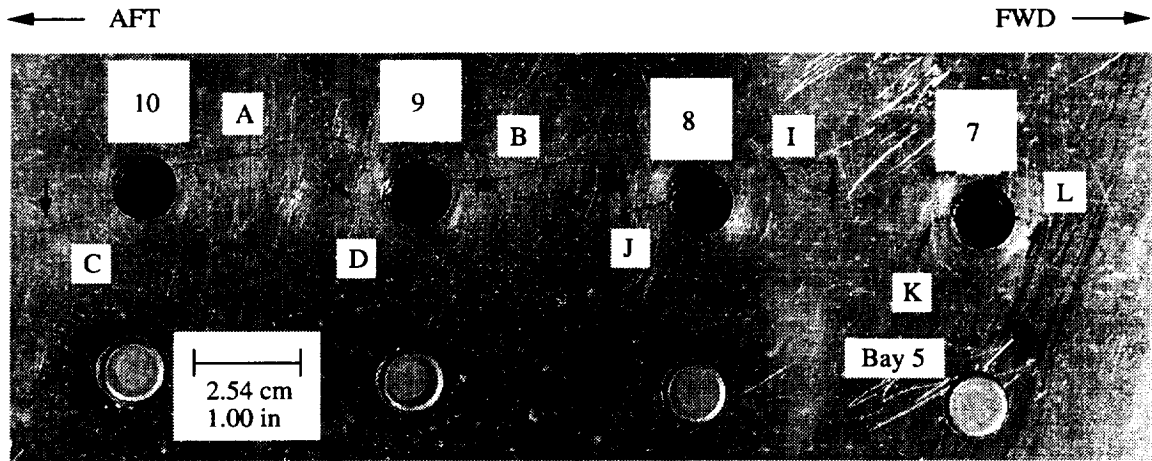
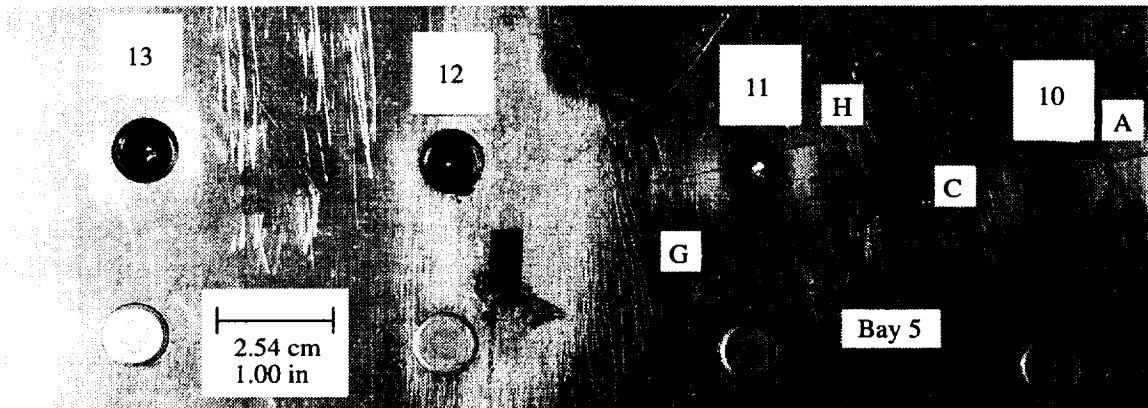
Figure 3.19 a) The photograph shows bay 5 upper rivet row holes 7 through 10. The position of fatigue crack fronts, detected by *in situ* visual observations, are noted by arrows at positions C, A, D, B, J, I, K, and L. b) The photograph shows bay 5 upper rivet row holes 10 through 13. The position of fatigue crack fronts, detected by *in situ* visual observations, are by arrows noted at positions G, H, C, and A.

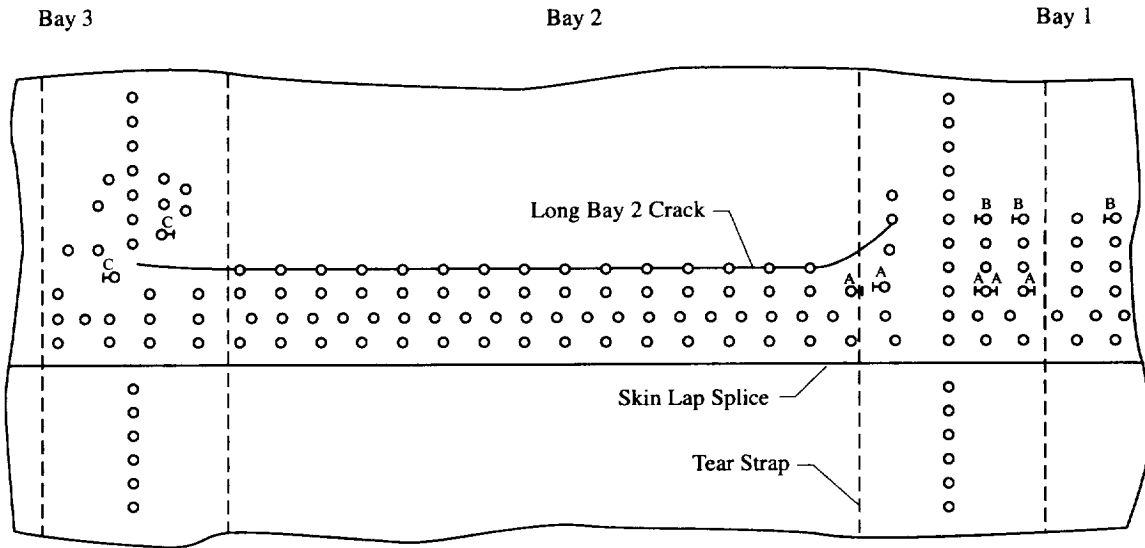
Figure 4.1 The schematic shows the location of possible cracks as detected by the eddy current inspection for the bay 2/3 T.S., bay 2 and the bay 1 T.S. regions. Dashed lines mark the tear strap regions. The long bay 2 crack (solid line) is shown in the upper rivet row of bay 2.

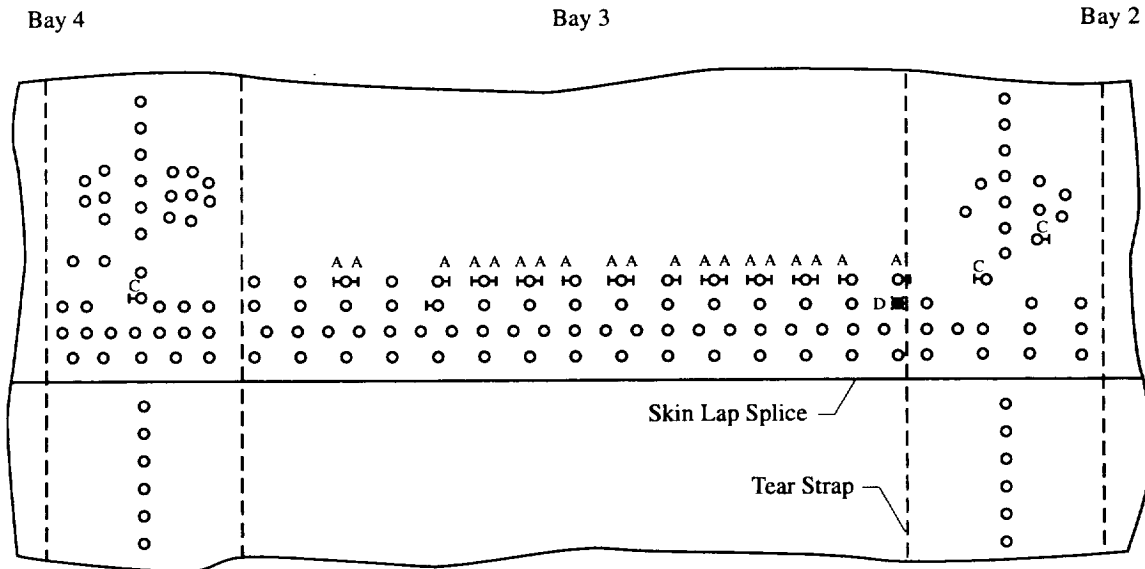
Figure 4.2 The schematic shows the location of possible cracks as detected by the eddy current inspection for the bay 3/4 T.S., bay 3 and the bay 2/3 T.S. regions. Dashed lines mark the tear strap regions.

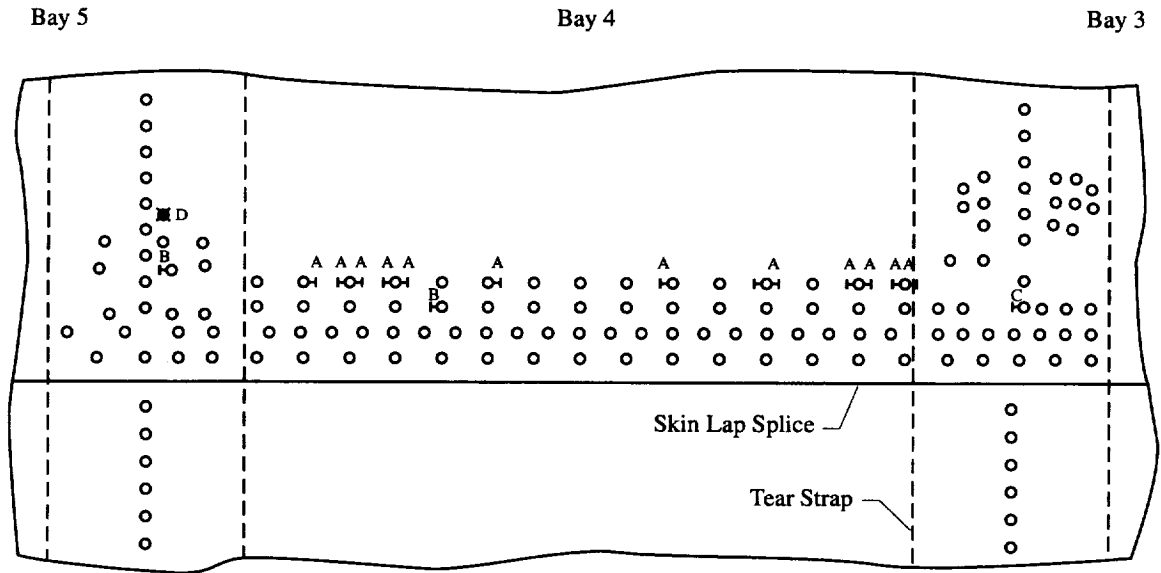
Figure 4.3 The schematic shows the location of possible cracks as detected by the eddy current inspection for the bay 4/5 T.S., bay 4 and the bay 3/4 T.S. regions. Dashed lines mark the tear strap regions. NDE was not performed on visible fatigue cracks.

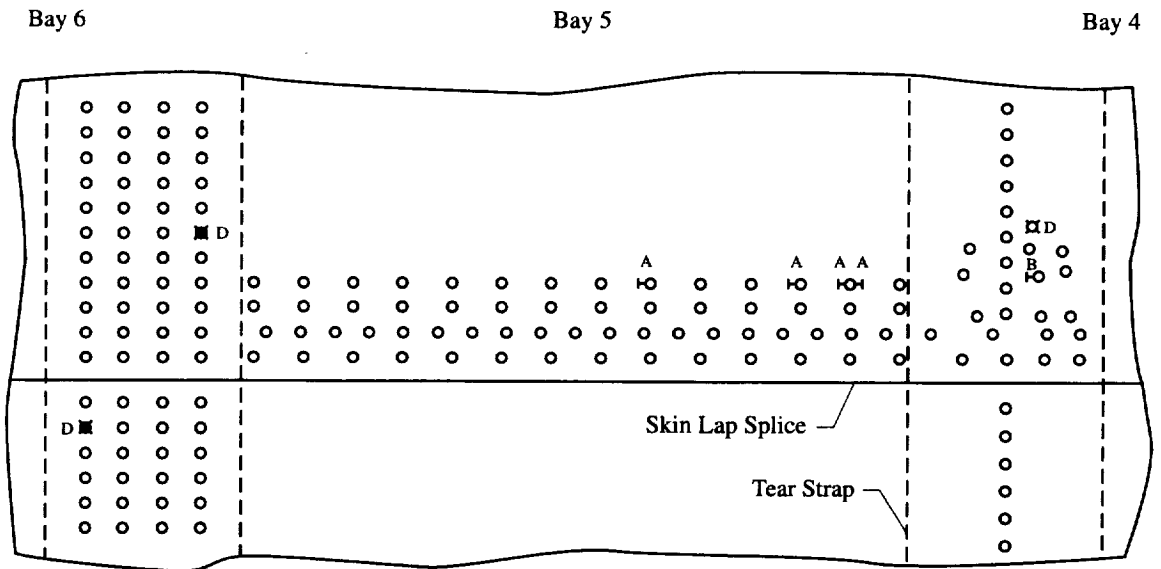
Figure 4.4 The schematic shows the location of possible cracks as detected by the eddy current inspection for the bay 6 T.S., bay 5 and the bay 4/5 T.S. regions. Dashed lines mark the tear strap regions.

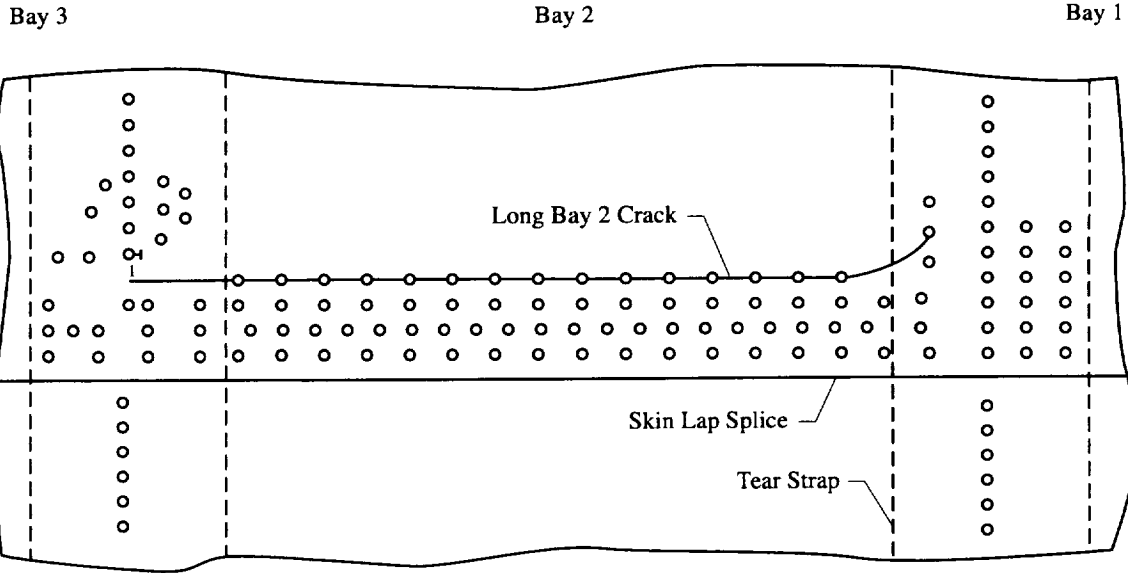
Figure 4.5 The schematic shows the location of possible cracks as detected by the X-ray inspection for the bay 2/3 T.S., bay 2 and the bay 1 T.S. regions. Crack indication #1 was found in the bay 2/3 T.S. The long bay 2 crack (solid line) is shown in the upper row of bay 2. Dashed lines mark the tear strap regions.

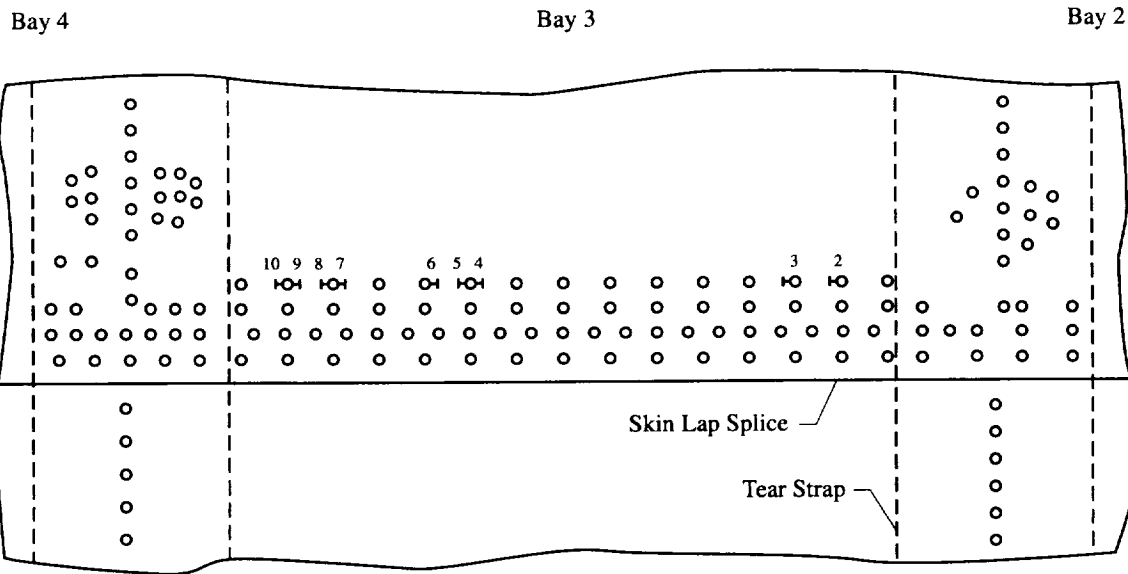
Figure 4.6 The schematic shows the location of possible cracks as detected by the X-ray inspection for the bay 3/4 T.S., bay 3 and the bay 2/3 T.S. regions. Cracks indications #4–10 were found in the upper rivet row of bay 3. Dashed lines mark the tear strap regions.

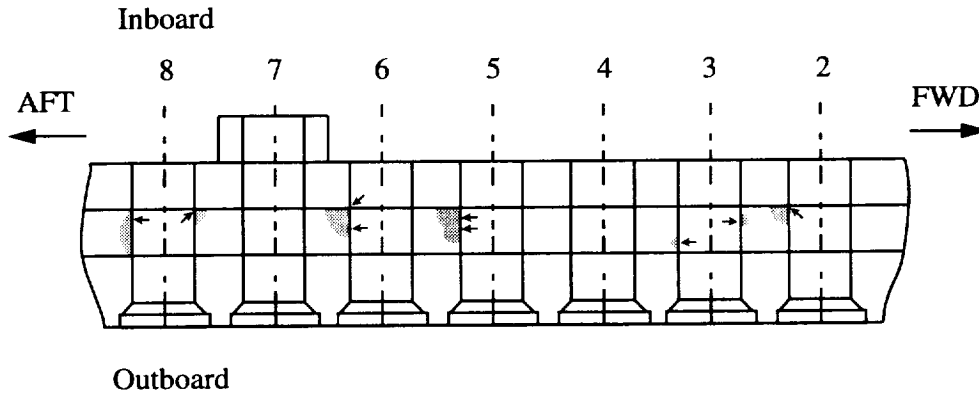
BAY 1 ROW L

6.4.1 Crack initiation site(s): Row L: Fatigue cracking was contained in the upper tear strap. Crack initiation occurred within the rivet hole surface or at a hole corner burr.

Hole #	Location	Length mm (in)	Type	Initiation site
2 (AFT)	U. tear strap	0.230 (0.009)	Corner	Inboard corner (I.C.)
3 (FWD)	U. tear strap	0.060 (0.002)	Multiple surface	Multiple center
3 (AFT)	U. tear strap	0.230 (0.009)	Multiple surface	Outboard side of center
5 (AFT)	U. tear strap	0.650 (0.026)	Multiple surface & corner	Surface and I.C.
6 (AFT)	U. tear strap	0.590 (0.023)	Multiple surface & corner	Multiple surface
8 (FWD)	U. tear strap	0.250 (0.010)	Corner	I.C.
8 (AFT)	U. tear strap	0.380 (0.015)	Corner	Inboard side of surface

Figure 6.5 The through thickness schematic shows the location and initiation site (small arrows) of fatigue cracks found in rivet row L from the bay 1 tear strap/lap splice joint region. The table summarizes crack location, crack length, crack type, and initiation site for each fatigue crack shown.

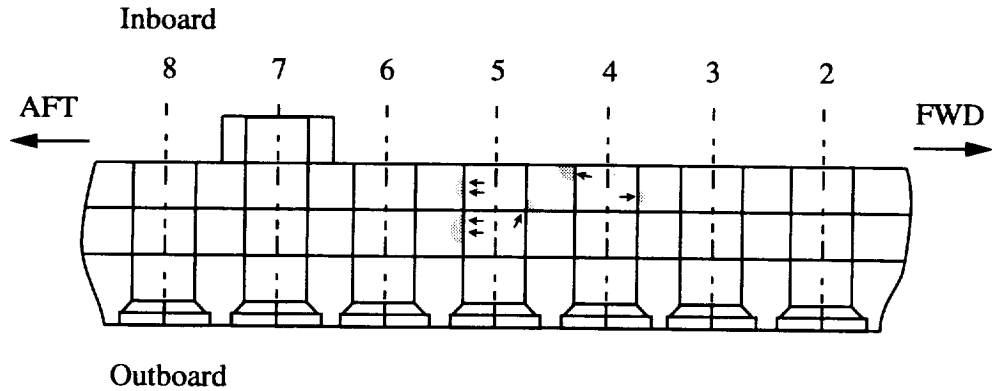
BAY 1 ROW J

Row J: Fatigue cracking was contained to the upper and lower tear strap. Crack initiation occurred within the rivet hole surface or at the hole corner.

Hole #	Location	Length mm (in)	Type	Initiation site
4 (AFT)	L.tear strap	0.425 (0.017)	Corner	Inboard corner
4 (FWD)	L.tear strap	0.220 (0.009)	Multiple surface	Outboard side of center
5 (1AFT)	U.tear strap	0.210 (0.008)	Multiple surface	Multiple sites in center
5 (2AFT)	L.tear strap	0.100 (0.004)	Multiple surface	Multiple sites in center
5 (FWD)	L.tear strap	0.260 (0.010)	Multiple corner	Outboard corner

Figure 6.6 The through thickness schematic shows the location and initiation site (small arrows) of fatigue cracks found in rivet row J from the bay 1 tear strap/lap splice joint region. The table summarizes crack location, crack length, crack type, and initiation site for each fatigue crack shown.

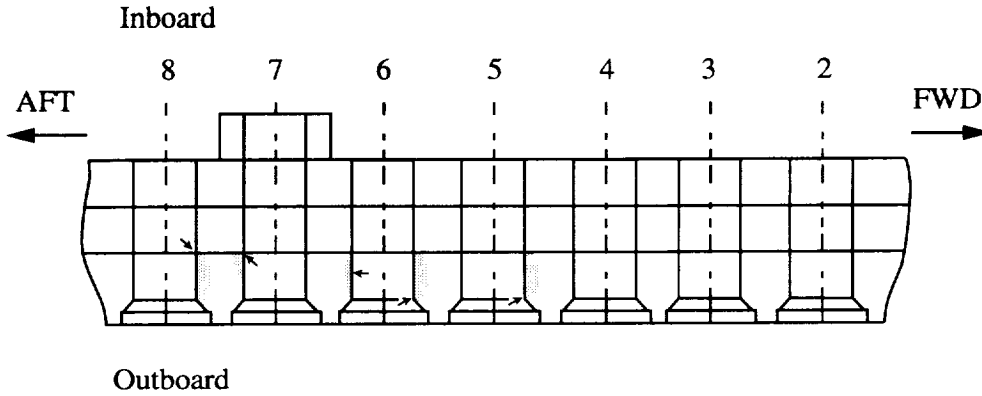
BAY 1 ROW I

Row I: Fatigue cracking was limited to the outer skin. Crack initiation occurred at the rivet hole shank region.

Hole #	Location	Length mm (in)	Type	Initiation site
5 (FWD)	Outer skin	0.420 (0.017)	Countersink	Outboard side of shank
6 (FWD)	Outer skin	1.160 (0.046)	Countersink	Outboard side of shank
6 (AFT)	Outer skin	0.200 (0.008)	Countersink	Center of shank
7 (AFT)	Outer skin	0.150 (0.006)	Countersink	Inboard side of shank
8 (FWD)	Outer skin	1.030 (0.041)	Countersink	Inboard side of shank

Figure 6.7 The through thickness row schematic shows the location and initiation site (small arrows) of fatigue cracks found in rivet row I from the bay 1 tear strap lap/splice joint region. The table summarizes crack location, crack length, crack type, and initiation site for each fatigue crack shown.
