NASA/TP-97-206257

The Characteristics of Fatigue Damage in the Fuselage Riveted Lap Splice Joint

Robert S. Piascik
Langley Research Center, Hampton, Virginia

November 1997

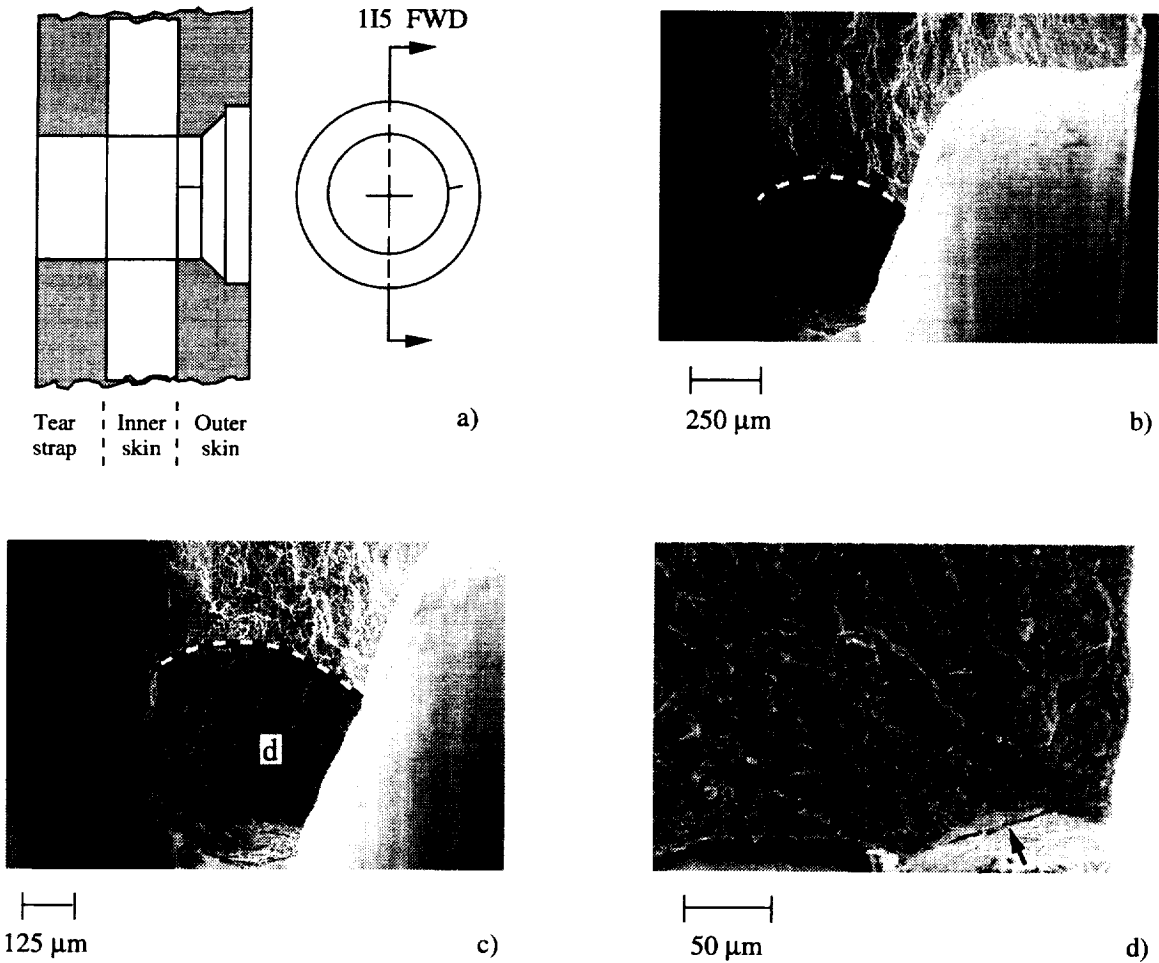
Figure 6.8 a) The schematic shows the rivet hole 115 configuration and the location of the outer skin fatigue crack oriented in the forward direction slightly above the 3 o'clock position. b) The SEM micrograph shows the fatigue crack location within the rivet hole. The dashed line marks the fatigue crack front. c) The SEM micrograph shows the fatigue crack region at higher magnification. d) The SEM micrograph shows region "d" in Figure 6.8.c at higher magnification. The likely crack initiation region is marked by an arrow. The mud cracking feature (upper right of arrow) is evidence of corrosion. The rivet was removed after pressure testing and the open rivet hole was exposed to the environment. It is likely corrosion occurred at that time.

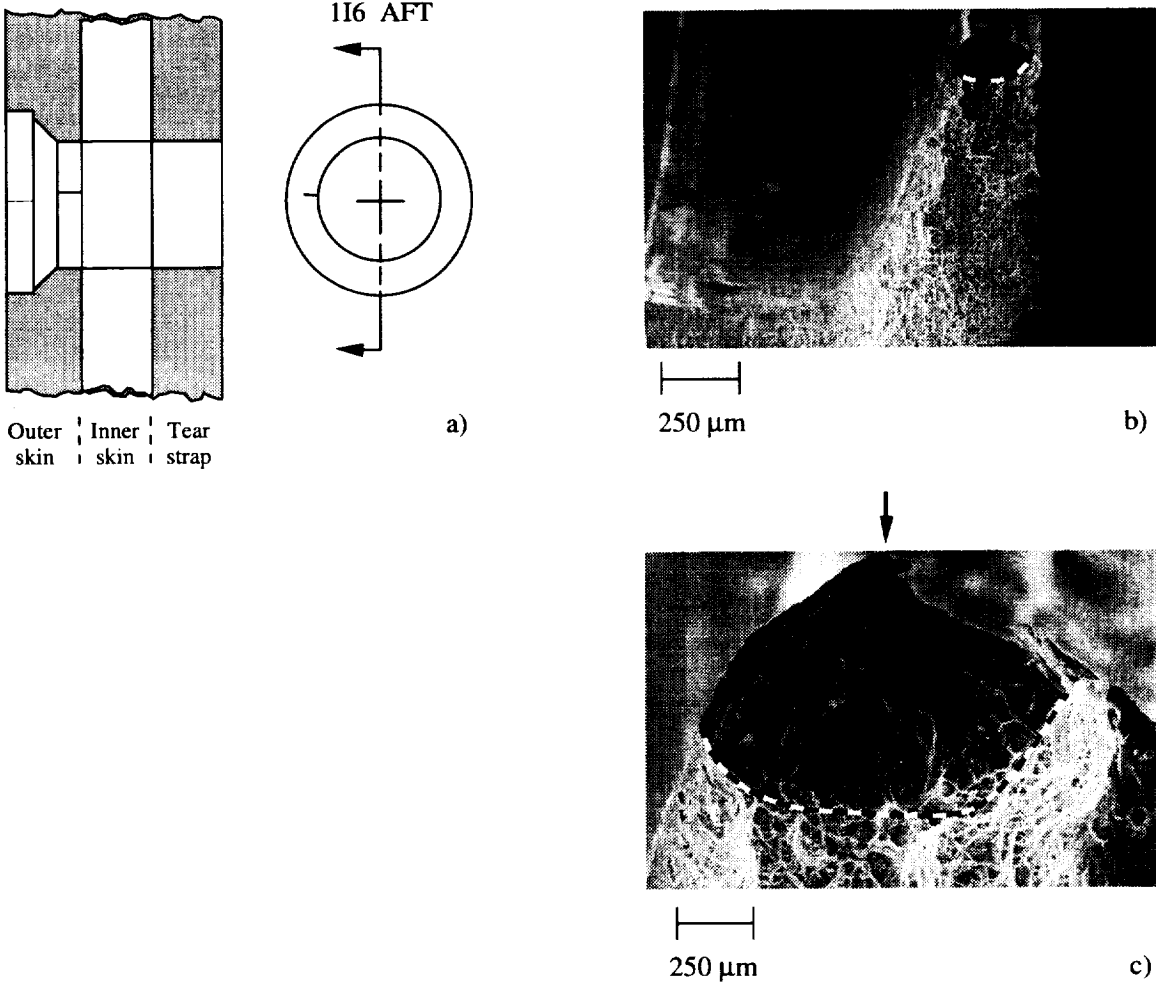
Figure 6.9 a) The schematic shows the rivet hole 1I6 configuration and the location of the outer skin fatigue crack oriented in the aft direction slightly above the 9 o'clock position. b) The SEM micrograph shows the fatigue crack location within the rivet hole. The dashed line marks the fatigue crack front. c) The SEM micrograph shows the fatigue crack region at higher magnification. The arrow marks the likely site of crack initiation. The dashed line marks the fatigue crack front.

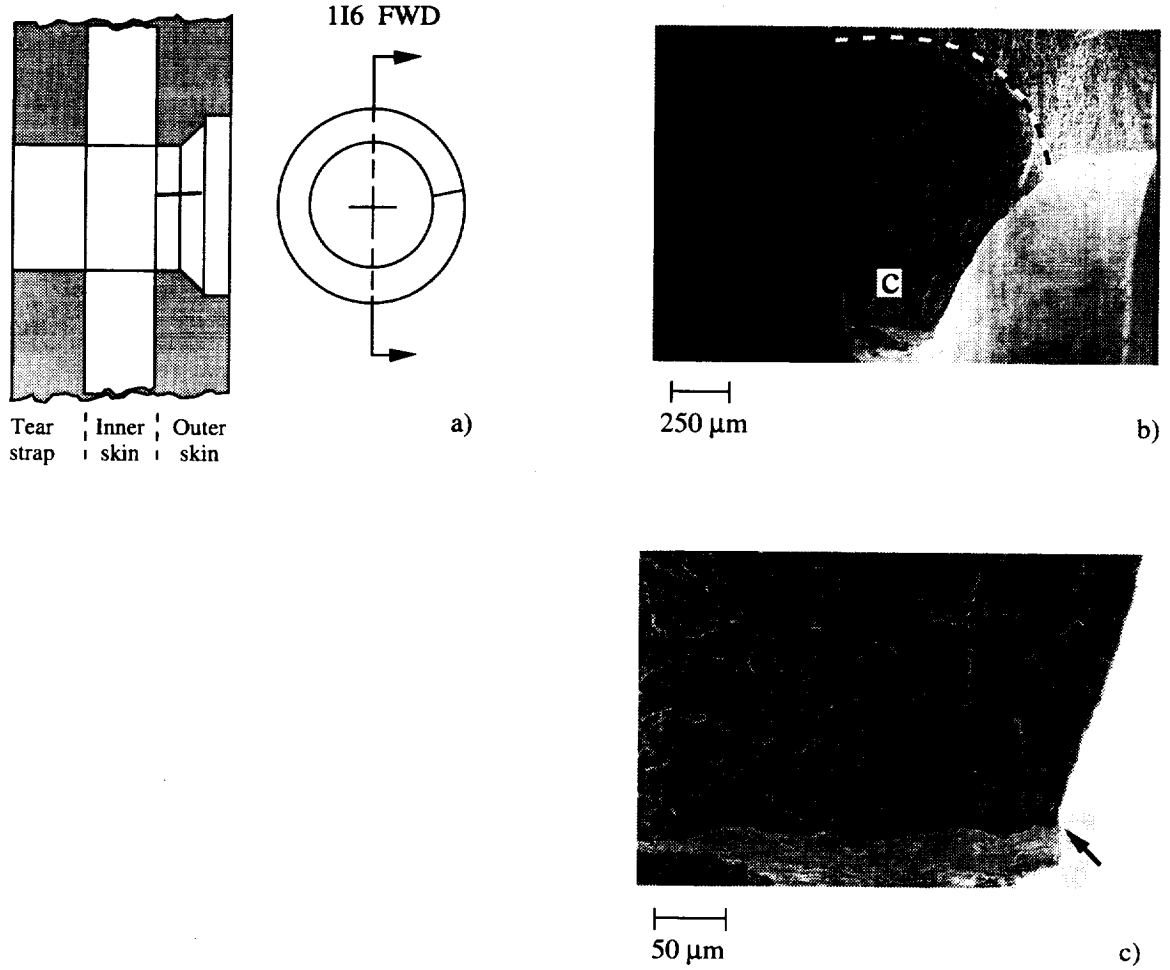
Figure 6.10 a) The schematic shows the rivet hole 116 configuration and the location of the outer skin fatigue crack oriented in the forward direction slightly above the 3 o'clock position. b) The SEM micrograph shows the fatigue crack location within the rivet hole. The dashed line marks the fatigue crack front. c) The SEM micrograph shows region "c" in Figure 6.10.b at higher magnification. The arrow marks the likely site of crack initiation.

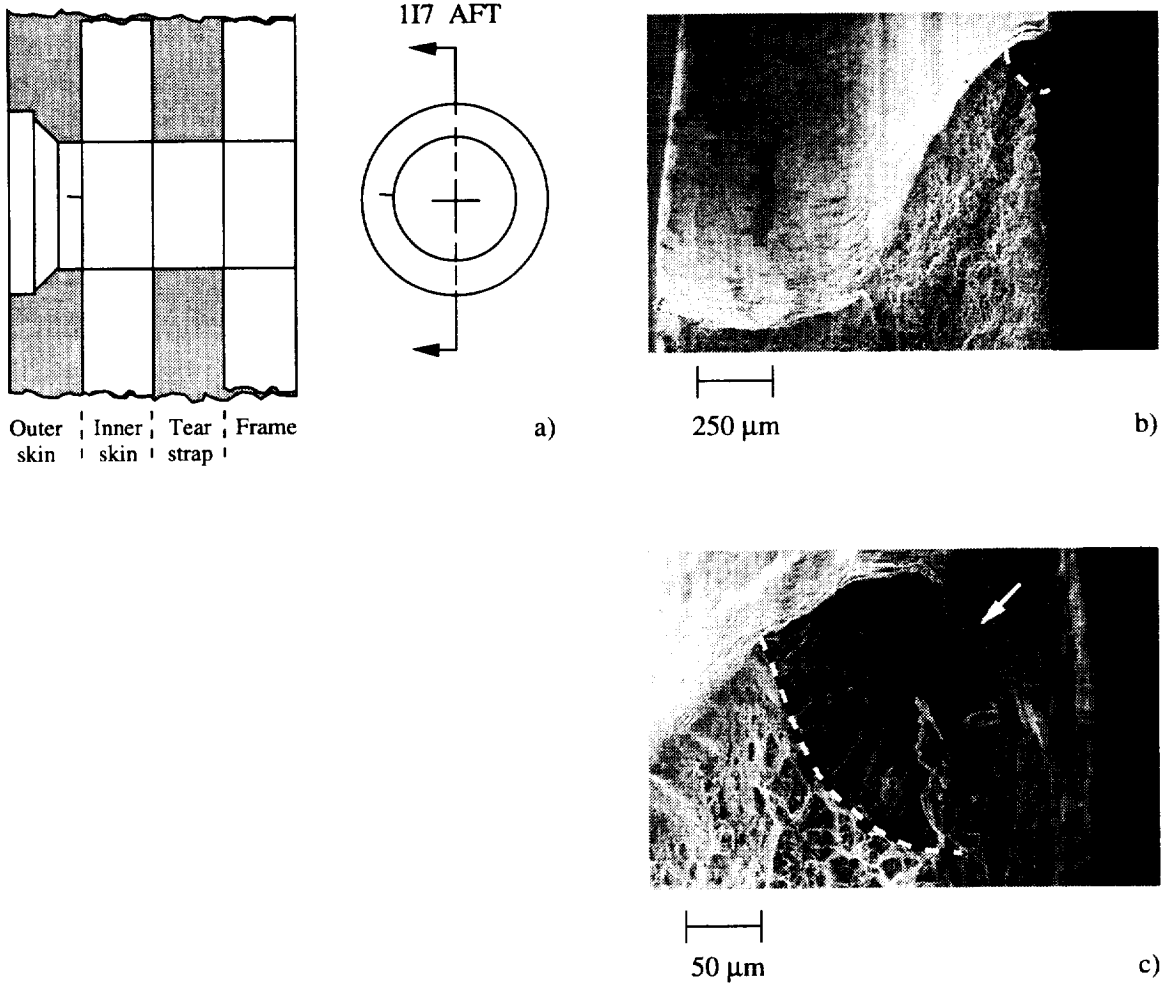
Figure 6.11 a) The schematic shows the rivet hole 117 configuration and the location of the outer skin fatigue crack oriented in the aft direction slightly above the 9 o'clock position. b) The SEM micrograph shows the fatigue crack location within the rivet hole. The dashed line marks the fatigue crack front. c) The SEM micrograph shows the fatigue crack region at higher magnification. The arrow marks the likely site of crack initiation.

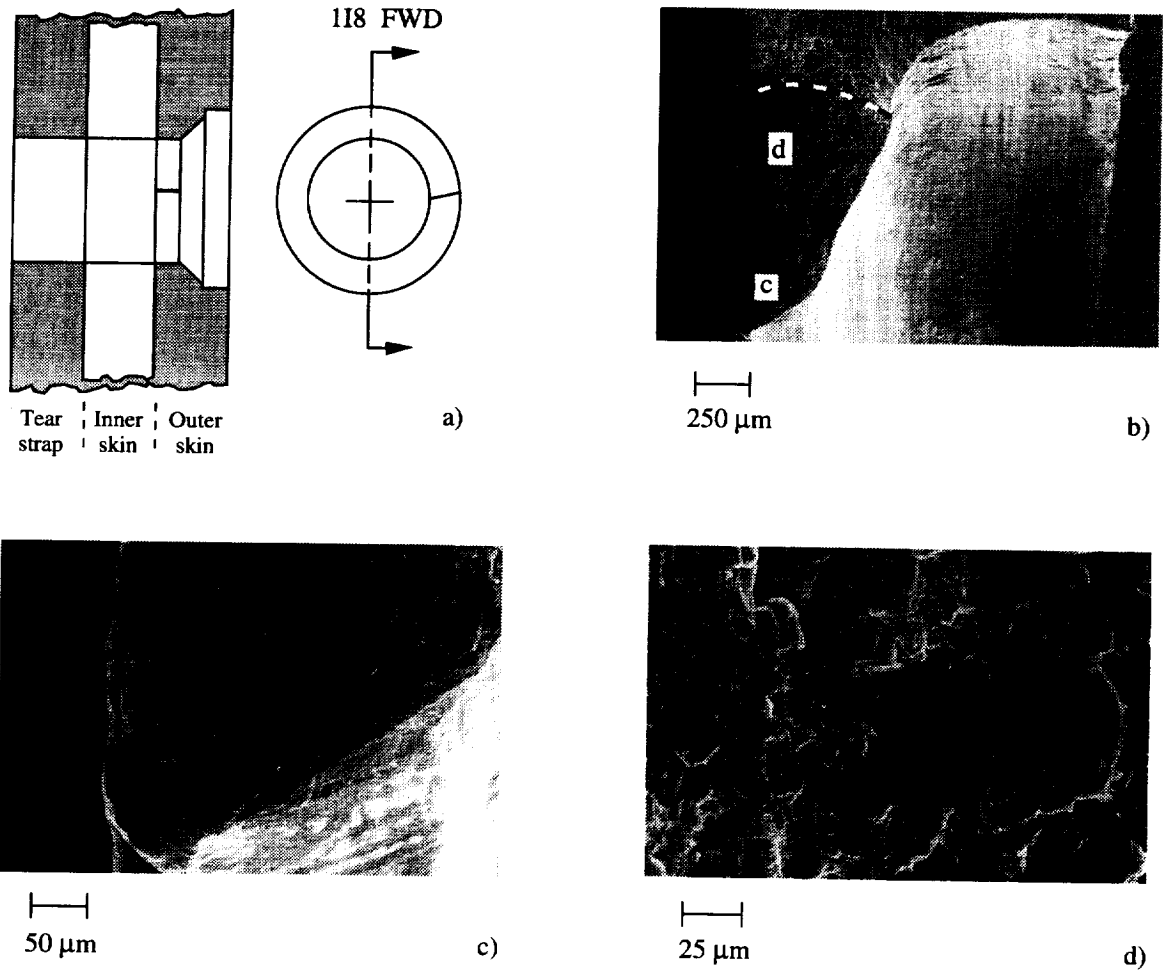
Figure 6.12 a) The schematic shows the rivet hole 118 configuration and the location of the outer skin fatigue crack oriented in the forward direction slightly above the 3 o'clock position. b) The SEM micrograph shows the fatigue crack location within the rivet hole. The dashed line marks the fatigue crack front. c) The SEM micrograph shows the crack initiation region "c" in Figure 6.12.b. Oxides covering the fracture surface mask the crack morphology around the site of crack initiation. d) The SEM micrograph shows the transgranular fatigue crack morphology in region "d" in Figure 6.12.b.

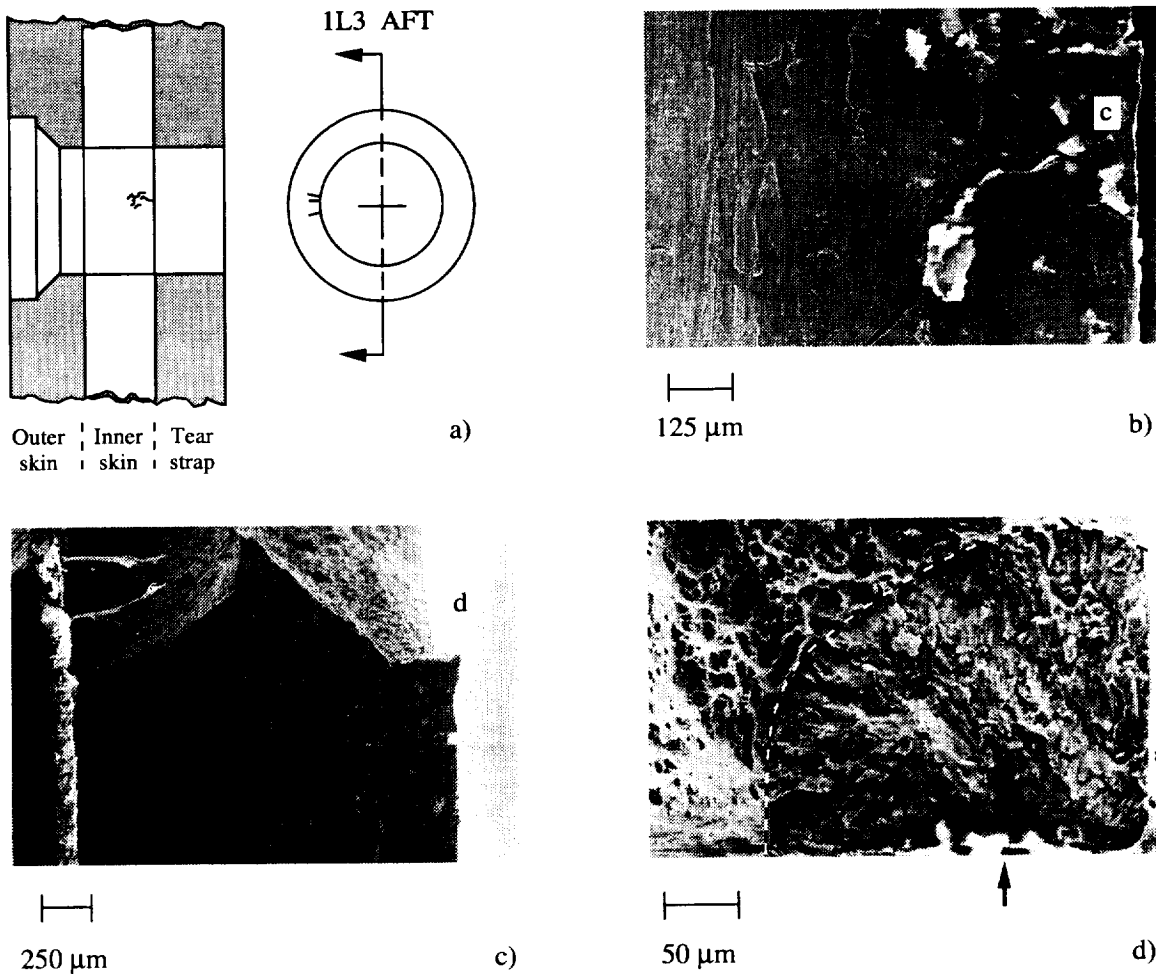
Figure 6.15 a) The schematic shows the rivet hole 1L3 configuration and the location of the upper tear strap fatigue crack oriented in the aft direction and about the 9 o'clock position. b) The SEM micrograph shows the multiple surface and corner fatigue cracks that have been partially opened during the destructive examination. c) The SEM micrograph shows the lower half (region "c" in Figure 6.15.b) fatigue crack region after the specimen was fractured. d) The SEM micrograph shows the fatigue fracture surface of the corner crack at region "d" in Figure 6.15.c. The dashed line marks the fatigue crack front. An arrow marks the likely region of crack initiation which exhibits a rough surface containing oxide debris (white region).

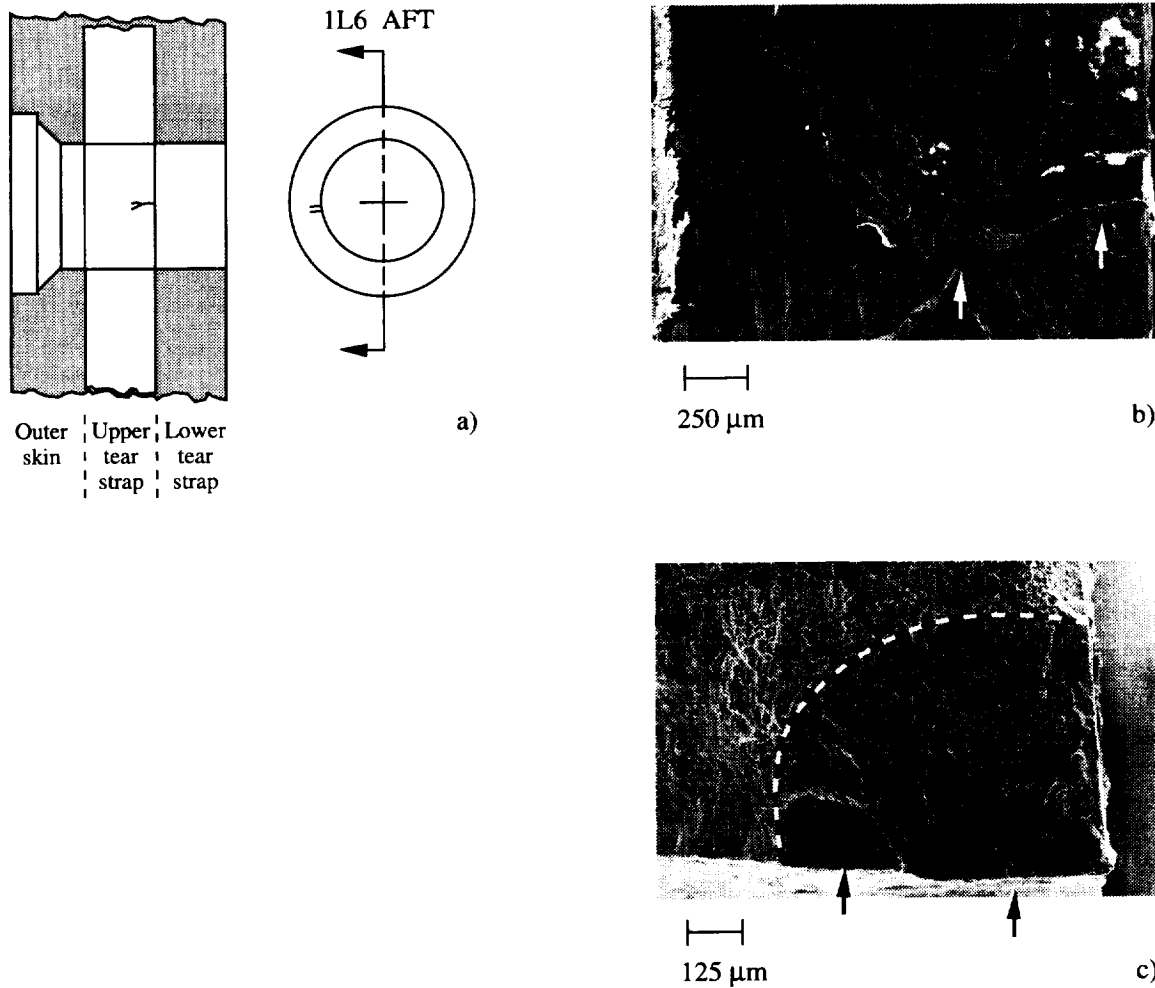
Figure 6.17 a) The schematic shows the rivet hole 1L6 configuration and the location of the upper tear strap fatigue crack oriented in the aft direction and about the 9 o'clock position. b) The SEM micrograph shows the surface and corner fatigue cracks that have been partially opened during the destructive examination. Arrows mark approximate location of crack initiation. c) The SEM micrograph shows the fatigue fracture surface of the corner and surface crack. The dashed line marks the fatigue crack front. Arrows mark the approximate location of crack initiation.

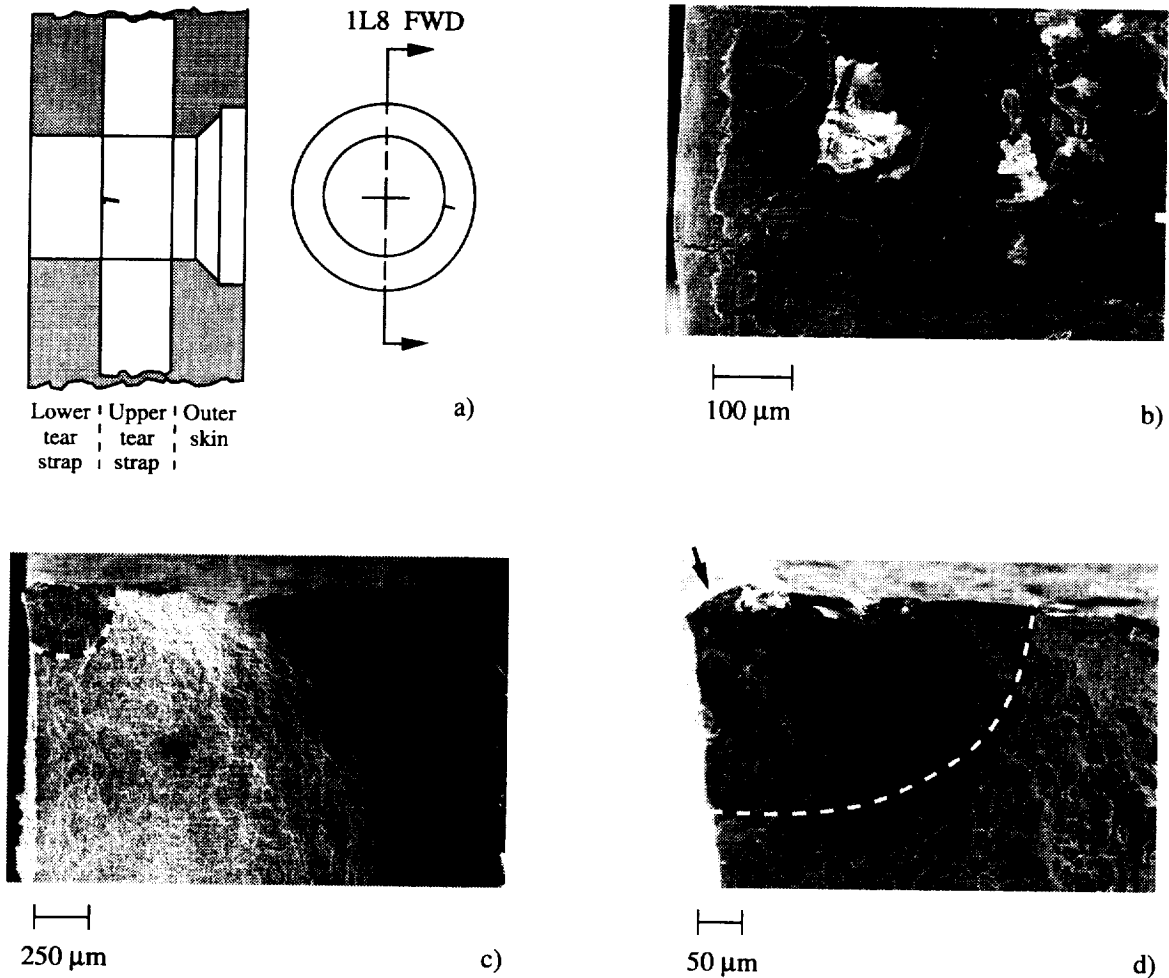
Figure 6.18 a) The schematic shows the rivet hole 1L8 configuration and the location of the upper tear strap fatigue crack oriented in the forward direction and about the 3 o'clock position. b) The SEM micrograph shows the tight corner fatigue crack prior to the destructive examination straining operation. c) The SEM micrograph shows the fatigue fracture surface of the corner crack. The dashed line marks the fatigue crack front. d) The SEM micrograph shows the fatigue fracture surface of the corner crack at higher magnification. White oxide debris near the corner marks the likely region of crack initiation (arrow).

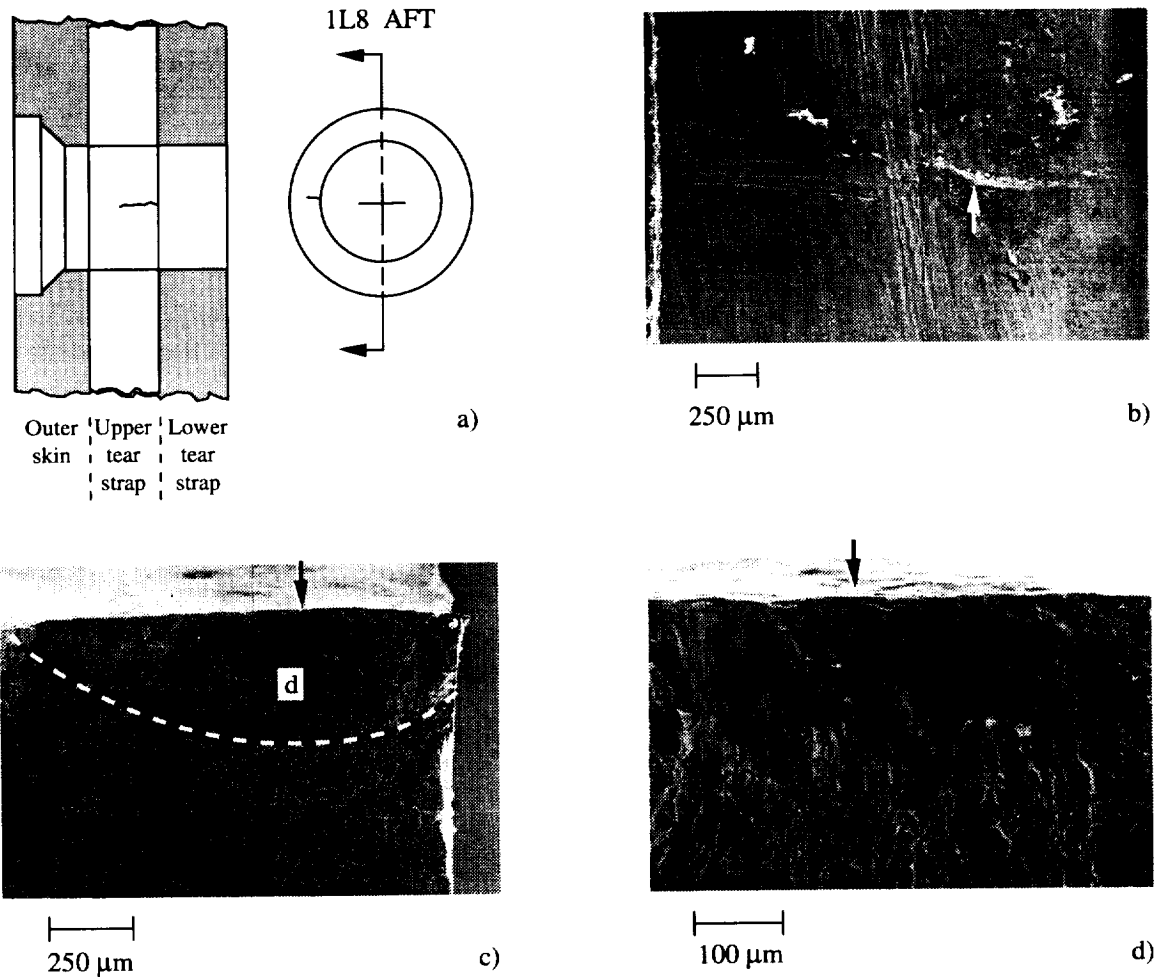
Figure 6.19 a) The schematic shows the rivet hole 1L8 configuration and the location of the upper tear strap fatigue crack oriented in the aft direction and about the 9 o'clock position. b) The SEM micrograph shows the tight corner fatigue crack (barely visible) prior to the destructive examination straining operation. The arrow marks the approximate crack initiation region. Note that a horizontal mark (disturbed metal) is located at the region of crack initiation. Other vertical markings are also visible. c) The SEM micrograph shows the fatigue fracture surface of the surface crack that has intersected the corner of the rivet hole. The arrow marks the approximate crack initiation region. The dashed line marks the fatigue crack front. d) The SEM micrograph shows the fatigue fracture surface of the crack initiation area, region "d" in Figure 6.19.c. Oxide debris is noted at the site of crack initiation.

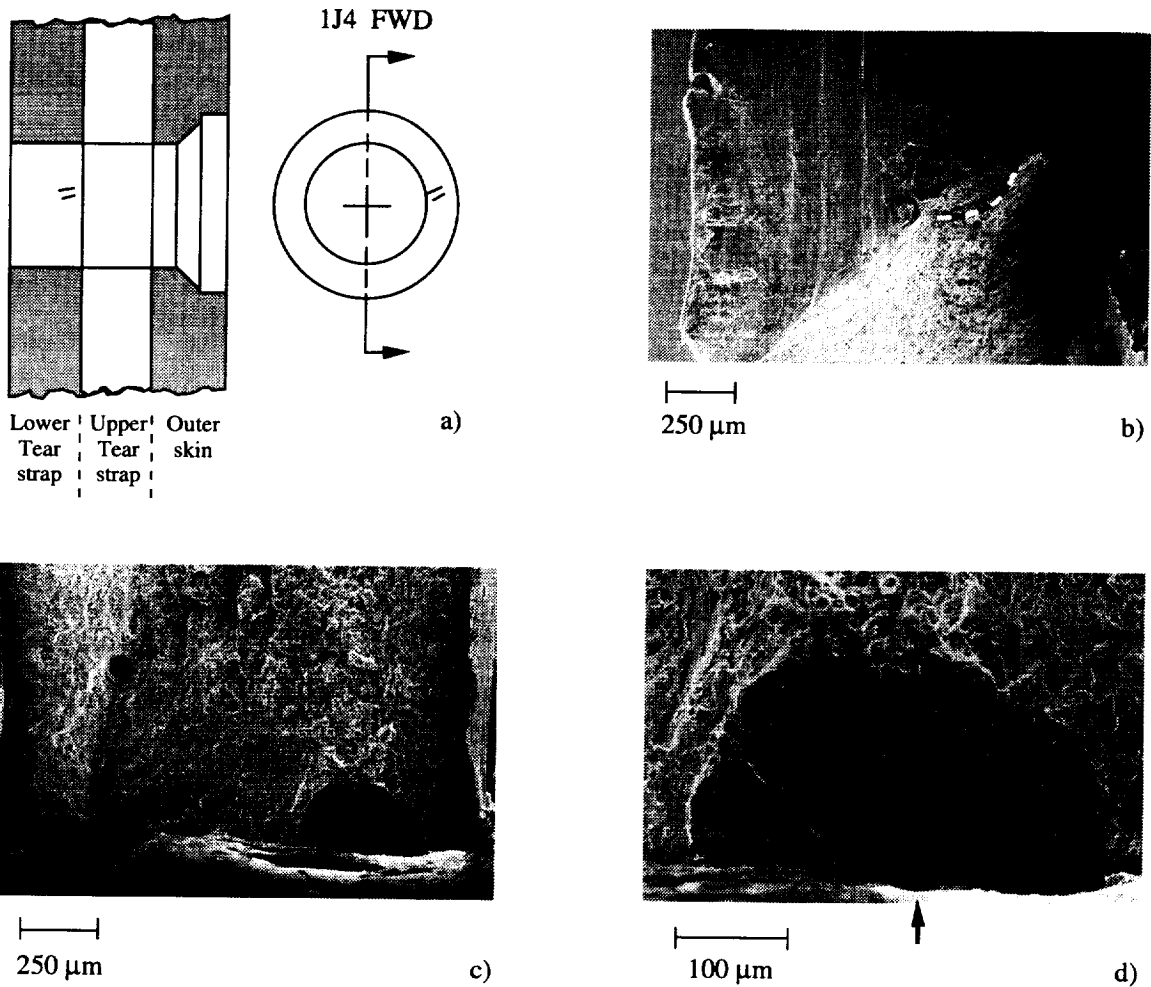
Figure 6.20 a) The schematic shows the rivet hole 1J4 configuration and the location of the lower tear strap fatigue cracks oriented in the forward direction and about the 3 o'clock position. b) The SEM micrograph shows the inside surface of the rivet hole and the fracture surface. The dashed line marks the position of the single surface fatigue crack on the fracture surface. Located above the fatigue fracture surface and on the rivet hole inside diameter are three incipient surface fatigue cracks. c) The SEM micrograph shows the semicircular fatigue fracture surface of the rivet hole surface crack. d) The SEM micrograph shows the semicircular fatigue fracture surface of the rivet hole surface crack at higher magnification. An arrow marks the likely site of fatigue crack initiation, and the dashed line marks the fatigue crack front.

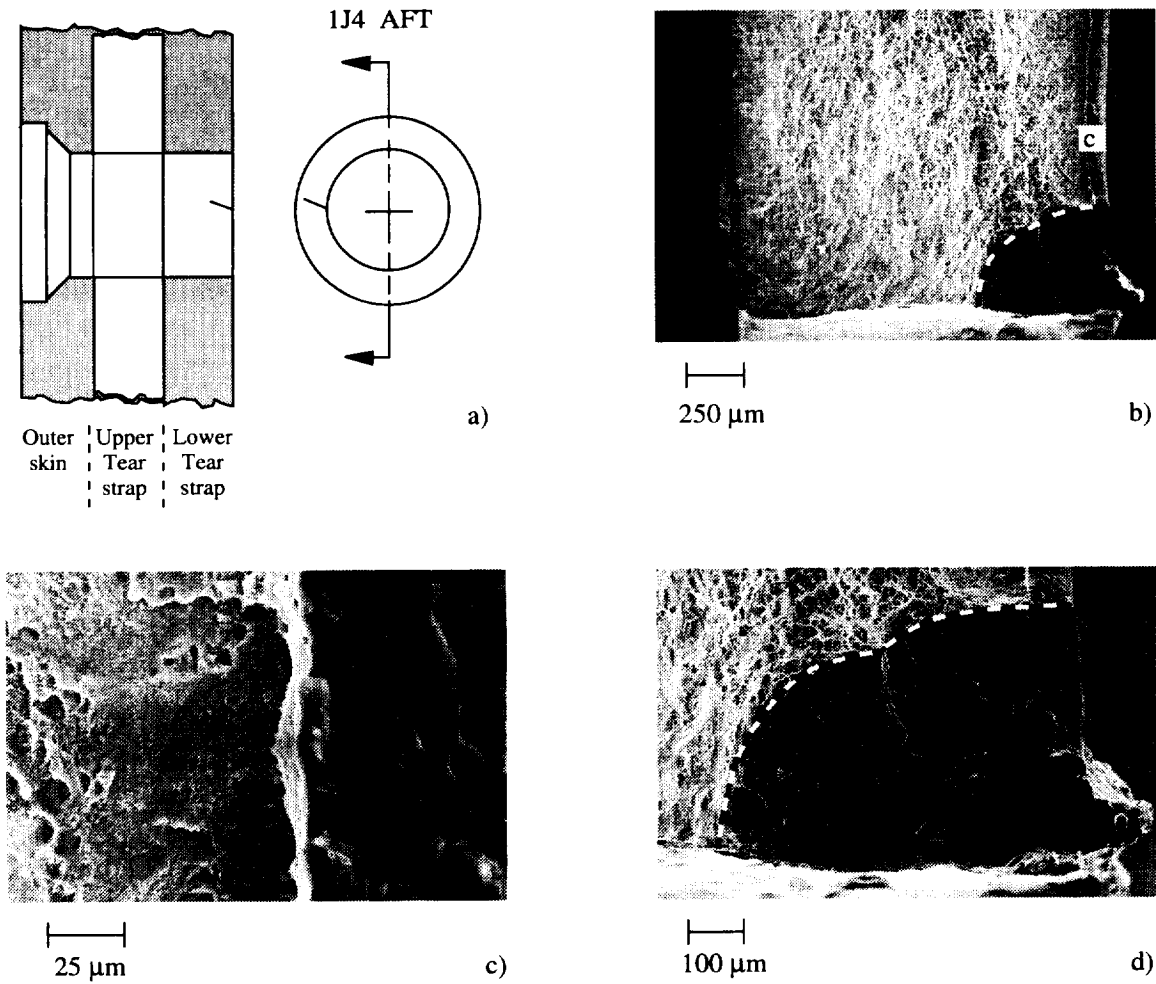
Figure 6.21 a) The schematic shows the rivet hole 1J4 configuration and the location of the lower tear strap fatigue crack oriented in the aft direction and about the 9 o'clock position. b) The SEM micrograph shows fatigue fracture surface of the rivet hole corner crack. Note the corner burr near the likely point of crack initiation (arrow). c) The SEM micrograph shows the clad/alloy interface at region "c" shown in Figure 6.21.c. d) The SEM micrograph shows the fatigue fracture surface of the rivet hole corner crack at high magnification. A dashed line marks the fatigue crack front.

Multiple site fatigue cracking in the lap splice inner skin and tear strap regions were primarily caused by damage at the rivet hole corner and along the rivet hole surface. Examples of corner cracks resulting from high K_T regions are shown in Figures 6.21 and 6.22, where cracks initiated at a corner burr, and Figure 7.34 is an example of a crack initiation from a corner imperfection. Examples of rivet hole fatigue cracking initiation by possible fretting between the rivet shank and the surface of the hole are shown in Figures 6.14-6.17, 6.20, 8.17. In each example, the surface of the hole exhibits a rough surface with microcracks (refer to Figures 6.14.b) in the region of fatigue crack initiation; this is an indication of possible fretting damage. Within hole fatigue crack initiation was also noted at surface imperfections as shown in Figures 8.14 and 8.32.

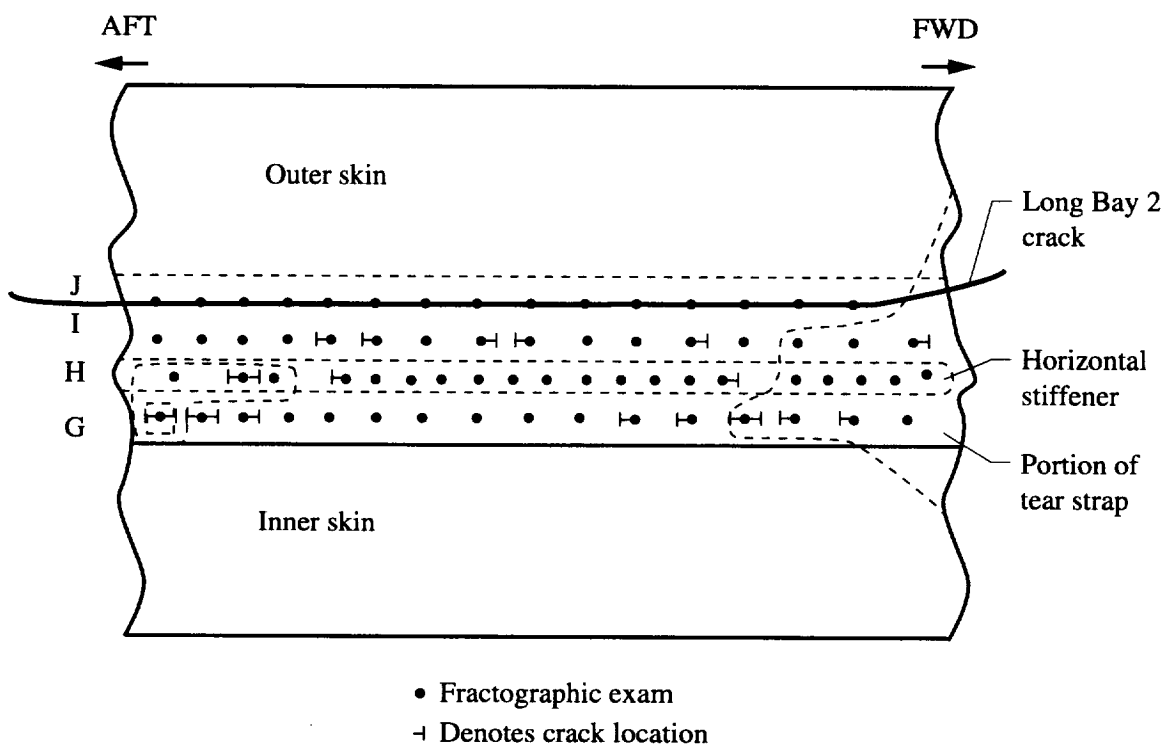
BAY 2 - MIDBAY

A total of sixty-seven rivet hole locations in bay 2 (identified by the filled hole symbols in Figure 7.1) were destructively examined. All fifteen upper rivet row locations exhibited fatigue cracking (a total of 30 fatigue cracks) prior to crack link-up. A single crack, 47.88 cm (18.85 in.) long, spanning the entire length of the bay 2 lap splice formed when fatigue crack link-up occurred at each upper rivet hole. Twenty-one fatigue cracks were found in the remaining rivet rows contained in bay 2: six cracks in row I, four cracks in row H, and eleven cracks in row G. Figures 7.2 and 7.3 show the location of all fatigue cracks found in the first layer (outer skin) and the second layer (inner skin), respectively. No fatigue cracks were found in the horizontal stiffener or tear strap. Rivet rows J and I contained outer skin cracks and rows H and G contained inner skin cracks. The through-thickness rivet hole schematics shown in Figures 7.4, 7.5 and 7.6 summarize crack location, crack length, crack type, and initiation site for rivet rows I, H, and G, respectively. Because all fatigue cracks are linked in row J and fracture surface detail was destroyed by surface abrasion, a through-thickness schematic detailing fatigue crack information is not shown for the upper row. The following is a detailed description of the fatigue damage in the bay 2 tear strap region. Figures 7.8 through 7.22 are detailed photographs showing the top portion of the long upper row crack (row J) shown in Figure 7.7 and corresponding crack growth data obtained from visual surface measurements performed during pressure testing. Figures 7.23 through 7.43 detail the location and fracture surface morphology of all fatigue cracks found in the remainder of bay 2 (rivet rows G, H, and I).

Figure 7.1 The schematic shows the location of all fatigue cracks found in the bay 2 lap splice joint by destructive examination. The long bay 2 crack is visible in row J. All bay 2 rivet holes were destructively examined.

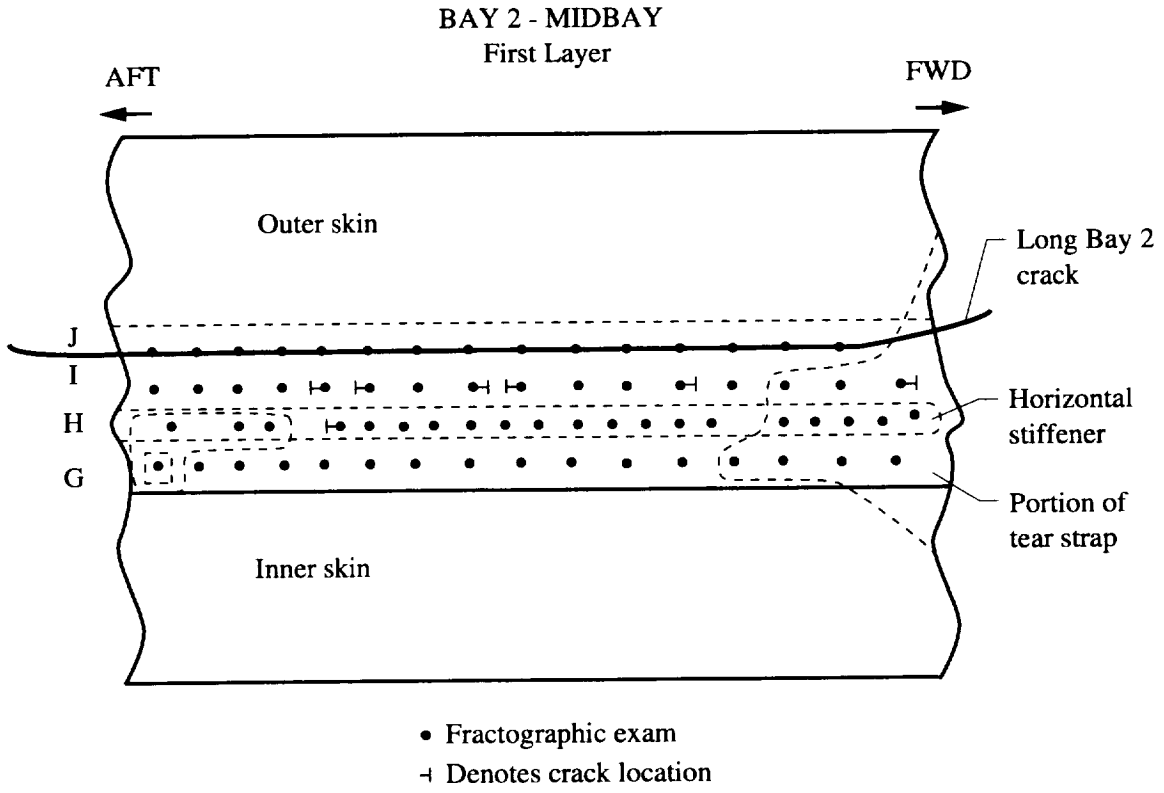
Figure 7.2 The schematic shows the location of fatigue cracks found in the first layer (outer skin) of the bay 2 lap splice joint by destructive examination. The long bay 2 crack is visible in row J.

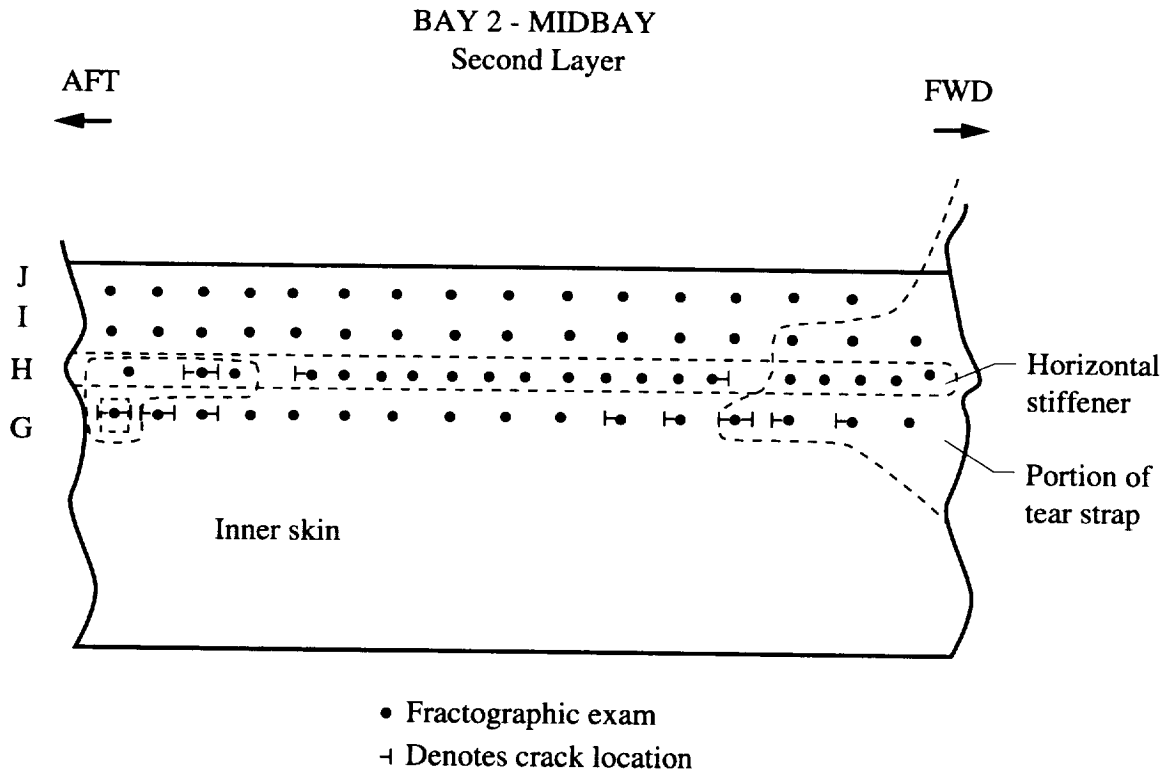
Figure 7.3 The schematic shows the location of fatigue cracks found in the second layer (inner skin) of the bay 2 lap splice joint by destructive examination.

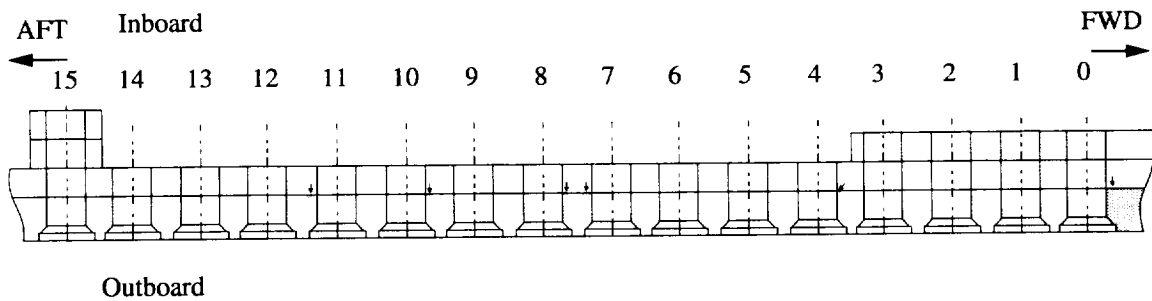
BAY 2 ROW I

Hole #	Location	Length mm(in)	Type	Initiation-site
0 (FWD)	Outer skin	2.33 (.092)	Through	Inner/outer skin interface
4 (FWD)	Outer skin	0.102 (.004)	Fretting	Inboard corner of shank
7 (Aft)	Outer skin	0.112 (.004)	Fretting	IS/OS
8 (FWD)	Outer skin	0.073 (.003)	Fretting	IS/OS
10 (FWD)	Outer skin	0.140 (.006)	Fretting	IS/OS
11 (Aft)	Outer skin	0.058 (.002)	Fretting	IS/OS

Figure 7.4 The through thickness schematic shows the location and initiation site (small arrows) of fatigue cracks found in rivet row I from bay 2. The table summarizes crack location, crack length, crack type, and initiation site for each fatigue crack shown.

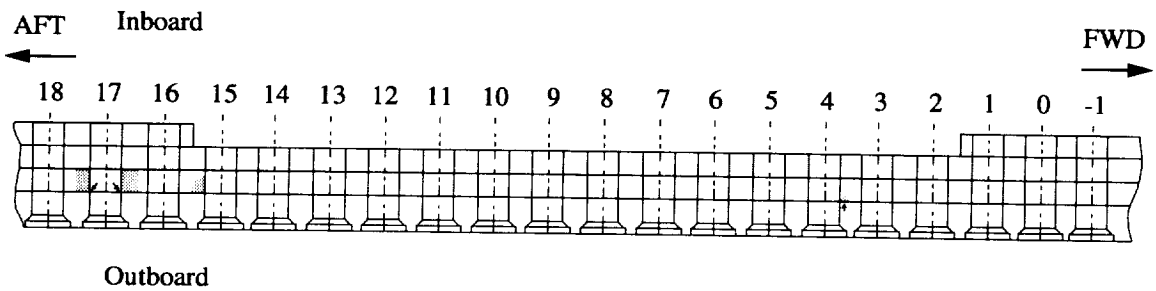
BAY 2 ROW H

Hole #	Location	Length mm(in)	Type	Initiation site
4 (FWD)	Inner skin	0.110 (.004)	Surface	IS / OS Interface
15 (Aft)	Inner skin	ND	Corner	Not determined
17 (FWD)	Inner skin	>2.43 (.096)	Through	Outboard corner
17 (Aft)	Inner skin	>1.63 (.064)	Through	Outboard corner

Figure 7.5 The through thickness schematic shows the location and initiation site (small arrows) of fatigue cracks found in rivet row H from bay 2. The table summarizes crack location, crack length, crack type, and initiation site for each fatigue crack shown.

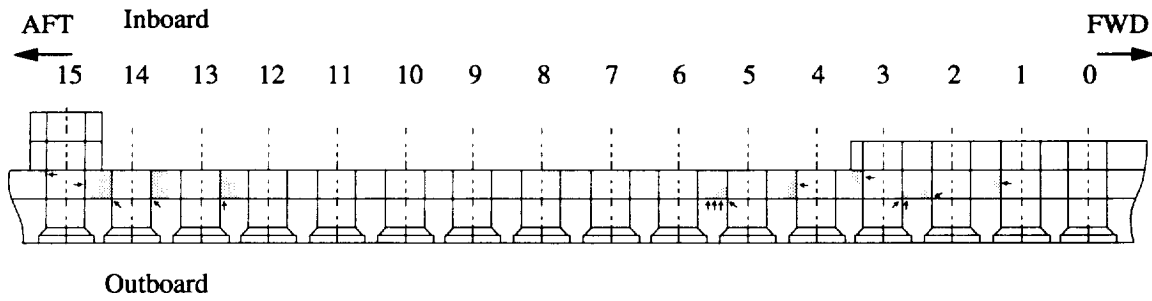
BAY 2 ROW G

Hole #	Location	Length mm(in.)	Type	Initiation site
1 (Aft)	Inner skin	0.250 (.010)	Surface	Center
2 (Aft)	Inner skin	0.100 (.004)	Corner	Outboard corner (OC)
3 (1FWD)	Inner skin	0.170 (.007)	Corner	OC
3 (2FWD)	Inner skin	0.335 (.013)	Corner	OC
3 (Aft)	Inner skin	0.360 (.014)	Corner	Surface (Inboard side)
4 (Aft)	Inner skin	0.615 (.024)	Through	Center
5 (Aft)	Inner skin	0.680 (.027)	Corner & fretting	Mutiple (OC & fretting)
13 (FWD)	Inner skin	~2.750 (.108)	Through	OC
14 (Aft)	Inner skin	~2.720 (.107)	Through	OC
14 (FWD)	Inner skin	>4.170 (.164)	Through	OC
15 (FWD)	Inner skin	0.163 (.006)	Surface	Center
15 (1-Aft)	Inner skin	0.115 (.004)	Corner	IC
15 (2-Aft)	Inner skin	0.128 (.005)	Corner	IC

Figure 7.6 The through thickness schematic shows the location and initiation site (small arrows) of fatigue cracks found in rivet row G from bay 2. The table summarizes crack location, crack length, crack type, and initiation site for each fatigue crack shown.

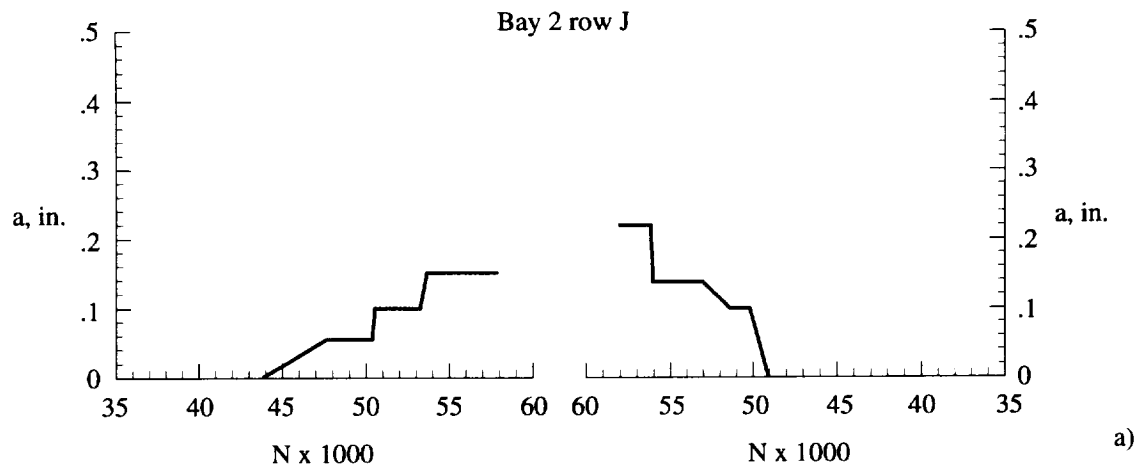
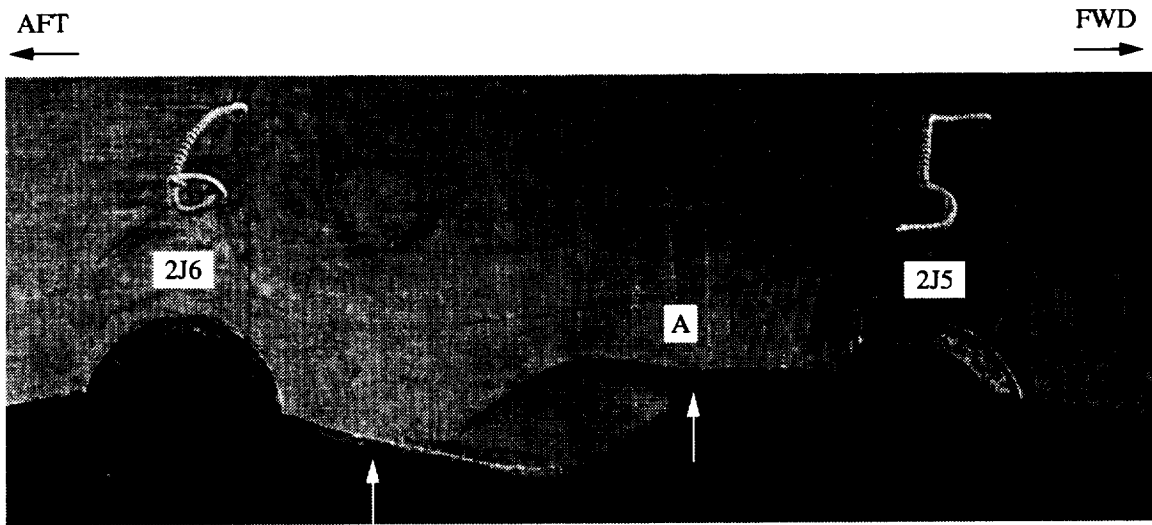
Figure 7.12 a) The figure is a plot of outer skin crack length (a) measured from the rivet outside diameter versus pressurization cycles (N). *In situ* visual crack length measurements were taken during pressure testing. Fatigue crack growth plots are shown for crack segments 2J5 aft and 2J6 forward. b) The photograph shows the upper portion of the outer skin crack surface between rivet holes 2J5 and 2J6. This region is also shown in Figure 7.7.b prior to destructive examination. Arrows mark the approximate final position of the fatigue cracks noted (visually) prior to crack link-up. Region A is the likely position where cracks from both holes had linked. Most of the crack surface shown in Figure 7.12.b exhibits a roughened appearance. This slant fracture region is characteristic of ductile tearing produced by relatively high crack tip stress intensity. The slant fracture region contains no scratches normal to the direction of crack propagation observed in other rivet hole regions. This suggests that this region was captured by the rivets and link-up occurred before large mode III displacement resulted from pillowing.

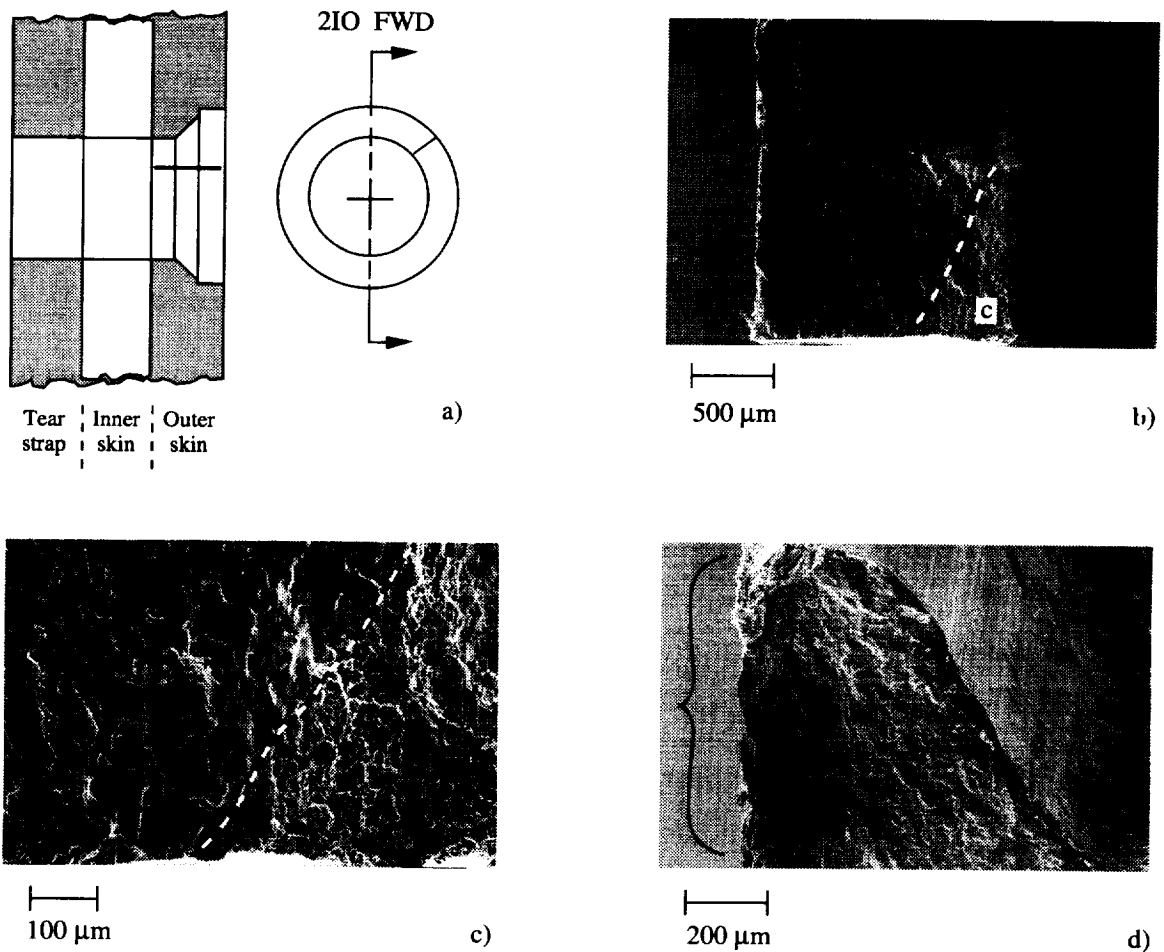
Figure 7.23 a) The schematic shows the rivet hole 2I0 configuration and the location of the outer skin fatigue crack oriented in the forward direction and about the 2 o'clock position. b) The SEM micrograph shows a portion of the fatigue crack and the rivet hole (top of the micrograph). The dashed line marks a portion of the fatigue crack front. The missing portion of the fracture surface was inadvertently cut during the destructive examination. c) The SEM micrograph shows the crack front region (region "c" in Figure 7.23.b), comparing the smooth transgranular fatigue crack morphology to the rough dimpled ductile tearing of the overload fracture surface (the dashed boundary line marks the fatigue crack front and overload regions) produced during destructive examination of the rivet hole. d) The SEM micrograph shows the fatigue fracture surface at the rivet hole shank region. The bracket marks the likely region of crack initiation along the faying surface.
