NASA/TP-97-206257

The Characteristics of Fatigue Damage in the Fuselage Riveted Lap Splice Joint

Robert S. Piascik
Langley Research Center, Hampton, Virginia

November 1997

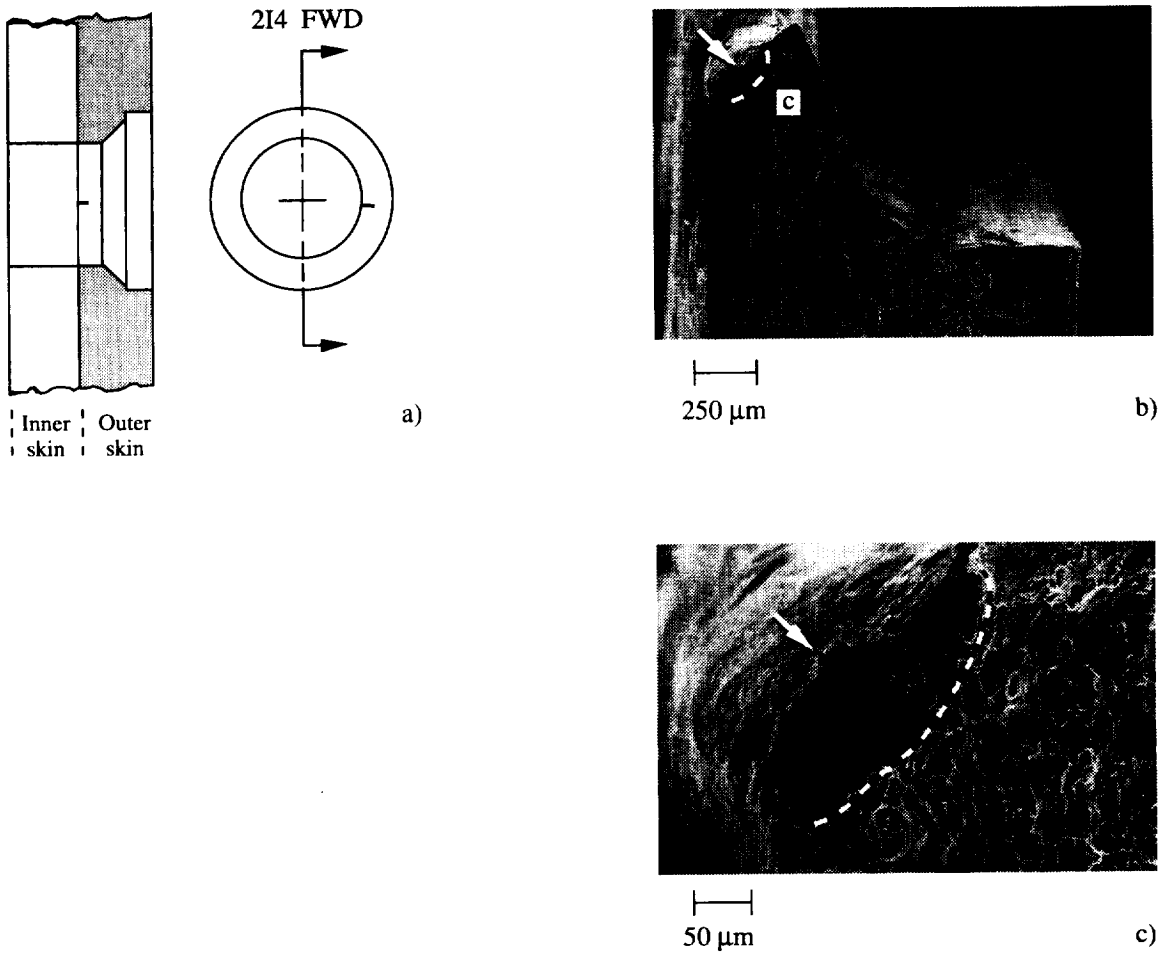
Figure 7.24 a) The schematic shows the rivet hole 2I4 configuration and the location of the outer skin fatigue crack oriented in the forward direction and about the 3 o'clock position. b) The SEM micrograph shows a small fatigue crack at the rivet hole corner marked by an arrow. c) The SEM micrograph shows the fatigue crack in Figure 7.24.b at higher magnification.

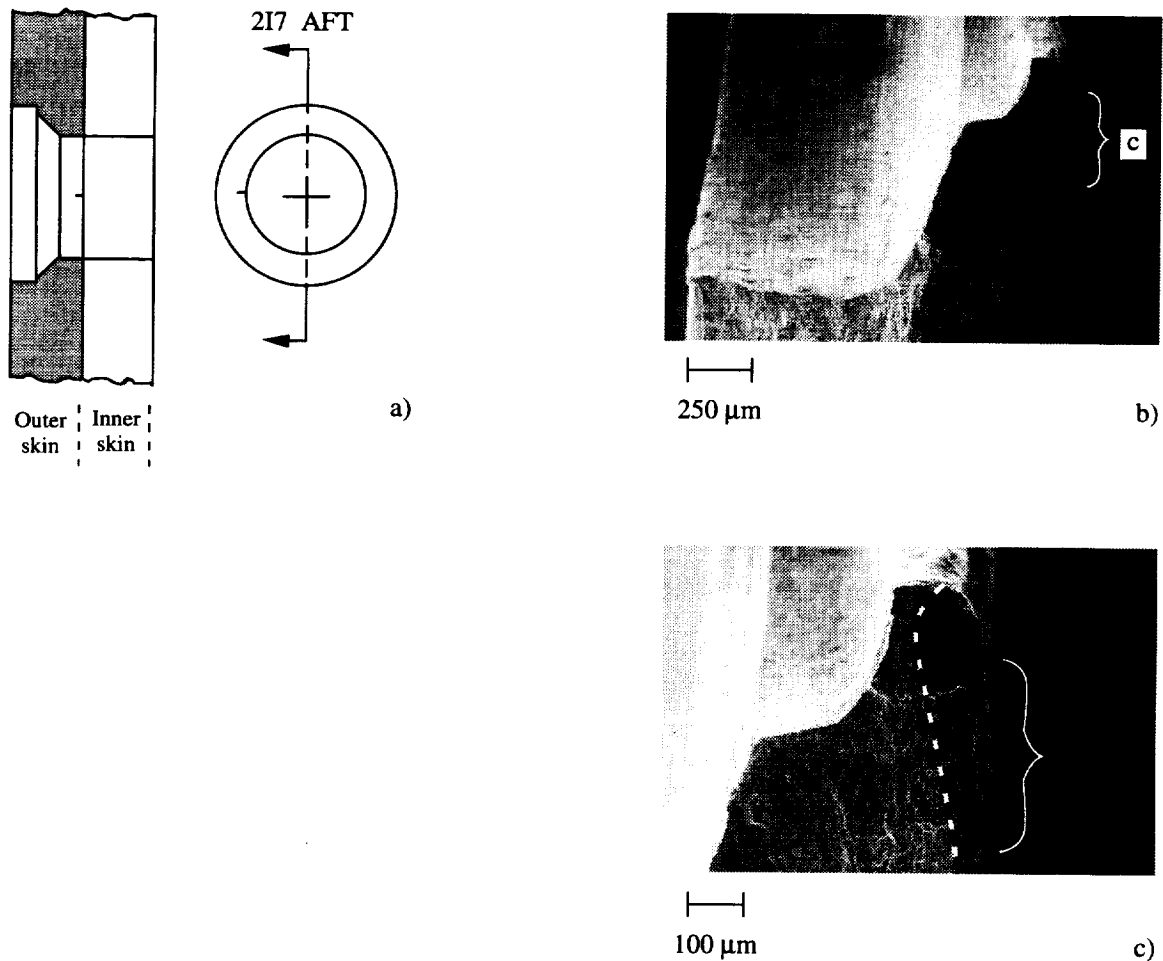
Figure 7.25 a) The schematic shows the rivet hole 2I7 configuration and the location of the outer skin fatigue crack oriented in the aft direction and about the 9 o'clock position. b) The SEM micrograph shows the fatigue crack along the faying surface. The bracket marks the region of crack initiation along the faying surface. Note the rivet hole shank region exhibits an anomalous configuration. c) The SEM micrograph shows the fatigue crack (region "c" in Figure 7.25.b) at high magnification. The dashed line marks the fatigue crack front. The bracket marks the region of crack initiation along the rough faying surface.

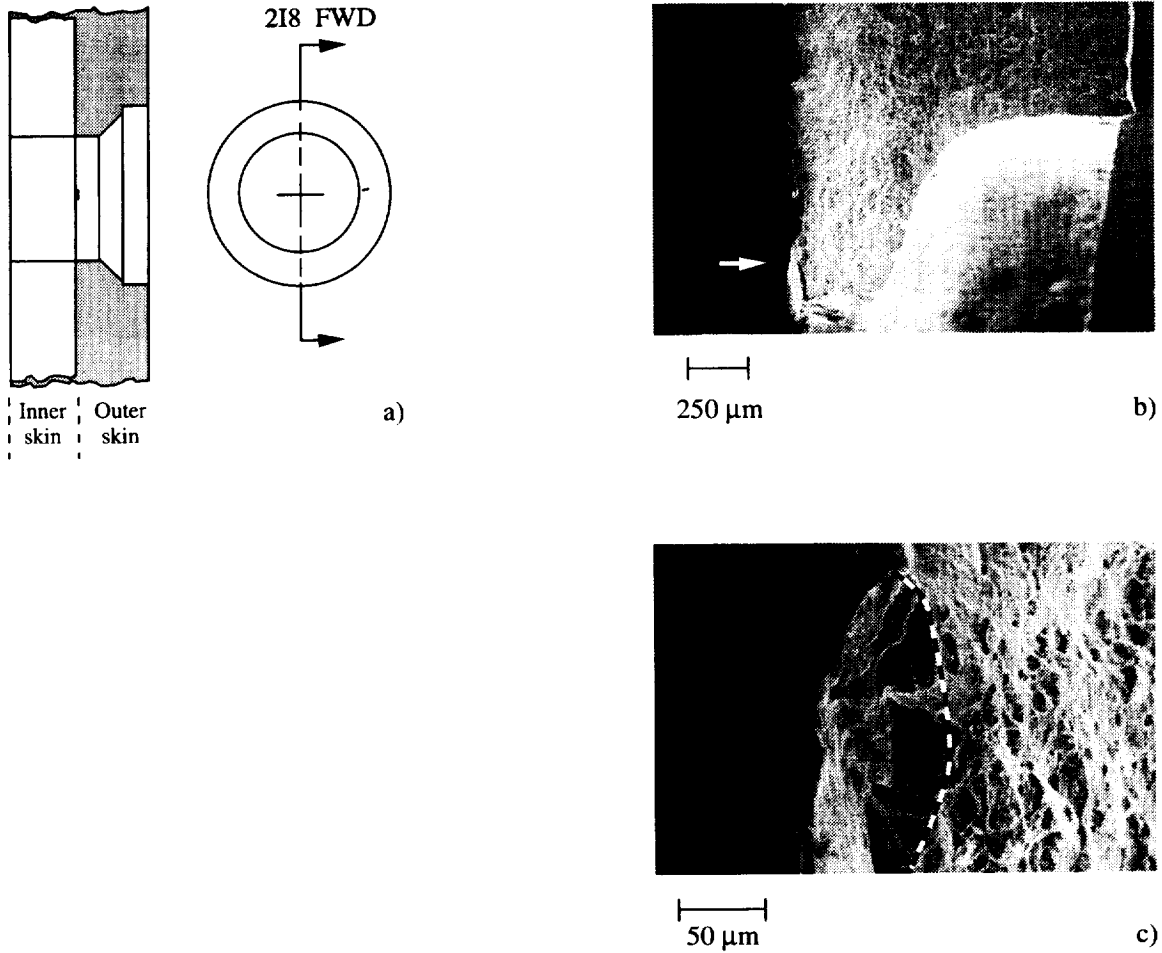
Figure 7.26 a) The schematic shows the rivet hole 2I8 configuration and the location of the outer skin fatigue crack oriented in the forward direction and about the 3 o'clock position. b) The SEM micrograph shows a small fatigue crack (marked by the arrow) located at the faying surface c) The SEM micrograph shows the small fatigue crack contained in the clad layer at high magnification. The dashed line marks the fatigue crack front. The crack initiated in a roughened surface region at the faying surface.

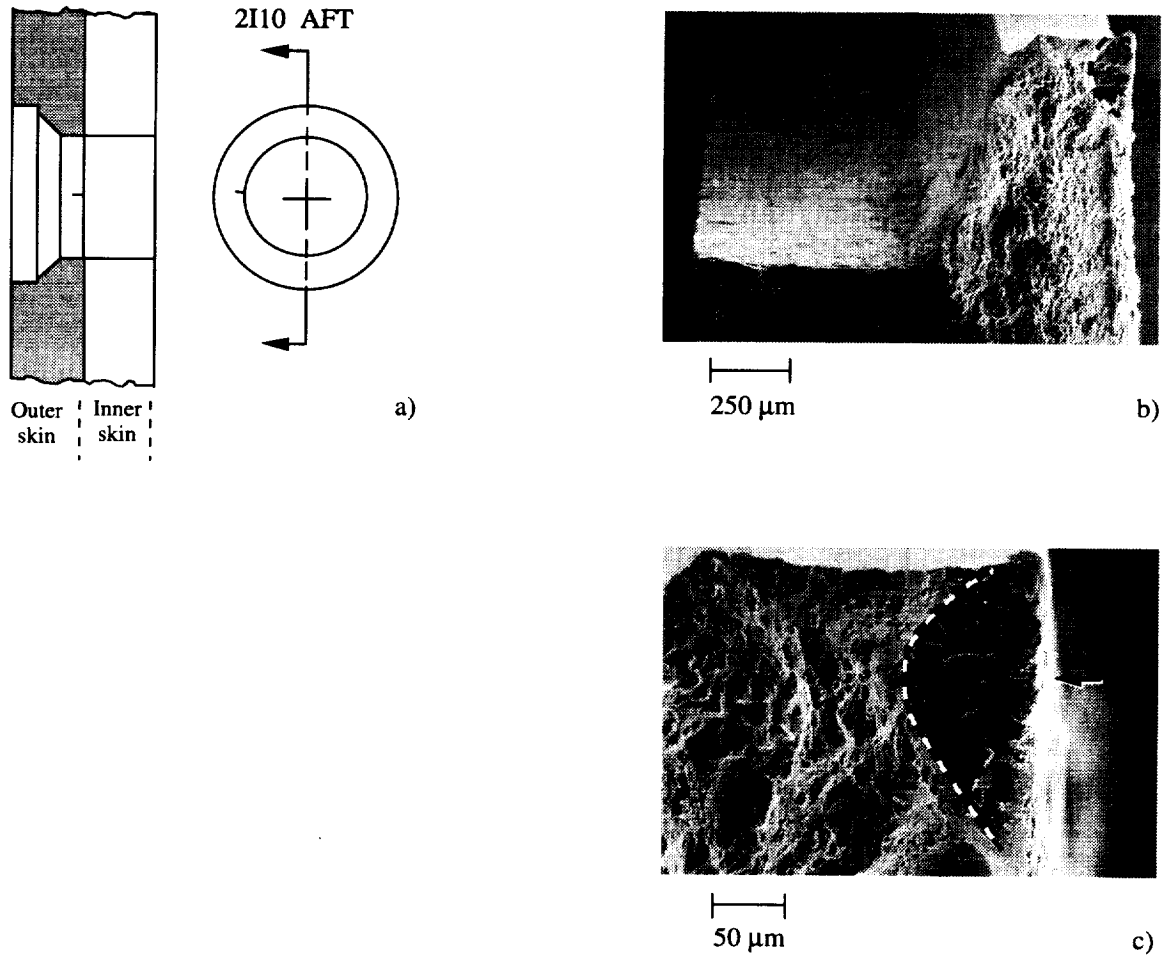
Figure 7.27 a) The schematic shows the rivet hole 2I10 configuration and the location of the outer skin fatigue crack oriented in the aft direction and about the 9 o'clock position. b) The SEM micrograph shows a small fatigue crack located at the rivet hole shank region along the faying surface. The dashed line marks the fatigue crack front. c) The SEM micrograph shows the small fatigue crack at high magnification. The dashed line marks the fatigue crack front. The crack initiated in a roughened region along the faying surface.

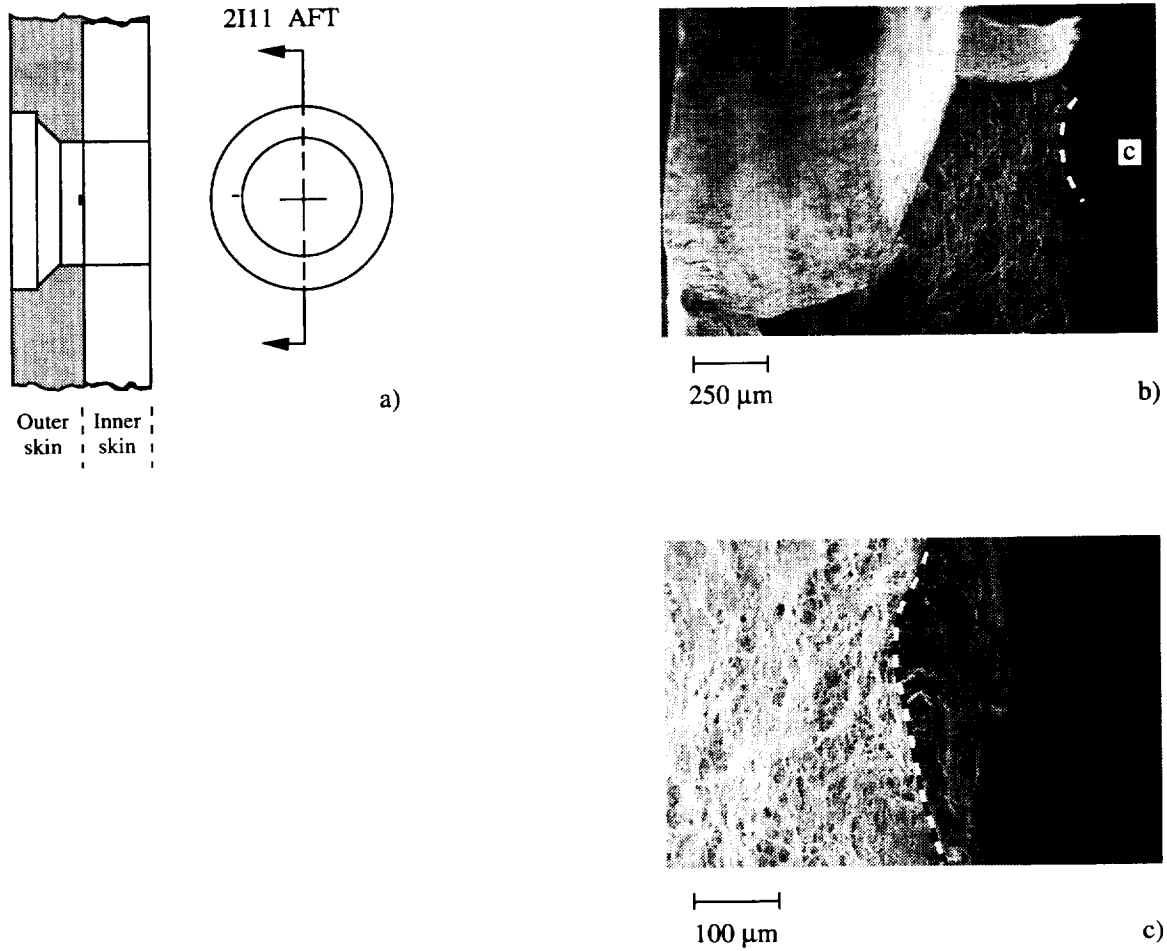
Figure 7.28 a) The schematic shows the rivet hole 2I11 configuration and the location of the outer skin fatigue crack oriented in the aft direction and about the 9 o'clock position. b) The SEM micrograph shows a small elongated fatigue crack located at the faying surface. The dashed line marks the fatigue crack front. c) The SEM micrograph shows the small fatigue crack contained in the clad layer at high magnification, region "c" in Figure 7.28.b. The dashed line marks the fatigue crack front. The crack initiated in a roughened region along the faying surface.

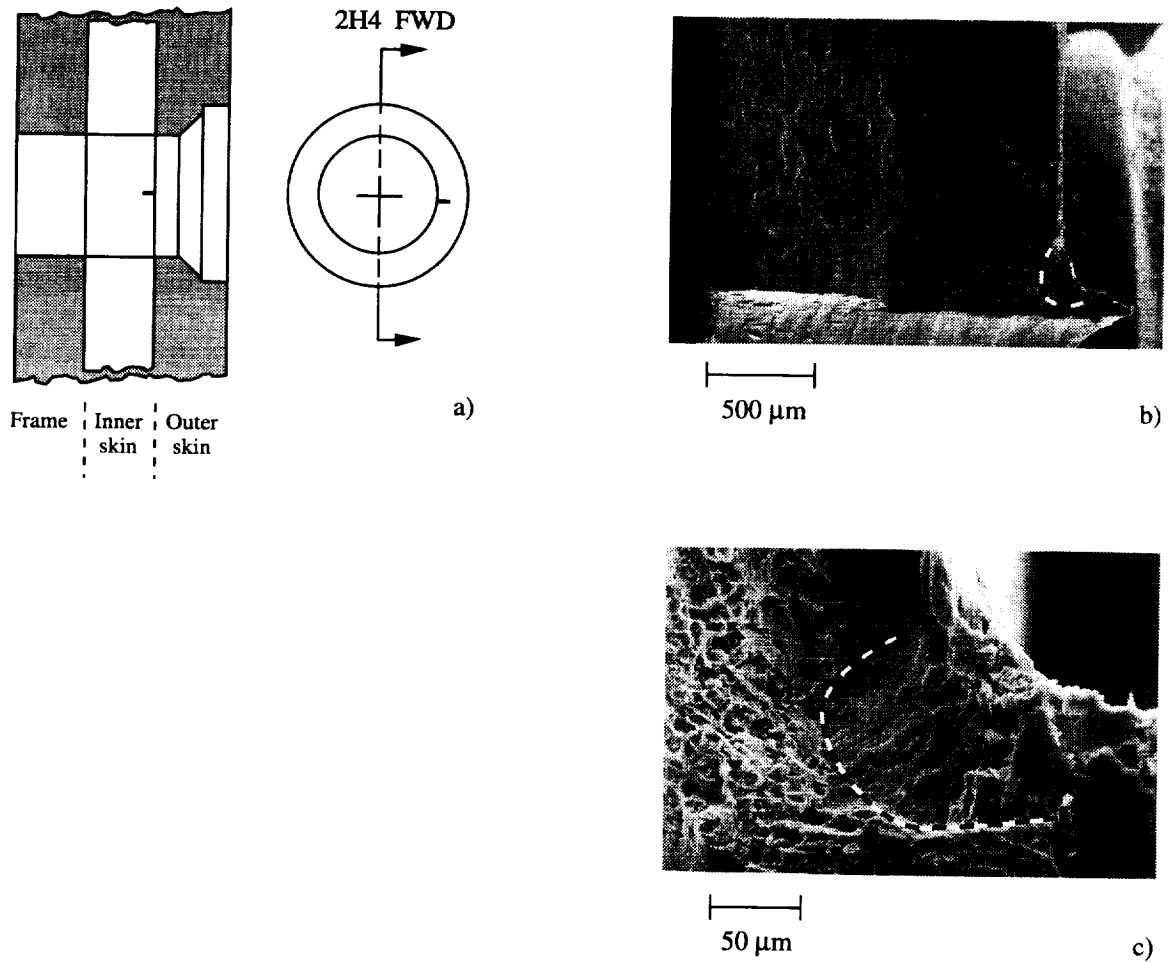
Figure 7.29 a) The schematic shows the rivet hole 2H4 configuration and the location of the inner skin fatigue crack oriented in the forward direction and about the 3 o'clock position. b) The SEM micrograph shows a small fatigue crack located near a rivet hole corner burr. The dashed line marks the fatigue crack front. c) The SEM micrograph shows the small fatigue crack at high magnification.

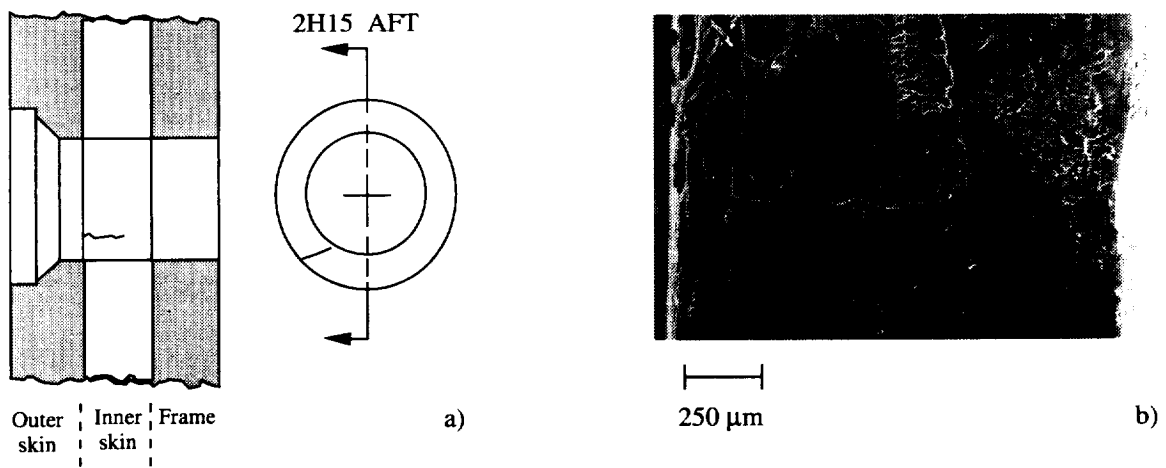
Figure 7.30 a) The schematic shows the rivet hole 2H15 configuration and the location of the inner skin fatigue crack oriented in the aft direction and below the 8 o'clock position. b) The SEM micrograph shows the inside surface of the rivet hole and a fatigue crack extending from the outboard corner. The crack was partially opened during the destructive examination. SEM examination into the partially opened corner crack verified that the crack was a transgranular fatigue crack.

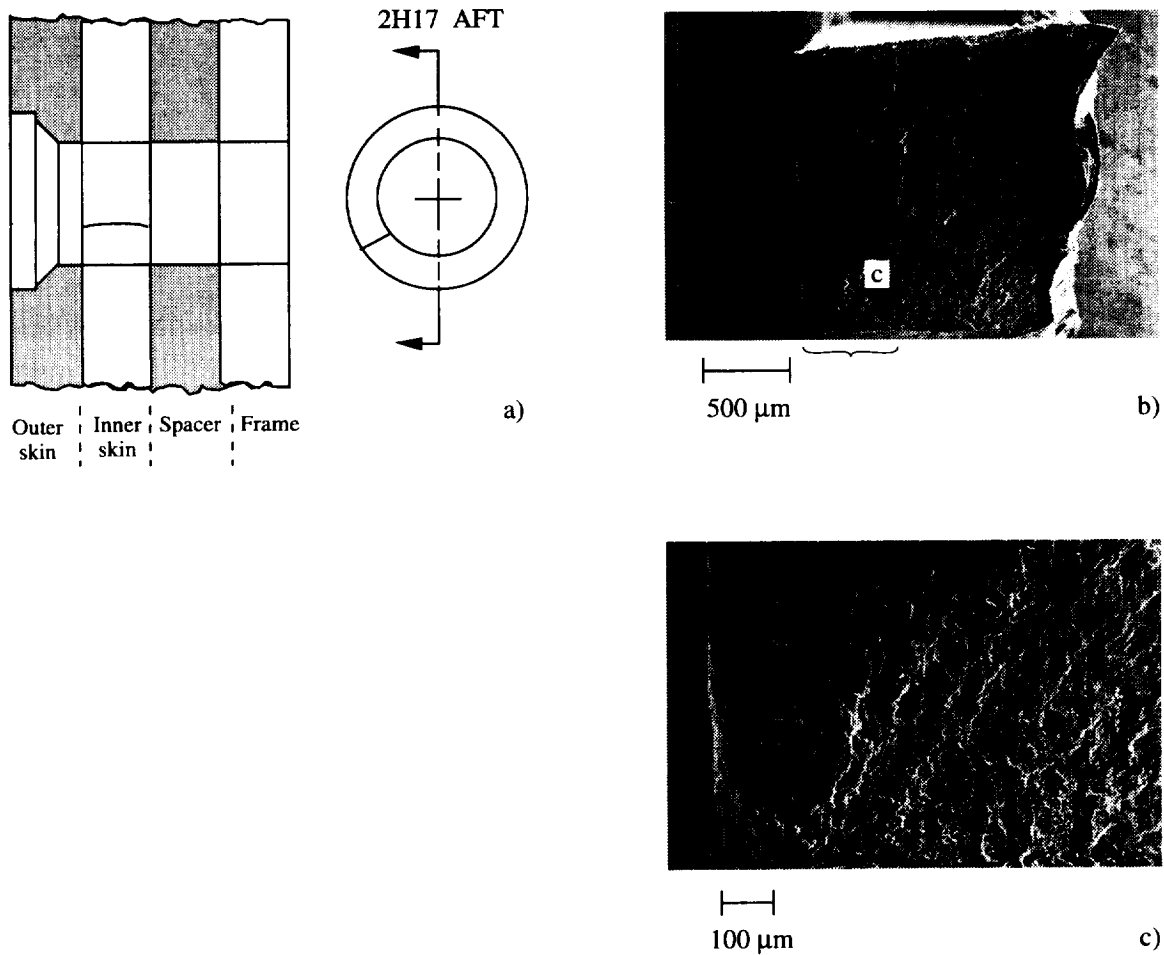
Figure 7.32 a) The schematic shows the rivet hole 2H17 configuration and the location of the inner skin fatigue crack oriented in the aft direction and below the 9 o'clock position. b) The SEM micrograph shows the inner skin fatigue crack fracture surface (the direction of crack propagation is from the bottom to the top of the figure). The rivet hole is located at the bottom of the micrograph. The fatigue crack was cut during the removal of the specimen from the panel and a portion of the fatigue crack surface is not shown in the figure. c) The SEM micrograph shows the fatigue crack surface at the outboard corner (approximate crack initiation site) of the rivet hole, region "c" in Figure 7.31.b.

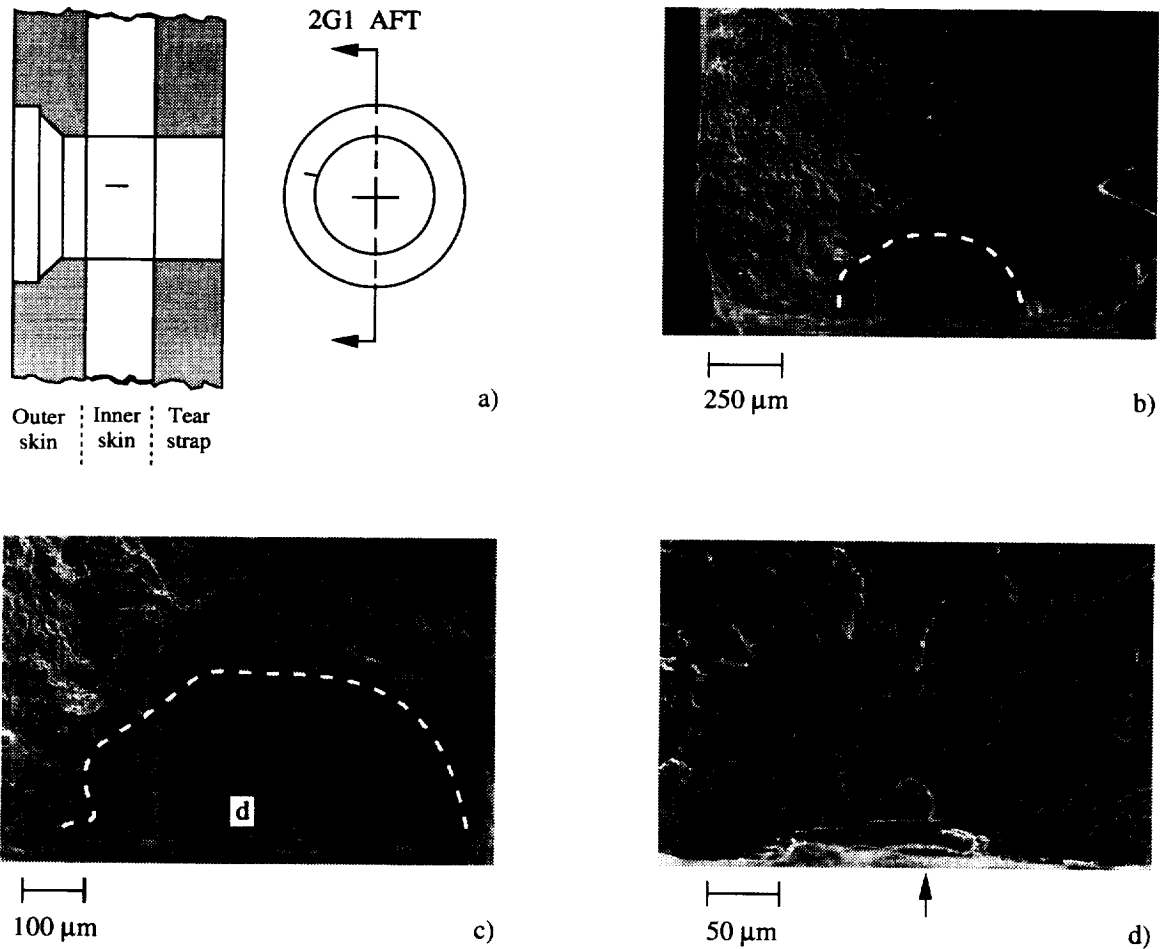
Figure 7.33 a) The schematic shows the rivet hole 2G1 configuration and the location of the inner skin fatigue crack oriented in the aft direction and above the 9 o'clock position. b) The SEM micrograph shows the fatigue crack at the mid-thickness location of the inner skin rivet hole (bottom of the micrograph). The dashed line marks the fatigue crack front. c) The SEM micrograph shows the semicircular shaped surface fatigue crack at higher magnification. The dashed line marks the fatigue crack front. d) The SEM micrograph shows the crack initiation region (region "d" in Figure 7.33.c). The region of crack initiation marked by an arrow along the inside surface of the rivet hole exhibits disturbed metal.

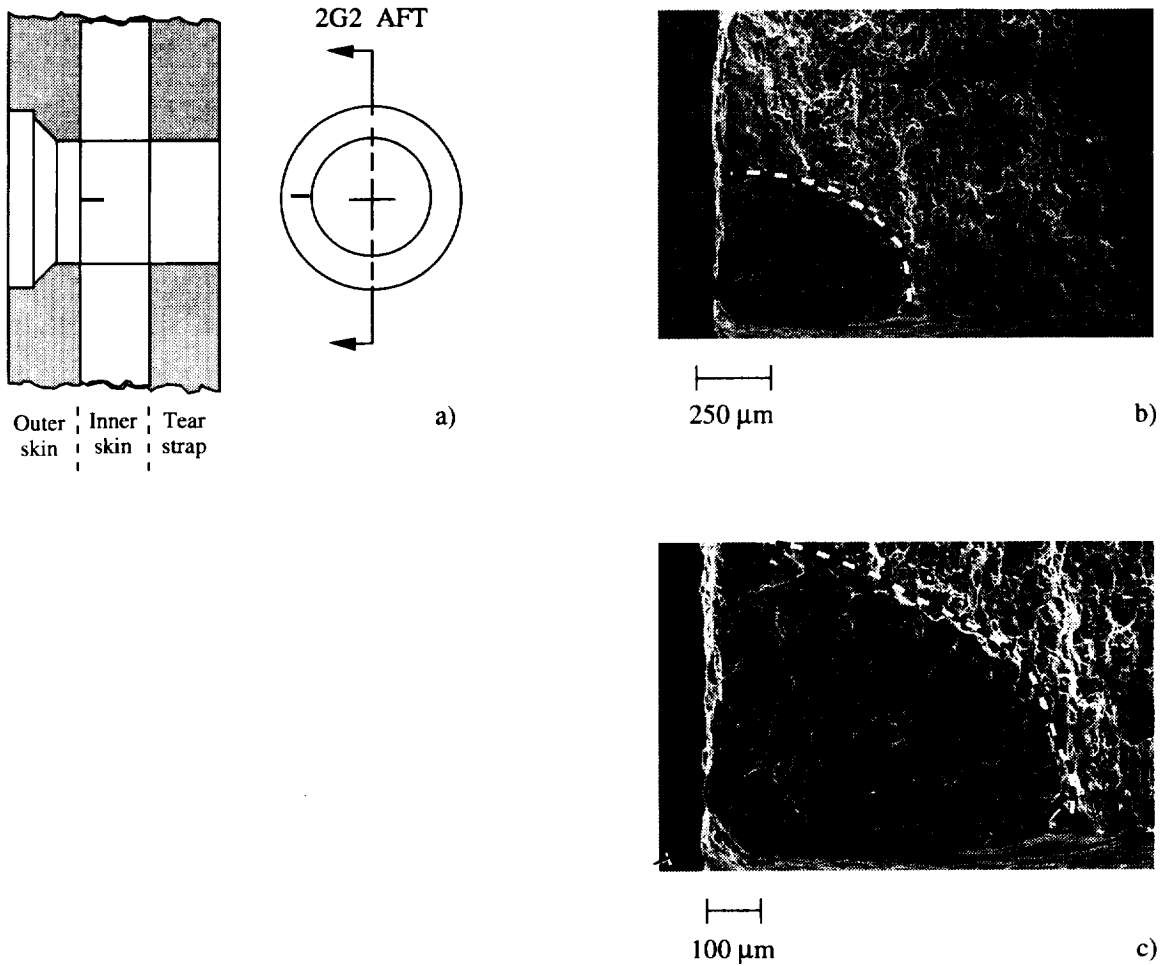
Figure 7.34 a) The schematic shows the rivet hole 2G2 configuration and the location of the inner skin fatigue crack oriented in the aft direction and at the 9 o'clock position. b) The SEM micrograph shows the fatigue crack fracture surface located at the outboard corner of the rivet hole (bottom-left of the micrograph). The dashed line marks the fatigue crack front. c) The SEM micrograph shows the corner fatigue crack at higher magnification. The arrow marks the region of crack initiation and the dashed line marks the fatigue crack front.

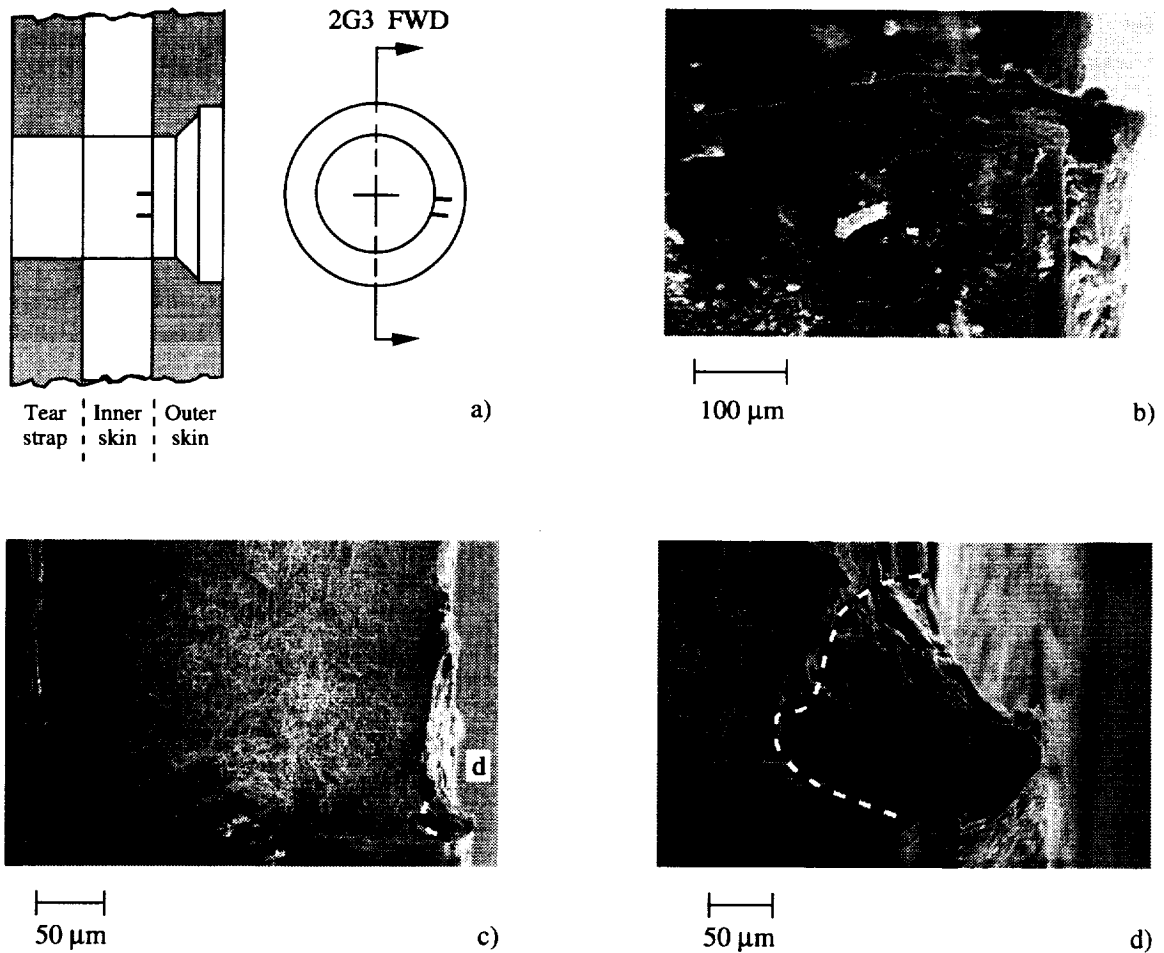
Figure 7.35 a) The schematic shows the rivet hole 2G3 configuration and the location of two inner skin fatigue cracks oriented in the forward direction and slightly below the 3 o'clock position. b) The SEM micrograph shows the surface of the rivet hole and a partially opened fatigue crack at the outboard corner after the initial destructive examination straining operation. A burr and disturbed metal are observed at the corner. c) The SEM micrograph shows the corner fatigue crack surface at the outboard corner of the rivet hole. The dashed line marks the fatigue crack front. d) The SEM micrograph shows the corner fatigue crack at high magnification (region "d" in Figure 7.35.c). The region of crack initiation is located near disturbed metal produced by a corner burr.

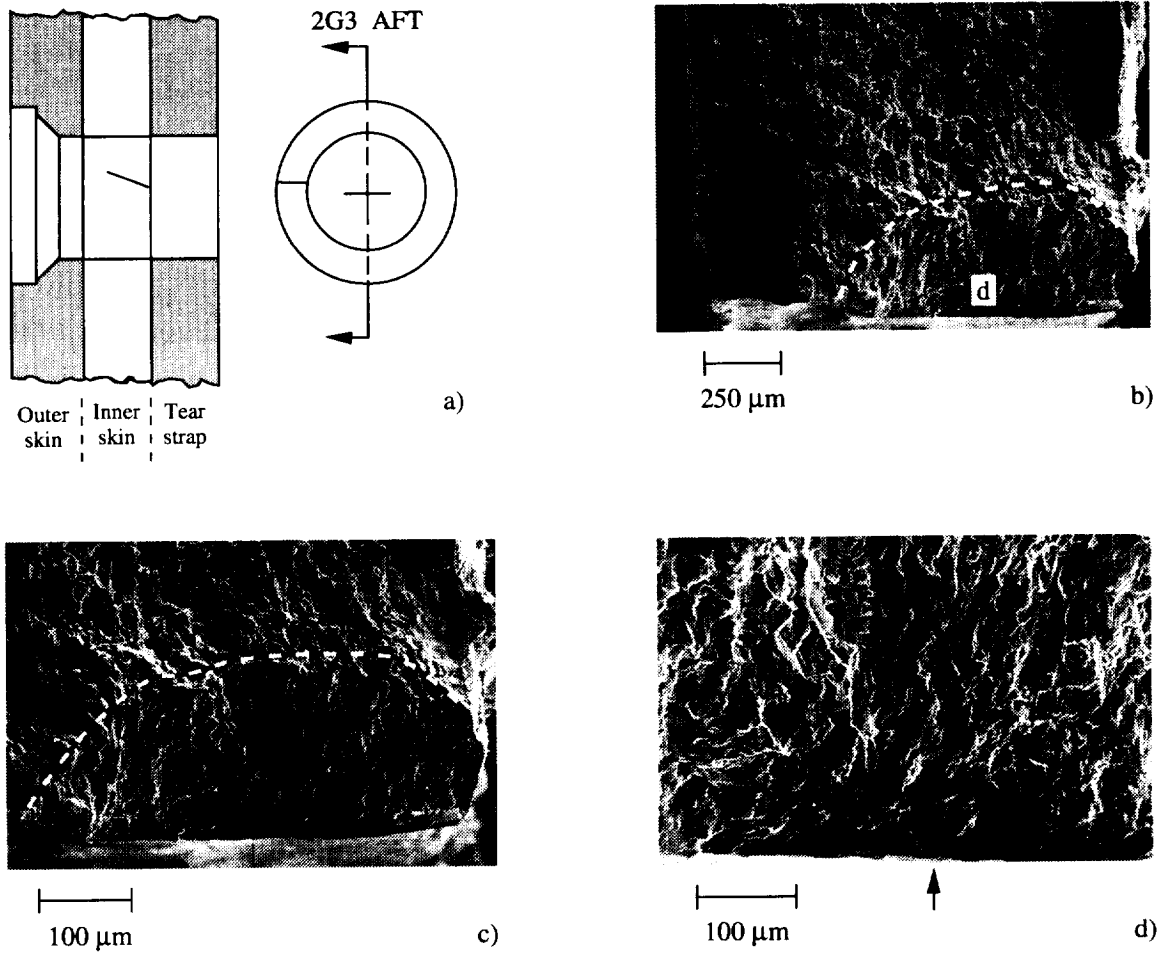
Figure 7.36 a) The schematic shows the rivet hole 2G3 configuration and the location of the inner skin fatigue crack oriented in the aft direction and about the 9 o'clock position. b) The SEM micrograph shows the fatigue crack oriented in the aft direction (bottom of the micrograph). The dashed line marks the fatigue crack front. c) The SEM micrograph shows the fatigue crack surface at higher magnification. The dashed line marks the fatigue crack front. d) The SEM micrograph shows the fatigue crack along the rivet hole inside surface (region "d" in Figure 7.36.b). The arrow marks the likely site of crack initiation.

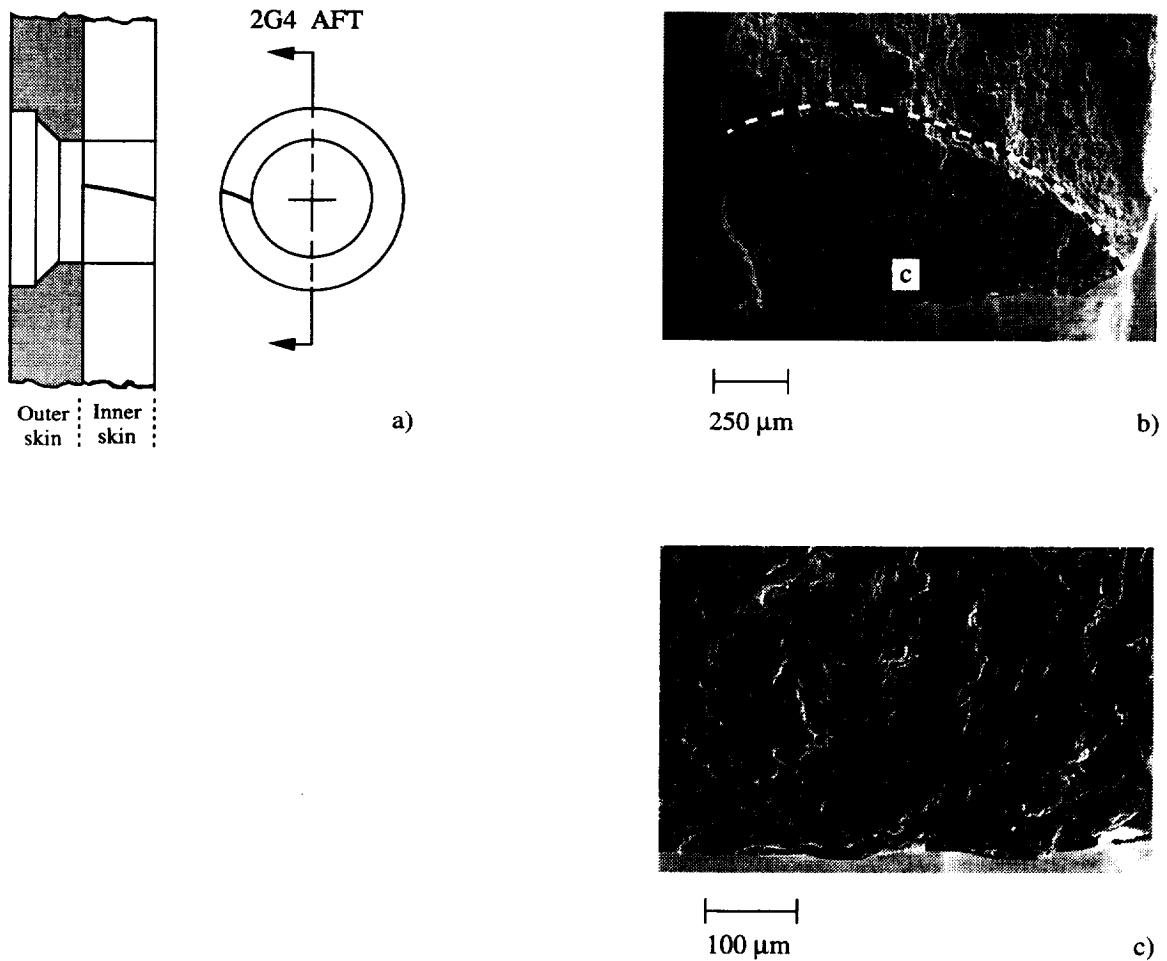
Figure 7.37 a) The schematic shows the rivet hole 2G4 configuration and the location of the inner skin fatigue crack oriented in the aft direction and about the 9 o'clock position. b) The SEM micrograph shows the fatigue crack fracture surface located along the rivet hole (bottom of micrograph). The fatigue crack extends nearly through the thickness of the inner skin. The dashed line marks the fatigue crack front. c) The SEM micrograph shows the rough surface of the rivet hole and the likely site of crack initiation (region "c" in Figure 7.36.b).

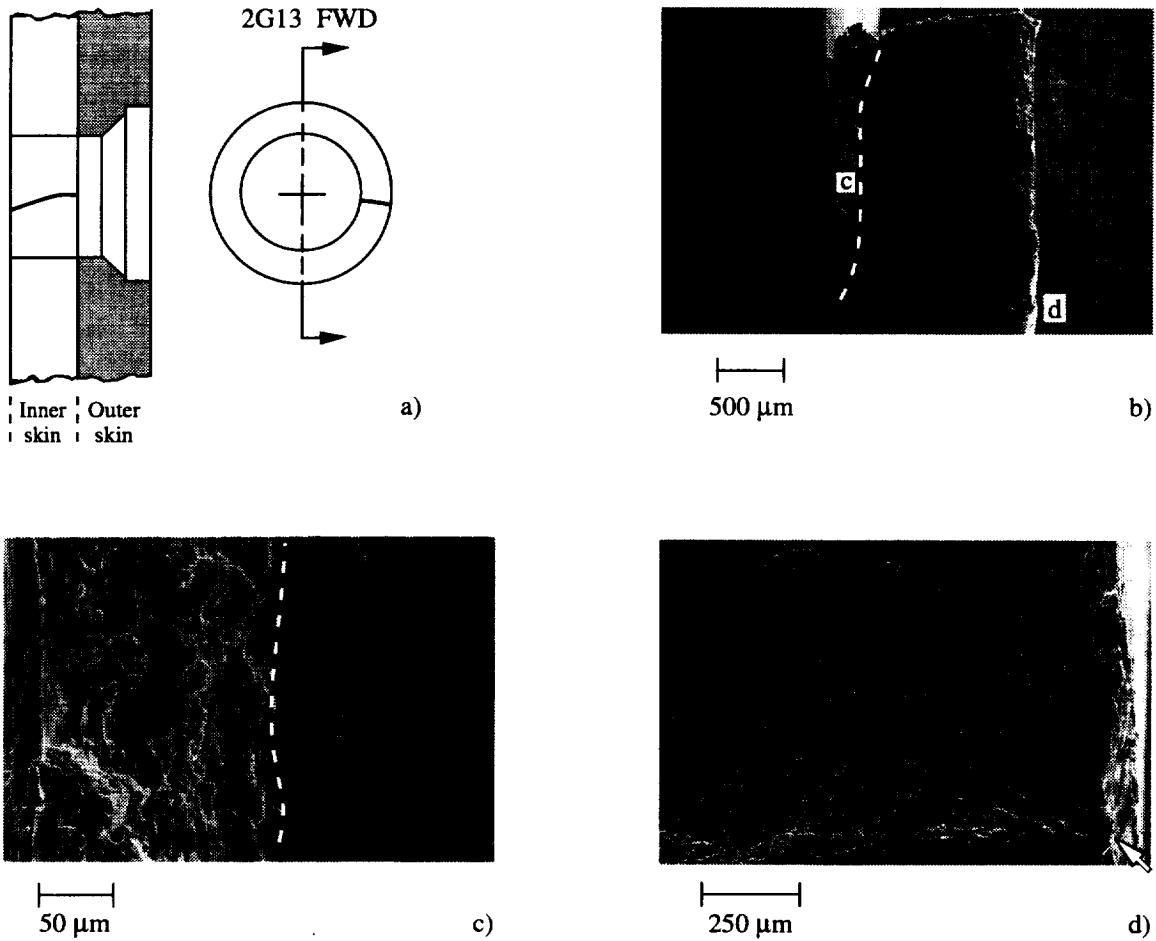
Figure 7.39 a) The schematic shows the rivet hole 2G13 configuration and the location of the inner skin fatigue crack oriented in the forward direction and about the 3 o'clock position. b) The SEM micrograph shows the fatigue crack fracture surface (the direction of crack propagation is from bottom to top of the figure) in the inner skin. The rivet hole is located at the bottom of the micrograph. The fatigue crack was cut during the removal of the specimen from the panel and a portion of the fatigue crack surface is not shown in the figure. The dashed line shows a portion of the fatigue crack front that extends nearly parallel to the inboard surface of the inner skin. c) The SEM micrograph shows the fatigue crack front region (dashed line) at region "c" in Figure 7.39.b. The fatigue fracture surface (right) exhibits a transgranular morphology while the overload fracture (left) exhibits a ductile appearance. d) The SEM micrograph region shows the outboard corner of the rivet hole (region "d" in Figure 7.39.b) at higher magnification. The arrow marks the likely site of crack initiation. The faying surface is located along the right side of the micrograph and the rivet hole is located at the bottom.

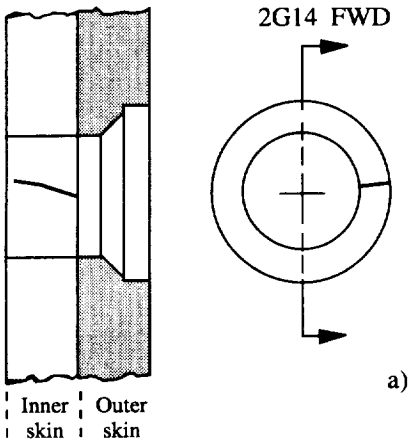
Figure 7.40 a) The schematic shows the rivet hole 2G14 configuration and the location of the inner skin fatigue crack oriented in the forward direction and about the 3 o'clock position. b) The SEM micrograph shows the fatigue crack that grew (the general direction of crack propagation is left to right) from the inner skin rivet hole which is located at the left of the micrograph. The fatigue crack was cut during the removal of the specimen from the panel and a portion of the fatigue crack surface is not shown in the figure. The fatigue crack initiated at the outboard corner of the rivet (bracket) hole at the faying surface (bottom left region of the micrograph).

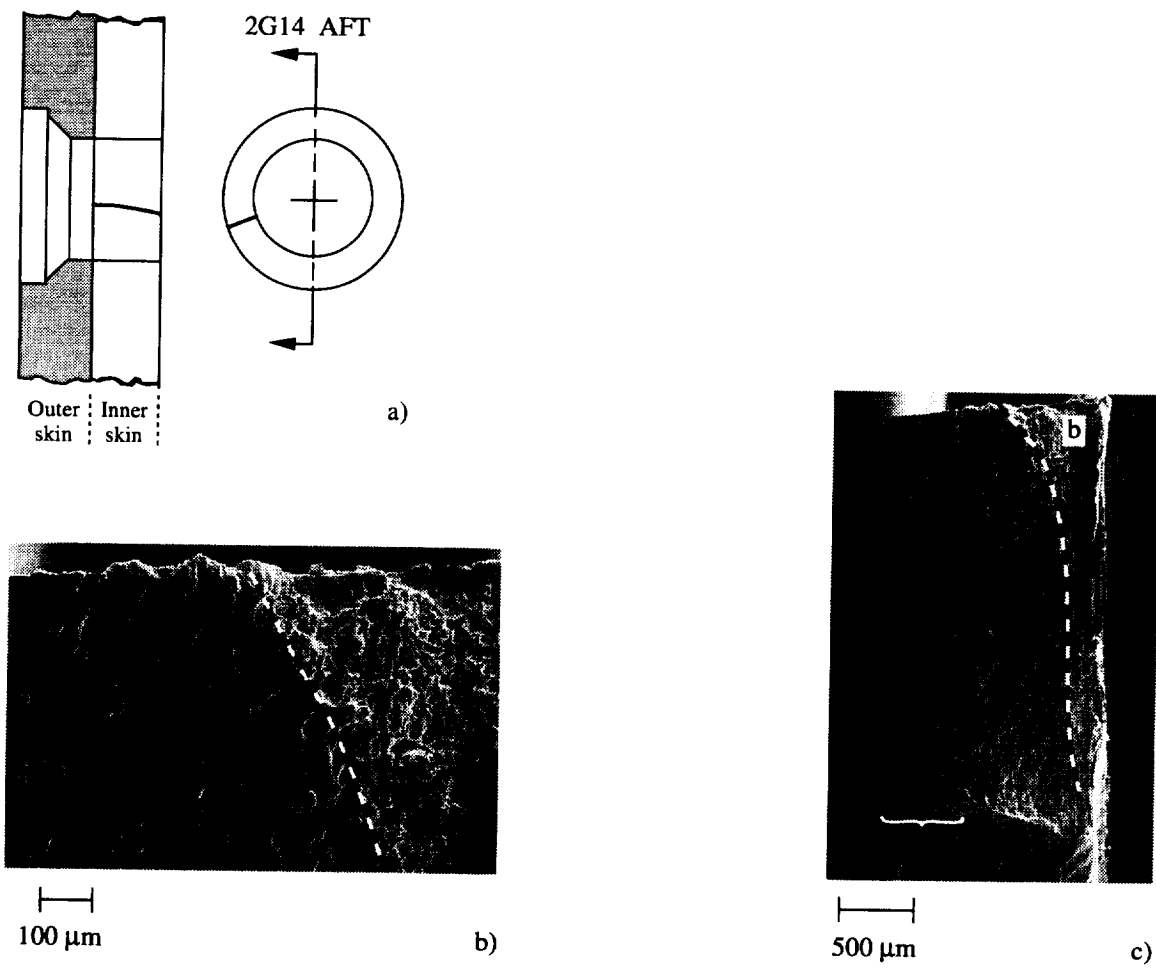
Figure 7.41 a) The schematic shows the rivet hole 2G14 configuration and the location of the inner skin fatigue crack oriented in the aft direction and below the 9 o'clock position. b) The SEM micrograph shows a portion of the fatigue crack front region (dashed line) at region "b" in Figure 7.41.c. The fatigue surface (left of the dashed line) exhibits a transgranular morphology and the overload fracture (right of the dashed line) exhibits a ductile appearance. A small portion of the fatigue crack surface is not shown in the figure. The fatigue crack was inadvertently cut during the removal of the specimen from the panel. c) The SEM micrograph shows the fatigue crack that grew (the direction of crack propagation is from bottom to top of the figure) from the inner skin rivet hole located at the bottom of the micrograph. The dashed line shows the fatigue crack front that extends nearly parallel to the inboard surface of the inner skin. A small portion of the fatigue crack surface is not shown in the figure. A bracket marks the fatigue crack initiation region.

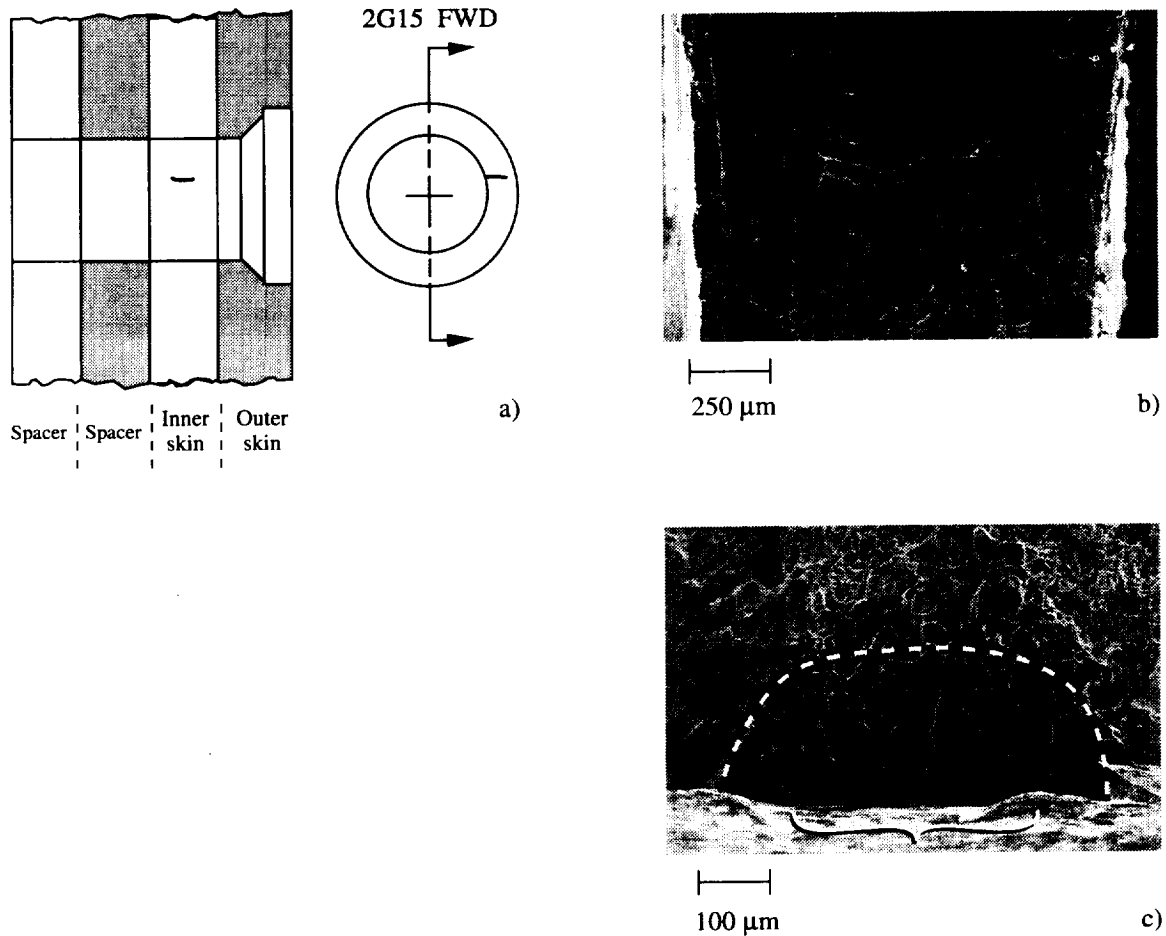
Figure 7.42 a) The schematic shows the rivet hole 2G15 configuration and the location of the inner skin fatigue crack oriented in the forward direction and above the 3 o'clock position. b) The SEM micrograph shows the partially opened surface crack on the inside diameter of the inner skin rivet hole. The fatigue crack was partially opened by the straining operation prior to breaking the specimen c) The SEM micrograph shows the surface fatigue crack extending from the rivet hole after the specimen was fractured. The dashed line marks the fatigue crack front. The crack initiated at multiple sites along the irregular surface of the rivet hole followed by cracks coalescing to form the single non semicircular fatigue crack. The bracket marks the region of crack initiation.

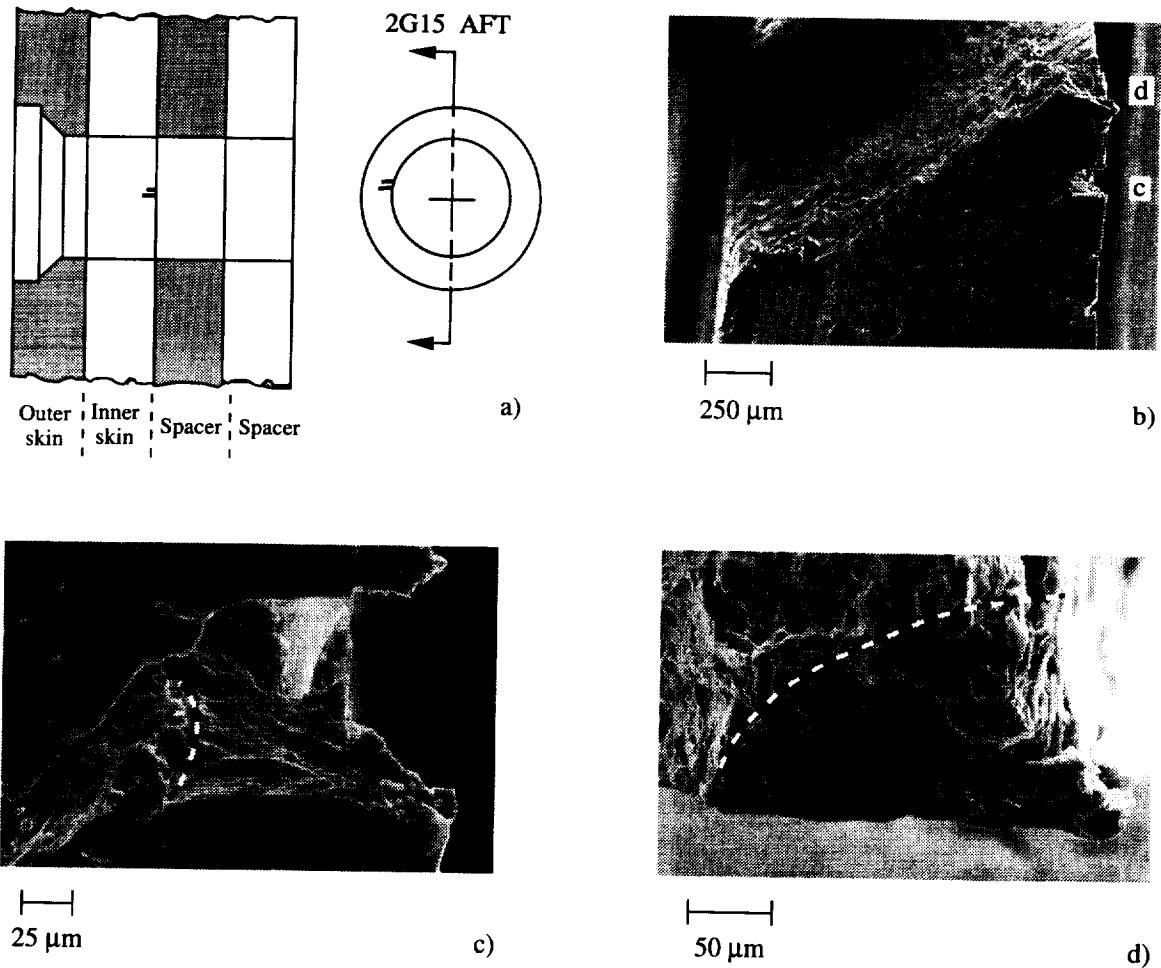
Figure 7.43 a) The schematic shows the rivet hole 2G15 configuration and the location of the inner skin fatigue crack oriented in the aft direction and about the 9 o'clock position. b) The SEM micrograph shows the rivet hole surface that has been partially fractured during the straining operation. Two fatigue cracks are noted at "c" and "d" along the outboard corner. c) The SEM micrograph shows the partially opened corner fatigue crack at region "c" in Figure 7.43.b. The dashed line marks the fatigue crack front. d) The SEM micrograph shows the corner fatigue crack at region "d" in Figure 7.43.b). The dashed line marks the fatigue crack front. The crack initiated at the burr on the corner.

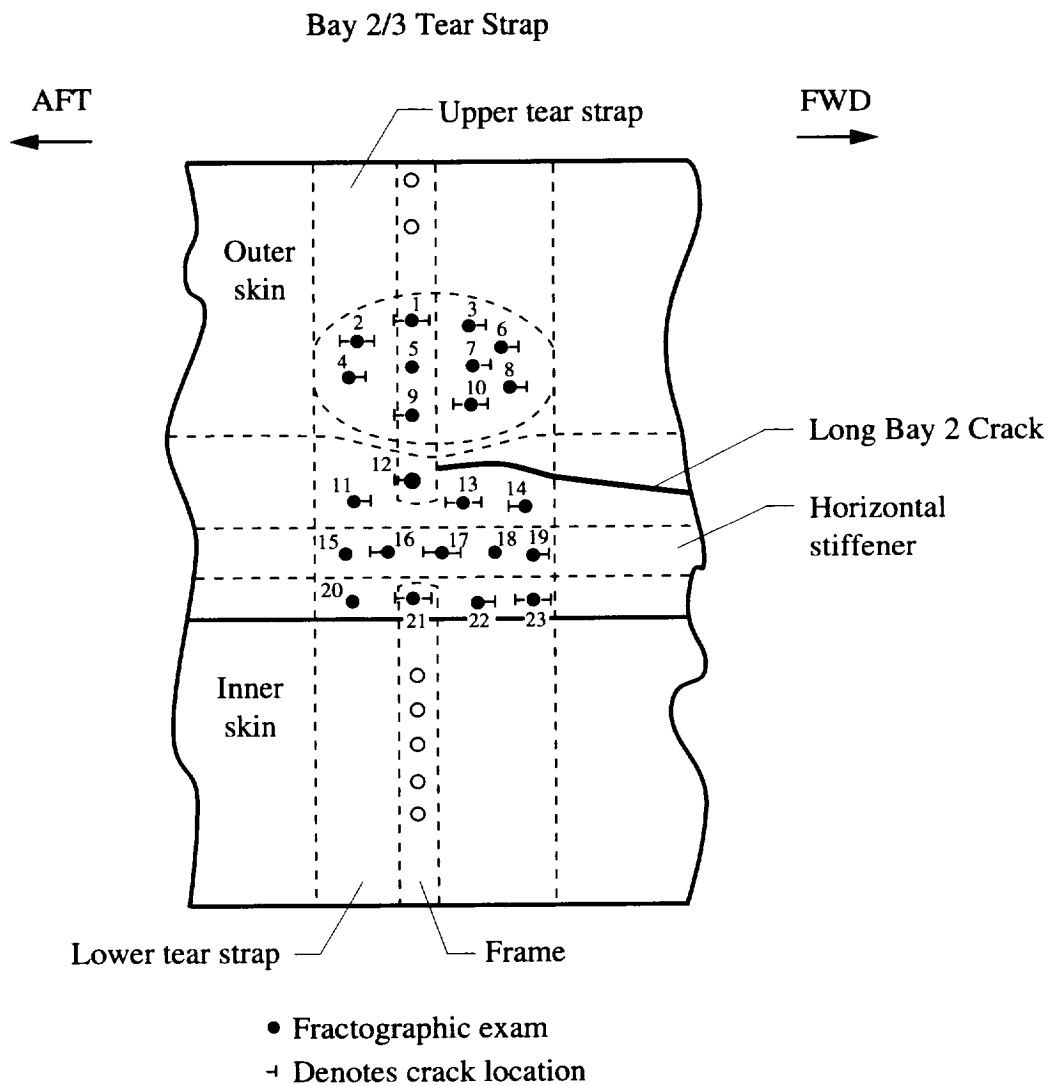
Figure 8.1 The schematic shows the location of all fatigue cracks found in the bay 2/3 tear strap by destructive examination. The solid dark line depicts one end of the long bay 2 crack extending into the tear strap.
